Architectural Recording
at
Poplar Farm
Stow Park Road
Marton near Gainsborough
Lincolnshire

Watching Brief Report Number: 1355

June 2013

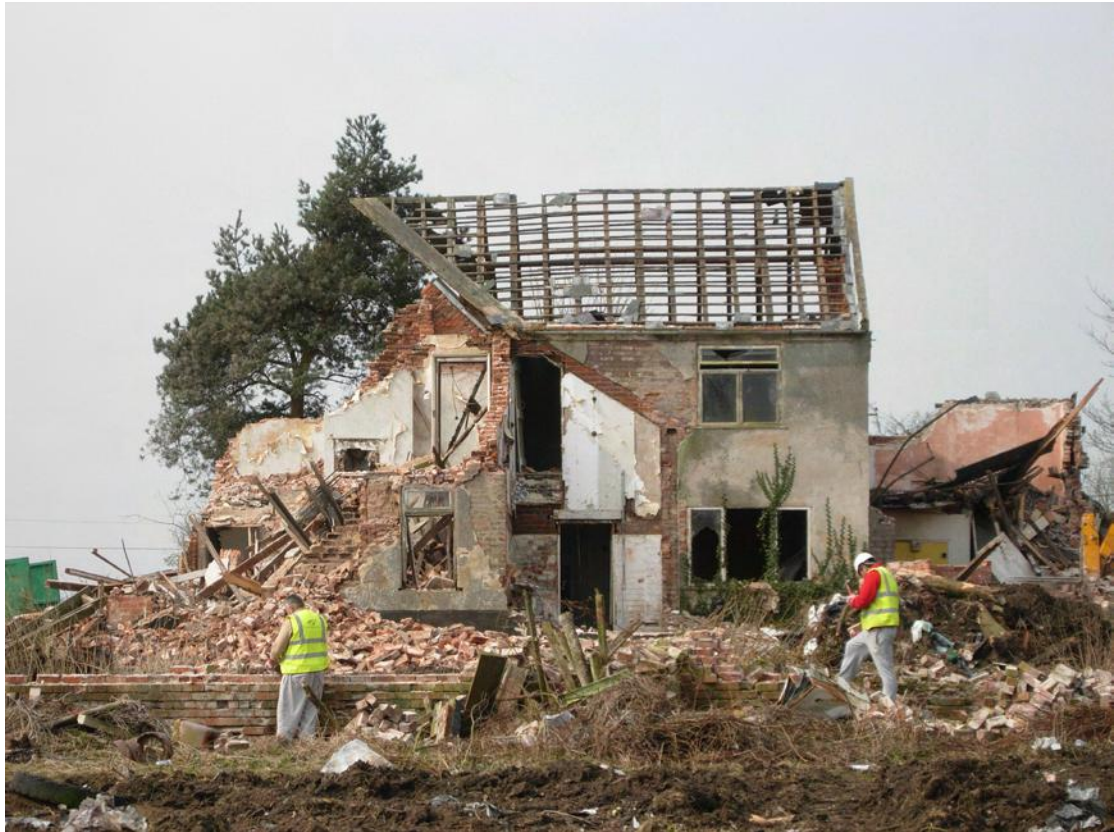
This was located a little to the south-west of the other farm buildings that are described and discussed below. Unfortunately, demolition of the farmhouse had commenced prior to HFA involvement in recording the site and close inspection of what remained of the house was not possible on health and safety grounds (Plate 1). The house would appear to have been contemporaneous with the nearby complex of farm buildings, i.e. dating to the late nineteenth century, and this is suggested by the Ordnance Survey map evidence (see above).

Plate 1 The farmhouse viewed from the east

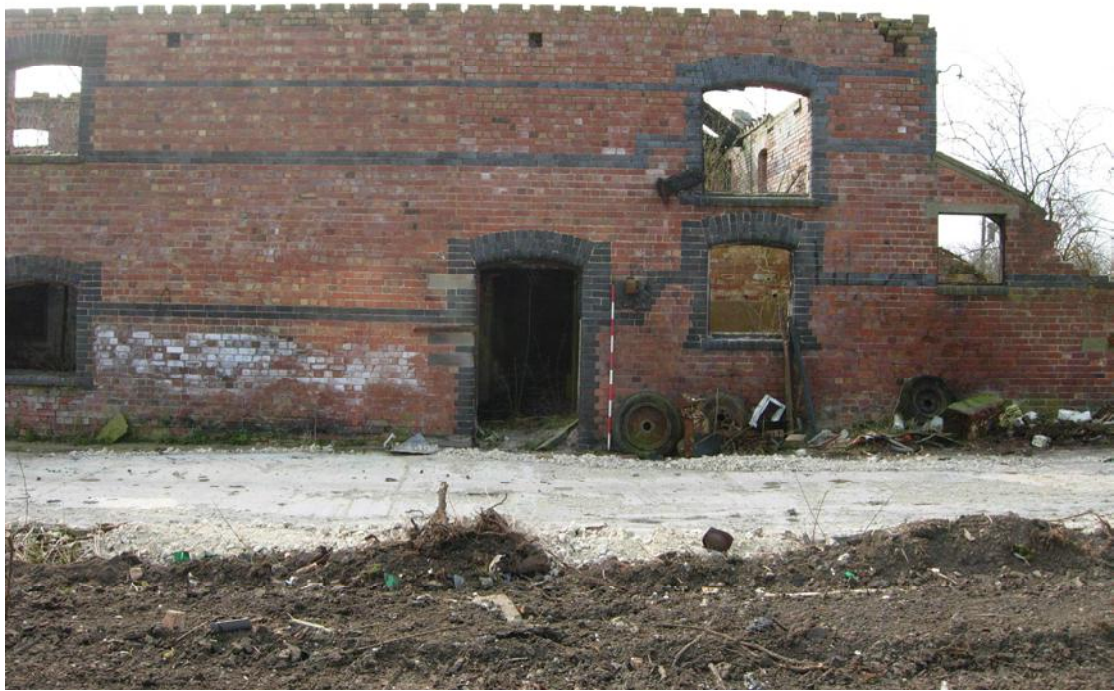
Throughout the northern elevation of this range the courses of orange-red brick were laid in English bond, with this brickwork being broken up by two double string courses of Staffordshire blues and a single course of the latter (Plates 3-5). All the doors and windows had surrounds of Staffordshire blue brick, with reveals, soffits and sills being typically of bullnosed brick. Within the central portion of the elevation there was a staircase leading up to first-floor level (Plate 4) and the steps were of dressed sandstone.

Plate 3 The western part of the north range viewed from the north-west (2m scale)

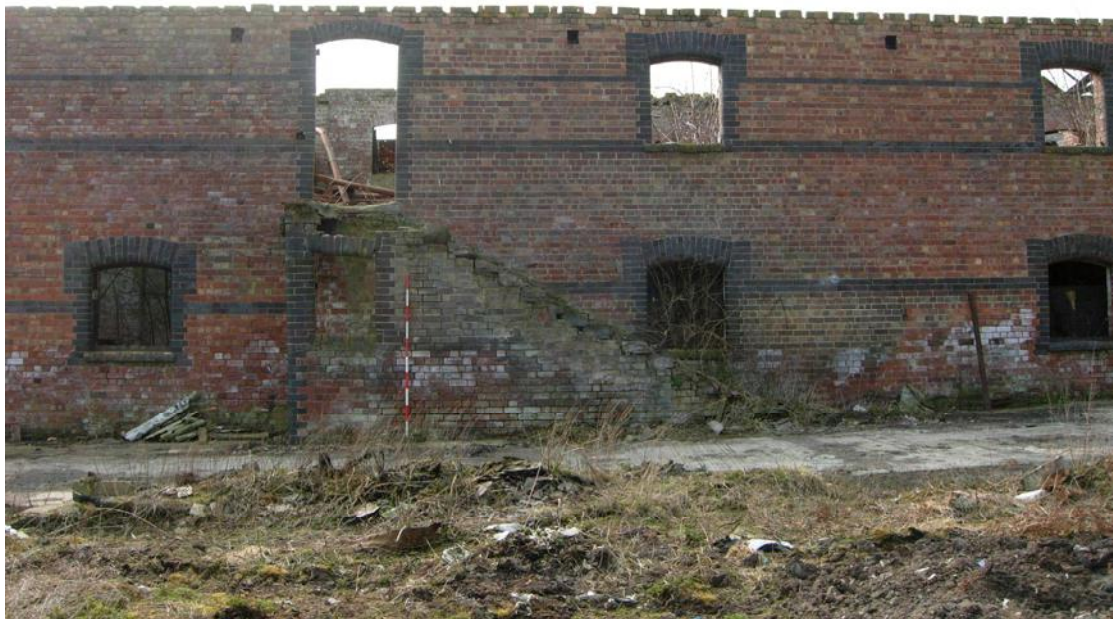
Plate 4 The central part of the north range (2m scale)

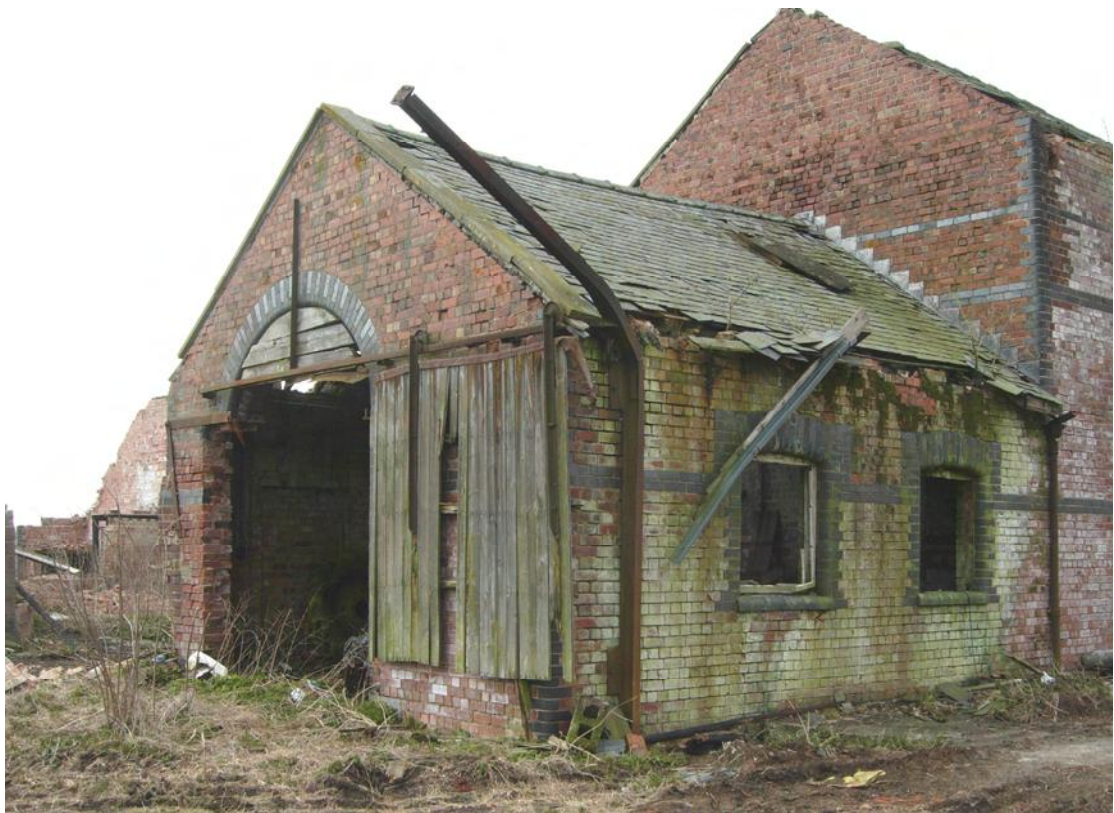
At the eastern end of the north range there was a single-storey shed that had most likely been built and used primarily as an engine house (Plates 6 and 7). Like the two-storey building, this had been built predominantly of orange-red brick laid in English bond. The lower of the double string courses noted above for the two-storey block continued around the northern and eastern side of the building. The gable end of the building had a large entrance with a semi-circular arch of Staffordshire blue brick. The entrance was shut by means of a part-extant sliding door and the gable was surmounted by coping stones of dressed sandstone, the roof being covered in slate.

Plate 6 The engine house at the east end of the north range

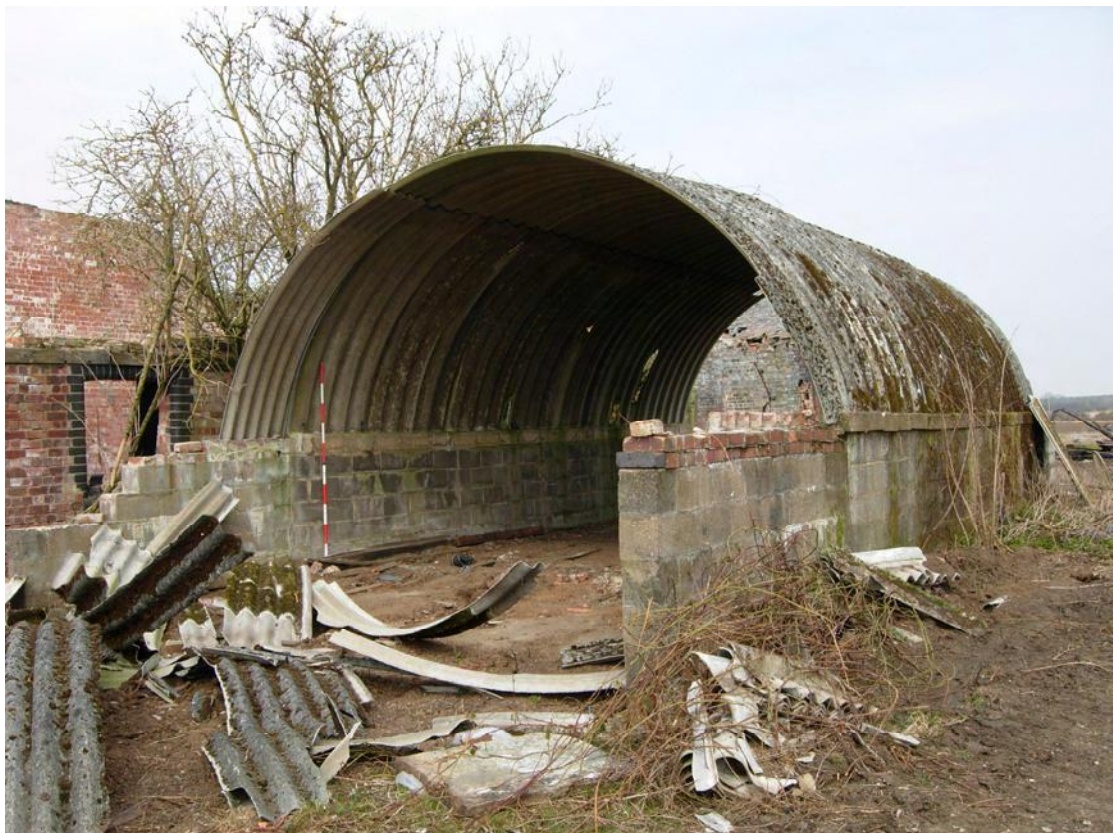
Immediately to the east of the crew yard buildings there was a breeze block and corrugated asbestos shed of modern origin (Plate 8).

Plate 8 The corrugated asbestos shelter to the east of the other farm buildings (2m scale)

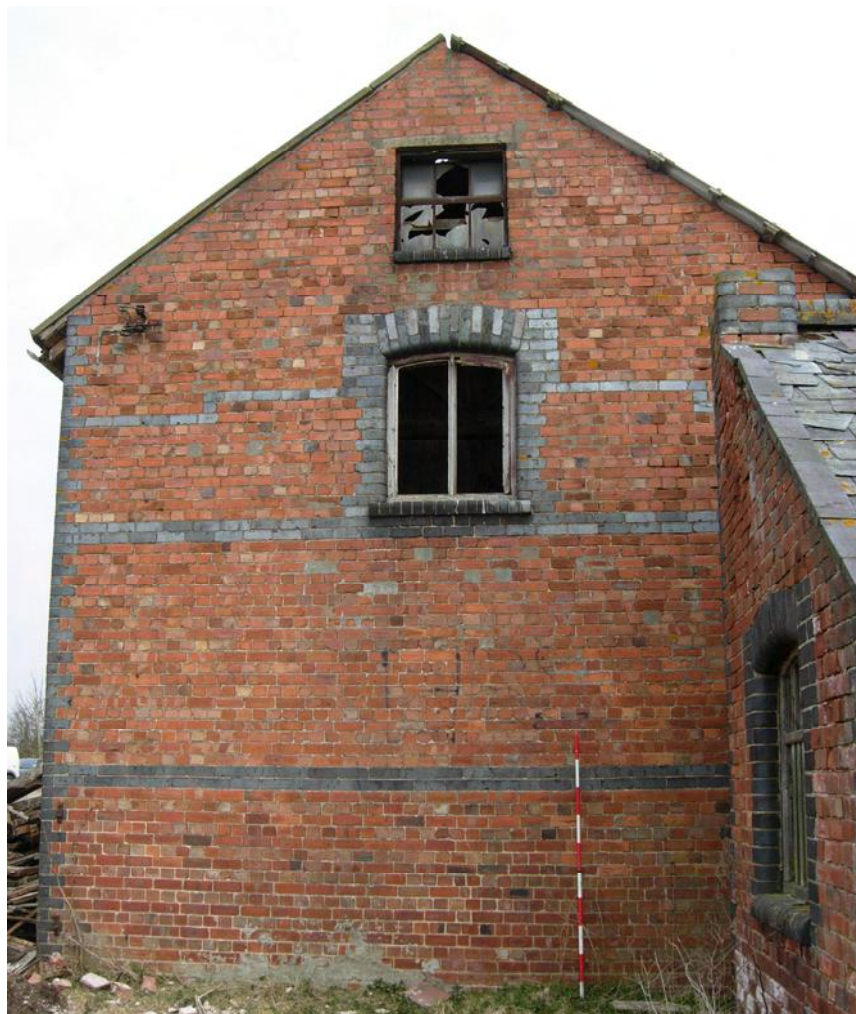
The south elevation had a window high up in its gable that departed from the pattern of others throughout the buildings in having a concrete lintel, though retaining the usual sill of bullnose Staffordshire blue bricks (Plate 12).

Plate 12 The south elevation of the west range (2m scale)

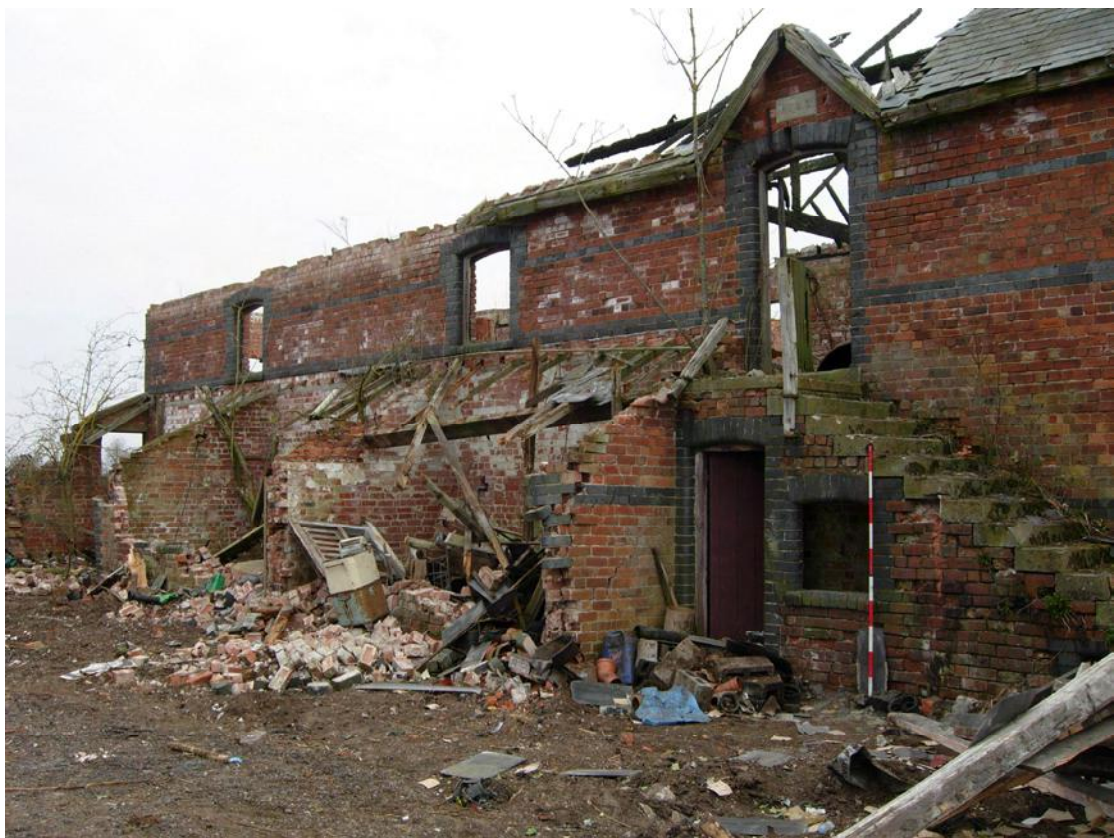
Against the north part of the elevation there were the remnants of a long lean-to structure that had been subdivided into four compartments (Plate 14). This lean-to structure appeared contemporaneous with and of the same brick design as the rest of the west range.

Plate 14 The northern portion of the west range (2m scale)

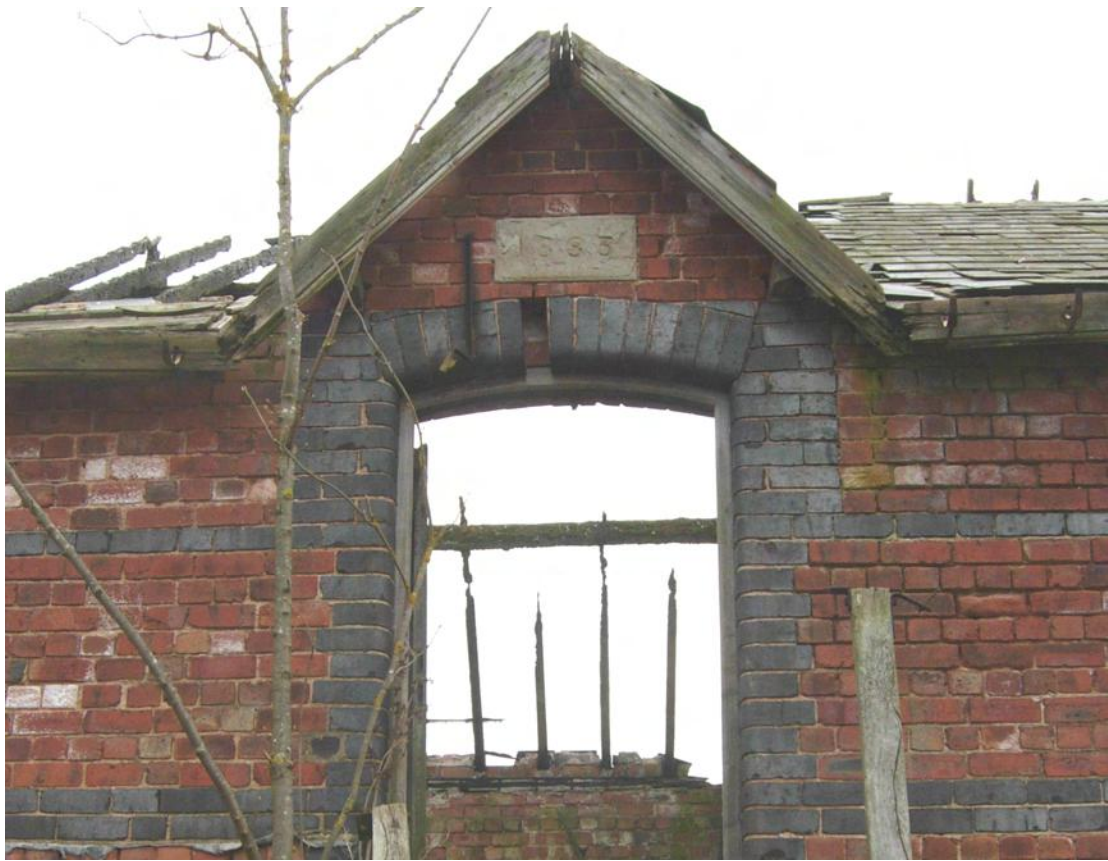
The west elevation had a centrally placed staircase with steps of dressed sandstone that was very similar to that in the north range (Plates 13 and 14). These steps lead up to a first-floor entrance that was surmounted by a gablet under which there was a simple date stone carrying the inscription '1883' (Plate 15).

Plate 15 Date stone (1883) over the central portion of the west range

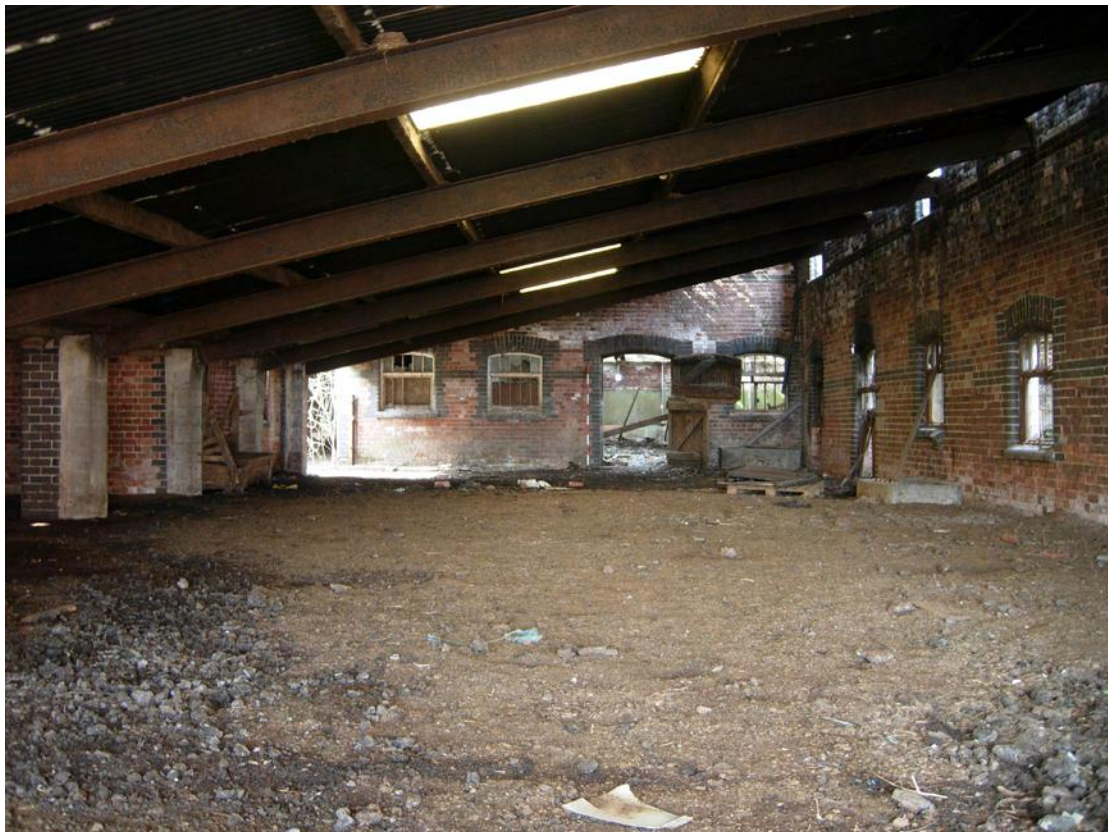
This had been covered at some time between 1956 and 1981 by a corrugated asbestos roof with a steep north-south fall. The 1980-81 Ordnance Survey map was the first to show the farm buildings without an open crew yard. The roof was supported by a series of RSJs running north to south, the southern ends of the RSJs being supported by additional breeze block built piers, or breeze block extensions to original Staffordshire blue brick piers (Plates 16 and 18).

Plate 16 The crew yard viewed from the east (2m scale)

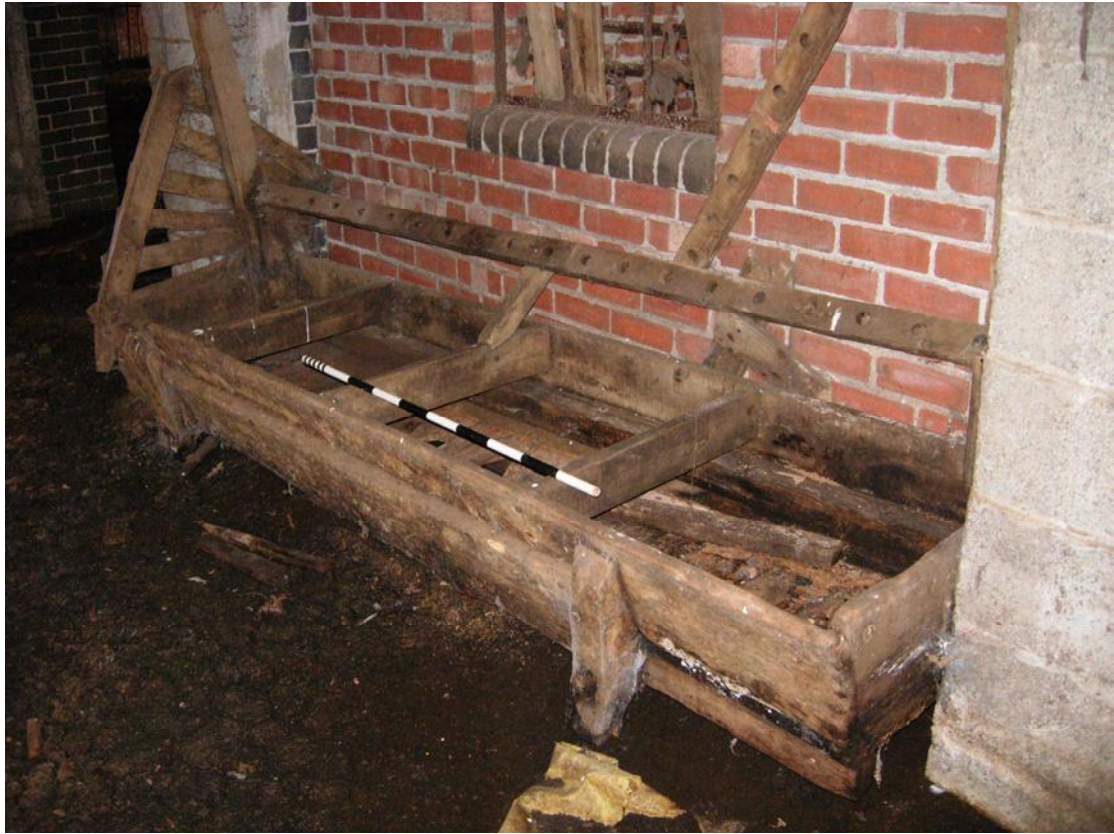
On the south side of the crew yard and adjacent to the calf house there was a timber trough that appeared to date back to the late nineteenth or early twentieth century (Plates 18 and 19).

Plate 19 Wooden feeding trough or manger (1m scale)

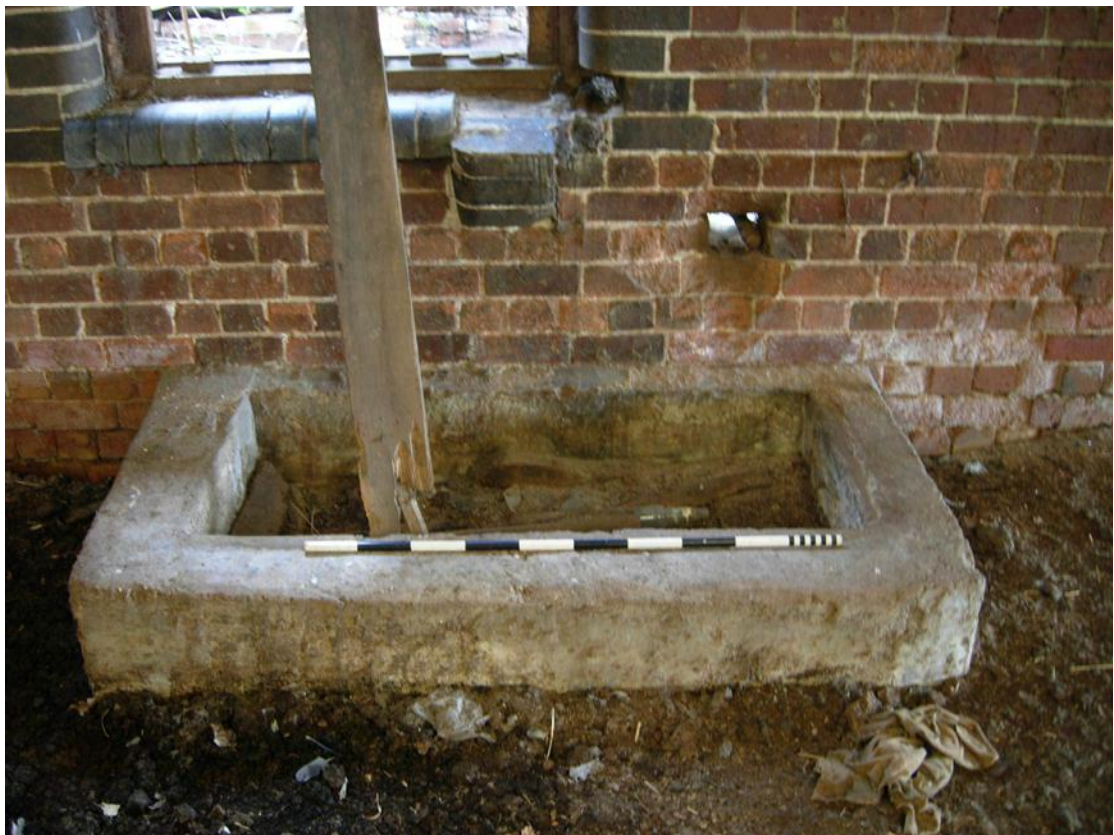
On the north side of the crew yard there was a stone pump trough that might also have dated back to the original build (Plates 17 and 20).

Plate 20 Stone pump trough (1m scale)

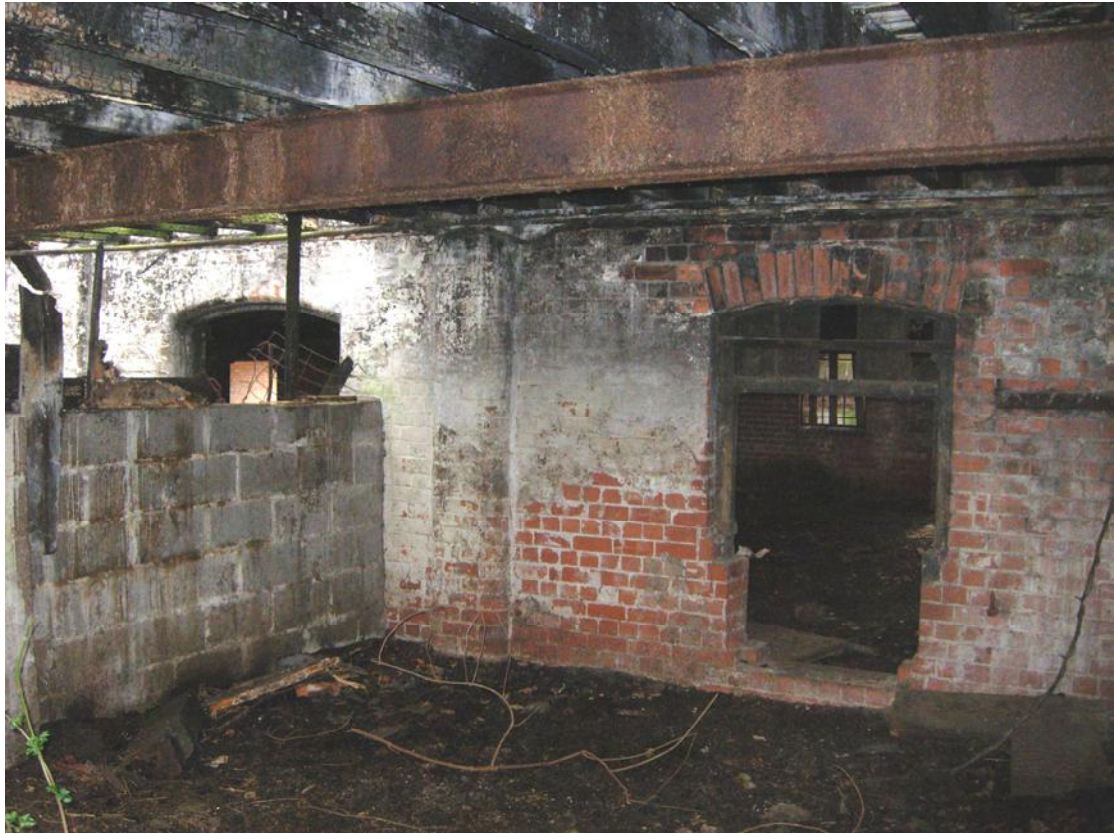
This was by far and away the largest space within the two-storey north range. Due to a fire having caused very serious damage within it, access was quite restricted. A single RSJ ran east to west along the western part of the room. This supported joists that appeared, where not completely destroyed by fire, to have been laterally stiffened by herringbone struts or cross-nogging (see Plate 24 for an illustration of such an arrangement from another room). This would have been used to stop the long thin joists from deforming under heavy loading (Brunskill 1989, 181). In the eastern portion of the room what appeared to be an inverted 'L'-section steel joist was supported by a series of square section wooden posts, though severe damage here prohibited closer inspection.

Plate 21 The interior of the western part (room 1) of the north range

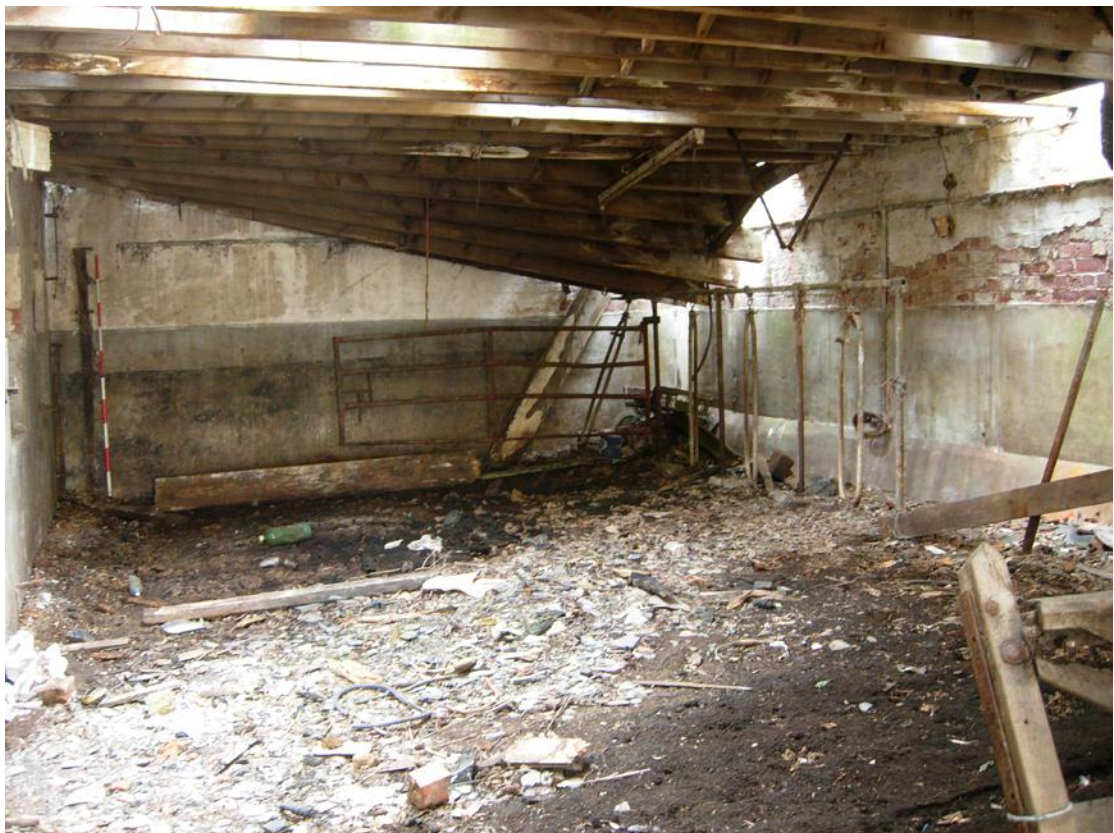
The presence of rendered walls and substantial lengths of pipe-work (Plate 22), suggested that this room would have been used as a milking parlour or shed – perhaps having been converted from its original role. This room again had had herringbone strutting between its joists.

Plate 22 Cow house/milking shed (room 3) viewed from the north (2m scale)

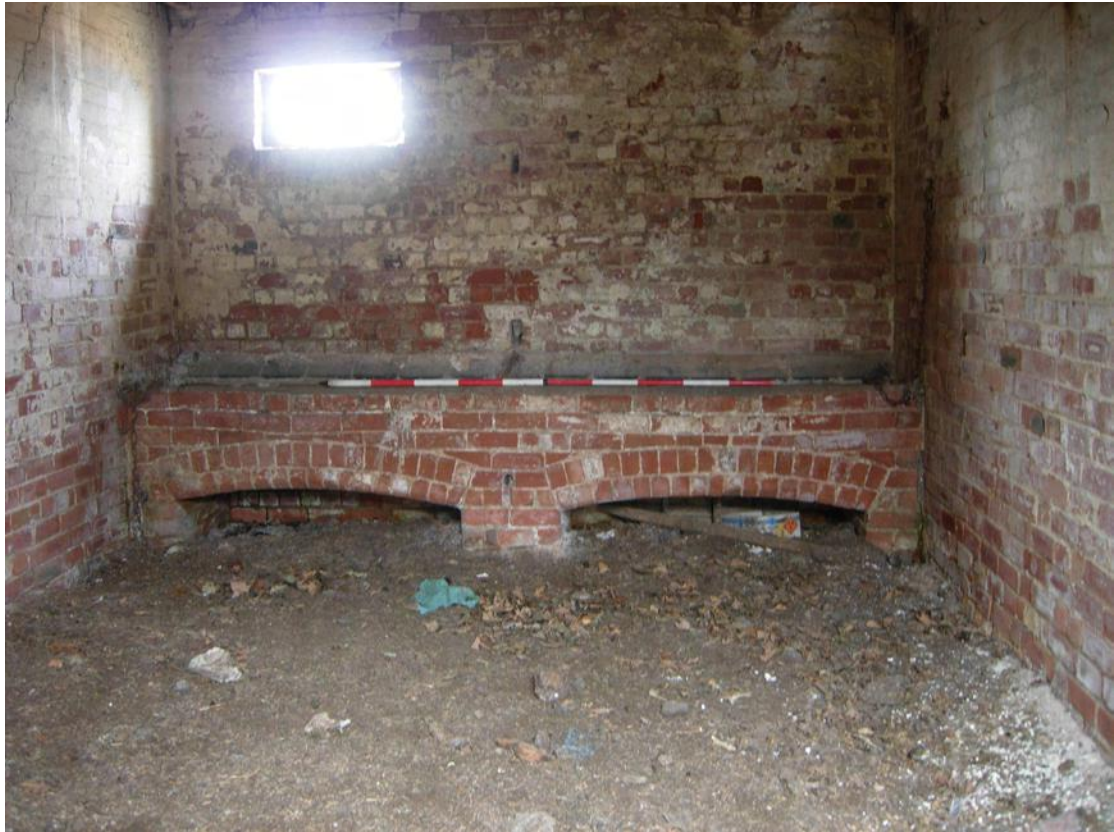
The brick-built manger (Plate 23) had arched openings below to accommodate the built up of litter and waste (Brett 2004, 15). There was herringbone strutting between the joists (Plate 24).

Plate 23 Loose box (room 4) with brick manger (2m scale)

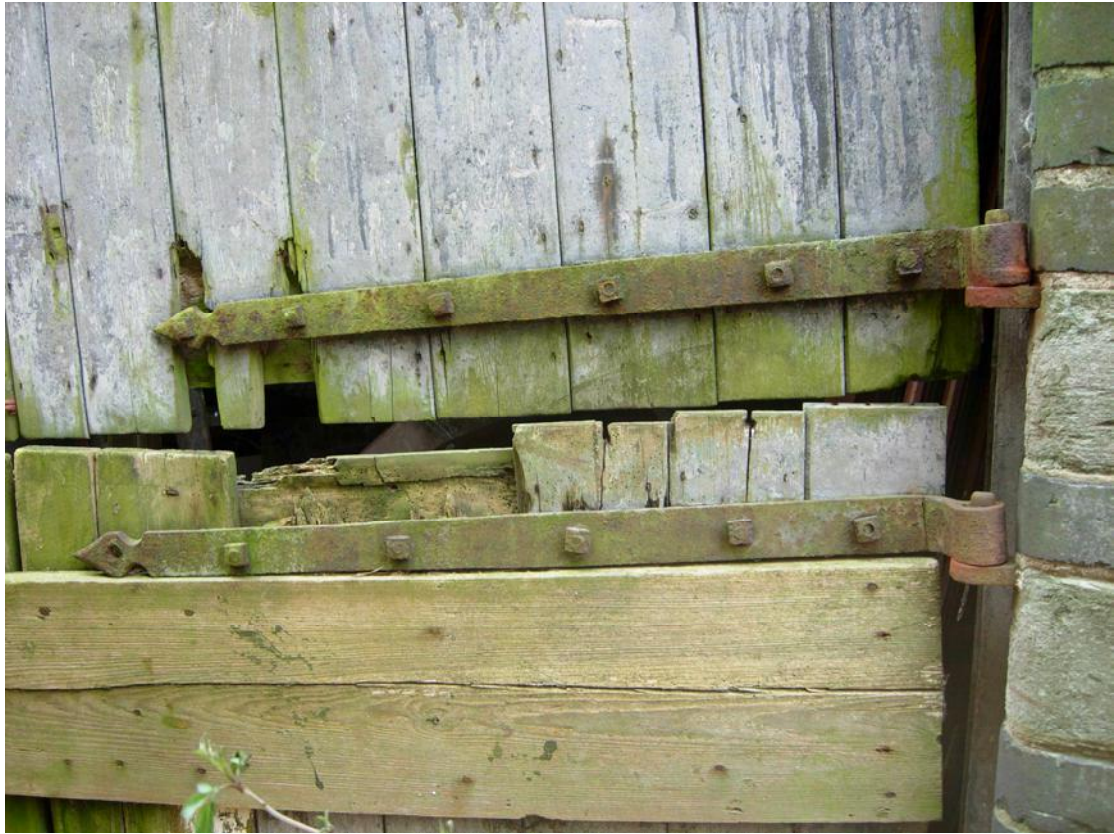
This loose box was filled with scrap material and so little could be seen of the interior. Herringbone strutting was again in evidence. The heck doors were affixed by wrought iron strap hinges decorated with spear finials and were doubtless of later 19th century date (Plate 25).

Plate 25 Detail of the iron straps on the heck doors of one of the loose boxes (room 5)

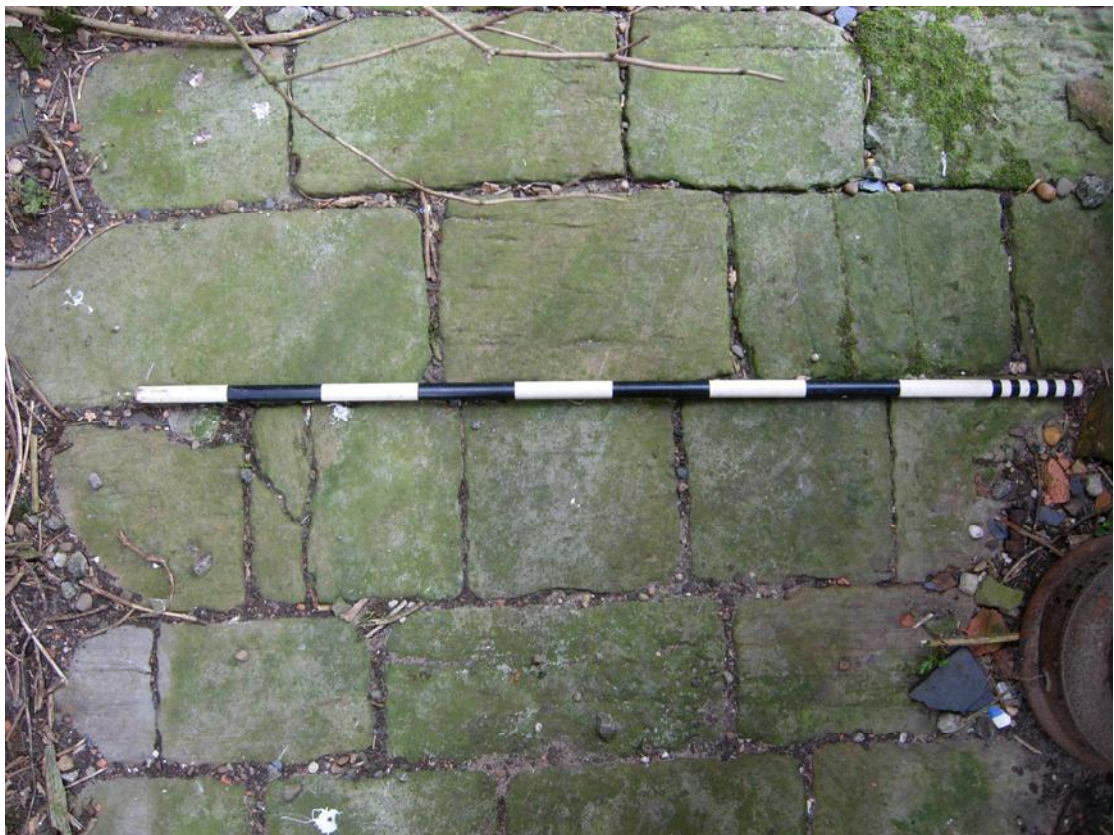
The passageway between the loose boxes and the calf house was surfaced in sandstone setts (Plate 26). These appear to be contemporary with the farm buildings.

Plate 26 Detail of the stone setts in the passageway between the calf house (?) and the loose boxes (1m scale)

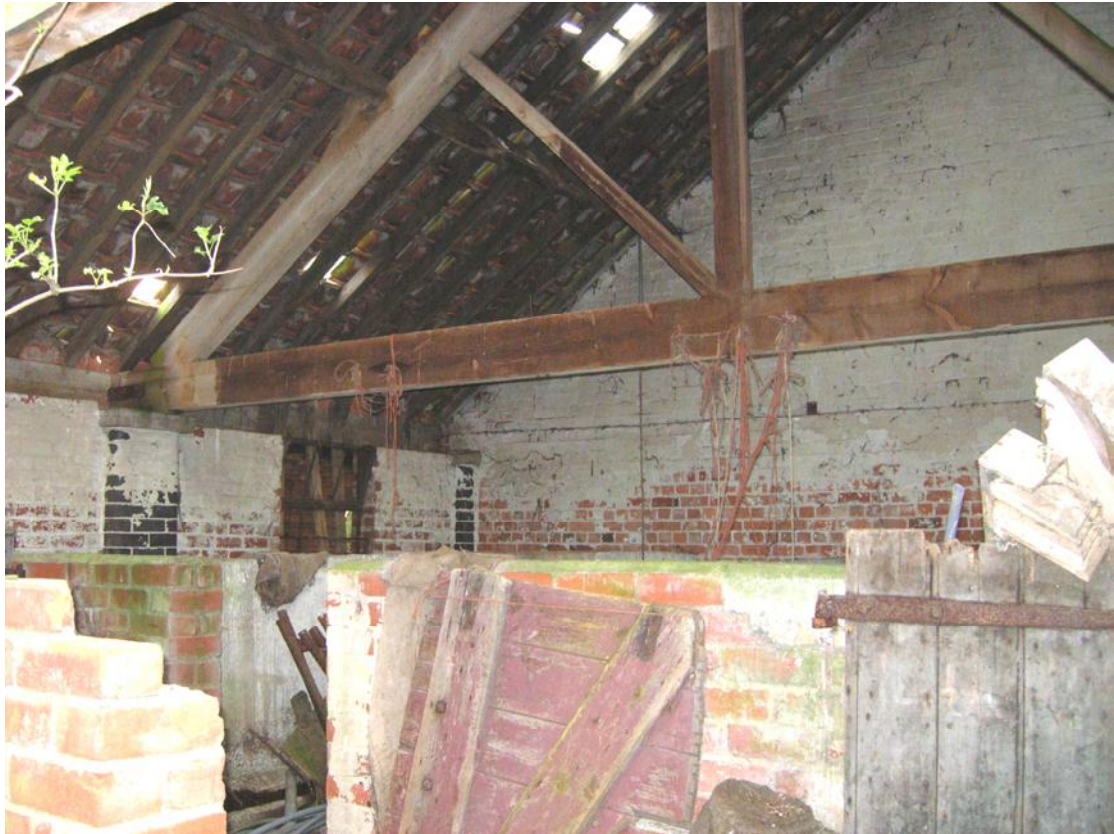
This building was divided in two, with each division being further subdivided by brick partitions into a series of stalls (Plate 27). Each brick partition was around 1.5m high. Close inspection of the stalls was not possible due to the accumulation of scrap and demolition debris, but the building may have functioned as a calf house, though it might also have been a piggery. The roof had intermediate support by means of a single north to south running queen-post and raking strut truss.

Plate 27 The north part of the calf house (?) (room 6)

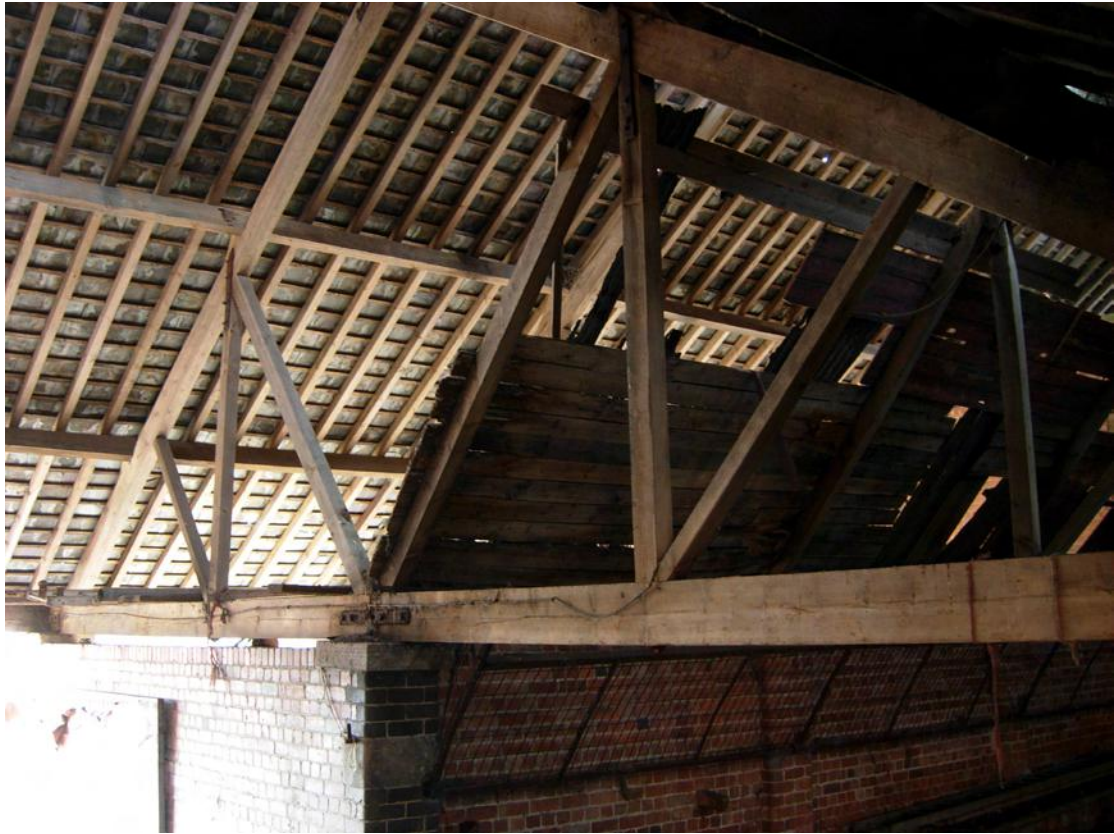
The roof was supported by three north to south running wooden trusses with queen-posts and raking struts (Plate 29). These trusses appeared to be of 20th-century rather than 19th-century date. At their northern and southern ends the trusses rested on piers built of Staffordshire blue brick (Plates 10 and 18). A whole series of boards had been laid along the struts lying immediately above the wall separating the inner and outer parts of the shed (Plate 29). This presumably had been done to protect the fodder from driving rain coming into the shed from the south.

Plate 29 Queen-post and raking strut truss along the west side of the crew yard ramp

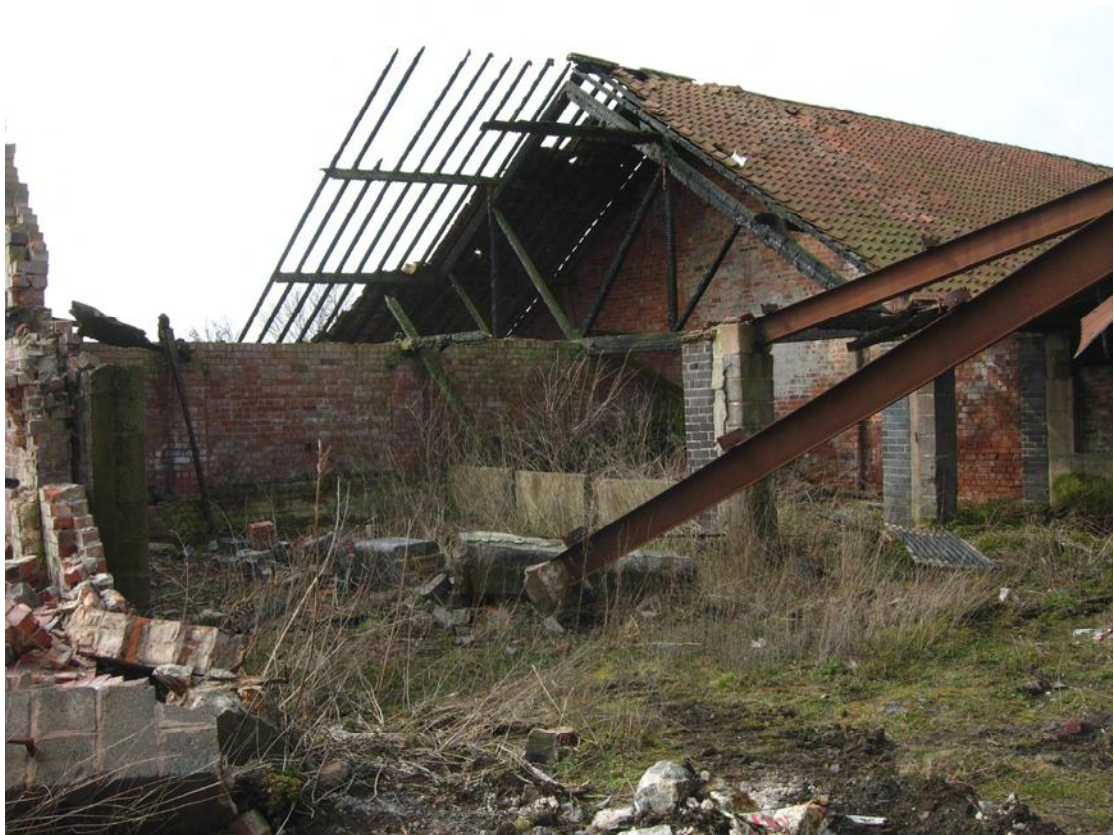
The easternmost shed had been very badly damaged by fire and the roof largely demolished, but enough remained to see that it would have been almost a mirror image of the one to the west (Plate 30).

Plate 30 The largely destroyed south-east part of the farm complex viewed from the north-east

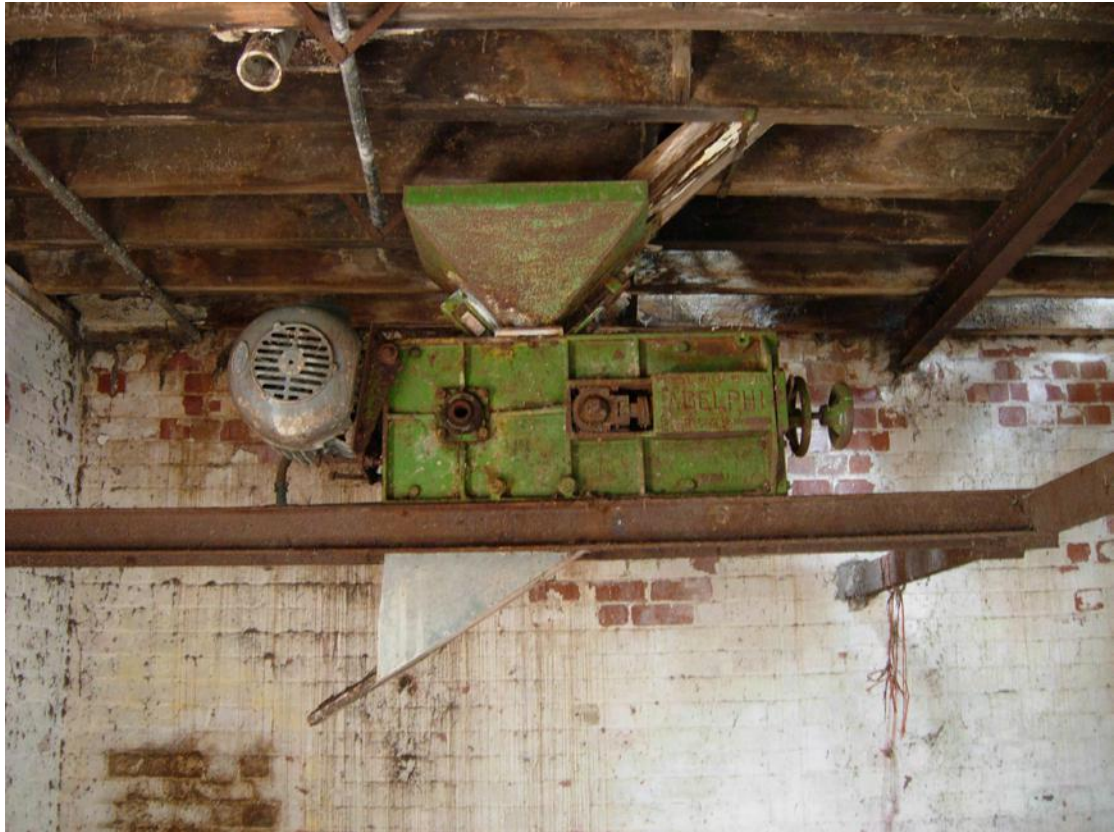
As in room 9 the floor above was supported by a single east to west running RSJ that supported joists with herringbone strutting. A single centrally placed cast-iron column supported the RSJ. There was a further framework of RSJs that supported a feed processing or milling machine (Figure 3 and Plate 31). This would have processed grain from the granary above to produce animal feed. The extant machine had clearly been powered by an electric motor and was inscribed with the single word 'ADELPHI'. Originally there would presumably have been a belt driven machine powered by the engine located in room 11 (see below).

Plate 31 Feed processing machinery in room 10

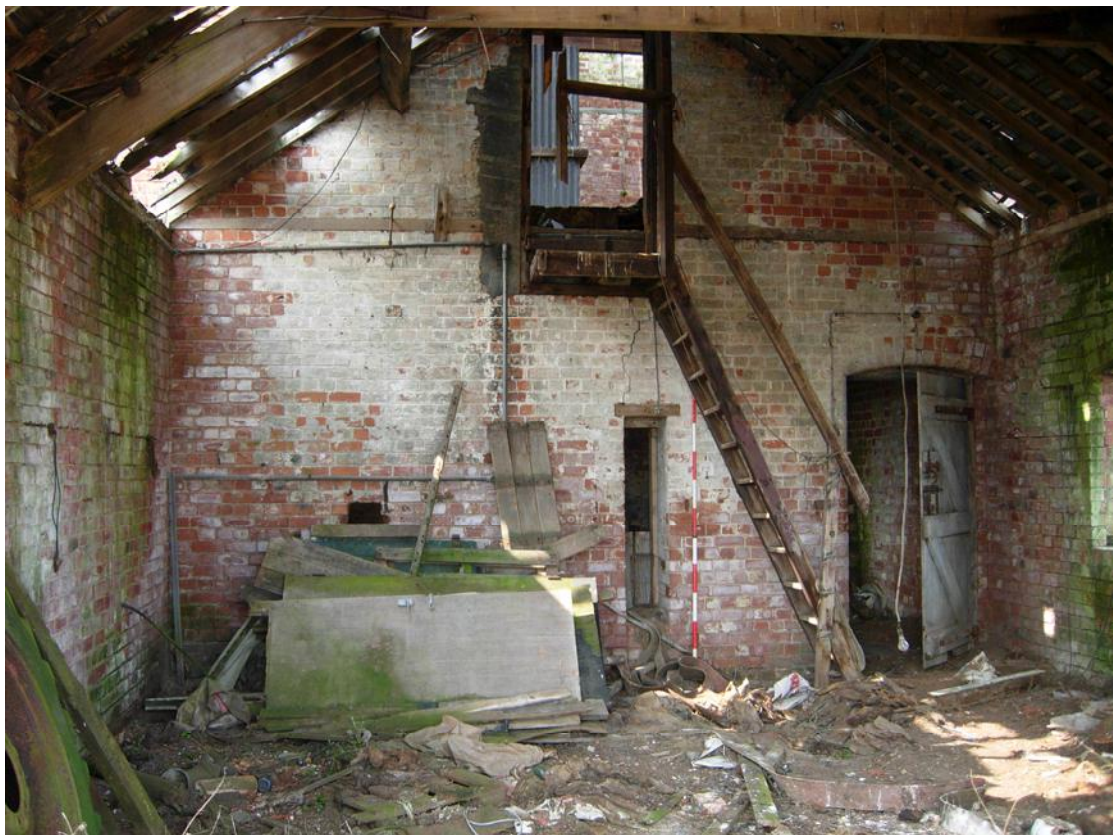
Aside from the external appearance of the building, one feature above all others indicated that this had been an engine shed and this was the transmission slot in the west wall of the building, immediately below the staircase leading to the first floor (Plate 32). A belt from the engine would have run through to room 10.

Plate 32 The engine house (room 11) viewed from the east (2m scale). Note the vertical transmission slot beneath the staircase
