Archaeological Observation
Investigation and Recording
at
122 Strensall Road
Huntington
York

Planning Reference: 06/01020/FUL National Grid Reference: SE 6027 5713 Site Code: WB2006.072

Watching Brief Report Number: 946 August 2007

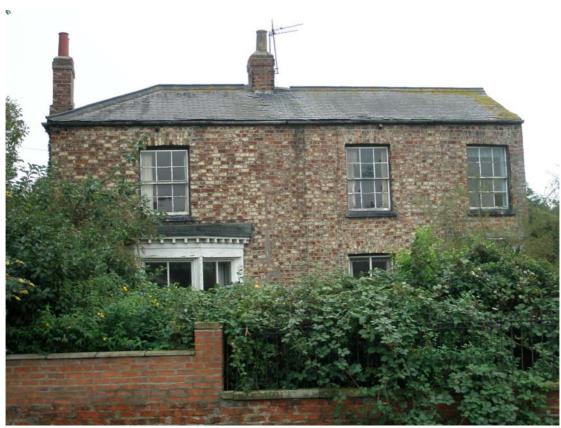
Plate 1 The farmhouse (Ilford House), west elevation

This was the principal elevation of the house, facing as it did the main road. All the brickwork was laid in Flemish Bond and there was a straight joint running from ground to eaves level, which appeared to have been repaired with brick 'stitching' in recent years. The straight joint was located a little to the south of the bay window (*Figure 3, Plate 1*), and its significance will be discussed later.

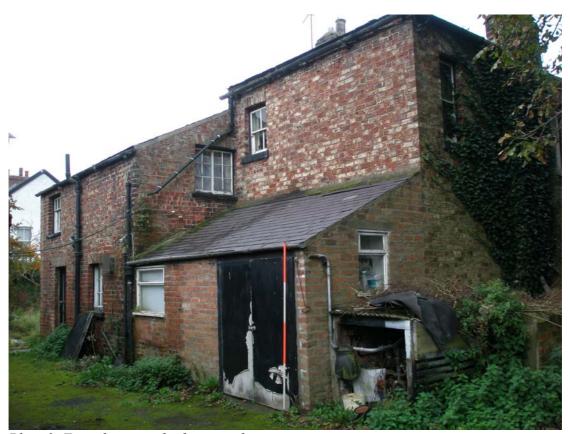
Plate 2 East elevation, looking south-west

The brick was laid in a more irregular English Garden Wall Bond (up to seven courses of stretchers to each of headers) (*Plate 2*). The single storey modern extension will not be mentioned further. The ground floor contained the back door to the property and a single 12-pane Yorkshire, or horizontal, sash with a crude brick lintel comprising a single soldier course.

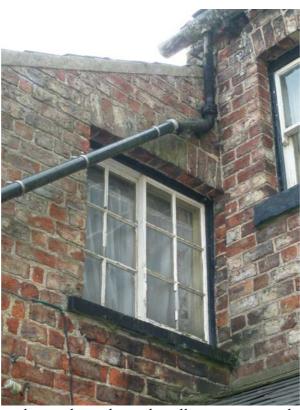
There were three first-floor windows, one of which was in the north facing part of this elevation, and which will be considered shortly. The window above the door was a 12-pane sash (4-panes over 8-panes rather than the classic '6-over-6'), and the north window was a 4-pane sash. The window in the north facing portion was a 12-pane Yorkshire sash, the brick lintel and west reveal of which was slightly obscured by the east of wall of the northern portion of the property (*Plate 3*). The significance of this will be discussed later.

Plate 3 Bathroom window with north-south wall part covering the west reveal, looking south-west

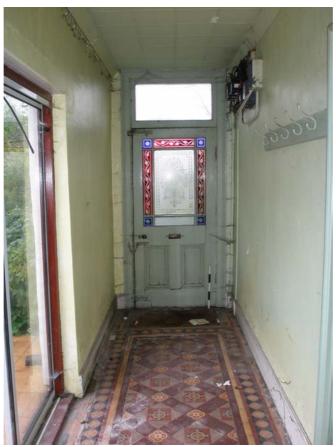
Plate 4 Hall, looking west

Measured 8.15m x 2.10m (max). The floor was covered throughout with encaustic tiles (*Plates 4 and 5*), and a moulded corbel helped to carry a north-south structural wall across the hall (*Plate 6*). The front door had a plain light above, but the door

proper had a central acid etched glass panel with a coloured glass edging comprising ruby red squares in the corners containing a glory star decoration, and cobalt blue edgings with a floral, or vine motif (*Plate 4*).

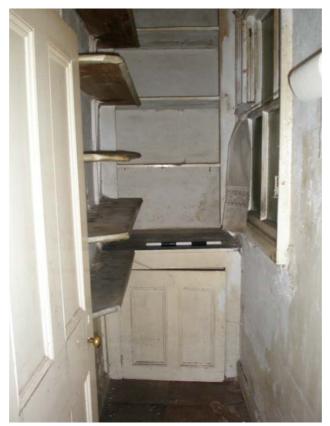
Plate 8 Room 3 (pantry), looking north

Measured 2.75m x 0.95m. There was a 4-pane sash in the east wall that would originally have been an external window, prior to the construction of the single storey extension (room 5). The cupboard at the rear of the pantry was probably an original feature (*Plate 8*).

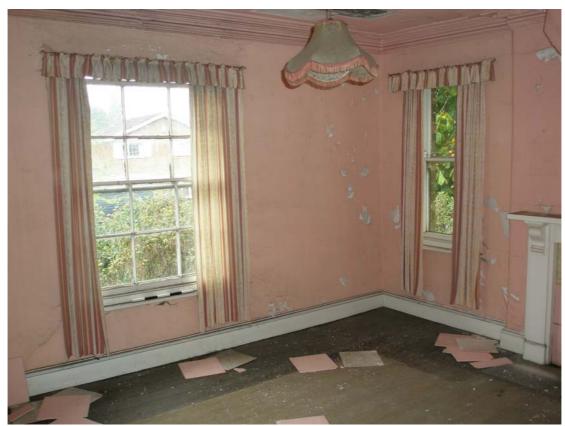
Plate 11 Room 9 (master bedroom), looking north-west

Measured 4.75m x 4.00m. The room retained its original skirting and moulded cornice (*Plate 11*). The floorboards were generally 140mm ( $5\frac{1}{2}$ ") wide. The simple stone fire surround had stone brackets or consoles and was probably original.

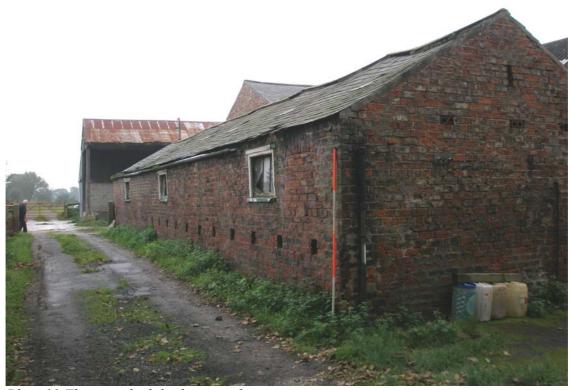
Plate 12 The cow shed, looking south-east

There was a door in the south-west corner and a ventilation slot high up in the gable. Further down there were three pairs of land drains used for extra ventilation (*Plate 12*).

The elevation contained two brick blocked windows together with three later ones (*Plate 12*). The brick blocked windows would have been the original ones for the cow shed when it was built in the late 19th century and the later ones presumably dated to the post-1945 period when the shed was renovated for the introduction of electric milking machinery.

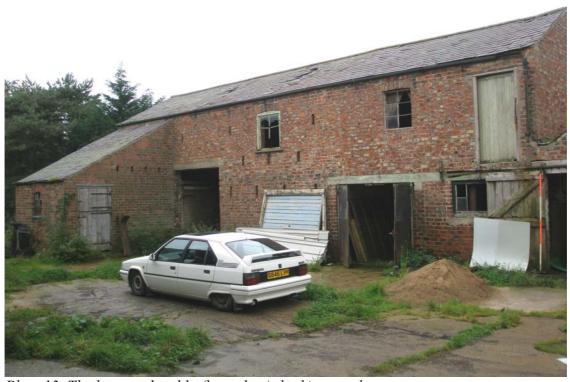
Plate 13 The barn and stable (loose box), looking south-west

There was a straight joint running from ground to eaves level and dividing the barn from the granary/milling room, though all three spaces were part of the same range (Figure 5, Plate 13). The barn had ventilation slots at three different levels, a large door with concrete lintel above, and a single first-floor window with a soldier course brick head. The granary/milling room had a large entrance with a timber lintel and double-leaf doors at ground-floor level, together with a small window that had been reinforced with an RSJ lintel. At first-floor level there was a single window of type described above and a loading door bearing the caption 'south room'.

Attached to the southern part of the elevation was a stable or loose box (*Figure 5*, *Plate 13*), which will be described separately below.

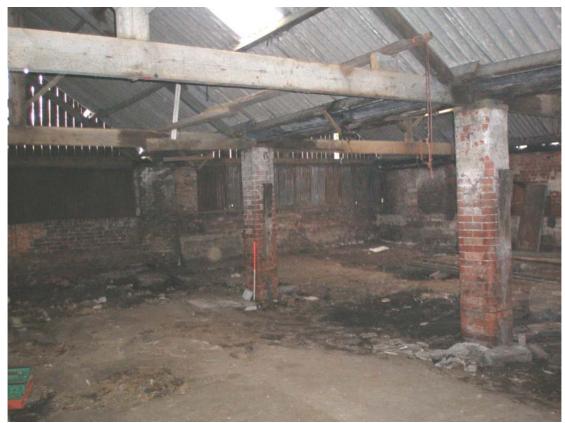
Plate 15 The covered fold-yard, looking north-west

Two 0.45m square brick piers with bullnose bricks at the corners supported four very large north-south running king-post trusses (*Figure 5, Plate 15*). The trusses in turn supported a corrugated asbestos roof. As has already been noted, the south ends of the two southern trusses were carried through into the piggery.

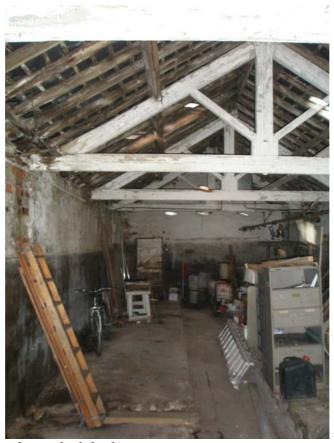
Plate 16 Interior of cow shed, looking west

This was partially split in two by a section of north-south wall. There were three kingpost trusses in the west part of the building (*Plate 16*), and two in the south, with a partial truss aligned with the section of wall noted above (*Figure 5*). There was a concrete floor throughout the shed, with a main channel running east-west and subsidiary ones running north-south. These would have carried away the slurry and spillages. The cows would have stood on a raised concrete slab running the whole length of the north side of the building, and would have been fed from concrete troughs.

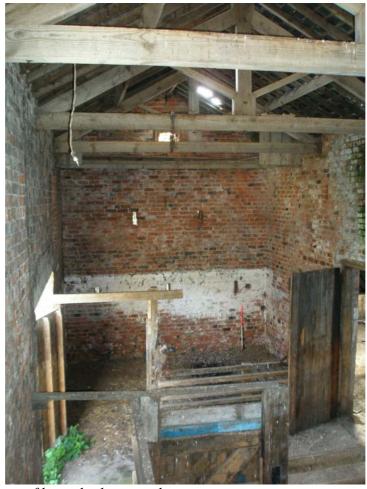
Plate 17 Interior of barn, looking south

The interior of the barn was a large open space spanned by three east-west aligned king-post trussses (*Plate 17*). The east and west ends of the space were fenced off by low timber structures to create animal pens. In the north-east corner of the barn there was a flight of steps with brick risers and York stone treads, that ran up to the granary.

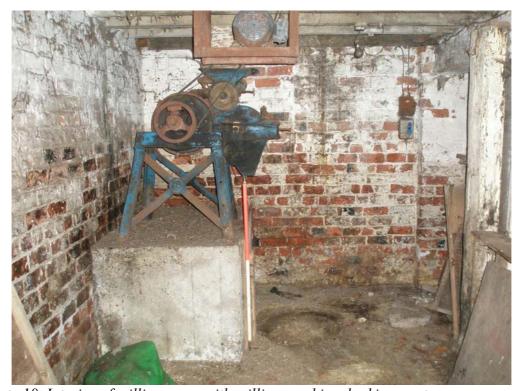
Plate 18 Interior of milling room with milling machine, looking west

The milling room was located at ground-floor level. In the south-west corner of the room there was an *in-situ* cast concrete block which carried the milling machine (*Figure 5, Plate 18*). The milling machine was largely of cast iron and carried the maker's (?) name, 'Bentale'. It had been powered by an electric motor.

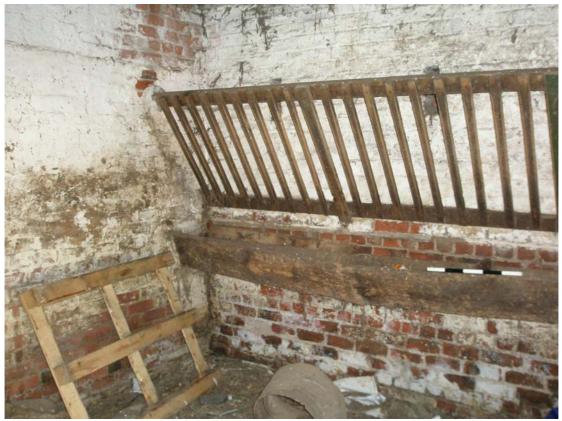
Plate 19 Interior of stable (loose box), looking south-west

Devoid of internal features except for a wooden trough set upon a brick plinth that ran along the west wall, and a continuous timber manger that ran above it (*Plate 19*).

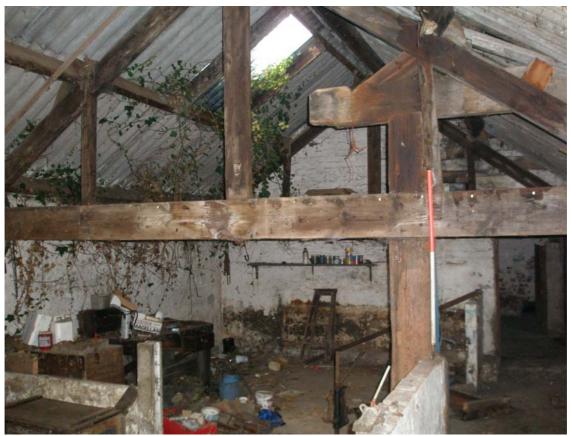
Plate 20 Interior of piggery, looking west

The east part of the piggery contained three trusses, each with a king-post and a subsidiary queen-post either side (*Figure 5, Plate 20*). There was also a timber post that supported the southern end of one of the roof trusses for the fold-yard roof (below) (*ibid*). The two southernmost trusses of this roof both penetrated the roof of the piggery. The east part was subdivided into pens by means of low brick walls and concrete fences. Dividing the east part from the west part (which may have functioned as a stable), was a roof high wall penetrated by a single heck door.

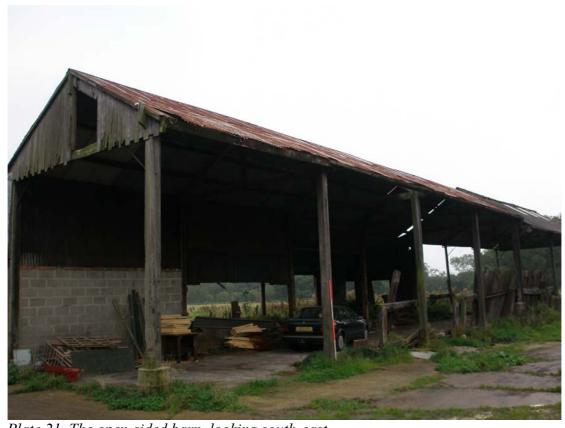
Plate 21 The open-sided barn, looking south-east

Description of this entirely 20th-century structure need only be cursory. It comprised an almost entirely open-sided building with its roof ridge running north-south (*Plate 21*). The northern part had five timber trusses of a king-post type without raking struts. These were supported by square-section timber posts measuring 0.20m x 0.20m

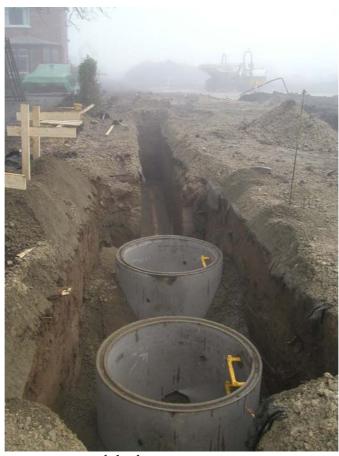
Plate 22 The main service trench looking east

The main service trench for the site was observed open for a length of around 27m, running east to west along the centreline of what would be the access road to the new dwelling (*Figure 7, Plate 22*). The trench was 1m wide, except for an area some 7m by 2.50m, intended to accommodate two manholes, and was generally around 2m deep. Throughout the base of the trench was a layer at least 1.50m thick of a firm yellow brown clay, that was largely free of inclusions (1004). Above this there was a 0.30m thick layer of a mid brown silt clay subsoil (1003) and a 0.20m thick layer of dark greyish brown topsoil (1002). No archaeological features were observed.

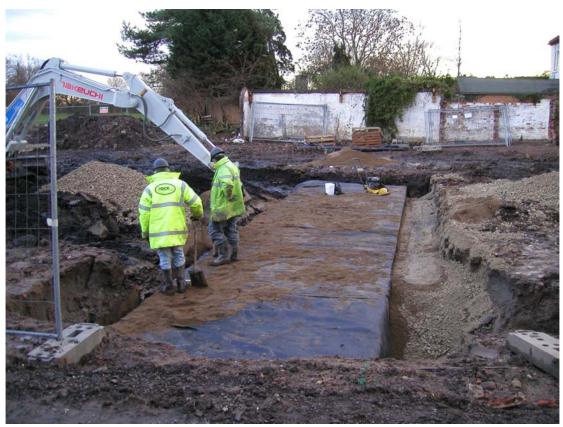
Plate 23 The Aquacell water storage tank in position, looking south

The 'Aquacell' water storage tank (*Figure 7, Plate 23*) was accommodated in an excavation some 13m long, 4m wide and up to 2.15m deep. The stratigraphy observed was as above, save that the (1004) was up to 1.65m thick and there was, within the (1002), a spread (1001) of especially contaminated topsoil containing ceramic building material and other demolition debris, together with a substantial number of ceramic and glass bottles and jars (see **5. Finds**).

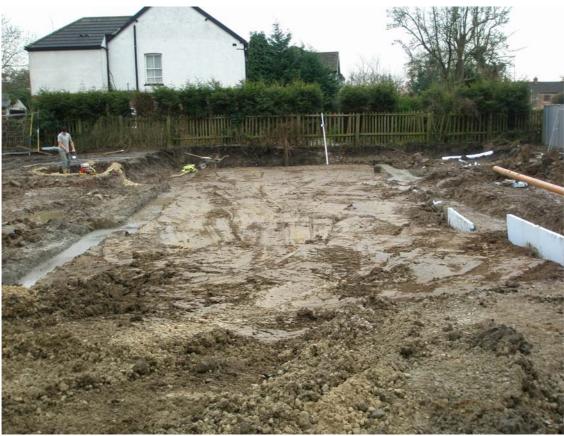
Plate 24 Plots 1-4 looking south

The foundation trenches for plots 1-4 covered an area measuring 21.5m from north to south and 9m from east to west (*Figure 7, Plate 24*). This area was stripped of topsoil (1002) and subsoil (1003) to a depth of around 0.50m. The foundation trenches were up to 2m deep and contained the stratigraphy observed for the main service trench, with the (1004) at least 2m thick. No archaeological features were observed.

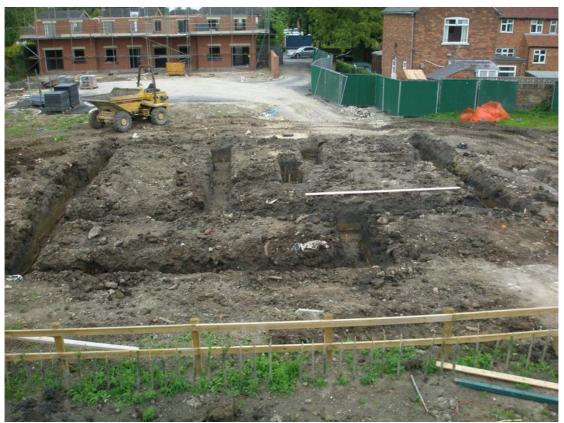
Plate 25 Plot 6 looking west

The foundation trenches for plots 5 and 6 both measured up to 13.50m by 12.50m (*Figure 7, Plate 25*). They were generally around 0.90m deep, with a layer of (1004) at least 0.40m thick in the base of the trenches. Above the (1004) was a 0.30m thick layer of a very dark charcoal grey silt that was largely free of inclusions (1005) (*Plate 26*). This in turn was covered by a 0.20m thick layer of (1002) that was heavily contaminated with demolition debris. No archaeological features were observed in either plot.
