ARCHAEOLOGICAL MONITORING WORKS

ST. SWITHINS CHURCH

SPROATLEY

Humber Field Archaeology Report no. 2183

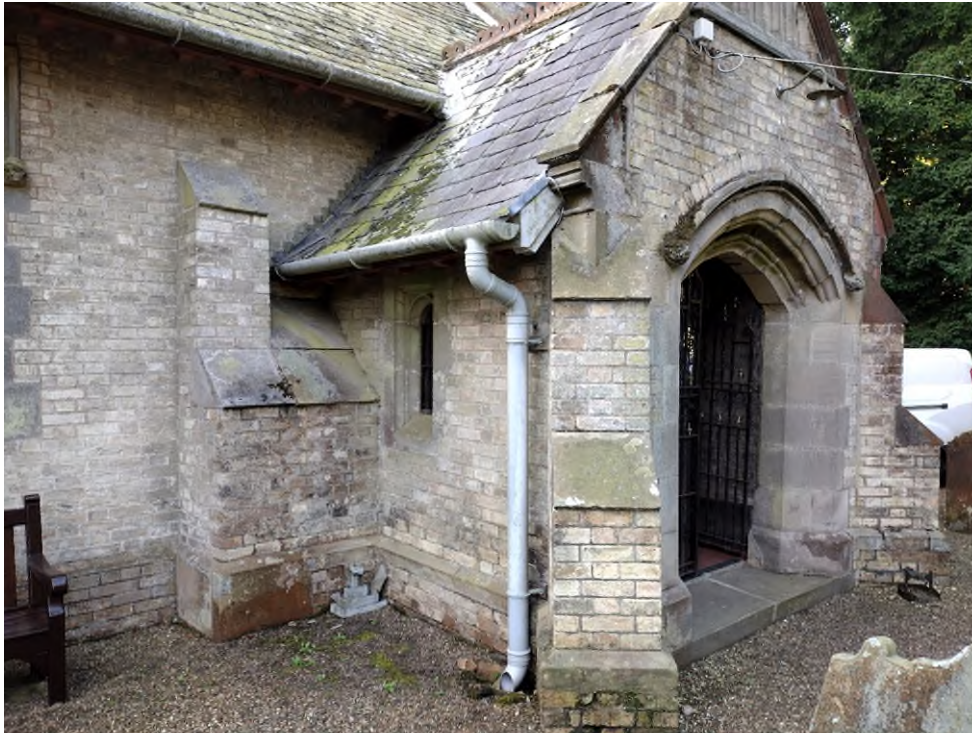
Plate 1 View of the north porch from the north-east.

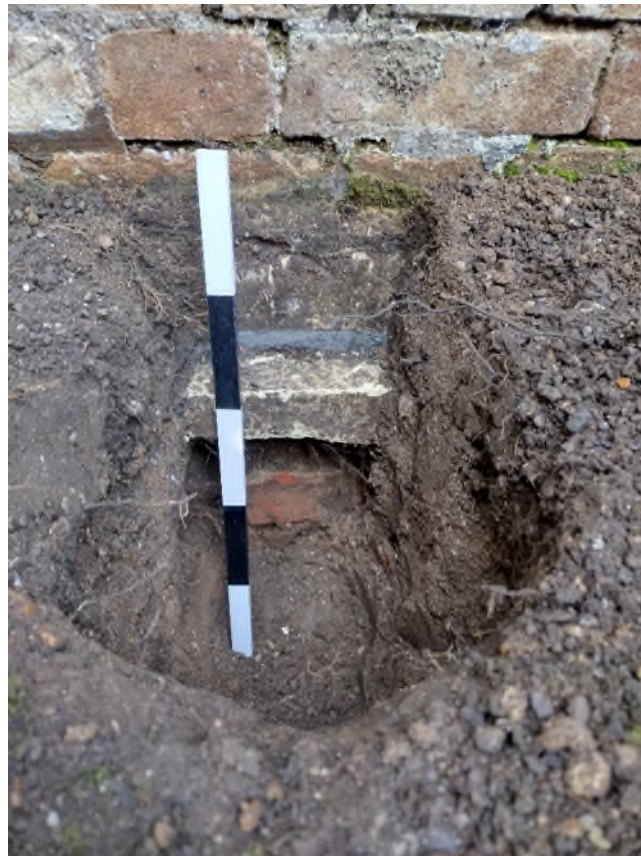
A hand cut intervention measuring 0.5m south-west to north-east and 0.3m north-west to south-east and up to 0.5m deep (24.54mOD) was positioned approximately halfway along the north-eastern side of the north porch.

Above this lay 103, a partially visible section of orange-red brick (120mm x 80mm, two visible dimensions present only) set as headers. These were bonded with a light cream brown lime mortar. This structural element was set back (recessed almost) from the overlying current north porch foundation (see 101 below).

Above 102 was the current stepped foundation for the current north porch 104. This element consisted of white brick (230mm x 100mm x 70mm) bonded with a much harder mortar, possibly containing a lime element, but also present was Portland-cement type mortar in part of the bonding. It was built in offset courses of headers and stretchers on bed.

The south-western side of the north porch appears to sit neatly on top of the earlier red brick foundation, running in line with it. However, the north-eastern wall of the north porch does not. Instead, the north-eastern wall overshoots the earlier foundation by approximately 0.1m and appears to rest solely on a thin layer of rammed or compacted earth (silt clay deposit 102). Clearly, this has not had a desirable outcome for the north porch, as the weaker support on the north-eastern side has probably had a significant impact upon the structural integrity of the porch, contributing heavily to its current state. Exacerbating this is the fact that the north porch was never tied into the main structure of the nave, and is bonded with a straight joint, leaving it susceptible to separating from the main fabric of the church.

Plate 2 Intervention pit #1 on the eastern side of the north porch, showing likely post-medieval brick footing 103 (red brick, pre-1814) set back and underneath the current north porch foundations 101 (white brick) which was built around 1866. Looking west, 0.5m scale.

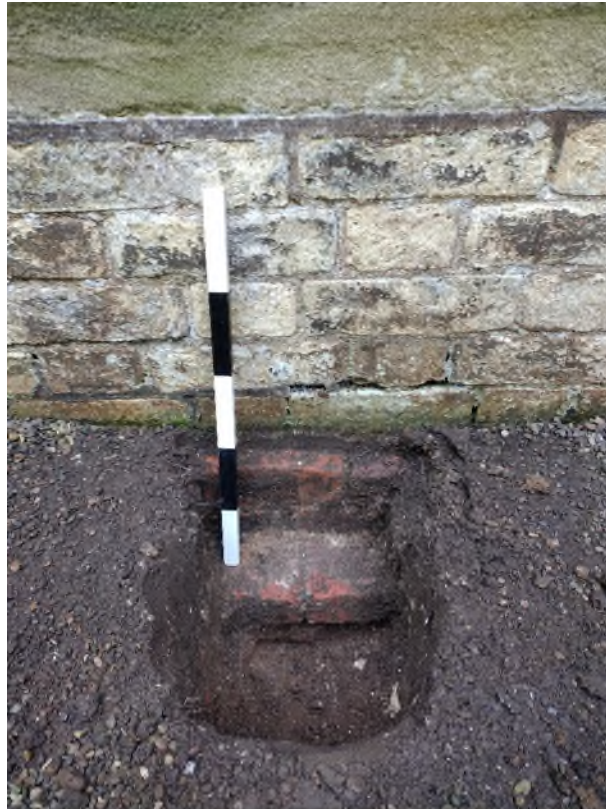
This second intervention was located on the south-western face of the north porch, again, positioned approximately halfway along. The intervention measured 0.4m north-east to south-west and 0.2m north-west to south-east and was up to 0.4m deep 24.53mOD).

Above 104, were three courses of the red brick foundation 103 (featuring similar brick dimensions), up to 0.2m high, with a stepped out basal course.

Sat atop this was the south-western wall of the north porch 101, again with similar brick dimensions and constructed in the same fashion as the north-eastern wall.

Plate 3 Intervention pit #2 on the western side of the north porch, showing a similar sequence of events as on the eastern side of the porch; post-medieval red brick stepped foundation 103, with the 1866 white brick north porch 101 sitting directly atop. Looking east, 0.5m scale.

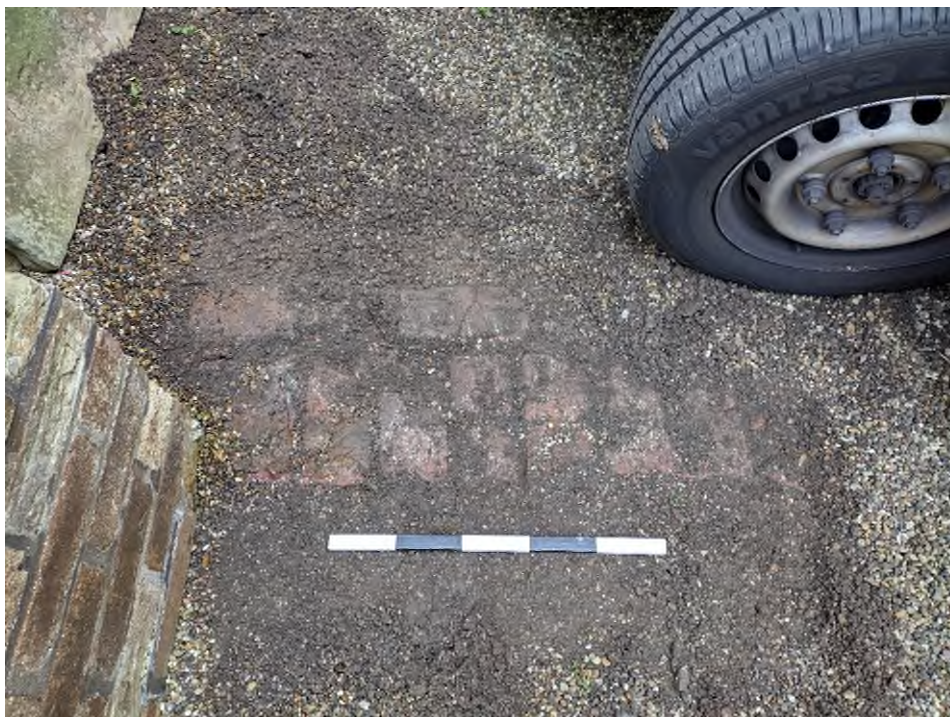
It appears that the demolition of the earlier church did not include (in the areas seen during the site work) the ‘grubbing out’ of the foundations and was perhaps just demolished to ground level. Further evidence of this can be seen at the external western corner of the nave, where the remains of another red brick and lime mortar foundation was seen to run to the south-west i.e., outside the current space occupied by the church (Plate 4).

Plate 4 A further example of the likely post-medieval red brick foundation remains of the church demolished pre-1814 surviving at the current ground level. This example lies to the south-west of the north porch and north of the tower.
