HISTORIC BUILDING RECORDING

**52A & 54 BRUNSWICK ARCADE
BEVERLEY ROAD
KINGSTON UPON HULL**

Humber Field Archaeology Report no. 2184

*Work carried out for NPS Humber
On behalf of
Hull City Council*

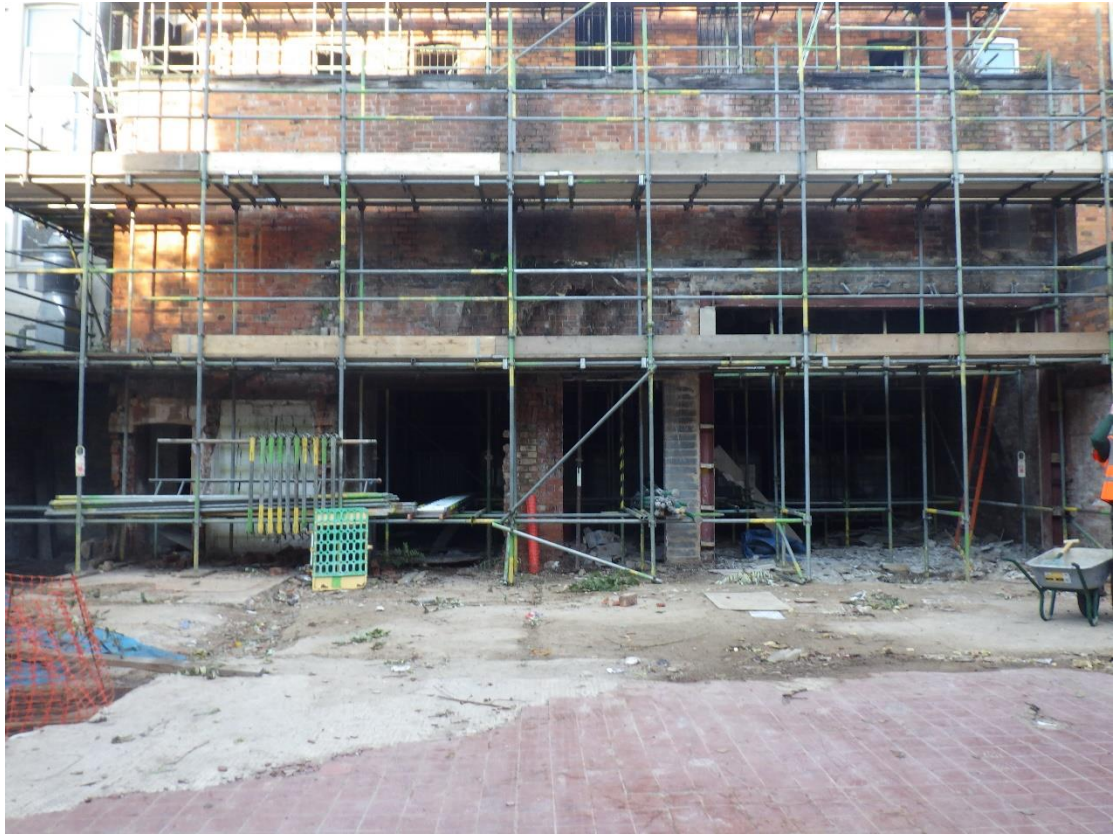
Plate 1 General view of eastern elevation, looking west.

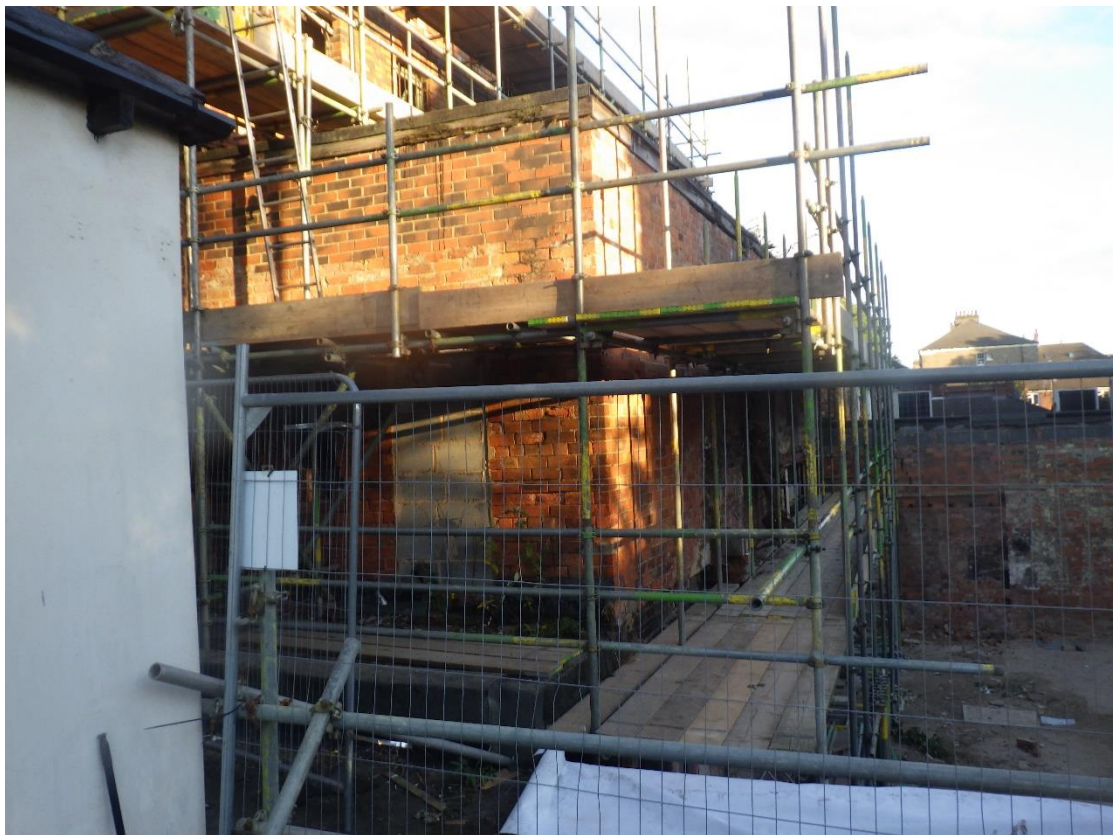
Plate 2 Oblique view of eastern elevation, looking north-west.

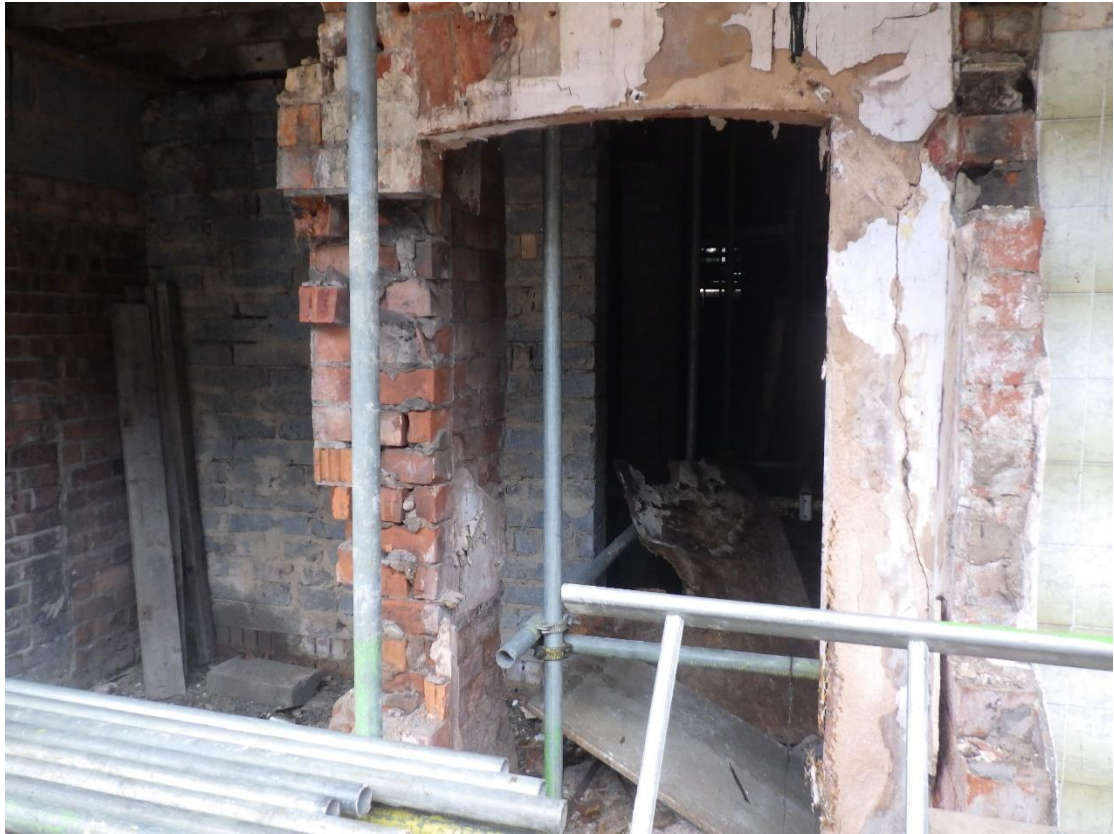
Plate 3 Detail shot of internal doorway on ground floor of eastern elevation, looking west.

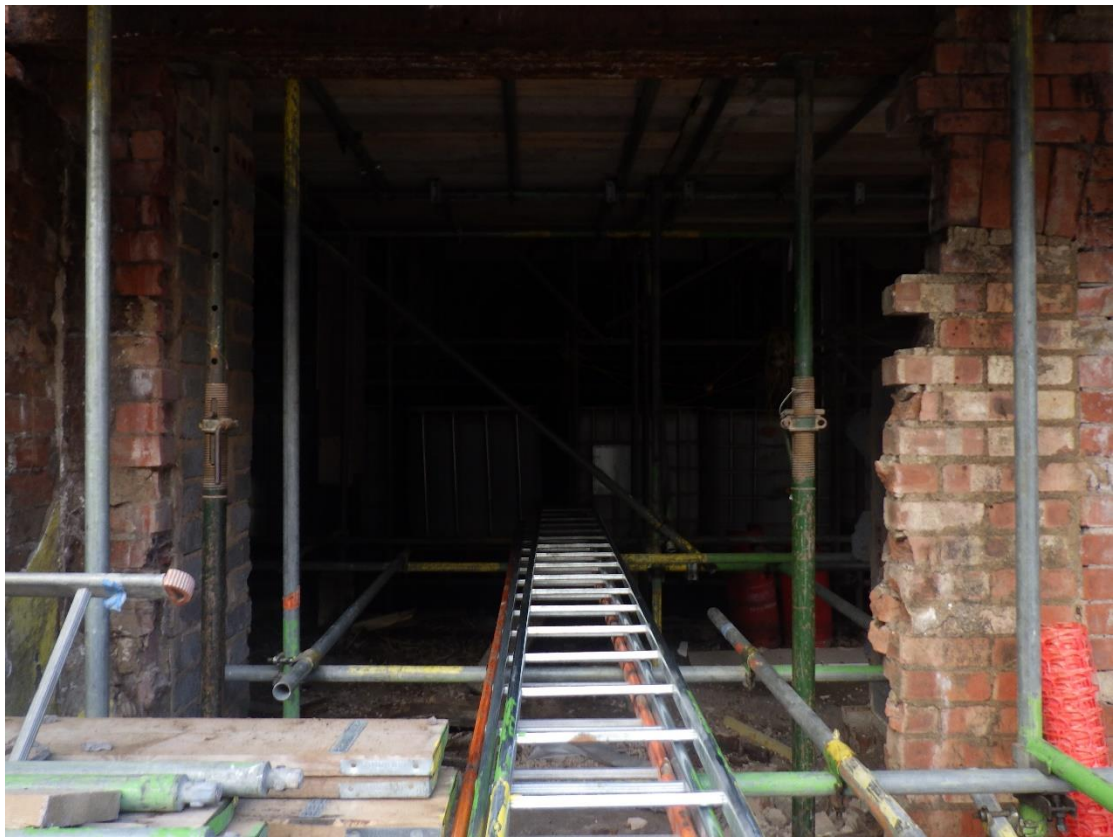
Plate 4 General view of opening on ground floor of eastern elevation, looking west.

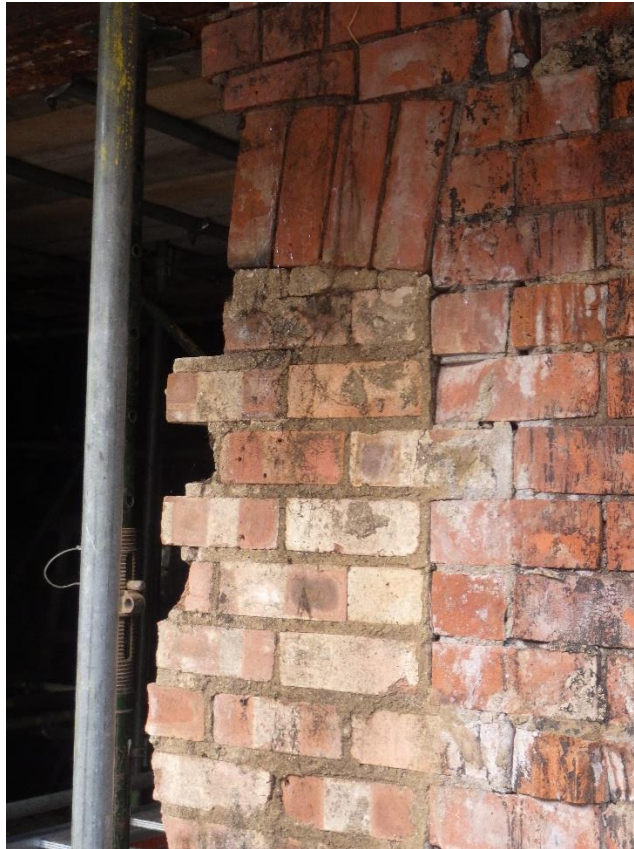
Plate 5 Detail shot of bricked up doorway on ground floor of eastern elevation, looking south-west.

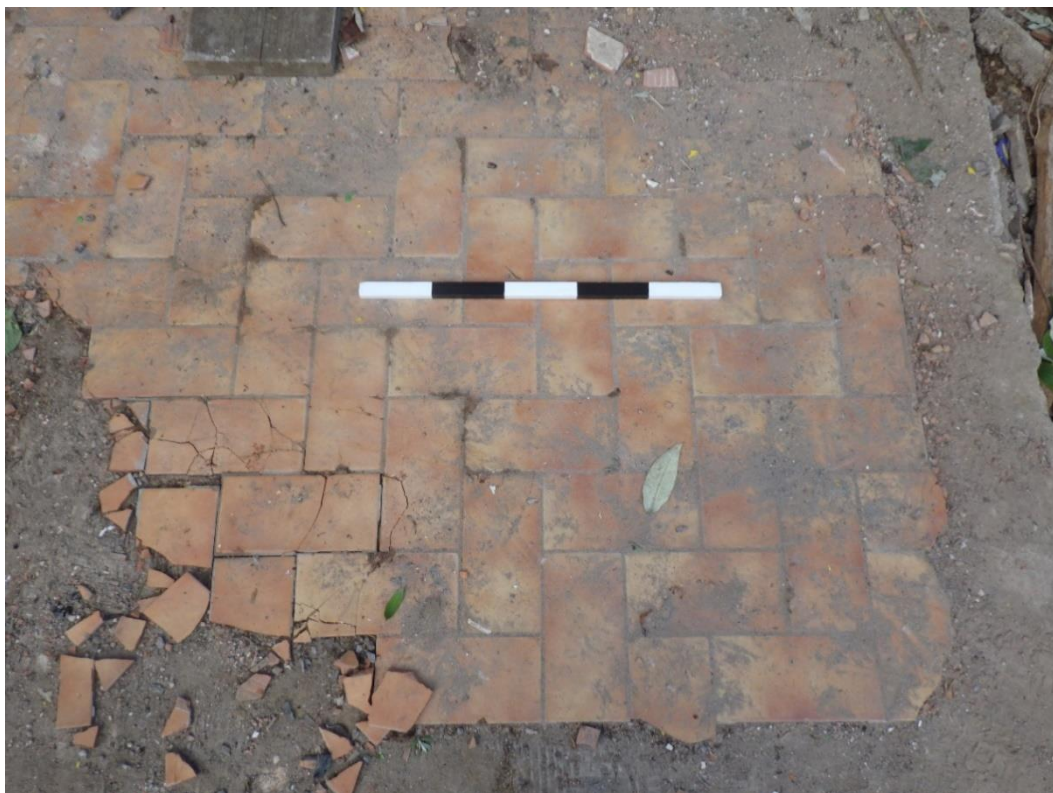
Plate 6 Detail shot of floor tiles on ground floor at rear of the property (0.50m scale).

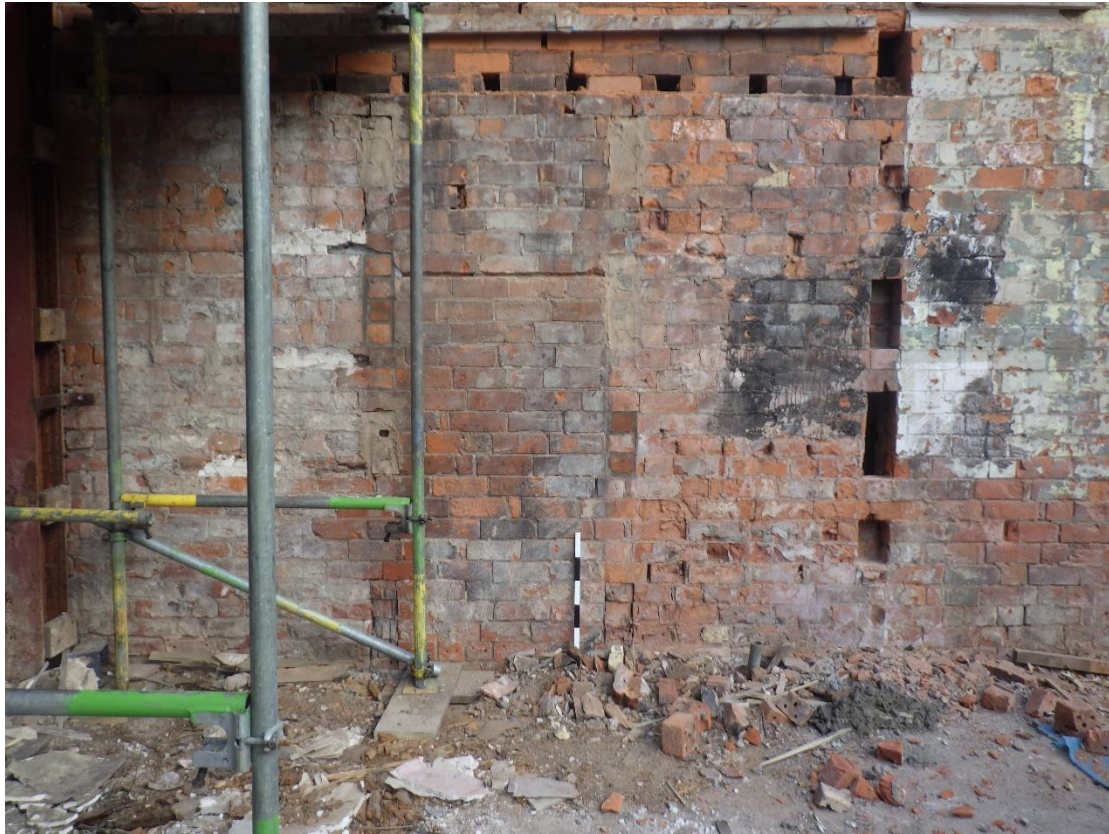
What remains of the building is of brick-and-mortar construction in Stretcher bond throughout which extended to the front elevation as well. Two entrances are present at the ground floor level with a smaller doorway with an arched top to the southern side of the elevation with a larger, degraded opening present more northerly. This northern entry also showed signs of a bricked up arched doorway on the northern edge (Plate 4) and the presence of internal floor tiles was also noted to the east of this larger entrance (Plate 6). Whilst recorded in previous plans, two flat roofed additions to the main building have since been demolished with the western most of the two surviving in the form of sockets that would have joined it to the northern adjoining wall (Plate 7).

Plate 7 Structural remains showing construction marks from a now demolished portion of the building, looking north (0.50m scale).

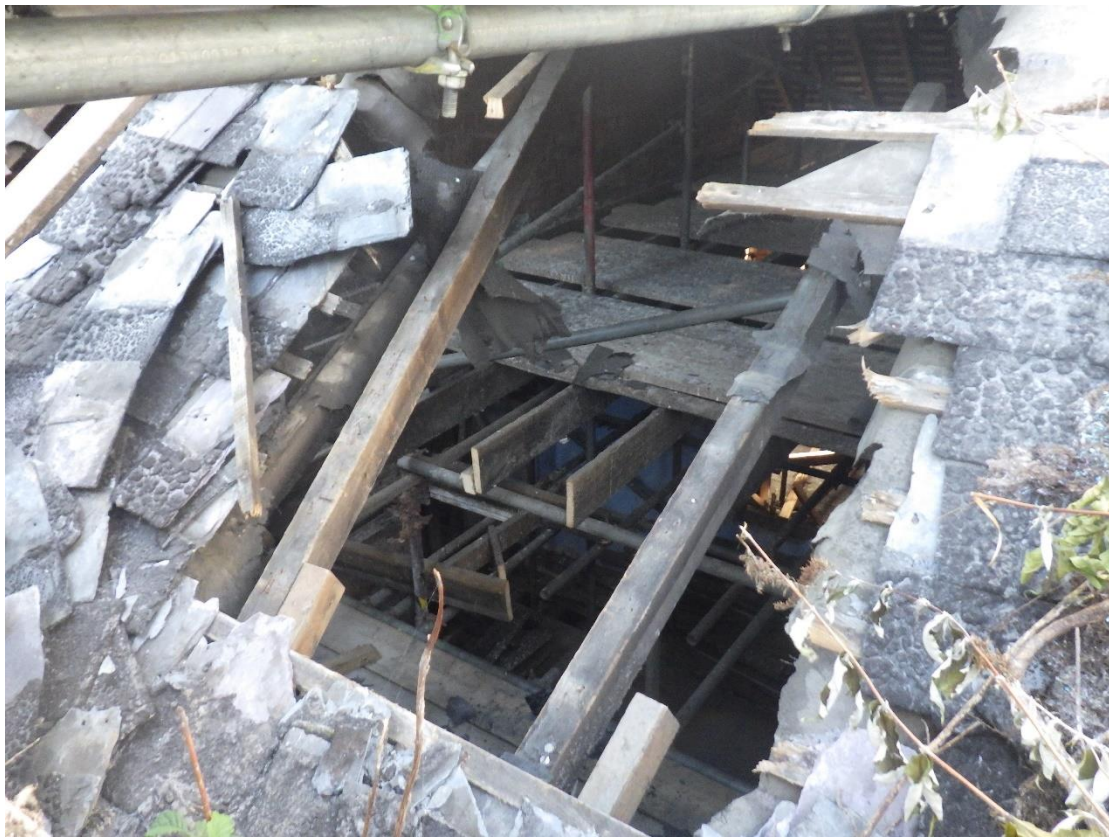
Plate 8 Detail shot of hole in the roof used to facilitate the construction of a scaffold, looking north-east.

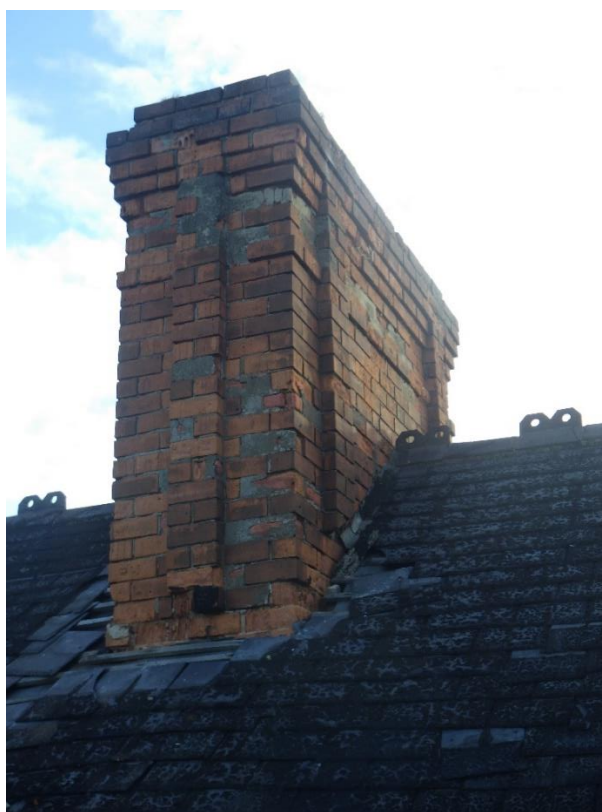
Plate 9 General shot of chimney stack showing outdented brick patterns, looking north-east

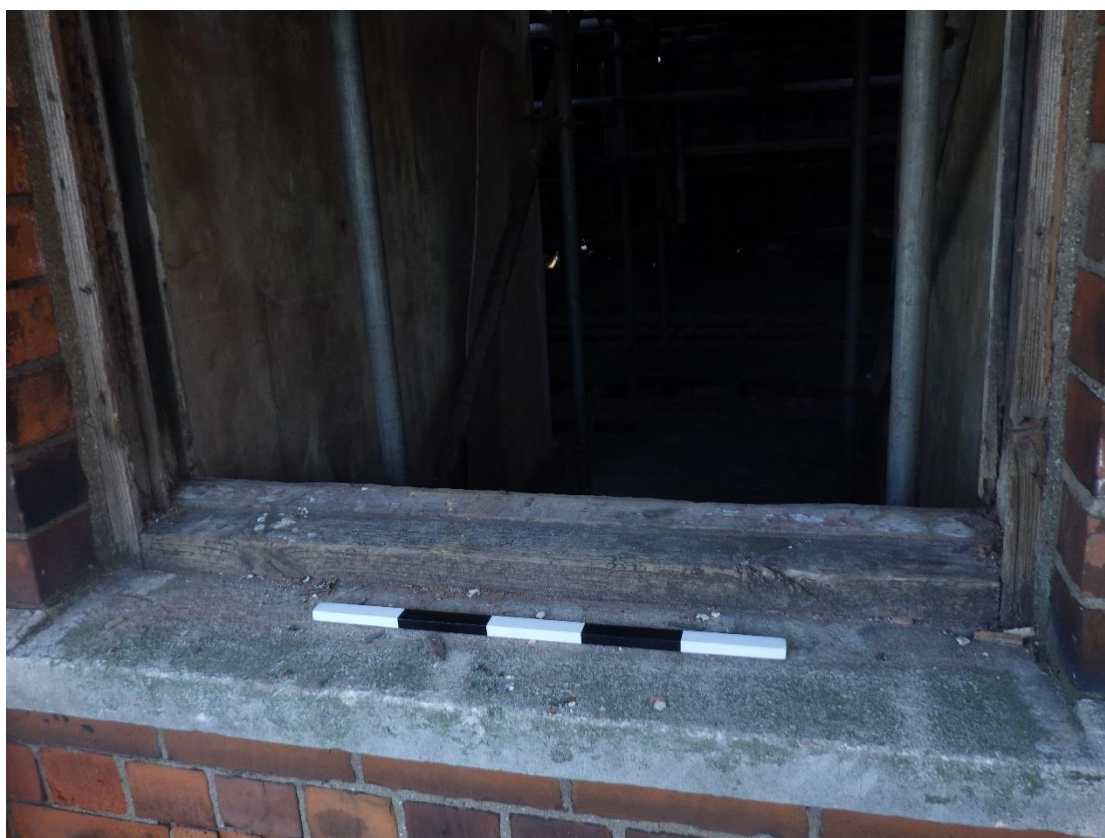
Plate 10 Detail shot of sill of dormer window, looking east (0.50m scale).

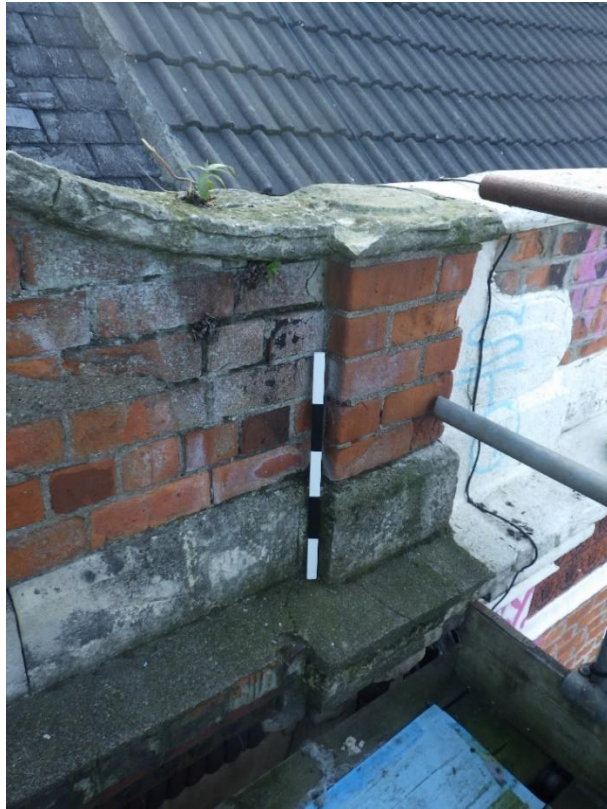
Plate 11 Brick details and end pillar to the south of dormer window, looking south-east (0.50m scale).

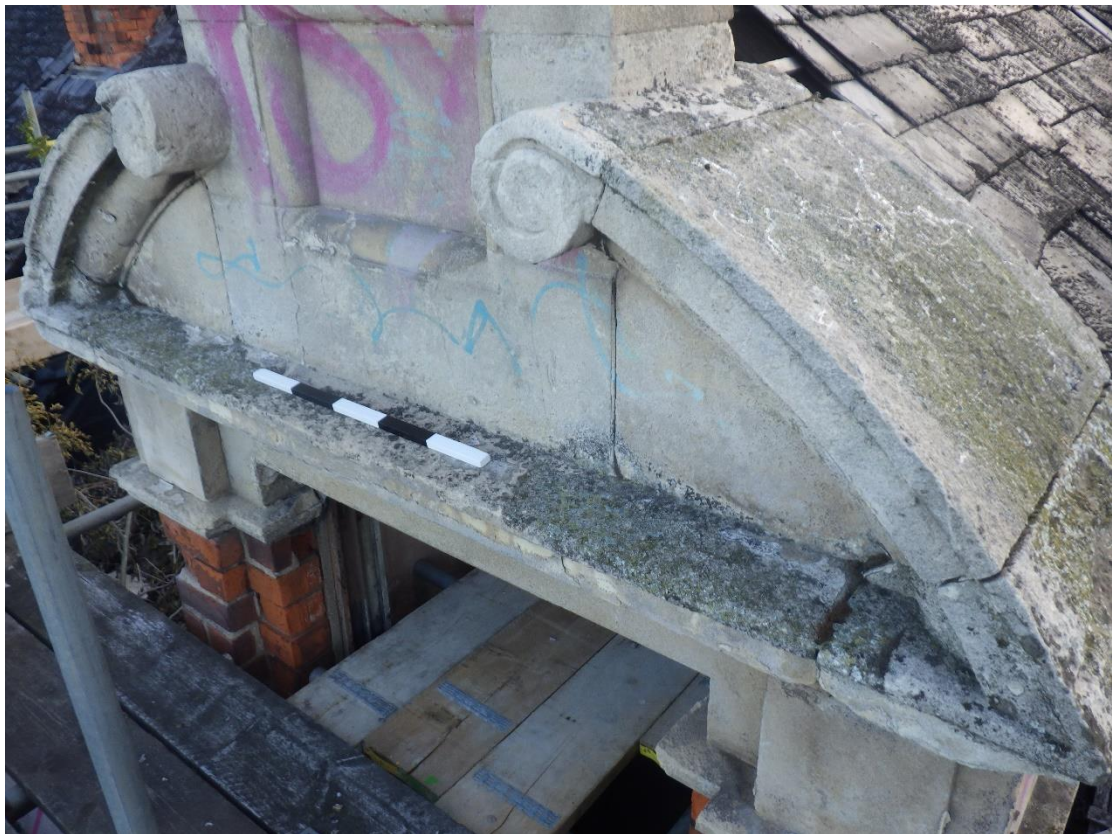
Plate 12 Overview of stone detail above dormer window, looking north-east (0.50m scale).

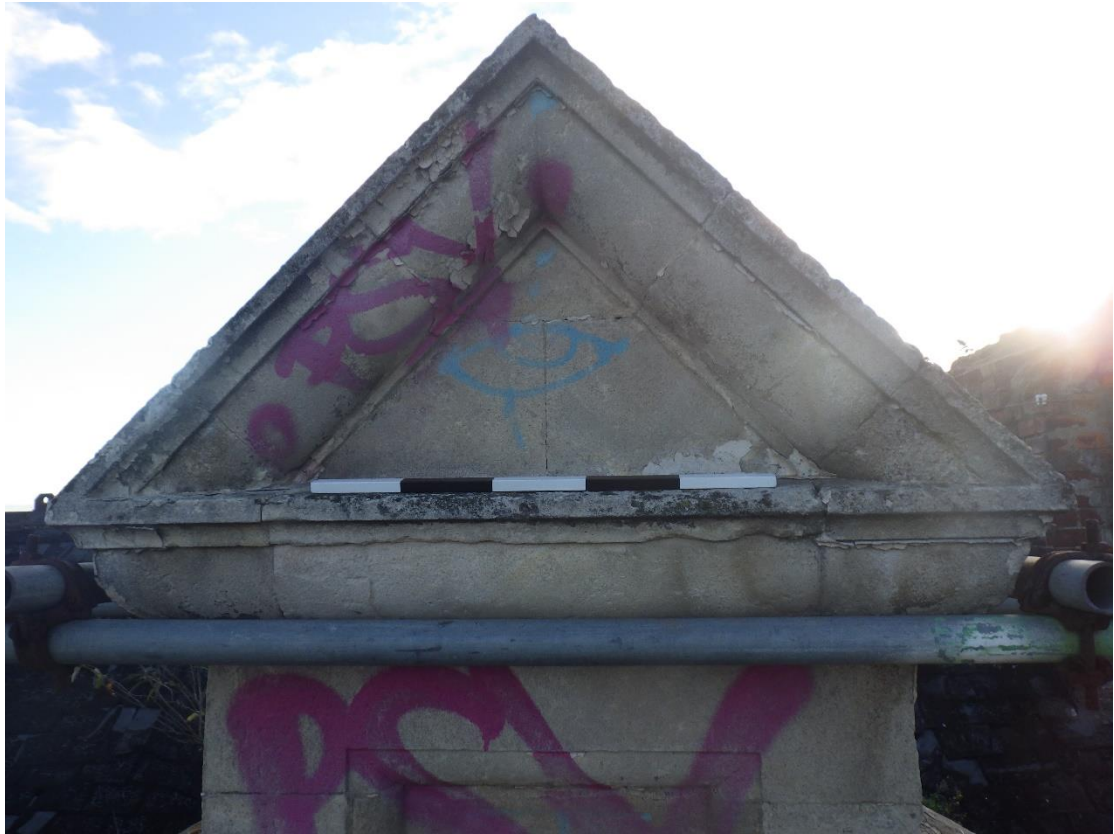
Plate 13 Decorative stone capping above dormer window, looking east (0.50m scale).

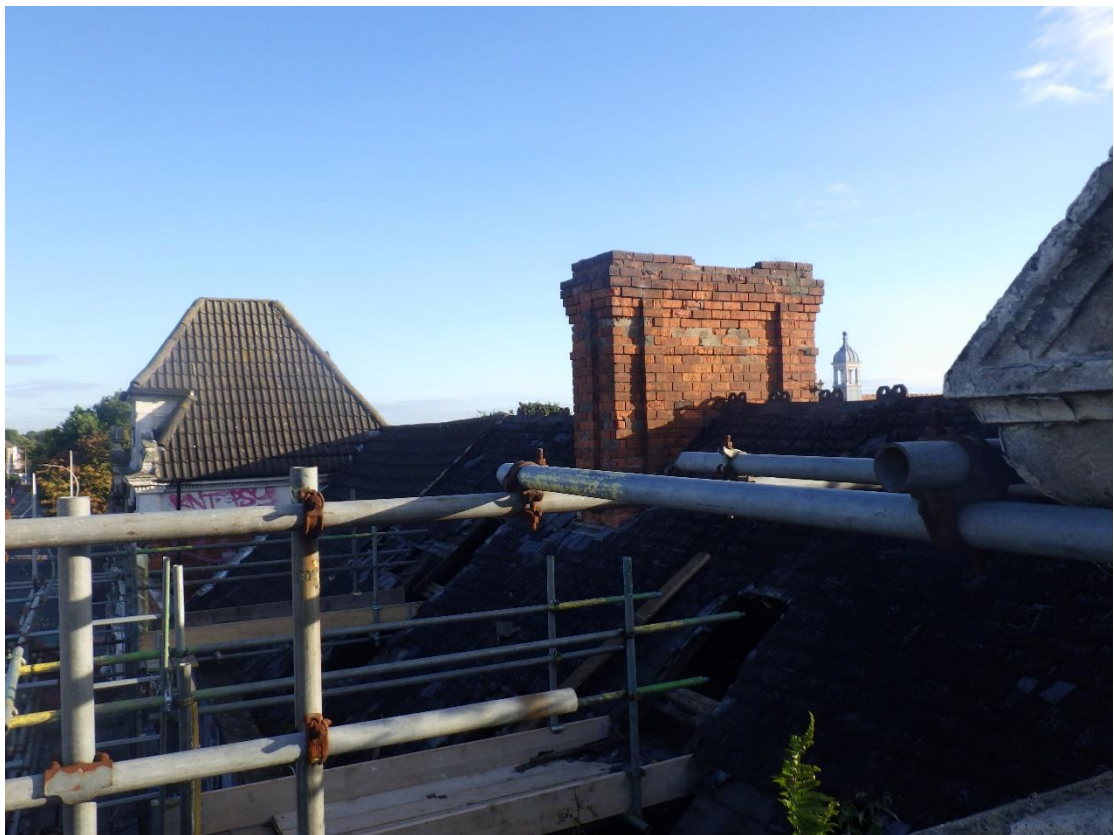
Plate 14 General view over rooftop of Brunswick Arcade, looking north-east.

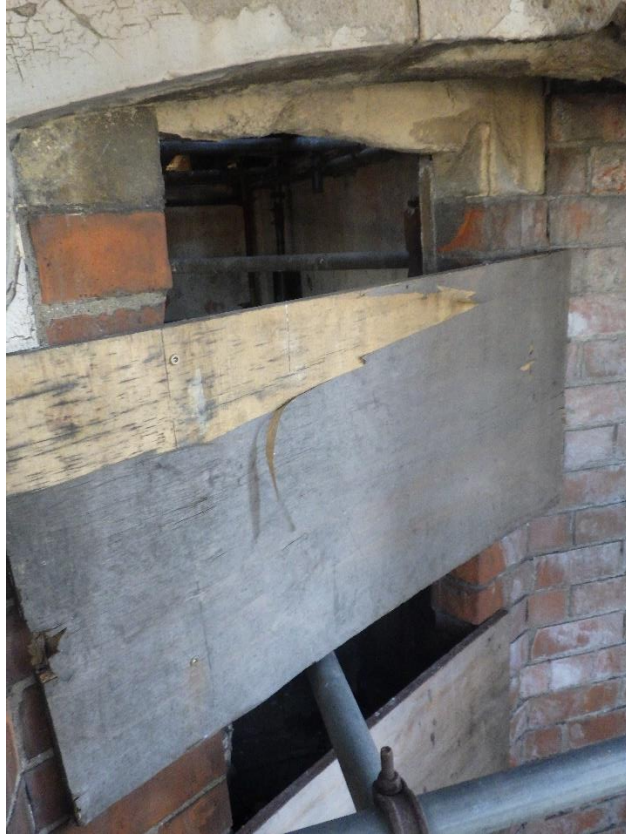
Plate 15 Boarded up window on the southern side of bay window on second storey, looking east.

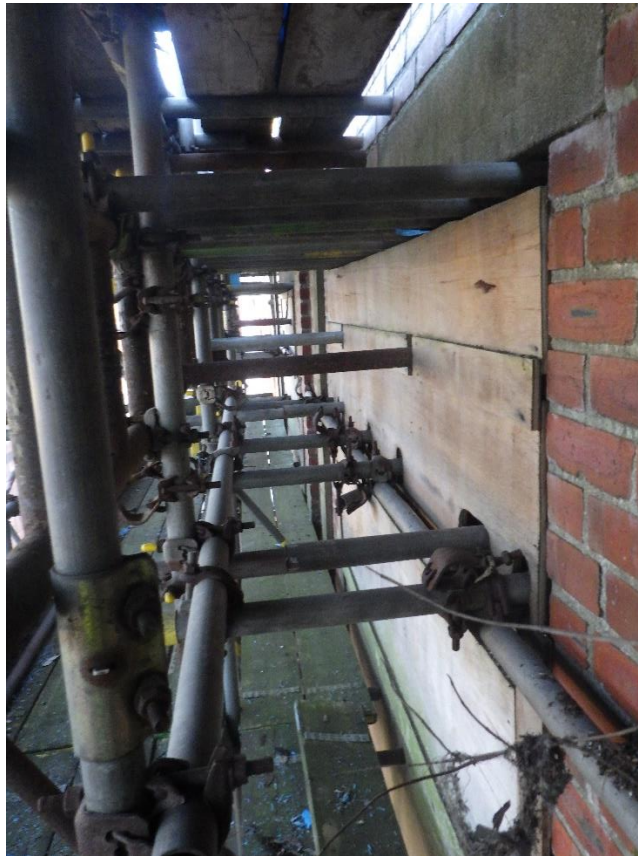
Plate 16 General view of boarded up windows on second storey, looking north.

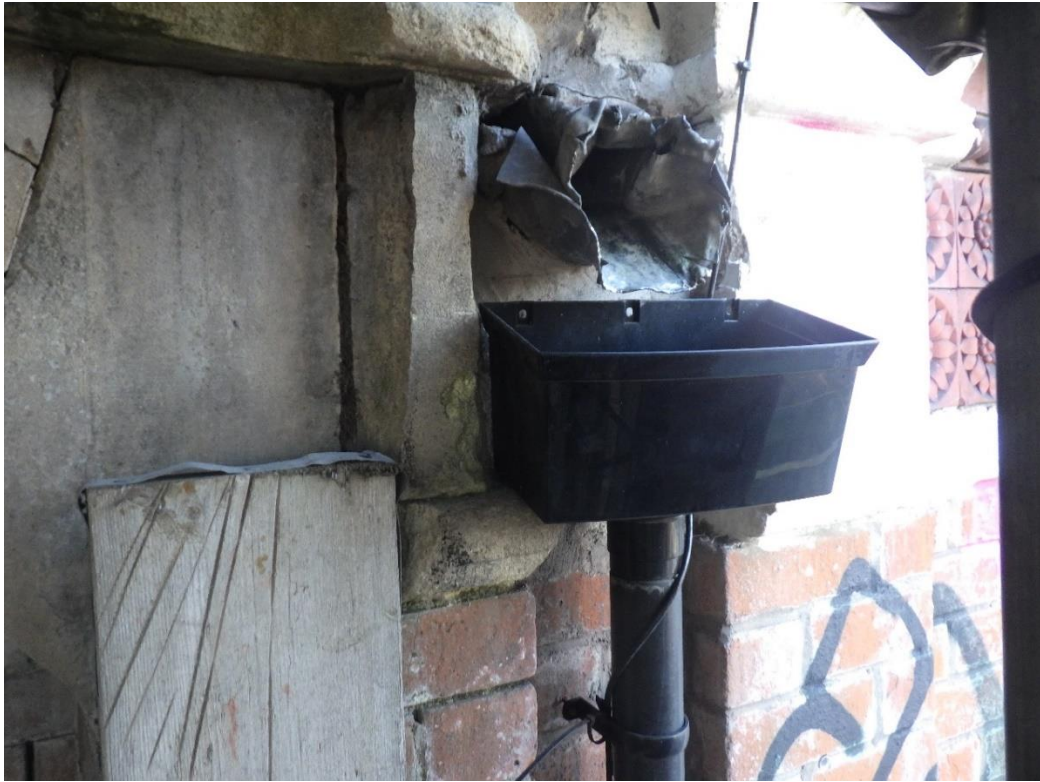
below was present continuing in the same formation it had taken previously, the main difference here being the absence of the ceramic pillars beneath the sills. At the southernmost edge of the building an in-situ drainpipe was identified (Plate 17) which now feeds into a modern addition.

Plate 17 In-situ drainpipe feeding into modern replacement fall pipe, looking south-east.

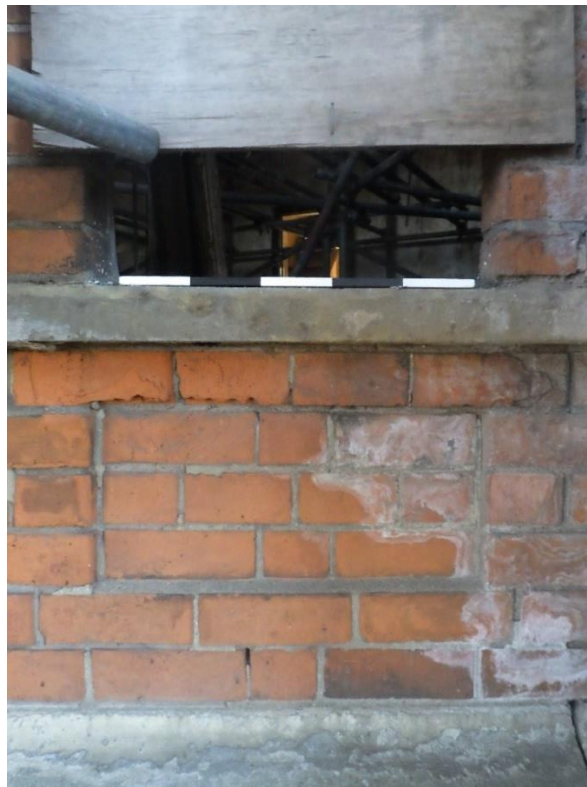
Plate 18 West facing sill and underlying indented brick pattern in bay window on first storey, looking east (0.50m scale).

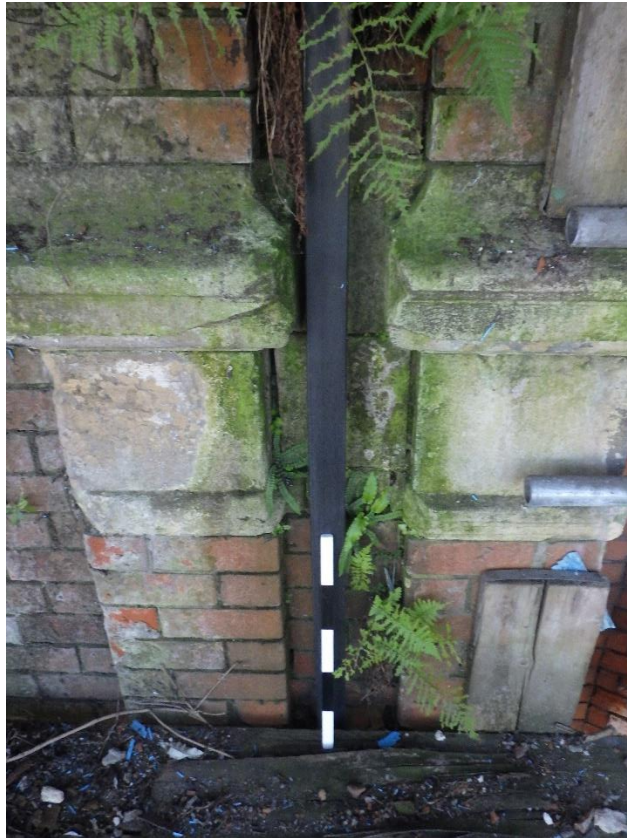
Plate 19 Detail shot of decorative stone capitals on brick columns situated on the western elevation, looking east (0.50m scale).

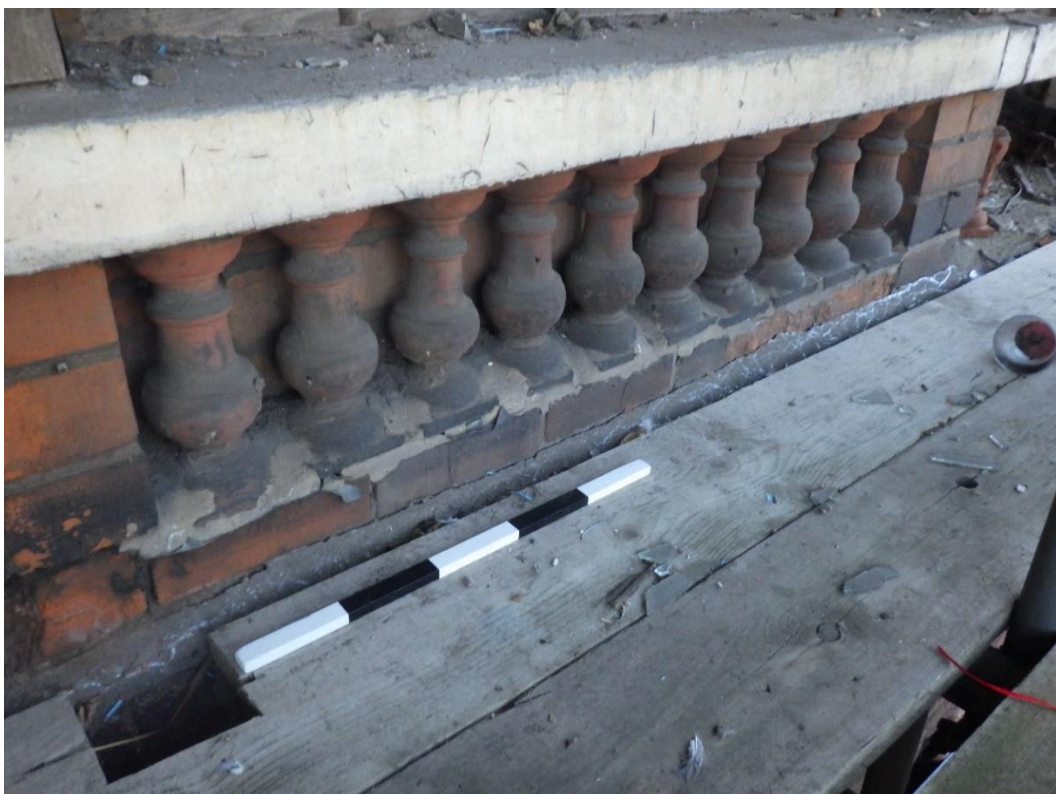
Plate 20 Detail shot of decorative columns underneath sill of bay window on first storey, looking south-east (0.50m scale).

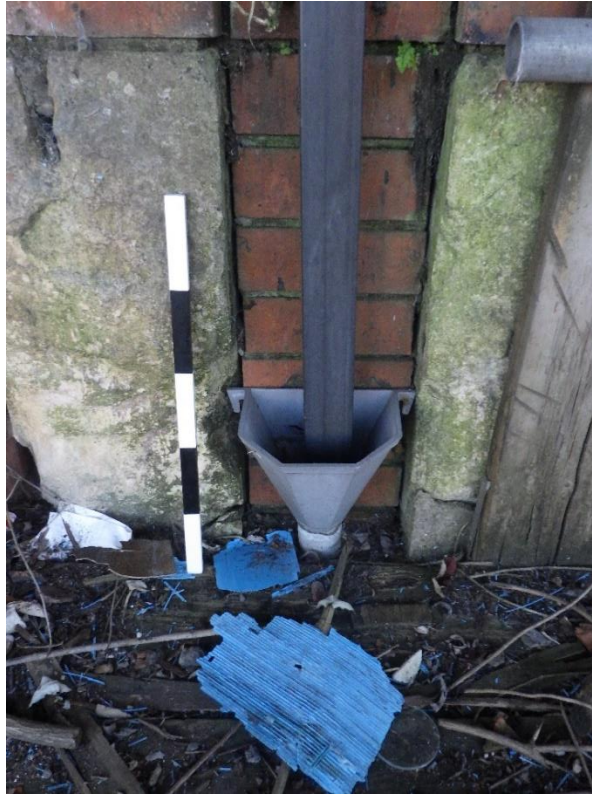
Plate 21 Detail shot of fall pipe feeding into hopper added as a later addition, looking east (0.50m scale).

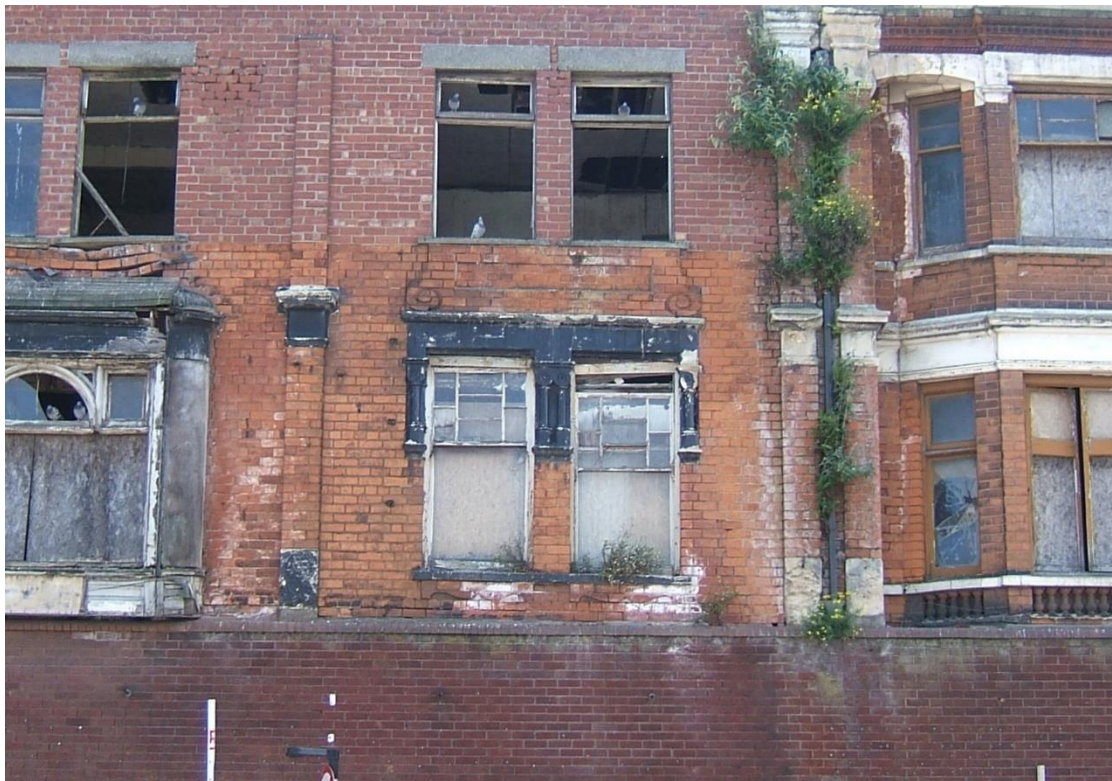
Plate 22 Detail shot of decorative brickwork showing a scrolled pattern between windows on the first storey, looking east.

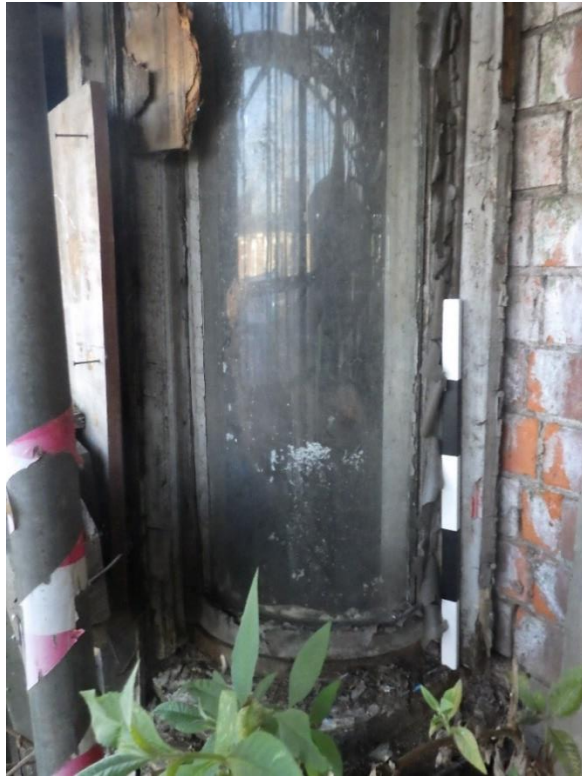
Plate 23 Detail shot of curved glass pane in northern bay window of first storey, looking north-east (0.50m scale).

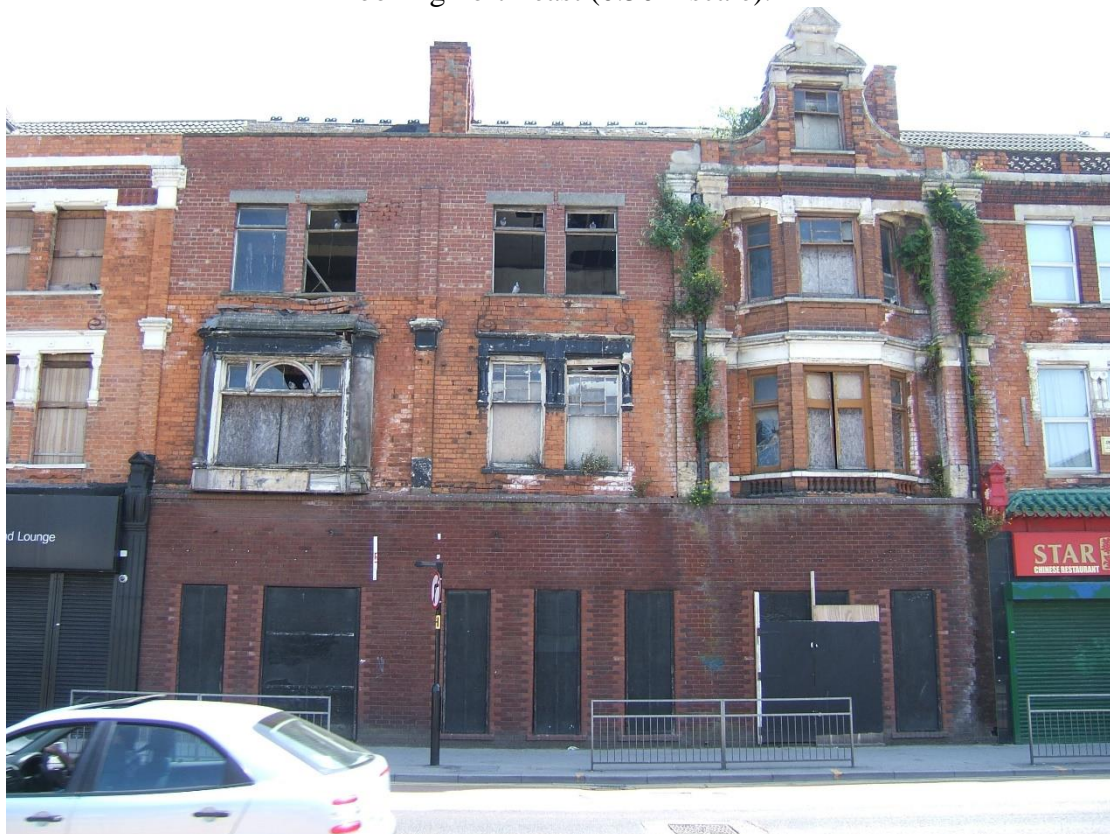
Plate 24 General view of western elevation prior to the addition of scaffolding, looking east.
