**Bank Farm, Butterton,
Staffordshire**

Building Recording

**A Building Recording Report
for Mr John Hewitt**

October 2021

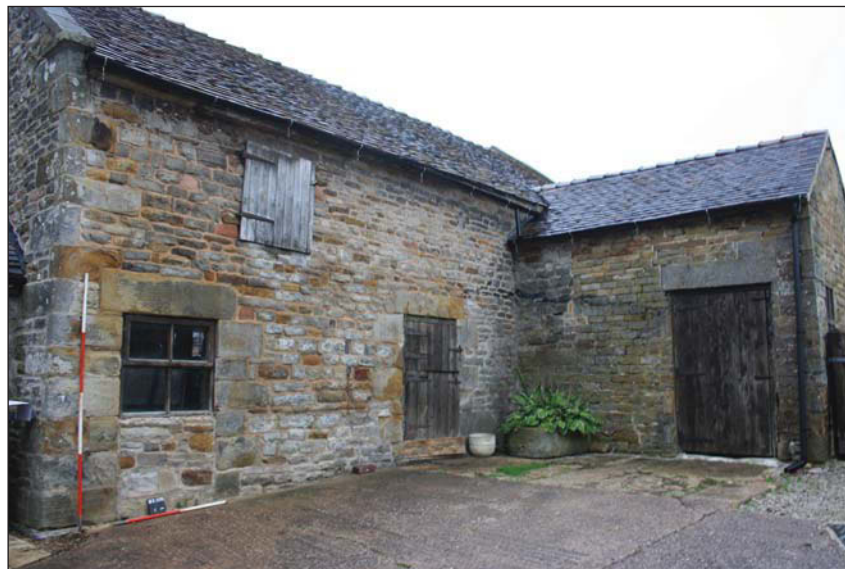
Plate 1. View of eastern elevation of cowhouse and southern elevation of stable, looking north-west,

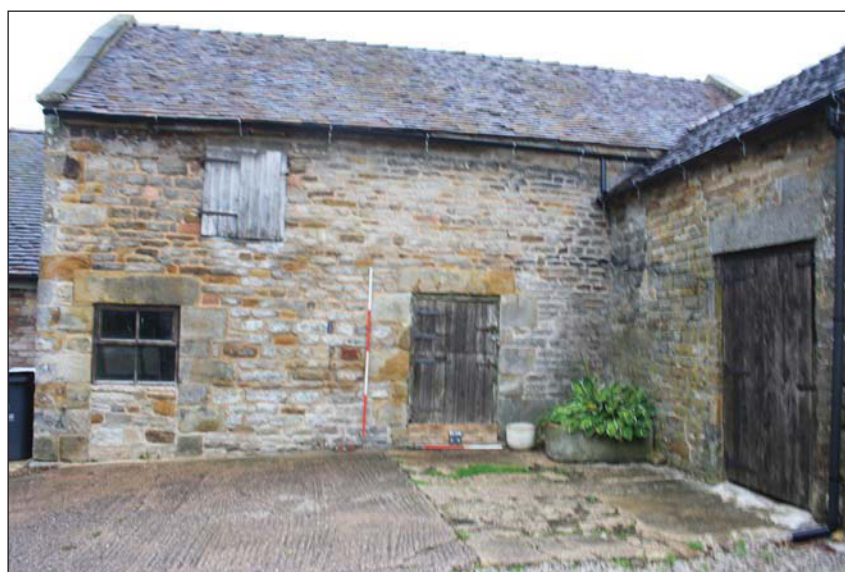
Plate 2. Eastern elevation of cowhouse showing how the structure is built onto the slope, looking west, Scales: 2m and 1m.

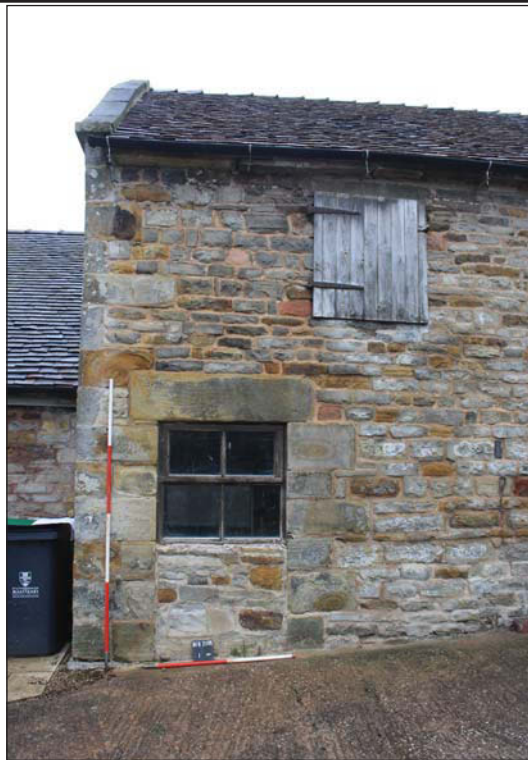
Plate 3. Former doorway (now window) in eastern elevation, looking west, Scales: 2m and 1m

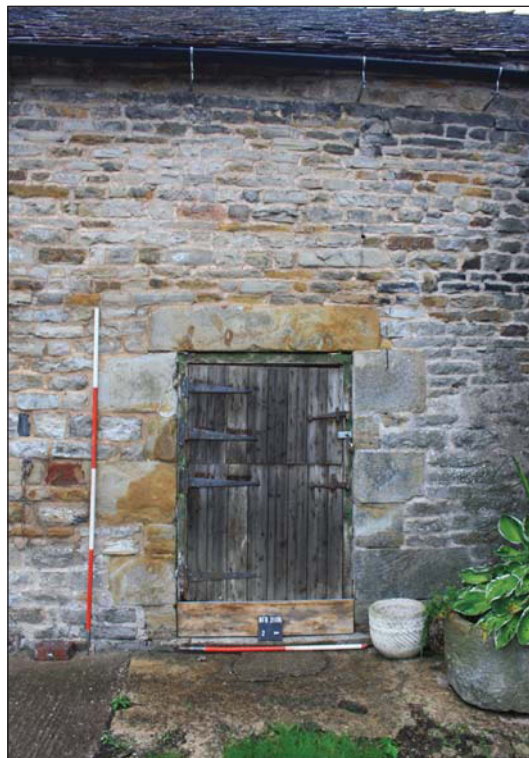
Plate 4. Door in north end of eastern elevation, looking west, Scales: 2m and 1m.

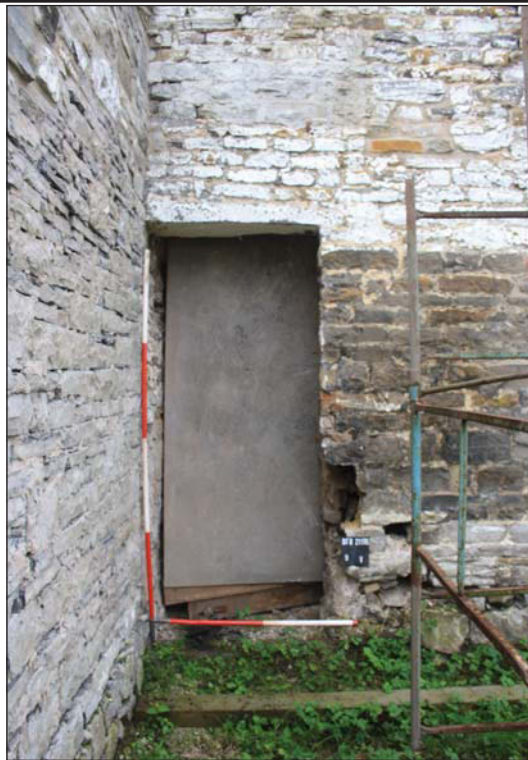
Plate 5. Additional later opening to north elevation of cow-house,
looking south, Scales: 2m and 1m.

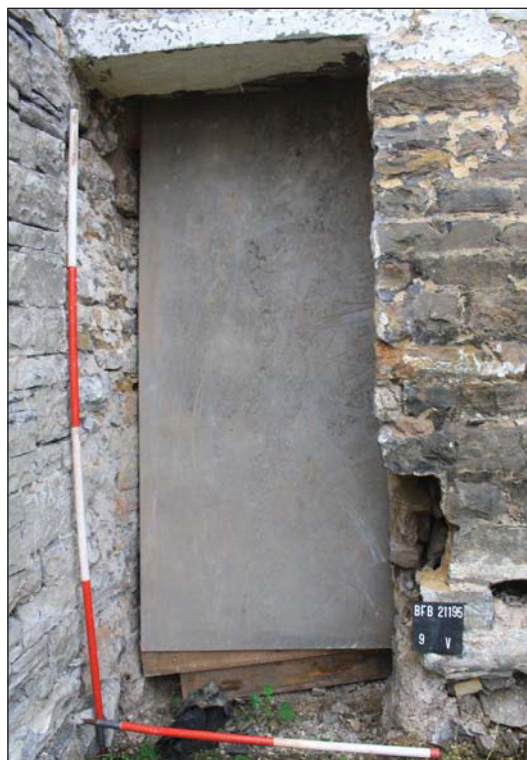
Plate 6. Detail of later doorway cut into northern cow-house wall,
looking south, Scales: 2m and 1m.

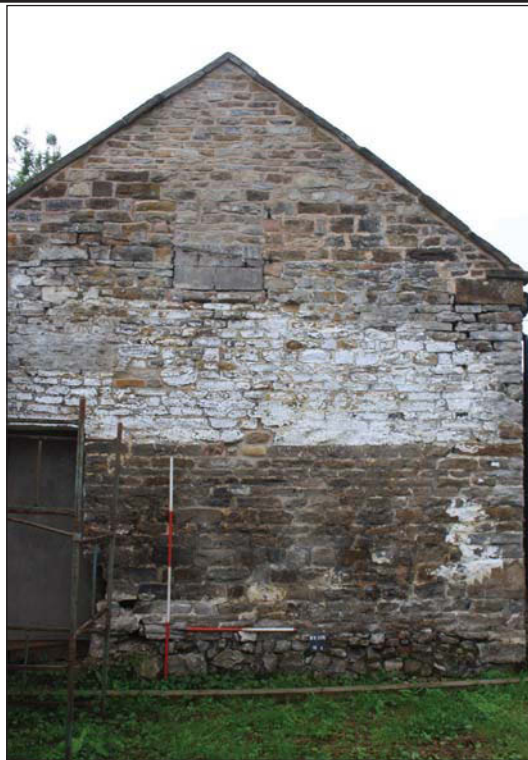
Plate 7. Northern elevation showing cow-house gable, looking south,
Scales: 2m and 1m.

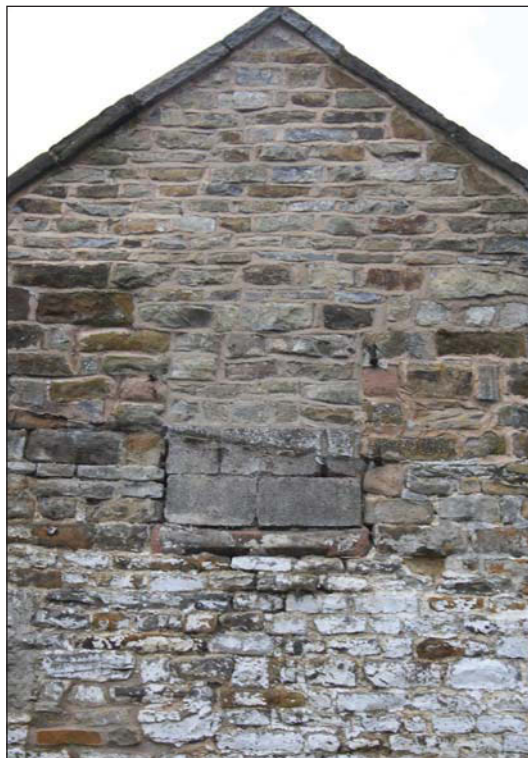
Plate 8. Detail of blocked hayloft opening in north gable of cow-
house, looking south,

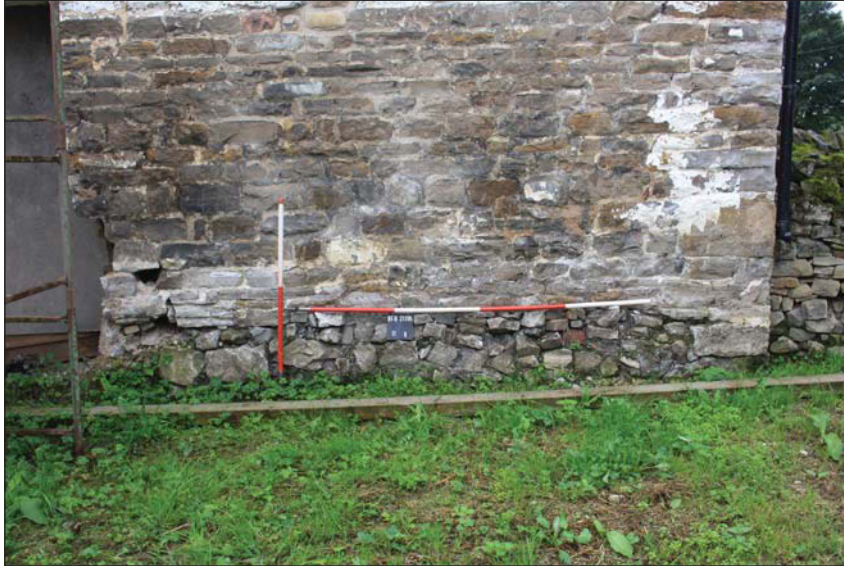
Plate 9. Rubble course walling visible at base of north gable of cow-house, looking south,
Scales: 2m and 1m

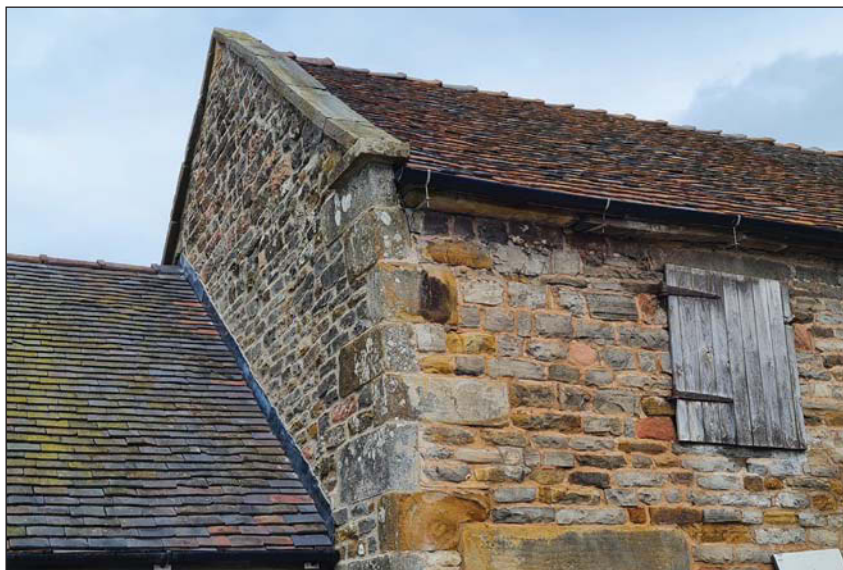
Plate 12. External view of south gable showing location of repair detail, looking west.

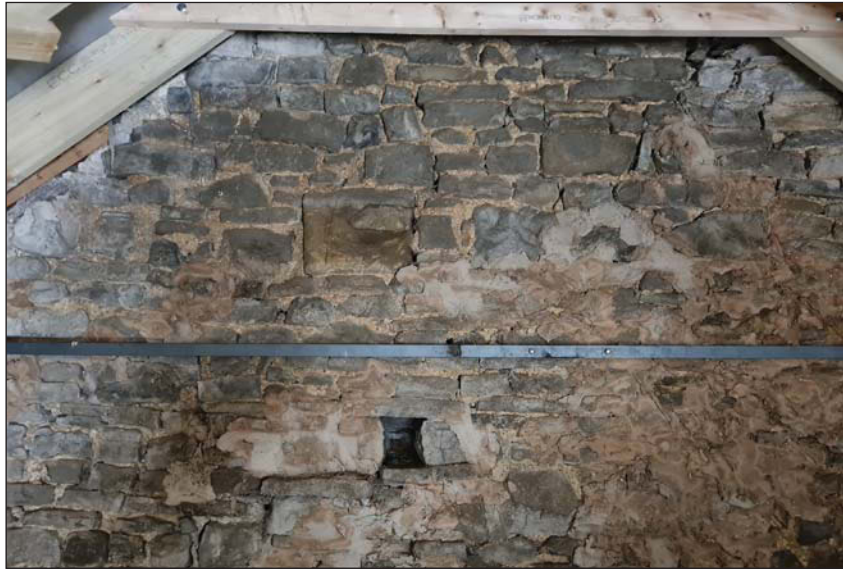
Plate 13. Internal view of repair detail in southern gable of cow-house, looking south.

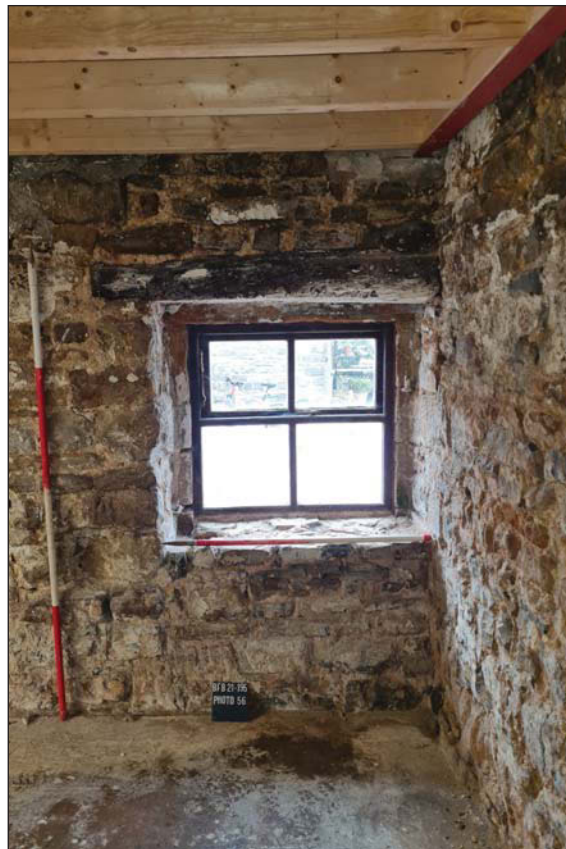
Plate 18. View to former door and replacement window, looking east, scales 2m and 1m

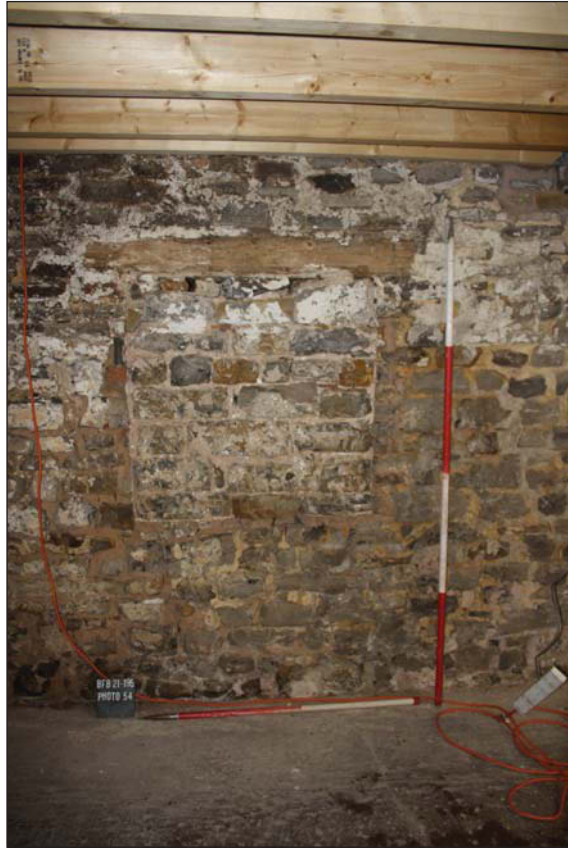
Plate 19. Blocked window / door, looking east, scales 2m and 1m.

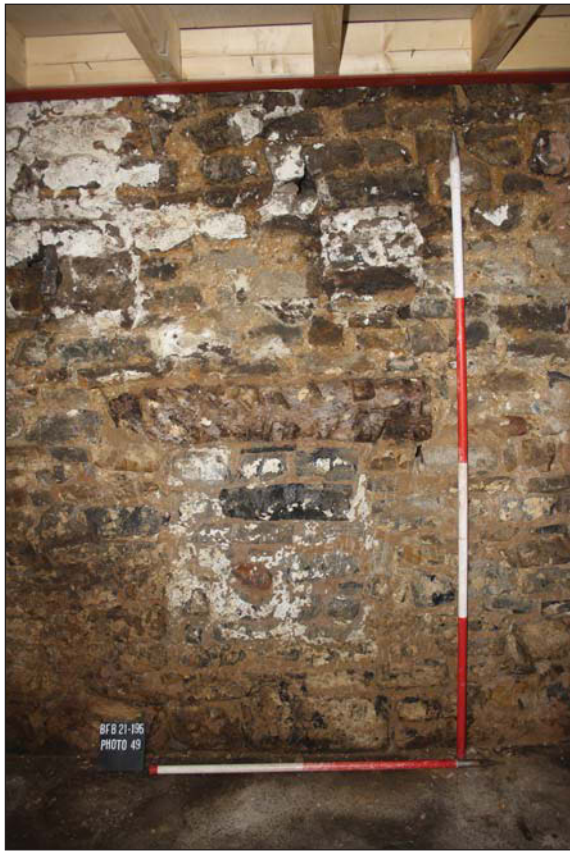
shutters and windows are modern 20th century replacements. Within the southern gable there is a wooden lintel above what appears to be a blocked feature (Pl. 21), though the limewashing on this area obscures the stonework. Its lower height as compared to the existing window suggests that if it was formerly a window it would correspond to the period when the floor was lower and perhaps prior to a building present to the south. There is no corresponding window, blocked or otherwise in the northern gable end.

Plate 21. Blocked window, looking south,
scales 2m and 1m

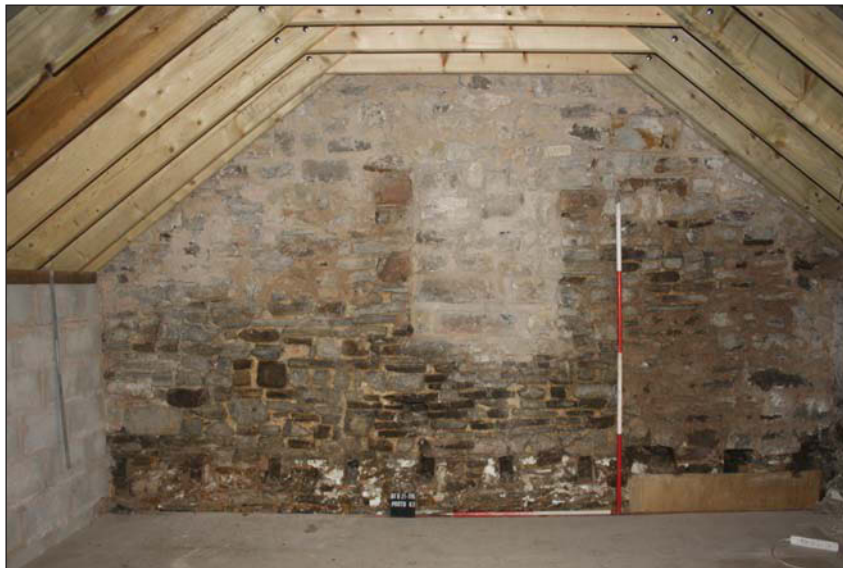
Plate 26. First floor blocked pitching eye and former floor joists, looking north, scales 2m and 1m.

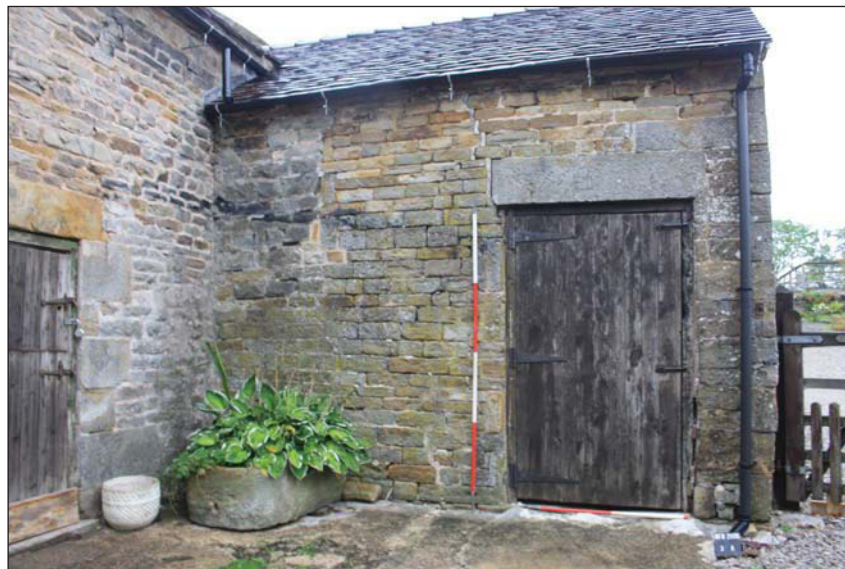
Plate 29. Southern stable elevation with blocked high-level pitching eye abutting the cow-house, looking north, Scales: 2m and 1m

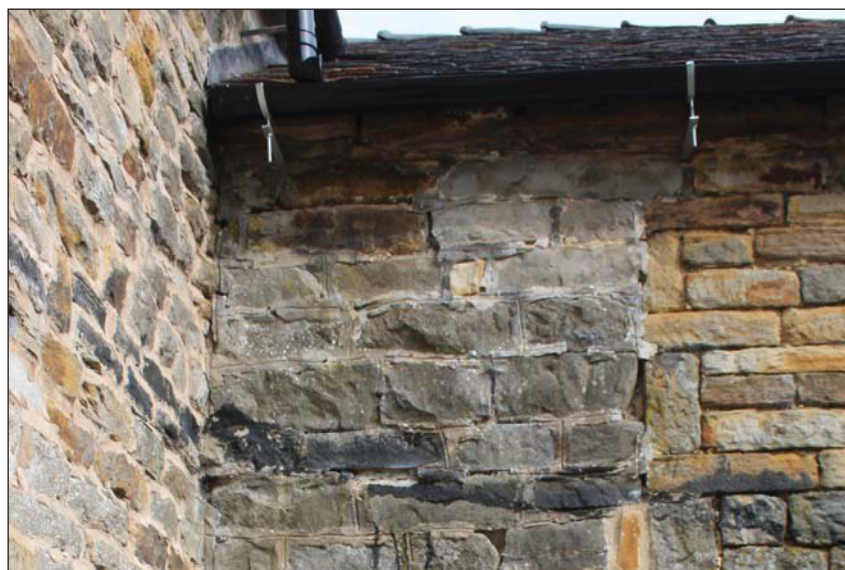
Plate 30. Detail of blocked high-level pitching eye on stable extension abutting the eastern elevation of the cow-house, looking north.

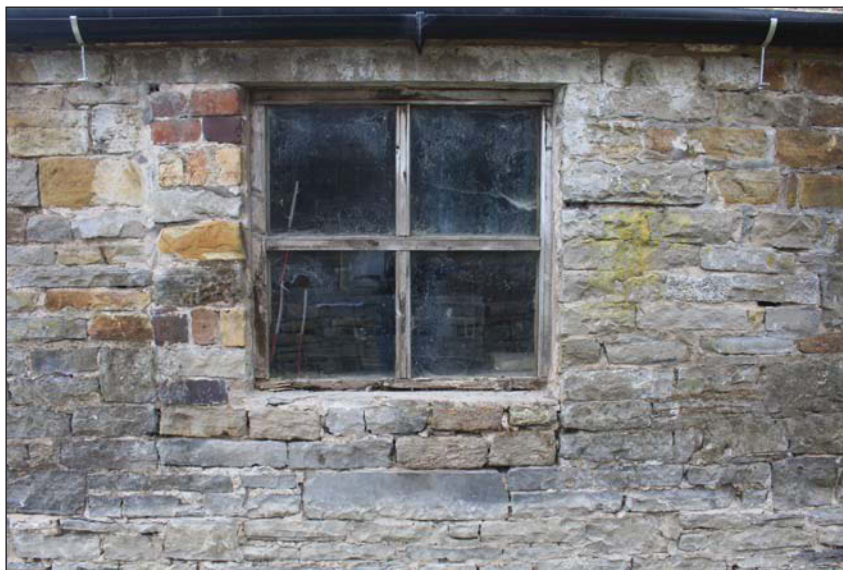
Plate 36. Detail of window in north elevation of lean-to showing the original extent,
looking south.

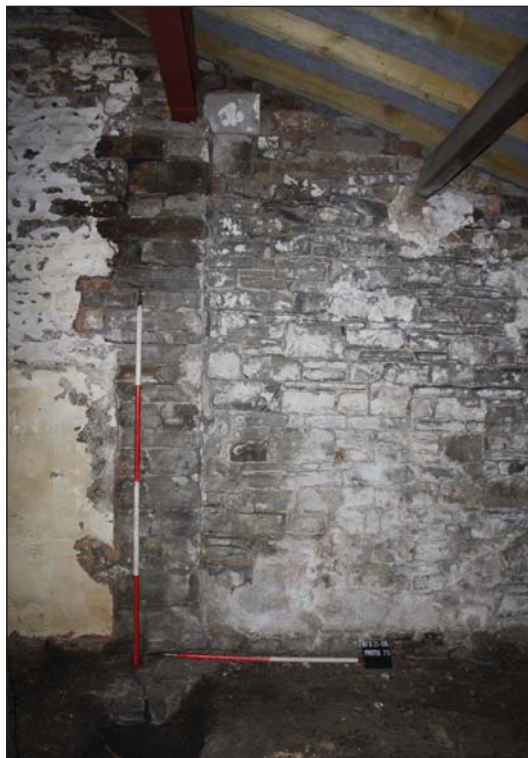
Plate 40. Former location of northern stable wall and steel beam,
looking west, Scales: 2m and 1m.

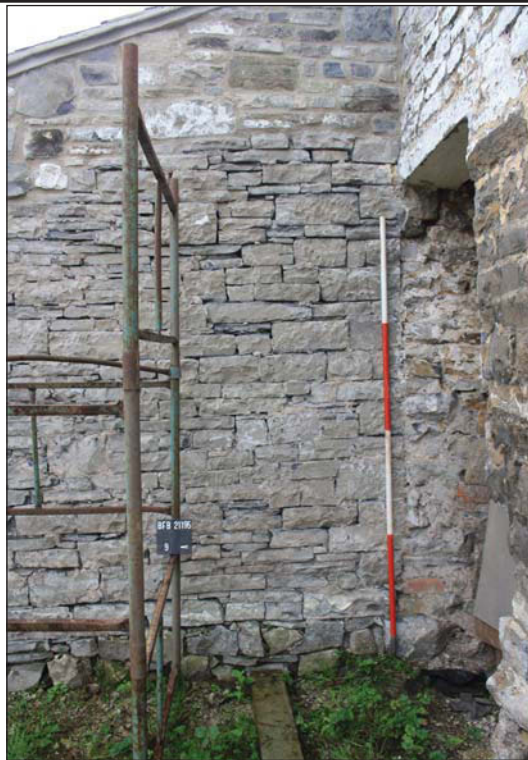
Plate 43. Open coursing on western elevation of lean-to and later opening to cow-house visible right, looking east, Scales: 2m and 1m.

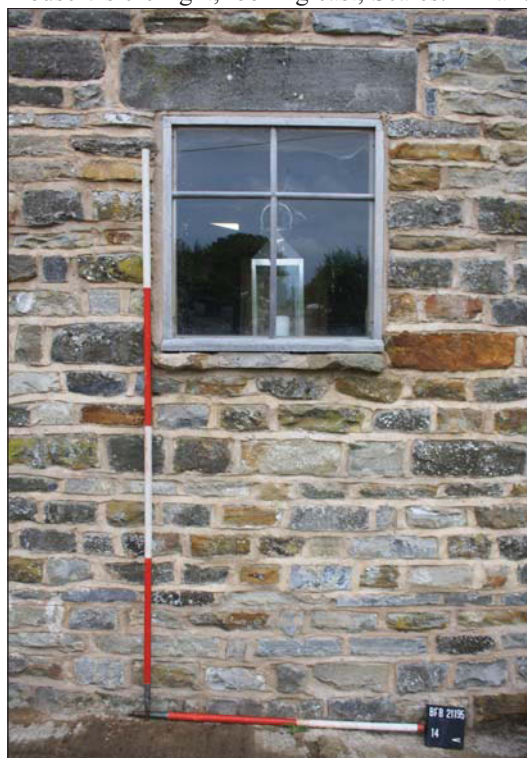
Plate 44. The replacement window and original lintel in the western elevation of cowhouse, looking east, Scales: 2m and 1m.

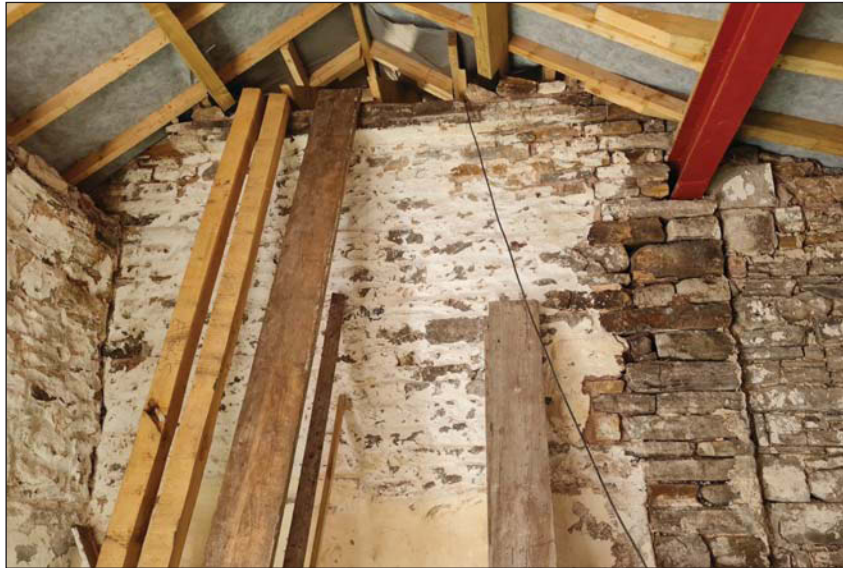
Plate 45. Internal view of previously exterior east gable of cowshed, but now interior and forming west wall of stable, showing straight joints where stable and later lean to attach, looking west.

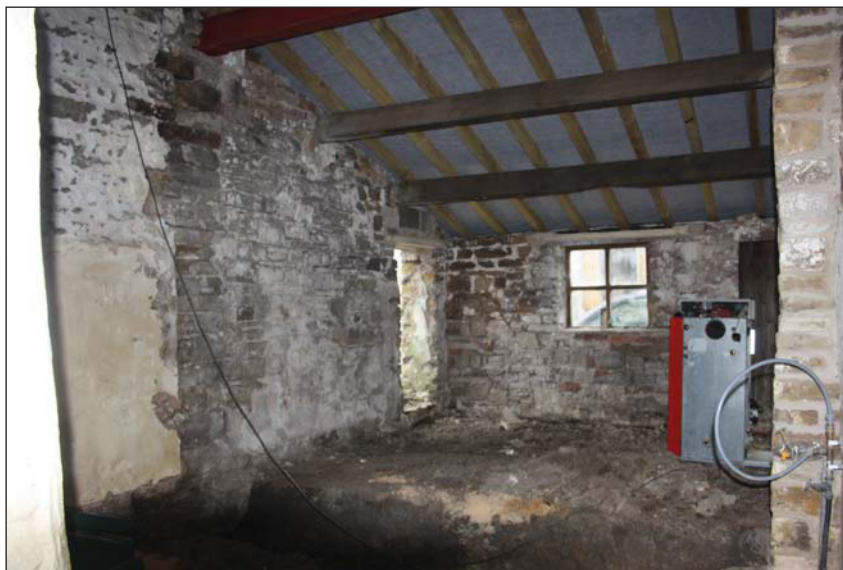
Plate 46. Oblique view of above gable showing interior of lean-to and extent of modern roof replacement on entire structure, looking north-west
