**Kiosks, Water Pumping Station, Tidmarsh Road,
Pangbourne, West Berkshire**

Building Recording

Site Code: TRP22/85

July 2022

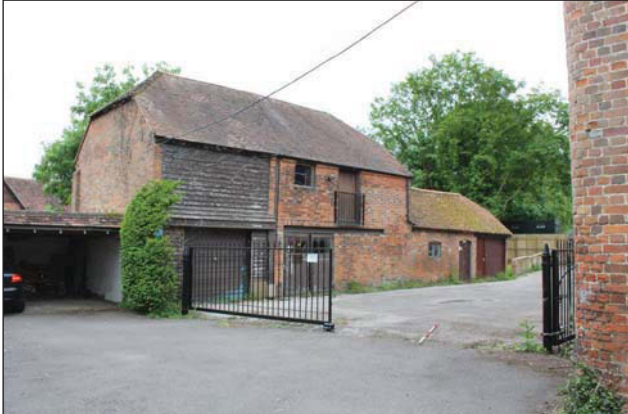
The Kiosks building is aligned north-south backing onto a branch of the River Pang. It consists of two buildings; the larger building to the north and a smaller building with outshot to the south (Pl. 1) (Fig. 7).

The northern building consists of a two-storey building with half-hipped roof. It is brick built in Flemish bond with a red clay tiled roof (Pl. 1).

Plate 1. Oblique view of building, looking South East;
Scale: 2m.

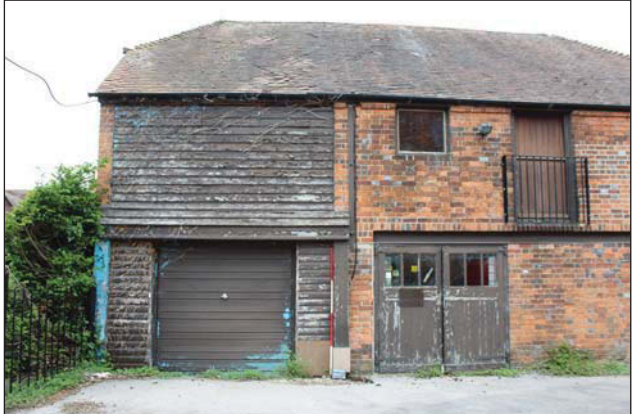
The main, western elevation (Fig. 10; Pls 2 and 3) consists of an area of horizontal weather boarding at the northern end, with the ground and first floors divided by a steel RSJ. On the ground floor the boarding is broken up by a modern garage door located centrally. To the south is a further steel RSJ dividing the ground and first floors. On the ground floor are a pair of wooden doors, each with three window lights in the top third. On the first floor is a window and a stable-type door with a wrought iron fence in front. The RSJ extends well beyond the first floor doorway but there is no indication as to its purpose. None of the openings appear to have been reduced in size; quarter bricks are present on either side of all the openings suggesting they are original and there appears to be no infilling of brickwork. Above the RSJ is a line of bricks laid rowlock bond. Within the weatherboarded section are two top-hung hatches that open outwards.

Plate 2. Frontage, north end, looking East; Scale: 2m.

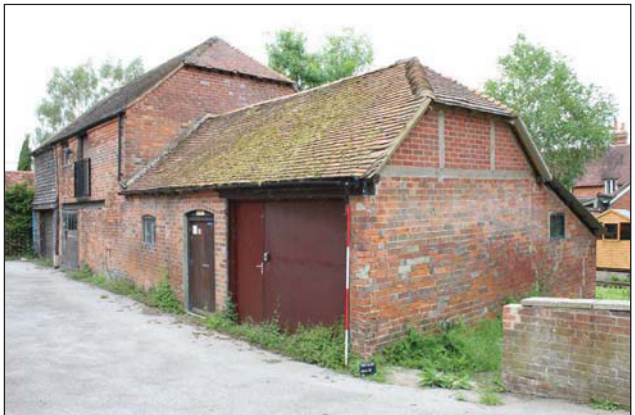
The southern gable end (Fig. 12; Pl. 4) is mainly obscured by the building to the south but the area above the roofline can be seen to consist of brickwork laid in Flemish bond up to the level of the wall plate, above which it appears to have been rebuilt in stretcher bond.

Plate 4. Southern gable end, oblique, looking North East;
Scale: 2m.

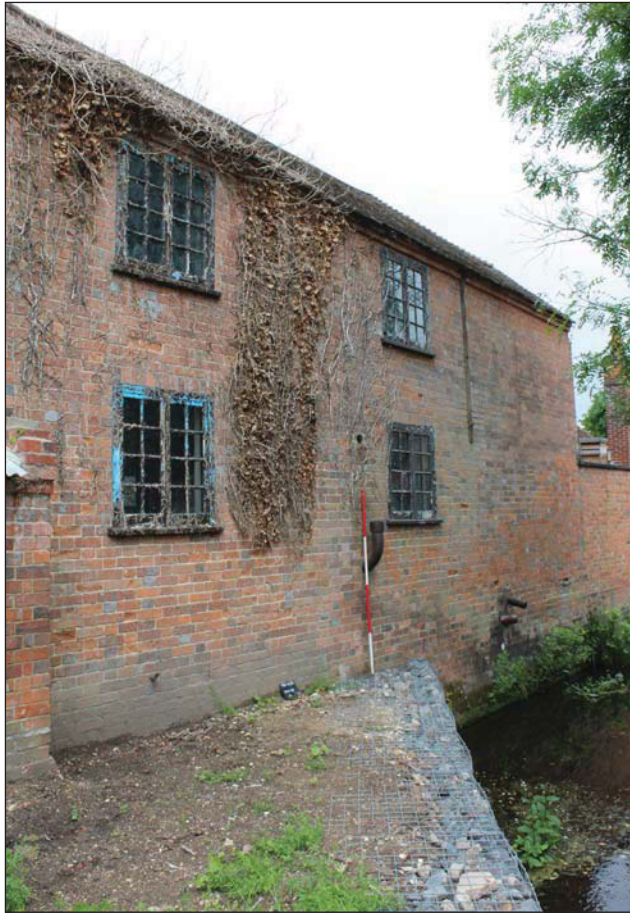
The rear, eastern elevation (Fig. 11; Pl. 5) has limited accessibility as it backs directly onto the river. It can be seen to be built entirely in Flemish bond, as the frontage. Within the elevation are four casement windows; two on each of the ground and first floors. The windows are wooden and contain eight lights each. Above the ground floor windows is a line of rowlock bond bricks.

Plate 5. Rear, northern end, looking North West.

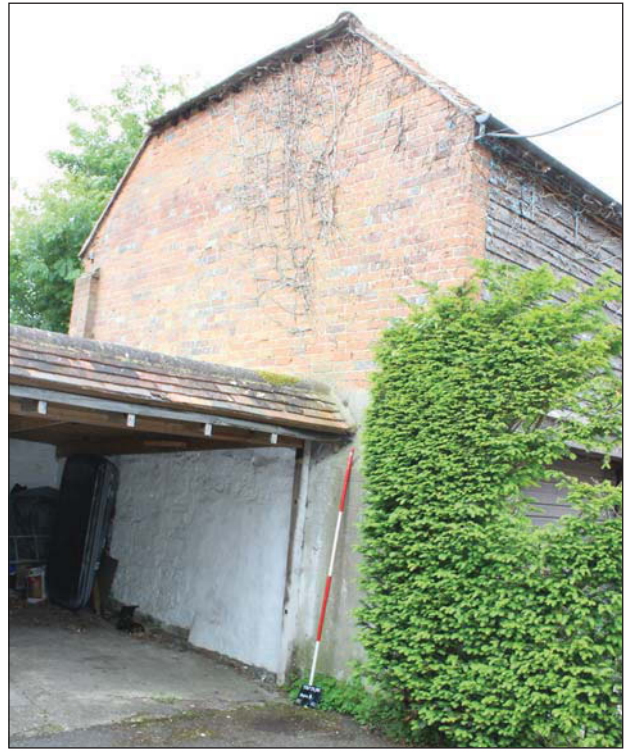
The northern gable end (Fig. 12; Pl. 6) is partially obscured by an adjacent, open garage building. Beneath the roofline the wall has been rendered over to create an ashlar effect whilst within the garage space the render is rough and painted white. Above the garage roofline the wall is brick built in Flemish bond with no openings. At the eastern end is a supporting pillar, ending just below the wall plate level.

Plate 6. Oblique to northern gable end, looking South East.

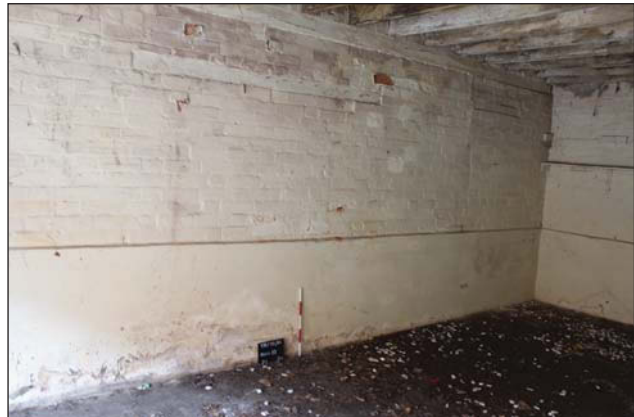
painted white (Pl. 7). The lower section of wall has been rendered and painted white. The northern wall contains a lintel, above which is a partial line of header bricks (Pl. 8). Its function is uncertain and there is no indication within the brickwork of a blocked opening. Within the eastern, rear wall is a central pillar (Pl. 7). Floor joists are laid on edge, aligned north-south. On the northern side they sit upon a wooden wall plate (Pl. 8) whilst on the southern side they appear to sit on wooden pads (Pl. 9). The southern side is more complex with gaps suggesting that the existing joists are a replacement for an earlier floor and that it is likely that the northern wall plate is also a replacement as there is no indication of the earlier floor.

Plate 8. Garage, Oblique view to north wall, looking North East; Scale: 0.5m.

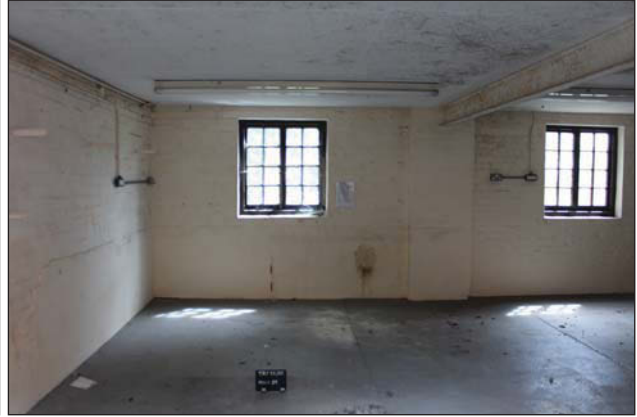
The southern room of the north building (room 1) is accessed via a pair of double doors leading straight into the room. The brick walls are painted white and the ceiling has been boarded over and painted white (Pl. 10). The floor is concrete. The ceiling contains a pair of steel RSJ's supporting the first floor (Pl. 11), both supported on a brick pillar in the east wall and the brick wall beneath the RSJ in the west wall. A set of stairs are located along the western wall giving access to the first floor (Pl. 12). These stairs are basic and of simple timber construction, consisting of a steep set of steps with a closed string but no balusters or hand rail. A metal hand rail is attached to the brick wall but the stairs are otherwise open. In the area beneath the stairs a kitchen has been inserted. The windows are simple consisting of a wooden frame and two casement windows each containing eight lights (Pl. 10). There is no window sill other than the brick wall in which the frame is inserted. Above the windows is a slim lintel. Within the south wall is access to the outshot to the rear of the southern building (room 2) (Pl. 11).

Plate 10. Room 1, View to window looking East; Scale: 0.5m.

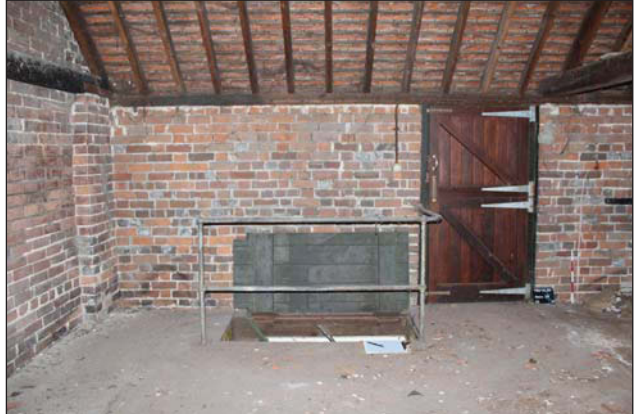
The first floor (Fig. 9; Pl. 13) consists of a single room (room 5) accessed via the staircase. A hatch and door are located within the floor of the room to close off the stairs (Pl. 14). The hatch is of plank construction and shadows within the wood show that it formerly had a diagonal bar holding the planks in place but it is now held together by a bar at either end. The walls and roof structure are exposed on the first floor and the floorboards are visible and consistent throughout. The windows are in the same style as those on the ground floor with a wooden lintel above. The weatherboarded opening (Pl. 15) in the west wall consists of a central post supporting a diagonal brace on each side. These in turn support other posts which extend to the wall plate. Across the top of the weather boarding are two hatches which open outwards as window openings. The central window in the west wall (Pl. 16) has a simple wooden frame containing a single pane of glass. It sits beneath the wall plate and has a wooden plank sill. The stable style door within the same wall is a modern plank door with modern hinges (Pls. 14 & 16). The northern gable end wall (Pl. 17) contains a central brick pier to support the end truss along with one at the western end of the wall. There is no pier at the eastern end of the wall, it is

Plate 14. Room 5, Stair opening, looking West; Scale: 0.5m.

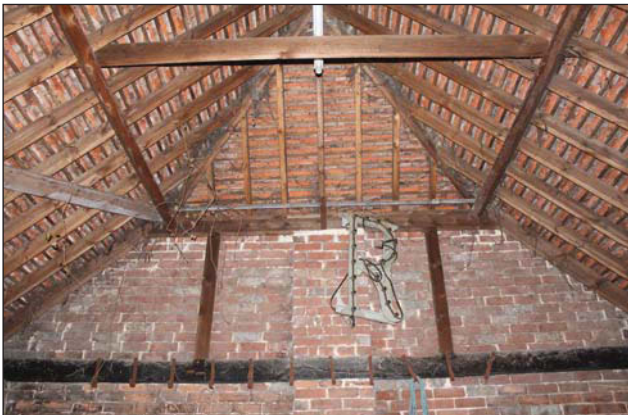
The roof structure consists of four trusses (Pl. 13); one at either end of the building of queen post type supporting a raised collar and the base of the half hip (Pl. 19) and two central trusses with a central iron bar and two raking struts (Pl. 20). The purlins are supported on the back of the principal rafters of the central trusses and on the raised collar of the end trusses. The common rafters are all laid on edge and meet at a central ridge plank. Diagonal bracing is present in some of the bays (Pl. 21).

Plate 19. Hip detail, looking South.

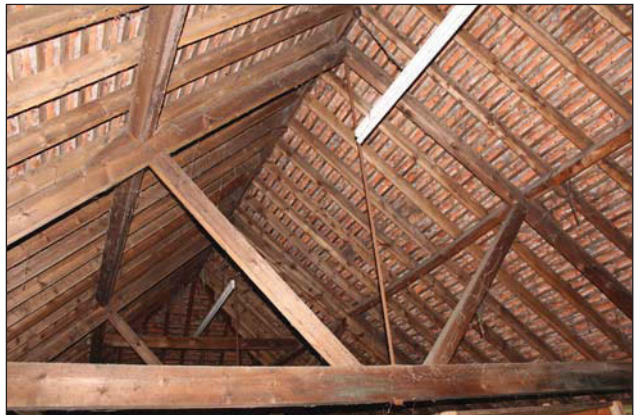
Plate 20. Roof detail, looking North East.

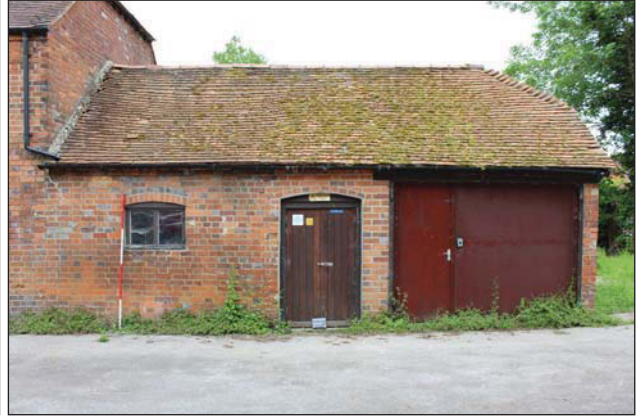
The main, western elevation (Fig. 10; Pl. 22), is bonded into the northern building in Flemish bond. At the northern end is a window containing two panes of glass set beneath a curved arch of rowlock bond bricks beneath a curved row of headers. To the south is a narrow set of double doors of plank construction set beneath a curved row of headers. The area above the door and to the south has been rebuilt using modern cement mortar. A narrow brick pillar to the south divides the door and the larger opening to the south that is infilled with a modern door and timber board panels.

Plate 22. Frontage, southern end, looking East;
Scale: 2m.

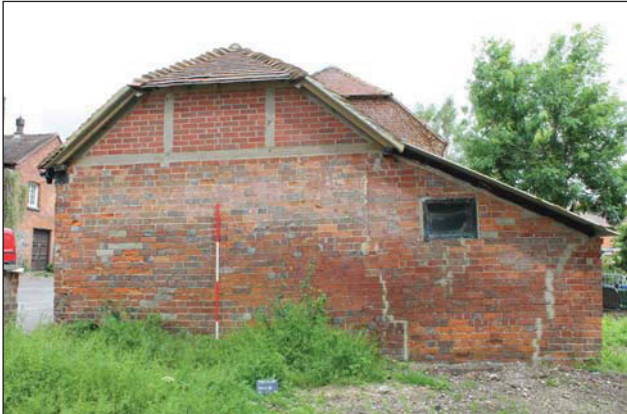
The southern gable end (Fig. 12; Pl. 23) is formed of two parts; the main building and the outshot to the east. The main wall is built in Monks bond and this extends across the outshot, with the walls tied in together. Above the tie beam in the main building the walls have been rebuilt in stretcher bond and modern cement mortar. The tie beam supports a pair of queen posts which in turn support a raised collar and the half hip. Within the outshot is a single wooden window containing one pane of glass.

Plate 23. Southern gable end, oblique, looking North,
Scale: 2m.

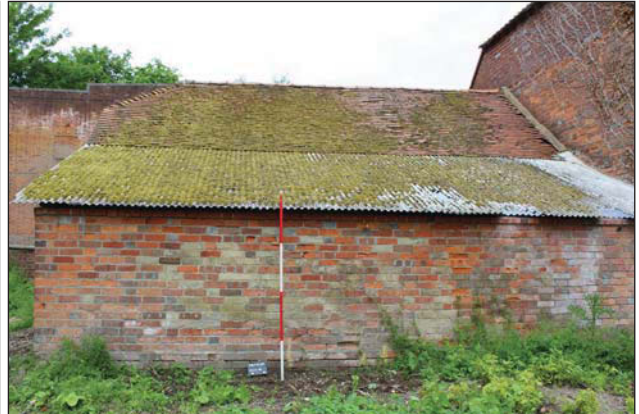
The rear, eastern wall consists solely of the outshot which contains no openings (Pl. 24). The wall is laid in Flemish garden wall bond. It extends further to the east than the northern building resulting in a small section of northern wall with a stepped finish at the top (Pl. 25).

Plate 24. Rear wall of outshot, looking North West;
Scale: 2m.

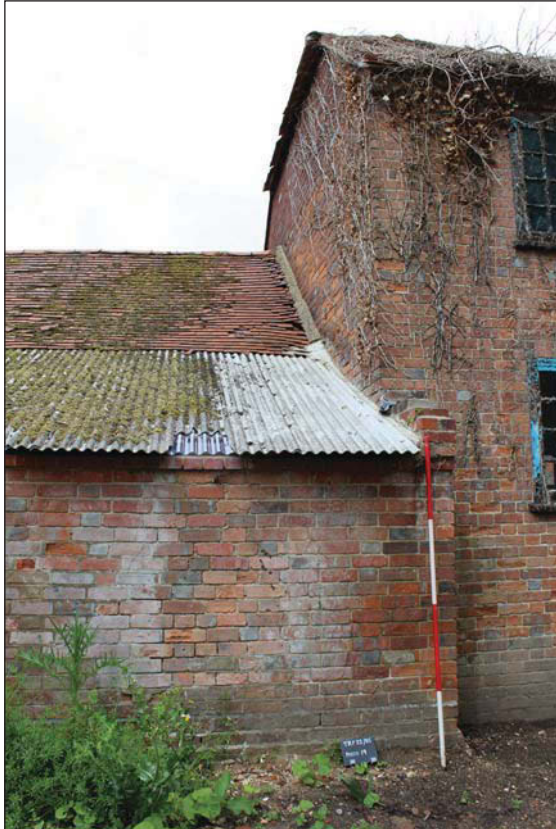
Plate 25. Rear, centre, looking West; Scale: 2m.

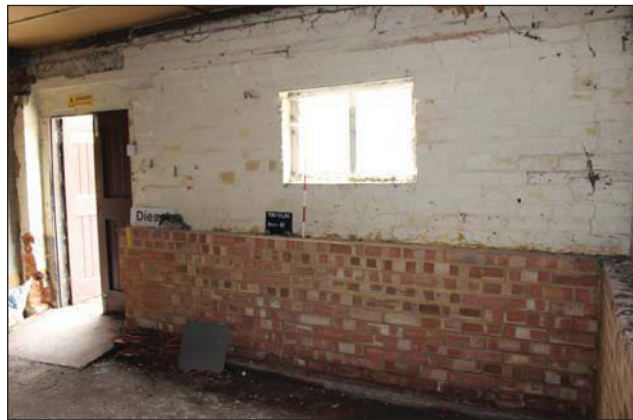
Room 3 (Pl. 28), forming the northern part of the southern main building is accessed from the doors in the west elevation into a single room. The floor is concrete and the walls vary in treatment. The upper part of the wall has been whitewashed whilst the lower part appears to have been reinforced with a second skin, laid in stretcher bond using Fletton bricks. The ceiling has been boarded over. Along with the main access a window is present within the western wall (Pl. 28). Within the northern wall part of the second skin of brickwork has been removed and a pipe inserted through the wall beneath a concrete lintel (Pl. 29). The area of the former doorway is present at the southern end of the eastern wall with the second skin of brick work obscuring the lower scar. The southern, dividing wall is of concrete blockwork.

Plate 28. Room 3, West wall, looking West; Scale: 0.5m.

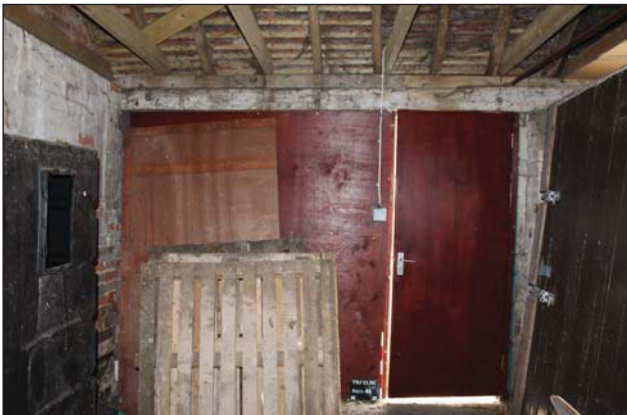
Room 4 (Pl. 30) has a separate access via a single door in the west elevation. Internally construction is similar with whitewashed walls and a concrete floor. The roof structure is exposed. The west wall can be seen to be a former opening, similar to the garage in the northern building (Pl. 31). The north wall is the concrete block dividing wall with room 3. There is no wall dividing the outshot from the main building (Pl. 30); the wall has been replaced with a wooden beam set on an upright post in addition to resting on the concrete block dividing wall and on the southern wall of room 3 (Pl. 30). Within the southern wall of the outshot is a single window opening (Pl. 32) and within the wall of the main building are three upright posts; two full-height and one slightly shorter. Two posts are joined with a rail. Roof construction consists of common rafters meeting at a ridge plank and resting on a purlin, which in turn rests on the raised collar in the southern wall (Pls 33 & 34).

Plate 31. Room 4, West wall, looking West, Scale: 0.5m.

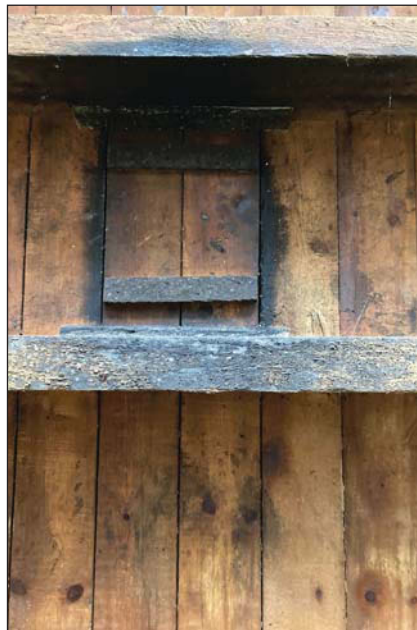
There was some evidence of fire damage on the first floor of building 1 with charred timbers within the gable end walls and evidence of burning from above in the roof of the garage (Pl. 35). A fire may well account for the replacement roof and parts of the floor.

Plate 35. Garage, evidence of burning in the ceiling, looking up.
