Rear of 19-21 Market Place, Henley-on-Thames, Oxfordshire

Building Recording

Site Code 19MSH11/41

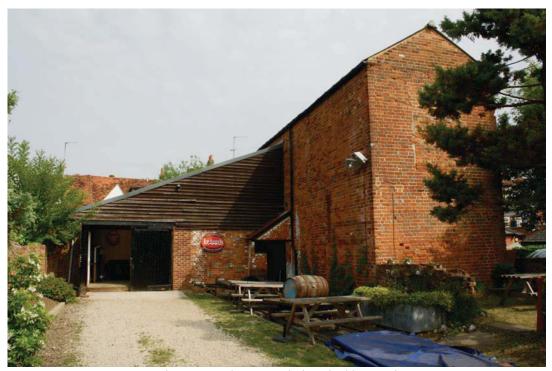
The brewery operates within the southern part of a long rectangular building, and within a large extension built to the west of this structure (Fig. 2). Both buildings are constructed from red bricks, although the upper part of the extension is timber framed and covered with weatherboards (Pl. 1). A number of historical features were noted on the main building, including blocked doors and windows, but not recorded in detail as part of this project. The extension building had also clearly been altered in the past, with the most obvious changes being visible in the south-facing elevation, where several phases of rebuilding were evident. One of the most striking was the blocking up of an earlier entrance, through which railway tracks had originally run. A section of the surviving rails was visible to the south of the extension. However, once again, these parts of the building were not recorded in detail.

Plate 1. Exterior, general view, looking north

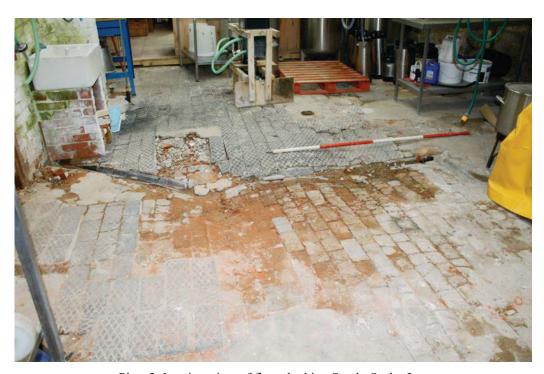
Plate 2. Interior, view of floor, looking South; Scale: 2m

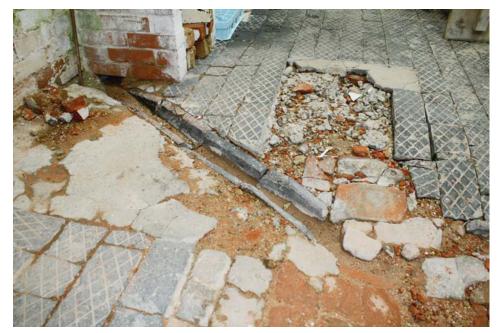
Plate 3. Detail of drain, looking east

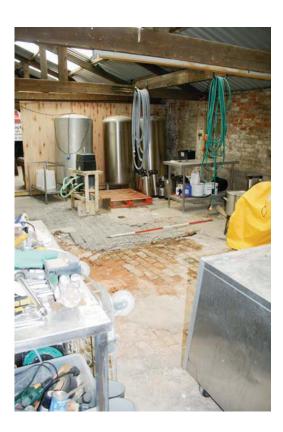
Much of the southern part of the room was covered with dark bluish grey stable bricks, which had a diamond pattern on their upper faces. These measured 253mm x 125mm x 50mm, which equates to 10" x 5" x 2" in imperial measurements. These bricks were produced from the Victorian period onwards, and were specifically manufactured to cover floor surfaces. The grooves within the diamond pattern were designed to expel water easily, and as a result they were frequently used outside, and within farmyards and stables, hence their name. As well as covering much of the southern half of the room, they also appeared along part of the eastern edge. A drainage channel, constructed from purpose-made tiles, crossed the centre of the room, although this feature was badly damaged in places (Pl. 3). It is interesting to note that the old red bricks appeared to the north of this channel, with stable bricks to the south (Pl. 4).

Plate 4. General view of room in NW corner of extension, looking SW; Scale: 2m
