**Lower Northbrook Farm, Titnore Lane,  
Worthing, West Sussex**

**Historic Building Recording**

**Historic Building Recording  
For Bloor Homes (Southern) Ltd**

Site Code LNF 12/182

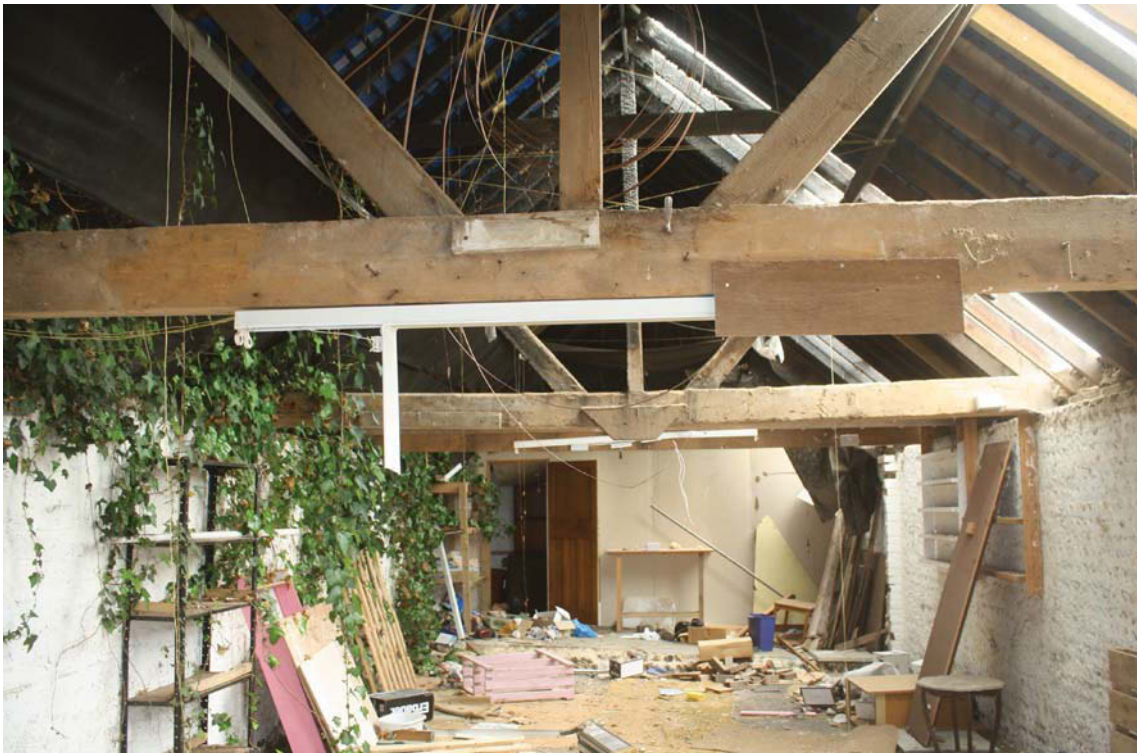
Plate 11. Interior of Building 5b, looking east.

Room B is accessible via an external doorway which leads into the western end of the room (Pl. 10). The north, west and south walls of the room are all constructed from regular courses of beach pebbles and flint, with red bricks used around the doorways (Pls 11–13). A doorway in the west wall, which would originally have provided access to room A, had been blocked up with breeze blocks. The eastern wall of the room is a modern stud partition, covered with plasterboard, but the scars of an earlier dividing wall could be seen about 2m west of this. Brickwork in the south-east corner of the room indicates the presence of a blocked window or doorway. It is not clear whether this is the same opening which can be seen externally to the east of building 7, but the measurements taken suggest that it is not. However, if it is, and the Ordnance Survey plan is slightly out, the breeze block eastern wall of room C would be oddly positioned across this entrance. Room C of the building is very small, measuring just 1.80m by 5.70m, and is clearly a modern creation, based on its east and west walls. There is no access from room C into rooms D and E. All of the timbers which compose the roof structure were machine cut and, unsurprisingly, no carpenter's marks were visible. The tie beams rested directly upon the north and south walls of the building. There were two struts and a central post projecting from each tie beam, which supported the purlins and ridge, respectively. Many of the roof timbers were badly scorched, indicating that there had been a fire in the building in the past, and this event had obviously led to some of the timbers being replaced. At the time of the site visit the roof covering was largely comprised of plastic panels.

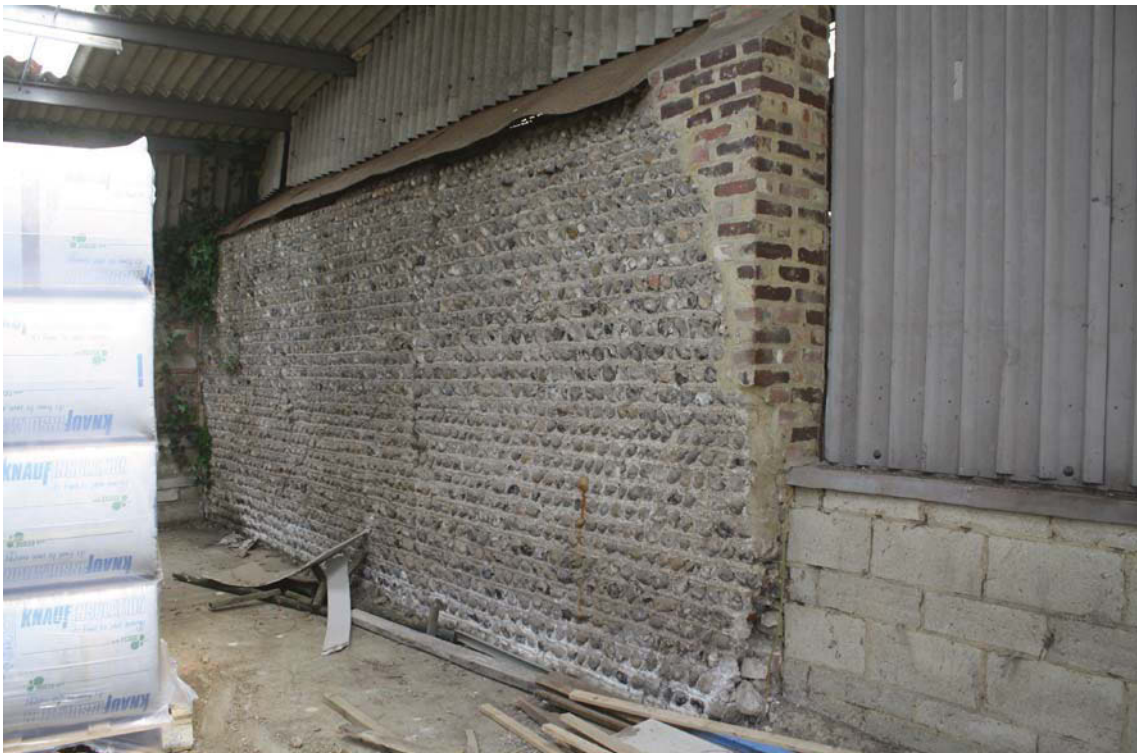
Plate 2. Interior of Building 1a, looking north-east.

Building 1 is located to the north of building 2, and is a large (56.10m by 22m) steel-framed rectangular structure built in the second half of the 20th century for agricultural purposes. The west, south and east sides of the building are of breeze block and asbestos panel construction, with internal lighting provided by Perspex sheets in the otherwise asbestos panel roof. The building is divided into two unequal sized rooms (A and B). The dividing wall between the rooms is of historical interest as the northern section, about 7m long, is obviously earlier than the majority of the building (Pl. 2). The west facing elevation of this section of wall is faced with regular courses of beach pebbles and flint, bonded with a sandy lime mortar. The southern end has been repaired by modern brickwork. However, the east facing elevation is constructed from a combination of red and grey bricks, generally laid in alternating header and stretcher courses. It therefore seems likely that this section of the dividing wall was originally the west wall of the large courtyard which is depicted on 19th century maps. This courtyard area was occupied by an orchard in 1875, but had become a farmyard by 1898. The north wall of room A is clearly modern as it is constructed from a combination of bricks and breeze blocks, whilst the north wall of room B (Pl. 3) is of the same red and grey brick construction seen in the east facing elevation of the dividing wall. It is possible that the pebble faced elevation actually predates 1875, as a boundary is shown roughly in this position on the 1839 tithe map, and that it was refaced on its eastern side in the second half of the 19th century, at the same time as the north wall was built. There is a small alcove in the north wall of room B, about 12m from the eastern end of the building, surmounted with an arch formed from a single course of bricks. The function of this feature is unclear, but the fact that it has been bricked up indicates that it may have been an entranceway into

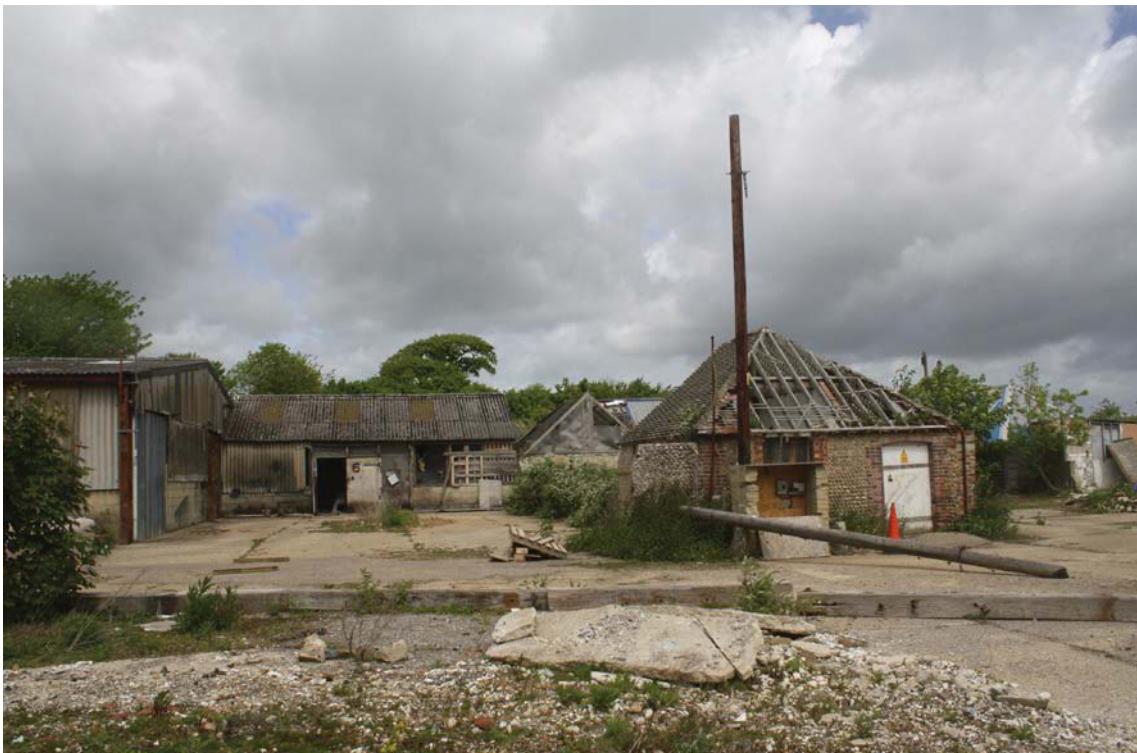
Plate 4. Buildings 3 and 4, looking north.

Building 3 (Pl. 4) is positioned between buildings 1 (to the west) and 5 (to the east), along the northern boundary of the site, and measures 10.80m by 7.50m. The south wall of the building is constructed from breeze blocks, surmounted by a timber frame, and covered with asbestos panels. It utilizes the breeze block eastern wall of building 1 and the pebble and flint western wall of building 5, at its west and east ends respectively. It is not clear whether the north wall of the building utilizes the main 19th century boundary wall as it is obscured by plasterwork. The asbestos panel roof is largely supported by simple steel trusses, some of which have been obscured behind timber panelling. The building was presumably used for commercial purposes until recently, and there is a large doorway in the southern wall (Pl. 9).

Building 4 (Pl. 4) was originally connected to building 5, but the section connecting them was demolished sometime after 2011, and it is therefore treated as a separate entity for the purposes of this report. The various Ordnance Survey maps indicate that these buildings were built between 1875 and 1898, and were part of a roughly L-shaped structure, which are described as stables on the early 20th-century maps. However, building 4 could not have been used for stabling horses as its doorways are too low, and is more likely to have functioned as an office or tack room. This is supported by the fact that the 1898 Ordnance Survey shows an internal dividing wall between building 4 and the rest of the L shaped building. Building 4 measures 5.30m by 5m, and its walls are 2m high up to the eaves. The west, south and east walls are faced with regular courses of beach pebbles and flint, with standard-sized red bricks used for the quoins and around the window and door openings. There are two decorative red brick string courses along the west facing elevation. These walls are bonded with sand and cement mortar with frequent shingle inclusions, and are 0.35m thick. There is one door and a window in the south facing elevation, whilst the east and west facing elevations have one window each, the west one being different with louvres above. The north wall of the building was originally an internal wall, but the materials used in its construction could not be identified due to it being rendered with plaster. This wall had one doorway providing access to the now-demolished section of the original structure. Due to health and safety concerns, the building is no longer accessible, but from looking through the doors and windows it was possible to glean that it contains two rooms. The timber roof structure was visible (Pls 6 to 8) as most of the tiles had been removed. Although it was not possible to enter to building, it was clear that the roof structure was wholly comprised of machine cut timbers. The one truss which was visible appeared to have two struts projecting from the tie beam

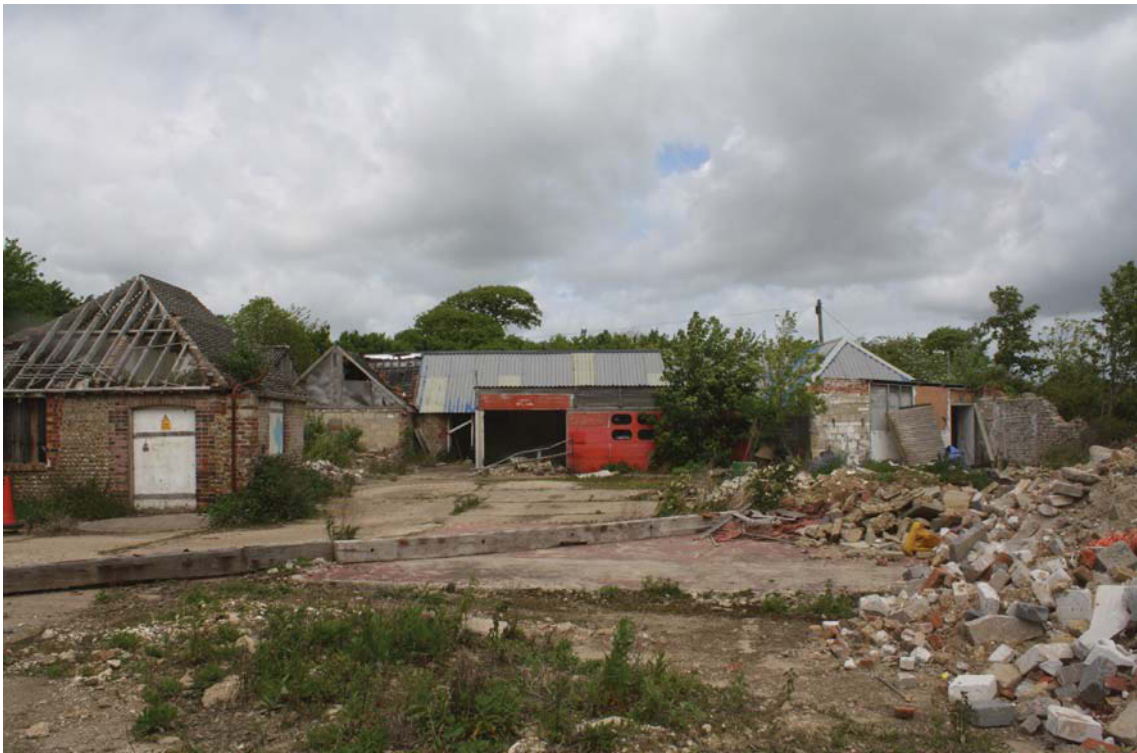
Plate 5. Building 7 with demolished area in foreground, looking north.

Building 7 (Pls 5 and 14) is a modern breeze block built structure, which utilizes the beach pebble and flint wall of building 5, to the north. The building is divided into two rooms, and was previously used as a mechanics workshop. It first appears in its present form sometime after 1972, although it is possible that the northern part may be earlier, as a building on the same footing appears on the 1972 Ordnance Survey.

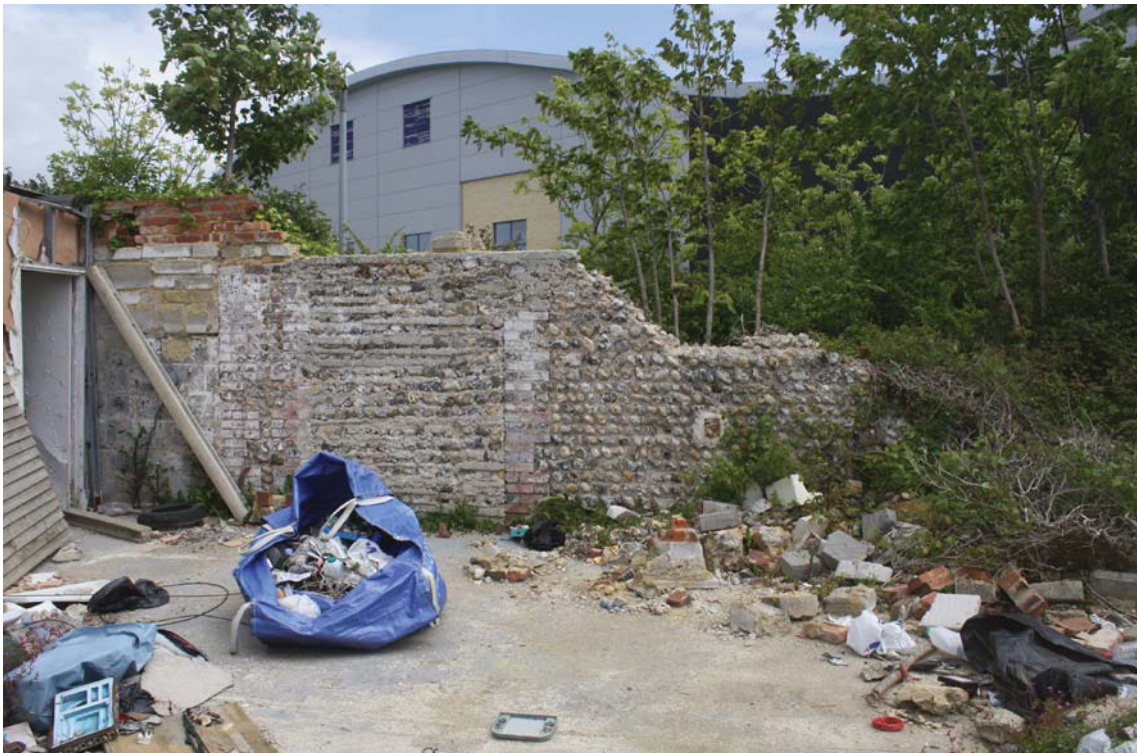
Plate 15. Demolished building at eastern end of site, looking east.

Building 6 is a small (3m by 2.80m) structure which was added immediately to the south of room E of building 5, sometime after 1972. Apart from its east wall, which represents part of the old pebble and flint external wall of the site, the walls of building 6 are all of modern breeze block construction, with red bricks being used for the upper courses. It is difficult to ascertain the former function of this room as it was, until very recently, connected with the range of buildings to the south which have been demolished. Very little remains of these demolished structures, apart from their concrete slab floors and some surviving sections of breeze block walls. A small section of the 19th-century beach pebble and flint wall, which once formed the eastern boundary of the site, is still visible to the south of building 6. However, this small section demonstrates how this wall was altered over time, and at least four different episodes of building and re-building are evident including blocking of a gateway (Pl. 15).

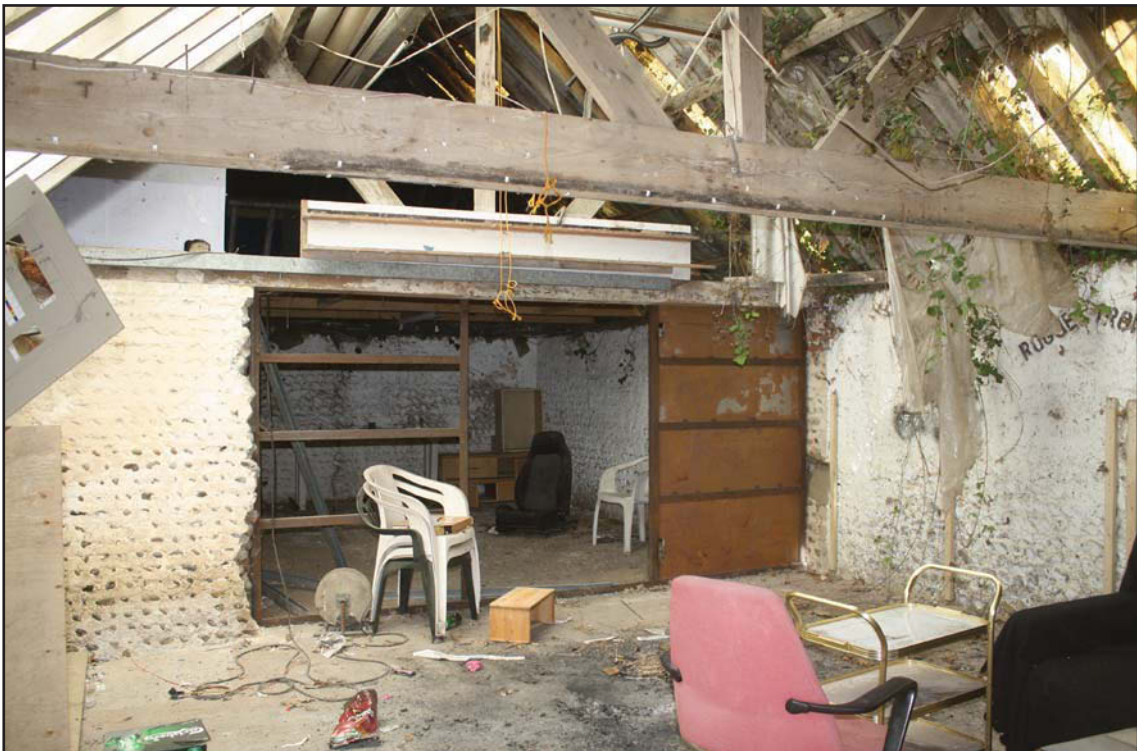
Plate 16. Interior of Building 5e, looking north.

two rooms, consisting of a metal sliding door, is a modern alteration (Pl. 18), and there was originally a pebble and flint dividing the two. The western section of this earlier wall is still present, and there is a corresponding scar on the east wall of room E (Pl. 16). Room D was probably part of the stable block mentioned on historic maps, although no features associated with this function are present (Pl. 17). The historic maps indicate that Room E has been substantially altered over the years and, prior to the 1972 Ordnance Survey, was previously shown as being separate from building 5. By comparing the 1972 map with the modern Ordnance Survey, it seems clear that room E was extended at some point after 1972. This is confirmed by the present structure, which has a breeze block southern wall, and a timber framed west wall covered with steel sheeting. The extension can also be detected in the pebble and flint east wall, as there is a clear divide between the section within the original room, which is whitewashed, and the part of the wall which previously an external wall. The roof was covered with modern plastic panels, and supported by a timber frame of machine cut timbers. No carpenter's marks were visible. The tie beams sat directly on the walls of the building, and had projecting struts and a central post, which supported the purlins and ridge respectively.
