**White Post House, Whitepost Hill,
Redhill, Surrey**

Building Recording

Site Code: WPR15/105

November 2015

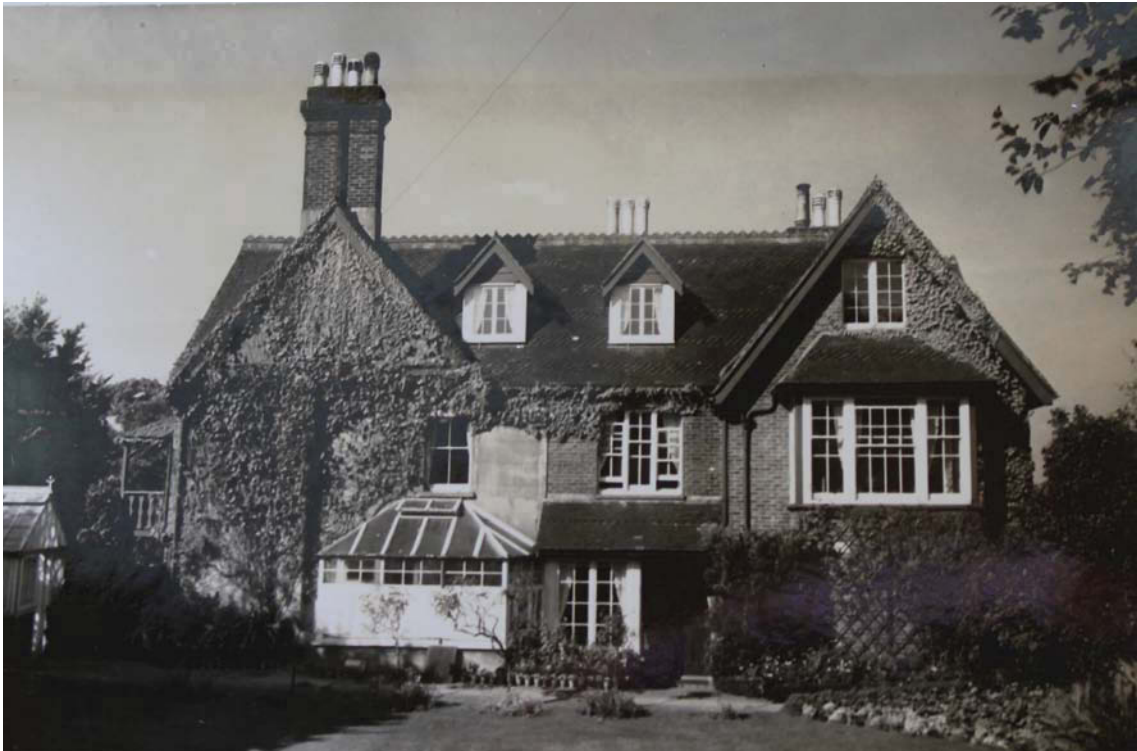
The photograph (Pl. 1) shows the southern elevation which is partially rendered. On the ground floor is an entrance and a glasshouse/conservatory. The first floor includes two different types of window, both of which are of the sash variety. Within the roof space are two dormer windows and a window in a gable end. Projecting from the west elevation appears to be a balcony, which appears to be of wooden construction with shaped balusters and a pitched roof.

Plate 1. The south elevation in 1938.

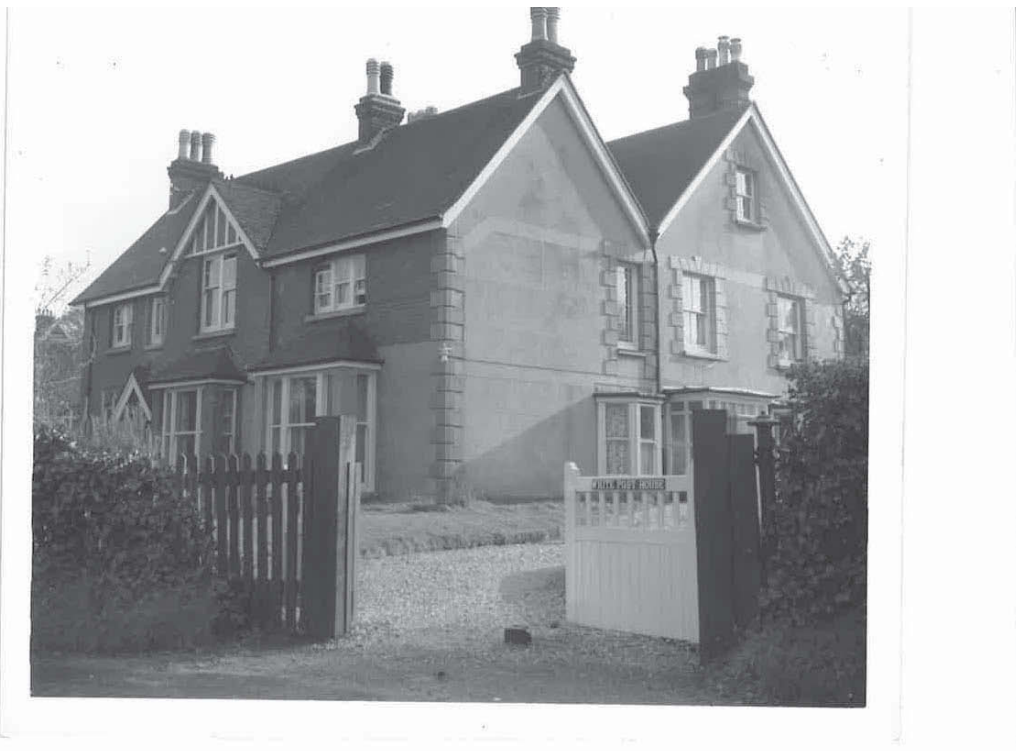
A second photograph (Pl. 2) from c. 1950 shows the north and west elevations. The entirety of the west elevation is rendered, where as only the ground floor is rendered on the north elevation. The windows are all sash windows. Within the north elevation, on the ground floor, are two bay windows and a probable porch, on the first floor are a further four windows. Within the west elevation can be seen at least one bay window (but probably two) and an entrance porch on the ground floor, three further windows on the first floor and a single window within a gable end on the second floor. Quoins were present on the corners of the west elevation and around the windows.

Plate 2. The north and west elevations, c. 1950.

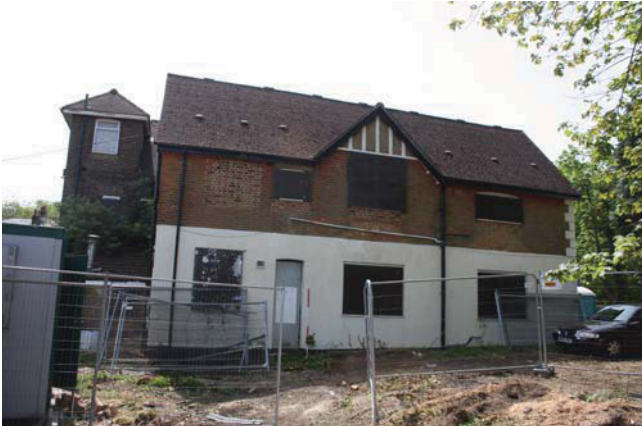
The north façade (Pl. 3) was rendered on the ground floor with exposed brickwork on the upper floor. The bricks were laid in Flemish bond with a shallow frog measuring 228mm x 105mm x 65mm (9" x 4 1/4" x 2 1/2"). Upon demolition it was seen that beneath the render the wall was of mixed construction, consisting of both bricks and rag/iron stone rubble (Pl. 4). The bricks measured 216mm x 108mm x 65mm (8 1/2" x 4" x 2 1/2") and were bonded in lime mortar. At the north-west corner was a line of quoins. On the ground floor were three windows and a door. Above the central and western most window there was evidence within the brickwork for a projecting roof as seen in the photograph from the 1950's (Pl. 2). On the first floor were a further three windows. At the eastern end it was clear within the brickwork that a window had been blocked up. Above the former eastern most window and the western most window was a brick arch. The smaller window above the door may be a later insertion as it had a concrete lintel above it. The central window had a gable above it, which was enhanced with vertical timbers above it, painted white and in-filled with pebble dash render. Set back from the main elevation was a more recent, single storey in-fill building of brick construction laid in stretcher bond (Pl. 5). The bricks measured 215mm x 100mm x 62mm (8 1/2" x 4" x 2 3/8"). Behind that was a tower structure, brick built in Flemish bond. The bricks were brown in colour as opposed to the redder colour of the rest of the north face and measured 220mm x 100mm x 65mm (8 5/8" x 3 7/8" x 2 1/2"). Two windows were present at approximately 1 1/2 storeys with a further window on the upper floor. Between the floors was a plat band consisting of dentilated brickwork.

Plate 3. North elevation, looking South,
Scales: 2m and 1m.

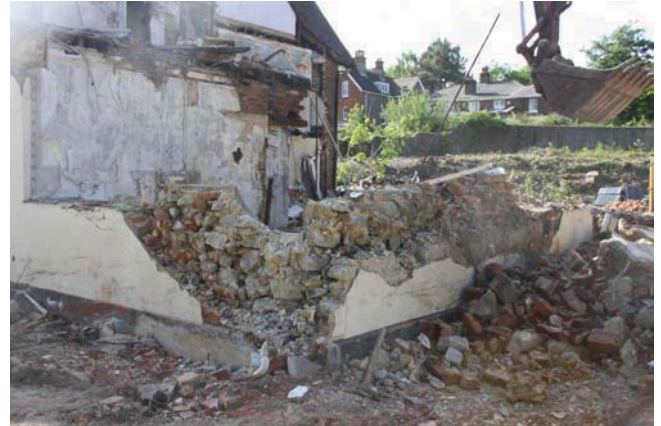
Accessed from the corridor at the east end was a room to the north (room 6) which was approximately square in plan with a window in both the north and west walls (Pl. 4). Entry to the room was unclear but there was evidence of a former entrance via a dog-leg, taken from the corner of room 8, now blocked up. Within the centre of the west wall was a chimney breast; no mantle piece, fire surround or grate was seen and it is assumed that the chimney was blocked up. Around the wall were the remains of a picture rail and demolition revealed the floor to be suspended timber floor boards above a shallow cavity. The dividing wall to the east appeared to be of timber stud construction above which were six rows of bricks laid in stretcher bond and bonded in cement mortar. This in turn supported the floor joists for the first floor (Pl. 20).

Plate 4. Rubble and brick wall in the NW gable end (Rm 6) looking southeast.

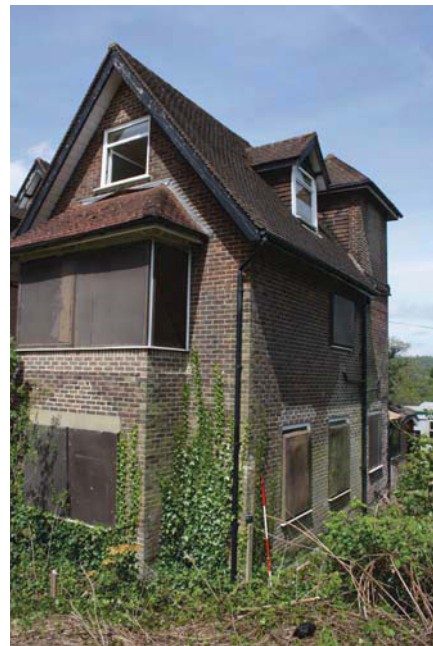
The east façade (Pl. 6) consisted of the brick-in-filled building discussed above, the three storey tower and the side of the southern projecting gable end of the main building. In this face, within the brick in-fill was a doorway with a brick arch above and a window. The tower was a part of the main façade, across which were three windows at ground floor level, one window within the first floor and an additional dormer window within the roof space. All the brickwork within this section was laid in stretcher bond, bonded in cement mortar; the same as those recorded in the tower structure above.

Plate 6. Oblique of south and east elevations, looking northwest, Scales: 2m

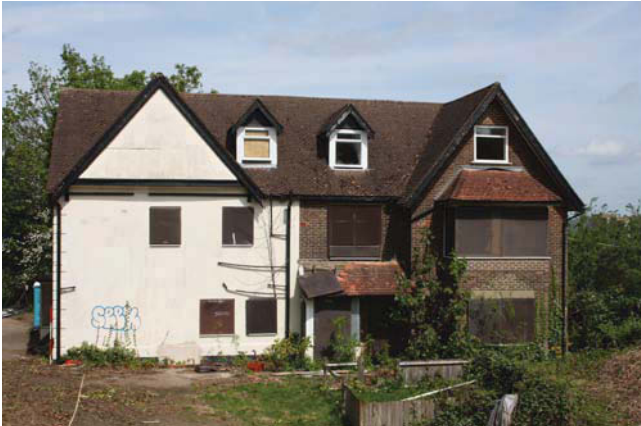
The south façade (Pl. 7) was composed of two parts; the east end which where the bricks could be seen and the west end which was entirely rendered. Within the roof were two projecting gables (one at either end) with two dormer windows between them. The brickwork at the eastern end of the building was the same as that on the east elevation - brown bricks laid in stretcher bond and bonded in cement mortar. Demolition revealed this section to contain a cavity within the wall. Within the easternmost gable was a two storey rectangular bay window; within the apex was a further window. Demolition revealed steel RSJ's above the bay window openings (Pl. 8). Within the centre of the façade was a porch and entrance with a window above. At the western end of the building were a further two windows on both the ground and first floors. On the south-west corner of the building was a line of quoins.

Plate 7. South elevation, looking North,
Scales: 2m and 1m.

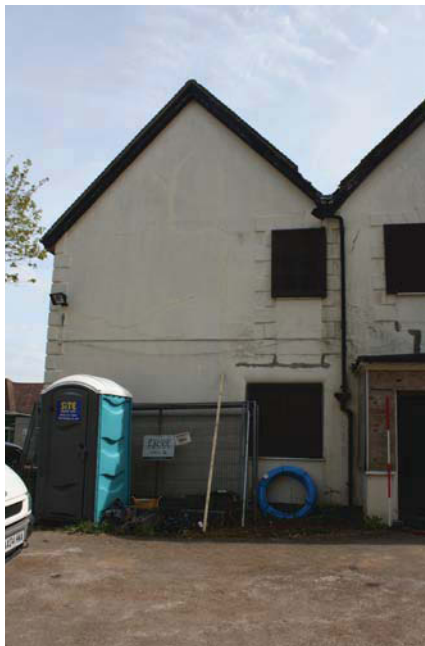
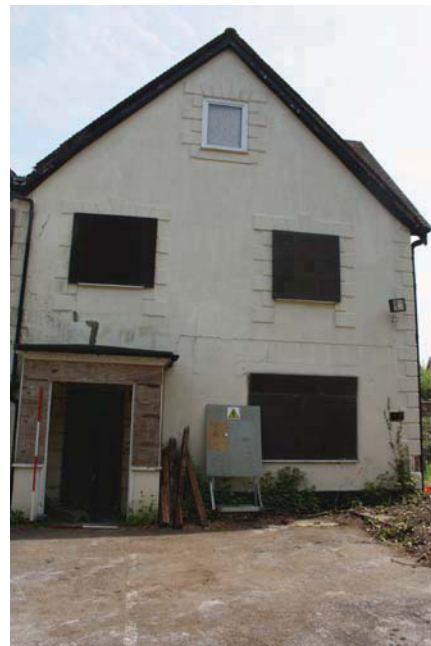
The west façade contained the main entrance to the house and was entirely rendered (Pls 9 and 10). Like the north façade, beneath the render the wall at the north end was constructed of a mixture of brick and stone rubble (Pl. 4). At either end of the building was a line of quoins as well as quoins around the windows on the upper floors and the door. A total of three windows were present on the first floor and all of the quoins extended below the line of the window sills. It can be seen in the photograph from c. 1950 (Pl. 2) that the windows were larger. However the window at the northern end of the façade had even longer quoins suggesting a larger window that had been partially blocked up by 1950. This may have been the location of a door to the balcony described in the 1938 sales particulars. Within the southern gable end was a further window on the second floor, also edged with quoins. On the ground floor were two further windows, either side of the main entrance, these were not enhanced with quoins and the photograph from the 1950's shows them to have been trapezoidal bay windows with flat roofs, extending down to ground level. The main entrance (Pl. 11) was slightly off centre, located at the northern end of the southernmost gable, immediately beneath one of the first floor windows. It was contained within a wooden porch structure with a flat roof. On all three sides were windows (boarded up). A single step up gave access to the porch area, the floor of which was tiled in a red, black and yellow geometric tile pattern, typical of the Victorian era. The porch was present by the 1950's photograph. The porch itself partially obscured the quoins around the door, which formed a pointed arch, typical of the gothic style.

Plate 9. Northern gable end, looking East, Scales: 2m

Plate 10. Southern gable end and main entrance, looking
East, Scales: 2m and 1m.

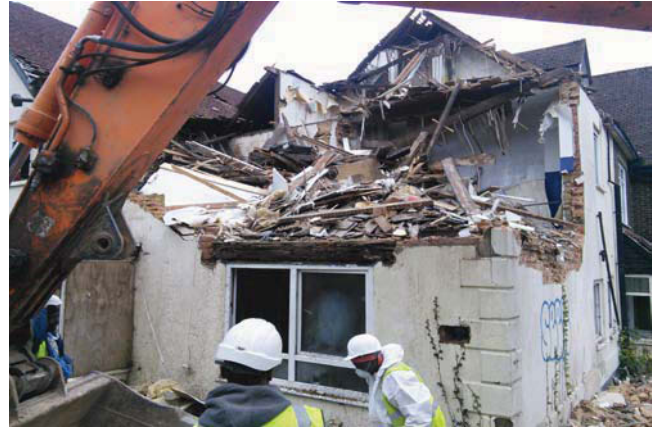
Demolition revealed the southernmost gable end to be bricks probably laid in Flemish bond, bonded in cement mortar. The bricks were orange in colour with a shallow frog and measured 228mm x 108mm x 70mm (9" x 4 1/4" x 2 3/4"). They look to have been stamped 'Foxes'. The lower parts of the windows have been blocked up with a combination of concrete blocks and brickwork. Above the windows was a wooden lintel (Pl.

Plate 12. Detail of 1st floor rooms and lintel above window (Rm 12) looking Northeast.

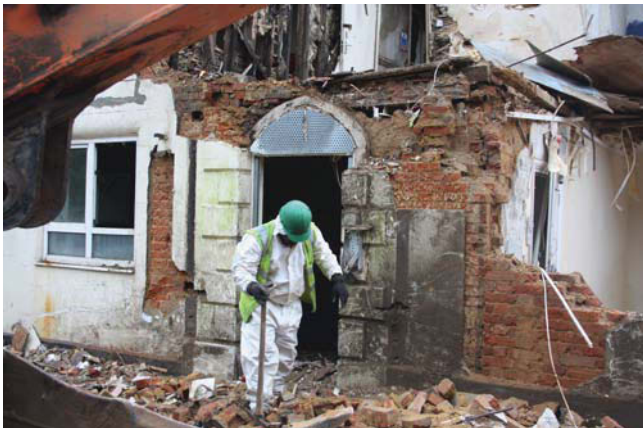
12). Immediately to the north of the door could be seen a scar in the brickwork in the form of a vertical line and disjuncting in the brick coursing (Pl. 13).

Plate 13. Scar either side of front door, looking North north-east.

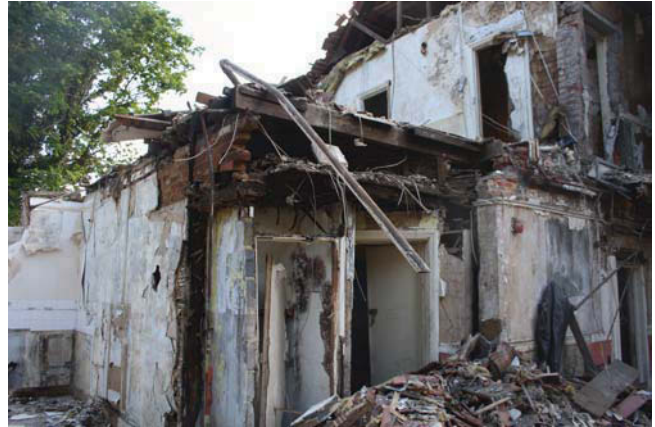
Plate 20. False ceiling and blocked doorway, looking Northeast.

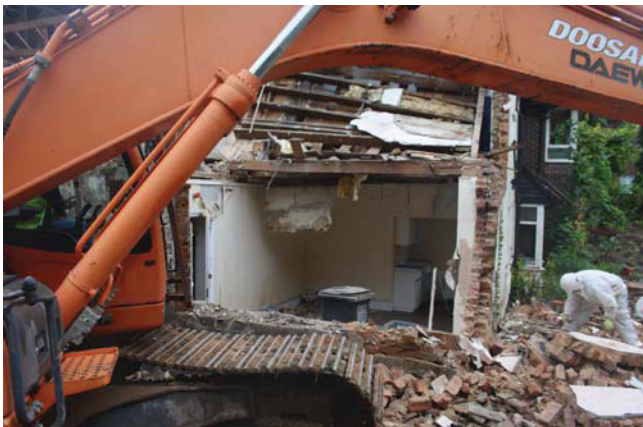
On the opposite side of the corridor was room 7 (to the south) which was rectangular in plan with a window in both the west and south walls (Pl. 21). The window within the west wall was splayed internally. There were no surviving historic features. An alcove at the eastern end of the room contained a kitchen and a separate window, the dividing wall appeared to be of timber and plasterboard construction as did the northern kitchen wall.

Plate 21. Detail of ground floor rooms in S. gable (Rm 7), looking East.

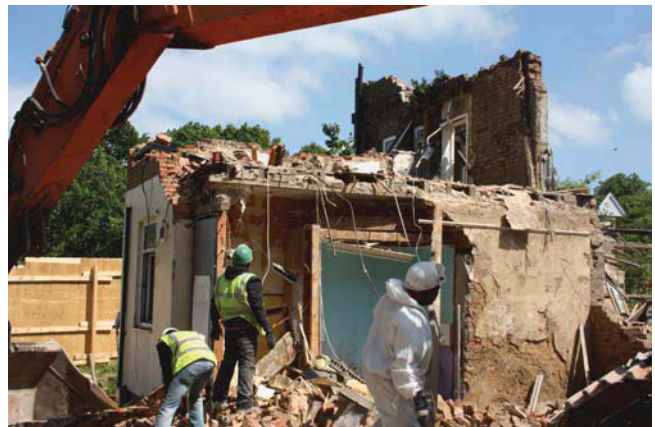
wall, beneath the gable roof. In the east wall was a small alcove of wood and plaster construction set within the corridor (Pl. 22). It was not clear whether the door in the north wall gave access to room 8 or was blocked up. Beyond room 8 the corridor turned to the north where a second set of stairs gave access to the upper floors. Beneath these stairs was access to the cellar stairs. The stairs were not clearly observed but appeared to also be of a winder type, turning to the south. No decorative details were seen within the rooms or the stairs. A further, small room appeared to be located beyond the door/alcove (room 9) containing a single window within the north wall. Within the north-east corner of the building was a room located within a lean-to extension.

Plate 22 Alcove in room 8, looking Southeast.

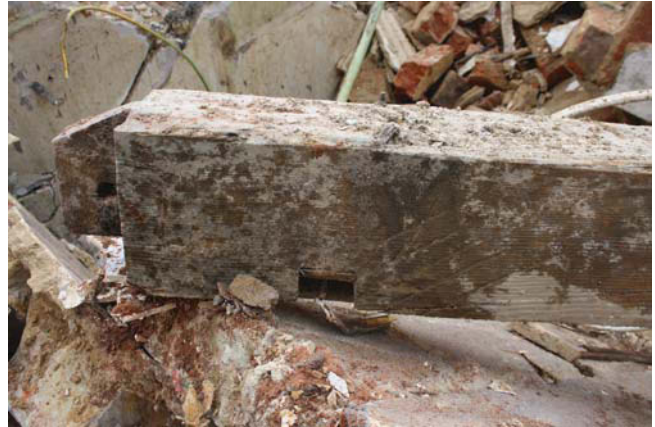
A pine timber from an unknown location (possibly a floor joist from the northern gable) contained a number of mortices and a scratched carpenter's mark (XIII) (Pl. 24). Scratched carpenter's marks are considered to be the earliest incarnation of marks and may reflect re-use of the timber and date to before the 17th century (Brunskill, 2007, 34).

Plate 24. Carpenters mark detail 'XIII'

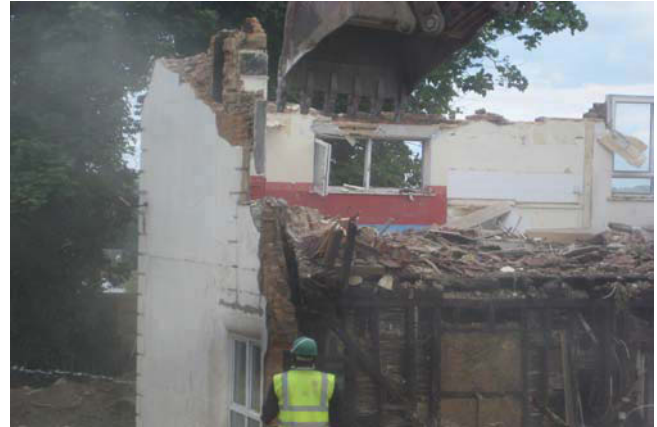
out of the room. Room 17 (Pl. 28) was located in the north-west corner of the building and contained a window in both the north and west walls. A chimney breast was also located within the west wall. The entrance into room 17 from the corridor, was taken from the corner of room 18, creating a dog-legged entry, most likely the same as that on the ground floor. No detail was seen of room 18, located to the east of room 17. At the north-west end of the building was room 19 which appeared to contain two doors into room 18 (possibly suggesting that like rooms 13 and 14 it was sub-divided) (Pl. 29). In the north wall was a single window, evidence could be seen externally for a second blocked window within the wall. The eastern wall certainly contained a window and a chimney breast (Pl. 30). A second window may have been present in the eastern wall or was potentially located within the stair well.

Plate 28. Room 17, looking North north-east.

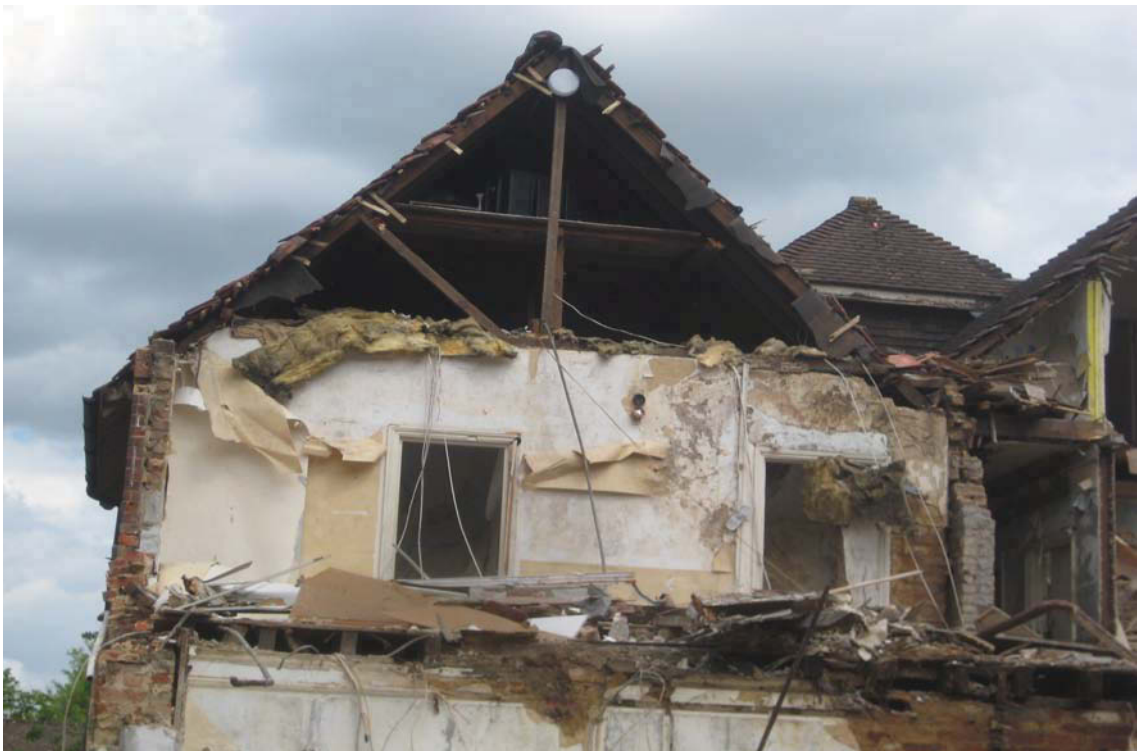
The two main east-west aligned roofs were of similar construction with what appeared to be principal rafters spaced along the length of the roof. These supported a purlin, which in turn supported the common rafters which were laid on edge and met at a central ridge plank and where the north and south roofs met were supported on a timber wall plate. The rafters were most likely of pine, measuring approximately 2" x 4". Within the northern roof space was a mezzanine level supporting a heating tank. As part of the construction was a king post, behind which was a set of vertical timbers to support the shelf (Pl. 32).

Plate 32. North gable roof structure, looking East.
