**Home Farm, Besford,
Worcestershire**

Building Recording

Site Code: HFB17/199

October 2017

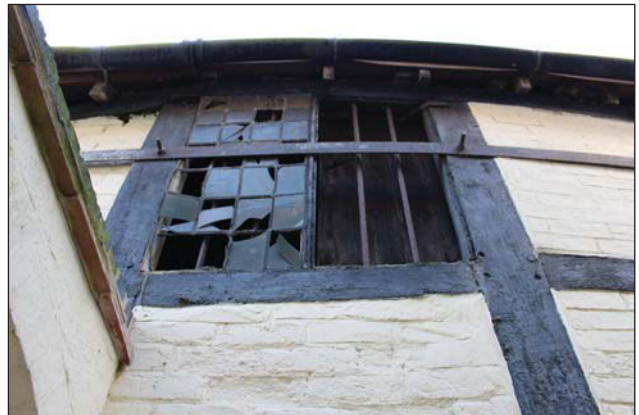
Plate 4. Exterior, north barn, first storey original window
condition,

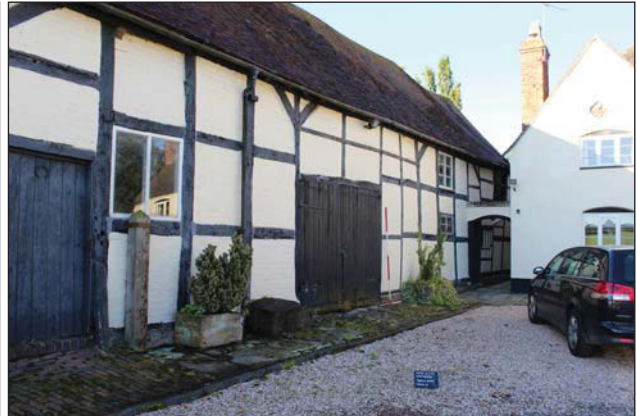
Bay 3 (Pl. 6) contains a pair of doors at its eastern end. These are of simple plank construction with large, plain hinges. The framing within this bay has undergone substantial change to accommodate these doors, possibly altering the location of an earlier door. The timber framing, whilst of the same style as the rest of the barn, varies in size, the eastern two sets of panels being wider than the western pair. This alone suggests that posts 10-12 are of later date. None of these three posts appear to have carpenters marks, empty pegholes or mortices. Principal post 9 is missing the straight brace but contains a pair of empty pegholes just below the roofline (Pl. 7). These are higher than the brace on the west side of the post and suggest the former presence of a rail. Principal post 13 has the straight brace present at the roofline as well as a carpenter's mark in the same place. This appears to show the numerals XI. The empty mortice and pegholes in the post beside the door are the former location of the hinge for the existing door as seen by the shadow in the paintwork on the door itself.

The missing brace in principal post 9 and raised pegholes suggest the location of a door in this location. That the principal post 13 has a brace and that the carpenters marks suggest that it is actually post 11 in the sequence indicate that the door was not the full width of the bay and that post X has been removed.

Plate 6. Exterior, north barn north elevation, looking south west, Scales: 2m and 1m.

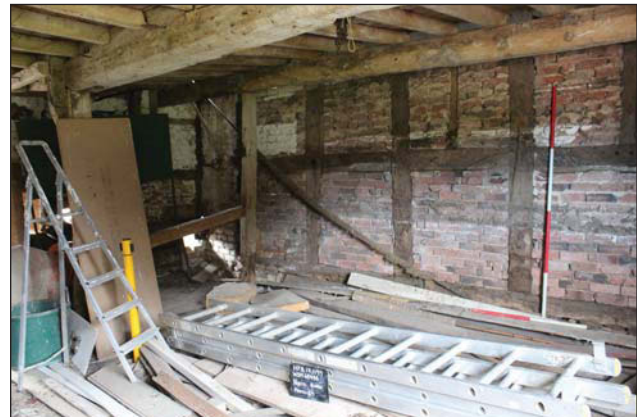
The former eastern gable end (Pl. 8) is now an internal partition between bays 4 and 5. It is five panels wide by three high, to the height of the tie beam. Above the tie beam it has been boarded over, but it can be seen that further vertical posts are present, slightly offset from those beneath the tie beam. On the underside of the tie-beam can be seen stave holes indicating the former wattle and daub infill to the panels (Pl. 9).

Plate 8. Interior, north barn, Bay 5, looking south west, Scales: 2m and 1m.

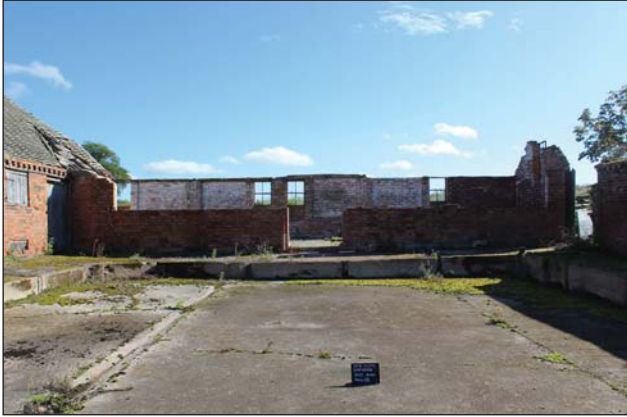
The east barn fronts onto the farmyard (Pl. 41), situated on a raised concrete platform above the main yard area and butts onto the north barn elevation. It is in a dilapidated condition, with no roof remaining and the windows and doors in the west elevation missing.

Plate 41. Exterior, east barn, west elevation,
Scales: 2m and 1m.

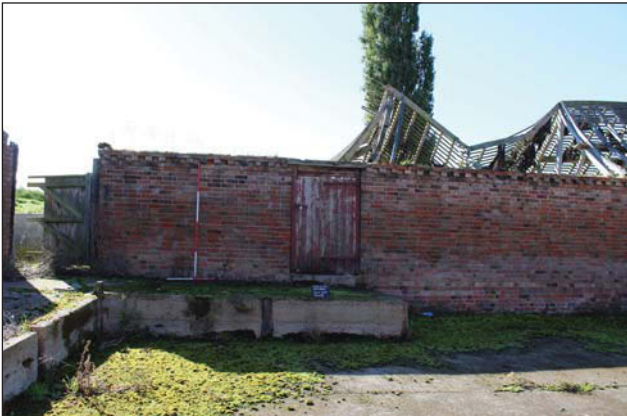
The south barn is open to the fields to the south of the farmyard. It is also in a dilapidated state, the trusses and roof having collapsed and making it unsafe to enter. All recording was done externally.

Plate 43. Exterior, south barn, looking south,
Scales: 2m and 1m.

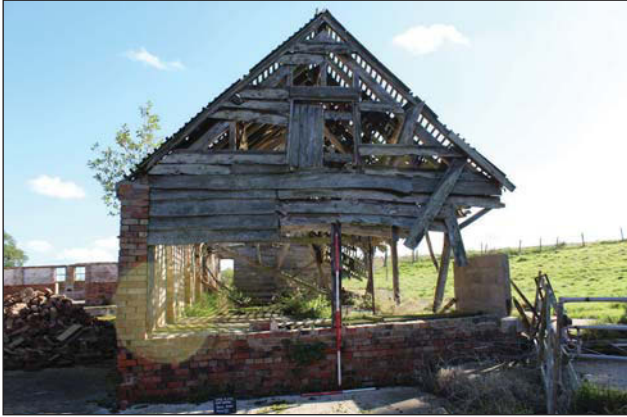
The same coursing continues round in the lower levels of the west elevation (Pl. 45), equivalent to the floor level within the shed. Above this is a central post, attached to which is timber weatherboarding. Within the gable end is the remains of a square door. Much of the timber weatherboarding is missing at the lower levels, along with all the support for the northern end of the gable.

Plate 45. Exterior, south barn, west gable,
Scales: 2m and 1m.

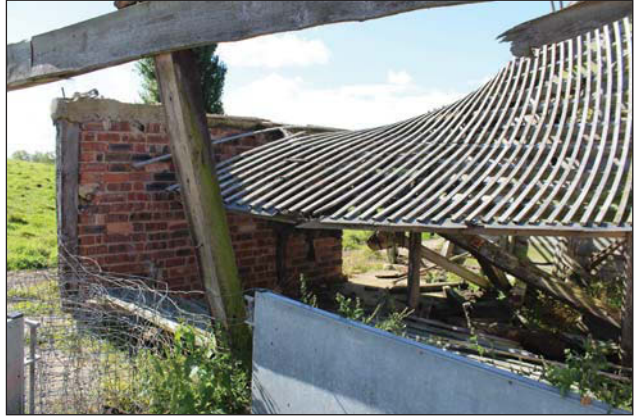
The east gable end (Pl. 46) would also have been constructed of a central timber post and weatherboarding; however, it has entirely collapsed. The post was positioned on a concrete foundation at the east end of the shed.

Plate 46. Exterior, south barn, collapsed roof.
