**Dale Gap Farm, Barrow Hill,
Rocester, Staffordshire**

Building Recording

Site Code: DGR18/78

May 2018

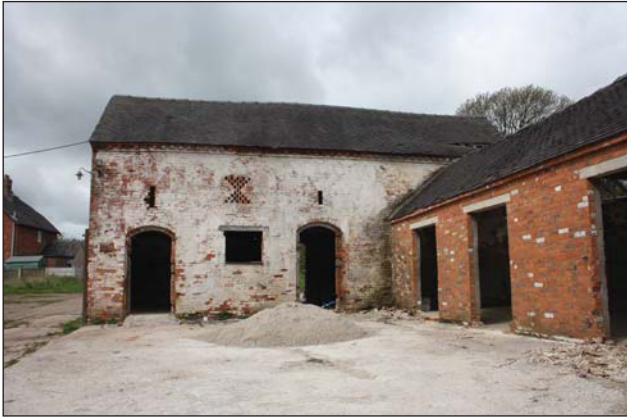
The main, farmyard side entrance is located on the north-east side (Pl. 1, Fig. 9). This elevation consists of a pair of doorways on the ground floor with a window between, and a pair of unequal sized slits on the first floor with lattice brickwork in between, arranged in the shape of an hour-glass. The two door openings are each set beneath a curved arch in rowlock bond with a recessed second skin of brickwork to form a sealed door. Set within this recessed brickwork, on both sides are dressed stone blocks. The window is situated beneath a plain timber lintel containing three equally spaced peg-holes. The wall has been painted white.

Plate 1. Barn A, exterior, looking east from courtyard.

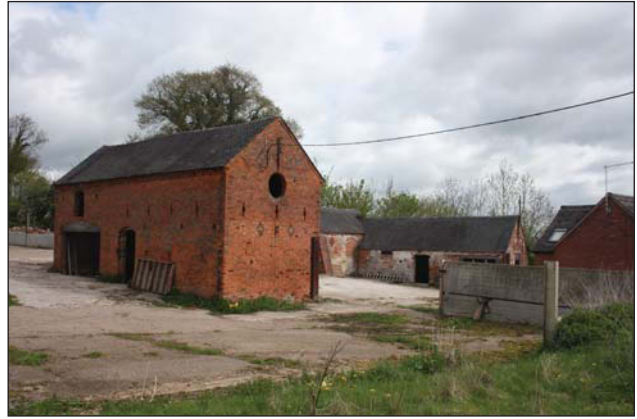
The south-east facing gable end (Pl. 2, Fig. 9) has the former farmyard gate fitting attached to the north-east corner, above which is a pair of diamonds created using burnt headers. Between these is a small blocked-up ventilation slit. Above the diamonds are three further ventilation holes arranged in a cross shape. Immediately beneath the gable is a circular opening edged in bricks laid on edge, above which are a further two burnt header diamonds.

Plate 2. Barn A, exterior, south and west elevations, looking north.

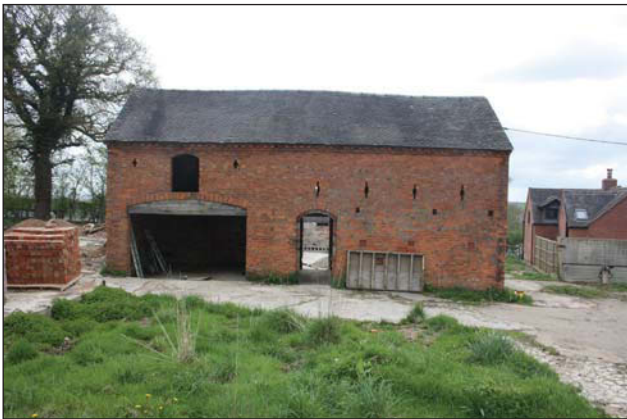
The south-west facing elevation (Pl. 3, Fig. 9) contains a central doorway and a larger arched opening at the north-west end. Each is set beneath a double curved brick arch, with the doorway having the same recessed brick and stone structure as on the north-east elevation. Once again no door is present, though the upper part of the large opening has been squared off with two timber planks, infilling the curve of the arch. To the south-east of the doorway are three square ventilation holes holding a ceramic vent. Above these are three small ventilation slits, above which are a further four cross-shaped ventilation slits, with the most easterly over the doorway. Above the large opening is a further opening beneath a single curved brick arch with a small crossed ventilation slit on either side.

Plate 3. Barn A, exterior, west elevation looking north-east.

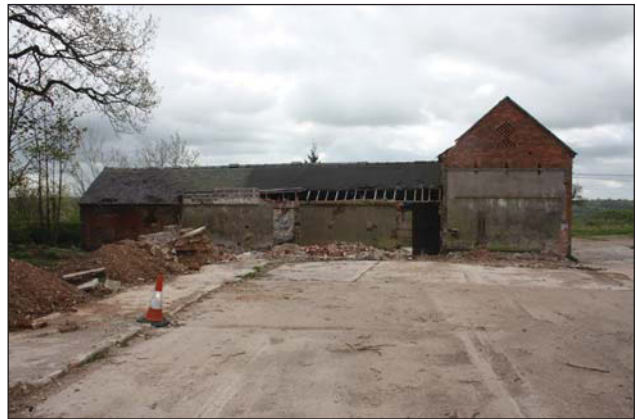
The north-west gable end (Pl. 4, Fig. 10) has been predominantly rendered over where there was a former extension. At the top of the render can be seen the remains of three cross-shaped ventilation slits, above which is lattice brickwork ventilation located in the apex of the gable in the shape of a triangle with diamond above.

The rear (north-west) elevation is partially obscured by render where later buildings have subsequently been demolished (Pl. 4, Fig. 10). Where brickwork is exposed, predominantly at the eastern end of the building there is an hour-glass shaped air vent of lattice brickwork (Pl. 14). The bricks and brick bonding pattern are the same as that at the eastern end of the front (south-east) elevation. Internally it is possible to see what appears to be a blocked window within bay 3 (Pl. 15), though it is partially covered in render. Externally it is entirely rendered over. The window is located beneath a curved brick arch and there are two worked stone blocks immediately to the east; one at window height, the other just above the floor.

Plate 4. Barns A and B, exterior, north elevation, looking south-east.

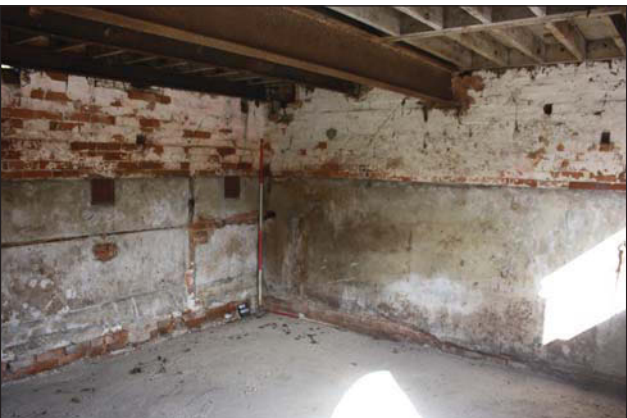
The ground floor is divided into three, unequal rooms numbered 1-3 from south to north. Room 1 is a self-contained room, accessed from the farmyard on the eastern side via a door at the southern end. At the time of the survey the door was no longer present, but earlier photographs show it to have been a stable door of plank construction on the lower half and a single sheet of plywood for the upper part. A window is also present, adjacent to the door though nothing survives of the fenestration. Within the room itself (Pl. 5) the floor is of concrete and the lower part of the walls rendered whilst the upper part is of white-washed brick. The first floor is supported on steel I-beams.

Plate 5. Barn A, interior, room 1, looking west, Scales: 2m and 1m.

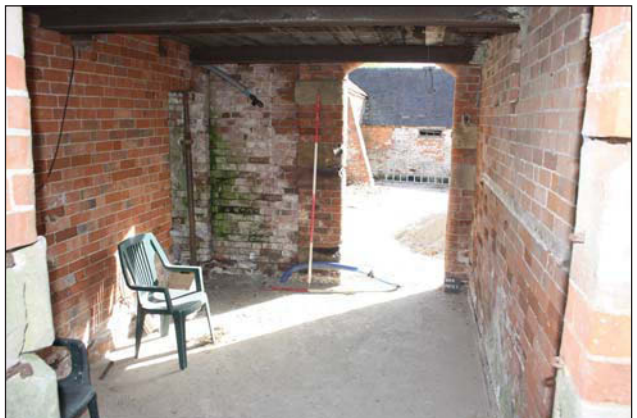
Room 2 (Pl. 6) is the central and smallest of the rooms. It has opposing doorways on both the east and west sides, though neither of the doors were present on the day of the survey and earlier photographs show only a temporary plywood door. The floor is of concrete and the dividing walls are of brick not bonded in to the external walls, once again predominantly laid in stretcher bond but with some headers present. The bricks are also markedly fresher than those of the external walls. An opening beneath a flat arch in the north wall at the east end gives access to room 3. The first floor is supported on steel I-beams.

Plate 6. Barn A, interior, looking north-east through doorway to courtyard. Scales: 2m and 1m.

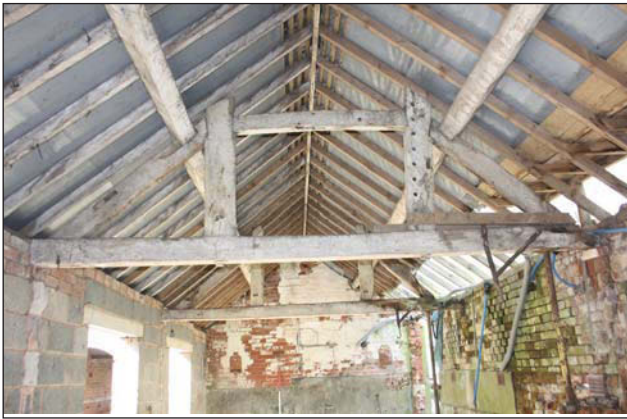
The roof trusses are predominantly of queen-strut type with clasped purlins supported on a raking strut tenoned into the vertical post (Pl. 19). The exception to this is the truss between bays 4 and 5 which is of king-post type with principal rafters supporting the purlin (Pl. 20). There is some evidence for reuse of wood: the northern post on truss 2 has a number of peg holes and an empty mortice, as does the collar tie in the same truss (Pl. 19). The rafters on the northern side of the roof have been entirely replaced in modern softwood, as have those at the western end of the building on the south side.

Plate 19. Barn B, interior, roof truss detail, looking south-west.

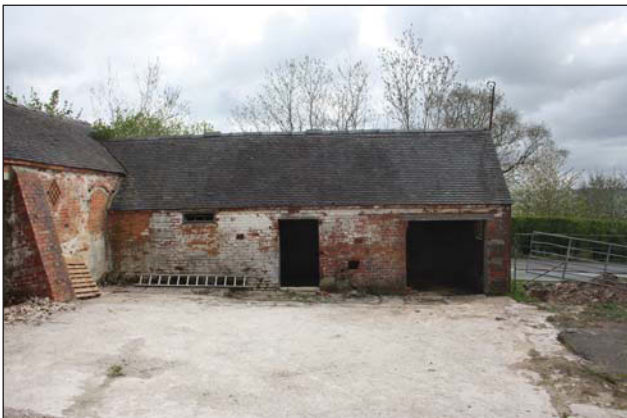
The main front (south-west) facing elevation is onto the farmyard (Pl. 21, Fig. 10). The elevation contains a blocked doorway at the northern end to the height of the topmost header course. Immediately to the south are three worked stone blocks. To the south of these is a narrow side hung casement window, three panes wide by one pane high in a wooden frame beneath a wooden lintel. The brickwork beneath the window is less white than the rest of the wall and the bricks are bonded with cement mortar, possibly indicating the former presence of a larger window. Approximately centrally within the wall is a doorway set beneath a concrete lintel. To the north of the opening is a single worked stone located just above the centre point, whilst to the south are a pair of worked stones, one at the top, and the other at the bottom, presumably the former locations of the hinges whilst the northern one represents the location of the latch. At the southern end of the wall is a larger opening located beneath a timber lintel. On the north side, supporting the lintel is a brick corbel in the shape of a jowl. On the southern side are two worked stone blocks embedded within the brickwork. Two modern vents and a square opening, possibly for another modern vent are also present.

Plate 21. Barn C, exterior, west elevation, looking north-east from courtyard.

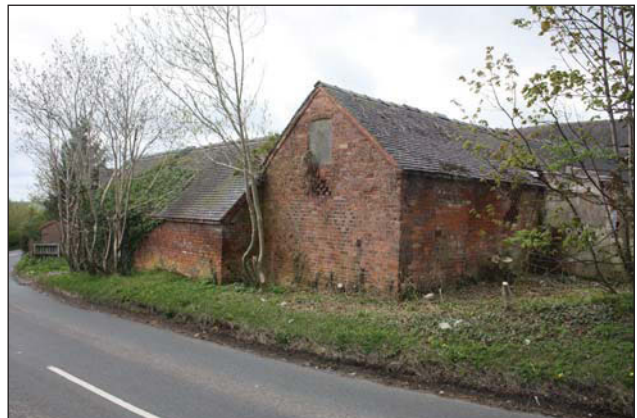
The north-west elevation is largely obscured by barn B, but the eastern end is visible and contains no features. The brickwork butts up against that of barn B (Pl. 22, Fig. 10).

Plate 22. Barns B and C, exterior, north and east elevations, looking south.

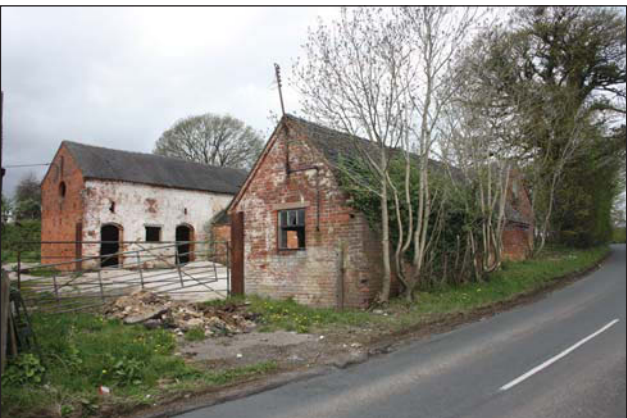
The south-east gable end (Pl. 23, Fig. 9) contains a central window beneath a concrete lintel. The fenestration consists of a wooden window frame; the upper third containing three panes of glass whilst the lower two thirds of the window is missing. At the eastern end of the wall is a timber post, presumably for a former gate, whilst at the western end of the wall is a large steel post (the same as that present on the gable end of barn A) with a farmyard gate still attached.

Plate 23. General view, into courtyard from outside, looking west.

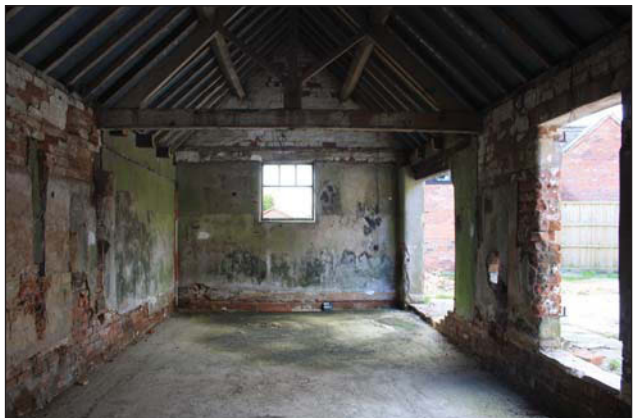
Internally there is a single room of three bays (8) (Pls. 24 and 25), accessed both from the farmyard and from barn B. The floor levels are significantly different between the two buildings, with barn C being approximately six courses of brick lower (the rendered walls within barn C make it hard to be precise). The floor slopes down again beneath the first roof truss by another four courses of brickwork. The floor itself is of concrete.

Plate 24. Barn C, interior, general view, looking south-east. Scales: 2m, 1m.

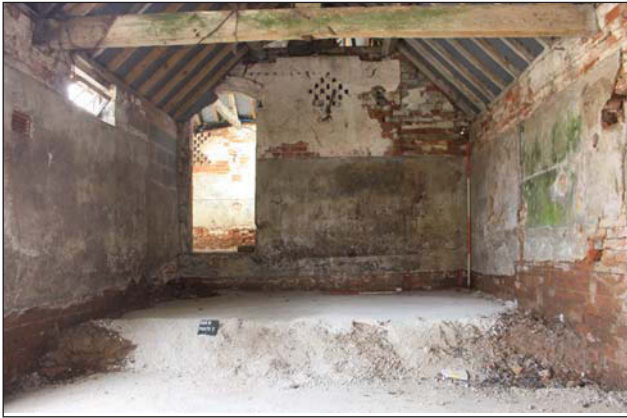
Plate 25. Barn C, interior, looking north-west to party wall with Barn B. Scales: 2m, 1m.

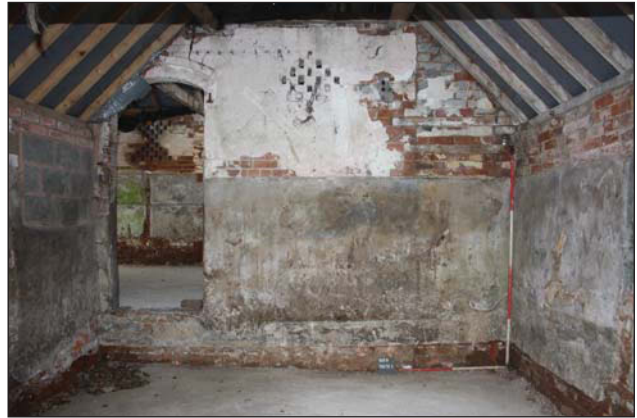
Within the north wall, the junction between barns B and C can be more clearly seen above the height of the render. The brickwork of barn C has been butted up against that of barn B with the exception of two planks of wood which have been bonded into the barn B brickwork via the removal of a stretcher-laid brick and a header laid brick (Pl. 26). Within the west wall it is possible to see that the doorway at the north end has been blocked using concrete blocks. Within the east wall, beneath truss 3 the remains of concrete blocks project out from the wall, indicating the location of a former wall. To the south of this former wall and immediately below the timber wall plate are the remains of three wooden joists that have been removed, with a fourth entirely removed leaving only the shape in the render. Presumably there was small raised platform in this location at one point (Pl. 27)

Plate 26. Barn C, interior, detail of party wall with Barn B, looking north-west. Scales: 2m, 1m.

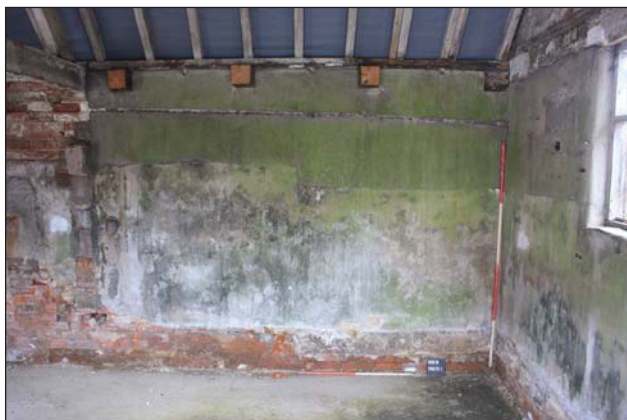
Plate 27. Barn C, interior, details of cut joists, looking north-east. Scales 2m, 1m.

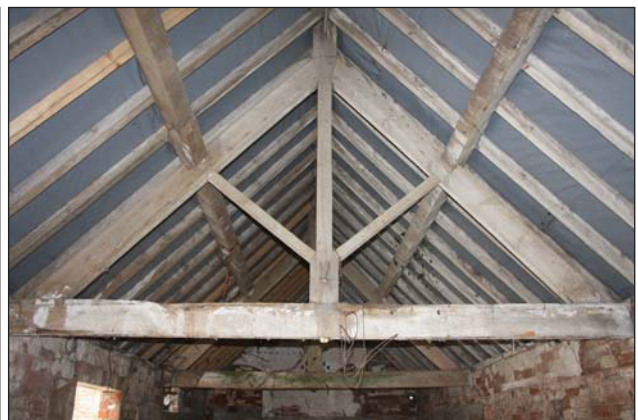
The roof is supported by three trusses of king-post type. A clasped purlin supports the common rafters which meet at a ridge plank. Some of the common rafters have been replaced, particularly at the north end on the west side (Pl. 28).

Plate 28. Barn C, interior, roof truss detail, looking north-west.
