**The Honiton Inn, Paris Street,
Exeter, Devon**

Building Recording

Site Code: HIE19/58BLD

**Building Recording
For Galliard Homes Limited**

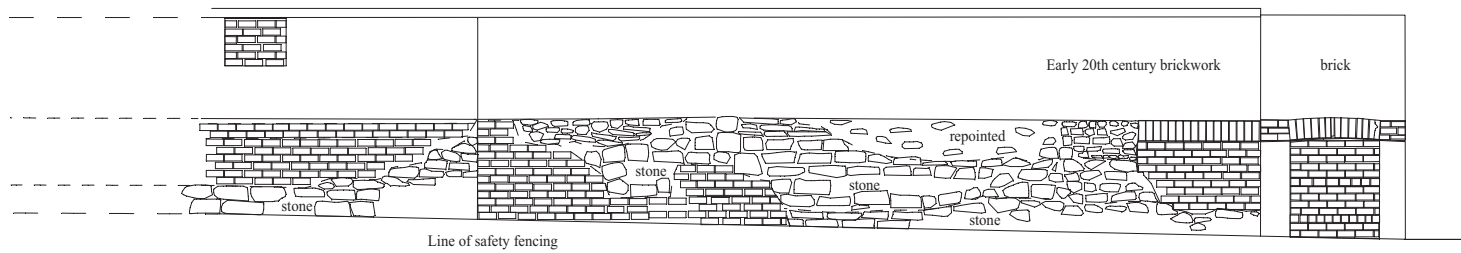
Figure 5. Boundary Wall (East-Facing Elevation)

The north end of the wall as seen at the time of the recording terminates in a substantial brick built enclave (Pl. 3). This comprises a mixture of English and Flemish bonds, with some irregularity. It is 31 courses high, with closers at the left and right, has no capping or coping at the top. It has a brick stretcher soldier arch supported by an iron strap. Beneath this, bricks of a probable later date (perhaps early 20th century) infill the enclave. The brickwork of the enclave projects 0.55m to the east, and this part of the structure is tied into the wall to the south of it, though a significant crack at the top of the wall extends to approximately 0.50m from the ground level.

To the south of this, the wall has flat-topped concrete coping, upper brickwork of modern date above a header soldier course and beneath this a phase of consistent English bond (Pl. 4). This lies over a phase of stone (primarily red sandstone) which is irregularly coursed and is of mixed size pieces, very roughly faced, with the exception of very occasional more neatly squared pieces (Pl. 5). Occasionally, small pieces of roof tile in a red fabric have been incorporated into the mortar. The thickness (14mm) and finish of the fragments observed suggest they are of broadly post-medieval date. Areas of the stonework have been repaired or repointed, but these are not readily datable, though some areas appear to be contemporary based on the similar light grey slightly friable sandy mortar. To the south (Pl. 6), a further large area of stonework has been repaired and repointed relatively recently with thick, light grey white mortar.

Here, the base of the wall is brick, though it is unclear if this is inserted or represents the original wall foundation at this part (Pl. 7). Further to the south, the upper part of the wall is of the same construction (concrete coping with late 19th- or early 20th-century Flemish bond), however the wall is thicker below, with concrete infilling to form a sloping sill (Pl. 8). Below this, two courses of irregular bond (likely to be of broadly 19th century date) overly further sandstone, with brick below. At the south end of the wall, the brick courses below the sill again overly the stonework, with the base of the wall not visible due to safety fencing.

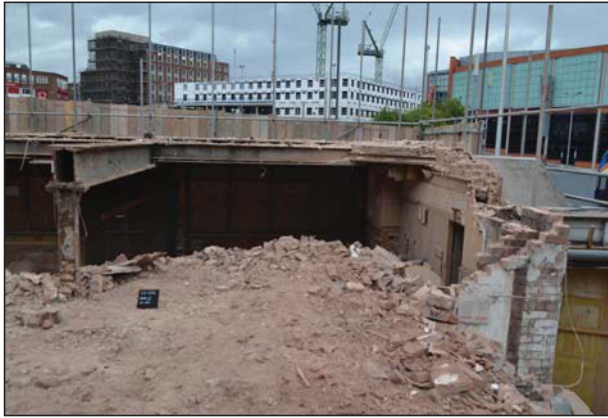
The building fronts the street, with the front elevation facing north, and its layout and character were recorded for the heritage assessment. At the time of the present recording, the rear part of the building, roof and first floor had been demolished and only the façade and east and west flanking walls remained (Pls 1 and 2).

Plate 1. Honiton Inn during demolition, looking north-northeast.

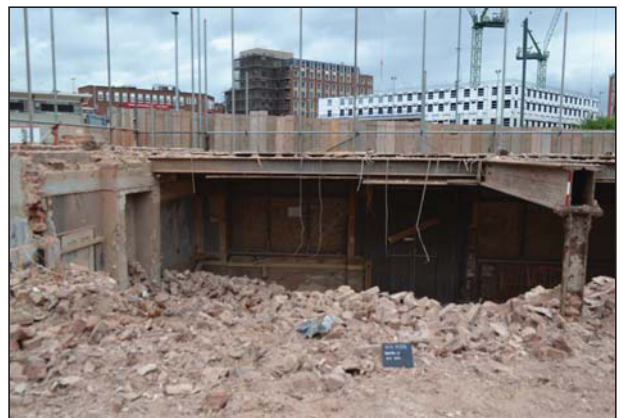
Plate 2. Honiton Inn during demolition, looking north-northwest.

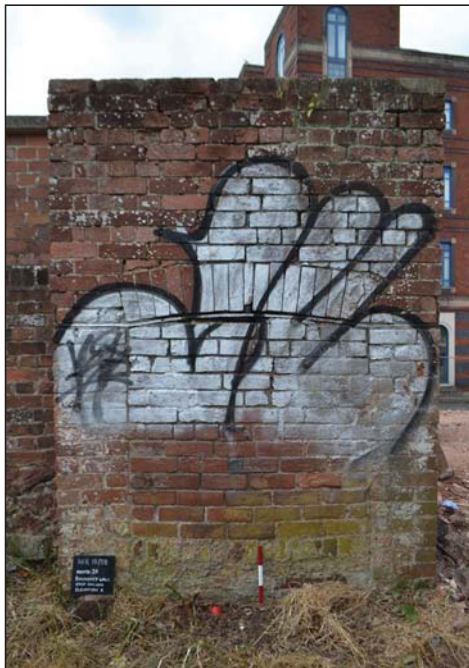
Plate 3. Boundary wall (north end), looking west, Scale: 0.3m.

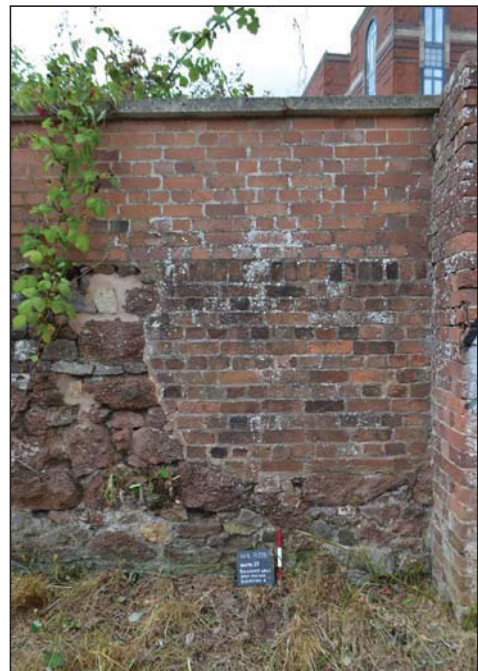
Plate 4. Boundary wall, looking west, Scale: 0.3m.

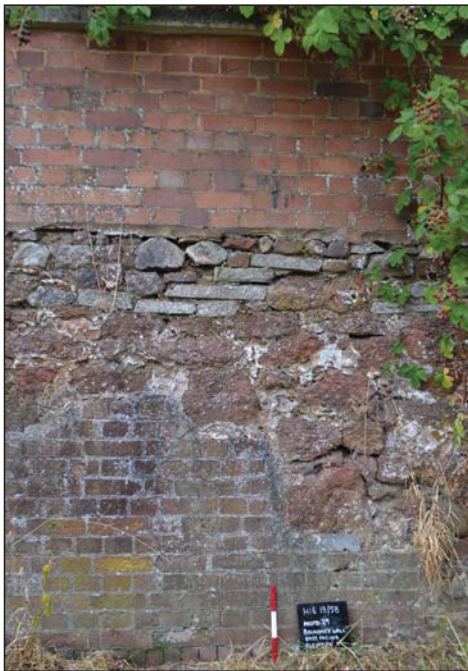
Plate 7. Boundary wall, looking west,
Scale: 0.3m.

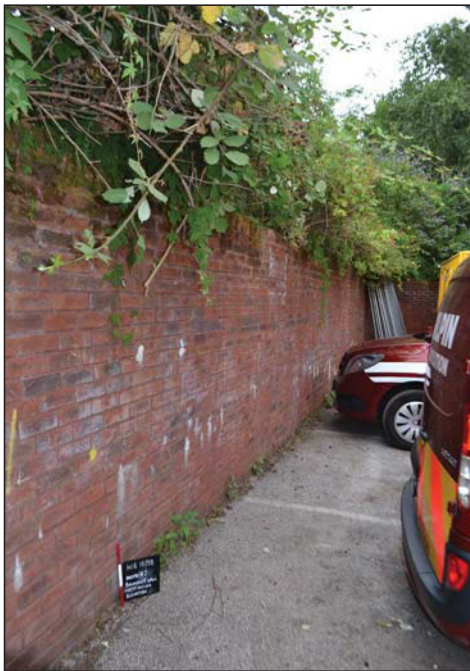
The west facing elevation of the historic wall is obscured to its full height and length by a modern wall comprising a single skin of stretcher bond abutting an interior wall of grey breeze blocks. It has a coping course of bricks on edge. At its north end, it has a return to the west, which has been removed as part of the building demolition (Pl. 10). The wall is of one phase and has a return to the west (Pl. 11) forming the rear site boundary.

Plate 11. West face of Boundary wall, looking south, Scale: 0.3m.

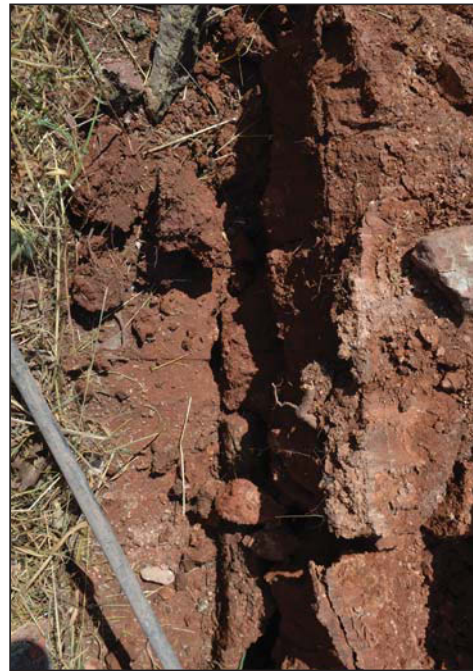
A third stage of recording was carried out on the footprint of the wall after demolition. This showed that a course of red sandstone remains *in situ* in at least one location beneath the wall, comprising a footing course. It was not possible to establish if this is part of an earlier wall foundation which has been rebuilt and it was observed only in one location (Pl. 14).

Plate 14. Boundary wall after demolition, foundation remains, looking west, Scale: 0.3m.

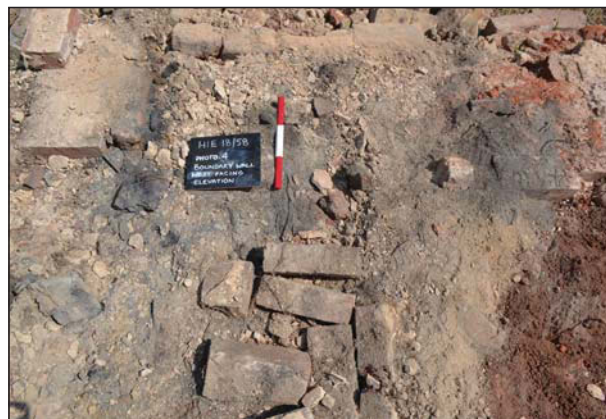
Following demolition of the northern end, the brick structure was removed to reveal ashy burnt deposits and brick rubble (Pl. 15). It is unclear what this represents and no dating evidence was obtained from the deposit. The deposit was not further excavated as the required level was reached and the remaining material was to be left *in situ*.

Plate 15. Boundary wall after demolition, remains of stone wall, looking east, Scale: 0.3m.
