Church of St Michael and All Angels, Waddesdon, Buckinghamshire

Archaeological Watching Brief

(Interior works - Phase 2)

Site Code: WCB17/52

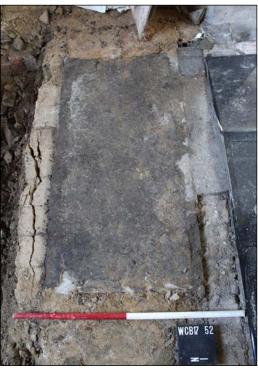
No brick crypts were identified in this portion of the floor, but groundworkers were generally aware of the presence of crypts and ledger slabs directly to the south in the western parts of the north aisle. Surfaces were covered to protect them during works. A possible heavily worn ledger slab (Pl. 1) was lifted during the excavation, but Victorian heating ducts lay directly underneath this slab which has obviously been replaced. A partially exposed exterior side of a brick crypt was observed in section, but there was no need to expose the interior and it remained intact (Pl. 2).

Plate 1. Heavily worn slab, prior to lifing, looking east, Scales: 1m.

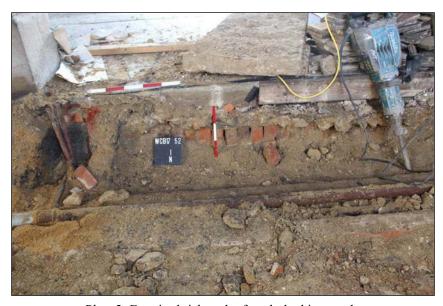
Plate 2. Exterior brickwork of vault, looking south, Scales: 0.5m and 0.3m.

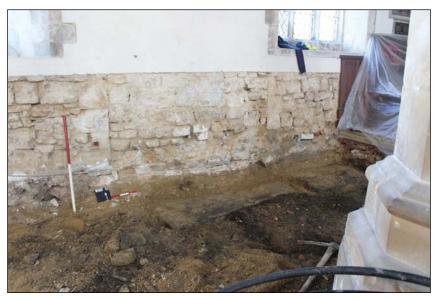
Prior to the archaeological observations starting, the plaster of the interior wall of the north aisle was removed from the previous floor level to a height of 1.1m, to expose the facing of the stone construction (Pl. 3). This has been undertaken to allow any damp in the stone structure on this side of the church is dry. It also exposed the structural fabric which until now had been obscured internally and externally. The exposed face, which stretched from the west wall of the north aisle, exposed all the construction of the north aisle to its east end, which housed the north aisle chapel. This had successfully been achieved, with limited success achieved undertaking the same in the south aisle, where the plaster was more resistant to removal. The exposed stone courses were mostly laid regularly, in the north-west part and central areas, with no obvious infilling especially under the inserted 15th century window to the west. Nor were there any changes to either side of the north doorway, suggestive of an alternative jam or lintel. The same was true for the two 14th century windows to the east.

Just to the east of the second 14th-century window, there was a vertical change, where large quoin stones, creating a straight divide. This was at least four courses high, to the top of the exposure (Pl. 3). Towards the upper visible coursing, there was an uneven, undulating course, but not to indicate any inserted change or change of construction from above. The vertical divide seems indicative of a change in original construction of the north aisle, marking the original, east end of the 14th-century extent and the join with the 15th-century extension. This point is in line with the fifth column base of the south aisle, which created the five bays of the arcade, suggesting these developments were contemporary, in the 15th century. The stonework visible reverts to seven courses high, and is partly mortared, at least towards floor level, with a dark grey sandy mortar. It is possible this pointing is a later addition.

Plate 3. Exposed stone construction of north aisle wall, looking north, Scales: 1m and 0.3m.

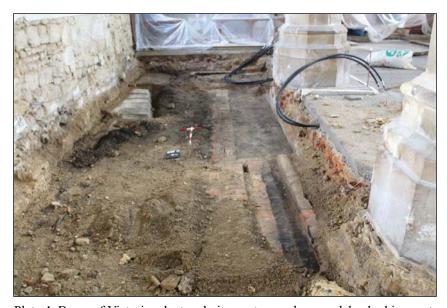
As the eastern part of the north aisle was reduced, the southern part exposed the base of a brick channel that contained the Victorian pipework linking the radiators on the north aisle (Pl. 4). This stretched along the northern length of the arcade, with jointing points of brick channels perpendicular to either side of the north door (Fig. 3). Reduction in the north-west part of the north aisle (the servery) required minimal works as much of the area that adjoined the west wall was already at the required level. This point also contained much of the modern pipe work leading into the main body of the church from the boiler house. The only reduction saw a the brick sides of the duct dismantled and the sides of the perpendicular ducts that joined from the western nave. The western nave is known is contain a number of crypts (Mundin 2017), and there is further potential as other grave slabs here may represent more positions.

Plate 4. Bases of Victorian duct and pipe system and grave slabs, looking east, Scales: 0.5m and 0.3m.

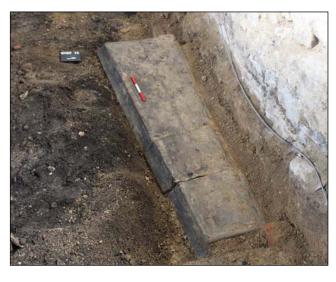
Plate 6. Grave slab 169.

At a depth of 0.43m deep in section, immediately adjacent to the north aisle wall, were two stone slabs. These were both laid horizontally, though the western of the two was sloping slightly to the east (169), possibly due to this side sinking into the void of the grave underneath. The eastern slab was level, though its east end was not visible, with potentially up to 0.5m of its length being under the north chapel.
