**River Arun Tidal Defence Scheme,  
Arundel, West Sussex**

**Building Recording**

**Building Recording  
For J T Mackley and Co Ltd**

**August 2020**

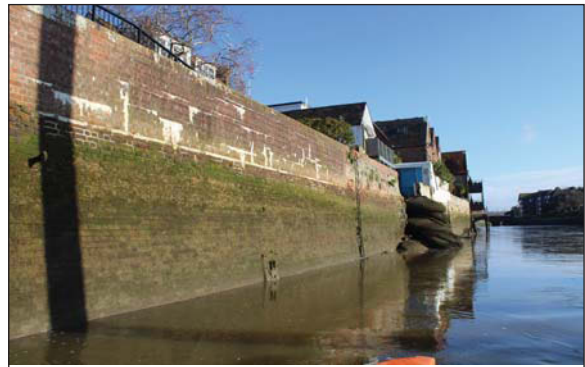
Along the flood wall between c. 35m and c.55m, the lower section consists wholly of brickwork, of which just over 3m was visible at low water. This lower section is constructed with alternating courses of headers and footers, and the high water mark is clearly visible as the brickwork has been stained green. A couple of mooring rings and an outflow pipe with an iron valve flap, were noted along this section of the wall. The upper brickwork section of the flood wall between c. 35 and c. 55m consists of two separately built sections, with the change occurring at c. 48m. At c. 55m there is a clear change in the lower brickwork section of the wall, and it appears that this part of the wall may have been rebuilt when an outflow pipe was inserted. It appears that this section of brickwork may have failed at some point in the past, as the lower section of wall immediately to the east is constructed from large sandstone blocks. The fact that some of the stonework overlies the brickwork indicates that the brickwork is almost certainly earlier. The section of the wall from c. 57m to c. 67m is where is latest serious breach took place in January 2016, after a period of high tides and heavy rainfall. The breach affected the section of stonework that actually ran from c. 55m to c.68m, and the surviving sections either side of the breach suggest that this section was quite poorly built in the first place. This idea is supported by the fact that there is a clear difference in the stonework at c. 68m, with the section of stonework from c. 68m to c. 76m appearing far more sturdy. The vertical break at c. 68m indicates that the two sections of stonework were built at different times. At the time of the survey, the breach in the wall between c. 57m and c. 67m had been temporarily filled with sandbags and large 'Kyowa' bags. The latter are large mesh bags filled with rocks, which are specially designed to protect from flooding. The name Kyowa derives from the Japanese company which pioneered these type of bags, which are also referred to as 'filter units'. Traditional sandbags had been placed in the eastern part of the breach to prop up a surviving section of the stonewall which was liable to collapse. Unsurprisingly, the breach also removed a large section of the upper brick wall, which had largely been covered in render in this area.

Plate 12. Wall section (c. 37m-50m), looking NNE.

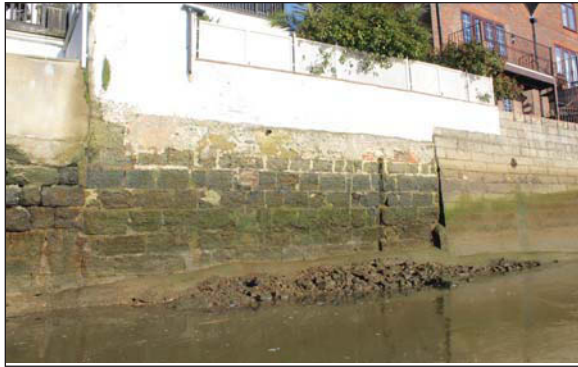
As mentioned above, the lower section of floodwall between c. 68m and c. 76m is constructed from large sandstone blocks. The courses appear to be of roughly equally sized stones, and there appears to be a possible repair, in brick, at c. 71m. The stonework is topped with a later wall, the western part of which is constructed from flint, and the eastern part from brick. This later wall appears to have been rendered in the past, although much of the render has fallen off. It is topped by a modern wall, which is fully rendered. There is quite a lot of rubble on the foreshore below the section of the wall between c. 68m and c. 76m, although it is not clear where this has come from.

Plate 19. Wall section (c. 68m-72m), looking NNW.

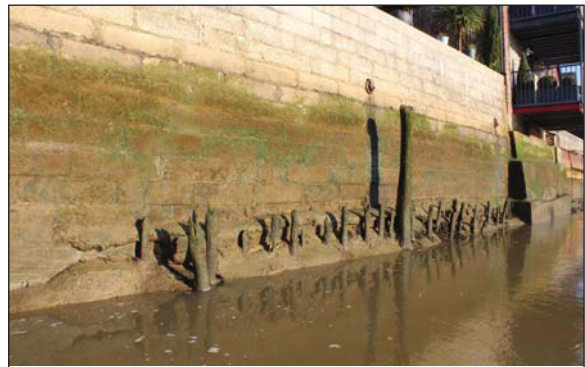
The final section of the flood wall covered by the survey, between c. 76m and c. 97m, is wholly constructed from equally sized stone blocks. There are four outflow pipes visible in this part of the wall. The stonework extends all the way to the top of the wall, and this is the only section of the surveyed wall which was not topped with brick.

Plate 22. Wall section (c. 86m-97m), looking NE.
