# Hospital Farm Barn, Rushton Road, Rothwell, Northamptonshire

**Building Recording**

Site Code: HFB20/170

February 2021

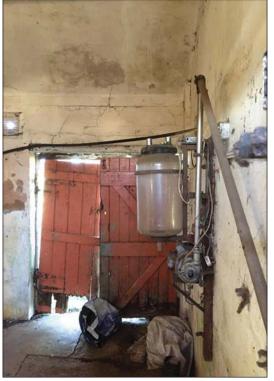
Plate 13. Room A1, Looking West

The building is split into two unequal sized sections (A1 and A2) by an internal brick wall, which has been rendered. Room A1 measures 3.65m by 3.07m, with some redundant fittings on the wall indicating that it was previously used for milking cows. The walls are fully rendered, and the roof structure is largely obscured by boards, although the purlins are visible. The western wall has a small air vent, along with a large doorway whose wooden doors in a poor state of repair (Pl. 13). The eastern wall had a smaller doorway, and the wooden door had partially fallen from its hinges. This wall also had a small window with much of the glass missing. The room has a concrete floor.

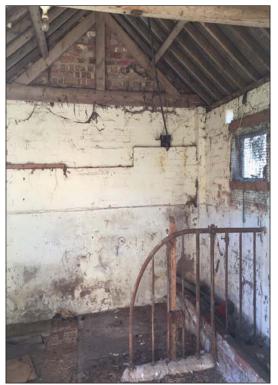
Plate 14. Room A2, Looking South.

Room A2 measures 6.02m by 3.70m. The lower sections of its brick walls have been rendered, whereas the upper portions have just been whitewashed. The former function of the room can be ascertained by the brick-built feeding trough along with western wall, and one surviving steel frame for tethering animals (Pls 14, 15). The floor is mostly concrete, although the former channel which would have been used for collecting manure from the animals appears to have been filled in with stock bricks. There are two windows in the west wall, along

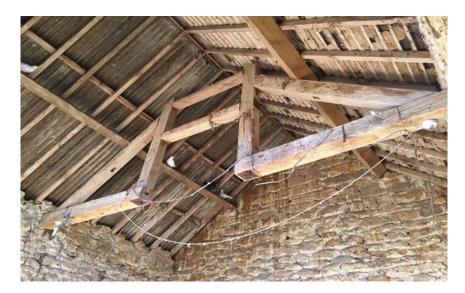
Plate 17. Building B Showing Roof Structure, Looking North West.

Building B is accessed via the door in its southern wall, and measures 4.40m by 4.26m internally. The walls of the room are wholly constructed from ironstone, apart from the bricked up doorway in the south-west corner and a small area around it. There is also a small brick-built recess between the existing and blocked up doorways (Pls 16, 18). The lower portions of the walls are all whitewashed. The building was presumably used as an animal shelter as there is a brick- and stone-built feeder along the entire length of the north wall. The floor appears to be largely comprised of stock bricks, although it was difficult to see during the survey as it was largely covered in a thick layer of bird droppings. The roof structure is largely supported by the east and west walls of the building, although there is a central truss dividing the room into two bays (Pl. 17). The truss is quite unusual as it is of hammer-beam type design, with no wall braces present. Instead there are two hammer beams and hammer posts which are secured in position by two collars. This frame supports the principal rafters, which in turn support the purlins.

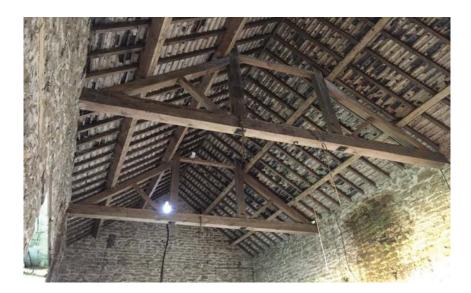
Plate 21. Building C Showing Roof Structure, Looking East South East.

The building measures 10.77m by 5.28m internally. The internal walls of the building are largely of unpainted ironstone blocks, although a small number of timbers have been incorporated into the structure, which were used for attaching hooks and other fittings. There are three wooden fittings on the western wall, whose function is unclear (Pl. 19). There is a small brick-built recess next to the southern doorway. The floor of the central area, between the two opposing doors, consists of uniform stock bricks, but a mixture of different bricks was utilized through the rest of the room (Pl. 20). The roof structure is supported by the western and eastern walls and two timber trusses. Both timber trusses have queen posts linked by a single collar. These queen posts support the principal rafters, which are also supported by struts. The purlins are supported by the principal rafters (Pl. 21).

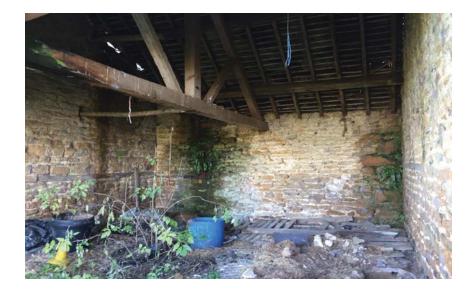
Plate 22. Room D1, Looking South South East.

This L-shaped building occupies the north-east corner of the farm complex, and actually consists of three separate 'rooms' (D1, D2 and D3). The building is wholly constructed from ironstone blocks, laid in irregular courses of varying size, as recorded in Buildings B and C. The southern wall of D1 seems to have been constructed at the same time as Building B, as there is no clear evidence of it being keyed in at a later date. Room D1 measures 5.60m by 4.40m internally, and was probably a cart shed as it is open on its northern side. It shares its western wall with Building C and its eastern wall with Room D2. A couple of timbers have been incorporated into the inside wall of Room D1, presumably to allow things to be hung on the walls. The floor of

the room was largely obscured, but appears to be concrete. It appears that the tiled roofs for Rooms D1, D2 and D3 were originally constructed at the same time. As a result, the roof of Room D1 is largely supported by the eastern and western walls, although there is a central timber truss dividing the room into two bays (Pl. 22). The principal rafters of this truss are supported by the tie beam, king post and two struts. The purlins are supported by the principal rafters.
