T H A M E S V A L L E Y

ARCHAEOLOGICAL

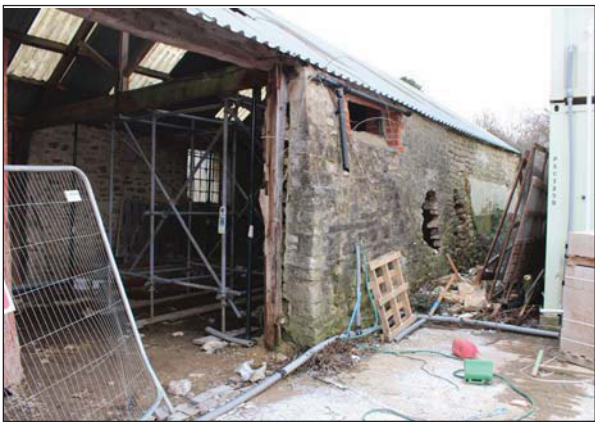
Plate 3. Barn door with nearby window and damage to the wall. Looking North

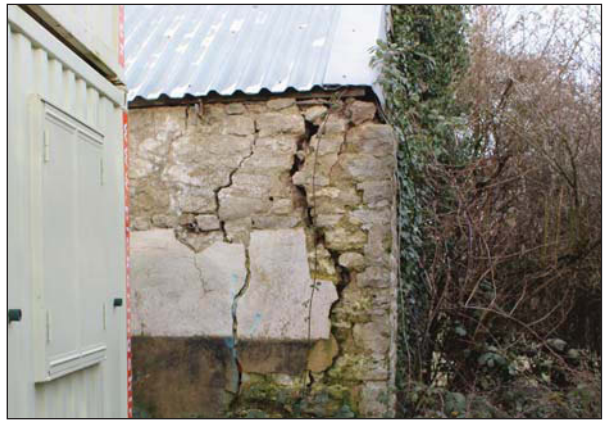
Plate 4. South eastern outer corner of barn, large cracks in the corner. Looking North West

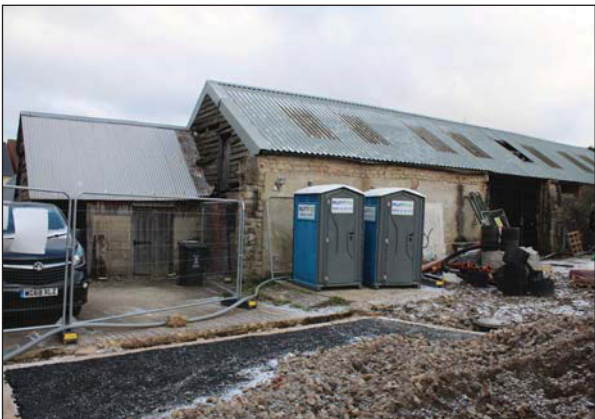
Plate 5. Southern half of barn with lean-to. Looking North

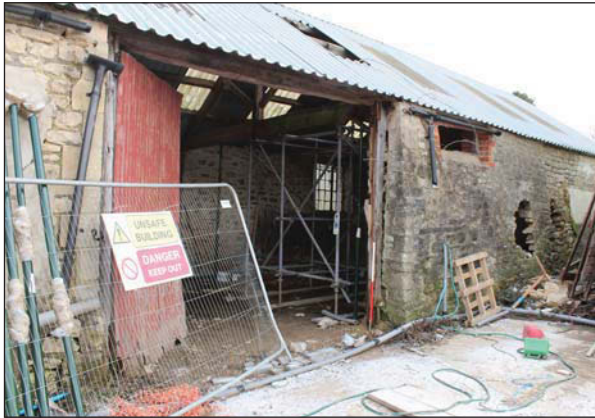
Plate 7. View of south west barn door, with rusted corrugated steel door. Looking North. Scale: 1m

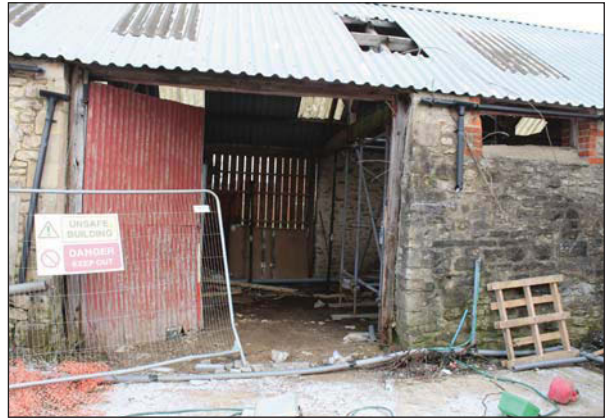
Plate 8. View of south west barn doorway, wooden slats of opposite door opening. Looking North West. Scale: 1m

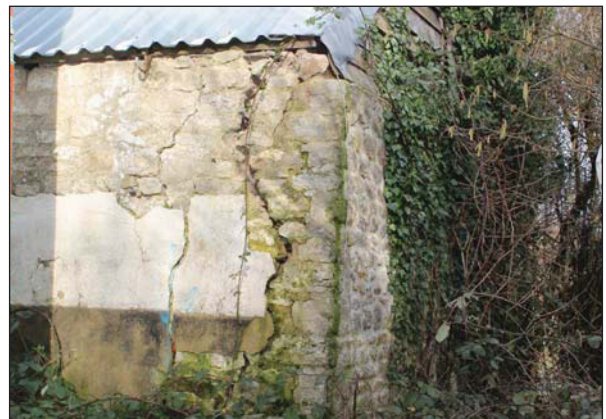
Plate 54. Close up of eastern corner of barn with cracks and render on the stone wall. Looking West.

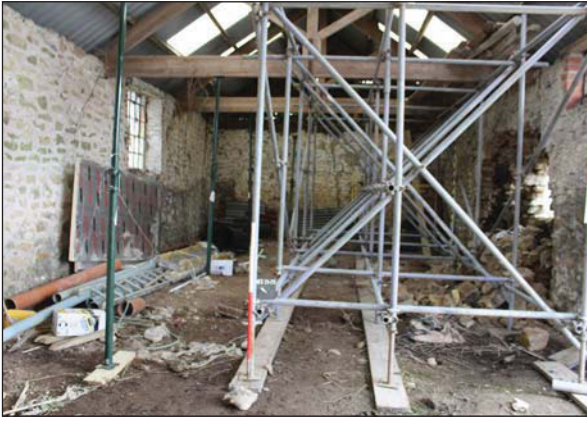
Plate 55. Interior of main barn. Damage to south eastern wall shown, rubble and gaps. Scaffolding holding up roof. Large glass window in north western wall. Looking North East. Scale: 1m

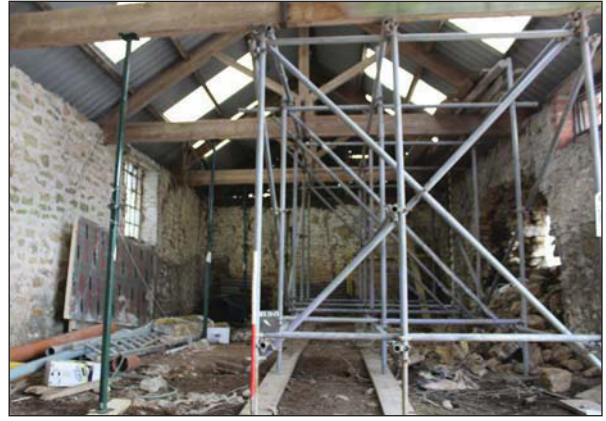
Plate 56. Interior of main barn. Damage to south eastern wall shown. Scaffolding holding up roof. Large glass window in north western wall. A frame wooden supports for steel roof. Looking North East. Scale: 1m

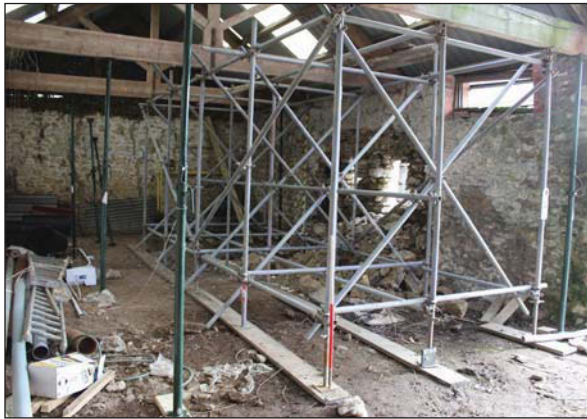
Plat 57. Damaged south western interior wall, rubble and gaps. Looking East. Scale: 1m

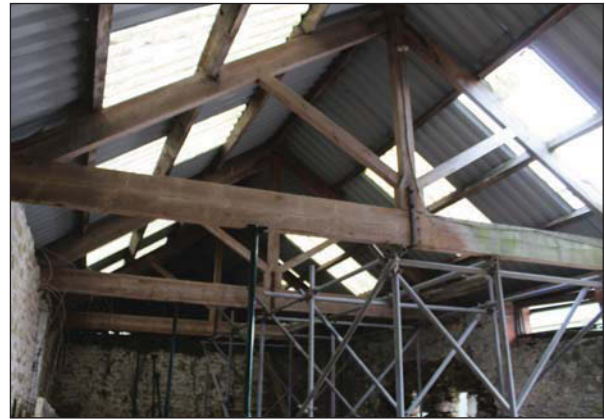
Plate 58. Interior main barn roof structure. Looking South East.

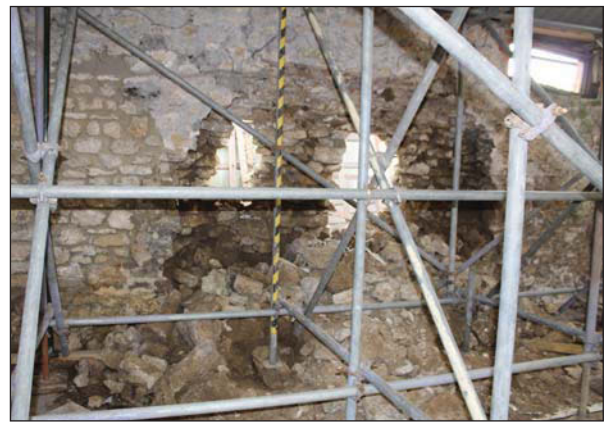
Plate 64. Close up of interior damage to south eastern wall, two large holes with stone rubble. Looking South East.

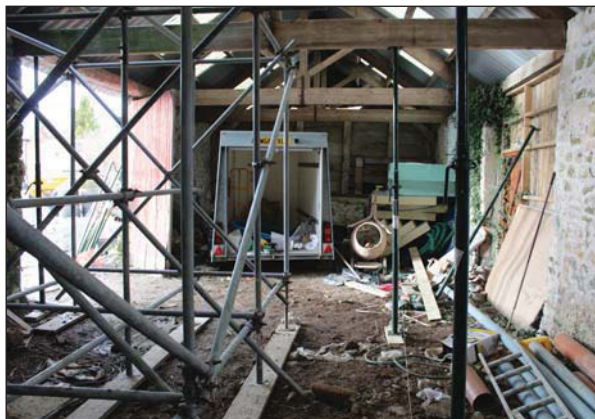
Plate 65. View of south western end of main barn including dividing wall. Looking South West.

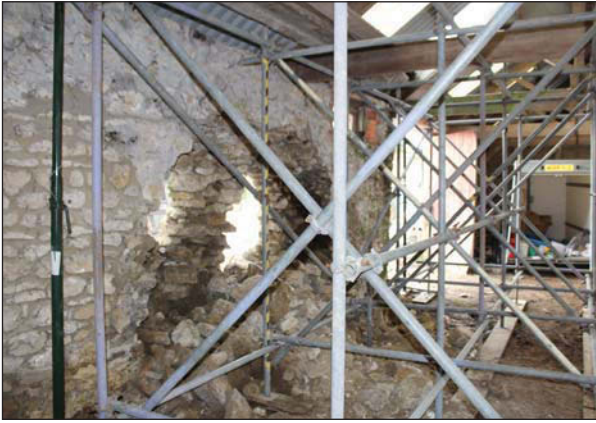
Plate 67. View of damage on south eastern wall.
Looking South.

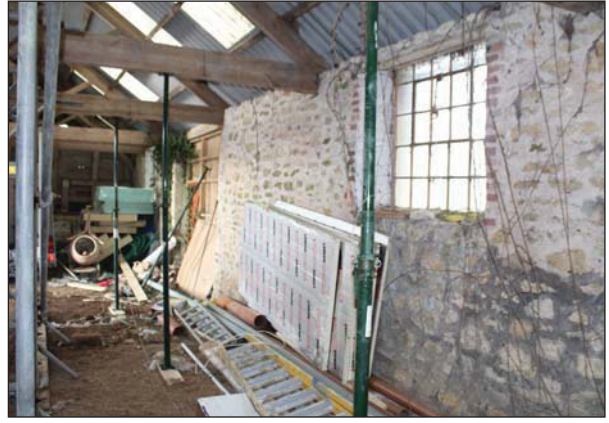
Plate 68. View of interior north western wall, glass window and doorway present. Looking West.
