**North Heath Farmhouse, North Heath,
Newbury, Berkshire**

Building Recording

Site Code: NHC23/16

Report 23/16

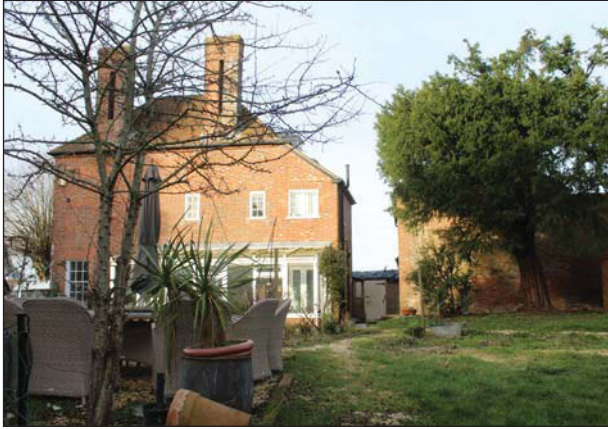
The building is located to the rear of the farm house (north side) approximately 4.3m away from the original rear of the main farmhouse and linked via a corridor (Pl. 1). In general, it is rectangular in shape, with an extension on the north side to form an ‘L’. The height of the building varies from single storey to two storey. It is brick built with a slate roof whilst the northern extension is covered in clay tiles (Pl. 2).

Plate 1. External: East elevation including the main house, looking South.

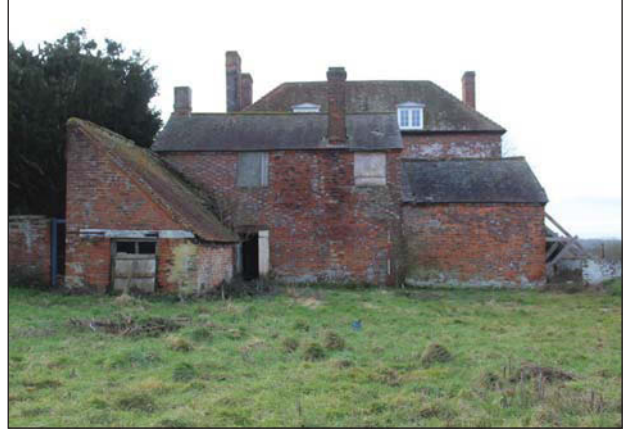
The main building is rectangular in shape, brick built with a gable end roof, two storeys high (Pl. 2). Bricks are laid in Flemish bond with a large number of blue headers. The roof is covered in slate. The building is linked to the main house by a link corridor. It is three bays wide and sub-divided into two rooms on each floor.

The north elevation (Pl. 2) contained a doorway beneath a segmental arch formed of rowlock bond bricks. The opening had been made smaller with the insertion of two planks of wood, presumably attached to the door frame which is not visible on the west side (Pl. 7). The door is of simple plank and batten type with a latch. Immediately to the east of the door is a window that has been boarded over. On the first floor are a further two boarded up windows. At the base of the east end of the building it is possible to see where the well house has been keyed into the building (Pl. 8). Beneath the eaves, a brick corbel is visible as a course of header bond beneath a course of stretcher bond. The eastern end of the building is obscured by the link to the rear building. Between the two windows on the first floor is an area of predominantly stretcher bond brickwork over the area of the rear of the chimney breast on the first floor. Contained within the brickwork are some smoke blackened bricks suggesting reuse and reconstruction of this section of wall.

Plate 2. External: Rear of buildings with main house in the background, looking South, Scales: 1x1m, 1x2m.

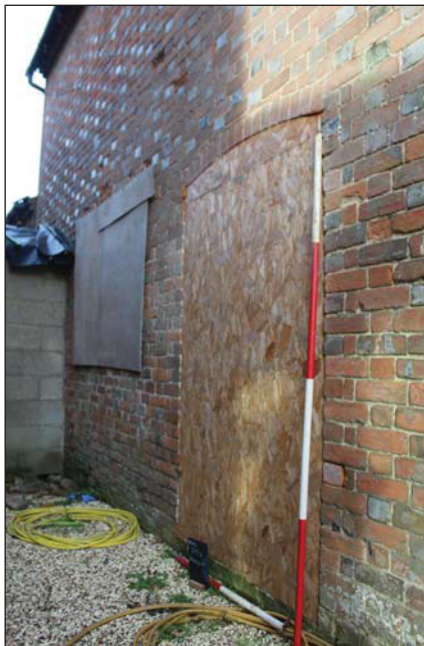
The south elevation, closest to the house and linked to it contains the main entrances to the building. The frontage is largely functional with two doors, accessing the two rooms and a window between the doors on the ground floor (Pl. 3). The window and external door had been boarded over. On the west side of the link corridor the keying in with the well house could be partially observed, though this was mainly visible within the well house wall (Pl. 4). The door within the link corridor was a simple plank and batten door with a latch. It had a wooden surround (Pl.5).

Plate 3. External: Door opening detail, looking North West, Scales: 1x1m, 1x2m.

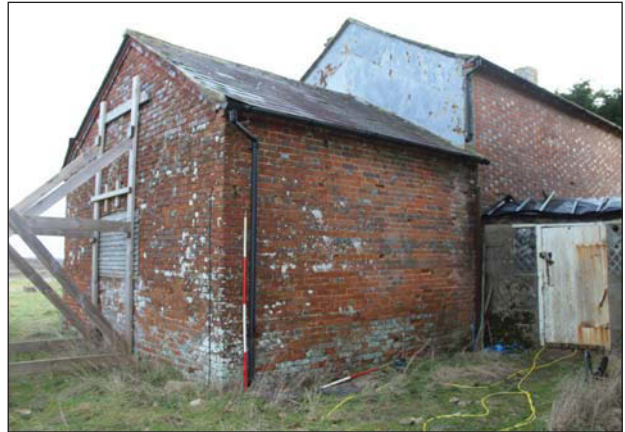
The west elevation is largely obscured by the well house, but the apex of the gable end is visible, covered in sheet metal (Pl. 6).

The well house (Pl. 6) is located at the western end of the range of buildings, is roughly square and has been keyed into the main building structure. It is single storey, but taller than the ground floor in the main building, brick built, laid in English garden wall bond. The eaves had two courses of corbelled brickwork consisting of a soldier course and a stretcher course to form the top of the wall. The roof is covered in slate.

The south elevation has no openings and consists solely of a brick wall (Pl. 6). The western end of the main building wall is keyed into the well house wall near the base for five courses of brick (Pl. 4). The house link corridor obscures the keying in from the well house into the main building. Higher up the buildings are not keyed into one another and there is a vertical scar at the junction of the two buildings.

Plate 6. External: Oblique of well house looking North East. Scales: 1x1m, 1x2m.

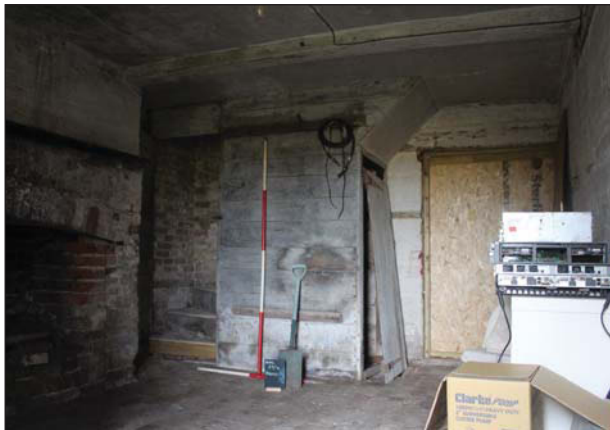
Room 1 (Pl. 11) is located on the east side of the building and is accessed via a door on both the north (Pl. 12) and south (Pl. 11) sides of the building, though the door on the south side was blocked on the day of the survey. Room 1 occupies half of the ground floor and is rectangular in shape. In general the walls are of exposed or painted brick, including the dividing wall between rooms 1 and 2 and the floor is also of brick (Pl. 13). The ceiling is plastered with two chamfered beams running east-west across it (Pl. 14). In the north-east corner part of the ceiling has been removed exposing two joists (Pl. 15). These joists appear to have been reused with an empty peghole and mortice present. The main feature within the room is a large fireplace in the centre of the east wall (Pl. 16). Within the north wall is a further door into the rear building link and a window (Pl. 12). On the south wall are stairs to the first floor (Pl. 11).

The stairs (Pl. 11) are located in the south-east corner of the room and consist of a winder staircase (Pl. 20) with the underside partitioned to create a cupboard beneath (Pl. 21). The partition is constructed of wooden

Plate 11. Main building 1: View to stairs and external door looking South East, Scales: 1x1m, 1x2m.

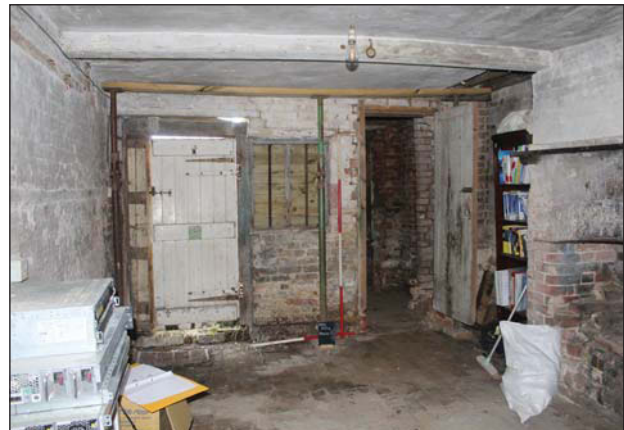
The two doors within the north wall (Pl. 11) are later insertions with an even later external door to fit a reduced opening. The internal door into the link consists of planks within a frame with a latch. The floor level within the link has been reduced as indicated by the gap beneath the door. The window has been reduced in size to accommodate the door and may have been more similar in size to that within room 2 (Pl. 17). It has a wooden frame with a central wooden post with iron rods on either side; there is no glass and it is likely that they did not contain glass at any point.

Plate 12. Main building 1: View to doors and window looking North, Scales: 1x1m, 1x2m

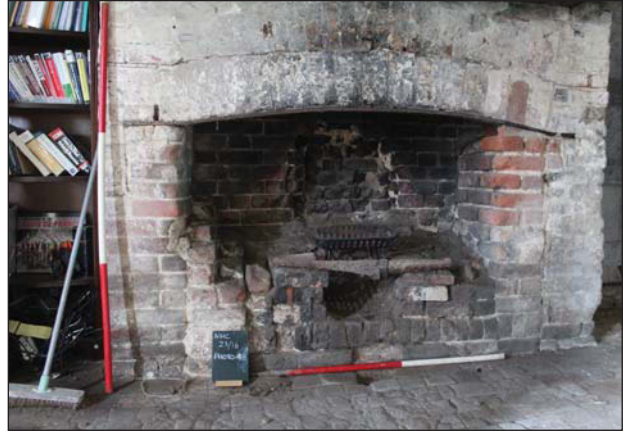
The fireplace (Pl. 18) protrudes into the room and is the dominant feature within it. It consists of an approximately 2m long by 0.6m deep fireplace of brick construction laid in stretcher bond and white-washed over. The opening has been reduced in size a number of times. In its original form the opening was located beneath a segmental arch in soldier bond, possibly beneath a shaped metal rod to form the arch and extended to the floor. The height of the opening has subsequently been reduced with a second segmental arch beneath the first using the same construction techniques. The southern end of the opening has been reduced in width by the length of a brick with the insertion of a wall extending to the back of the fireplace. The same appears to have happened on the northern side of the opening but it has since been partially removed. The remaining opening has then been decreased in height with the addition of two courses of bricks laid on the floor, one stretcher course beneath a rowlock bond course. Lastly the centre of the fireplace has been further raised and scrap metal overlaid to create a raised grate (Pl. 19). Scarring within the back wall of the fireplace suggests that a back plate was once present. A wooden shelf has been installed above the two arches to create a mantle-piece.

Plate 18. Main building 1: Fireplace detail looking East, Scales: 1x1m, 1x2m.

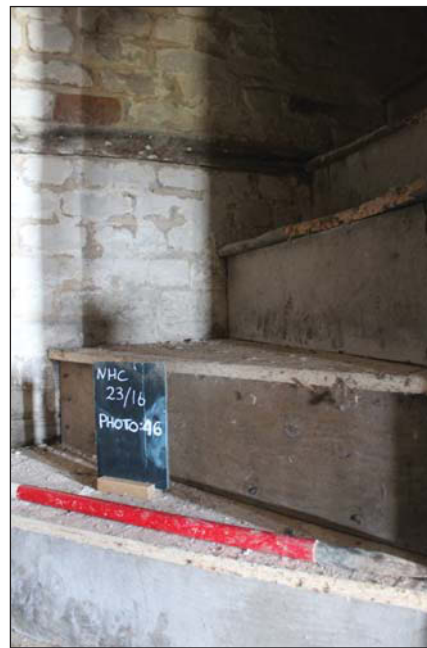
Plate 20. Main building 1: Main building 1, looking South, Scale:1m

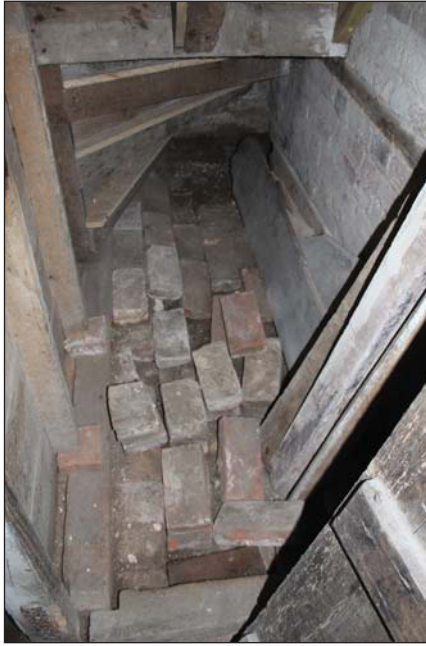
boards laid horizontally and nailed on. Construction of the stairs appears to be wooden battens inserted into the wall resting on a timber plate built into the brickwork.

Plate 21. Main building 1: Under the stairs looking East

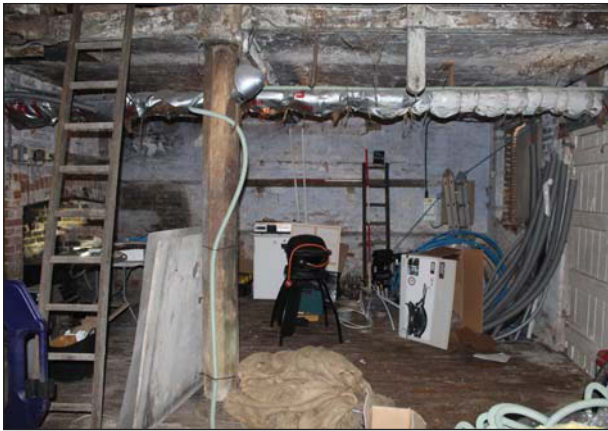
Room 2 (Pl. 23) is in the western half of the original main building (now the centre with the well room added to its west) and accessed only via a door on the south side of the building, now linked by a short section of corridor to the main house. Like room 1 the brick walls are whitewashed and the floor is laid in bricks (Pl. 24). The west wall has been removed and the building extended to include the well. The ceiling has been plastered over and there is a central beam that has been boxed in; no joists are visible (Pl. 25). The western end of the beam is supported on a post set on a stone above the floor level (Pl. 23). The post is octagonal in shape and is almost certainly the axle from a large wheel to raise water from the well, such as the treadwheel from Catherington at the Weald and Downland Museum, or a larger donkey wheel. No mortices remain in it for spokes of the wheel and it may have been cut to fit the space. No indication remains as to how the water was raised from the well subsequent to the axle being used as a post and the well house incorporated into the main building.

Plate 23. Main building 2: View to east wall
looking East

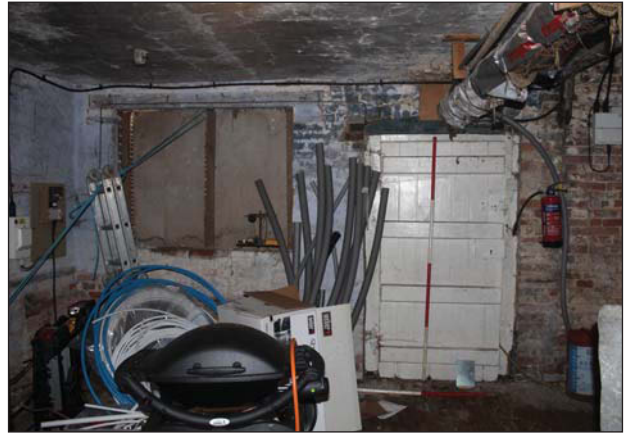
There is a door and window in the south wall (Pl. 26) and once again the room is dominated by a large chimney breast, this one in the north wall (Pl. 27).

The door is of simple plank and batten type set beneath a rowlock bond segmental arch within a wooden frame (Pl. 26). The window is located to the east of the door beneath a timber lintel, which may have been raised by two courses of brick to increase the height of the window. Currently there is no window or frame remaining (Pl. 26).

Plate 26. Main building 2, View to door and window looking South, Scales: 1x1m, 1x2m

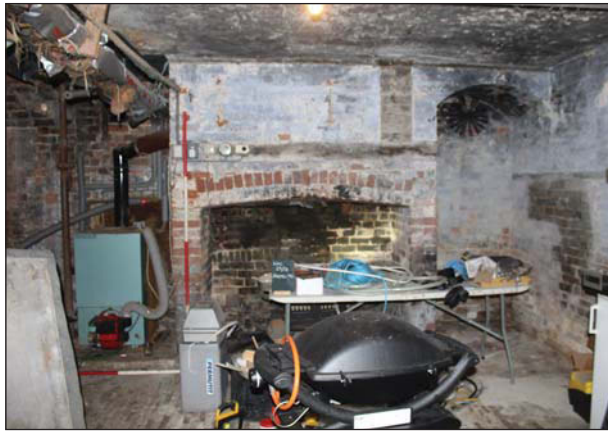
The fireplace protrudes into the room and is the dominant feature within it (Pl. 27). It consists of an approximately 2m long by 0.7m deep fireplace of brick construction laid in stretcher bond and white-washed over. It is similar in construction to the chimney breast within room 1 with a segmental brick arch over the opening supported on a metal rod. The arch consists of two courses of rowlock bond bricks above which is a wooden timber set into the brickwork. To the rear of the opening is a small alcove beneath a brick arch (Pl. 28). A metal rod was connected to the arch and jamb of the main chimney. It is likely that this was part of a small bread oven or warming area. To the east of the chimney breast is an alcove with an arch above (Pl. 29). Within the floor is a circular arrangement of bricks and a gully aligned NE-SW sloping down from the jamb of the

Plate 27. Main building 2: Chimney breast looking North, Scales: 1x1m, 1x2m

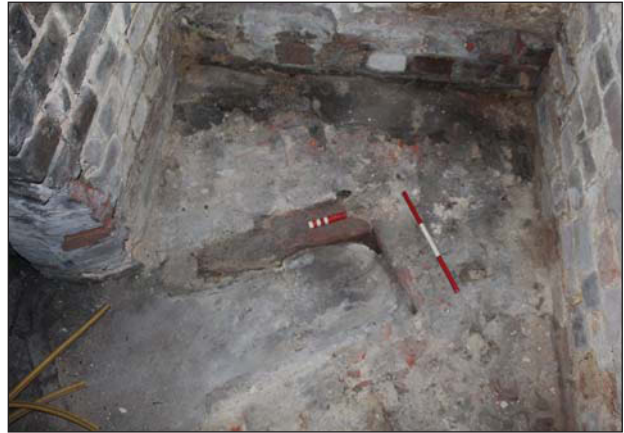
Plate 30. Main building 2, Floor detail looking North,
Scales: 1x 0.1m, 1x0.3m

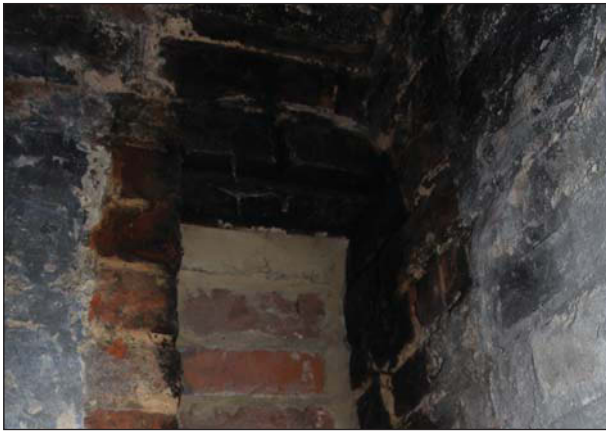
chimney breast (Pl. 30). Within the jamb of the chimney breast, located within the alcove, is a further alcove which is smoke blackened (Pl. 31). The four bricks at the top of the opening are a later blocking of a flue that fed into the main chimney stack. This is likely to have been the location of a larger bread oven with the gully being to collect the fallen ashes. The existing boiler for the house is located on the west side of the chimney and it is possible that this is a historic location for an old copper boiler.

Plate 31. Main building 2: Alcove detail
looking North West.

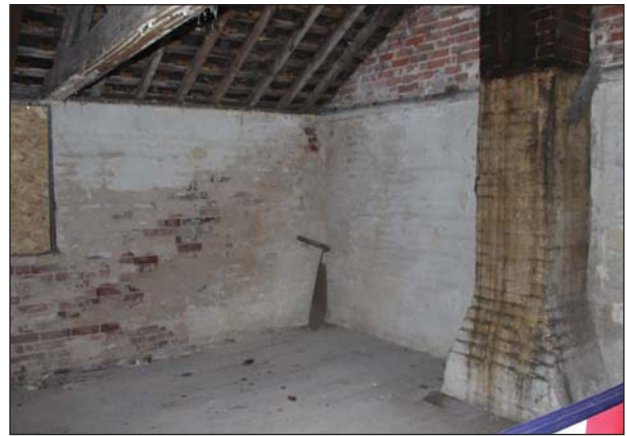
Room 3 is located above room 1 and directly accessed via the stairs within room 1 (Fig. 8; Pl. 32). Much of it was inaccessible on the day of the survey due to the weak floor, but was visible. The stairs opened directly into the room. Immediately to the west is access to room 4 via a doorway. Within the north-west corner of the room is a window that has been boarded up (Pl. 33) and the chimney stack rises up through the floor within the east wall (Pl. 32). The external walls are painted brickwork beneath the wall plate whilst the internal wall is plastered and painted. Floorboards are exposed and the room is open to the roof. The dividing wall extends to the underside of the roof trusses; together with the painting of the bricks and a batten on the east wall this suggests that there was previously a ceiling present. The chimney consisted only of the stack (Pl. 32), considerably narrower than the fireplace below, but wider at the base before continuing through the roof. The stairs have a basic wooden gallery balustrade which is attached to the wall at the east end and to the wooden partition within room 1 (Pl. 34). The handrail has been rounded at the end and the gap between that and the opening for the stairs partially infilled with horizontal planks; one of which appears to be missing. The floorboards have been rounded along the edge.

Plate 32. Main building 1: Oblique of room 3 to
chimney stack, looking North East.

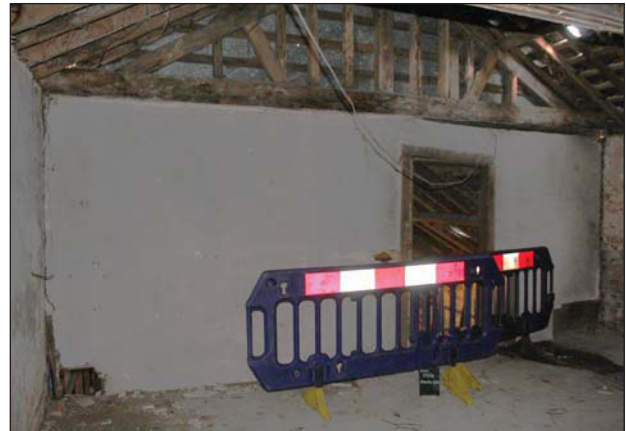
Room 4 (Pl. 35) is located above room 2 and accessed via an opening from room 1. Secondary access is available via a ladder from the rooms below through the west wall (Pl. 36). There is a boarded-up window in the north wall, to the west of the chimney breast. The walls have mainly been plastered, with the exception of the area around the window and the floorboards are once again exposed. Once again plastering has finished at the wall plate level and may suggest the presence of a former ceiling. The principal feature of the room is the large chimney breast, a continuation in size of that within room 1, but extending further east than on the floor below. It appears to be constructed of solid brick with no indication of a former fireplace contained within it. The stack is located at the western end of the chimney breast and appears to be constructed in English garden wall bond (Pl. 37). A truss rests approximately centrally on the chimney breast. The west wall is of timber frame construction, best viewed from the well house, though some of the timbers have been overlaid by rafters to construct the well house roof (Pl. 38). The area beneath the tie-beam is close studded with a diagonal brace on either side. On the north side this diagonal brace has been cut through to create the opening within the wall. Laths had been applied

on the east side of the wall and plastered over. Plaster has also been added between the close studs on the west side of the wall.

Plate 36. Main building 4: Oblique west wall looking West.

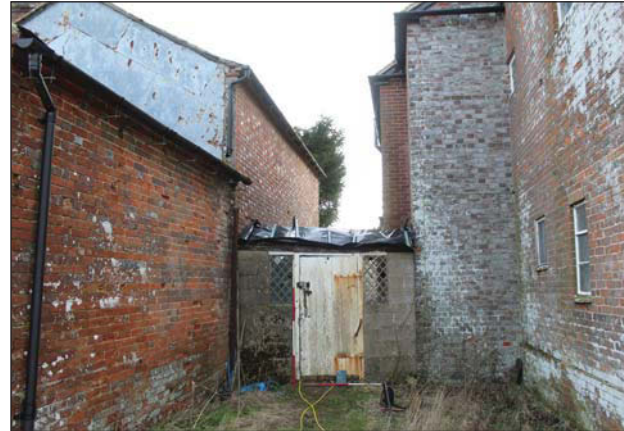
The main building and house are linked by a narrow corridor (Pl. 44). The corridor runs at an angle connecting the two doors of the buildings. In order to understand the link corridor it is necessary to understand the rear of the farmhouse. An approximately central external door is present on the north side of the house with two steps leading down into the link corridor. The door is located within a small extension to the farmhouse, perhaps originally a porch that has subsequently been raised to link a further rear extension to the rest of the farmhouse at first floor level. Evidence for the raising can be seen in the brickwork that is header bond at ground floor height changing to Flemish bond above the height of the ground floor windows. The extension is likely later than the farmhouse with the bricks not keyed into the main structure. Within the raised section is a bell crank (Pl. 45), the remains of a servant bell system, a similar one of which is illustrated in the 1908 Chambers English Dictionary (Davidson 2011).

The link itself is of basic construction, of concrete blocks laid on edge. On either side is a central doorway with a window on either side. The pitched roof is currently covered in plastic sheeting. The doors and windows extend to the height of the wooden wall plate and are of basic construction again, the door of planks and the

Plate 44. External: House link corridor looking North East, Scales: 1x1m, 1x2m

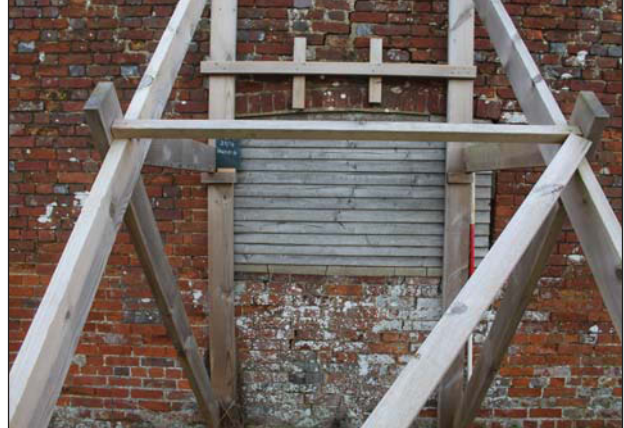
The west elevation contained a single window, located approximately centrally (Pl. 46) beneath a segmental arch of rowlock bond brickwork. On the day of the survey, it had been boarded up and the gable wall propped.

Plate 46. External: Window detail, looking east, Scale: 2m.

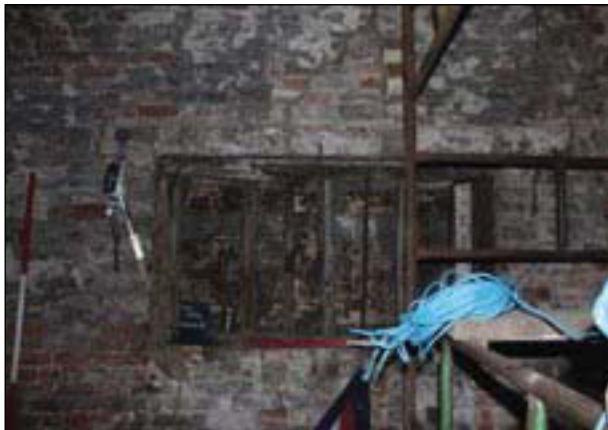
Within the gable end wall the window (Pl. 51) can be seen to be of wooden construction with square wooden posts, one of which has been replaced by an iron bar. Above the window, in the apex of the wall are ventilation holes within the brickwork arranged in a triangular pattern of five vents (Pl. 52). Features within the north and south walls are the reverse of those seen externally and there is no more to add to the observations of the keying together of the two buildings.

Plate 51. Well house: Window detail, looking west, 2m and 1m.
