**Archaeological Standing Building  
Recording**

**Lodge Hill Farm**

**Whitby, North Yorkshire**

**July 2021**

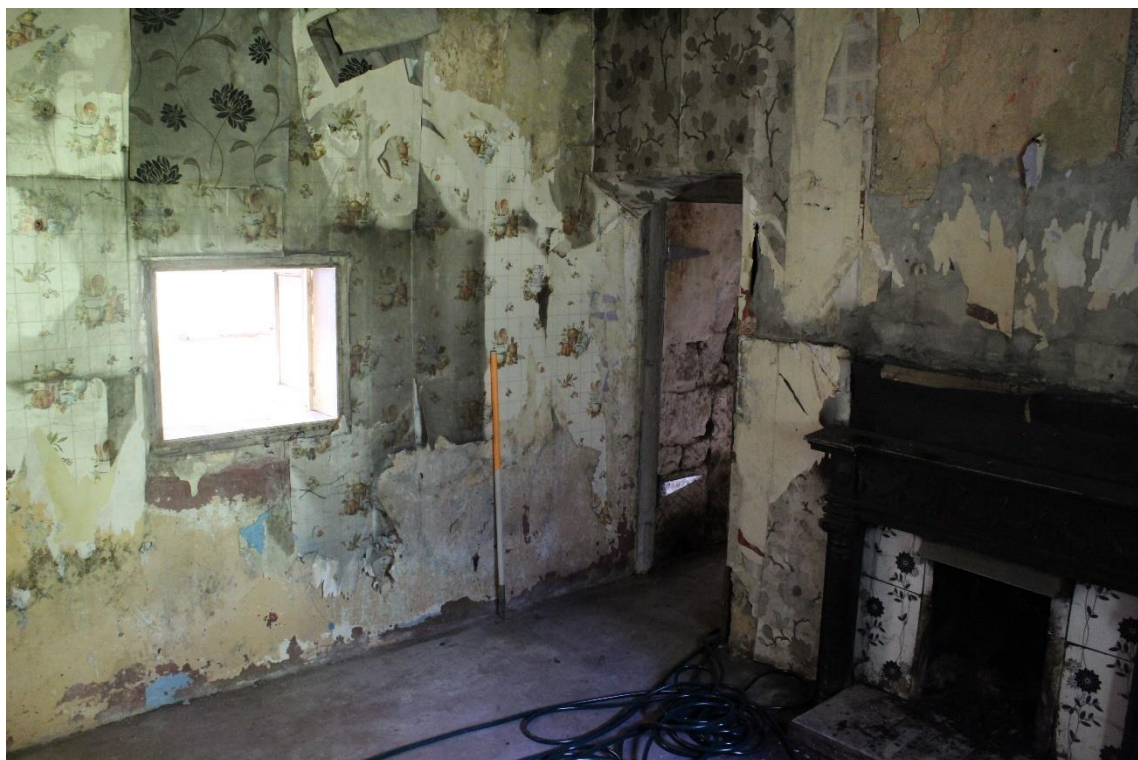
The kitchen opens W from the N end of the central hallway (*Plates 25-30*) and leads through into the single-storey outhouse (*Plate 26*). The walls appear heavily sooted but no discernible fire damage was noted. The floor is concrete and the walls plastered, with exposed chamfered ceiling beams and the underside of the first-floor floorboards again visible (*Plate 30*). The room is lit by a two-light casement in the N wall (*Plate 29*) while the W wall contains a central coal-grate with tile-and-wood surround over earlier mosaic tile (*Plate 25*). The S wall contains a service-hatch through into the first sitting room (*Plate 26*).

*Plate 26: internal view SSW within ground floor kitchen – Building No. 1*

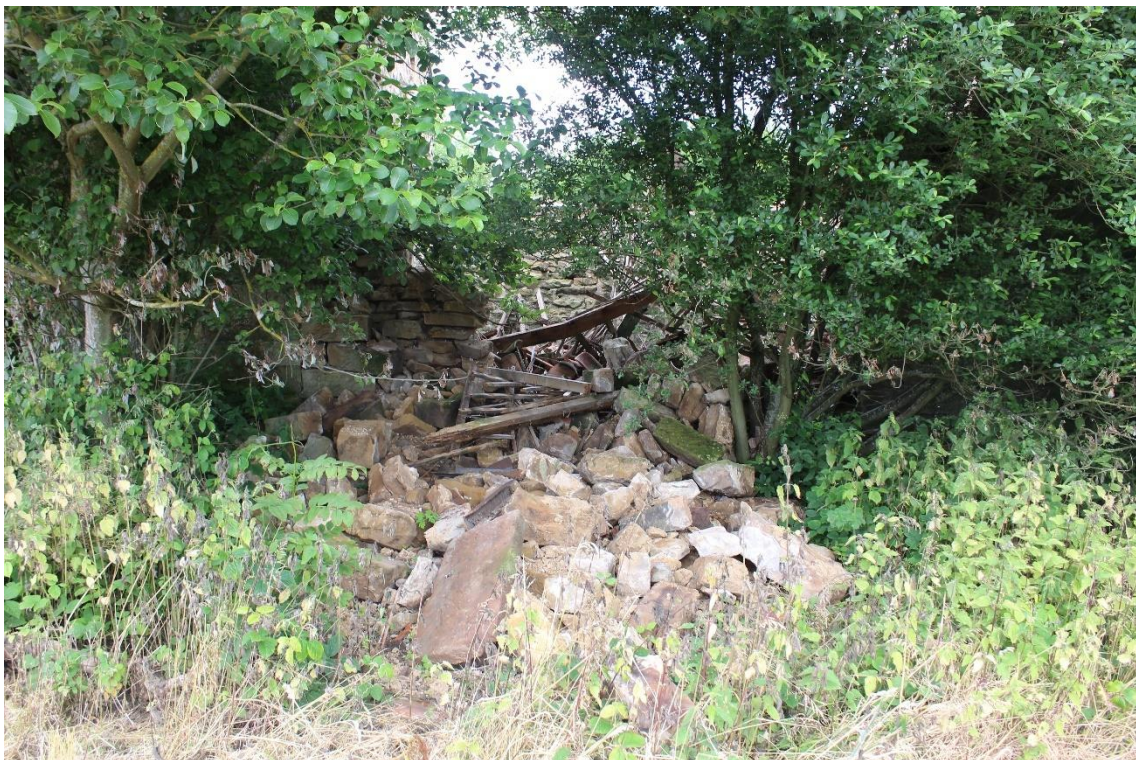
*Plate 122: External views N of the collapsed third section of the S-facing principal elevation*

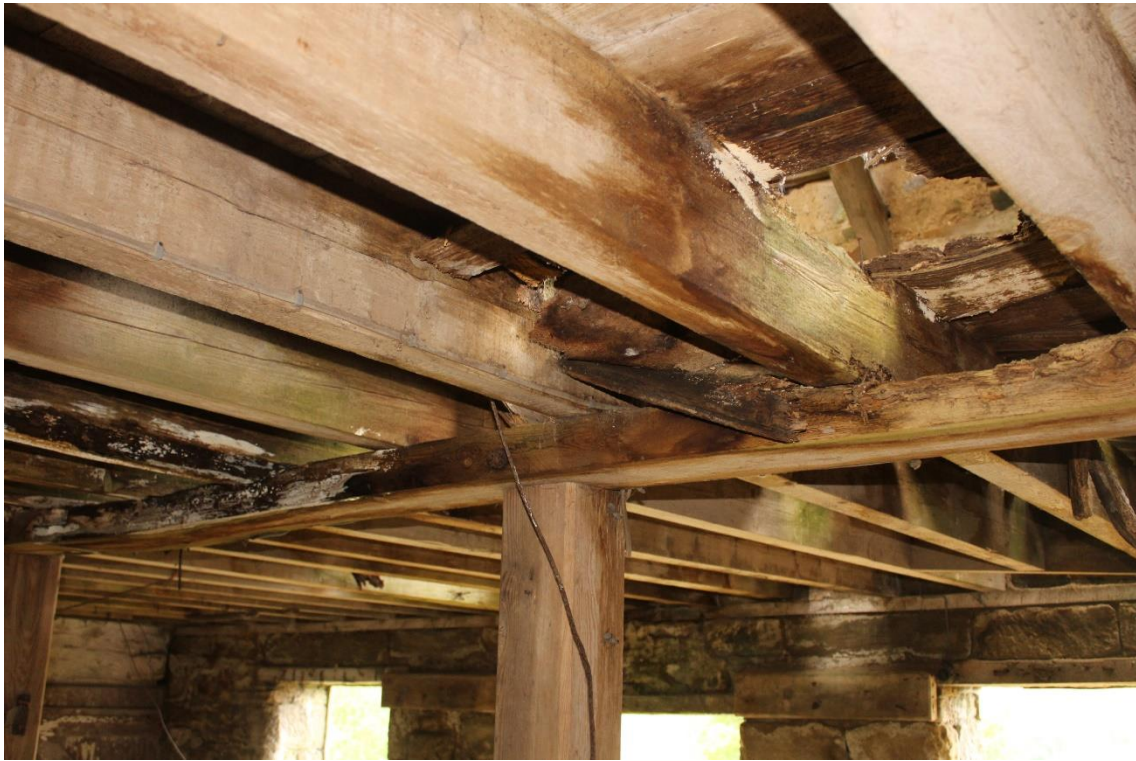
*Plate 131: Internal view ESE of rotten ceiling timbers within the first compartment of Building No.4*

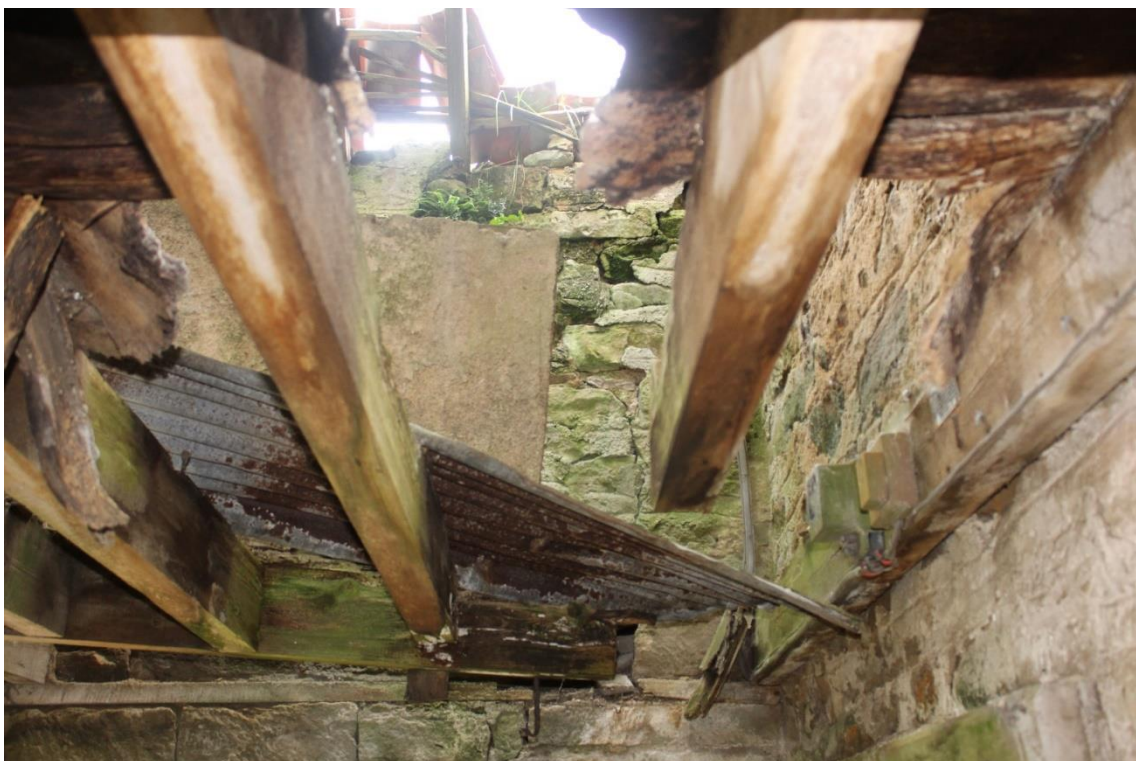
*Plate 132: Internal view S of rotten ceiling timbers within the first compartment of Building No.4*

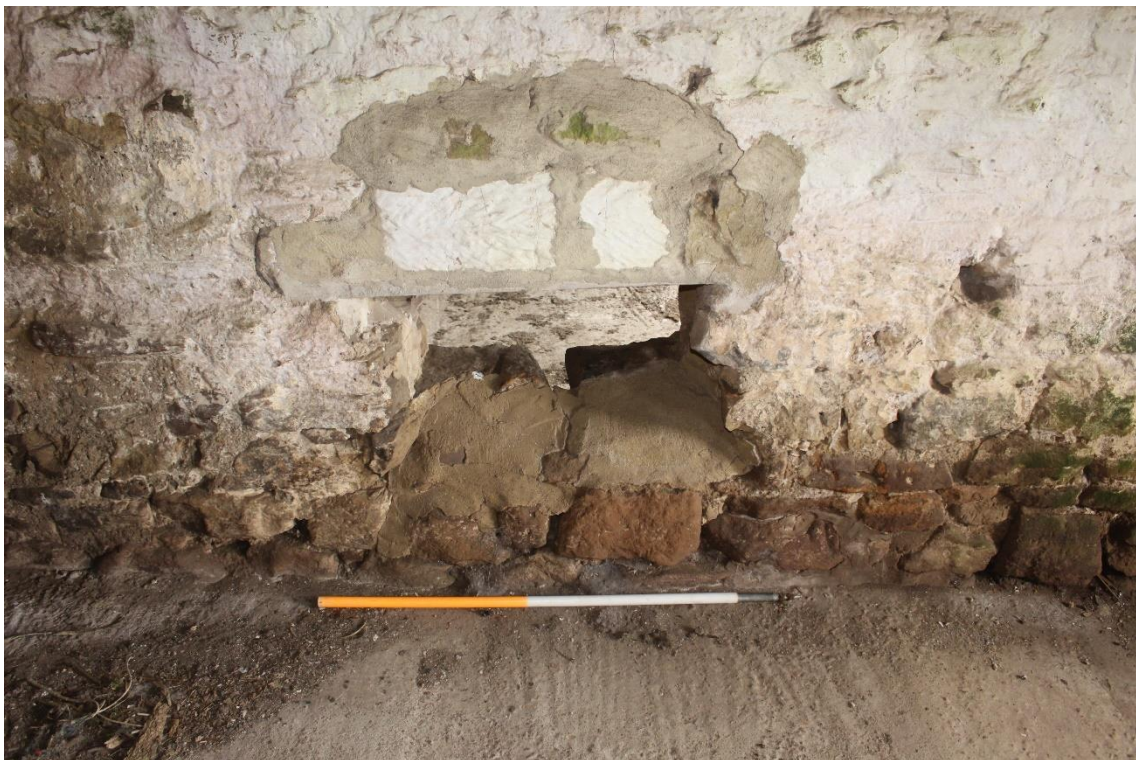
*Plate 134: Internal view E of hole in E wall within the first compartment of Building No.4*

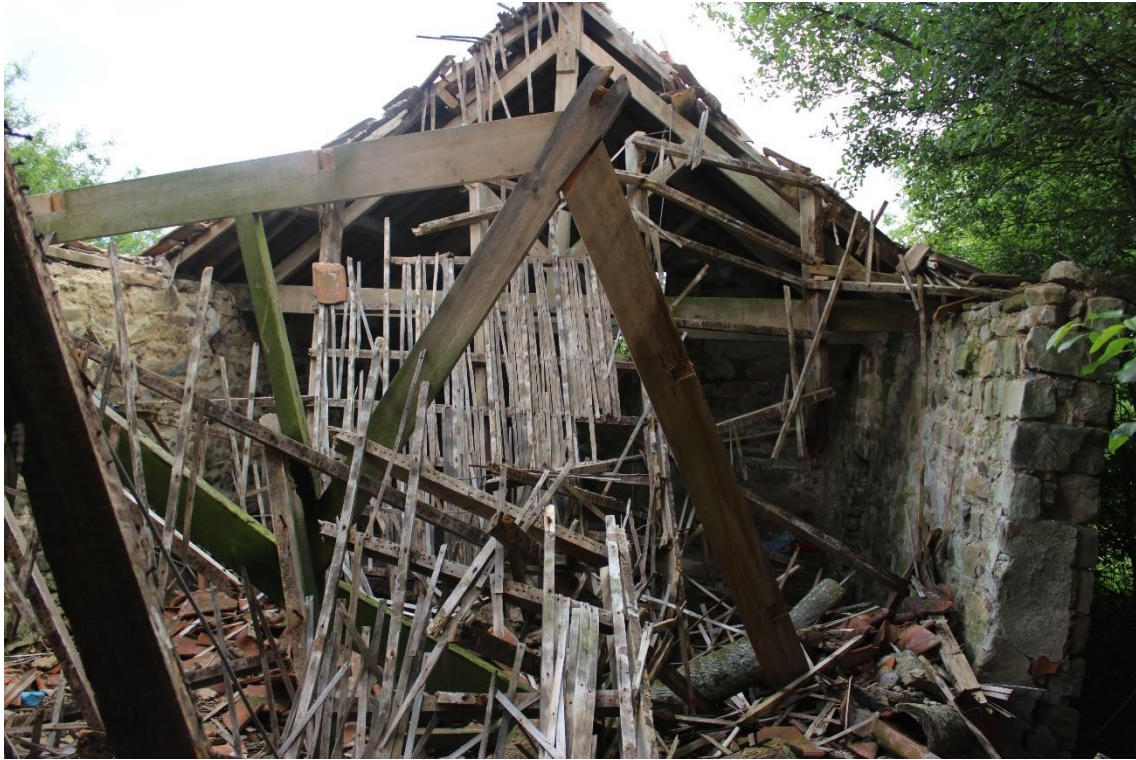
The fourth compartment was inaccessible due to recent roof and wall collapse (*Plate 145*). An earlier photograph supplied by the client shows the compartment to be open plan with a single-light window and two doors in the E wall, which it corroborated by the architects' drawings (*Fig. 9*)

*Plate 145: Internal view E from the third compartment into the fourth compartment of Building No.4*
