New House Farm, Lucton, Herefordshire

Archaeological Record

BORDER ARCHAEOLOGY

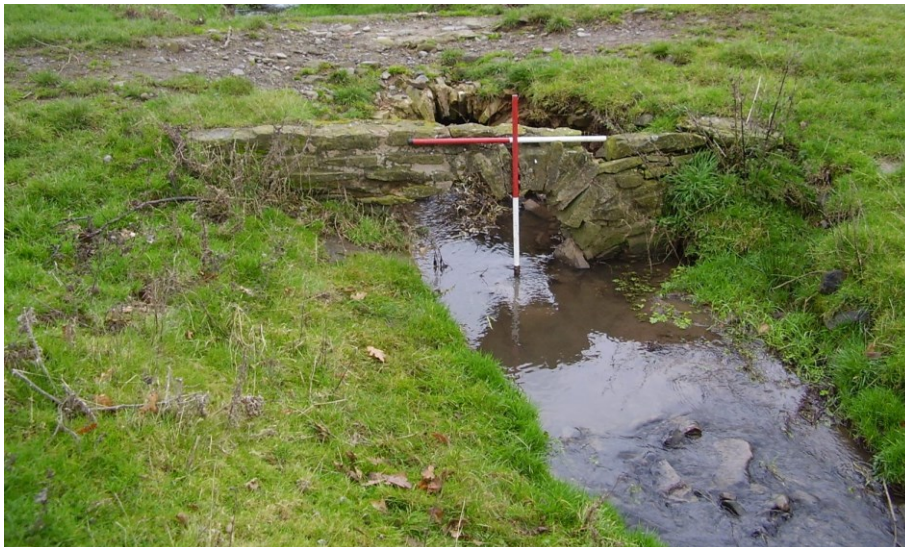
Plate 1: Overview of culvert. View NE

The culvert was originally part of a water management & control system within the adjoining fields and the remains of the culvert consisted of two main sections both constructed of irregularly coursed stone. To the SW were the collapsed remains of two stone arches, the most south westerly of which was set within an irregularly coursed masonry wall of roughly worked and shaped stones. This section appeared to form the outer face of the culvert on the SW side. The remains of a cement re-pointing were observed on the SW face of this section, although traces of an earlier mortar were observed within parts of the masonry.

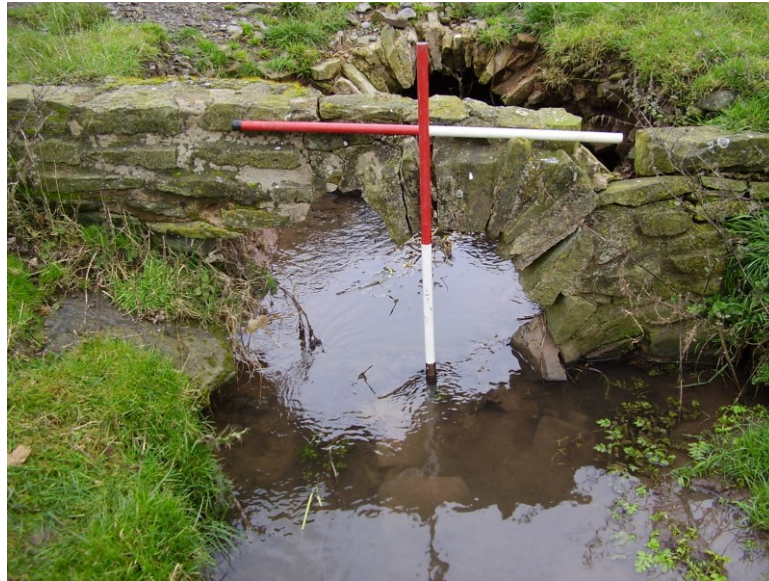
Plate 2: View NE showing SW outer face of culvert

In total, approximately 40 per cent of the culvert structure had collapsed and there was substantial damage to the SW face. The NE face appeared to have been significantly repaired and it was not clear whether the difference in construction could suggest that this section had previously collapsed and been subject to repair, although the cement bonding on this section is indicative of this possibility.

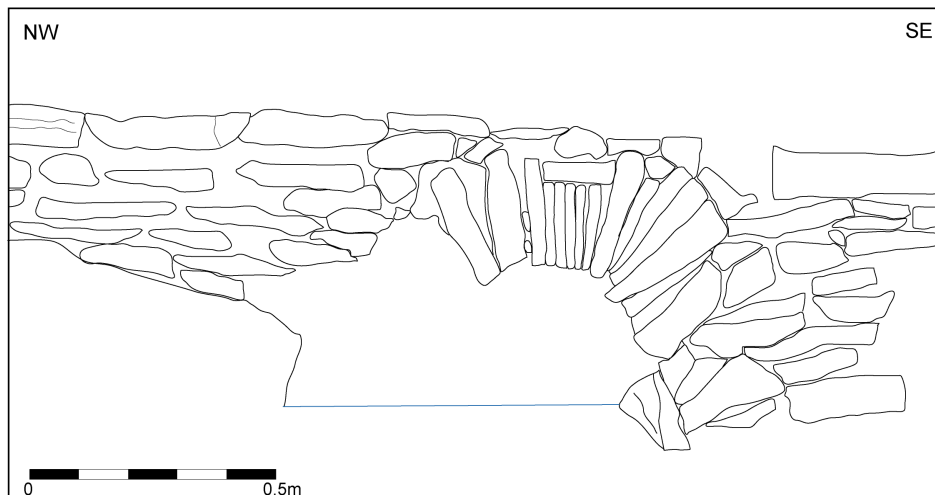
Fig 2: Elevation of SW outer face of culvert

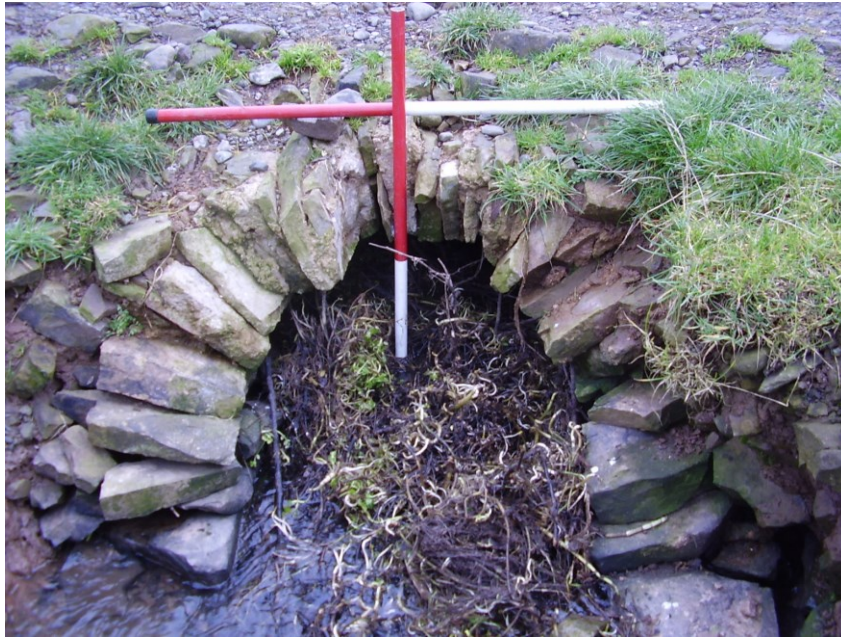
The central section consisted solely of an arch of loosely shaped stone, with redeposited rubble and sandy clay covering it on either side of the ditch. The culvert in between these two sections had collapsed entirely and the majority of the stone from this collapse had been removed to avoid the stream becoming blocked, although some of the material had been washed downstream.

Plate 3: Central section of culvert, detailing construction. View NE.

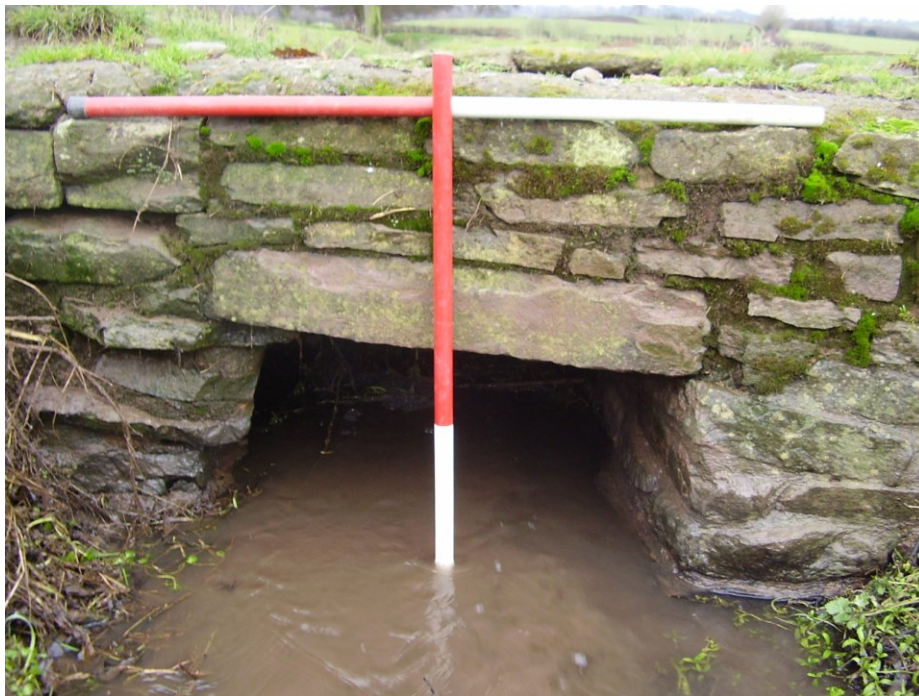
The NE face of the culvert was of a slightly different construction to the rest of culvert and consisted of irregularly coursed masonry constructed around a 0.70m long, 0.12m thick lintel spanning the stream. Bonding the lintel and the wall were the remains of a lime mortar. The visible dimensions of this section were 2.2 x 1.2 x 0.80m. The ground overlying this section had been covered by cement-bonded rubble.

Plate 4: NE face of culvert. View SW

Considering the limited survival of the original culvert following the collapse and the fact that part of its structure had already been subject to a considerable level of repair and alteration, Border Archaeology recommends that the culvert should be reconstructed in its entirety using as much of the original fabric and local stone material as possible.

Such repairs that have been made can only be construed as temporary and with the use of concrete not in keeping with its original character.

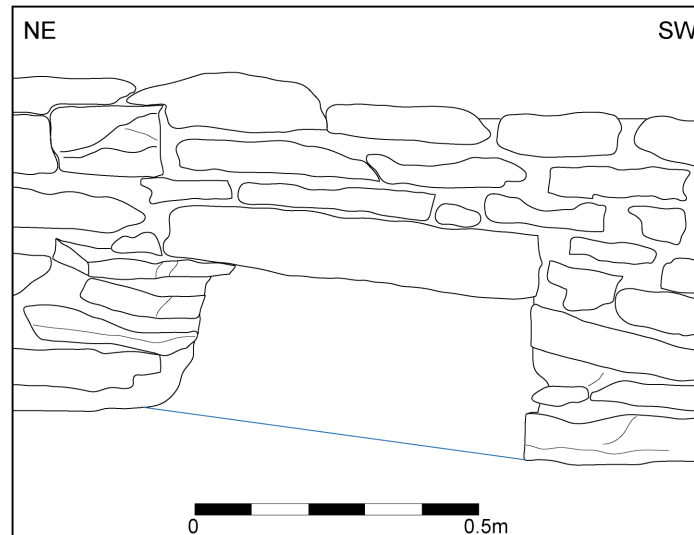
Fig 3: Elevation of NE outer face of culvert
