STANDING BUILDING RECORDING SURVEY

Stretford Bridge Farm
Stretford
Leominster
Herefordshire HR6 9DQ

NGR: SO 44118 55325
JOB No: BA1134SBFSL
SMR Event No. 1928

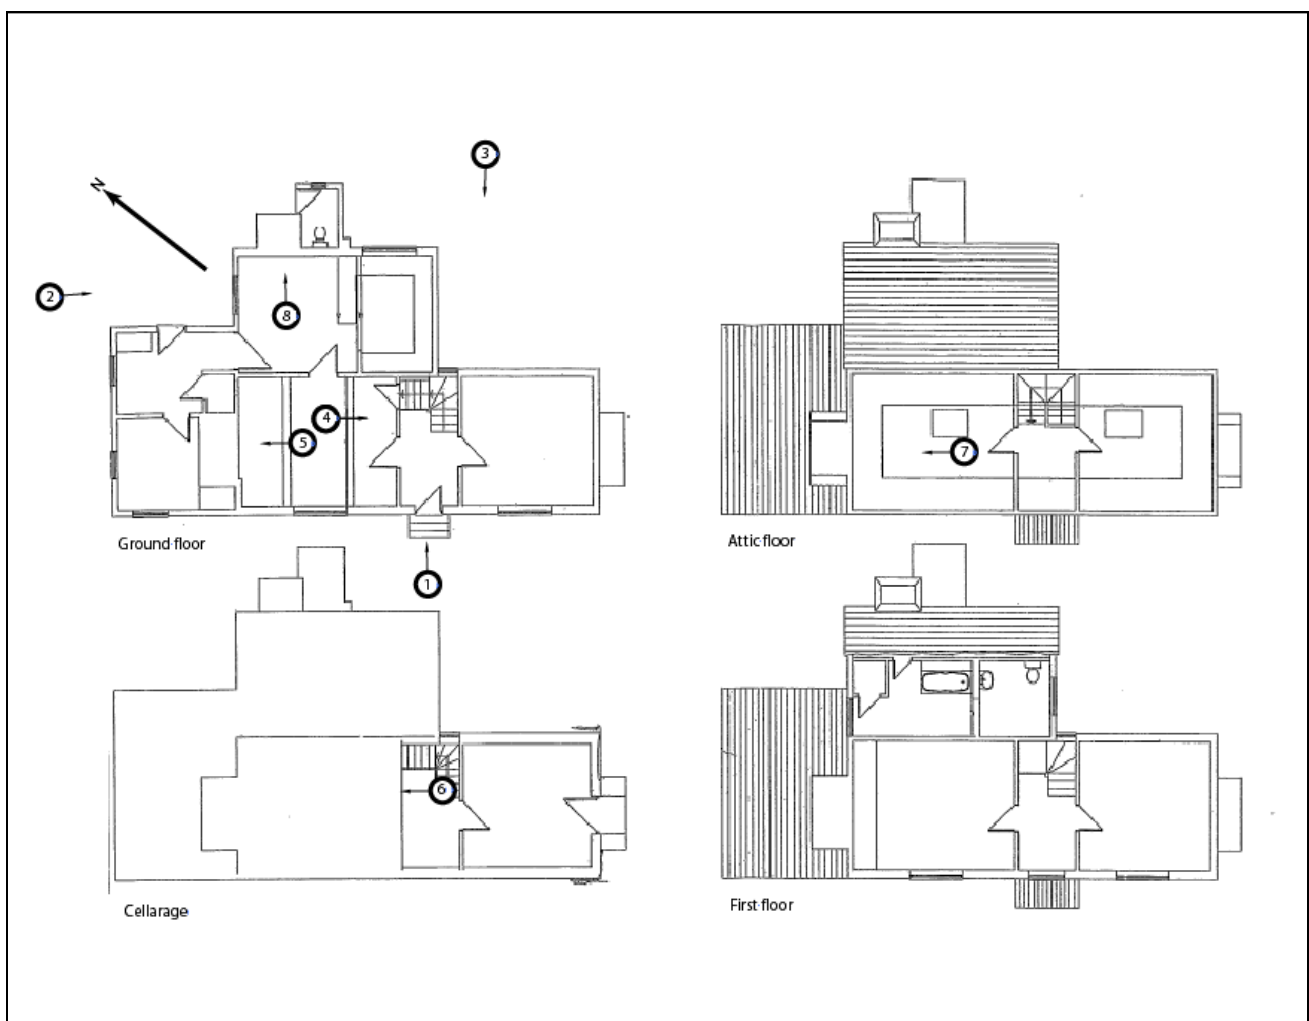
Fig. 4 Annotated sketch plan of existing farmhouse at Stretford Bridge Farm (Scale 1:100)

The farmhouse forming the subject of this programme of standing building recording is located at Stretford Bridge Farm, within a narrow oblong plot of land immediately N of the junction of the A4110 and B4457 roads. The farmhouse is oriented NW-SE, of two and a half storeys (including a converted attic) with a pitched slate roof and a substantial cellar located beneath the SE end of the building, and two lean-to extensions added to the NE and NW of the property.

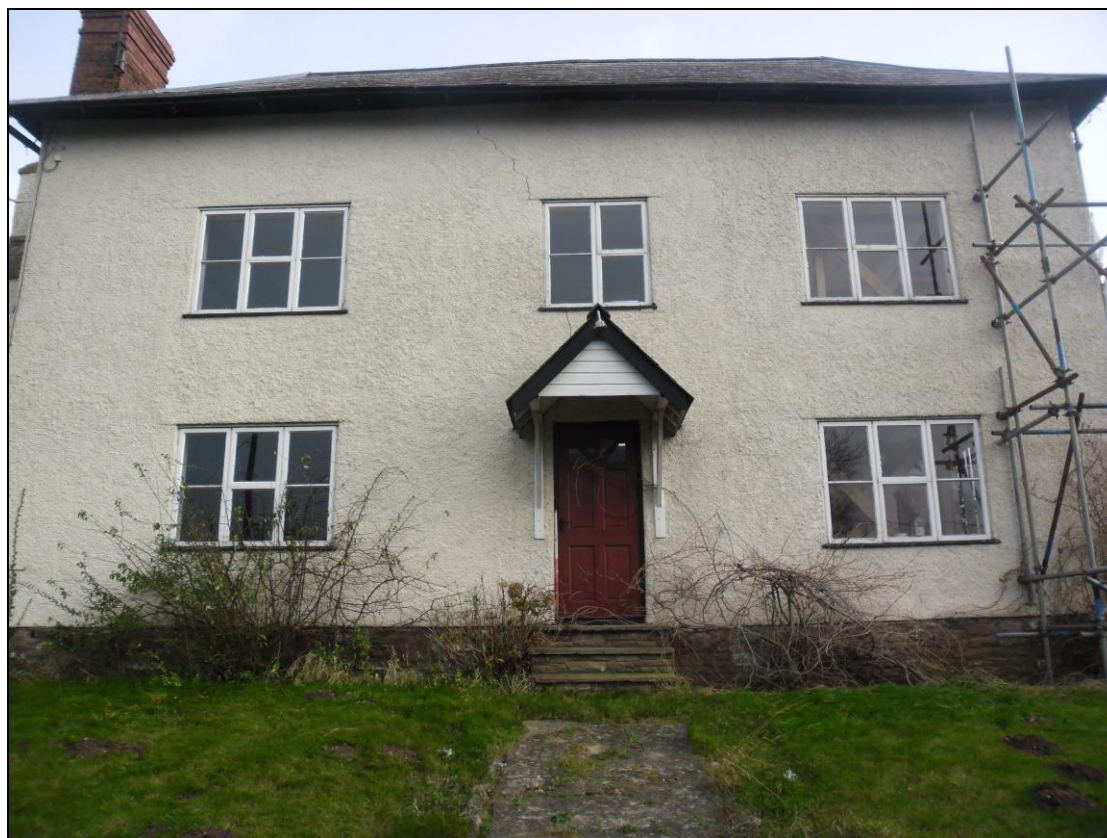
The fenestration of the principal (SW-facing) elevation consists of a centrally placed doorway with a gabled, weatherboarded porch at ground level accessed by a flight of stone steps and flanked by two six-light flat headed casemented windows; above the doorway is a single four-light flat headed casemented window, again flanked by two six light casements. The door and casement window fittings all appear to be of recent (eg. late 20th century) date.

Plate 1: View looking NE showing principal (SW-facing) elevation of farmhouse

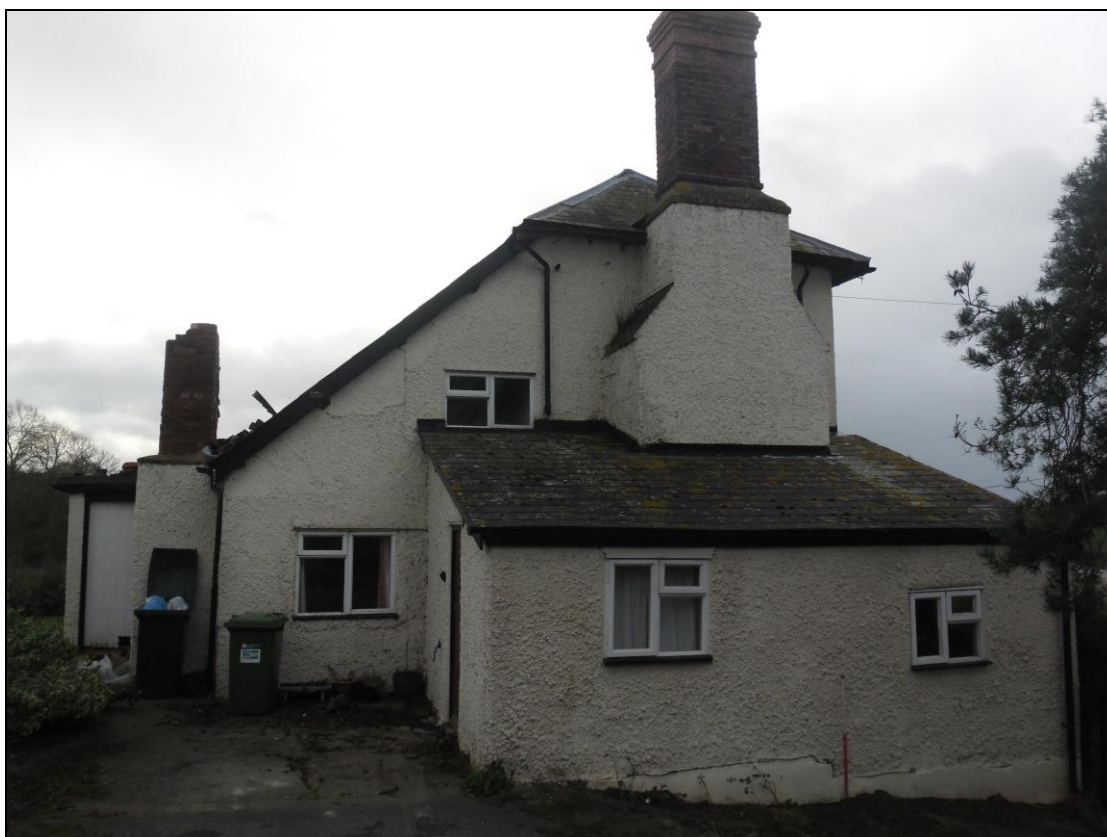
The most noteworthy feature of the NW-facing elevation is the substantial projecting tiered chimney stack (**Plate 2**). It is unclear whether the lower stages, which are completely covered in roughcast, are of masonry or brick construction (the latter being more likely) however the uppermost tier is evidently brick-built. Also attached to the NW elevation (and obscuring the lower stages of the chimney stack) is a single storey lean-to extension, two bays long and a single bay in width, with a catslide slate roof containing a lobby and utility room. This extension appears to have been added in the 1960s-early 1970s, it is first shown on an Ordnance Survey OS 1:2500 map of 1974.

Plate 2: View looking SE showing NW-facing elevation with projecting chimney stack and single storey lean-to extension.

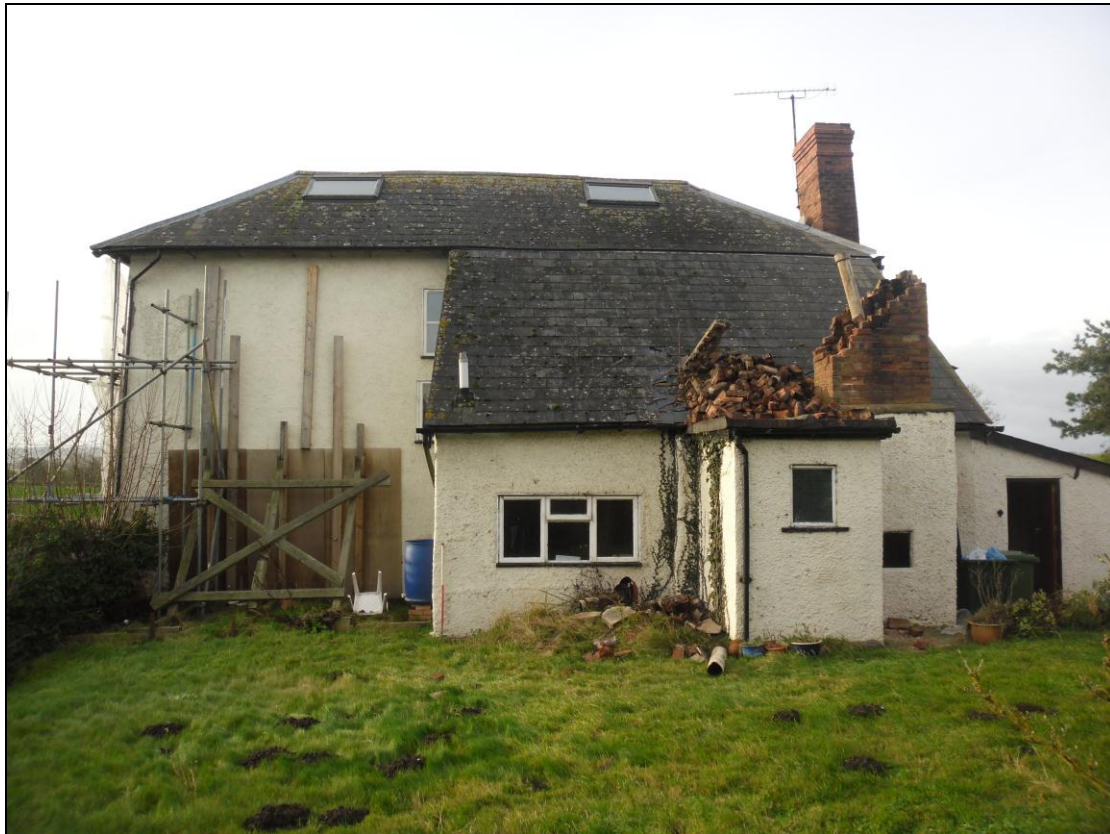
Attached to the rear (NE-facing) elevation is a substantial lean-to extension with a steeply pitched catslide roof, one and half storeys in height, three bays long and two bays in width, with a kitchen and dining area at ground floor level and a substantial attic space which has been converted to use as a bathroom (**Plate 3**). A substantial brick chimney stack (the upper tier of which has collapsed) projects from the NW corner of the extension, adjoining which is a rectangular, brick-built outhouse with a flat roof. This extension is first shown on the OS 1st edition map of 1887, which indicates a probable mid to late 19th century date for its construction. The rest of the NE elevation is largely devoid of detailing, with the exception of three flat headed single light windows inserted at cellar, first floor landing and eaves level.

Plate 3: View looking SW showing rear (NE-facing) elevation with projecting one and a half storey extension (and partially collapsed chimney)

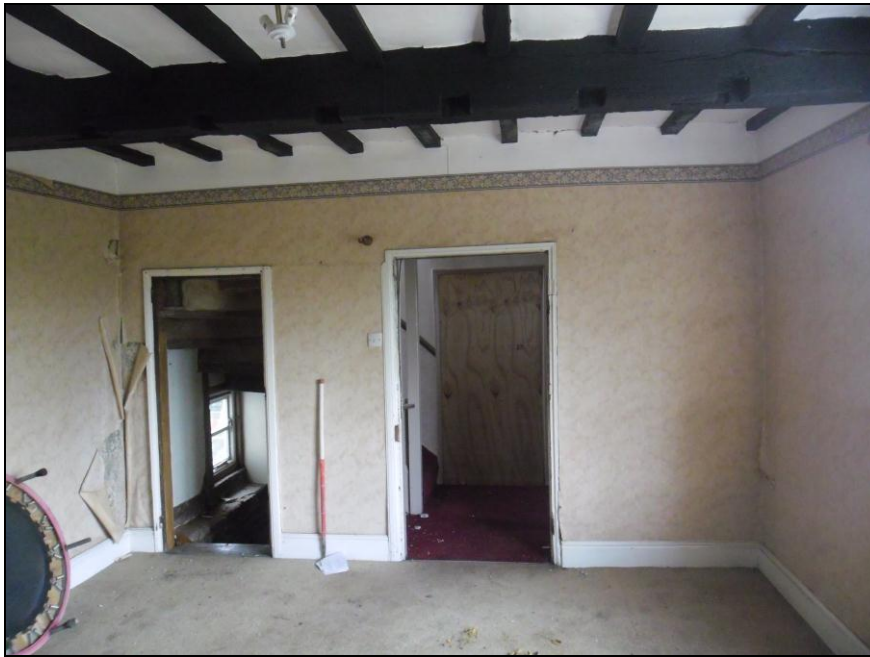
Little architectural detailing was visible in the living room with the exception of the exposed ceiling beams and rafters. A series of regularly distributed mortice slots had been inserted into the ceiling beam nearest the hallway; these could simply be an indicator that the beam was salvaged from another building or they could represent evidence for a wooden partition wall dividing the room into two compartments (**Plate 4**). The stone fireplace and surround at the NW end of the living room is clearly a modern insertion (**Plate 5**).

Plate 4: Internal view of living room looking SE showing exposed ceiling beam with mortice slots and doorways to hallway and cellar (to left)

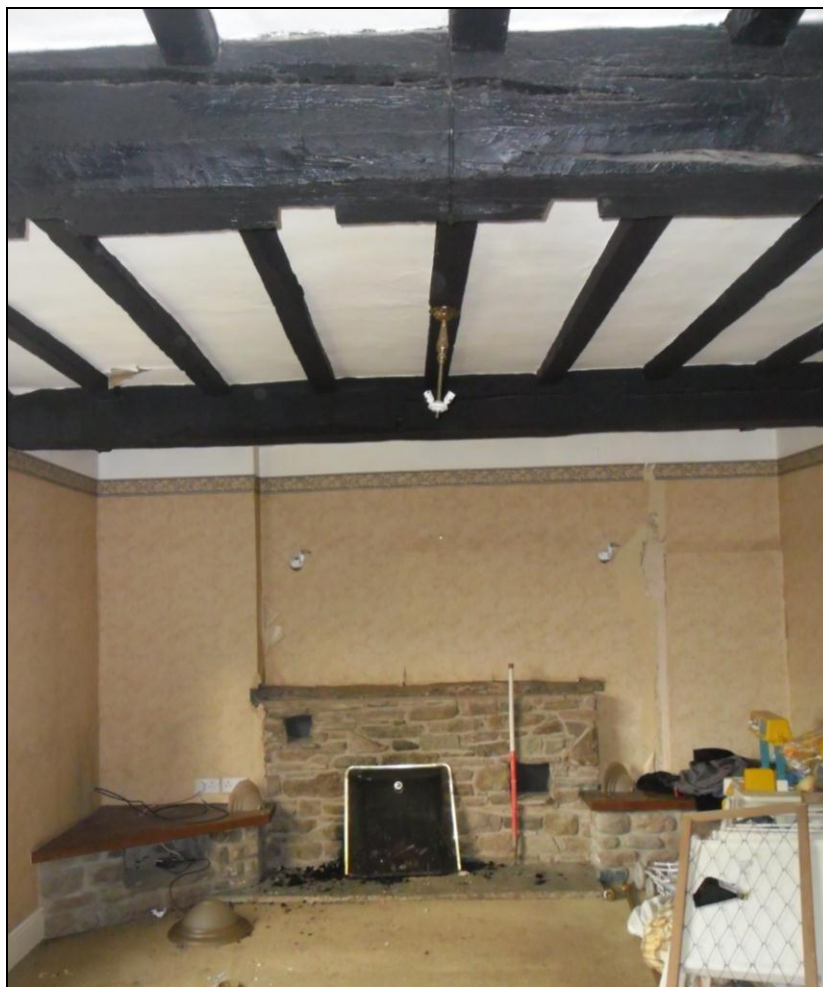
Plate 5: Internal view of living room looking NW showing exposed ceiling beams and fireplace

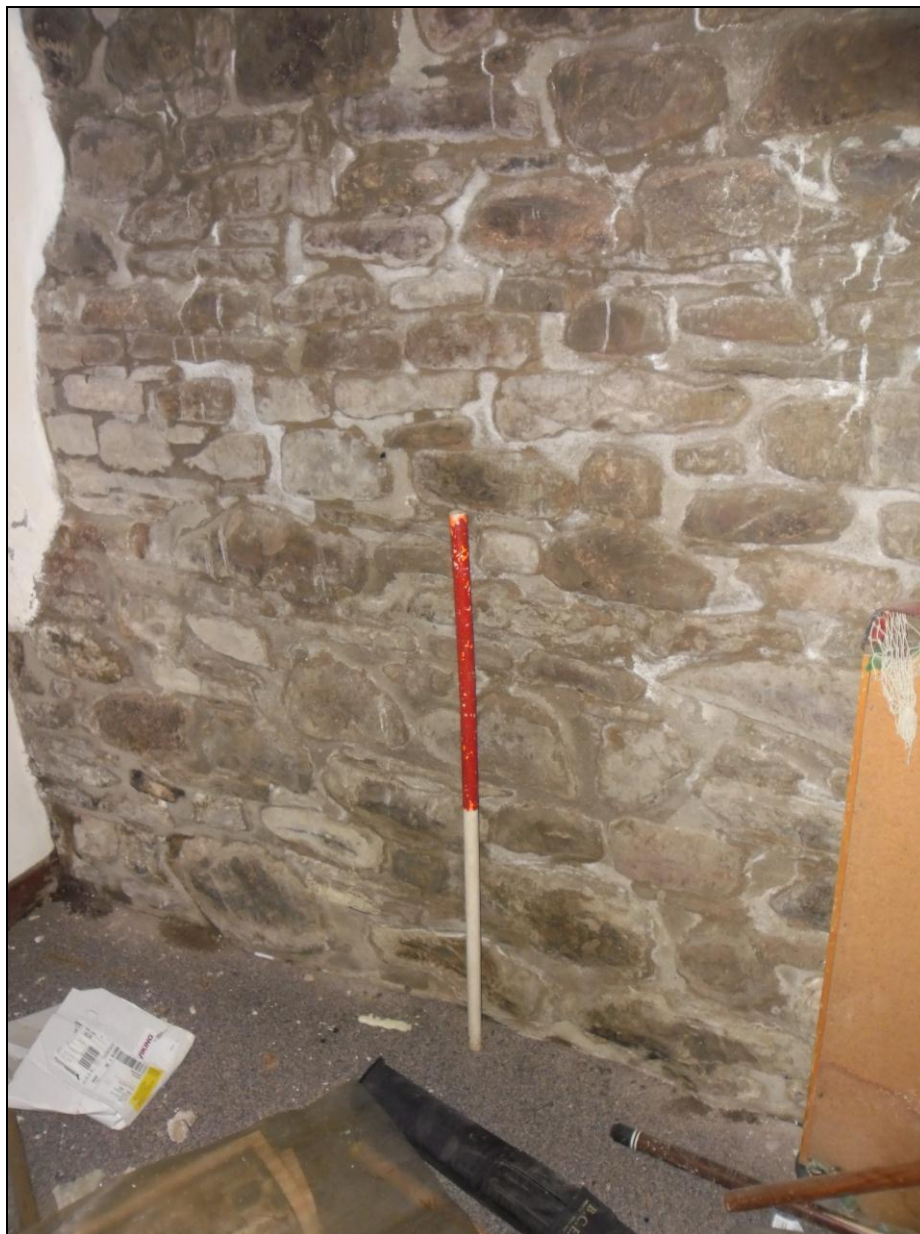
In the SE corner of the living room, to the left of the door leading to the hallway, a flat headed doorway leads down via a narrow wooden staircase to the cellar space. Only the cellar staircase and landing were accessible as the majority of the cellar is located beneath the SE half of the house which could not be accessed for safety reasons. An exposed section of the NW cellar wall was visible, constructed of roughly coursed, irregularly sized sandstone masonry blocks bonded with a greyish white mortar, heavily repointed in cement (**Plate 6**). The construction of the NE wall of the building was also visible, with timber framed panels (the brick infill concealed by plaster) resting on a roughly coursed masonry plinth.

Plate 6: Internal view showing NW cellar wall with roughly coursed, irregularly sized masonry blocks

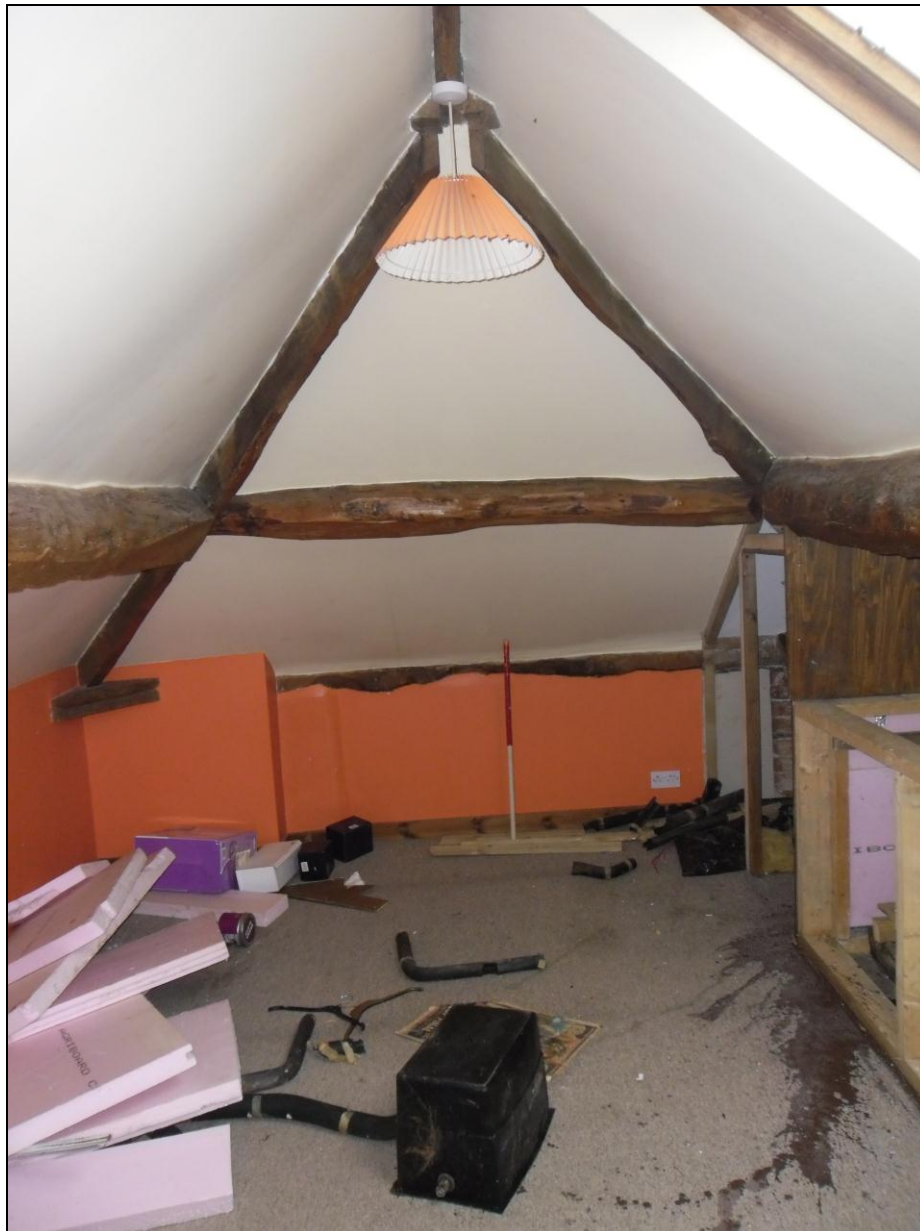
At first floor level, the only accessible room was the NW bedroom, which was largely devoid of architectural detail, the ceiling beams having been concealed by plaster. The attic has been converted into a bedroom in fairly recent years, as evidenced by the large rectangular window inserted into the roof. Within the accessible part of the attic space, the exposed timbers of the roof were clearly visible, consisting of a simple collar truss construction (**Plate 7**). The collar, principal rafters and purlins are all roughly hewn timbers which appear to have been heavily refurbished in recent years.

Plate 7: Internal view looking NW showing detail of collar truss roof construction in attic

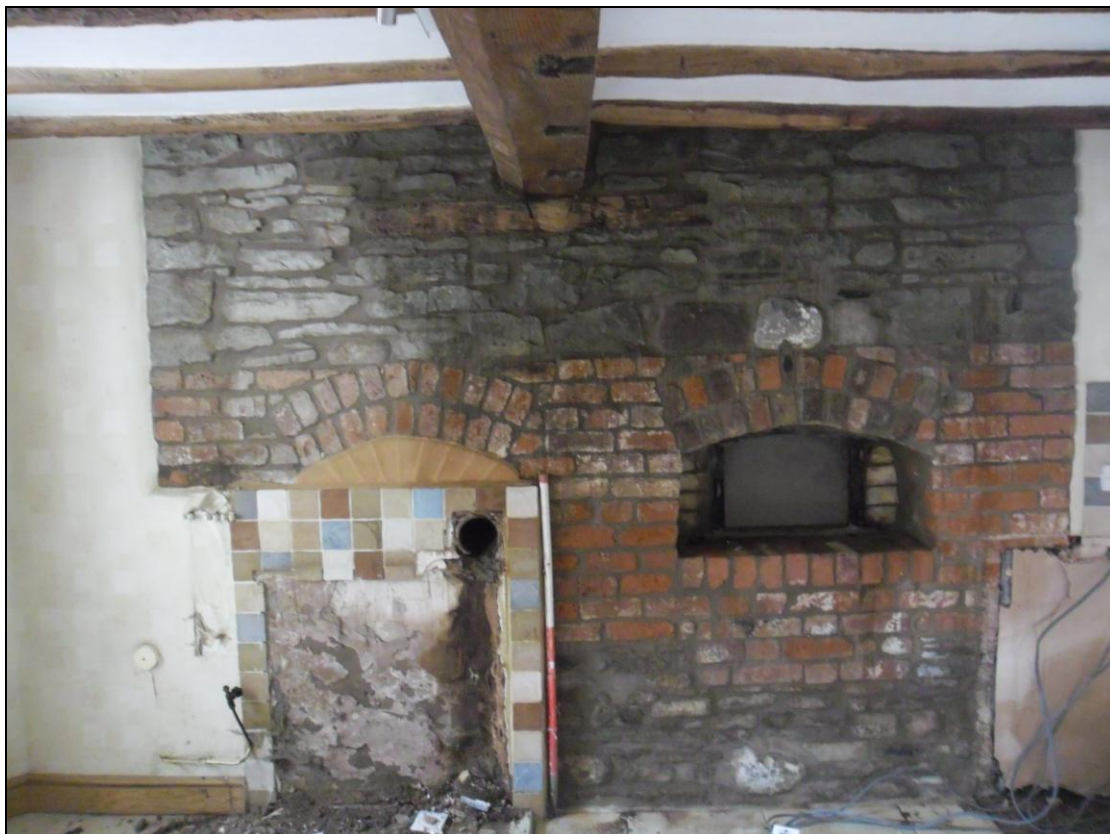
The three-bay extension to the rear of the main block was formerly used as a kitchen and dining room. It appears to have been largely built of roughly coursed masonry with evidence of extensive repairs in brick, as evidenced by an exposed section of the NE wall where the plaster and tiling has been removed. Evidence of a brick segmental arched fireplace and a brick segmental arched oven was noted, inserted into the thickness of the masonry wall (**Plate 8**). The segmental arched fireplace in turn appears to have been blocked up and replaced by a gas stove with a plain tiled surround (probably of mid-20th century date). Also of note are the exposed beams and rafters; the ceiling beam adjacent to the blocked up fireplace shows evidence of mortice slots which may indicate that the beams were re-used from another building or that they represent evidence of internal partitions.

Plate 8: Internal view looking NE showing blocked up segmental brick fireplace and adjacent oven in rear extension (kitchen)
