# Archaeological Observation & Archaeological Building Investigation and Recording

**Phase 3  
New Manufacturing Facility  
Rolls-Royce  
Filton  
Bristol**

**NGR: ST 606 807**

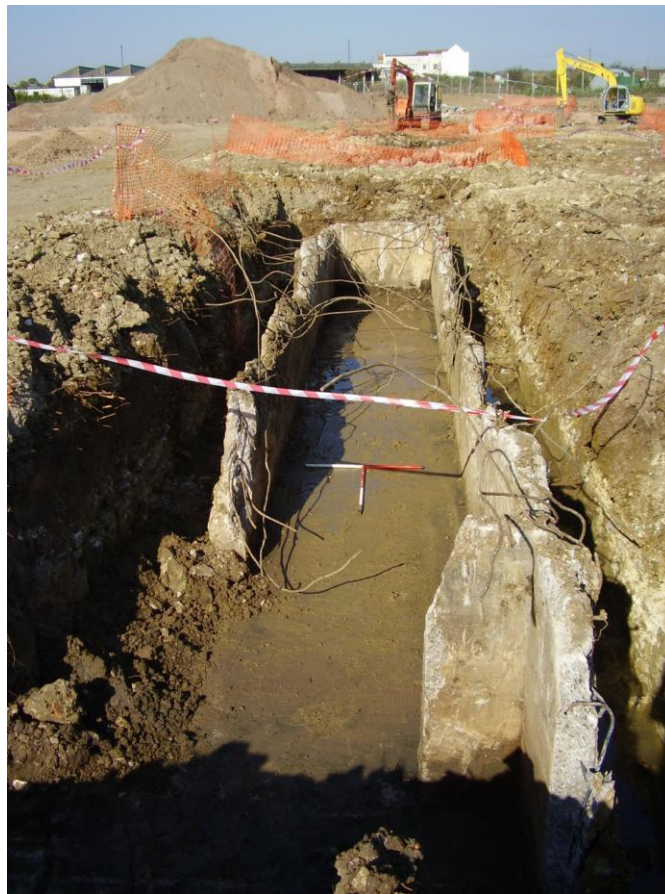
Dimensions – 12.86m x 1.98m x 1.48m (**Plates 1 & 2**). The SE entrance end of the shelter was badly damaged and very little remained of the concrete steps. As with all of the shelters except Shelter 1 the roof had collapsed and only the sides and base remained, implying that most of the surviving structure had been underground. No internal fixtures or fittings remained, other than a drain located in the entrance area.

Plate 1: Air-raid shelter 2. Facing NW

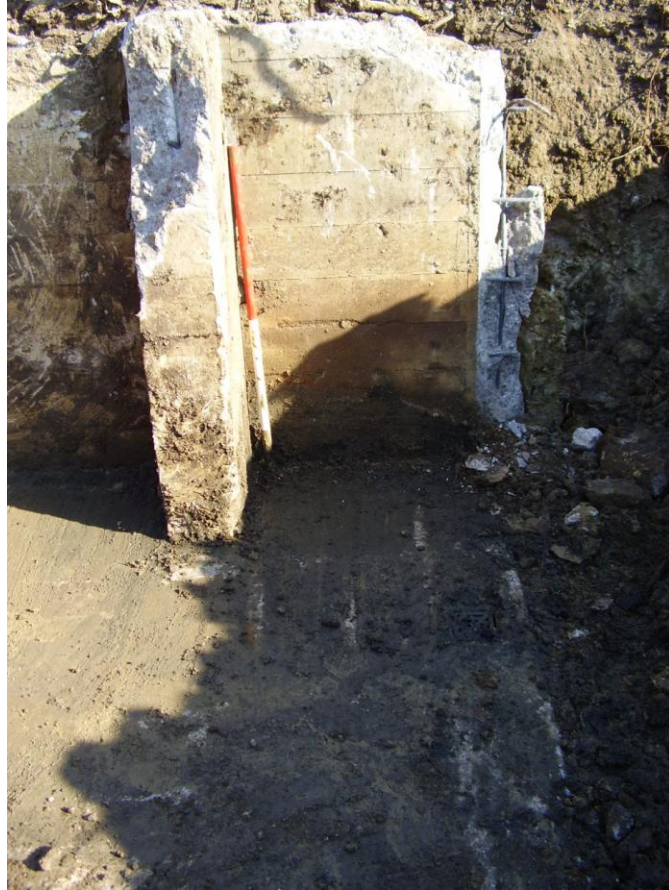
Plate 2: Air-raid Shelter 2 – Entrance. Facing NE

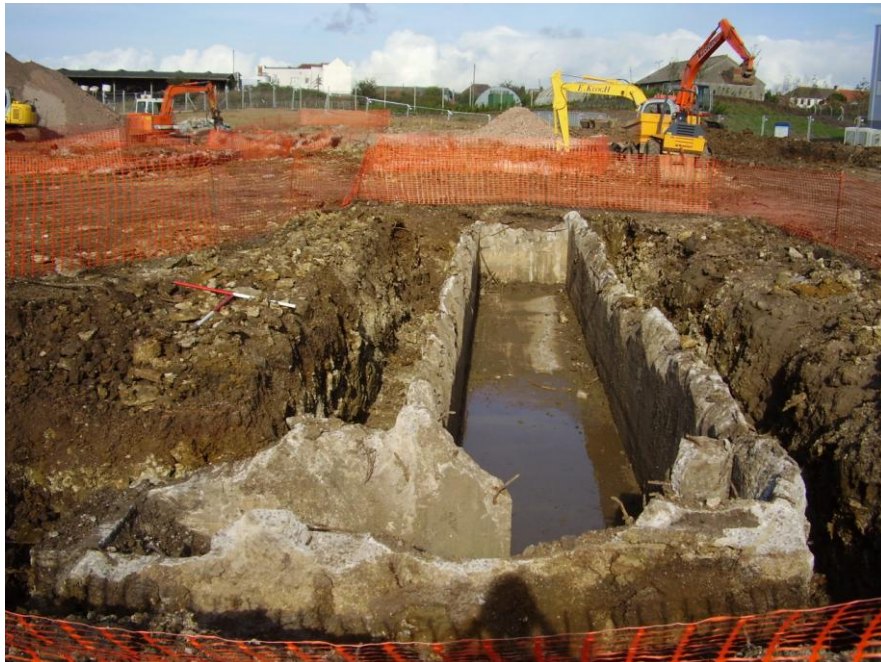
Dimensions – 12.75m x 1.88m x 1.3m (**Plates 3 & 4**). Most of the base of this shelter was intact, with four steps remaining within the SE entrance area. Again, no internal fixtures or fittings were present, other than a drain in the entrance area.

Plate 3: Air-raid Shelter 3, facing NW

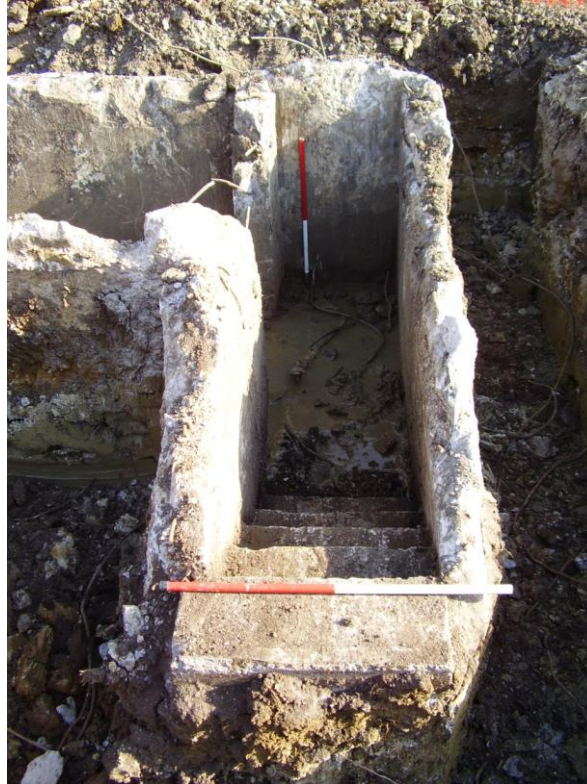
Plate 4: Air-raid Shelter 3 – Entrance. Facing NE

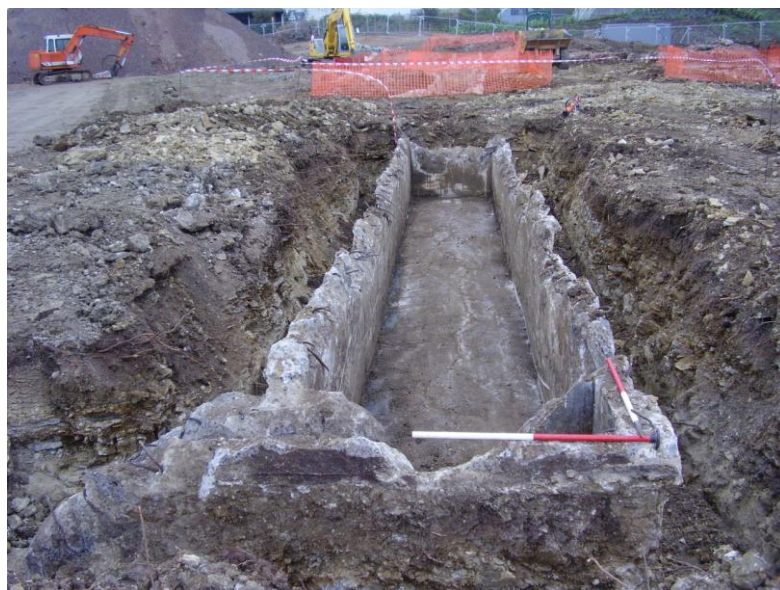
Dimensions – 12.8m x 1.9m x 1.2m. Shelter 4 consisted of a relatively complete base with three remaining entrance steps, the other steps forming part of the backfill material. A single iron bracket was located on the SW-facing back wall of the entrance, which appeared to relate to the electrical system, possibly a fuse box bracket or similar. A drain was present in the entrance. No other items of internal furnishing were identified.

Plate 5: Air-raid Shelter 4. Facing NW

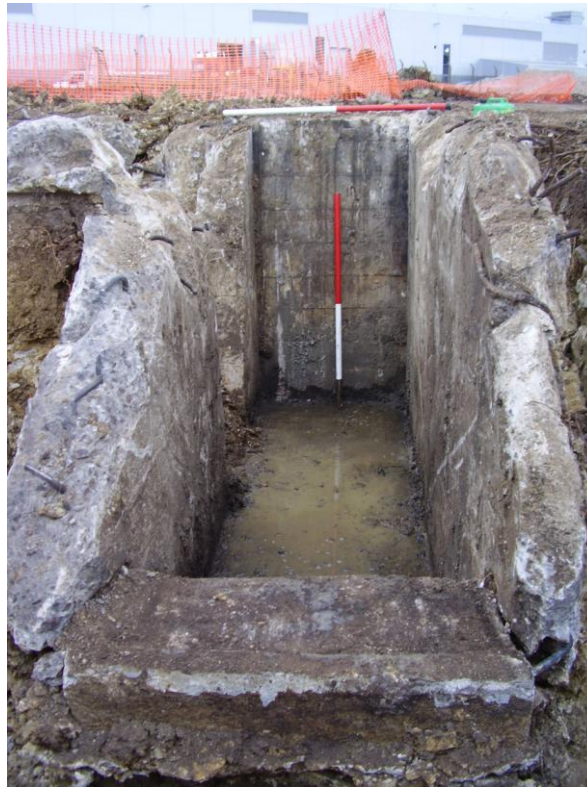
Plate 6: Air-raid Shelter 4 – Entrance. Facing NE

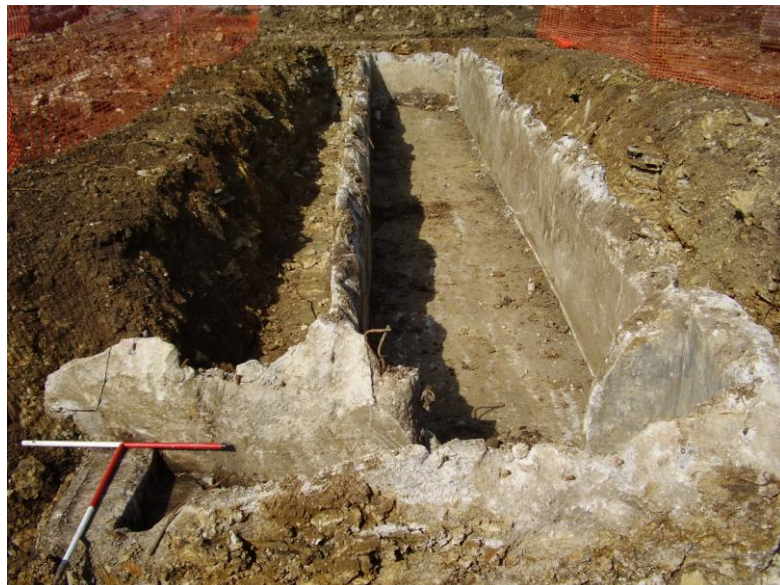
Dimensions – 12.97m x 1.9m x 1.15m (**Plates 7 & 8**). Shelter 5 consisted of a relatively complete base with three remaining entrance steps, the other steps being located as part of the backfill. A drain was present in the entrance. No other internal furnishings or decoration were located.

Plate 7: Air-raid Shelter 5, facing NW

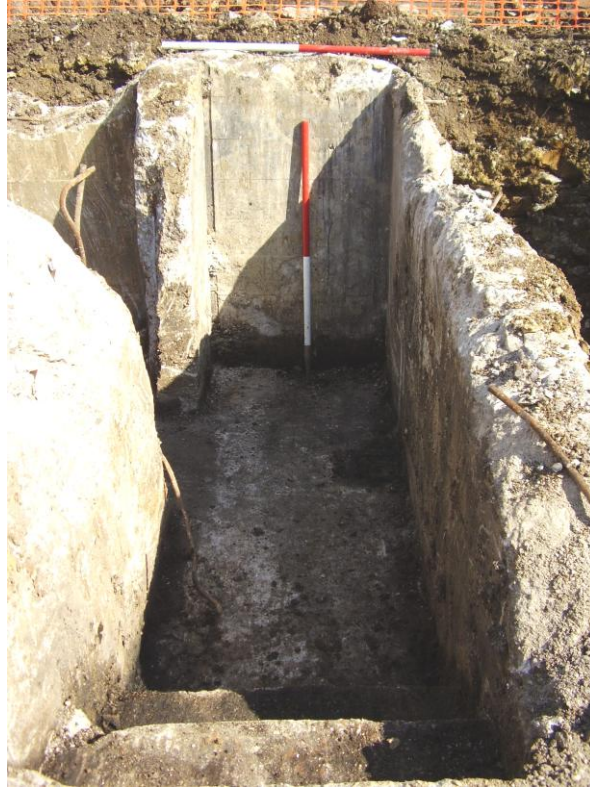
Plate 8: Entrance to Air-raid Shelter 5, facing NE

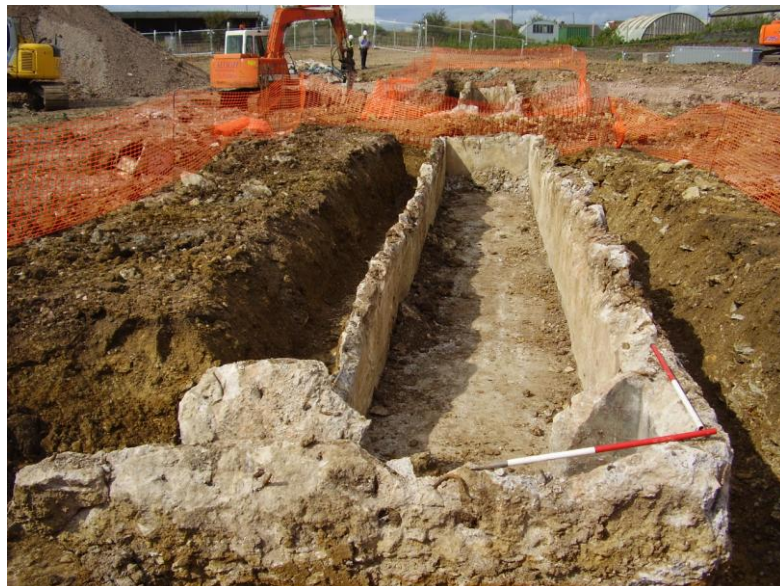
Dimensions – 12.95m x 1.93m x 1m (**Plates 9 & 10**). Shelter 6 was badly damaged at the SE end, with no steps remaining; however, much of the base was intact. A drain was present in the entrance area. No other internal fittings were present.

Plate 9: Air-raid Shelter 6. Facing NW

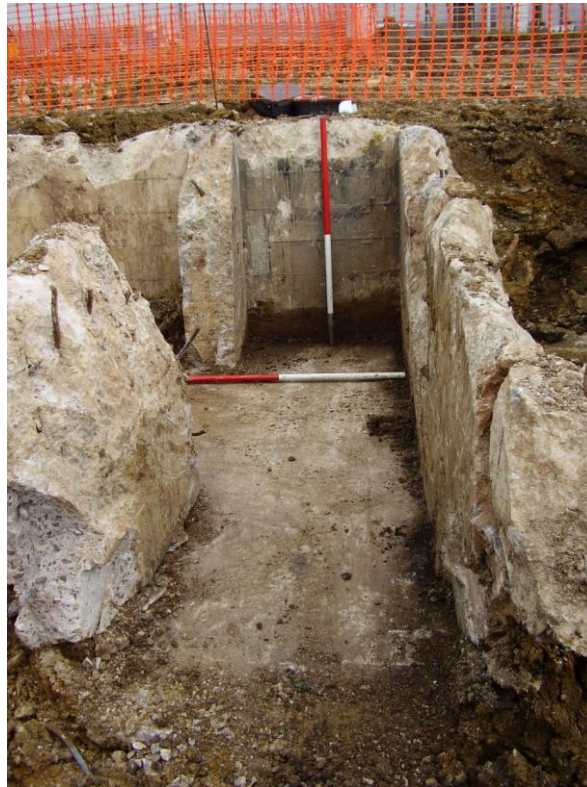
Plate 10: Entrance to Air-raid Shelter 6, facing NE

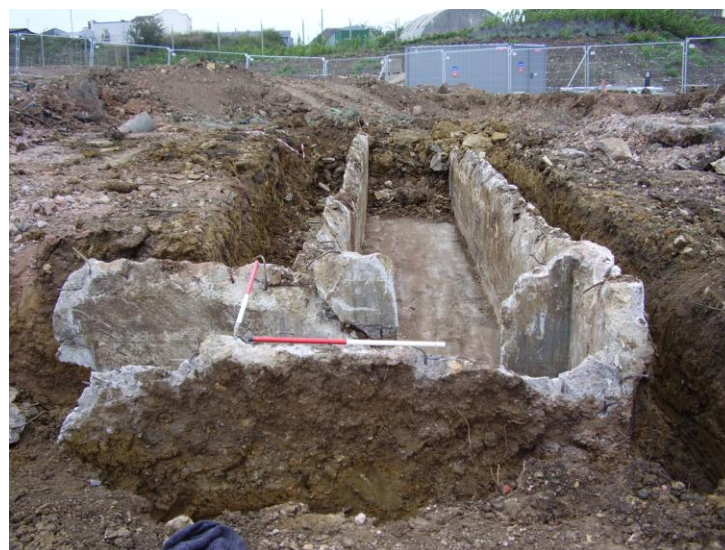
Dimensions – 12.1m x 1.95m x 1.15m (**Plates 11-13**). The base of Shelter 7 was damaged at the NW and SE ends. Only two steps remained *in situ* in the entrance area and at the NW end the installation of modern services had resulted in the demolition of part of the shelter. Two iron brackets were located within the entrance on the SW-facing wall and, as in Shelter 4, these appear to have been fittings for a fuse box or similar installation associated with the electricity supply. A drain was present in the entrance area.

Plate 11: Air-raid Shelter 7, facing NW

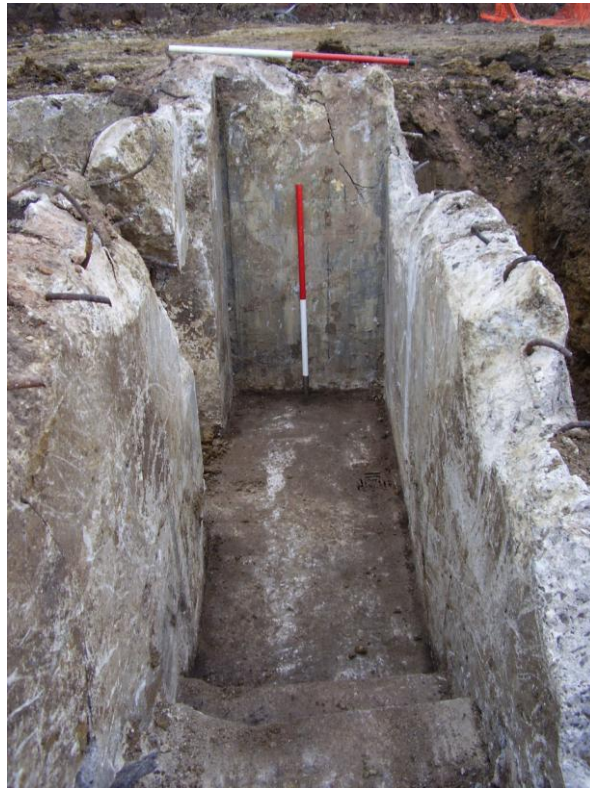
Plate 12: Entrance to Air-raid Shelter 7, facing NE

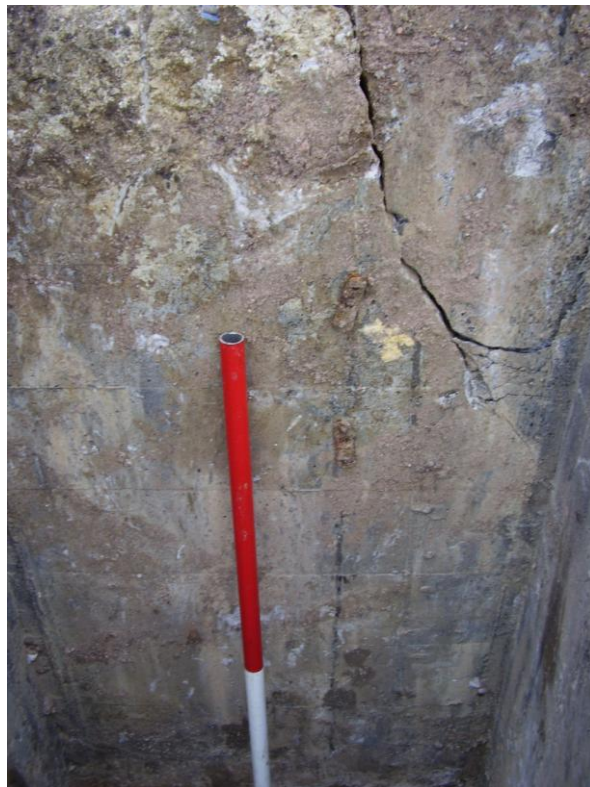
Plate 13: Entrance to Air-raid Shelter 7 showing iron brackets, facing NE

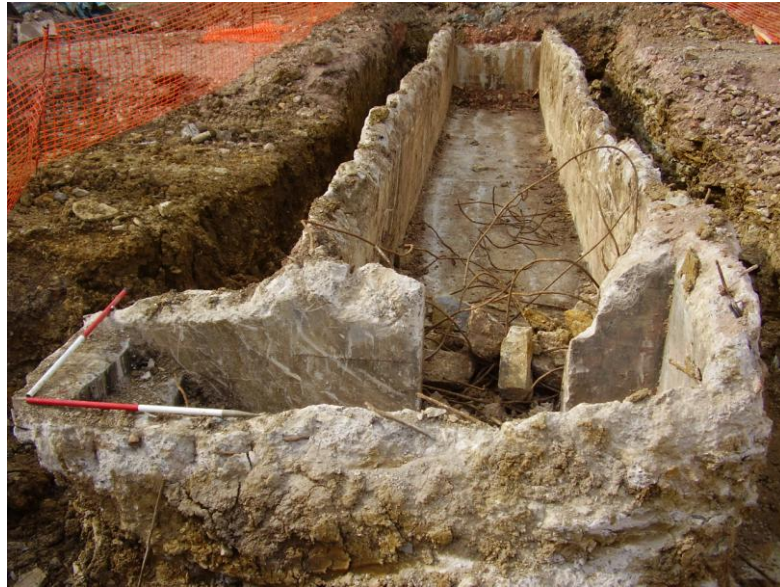
Dimensions – 12.93m x 1.98m x 1.24m (**Plates 14 & 15**). The sides of this structure were more heavily damaged, particularly around the entrance area, than the other shelters. A drain was located in the entrance but no other internal features were present.

Plate 14: Air-raid Shelter 8, facing NW

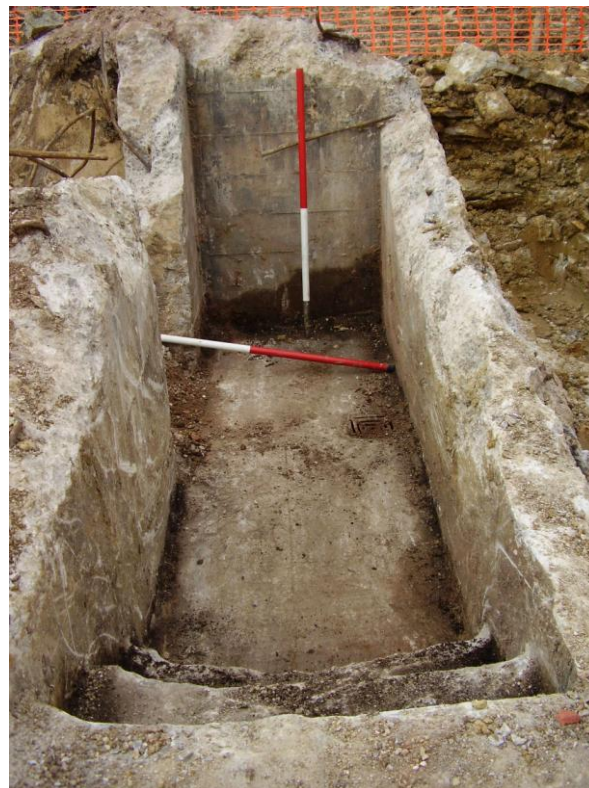
Plate 15: Entrance to Air-raid Shelter 8, facing NE

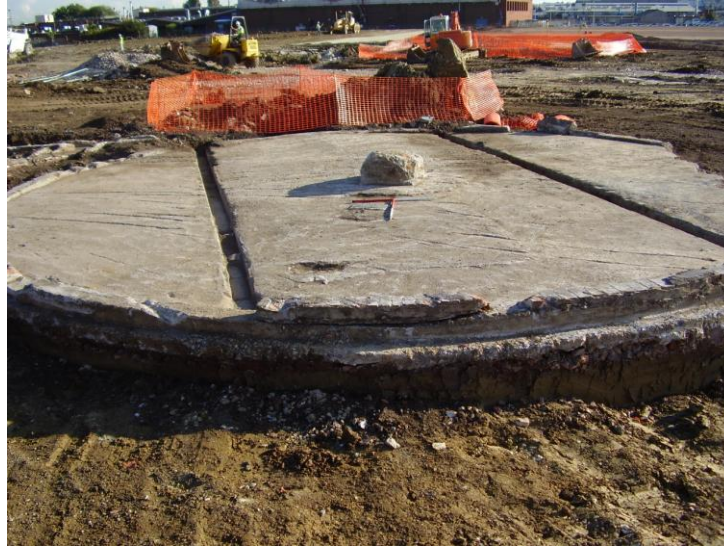
Plate 18: Western filter bed (306), facing SE

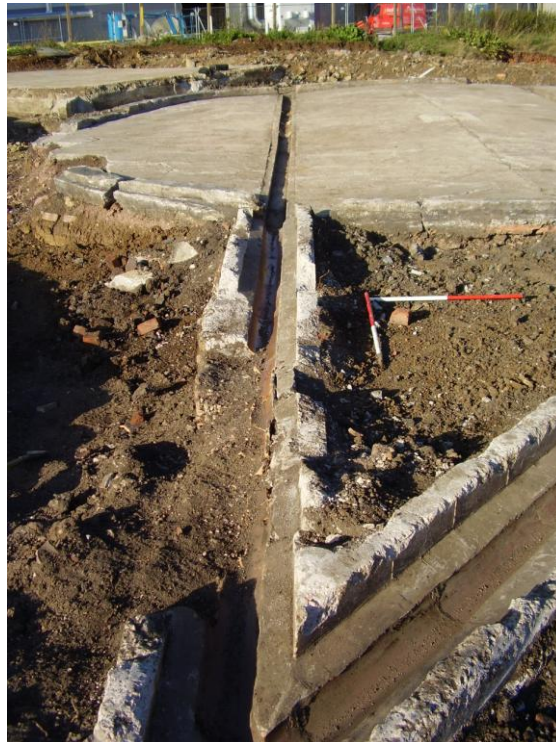
The concrete drainage channels in the western filtration bed ran into a brick holding chamber (313) measuring 4.3m x 2.6m located to the S of the beds; this was heavily contaminated with accumulated diesel waste and was thus not fully investigated. This chamber was constructed of 11 courses of standard gauge unfrosted brick, which was laid in stretcher bond. The two drainage channels in the eastern bed were orientated slightly differently from those of the western bed at a NE–SW alignment. The two channels ran into a concrete and ceramic-drainage-pipe-lined gully (314) to the S of the filtration bed, which was orientated NE-SW. This gully ran to the S of the western filtration bed and appears to have emptied liquid from the bed into the brick holding chamber (313).

Plate 19: Concrete drains (314), facing NE/E

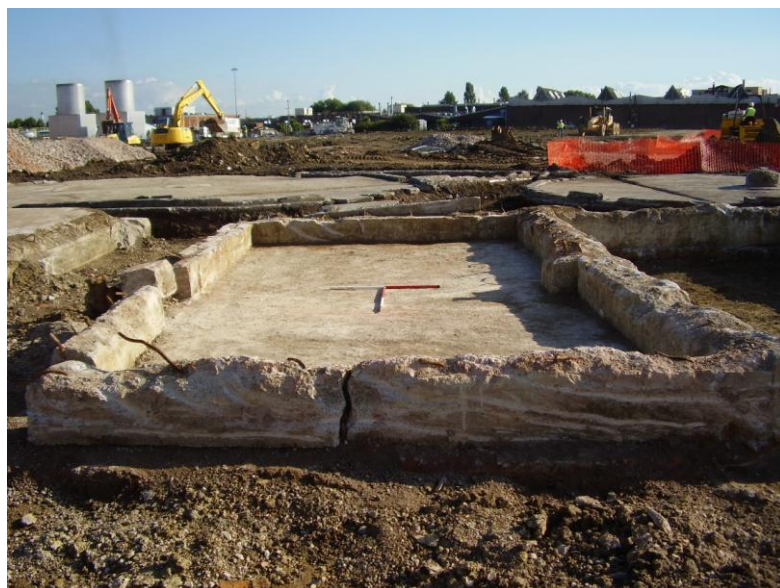
Plate 21: View SE showing holding tank remains (318)

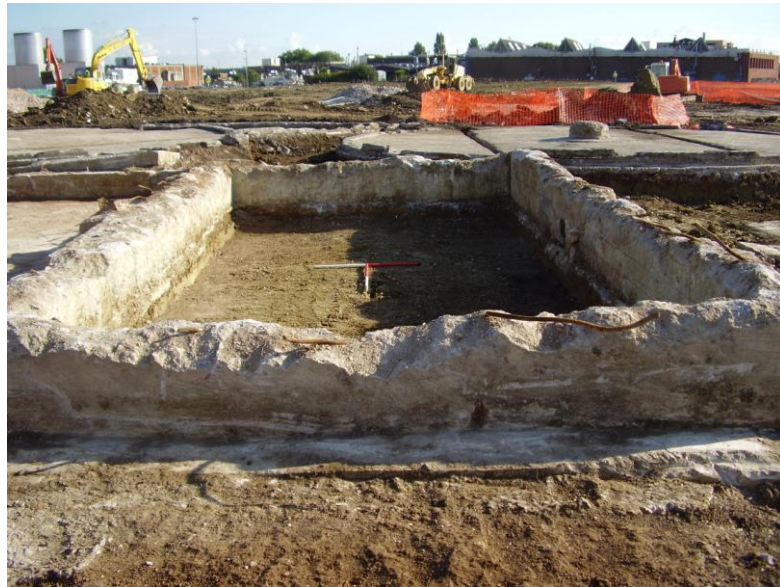
The second chamber consisted of a concrete wall (321) overlying a concrete rectangular foundation (322). Unlike (318), there was no concrete platform underlying the wall (321) and the interior of the tank was entirely earthen (334). Both tanks appear originally to have possessed higher exterior steel reinforced walls but these seem to have been demolished.

Plate 22: Holding tank remains (321), facing SE

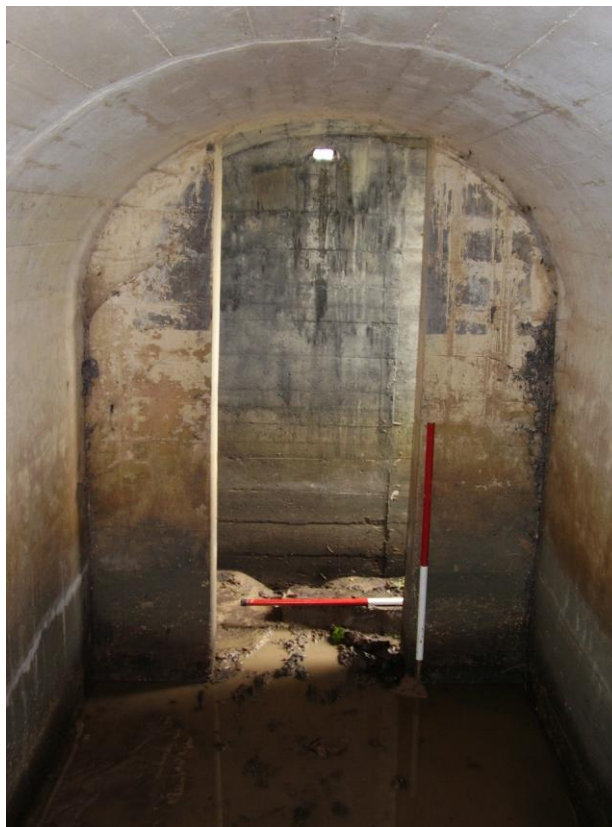
A small rectangular aperture was visible at the eastern end of the shelter (**Plate 7**) but as the surrounding area was damaged it was not clear whether this was an original feature or simply the result of damage.

Plate 7: View E showing entrance area, with aperture visible in E wall

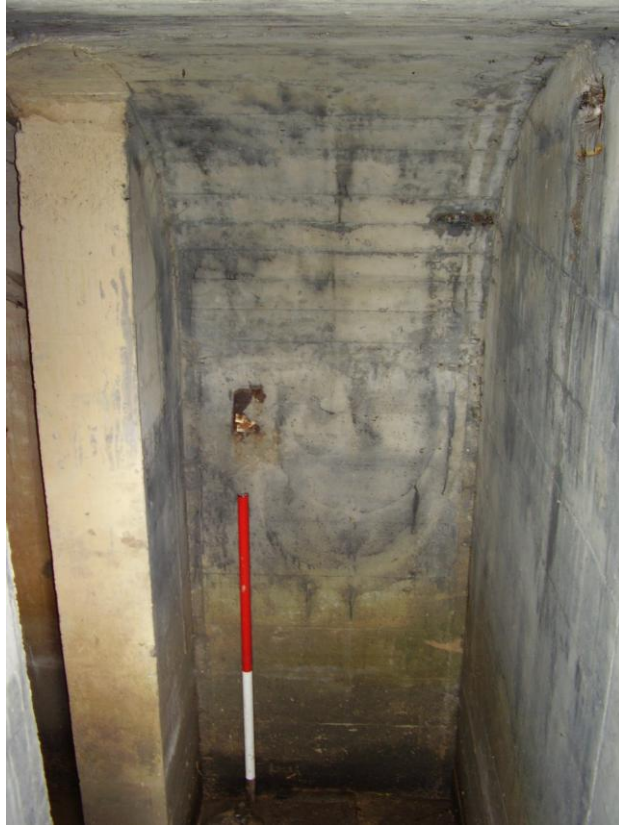
The interior of the shelter had been flooded for quite some time. Within the entrance area was a drain running out from the shelter to the E and then S, which was evidently designed to prevent flooding but which had become silted up. After the drain had been cleared, it was apparent that the floor of the shelter sloped slightly to the E. A 0.05m layer of silt had built up in the base of the shelter and this prevented full recording of the floor surface, although investigation suggested this was, again, of concrete construction. Within the entrance was an opening to the W into the main body of the shelter. Two small iron fittings were attached to the northern wall of the entrance, both of which were heavily corroded; one appeared to be a hinge but the other had decayed beyond recognition (**Plate 9**).

Plate 9: Northern wall of entrance area

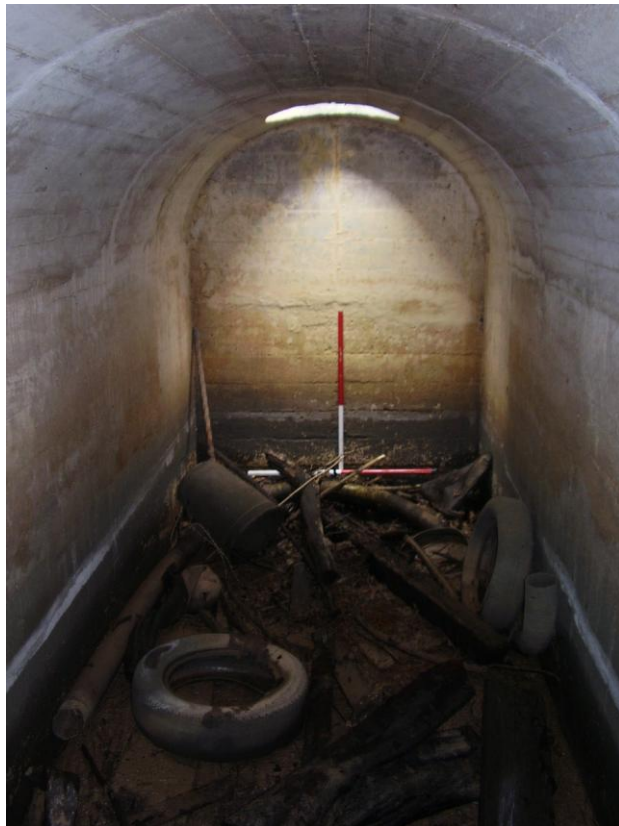
The main body of the shelter consisted of a long narrow room with no internal décor evident; again the stencilling affect seems to have been used on the walls. The ceiling was arched, presumably to strengthen the construction, and rose to 2m above floor level. At the western end of the roof was the base of the vent that was visible externally (**Plate 10**). Recent detritus seemed to have been deposited through the vent into the shelter; including tyres, plastic hubcaps and various alcoholic drink bottles (**Plate 10**). No contemporary or later graffiti were observed on the walls.

Plate 10: Interior view, looking W, showing vent in roof and internal debris
