**Archaeological Standing
Building Recording**

Gloucester City Homes

**The Old Coach House (Plot 12)
St James' Close
Quedgeley
Gloucester GL2 4PL**

June 2019

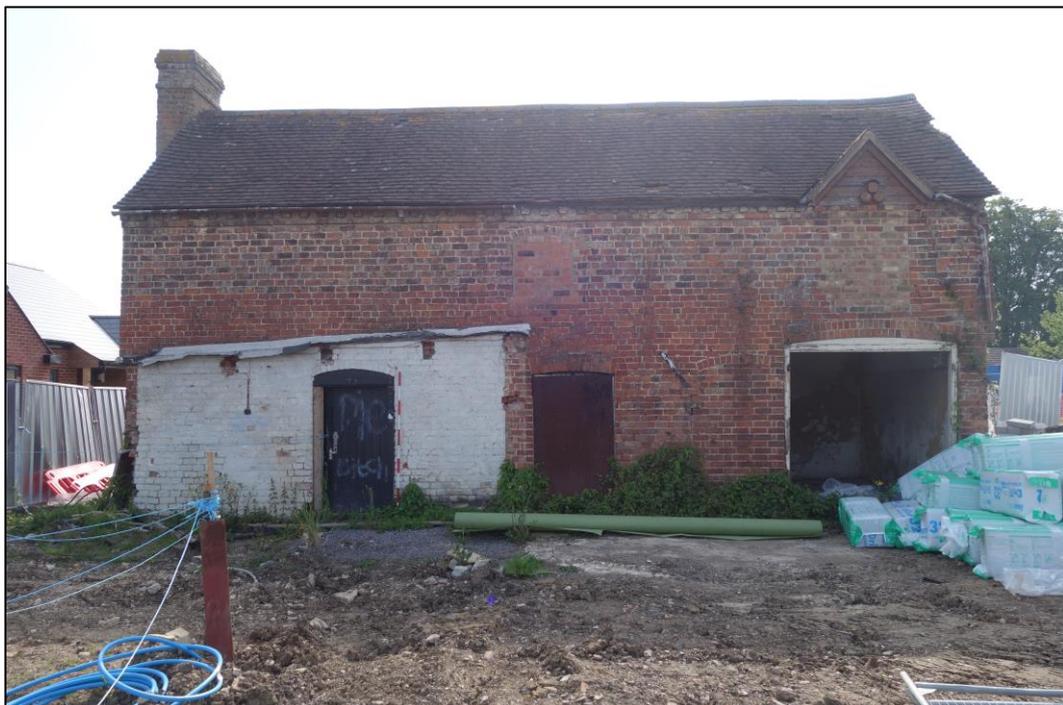
The principal W-facing elevation of the building is three bays long (*Plate 2*); the modern single storey lean-to extension, of brick construction with a corrugated metal sheet roof, which was attached to the northernmost bay has been removed although its position is indicated by its former roofline and a section of whitewashed brickwork. Inserted slightly off-centre within this bay is a segmental arched doorway with a wooden architrave and plank and batten door (*Plate 3*).

Plate 2: External view looking E showing principal W-facing elevation of the 'Old Coach House'

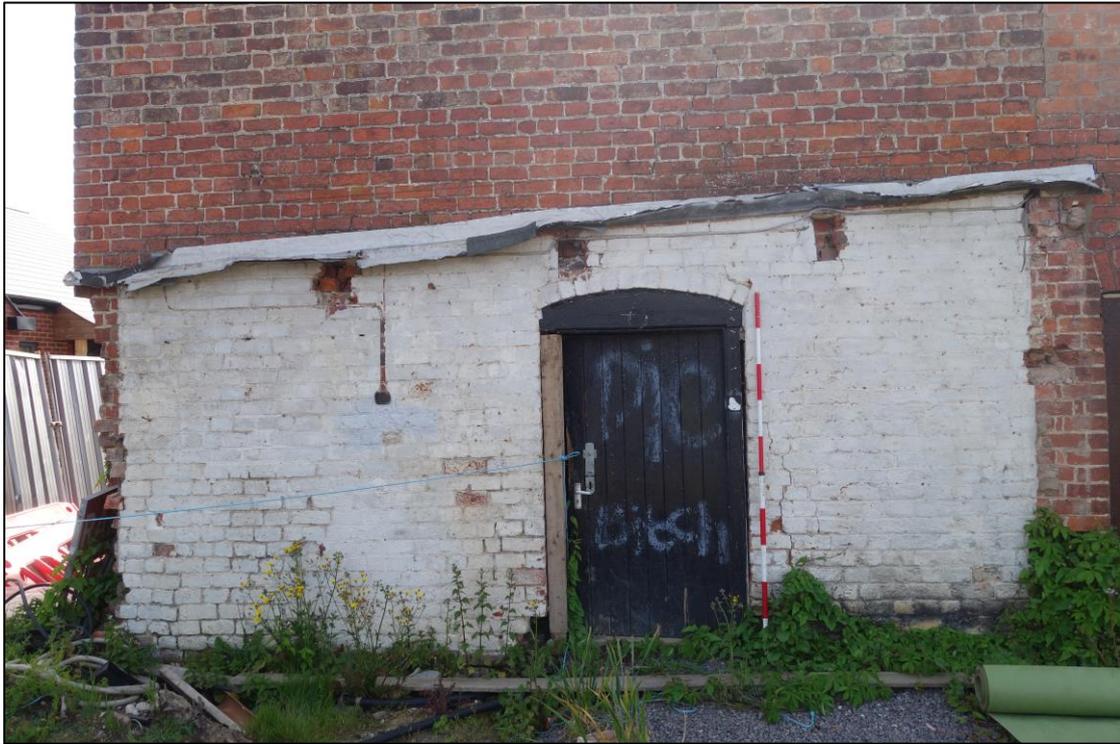
Plate 3: External view looking E showing detail of northernmost bay of W-facing elevation with segmental-arched doorway and roofline of demolished single-storey modern extension

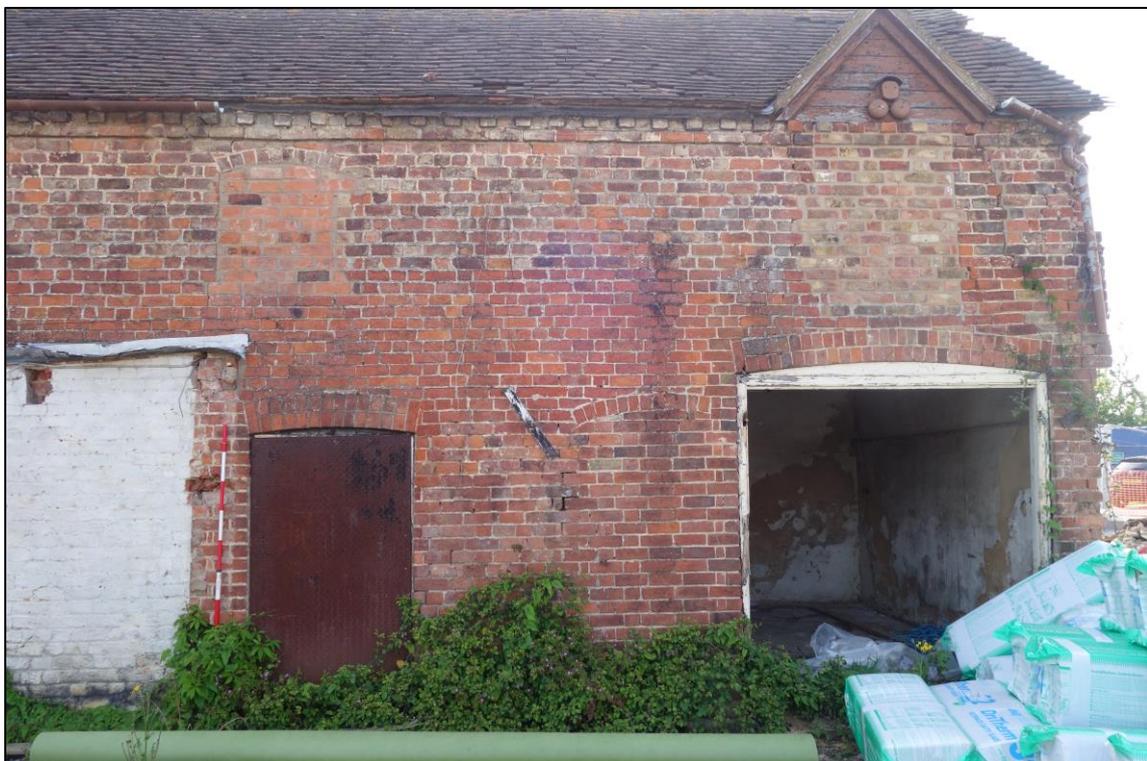
Located within the central bay of the W-facing elevation is a low-arched doorway with a segmental gauged-brick arch (*Plate 4*). The archway consists of two courses of headers with a single stretcher at either end. The wooden door and its door-case have been removed and replaced by a steel door. Immediately to the right of this doorway is another low segmental arch, either for a window or (more likely) a doorway, set into the thickness of the wall. The form of the arch (consisting of a single course of headers) is identical to the doorway in the northernmost bay of the elevation. The opening for this arch appears to have been completely obliterated by the reconstruction of the section of walling beneath it.

Plate 4: External view looking E showing detail of central and southern bays of principal W-facing elevation

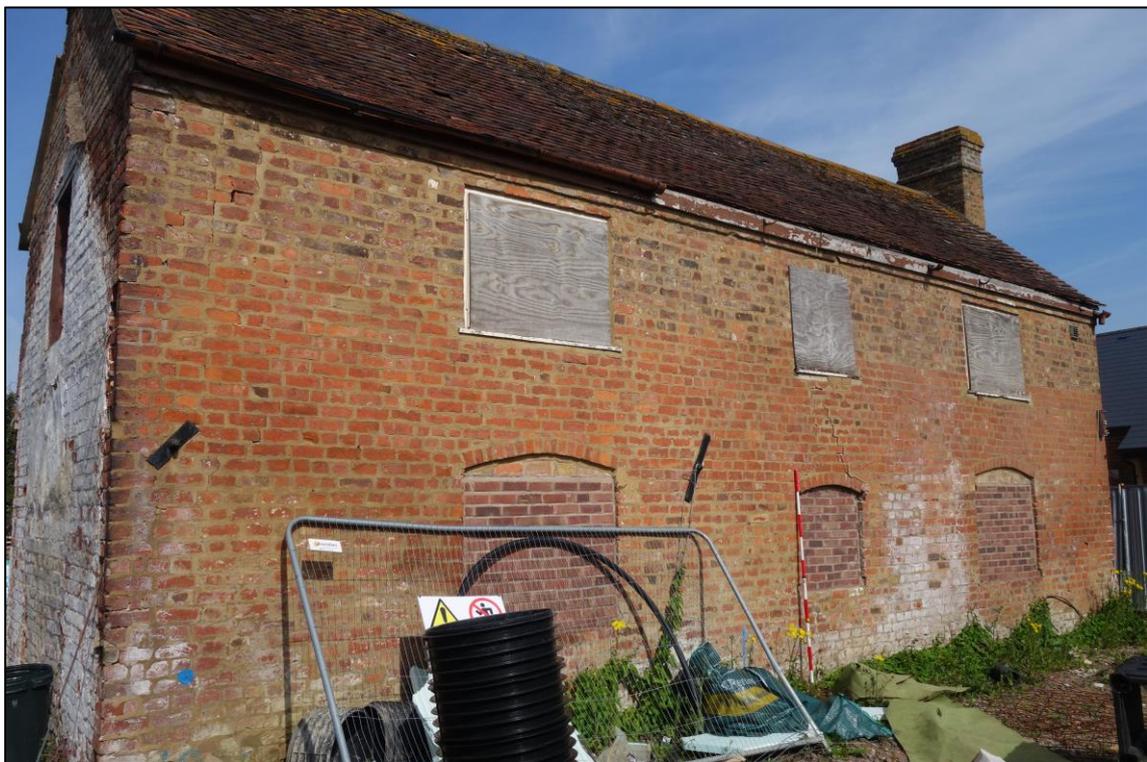
The rear (E-facing) elevation of the Old Coach House has now been cleared of trees and undergrowth, fully exposing the fabric which was largely concealed by trees and undergrowth at the time of the 2015 recording (*Plate 6*). A marked change in brickwork is discernible between the upper and lower storeys, in an identical position to that noted on the W-facing elevation. As in the case of the W-facing elevation, two cast-iron diagonal wall-ties are attached to the masonry of the central and southern bays of the E-facing elevation.

Plate 6: External view looking NW showing exposed rear (E-facing elevation) of 'Old Coach House'

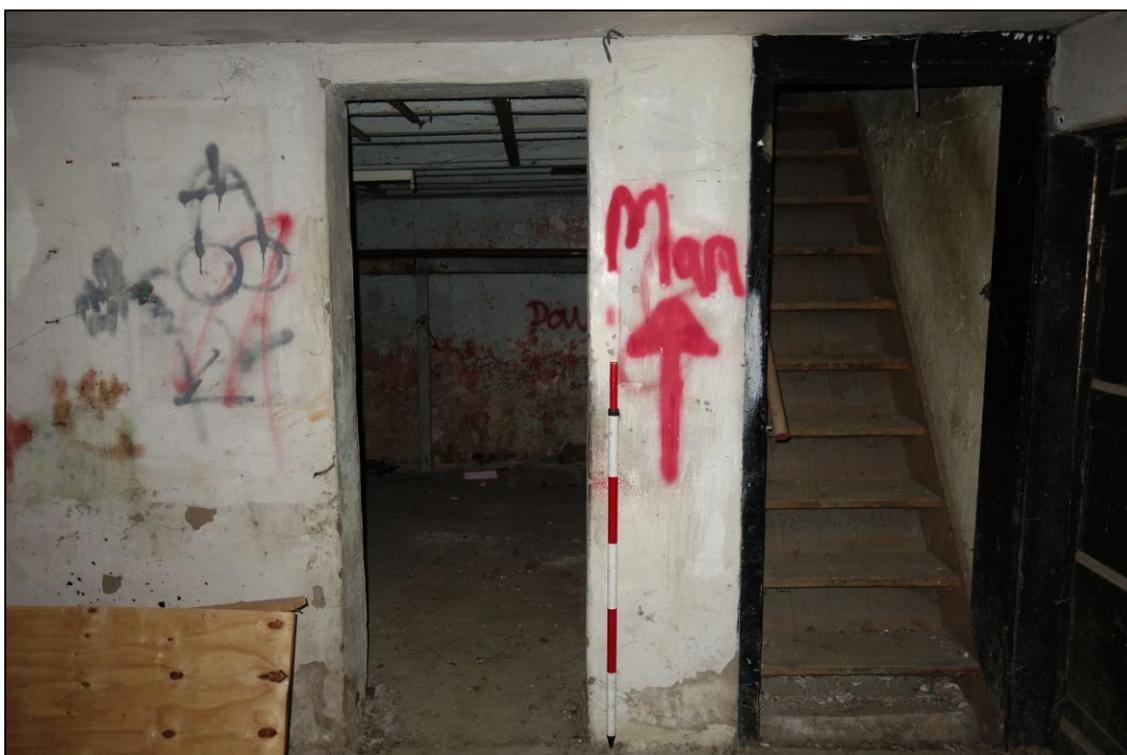
A doorway inserted in the S wall provides access to a second room, occupying the central portion of the building, which may be identified with the 'Harness Room' mentioned in the 1889 inspection report (*Plate 12*). As in the case of the northern room, very few features, fixings or fittings of interest were noted.

Plate 12: Internal view looking S showing doorway leading to central compartment at ground floor, to the right of which is a stairway leading to the first floor

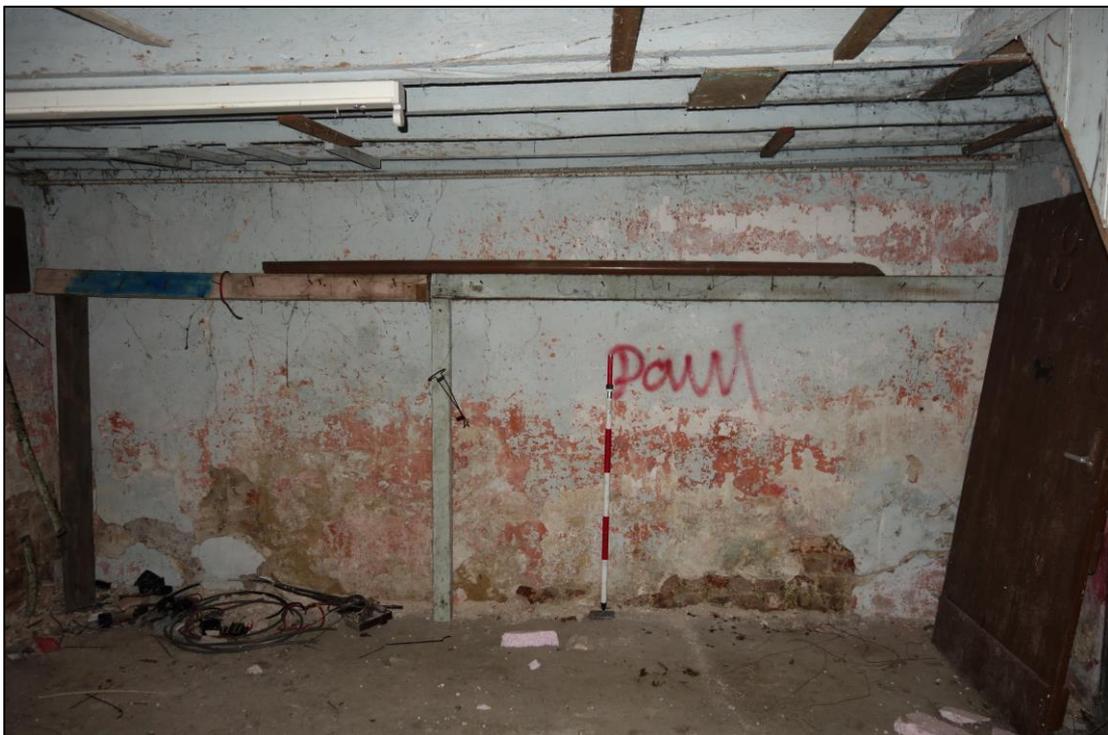
Attached to the S wall of the room is a horizontal wooden rail with a row of nails projecting from it; it is possible that the nails may have been used for hanging horse tackle or harness but this remains unconfirmed (*Plate 16*). No evidence was noted for a connecting door linking this room to the Coach House, occupying the S portion of the building; if there had been a doorway in the S wall, it has evidently been walled-up and plastered over.

Plate 16: Internal view looking S showing S wall of central compartment on ground floor with wooden horizontal rails, possibly for hanging harnesses

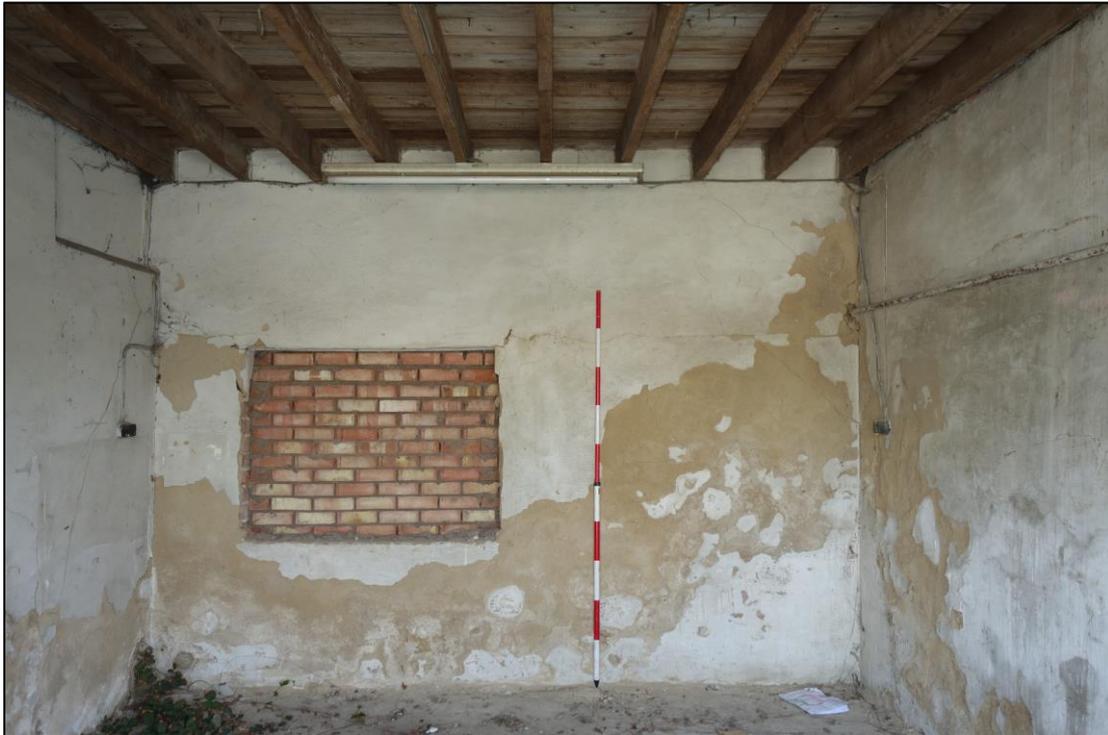
The walls have been coated in thick white plaster (partially denuded in places) and the original floor has been replaced by concrete hardstanding, while the window in the E wall has been bricked up (*Plate 17*). The ceiling appears to have been significantly heightened in the late 20th century (as evidenced by the modern joists and the bar light fitting just beneath the ceiling); however the line of the original ceiling is still discernible, together with the lower part of what appears to be the lower part of the door leading from the first floor landing to the loft above (*Plate 18*).

Plate 17: Interior view of southernmost compartment ('Coach House') at ground floor level, with blocked window in E wall and heightened ceiling

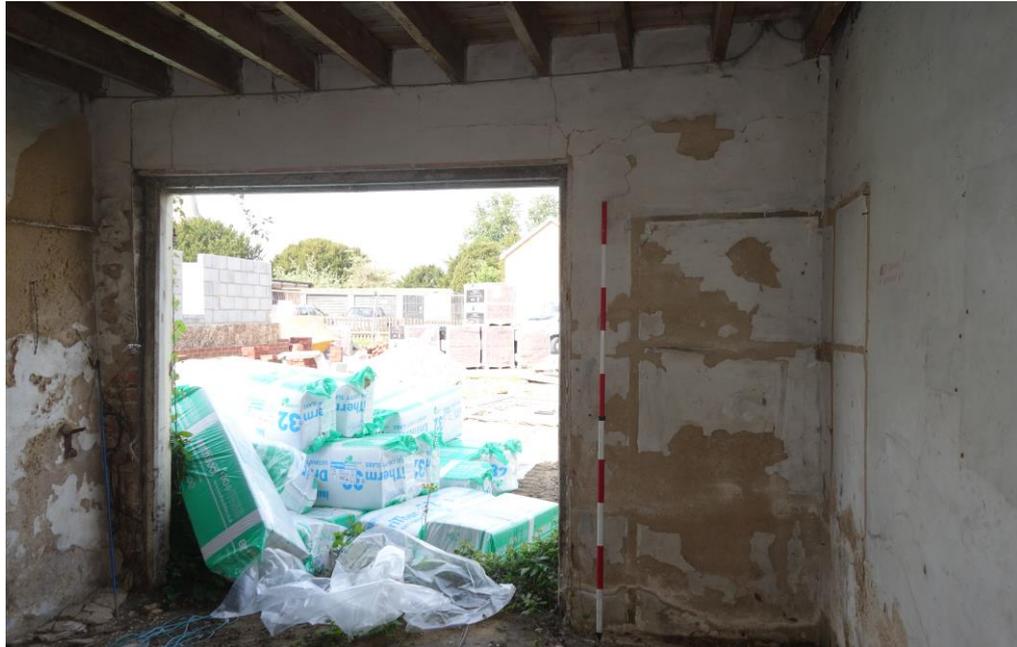
The indentations for a number of cupboards and wall fittings are visible in the W and N walls of the room (*Plate 19*), however no clear evidence was observed for a door connecting this room with the central compartment ('harness room') immediately to the N.

Plate 19: Internal view looking W showing W wall of southernmost compartment on ground floor with indentations for cupboards to right of doorway

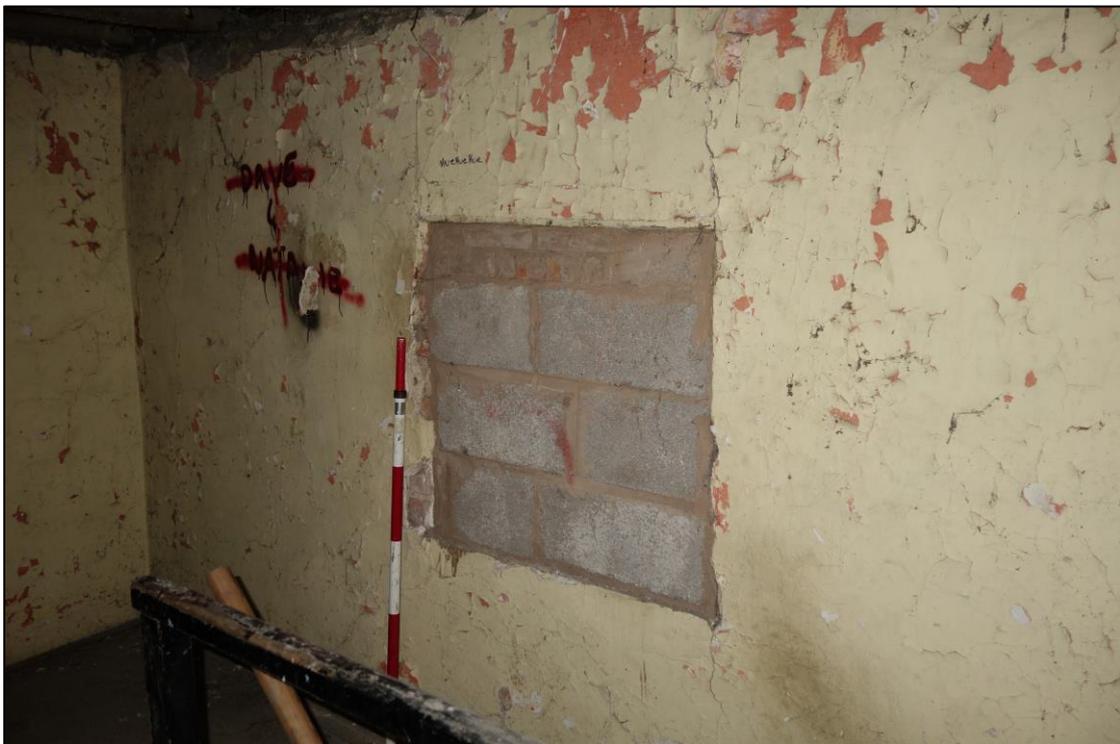
The first-floor landing was originally lit by a window in the W wall, above and to the right of the staircase, which was probably blocked in the mid-late 20th century (*Plate 22*). Two plain moulded doorways lead off to rooms to the N and E of the landing (*Plate 21*): the original doors appear to have been replaced by modern doors (probably installed as part of the mid-late 20th -century refurbishment phase).

Plate 22: Internal view looking SSW showing blocked window in W wall of first floor landing

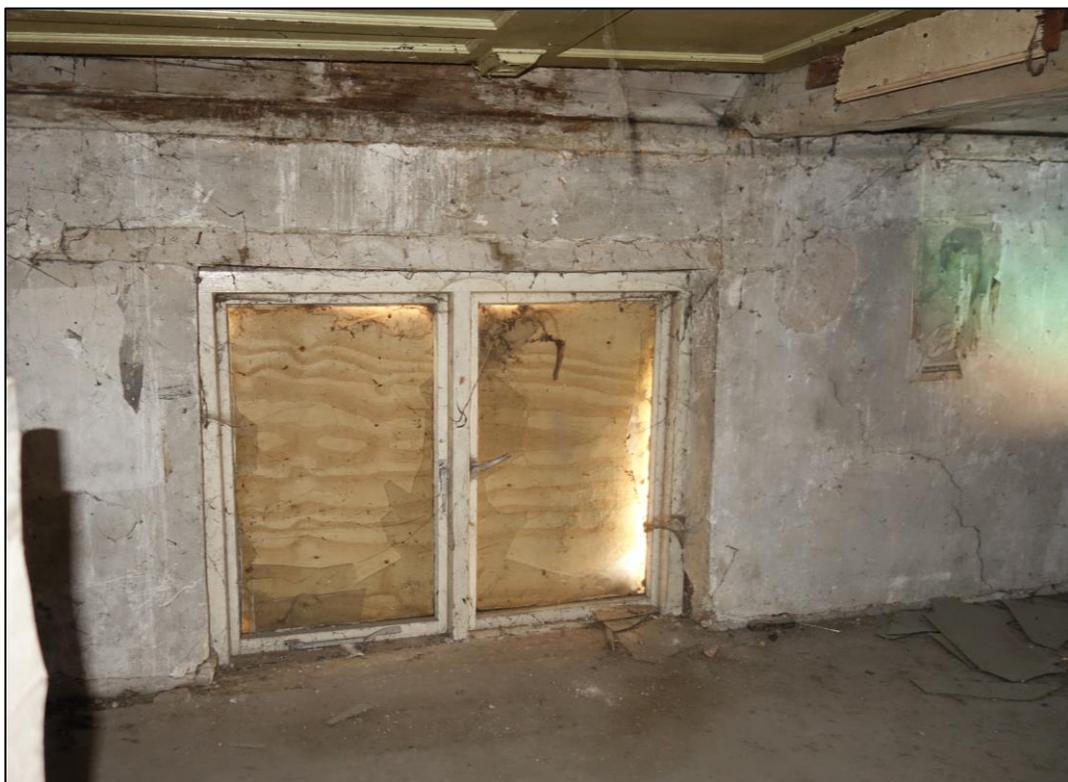
The window in the E wall of the loft has survived, although the existing two-light casement is clearly a modern replacement (*Plate 30*), while the window in the W wall of the loft has been completely blocked-up and concealed by plaster, although its position is indicated by a wooden lintel (*Plate 31*).

Plate 30 Internal view looking SE showing casement window in E wall of loft compartment

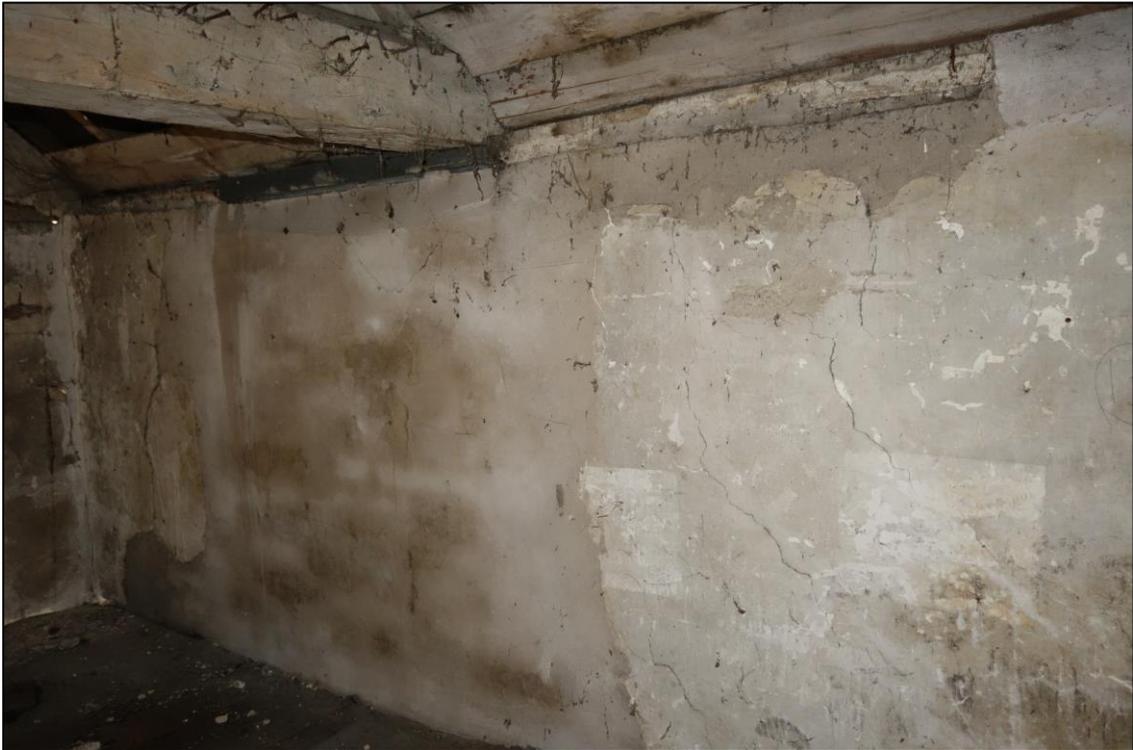
Plate 31: Internal view looking SW showing blocked window (with lintel) in W wall of loft compartment

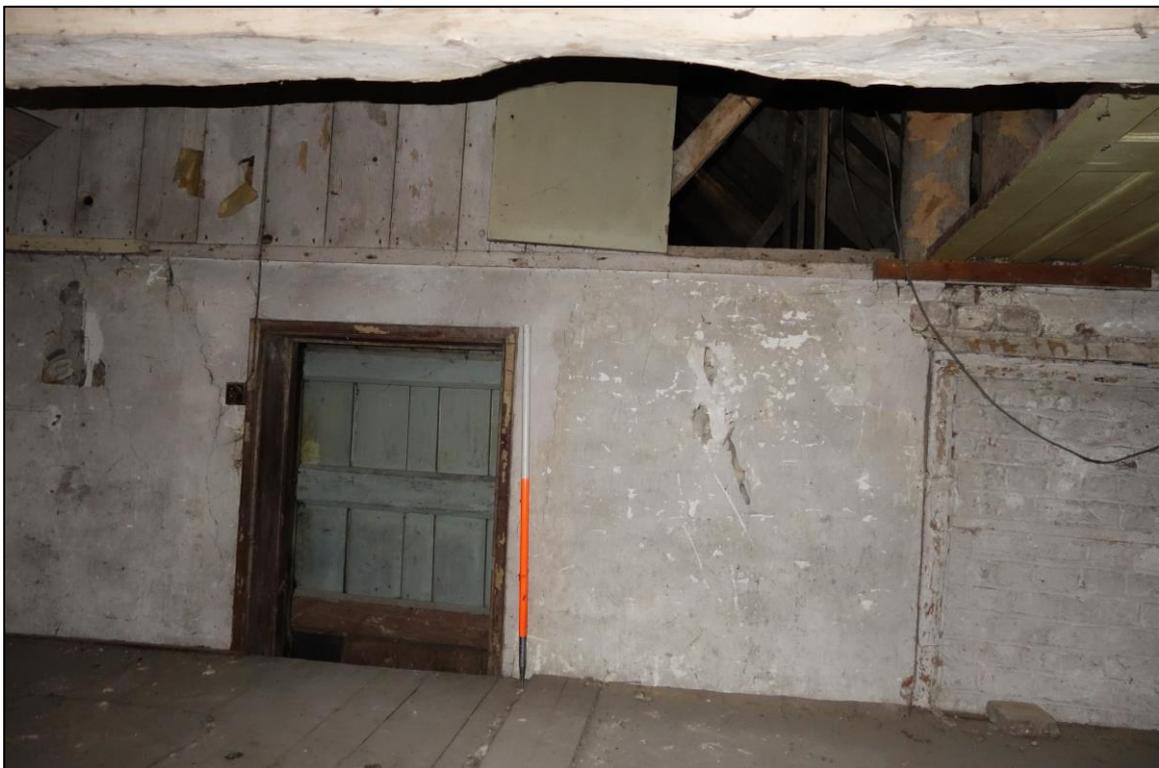
A rectangular hatch with plank and batten door located within the upper part of the N wall of the loft provides access to the roof space (*Plate 32*). To the right of this hatchway is a blocked door with wooden lintel which presumably gave access to the narrow compartment immediately to the E of the landing. This appeared to correspond to the same blocked doorway which was partially visible in the compartment below.

Plate 32: Internal view looking N showing N wall of loft with doorway to landing, above which is hatch leading to roof space with a blocked doorway to far right of picture

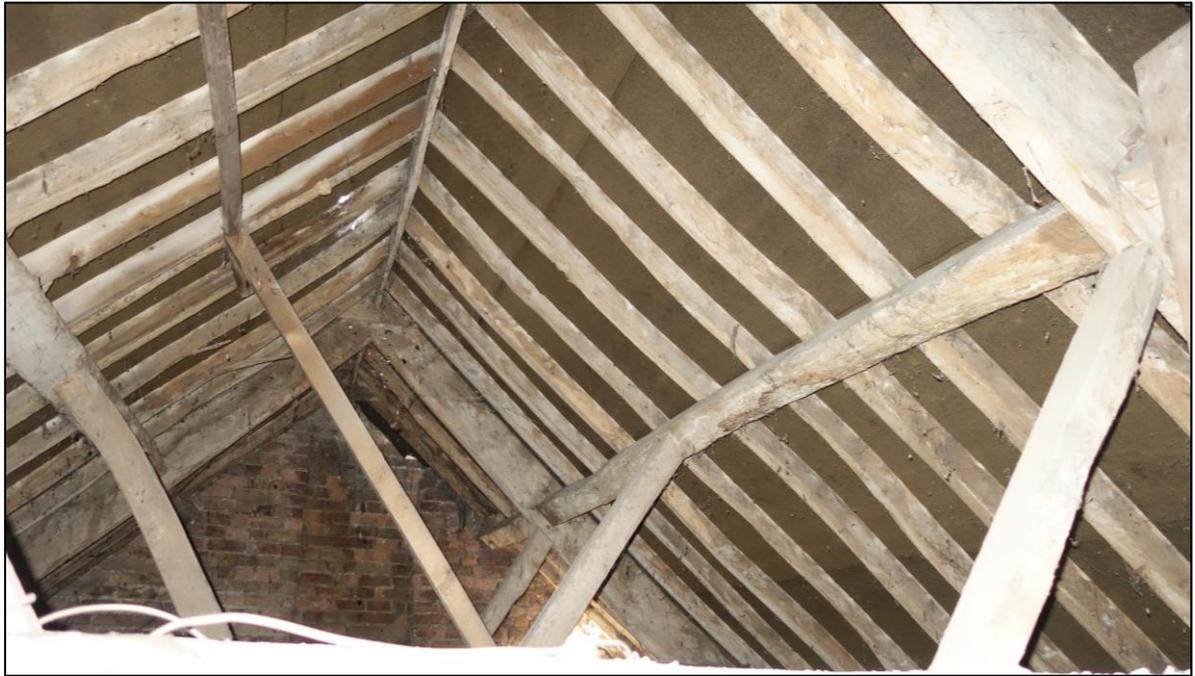
Due to health and safety constraints, it was not possible to fully inspect the roof space, however it was of open-truss type with a single set of trenched purlins (*Plate 33*). A number of the angled struts connected to the principal rafters appear to have been replaced.

Plate 33: Internal view looking N showing detail of roof structure with angled struts connected to the principal rafters
