REPORT ON BUILDING RECORDING & PHOTOGRAPHIC SURVEY

FORMER SUNDAY SCHOOL,

12 – 14 VILLIERS STREET, SUNDERLAND SR1 1HA

Date: Apr 2007

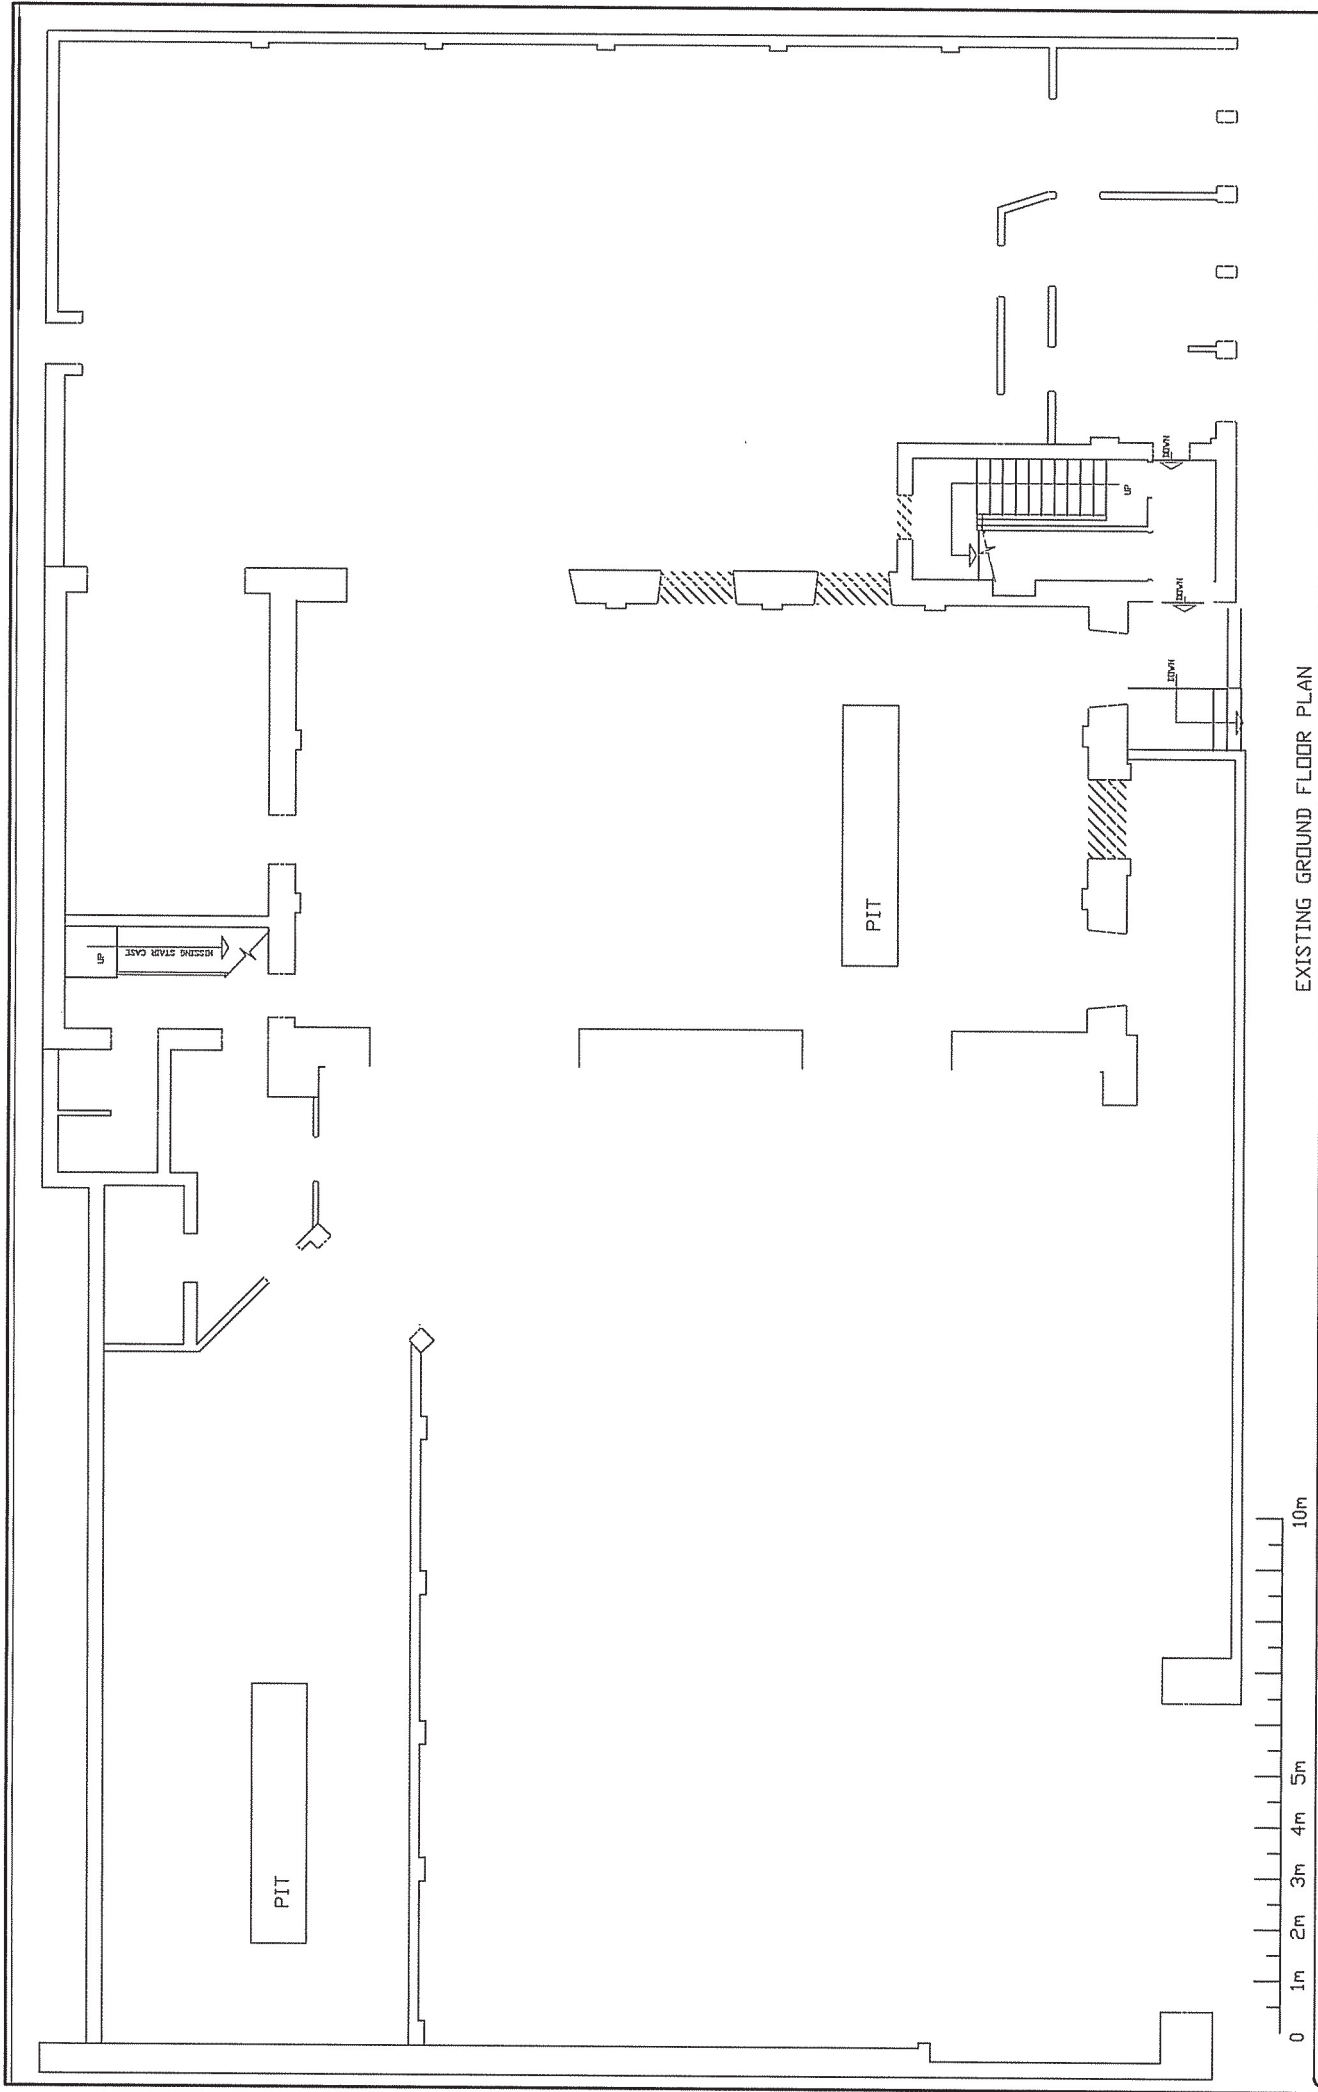
EXISTING GROUND FLOOR PLAN

- 6.1.5 Centrally to the site is the rectangular former Sunday School with its thick walls. In its southern wall are two large gates, in its eastern wall are two windows and a blocked doorway (not indicated, the one with the sink on the other side), in its northern wall are a blocked doorway, two blocked windows and a large gate, and in its western wall are two doors. The Sunday School had last been used as part of a now redundant garage. A second inspection pit is shown and fittings of former machinery are visible in the concrete floor.

- 6.1.6 The northern large gate leads into another part of the redundant garage. To its east is the redundant office tract. There are no openings in the northern brick wall. There is only a single fore exit in the western brick wall. In the south-western corner is a gate.

- 6.1.7 Both, the central doorway in the western wall of the former Sunday School and the gate in the south-western corner of the redundant garage lead into a rectangular room which is clad in asbestos.

- 6.2.3 Documentary and cartographic evidence as well as the walkover survey and building recording leave no doubt as to the existing building central to the site being the former Sunday School. Noteworthy is the thickness of the walls of the original rectangular building of 1849. The openings in the eastern wall are original as are the blocked door and windows in the northern wall. The central door in the western wall may be original while the southern door was constructed to allow access into the later infant school (see below). The large gates in the southern and northern walls are associated with the garage to allow vehicular access to the workshop.

- 6.2.4 The asbestos-clad room and staircase to the west are believed to be the infant school proposed in building control plans of 1869. By 1897, the protrusion

which houses another staircase had been built and also survives on site. Noticeable are wall thicknesses of about one whole brick.

6.2.5 Peculiarly, a bricked-up archway in the north wall of the protrusion would have allowed access into the protrusion which is denied entirely by there being the staff toilet wall from the other side. The possibility to look into this closed space through a hole under the stairs has been mentioned in the walkover survey.

6.2.6 All other features on site are believed to be modern structures in association with the redundant garage. Their walls are half a brick wide. The corridor and double doors in the offices presumably served to reduce noise and fumes from the workshop.

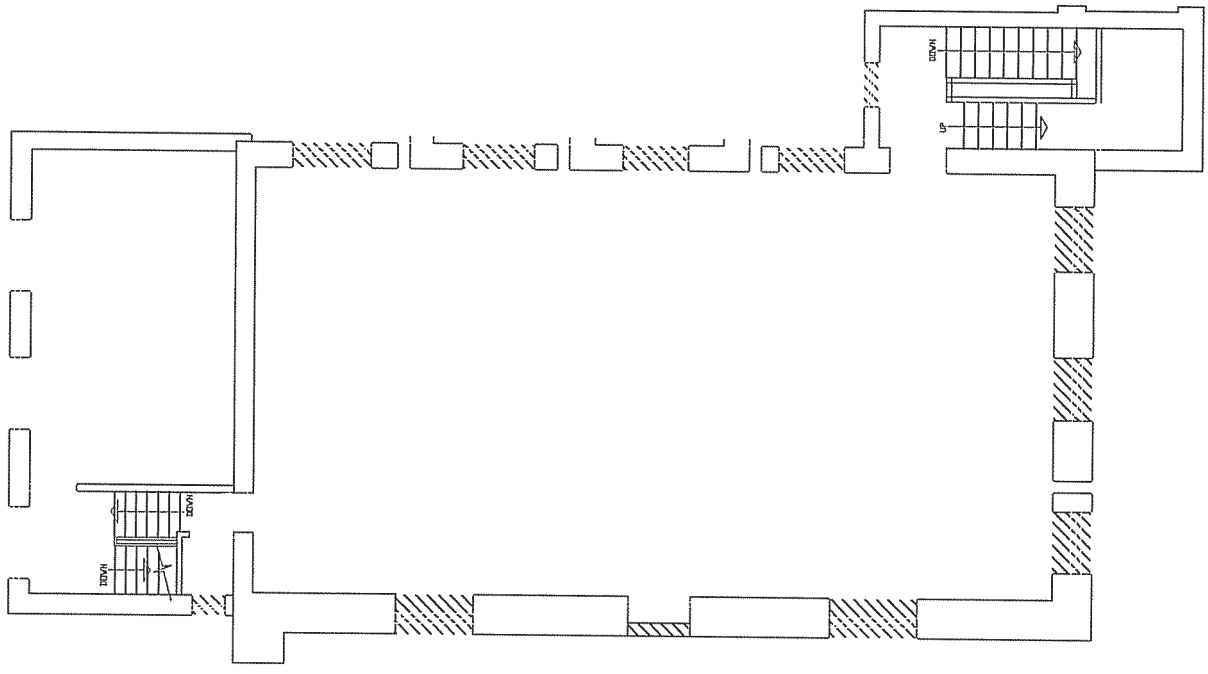
Title: FIRST FLOOR
Project: EXISTING DRAWINGS OF 12-14 VILLIERS ST SUNDERLAND TYNEWEAR SR1 1HA

6.3.2 The first floor of the former Sunday School is open-plan. There are three bricked windows in the eastern wall, a doorway and four bricked windows in the northern wall, a doorway in the western wall, and two blocked windows with a central blocked doorway in the southern wall.

6.3.3 The doorway in the northern wall leads into the protrusion with a blocked west-facing window and its staircase going down. The intermediate level also incorporates a west-facing blocked window.

6.3.4 The doorway in the western wall leads into the western extension of the infants' schools comprising a staircase which has been partially destroyed and is unusable, and the school room. There are four windows in the western wall.

6.4.2 From 1849, the doorway in the southern wall must have connected the former Chapel's gallery with the schoolroom. At the time, its may have been the only point of entry, with the infants' school staircase having been built twenty years later, and the protrusion first appearing on a map of 1897.

6.4.3 The first floor plan indicates the features on the first floor belonging to the former Sunday School, with later building phases merely comprising the barricading of openings.

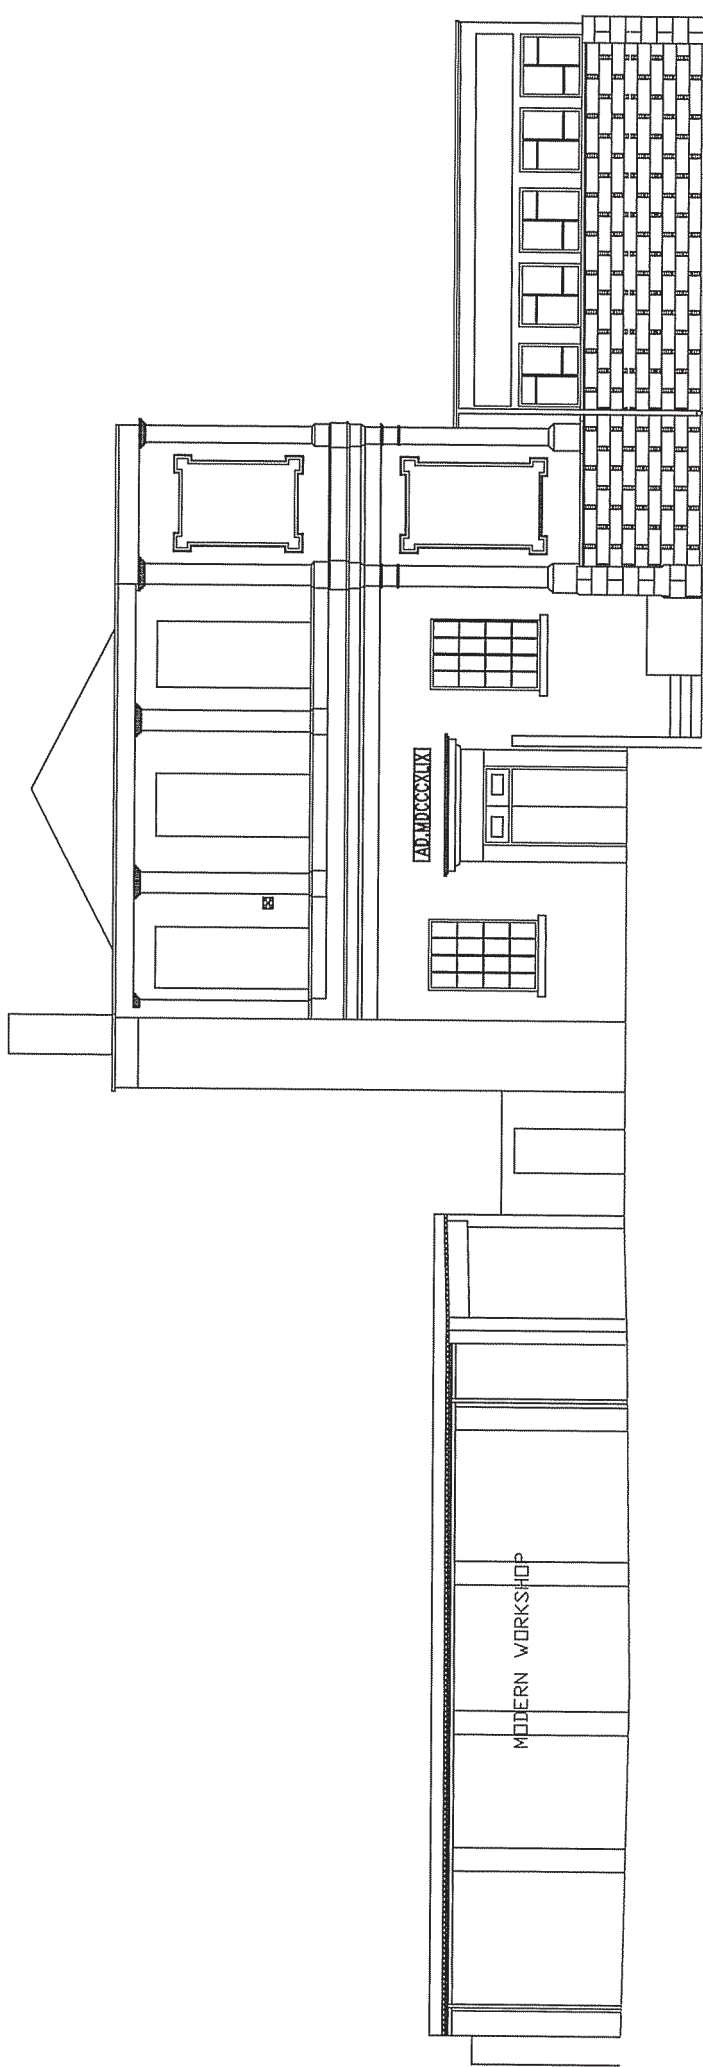
EAST ELEVATION

- 6.5.3 The north of the drawing visualises the eastern façade of the former two-storey Sunday School, its protrusion and the single-storey extension of the redundant garage.

- 6.5.4 The ground floor of the former Sunday School displays a central doorway with two doors above which the Roman numerals for 1849 can be read. Two windows appear to either side of the doorway.

- 6.5.5 The upper floor of the former Sunday School shows three bricked-up windows.
- 6.5.6 Although decorated, the protrusion has no eastern openings in either the ground or the first floor.

- 6.5.7 There is a southern gable which is not part of the roof that actually spans the former school and the protrusion.
- 6.5.8 The protrusion appears to be founded on a stone wall which runs parallel to Villiers Street to the north, and as such can also be seen beneath the five front windows of the redundant single-storey garage.

- 6.5.9 The front of the garage, which has no door, is held in brick.

- 6.6.1 This interpretation is based on the findings of report no. 11005.
- 6.6.2 The date above the door is thought to be contemporary with the reminder of the School's façade.
- 6.6.3 The protrusion is thought to be that first visible on the map of 1897 and to not have been altered.
- 6.6.4 The wall beneath the protrusion is thought to have been the cemetery wall, but perhaps not in its earliest form (see below).
- 6.6.5 The original roof is thought to have adopted the design of the former Chapel, now demolished, and to have incorporated the southern gable. Phases of rebuilding are not immediately obvious but are thought to have started with the construction of the infants' school and continued during the work on the protrusion.

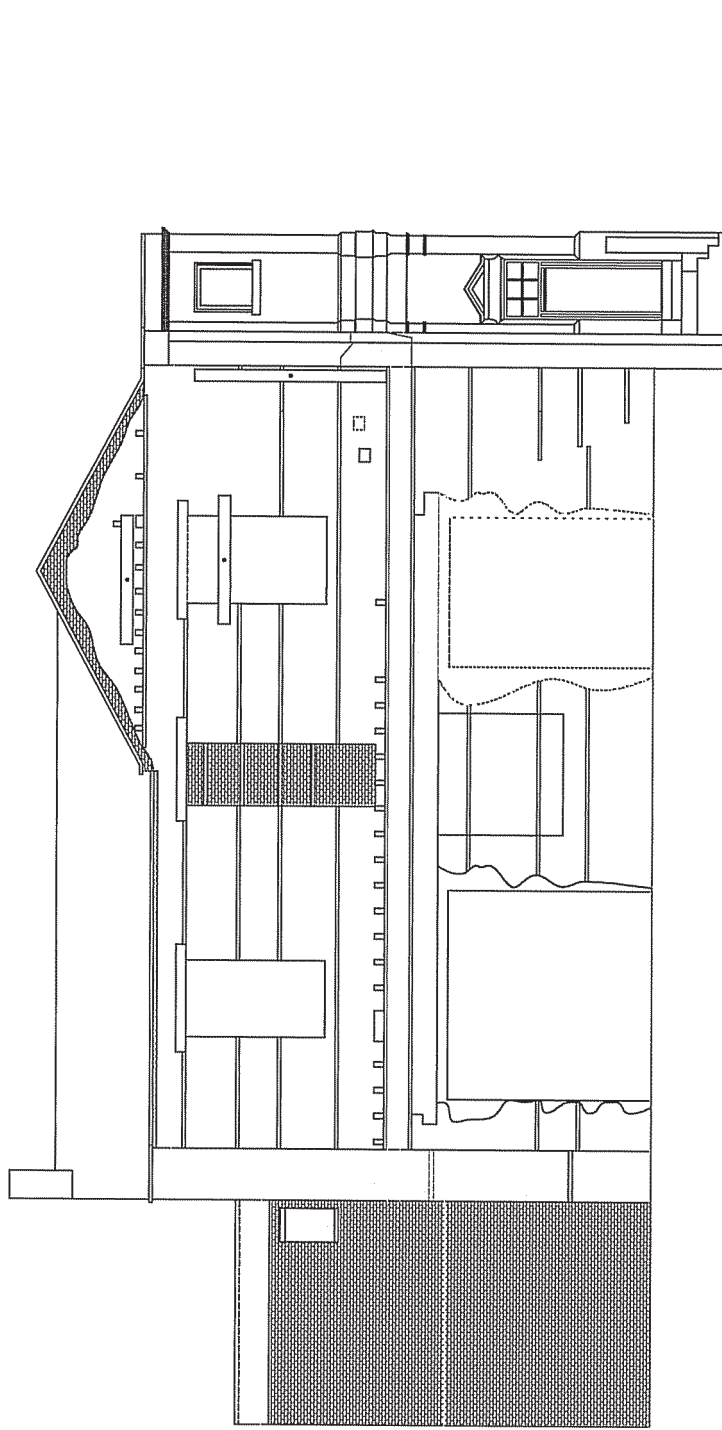
SOUTH ELEVATION

- 6.7.1 Observations should be read in conjunction with Drg No 6 of 11, included in Appendix 2.
- 6.7.2 The south elevation clearly shows the southern door in the ground floor of the protrusion as well as the window in its first floor.
- 6.7.3 The external walls of the ground and first floor of the former Sunday School were built in limestone with wooden stabilisers.
- 6.7.4 In the ground floor wall are two large gates with a central shallow bay.
- 6.7.5 In the first floor are three blocked openings and at the eastern end are metal brackets.
- 6.7.6 There is a gable which also incorporates a metal bracket.
- 6.7.7 To the west in the extension of the former infants' school.

- 6.8.1 This interpretation is based on the findings of report no. 11005.
- 6.8.2 Again, features of the protrusion are thought to be original and unaltered.

- 6.8.3 The limestone wall construction of the former Sunday School is thought to be original, with all brick features being later.
- 6.8.4 The first of these brick features would have been the blocking of the central doorway in the first floor (see 6.3.2), the brick being levelled with wood similar to that within the limestone construction and a sign of the times.

- 6.8.5 The brick type matches that used to construct the infants' school, hence they are believed to be contemporary. If until then the upper floor of the Sunday School could only be reached via the former Chapel's gallery, there was now a staircase in the infant's school to take care of access. Perhaps a doorway within the southern wall interfered with the proceedings either in the School or in the Chapel.

- 6.8.6 This brick type can also be observed within the gable, leading to the suggestion that the roof was re-built at around 1869.
- 6.8.7 Another brick type was used to block the windows in the School's upper floor, without using wood. This type can also be found surrounding the gates within the ground floor wall, the western corner of the building and along the top edge of the infants' school.

6.8.8 The gates could have perhaps been built while the Chapel was on site, breaching internal walls, but there would not have been a need to repair the corner of the building until after its demolition between 1978 and 1982.

6.8.9 The shallow bay within the ground floor plan is thought to have been built around some external feature on the Chapel at the time.

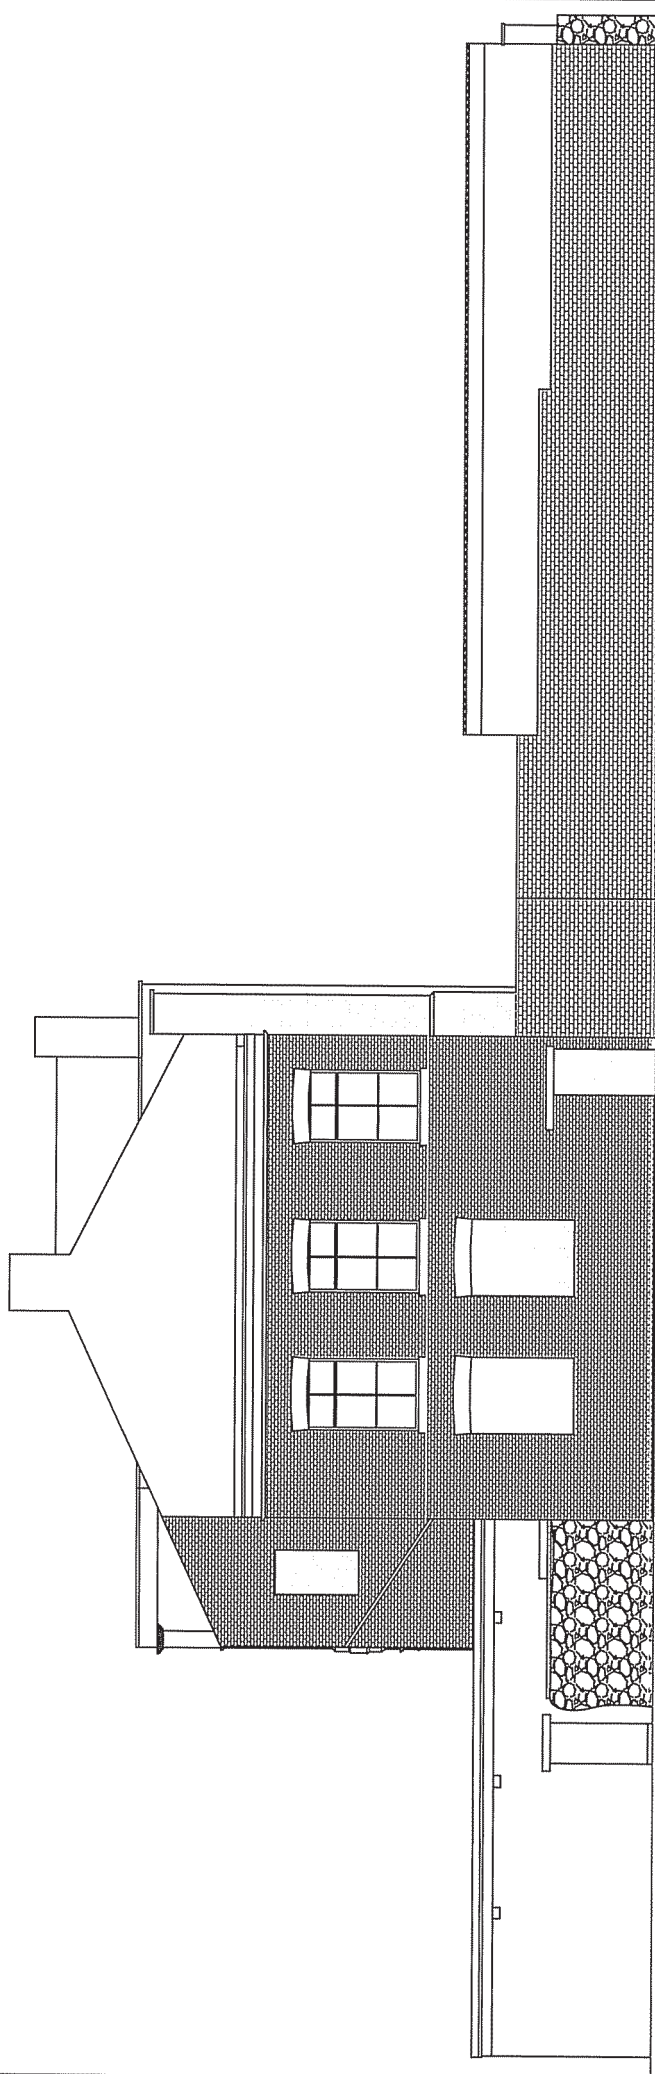
WEST ELEVATION

6.9.2 The north of the drawing is occupied by the brick-built west wall of the redundant single-storey garage which incorporates a fire exit and a fragment of limestone wall.

6.9.3 Behind it, the brick-built western wall of the protrusion can be seen which has a single bricked-up window.

6.9.4 The limestone wall abuts the western brick-built wall of the former infants' school. The windows in the upper floor are unobstructed while the windows and door way in the ground floor are bricked up.

6.9.5 To the south of the infants' school, the corner of the former Sunday School juts out.

6.9.6 A brick wall runs along the western boundary parallel to the lane and joins a fragment of the southern limestone wall.

6.10.2 The infants' includes a stone lintel over what appears to be its original entrance, albeit blocked.

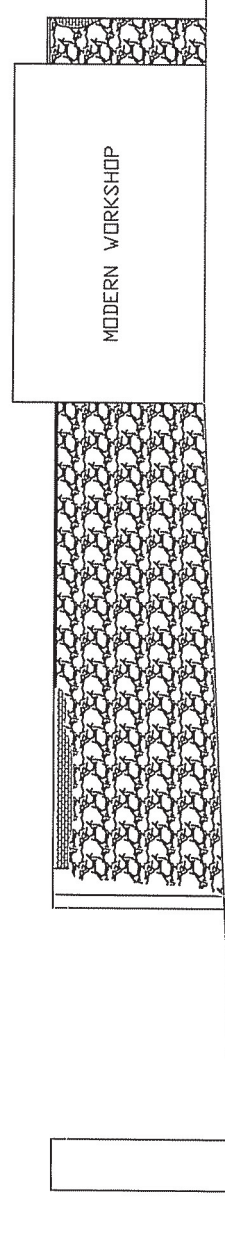
NORTH ELEVATION OF SOUTH BOUNDARY WALL

- 6.13.1 Observations should be read in conjunction with Drg No 8 of 11, included in Appendix 2.
- 6.13.2 The south boundary wall consists largely of limestone, repaired with brick type 1 and added onto with brick type 3.
- 6.13.3 Hence, this limestone wall and presumably the fragment in the western wall are earlier than the type 1 built infants' school and was extended to fit the needs of the redundant garage.
