Report on Conservation Work carried out at Walltown Crags (SM listing: 10017535) and Mucklebank Turret 44b (SM listing: 115596) in 2020 as part of the WallCAP Project

Walltown Crags conservation work: Issue 1

Mucklebank Turret conservation work: Issue 2

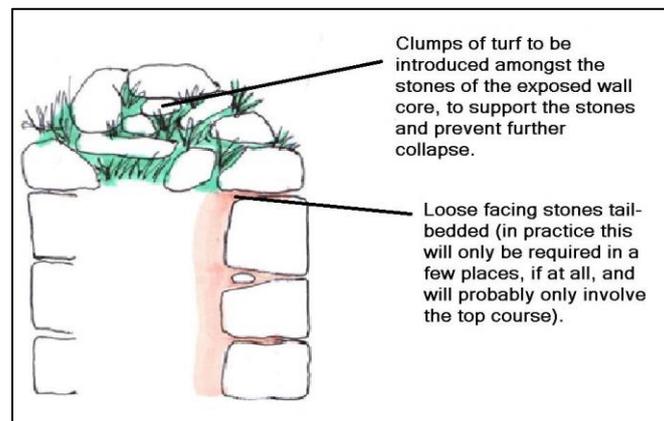
Fig. 1: schematic section across the curtain demonstrating clumped turfs supporting exposed stones of the core, stabilising the structure but maintaining a natural appearance.

5.3 Once the faces are deemed stable, clumps of turf will be placed, in an apparently random and uneven manner, on top of the Wall amongst the stones of the core [fig. 1]. Where necessary, this turf will be secured with short timber pegs. This newly introduced turf should merge into the wall top as the grass grows, providing support for the facing stones and precluding further collapse... The turf will be sourced as locally as possible, but from outside the scheduled area’ (WallCAP Sept. 2020, pp.10-11).

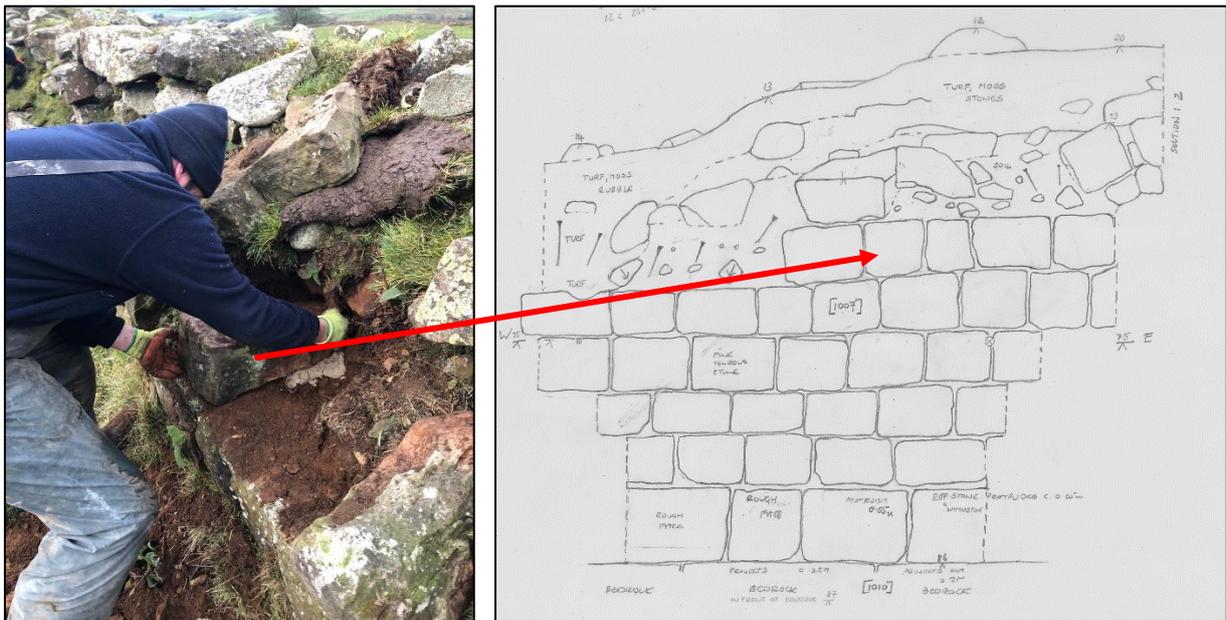
Fig. 3: left, rebedding at work in the Trench 1 area after backfilling; right, field drawing facing south showing re-set partial course and tail-bedded single stone of course above

1. The uppermost slipped facing stone in the WTC20 Trench 1 area (NGR 367659.71, 566570.97) was replaced and tail-bedded. Facing stones in the course below were reset to consolidate the course but without tail bedding (fig. 3).

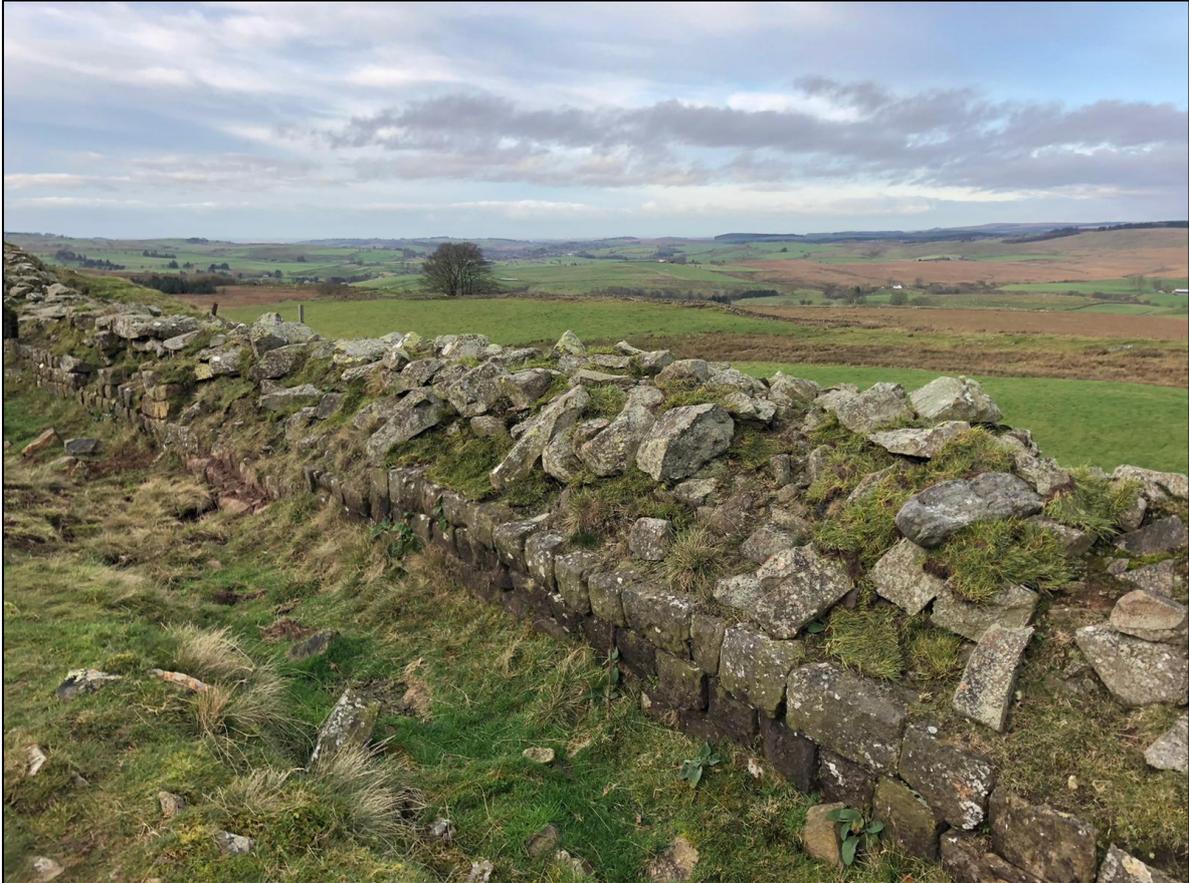
Fig. 4: consolidated wall core looking west; backfilled Trench 2 is visible on the left in the photo against the south face of the Wall

2. The exposed stones of the core from just east of Trench 1 (NGR: 367657, 566571) south-west over and including Trench 2 and to the old fence line just west of the quarry (NGR: 367635, 566556), were consolidated as described above, using appropriately sourced turf (figs 4-6). This covered around 25 metres of Wall core.

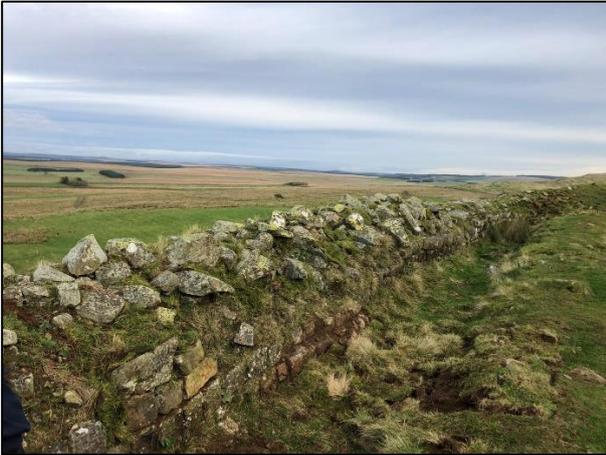
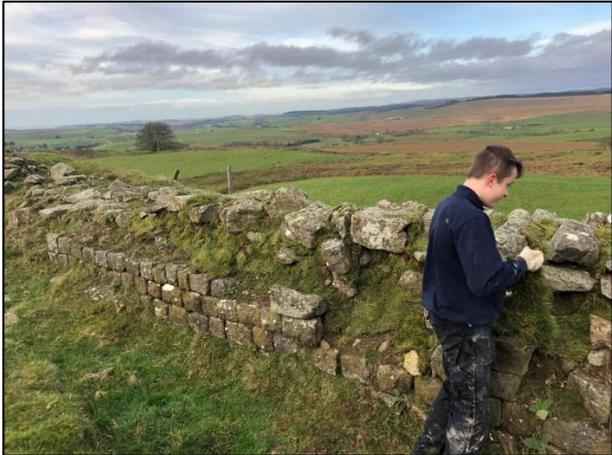
Figs 5 and 6: left, consolidated wall core looking north-east; right, consolidating the Trench 1 area

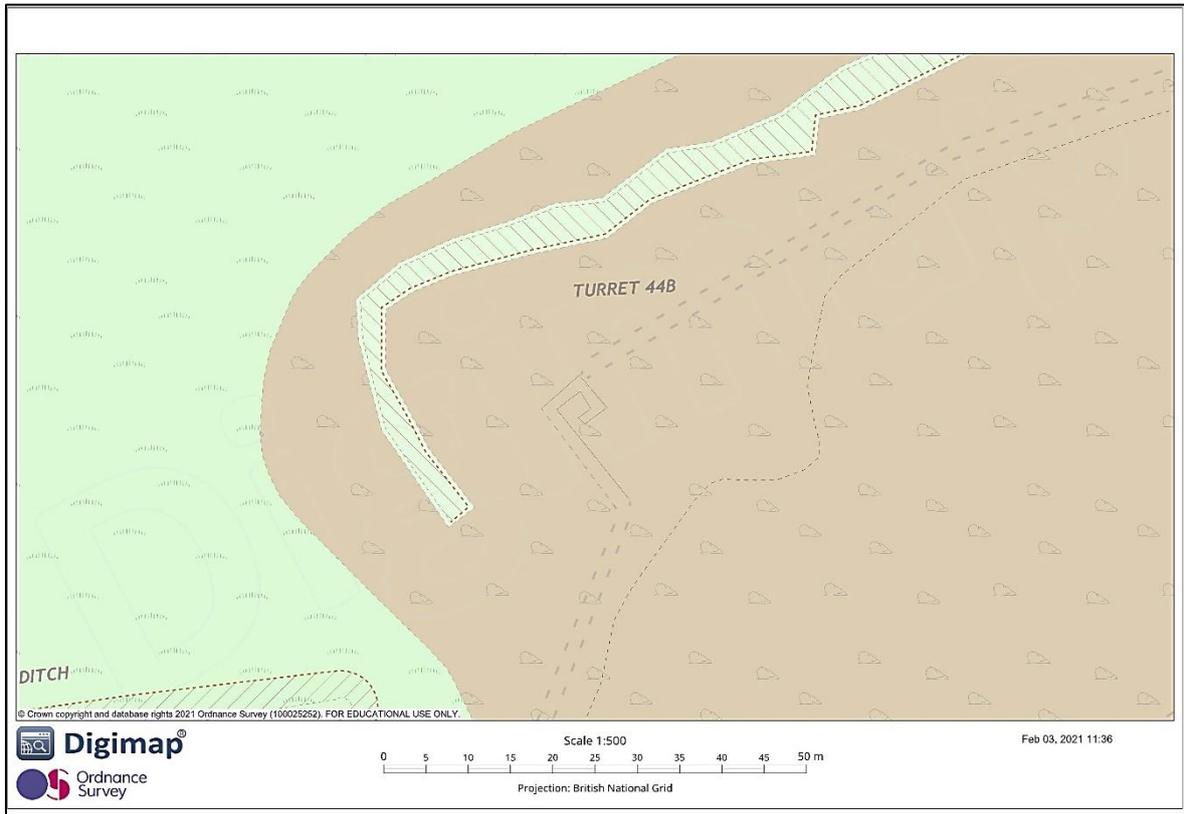
Fig. 7: Turret 44b

The conservation work to address issues at Mucklebank Turret was carried out by *Heritage Consolidation* in October 2020 while the WallCAP excavations were underway at Walltown Crag. The loose stonework at the remains of Turret 44b (fig. 7) was consolidated and where necessary tail-bedded, and the top turfed using the method described above. Work focused on the SE corner (NGR: 3681409, 566703), which was where facing stones were tail-bedded (figs, 8-10).

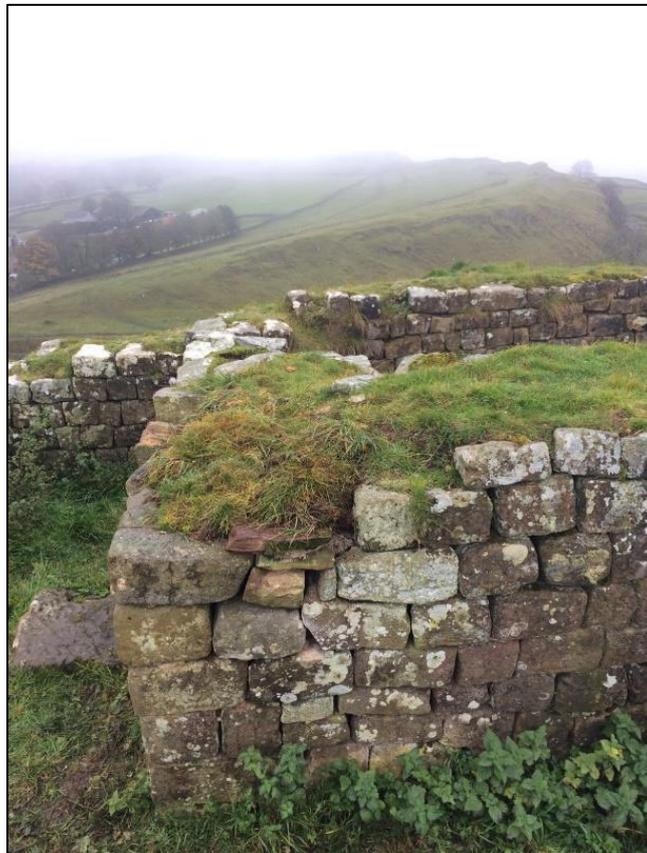
Fig. 8: SE corner, Turret 44b after conservation

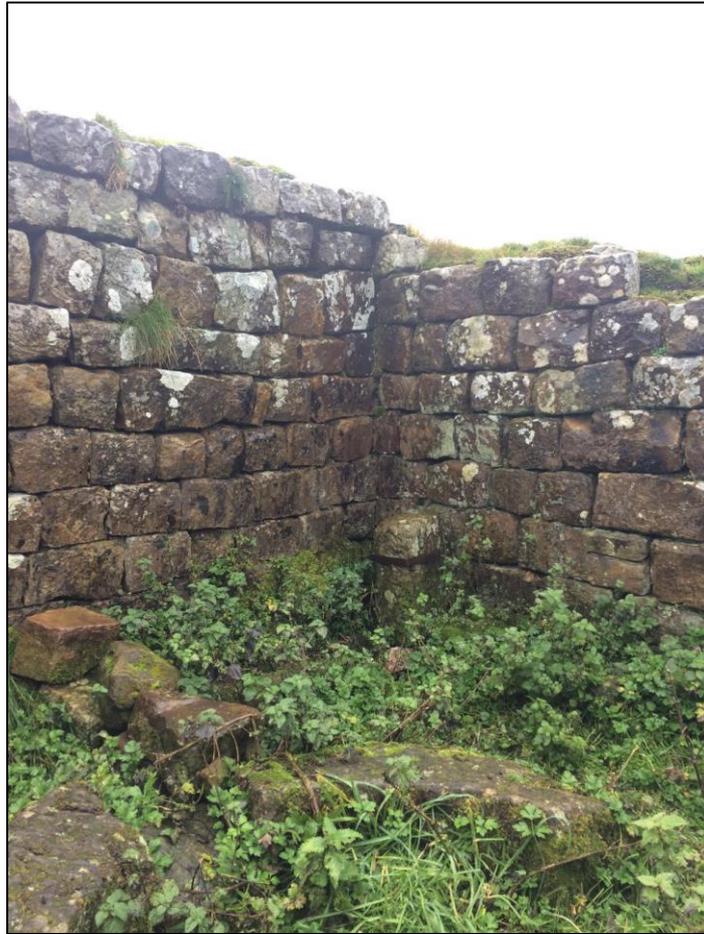
Fig. 9: interior of Turret 44b looking east after conservation

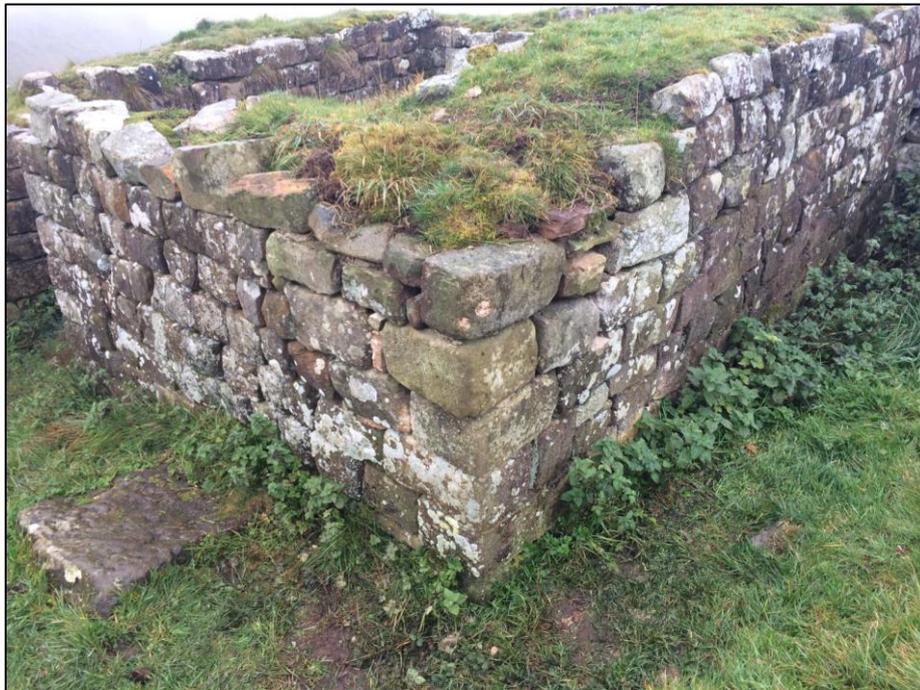
Fig. 10: SE corner, Turret 44b after conservation
