Project No. 1324
July 2005

**New Union Mill, Grosvenor Street West, Birmingham
Historic Building Recording and Fabric Analysis 2005**

New Union Mill, Grosvenor Street West, Birmingham: Archaeological Building Recording and Analysis 2005

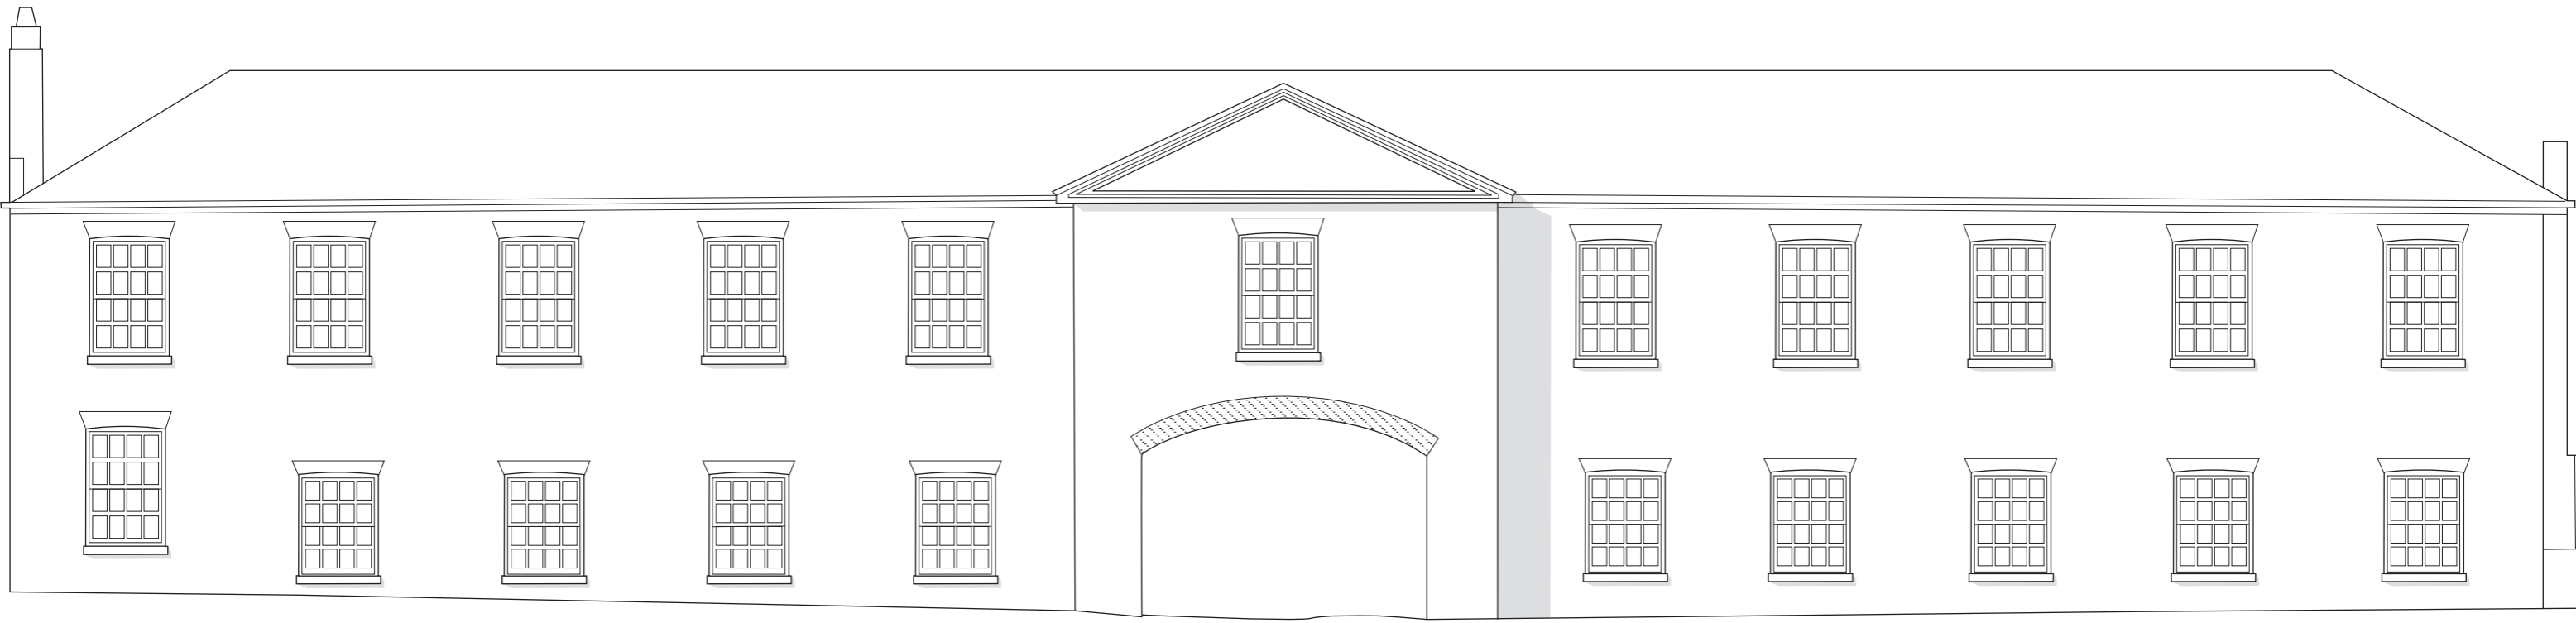
Fig. 6 : South Facing Elevation

The existing building dates from *circa* 1813. It is constructed in red brick laid in Flemish bond, and has a hipped slate roof with oversailing eaves. The principal range is aligned NE-SW facing SE, and the SW range NW-SE facing NE towards the courtyard. It is a two-storey structure, the 11-bay front (SE) elevation being articulated by a central pedimented entrance bay, breaking forward from the main line of the elevation (Plate 2). A segmental-arched carriage entrance occupies the ground storey of the central bay. All other openings on this front are 16-pane glazing bar sash windows with horns, painted stone sills, shallow segmental arches and brick wedge lintels (Plate 3). The principal alterations to this front are the 20th-century reconstructions of the arches over the main entrance and one of the ground floor windows (Fig. 6)

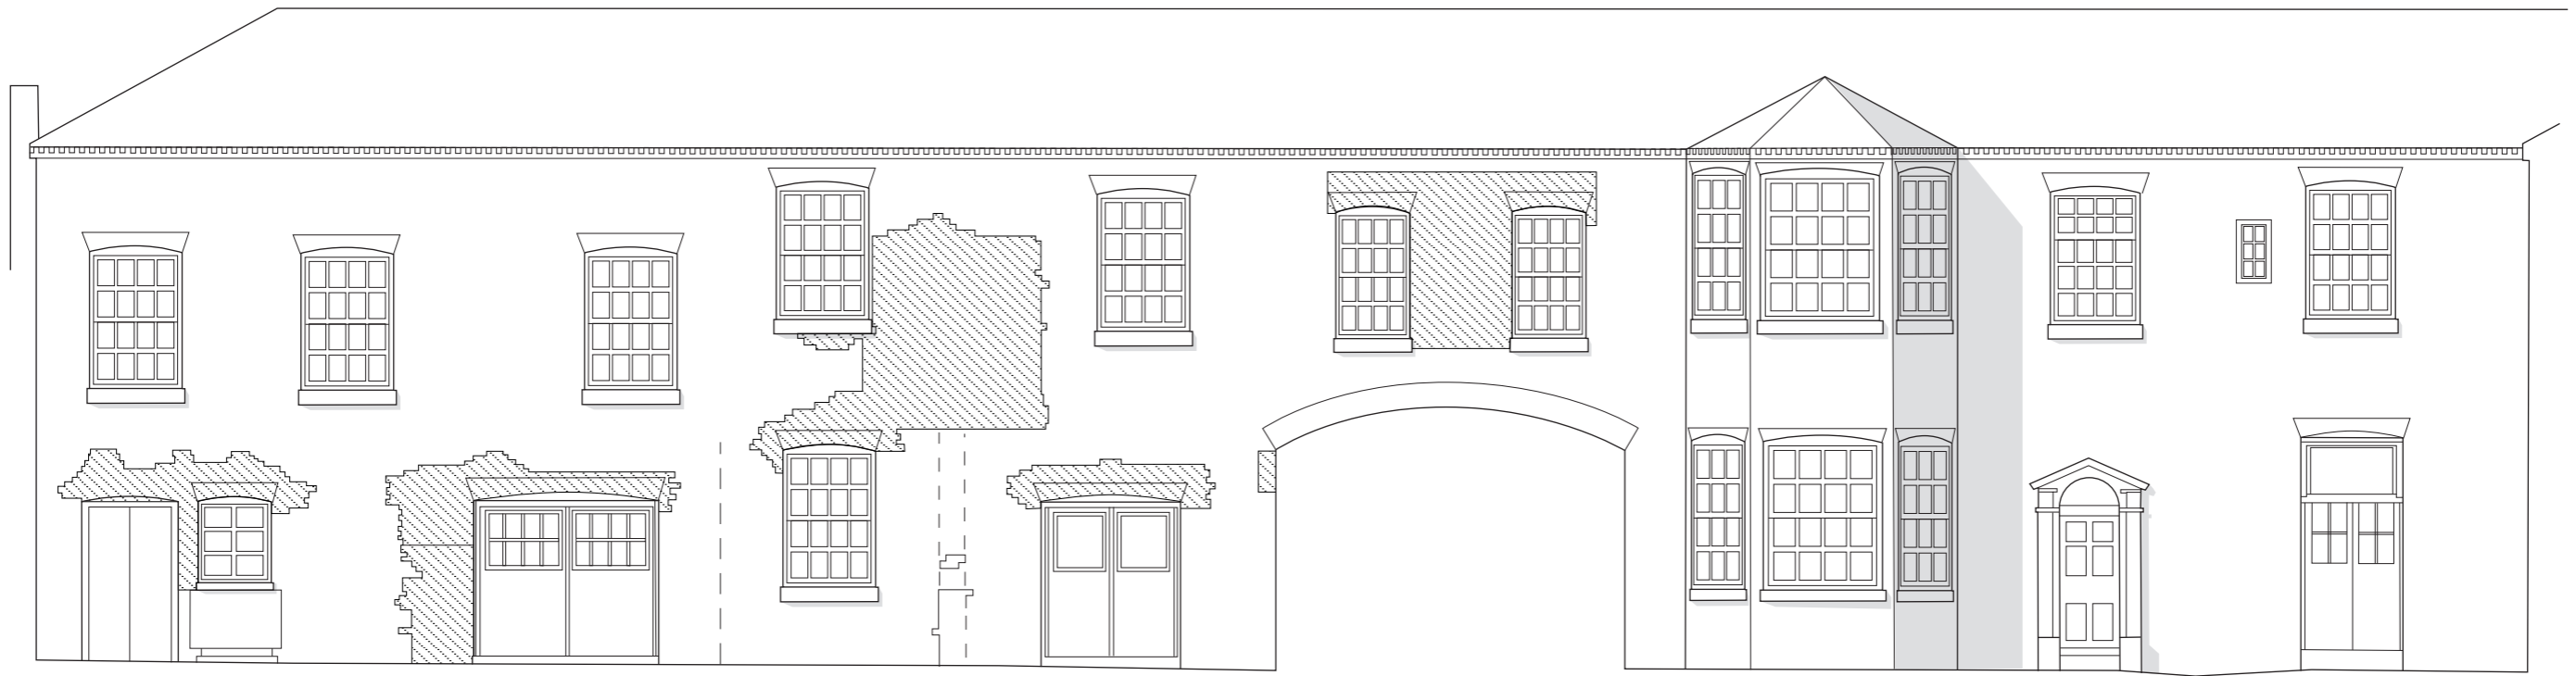
Fig. 7 : Northwest Facing Elevation

Whereas the front (SE) elevation displays a high degree of symmetry, the rear (NW) elevation is rather more irregular, and reproduces more faithfully the internal layout. To the right (SW) of the carriage entrance is a 2-storey canted bay window with hipped roof, and, immediately right (SW) of the bay, an early 19th-century 6-panelled door with plain fanlight, and panelled and pilastered doorcase with open-base pediment (Plate 5). To the right of this doorway is a 20th-century doorway, probably a conversion of a window, of which the segmental arch survives. To the left of the carriageway is a series of three 20th-century entrances with double doors, all of which have resulted in some reconstruction of the brickwork. The left-hand (NE) and centre ones are insertions, but the right-hand (SW) one may occupy the site of an original opening. To the right of the left hand (NE) doorway is a 20th-century 6-pane sash window, which partially occupies a blocked doorway. Between the centre and right-hand doorways are a vertical line of stitching between the brickwork (NE), and a vertical wall scar (SW), above which, at first floor level, a large area of the wall has been rebuilt. There is another area of rebuilding at this level over the gateway.

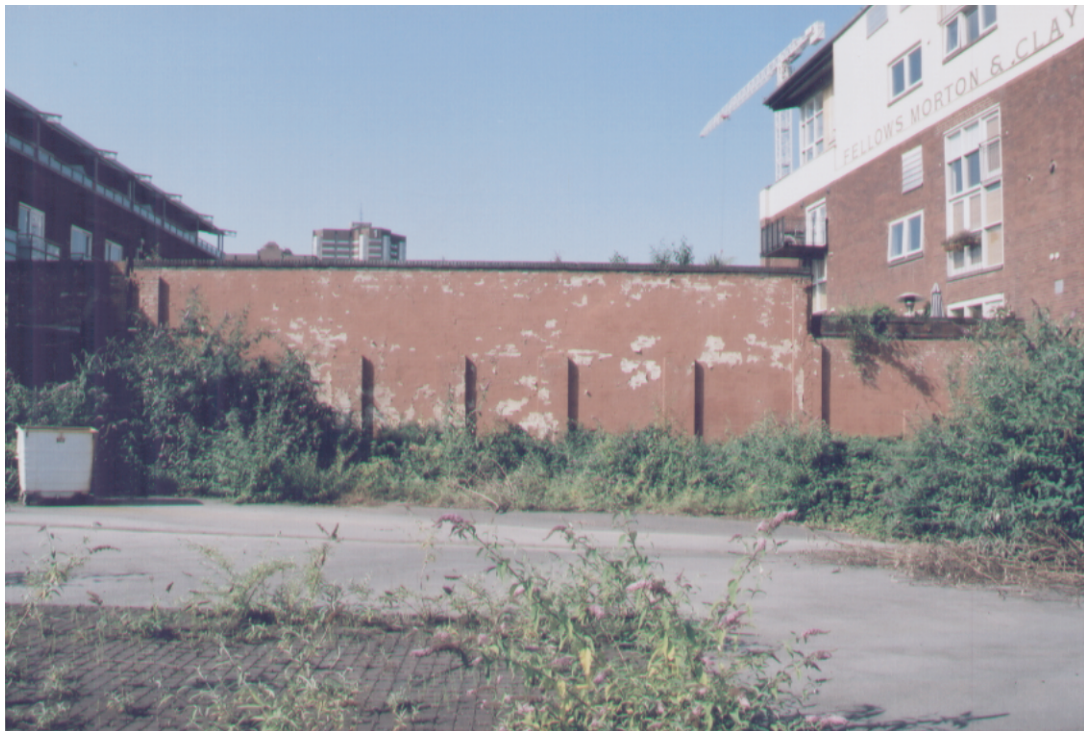
Plate 6

At the left-hand (SE) end of this elevation, attached to the SE range, is a 2-storey, 2-bay house front. To the left (SE) is a 6-panelled door with plain fanlight and pilastered and pedimented doorcase. To the right (NW) is a 20th-century french window with segmental arch, possibly original. At first-floor level is a pair of 16-pane sash windows with painted stone sills and segmental arches. The eaves are decorated with a brick dentilled band. Attached to the right-hand (NW) side of this structure is an early 20th-century single-storey brick structure with flat roof, not of special interest. A recessed porch and window have concrete lintels. Behind this, and extending the full length of the site is a brick-built boundary wall, which incorporates a series of pilaster buttresses (Plate 6).

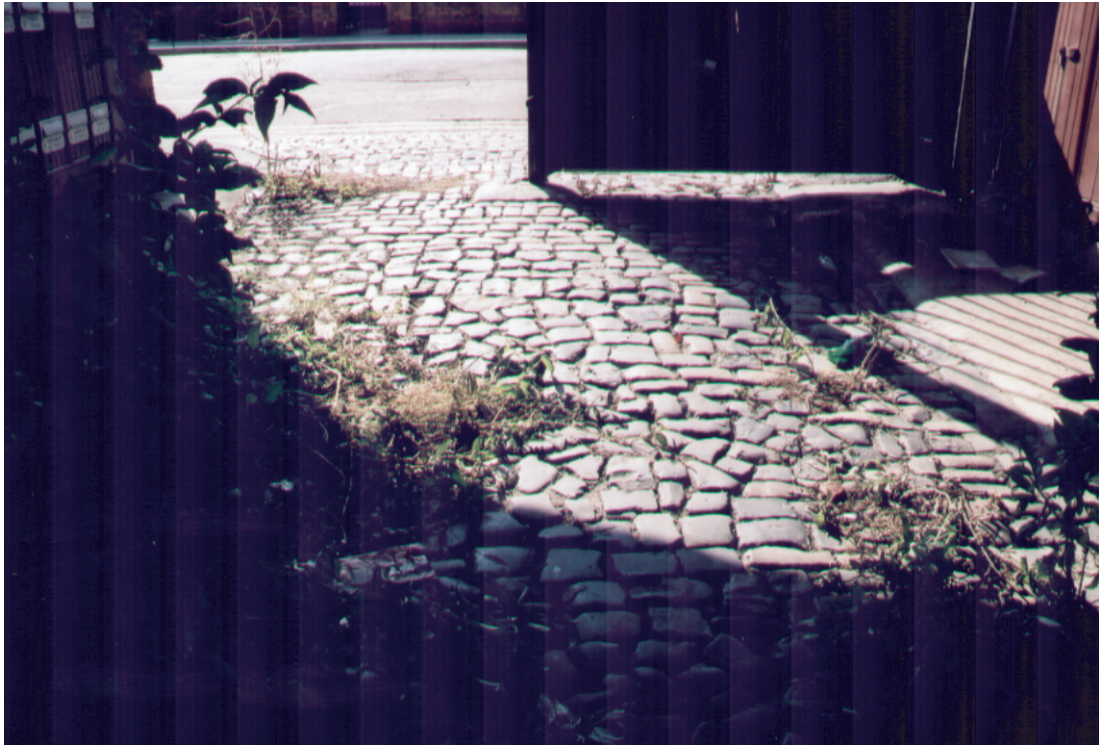
Plate 7

Gate passage. Irregular cobbled carriageway, probably early 19th century, with late 20th century concrete pavements to each side (Plate 7). Two inserted openings in the SW wall:

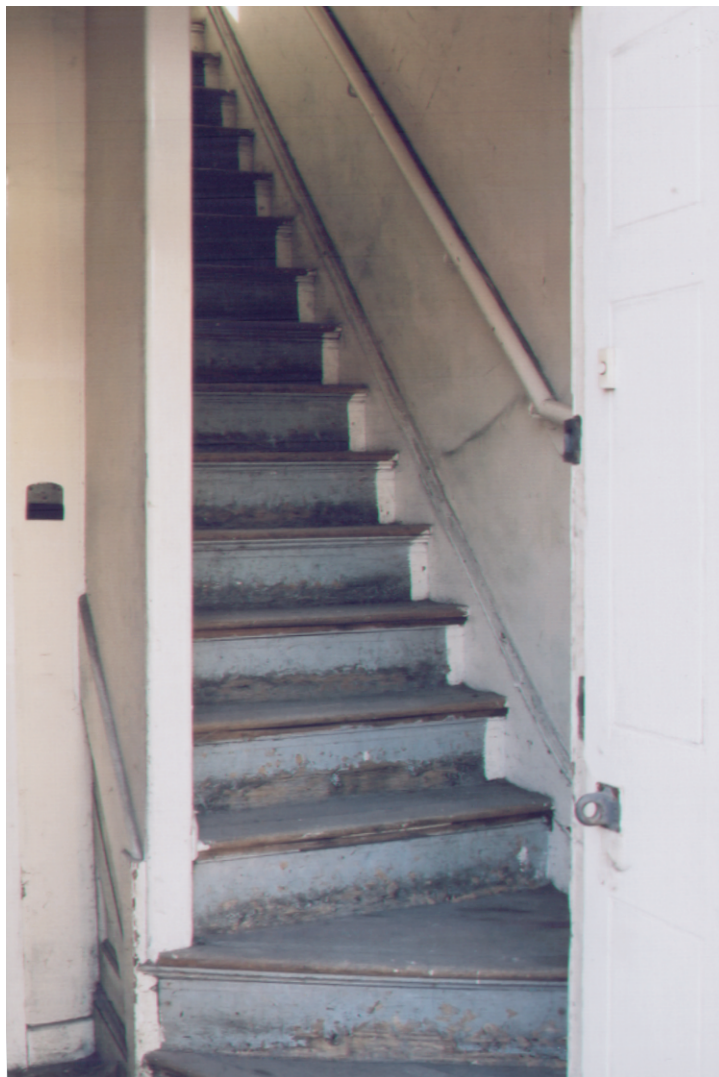
Plate 8

Hall and staircase. 20th-century concrete floor probably overlying 19th-century quarry tiles, which survive in the cupboard under the stairs. Late 20th-century skirting boards except for the staircase itself, which retains its original boards with simple beaded design (Plate 8). 19th-century panelled staircase with carved tread ends to the bottom two steps, but the rest of the string has been modified or covered over, and the balustrade boxed in. A pendant is visible at ceiling level.

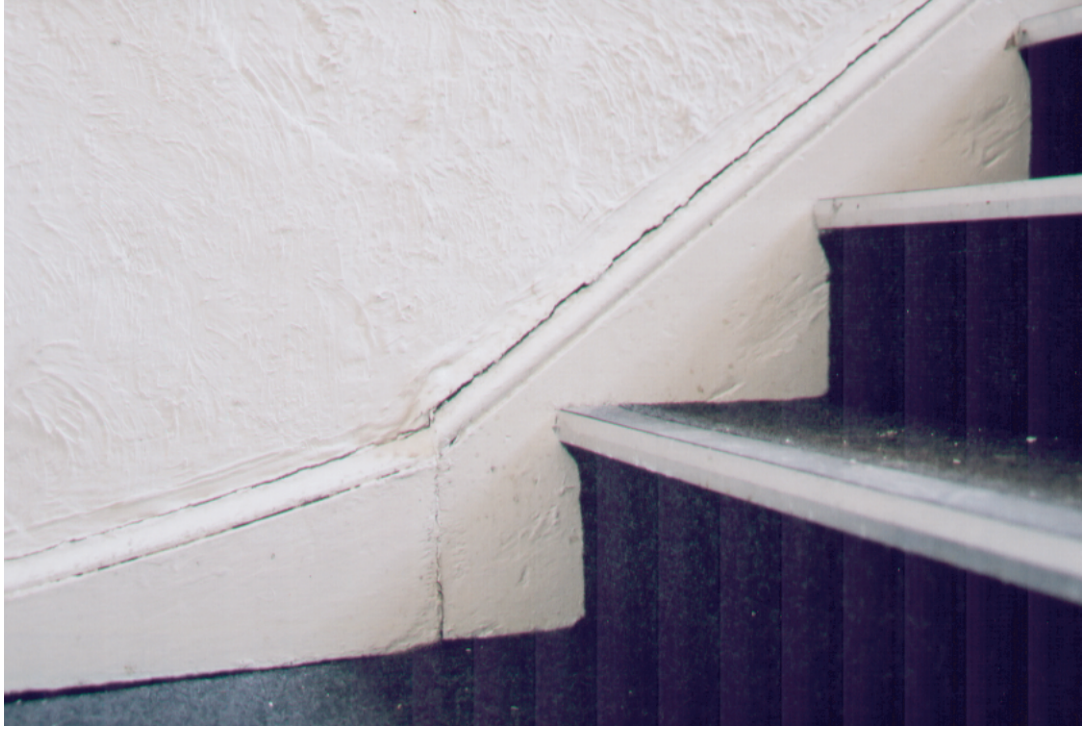
Plate 9

Hall and staircase. 20th-century concrete floor with plywood over. Late 20th-century skirting boards. Late 20th-century dog-leg staircase but in the position of the original stair judging from the original skirting board, which survives, although some has been replaced with boarding of a different design (Plate 9). Other elements of the 19th-century staircase that remain are a newel post at the turn (Plate 10), and some panelling in a cupboard under the stairs (Plate 11). This cupboard under the stairs appears to have been the access to a now filled in cellar; the segmental arch of the entrance can be seen in the SE wall. Late 20th-century plasterboard ceiling over G8 fixed to wooden joists.

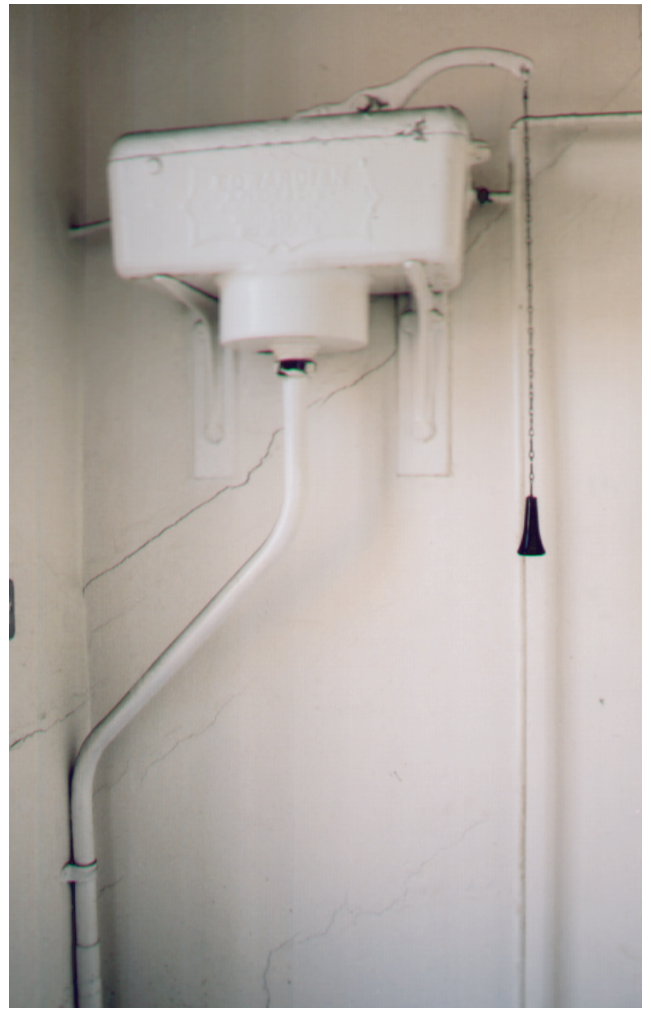
Plate 12

Landing, now divided by 20th-century partitioning. Floor of 20th-century boards. 20th-century skirting boards, except the stair (SW) and the SE wall, which is original. Sash window in SE wall partially obscured by NE wall. All doorways are 20th century in date. At the NW end of the NE wall is an early 20th-century water closet with cast iron cistern (chain replaced) embossed with the legend 'EDWARDIAN/A.PEERS & CO. LTD/SANITARY ENGINEERS/WHEELLEYS ROAD, BIRMINGHAM' (Plate 12). Late 20th-century artexed plasterboard ceiling.

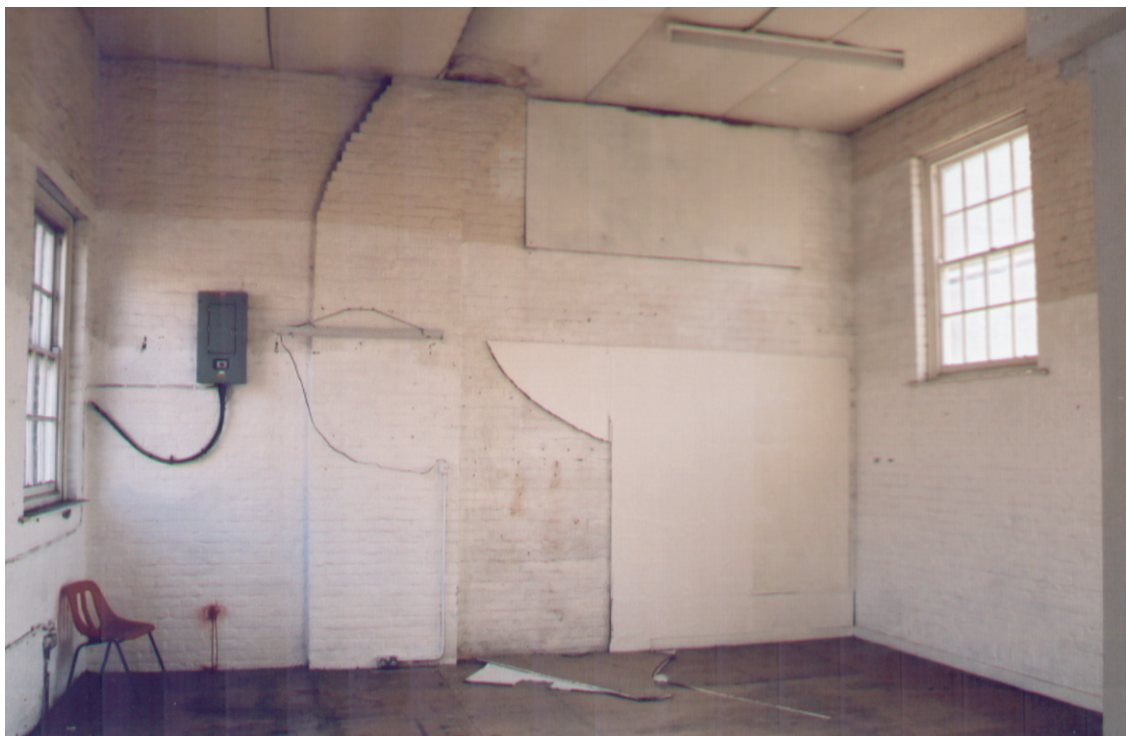
Plate 13

Situated at the NE end of the main range, F9 is at a lower level than the rest of the rest of the range (Plate 13). It is now divided by late 20th-century partitioning. The floor is covered in plywood but there appear to be 19th-century boards beneath. 20th-century skirting boards throughout. Painted brick walls. Narrow chimneybreast in the NE wall, but no fireplace, Three sash windows high up in the SE wall, and three at normal height in the NW wall.
