**Project No. 1150**

**High Cross House, Sharnford, Leicestershire**

**An Historic Building Assessment**

By  
Malcolm Hislop

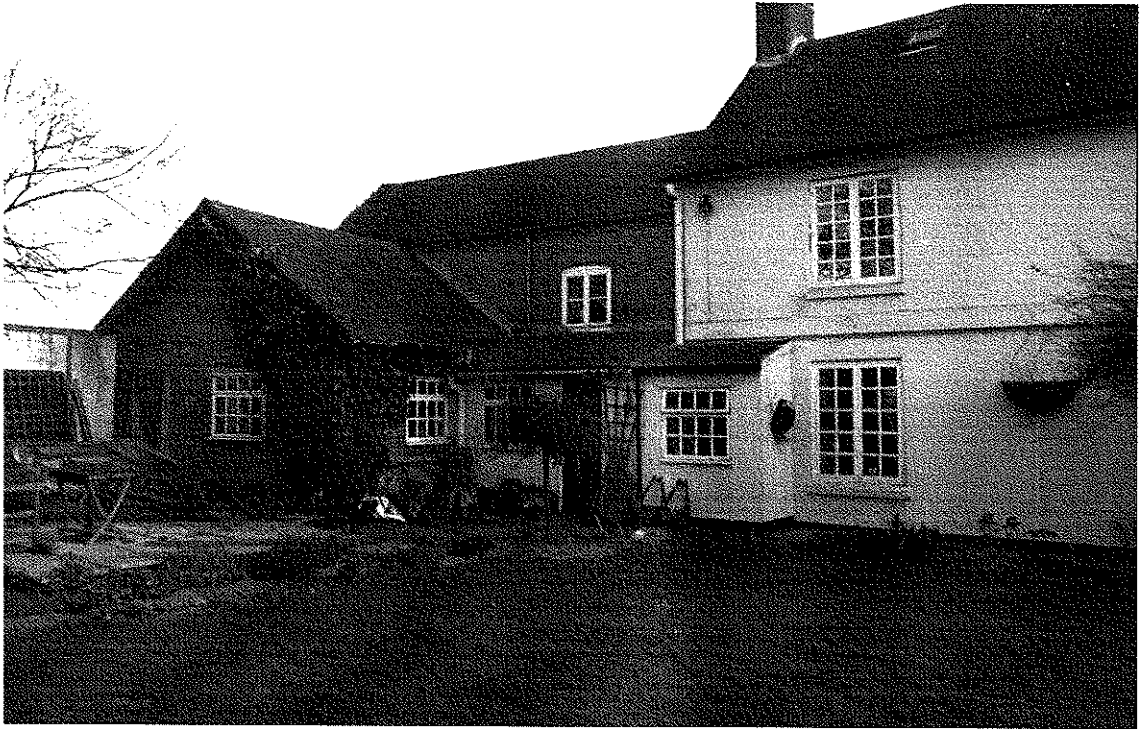
Plate 1

Lower red brick (Flemish garden wall bond) outhouse extension with plain tile roof attached to the left (northwest) (Plate 1). Two storeys with dentilled eaves band. One first floor window visible, 20<sup>th</sup>-century casement in 19<sup>th</sup>-century surround. Breaking forward from the left-hand (northwest) end of this extension is another red brick gabled outhouse (now kitchen) wing with segmental-arched blocked doorway to left, inserted 20<sup>th</sup>-century window to centre with concrete lintel and blocked upper window.

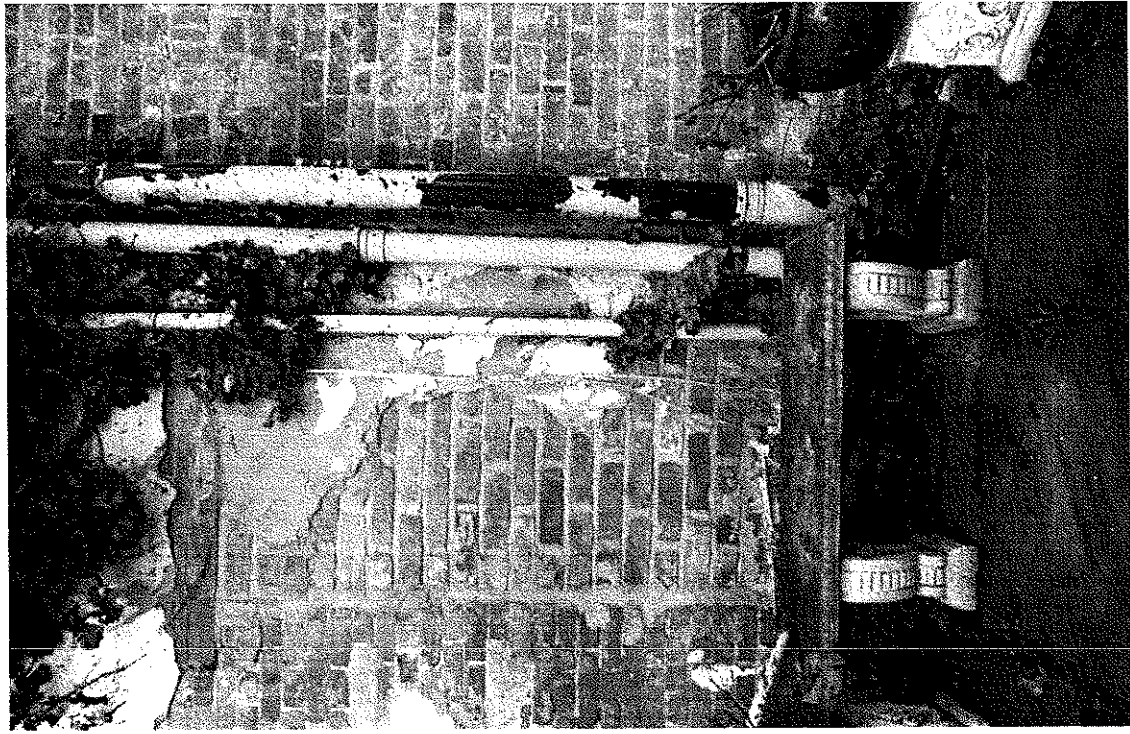
Plate 3

Main range to left has turret with lean-to roof attached to rear. In the angle between the main range and rear wing are some projections largely of 19<sup>th</sup>-century date with rendered walls, plain tile roofs, and 20<sup>th</sup>-century casements within segmental-arched openings. 20<sup>th</sup>-century glazed porch in front, not of special interest (Plate 2). Northeast end of rear wing set back to right with segmental-arched window to the left (southeast) and blocked, probably inserted, door to right (Plate 3). This wing is built of 2¼" thick red bricks laid in Flemish bond, which would not be incompatible with a late 17<sup>th</sup>-century date. Vertical joint between this wing and the outhouse extension to the right (northeast). The latter has a blocked segmental-arched door to the left (Plate 4), current entrance to right of centre

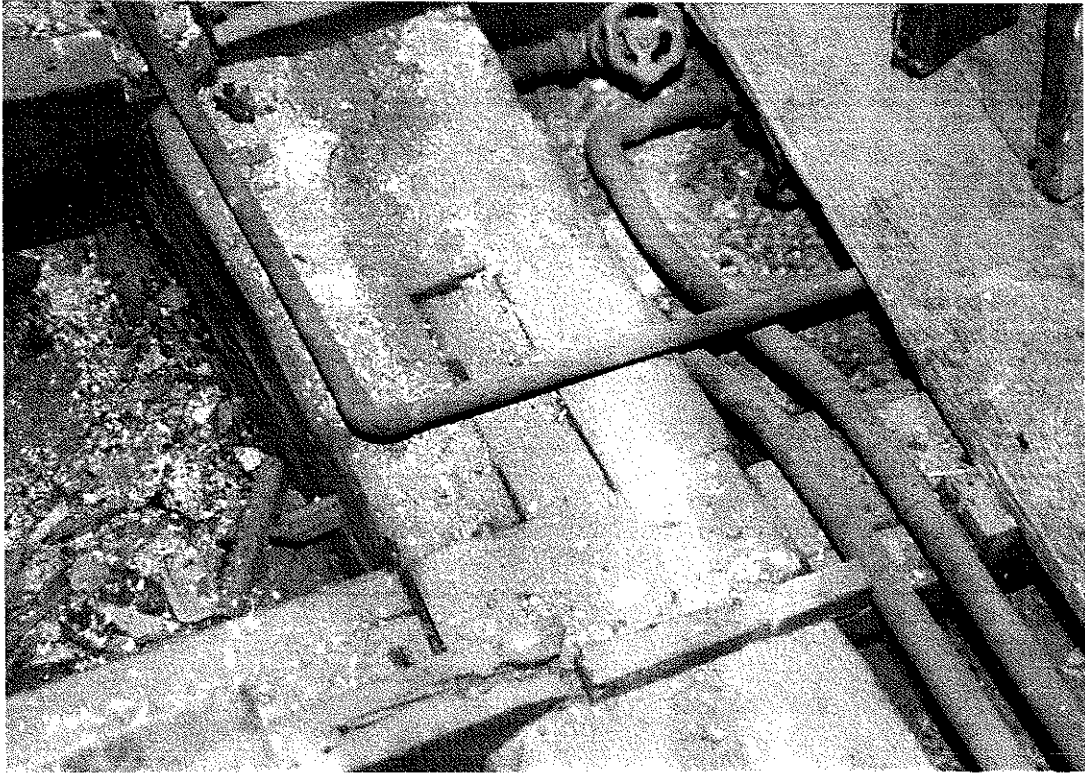
Plate 5

All 20<sup>th</sup> century features except for a northeast-southwest floor beam exposed at the time of the survey (Plate 5). Unusually this contains a scarf joint, probably 17<sup>th</sup> century in date. The full extent of joint was not visible but it was bridled and edge-pegged and was probably edge-halved. Directly above this beam the end of a 17<sup>th</sup>/18<sup>th</sup>-century chamfered and stopped ceiling beam protrudes from the northeast wall; abutting it to the northwest is a plain, probably late 17<sup>th</sup>-century, beam.

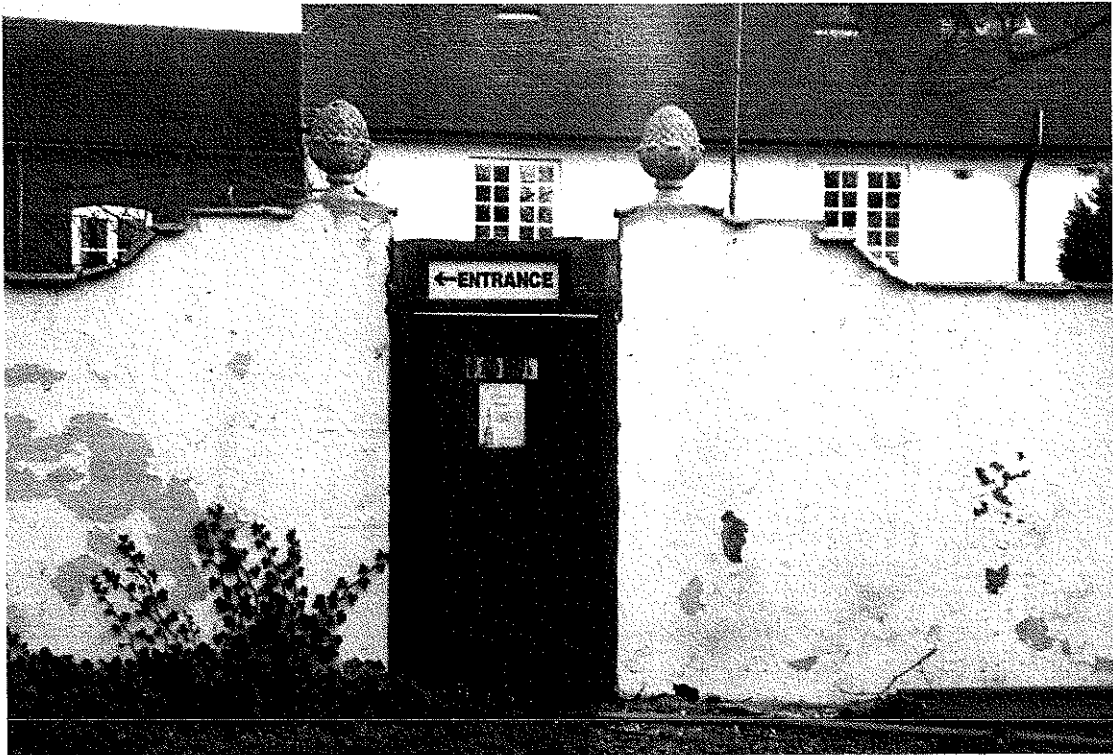
Plate 6

Wall enclosing garden to the west of the house. A short stretch on the northeast side is attached to and contemporary with the present kitchen wing. The remainder dates from the late 20<sup>th</sup> century and is constructed of breezeblocks, rendered and painted. In the northwest side is a gate, the wall being ramped up on either side and surmounted by a pair of pineapple finials, probably reproductions, though as they are painted it is difficult to tell.
