## Dunbeath Broch: Stemming the Tide of History

Iain Banks

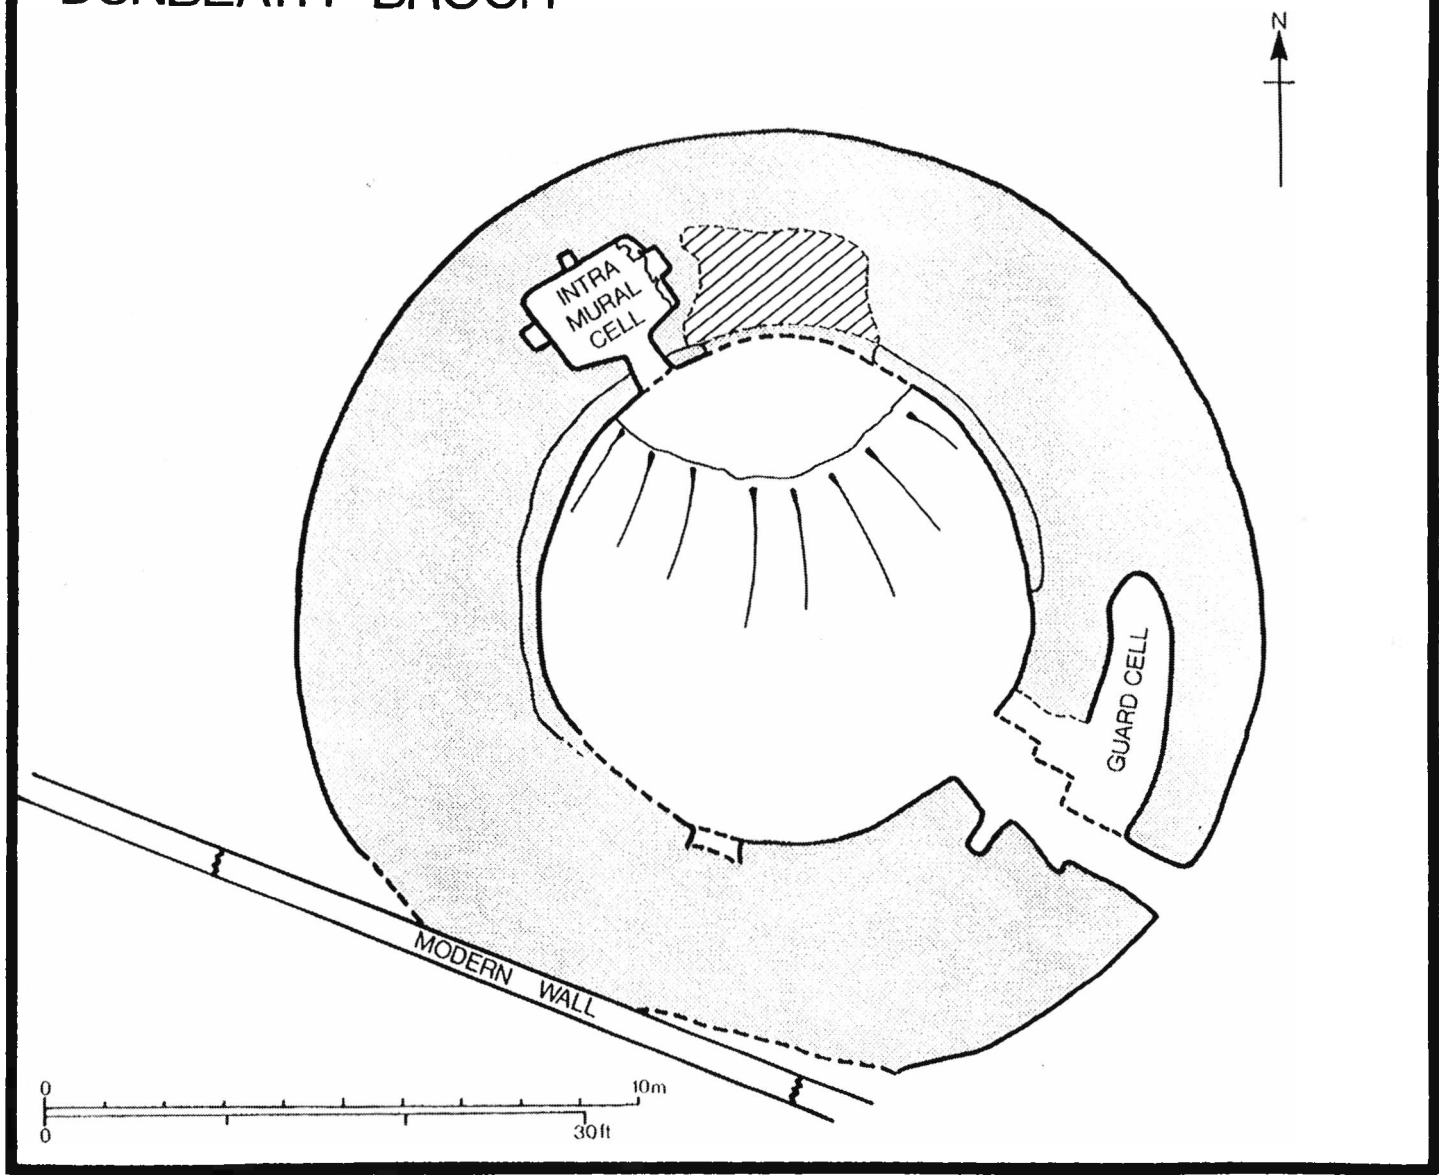
Fig. 1. Plan of Dunbeath broch.

Of the history of the broch, little is known. There is a reference to *Dun Beitt* being besieged in 680 AD, a reference which has been linked to the broch but whose connection remains unproven, but other than this, the site is unrecorded until the nineteenth century. The monument was opened and excavated by the landowner, WS Thompson Sinclair the younger, in 1866. Although brief details of the results of the excavation were passed on to Joseph Anderson, no proper record of the excavation was made. Indeed, the excavation only came to a wider audience's attention in 1890 when Anderson's paper on excavations at a series of Caithness brochs was published in *Archaeologia Scotica*. Accordingly, no record survives of the extent of the excavation or the location of any trenches, and Anderson's account relied entirely upon a letter written to him by Thompson Sinclair. The result of the excavation was to leave the site opened to the elements, with the structure of the broch visible after centuries of being a green mound. However, while the site could now be seen as a broch (Fig. 1), the evidence of its internal occupation had apparently

The excavation revealed that the broch consisted of a narrow entrance passage, with a 'guard-cell' on the south-east, leading into a circular fosse sloping up to the rear of the broch. Only one internal structure was apparent, a chamber in the back wall opposite the entrance. Beyond this, there were no indications of any further intra-mural features such as a staircase. The chamber is quite unusual, having a corbelled roof rising to nearly 3m in height. The two side walls both have a well-constructed aumbry. The walls also bear the evidence of generations of visitors who have left their names and initials carved in the stone. One of the most evocative of these graffiti is the initials of 'A Poulson', a name which is also recorded in Dunbeath village on the War memorial at the Post Office (T. Pollard, pers. comm.).

The consolidation process involved replacing decayed stones with stone from the estate and re-building in a more sympathetic fashion areas which had clearly been altered in the recent past. The stones used were all local but were appreciably different to the original stones in order to make the interventions plain. Moving clockwise from the entrance (Fig. 1), the work carried out was as follows:

The west side of the entrance was exposed and cleared. Original stonework was reduced almost to ground level, but was complete enough to reconstruct this side of the entrance to a level of about five courses of stonework, preserving the original line. A small niche was discovered towards the back of the entrance, roughly 0.5 by 0.3 m, seemingly a slot or check for the doorway.

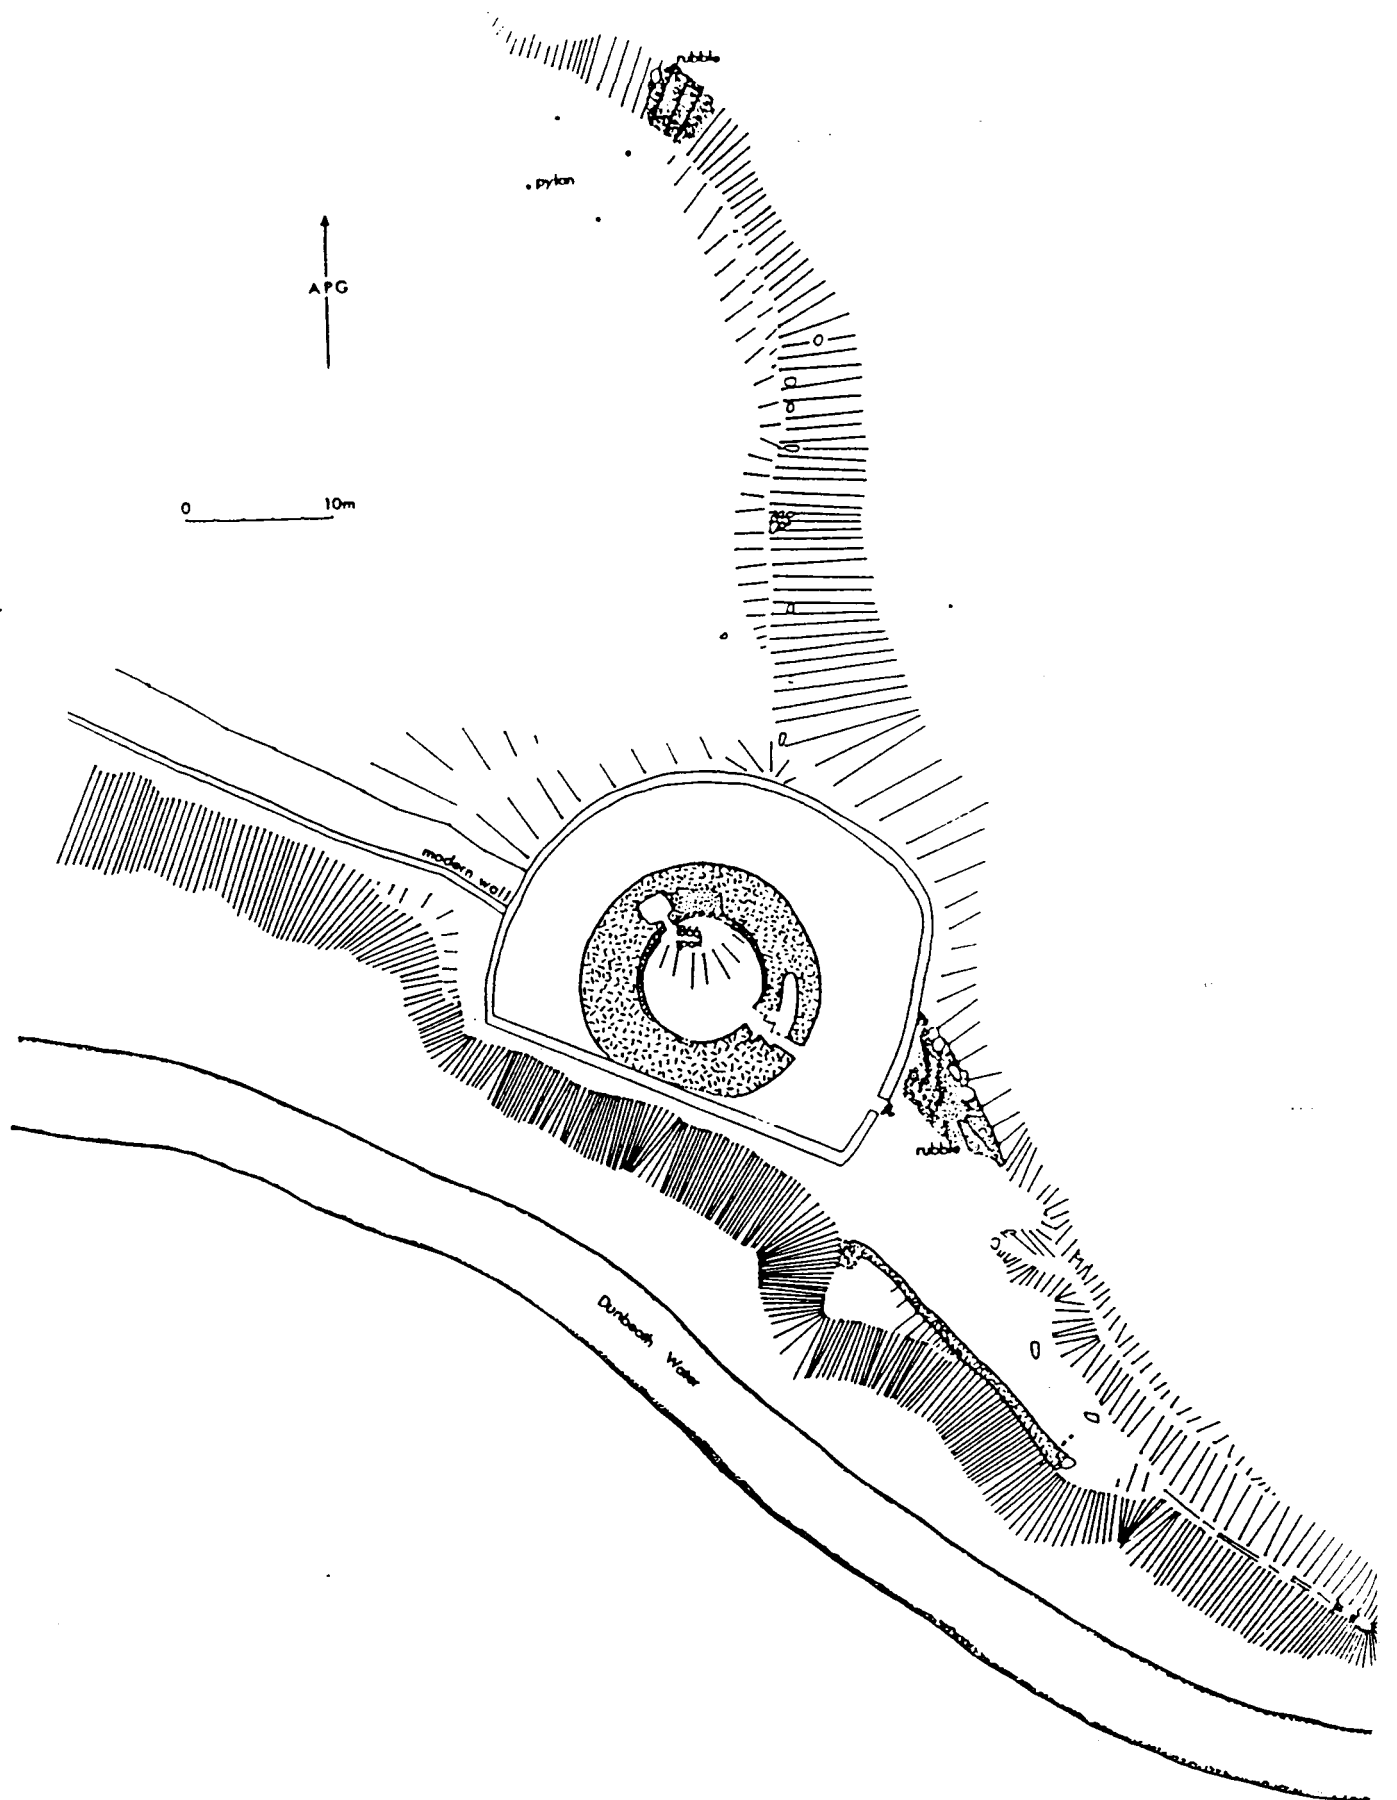
Fig. 2. Plan of Dunbeath broch and locality.

Surrounding the broch is a large stone wall which may well have been constructed at the time of the excavation (Fig. 2). Its main purpose seems to have been to prevent cattle from straying over the precipice on which the broch stands (Swanson 1985a). It presumably utilised much of the rubble from within the broch, although there was still a great deal of rubble inside, particularly against the internal face on the north-north-west beside the chamber entrance. The later wall was also considered to be a possible explanation for the lack of external features which are reasonably common in Caithness and Orkney (Swanson 1985b). The dating of the wall to the excavation is suggested by a nineteenth century photograph of the Ballachly croft in which broch is visible in the background as a mound; the wall had not yet been built and there were no trees present. A couple of now-vanished small mounds also lay near the broch (G. Bethune, pers. comm.). Certainly, from this photograph, the folk etymology of the name *Dunbeath* as the 'fort of the beech trees' (Morrison 1996) would be less easy to accept than it is today with the vigorous tree growth inside the wall.

In addition, the project allowed a brief investigation of the environs of the broch. As noted earlier, it was unusual for the broch to have no external features and examination of the surrounding area indicated that the absence of external features might well be more apparent than real. As the plan indicates (Fig. 2), there are a series of possible earthen enclosures surrounding the broch.
