CONSERVATION RECORD SHEET

PROJECT NAME: HAD160		PROJECT CODE: 171090	
RF NO.: <1>	CONTEXT: 2/004	X-RAY No.: 498	
OBJECT NAME: Pin?		MATERIAL: Copper alloy	
CONSERVATOR: EB

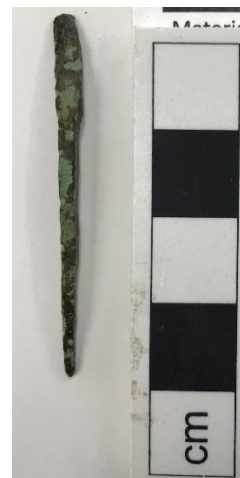
Covered with light amount of soil, evident copper chloride pitting. The object has a square section shaft, one end flattened. Radiography shows a weak core.

The soil was gently removed with brushes and swabs immersed in 50:50 solution of water and ethanol. Corrosion products were removed mechanically.

After cleaning, the piece was dehydrated in 100% solution of ethanol, was stabilised in a solution of 3% BTA in ethanol, followed by 5% Paraloid B44 in acetone.

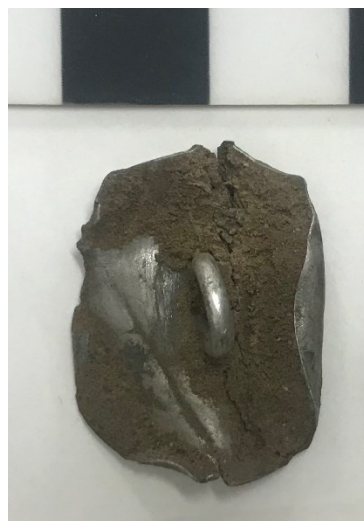
Before

Covered with soil and tarnishing. The object is composed of a silver thin sheet, now irregular in shape, with bent edges. A silver loop is soldered at the back. The sheet is clearly bent and fragile, fine line cracking is particularly evident on the x-ray, as well as IHS stamp within heart or shield. 22 mm x 18 mm x 9 mm height

The soil was gently removed with brushes and swabs immersed in 50:50 solution of water and ethanol. Cleaning revealed most of the IHS stamp at the back; the bent sheet that covers part of it was not flattened. Superficial scratching of the upper side also became visible upon cleaning. After cleaning, the piece was dewatered in 100% solution of ethanol, was stabilised in a solution of 3% BTA in ethanol, followed by 5% Paraloid B44 in acetone.

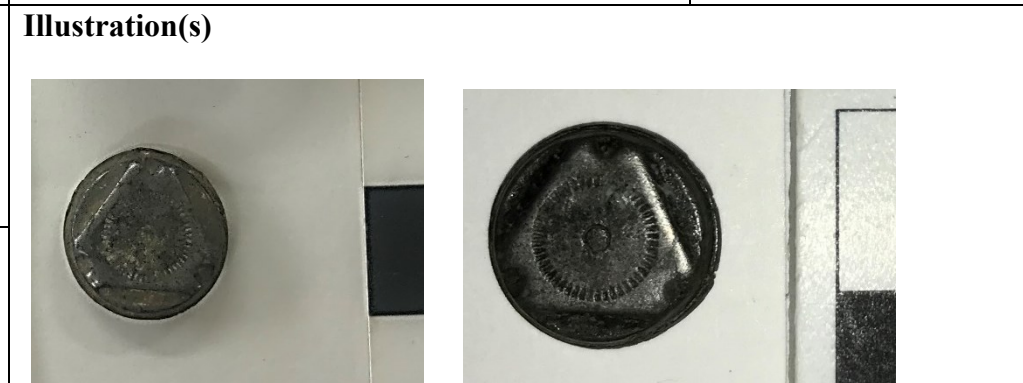
Description / Condition
 Circular cuff link, soil on both sides, top part decorated with a raised triangular shaped decorative motif, with central dot and a circle of scored lines around it. The back shows possible evidence of broken loop, with some denser area visible from the radiographic plate. Diam 12.5 mm, height 2.5 mm

Treatment
 The soil was gently removed with brushes and swabs immersed in 50:50 solution of water and ethanol. Upon cleaning the decorative motif was revealed further. Some dark products/paste became evident at the sides of the triangle; these could be silver corrosion products, but also niello. Analysis could confirm its identification. At the back, the possible broken loop was left for later cleaning to be carried out with chemically, since gentle removal of the corrosion product proved to be unsuccessful. After cleaning, the piece was dewatered in 100% solution of ethanol, was stabilised in a solution of 3% BTA in ethanol, followed by 5% Paraloid B44 in acetone.
Note: on 04/09/18 visual analysis has uncovered that the back loop remains are missing. Probably became detached during specialist research

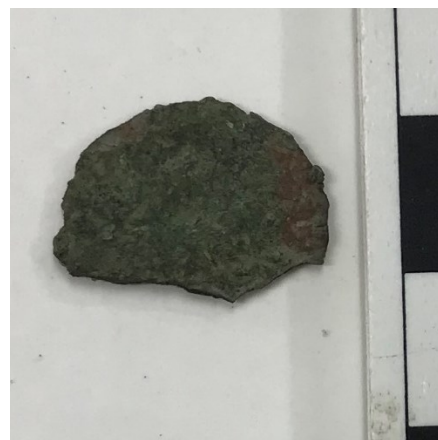
Covered with thin layer of soil and copper corrosion products, mainly dark green carbonates, with small chloride pitting evident on the outer edge. Radiography evidences radiate crown.
Diam. 17.5 mm

The pieces were gently cleaning with swabs in 50:50 acetone and water. The fragments recovered might belong to the coin, however, there they could not be re-adhered, since no clear joint was evident. After cleaning, the other two parts were dehydrated in 100% solution of ethanol, immersed in 3% BTA in ethanol, followed by 5% Paraloid B44 in Acetone.

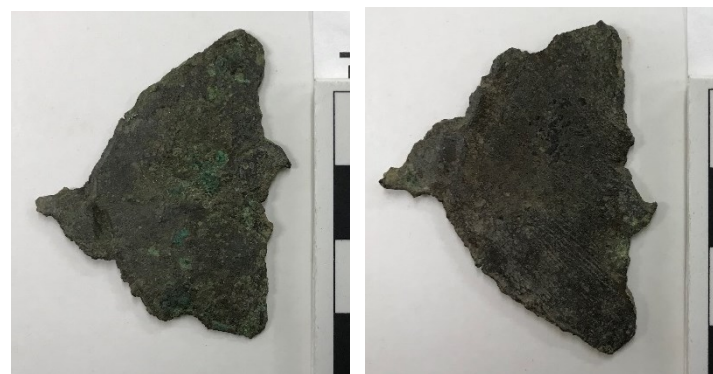
Unidentified object, semi-circular in shape, no clear true edge, covered with soil and dark green copper carbonates. Pitting of copper chloride products visible on both surfaces. Radiography shows a weak metallic core with possible casting voids, as well as thickening of t48 mm x 35 mm

The soil was gently removed with brushes and swabs immersed in 50:50 solution of water and ethanol. Corrosion products were removed mechanically. Upon cleaning, some scratches on one side became visible. These seem to be left-over from production. In addition, the central thicker area was evidenced by cleaning, but no further information could be obtained regarding its function.

After cleaning, the piece was dewatered in 100% solution of ethanol, was stabilised in a solution of 3% BTA in ethanol, followed by 5% Paraloid B44 in acetone.

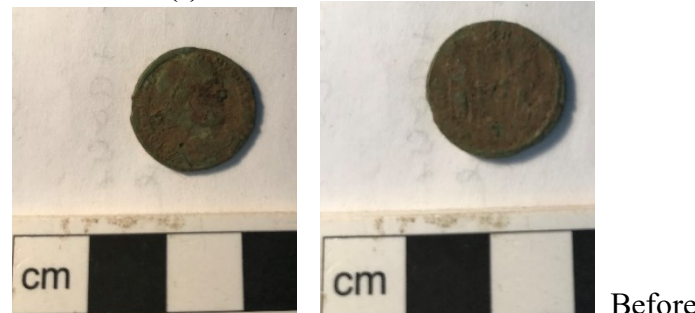
Before

Coin, covered with thick layer of soil and some corrosion products, otherwise in good conditions and quite legible. However, cleaning is recommended for a more detailed interpretation

Radiography: good metal core
