WP 029 D – Digbeth Canal Wall – Enabling Works North Contract Interim Report for Historic Building Recording

Document Number: 1EW04-LMJ-EV-REP-NS08-029017

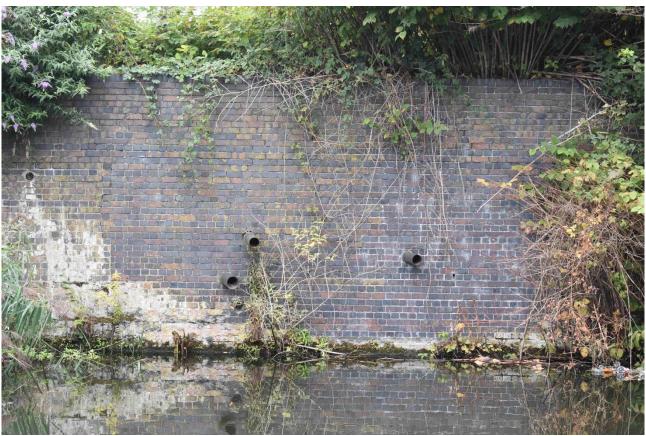
Plate 5: North section of the canal wall (Section A) taken 14 August 2020. Note vertical break towards left edge of image with yellow bricks to south (possibly late 19 th or early 20th-century rebuild) and red/blue bands of brick to north (late 19th century) which was favoured by the LNWR. The upper 10 courses across both areas are from a later phase when the canal wall was raised.

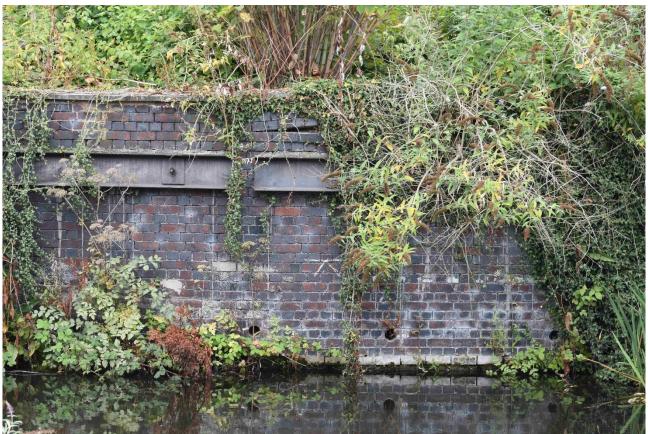
- The brickwork in Section B to the north of the kink or splay (Plate 6) appears the same as the 4.1.6 possibly early 20th-century brickwork in the upper part of the section immediately to the south. The steel anchor beam continues across this area.

Plate 6: Section B (central part of the canal wall). Note extent of vegetation cover and bulging of brickwork towards top of the canal wall (taken 14 August 2020)

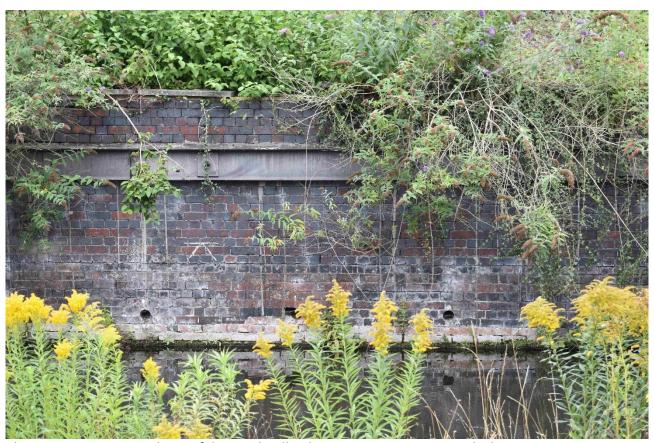
Plate 7: Section B (central part of the canal wall) taken 14 August 2020. Note the lower 10 courses (probably mid to late 19th century) older than courses above.

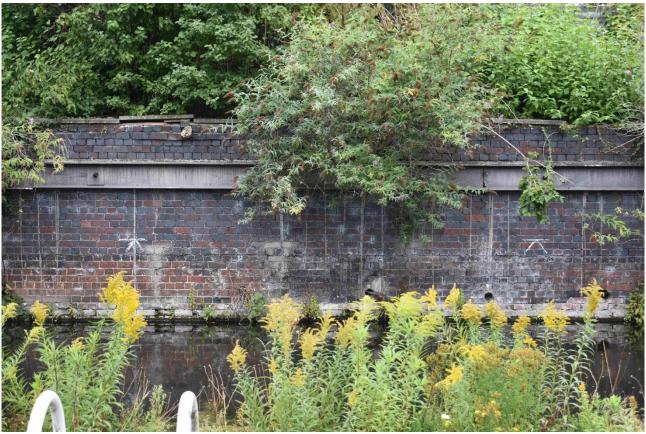
Plate 8: Section B (central part of the canal wall) taken 14 August 2020. Note the lower 10 courses older than courses above. Also note vegetation and poor condition of the canal wall

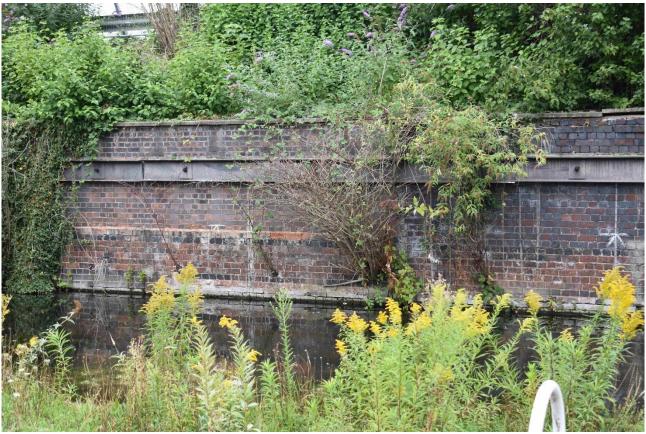
Plate 9: Section B (central part of the canal wall) taken 14 August 2020. The upper part of the brickwork to the left side of the photo is probably of late 20th-century date. Note vegetation and poor condition of the canal wall.

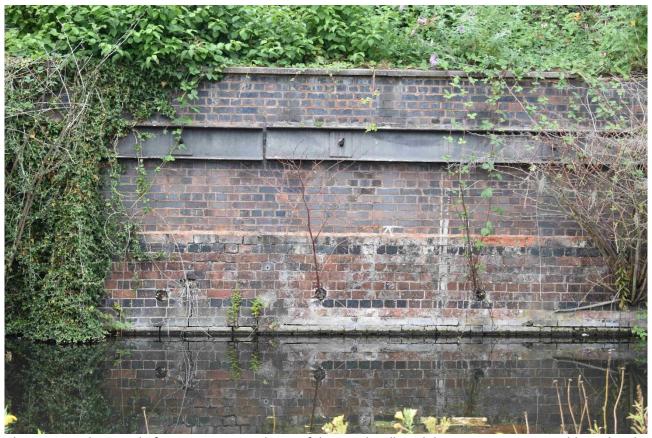
Plate 10: Southern end of Section B (central part of the canal wall) with lower 10 courses possibly mid 19th century in date and upper part of wall (c.19 courses) dating to a much later rebuild (late 20th or 21st century). Taken 14 August 2020

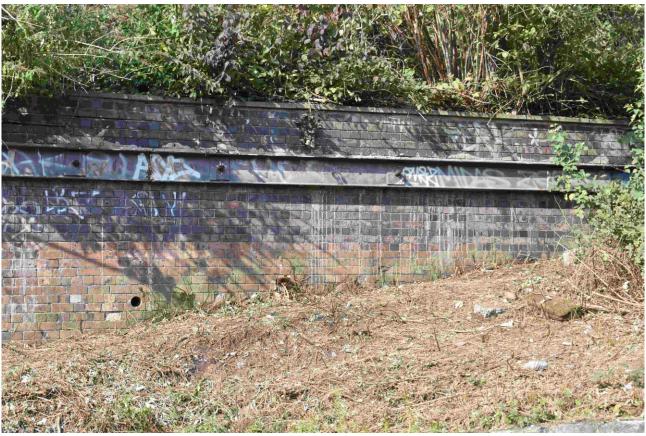
Plate 18: Northern part of Section C after vegetation removal (taken 21 September 2020). The lower part of the brickwork here may be mid-late 19th century while the darker upper part may be late 19th or early 20th century.

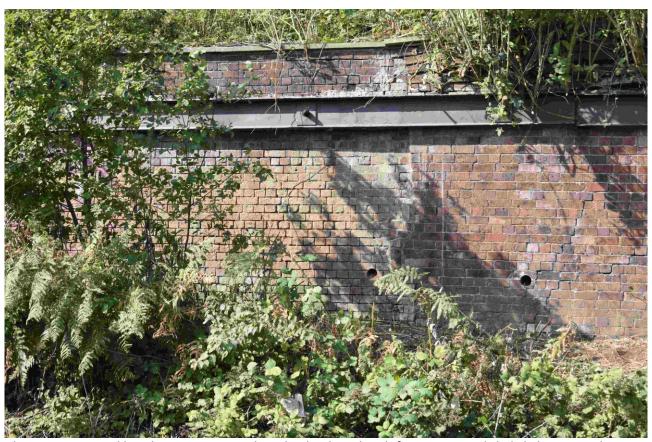
Plate 19: Structural break in Section C with earlier brickwork to left (c.1830s) and slightly later to right (taken 21 September 2020)

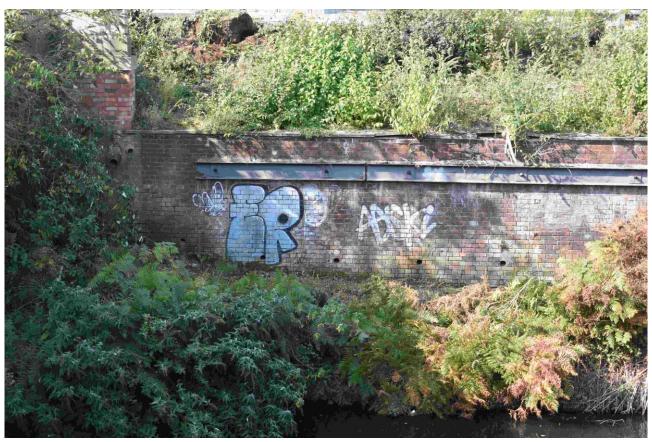
Plate 21: Southern end of Section C, adjacent to 1838 railway bridge, after vegetation removal (taken 21 September 2020). This brickwork is probably largely contemporary with the 1838 bridge.

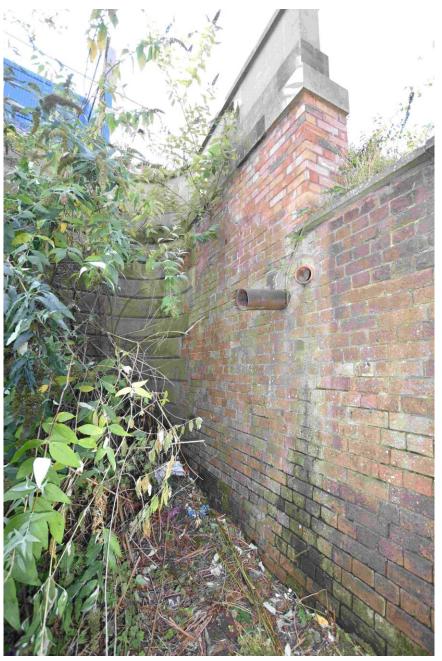
Plate 22: Southern end of wall, adjacent to 1838 railway bridge and probably largely contemporary with it (taken 21 September 2020)

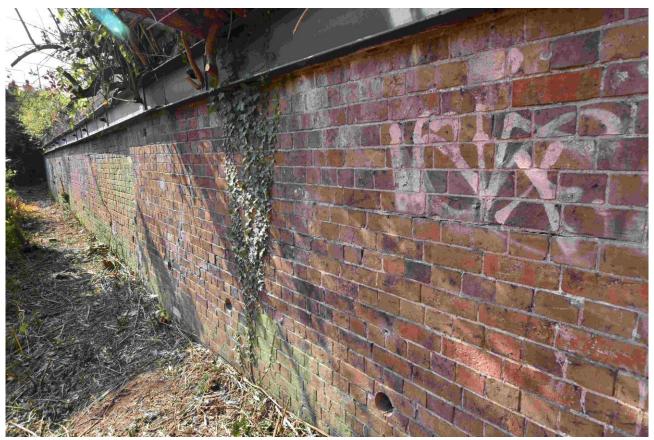
Plate 23: Section C looking southwards (taken 21 September 2020). The brickwork in the foreground is probably mid 19th-century in date and slightly later than the 1838 brickwork in the distance.

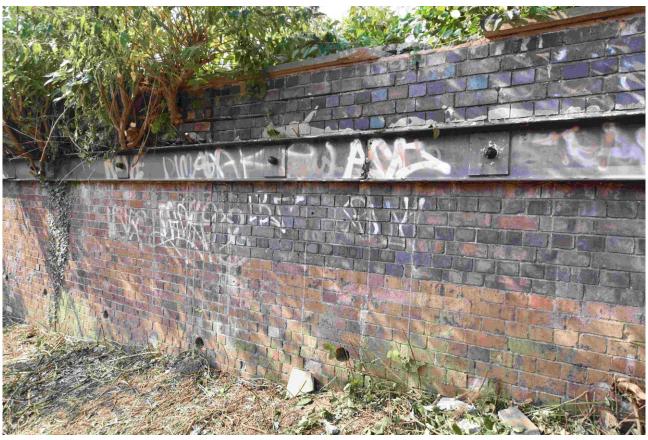
Plate 24: Northern part of Section C with later area of dark blue brick (taken 21 September 2020)

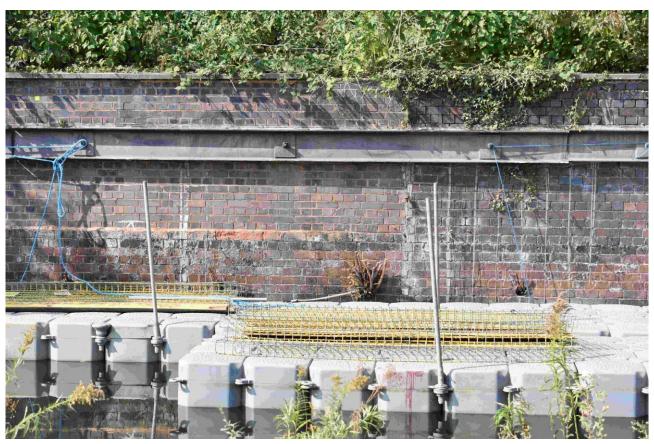
Plate 25: Structural break in Section B after vegetation removal (taken 21 September 2020)

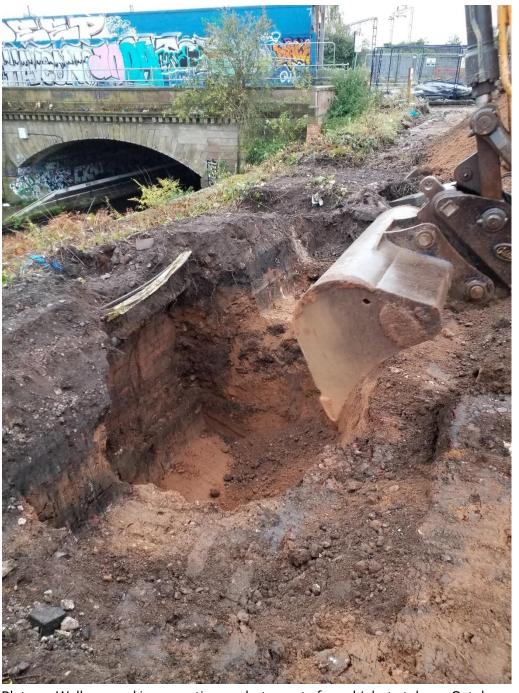
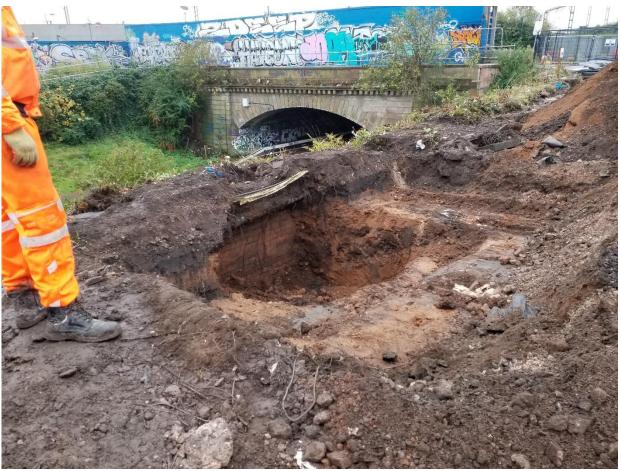
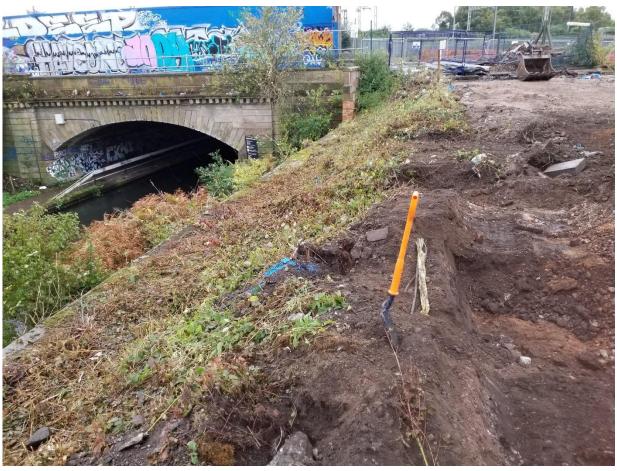
- 4.1.10 Buried wall to west of canal wall: As referred to above contractors started ground reduction works to the west of the main canal wall and they exposed part of a buried wall. Due to concerns over the stability of this area it was necessary to back fill the excavation before archaeologists had the opportunity to visit and record the structure. Some outline photographs were taken by the contractors and provided to the archaeologists (Plates 33-35) but it is not possible to form any clear understanding of the wall from these. The wall appears to be c.3m to the west of the main canal wall and orientated parallel with it (N-S). At least fourteen brick courses were exposed from the top of the wall.

Plate 33: Wall exposed in excavation works to west of canal (photo taken 2 October 2020 by LM)
