1EW03 - Enabling Works Central

Historic Building Recording

Shepherd's Furze Farmhouse,
Steeple Claydon,
Buckinghamshire

Document Number: 1EW03-FUS_COP-EV-REP-CS06_CL09-000014

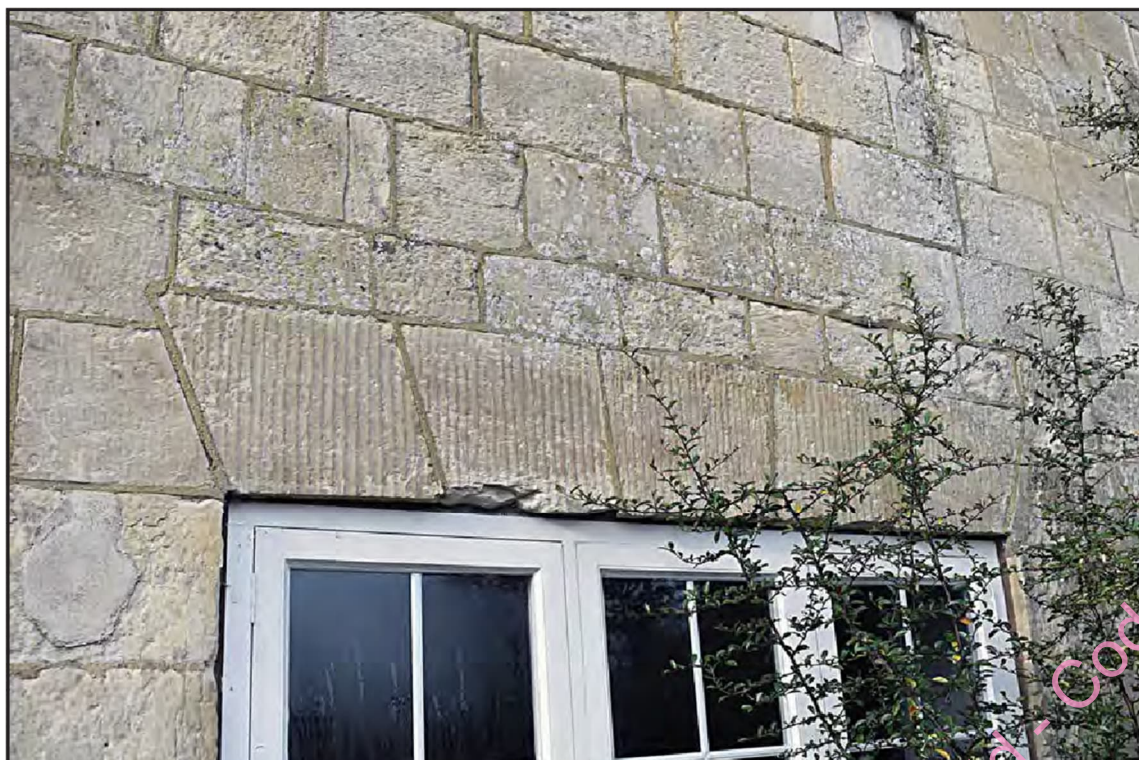
Photo A- 6: Detail of window head to the front elevation

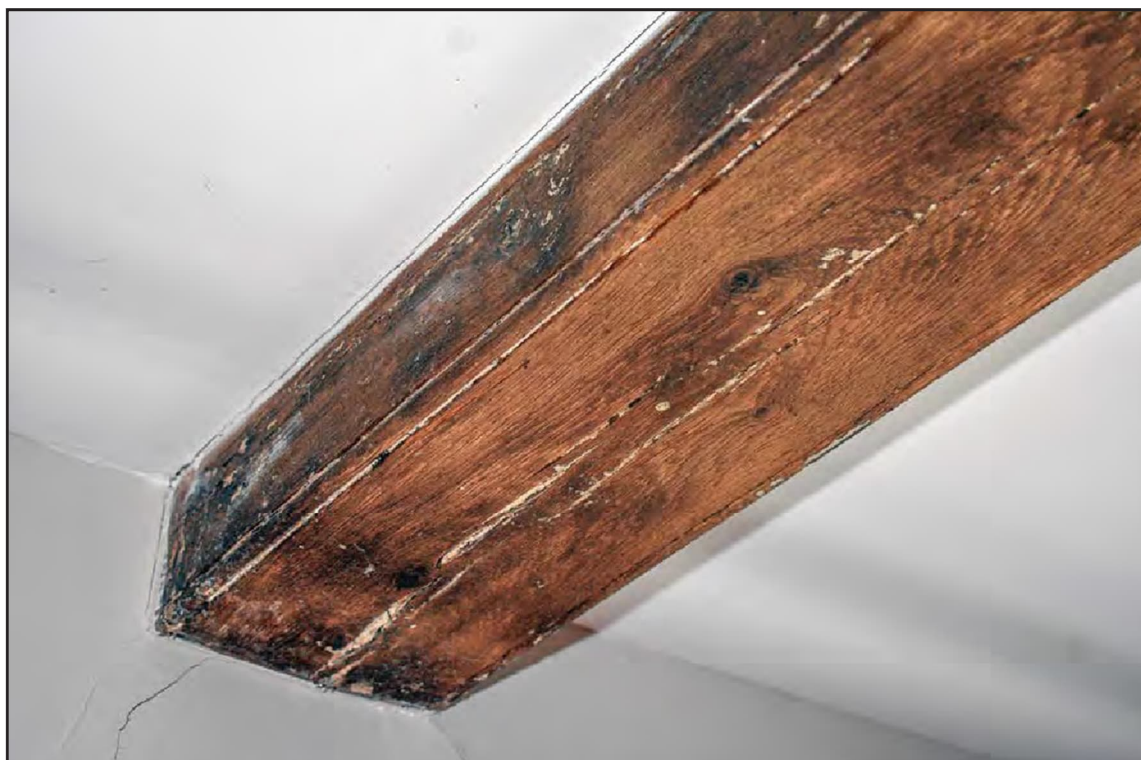
Photo A- 19: Ceiling beam in G1, north-west

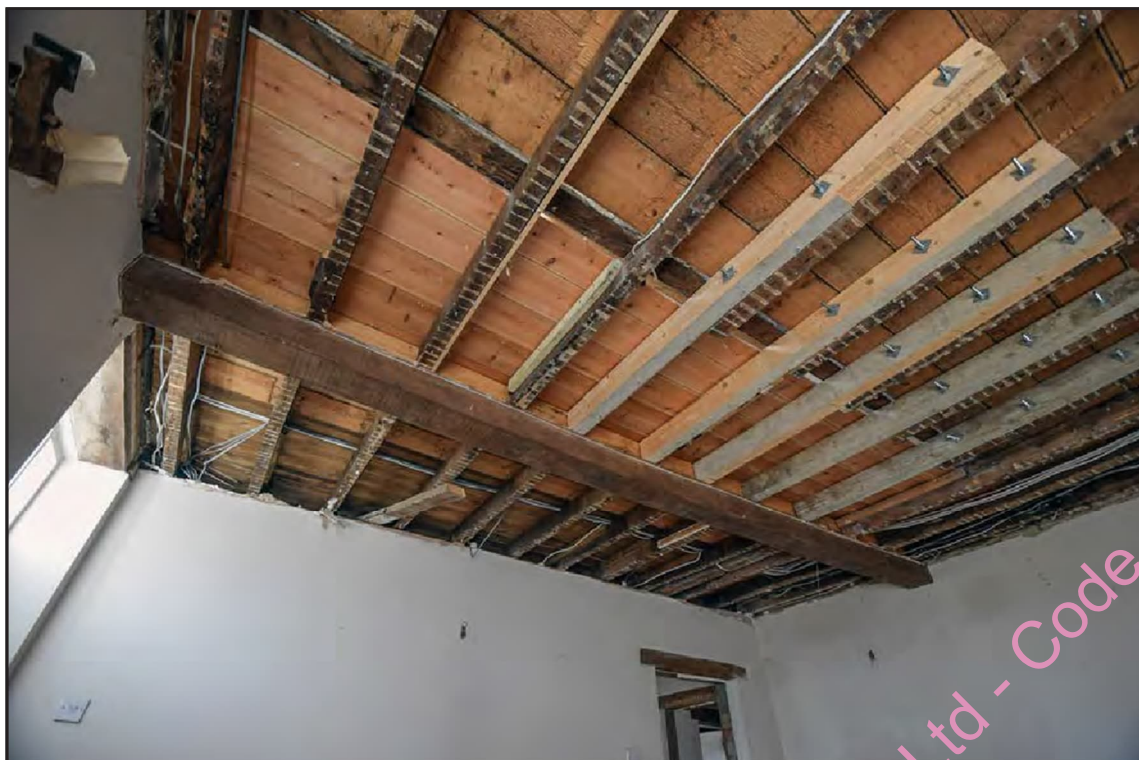
Photo A- 22 Ceiling structure G1 during soft strip showing stair void

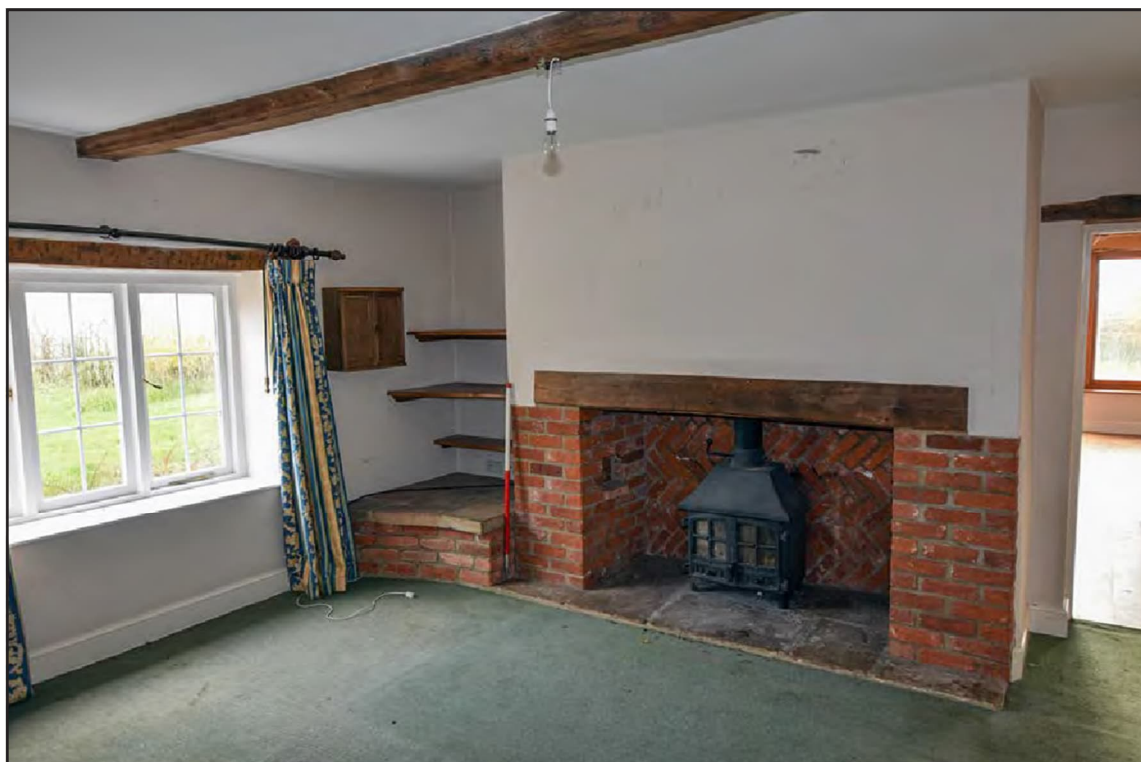
- 5.3.16 In the south wall there is a chimney breast with a large opening but the brickwork is entirely modern. It has been rebuilt with modern red brick and cement and the interior wall is modern brick in a herringbone pattern. The flagstones that the modern stove sits on may be original but the timber lintel is not convincingly old and may also be a replacement. On the east side of the chimney breast is a modern, red brick and cement plinth for a TV unit, over which is modern timber shelving. The modern skirting board appears to be contemporary with the door joinery.

Photo A- 23: Front room G2 fireplace in south wall

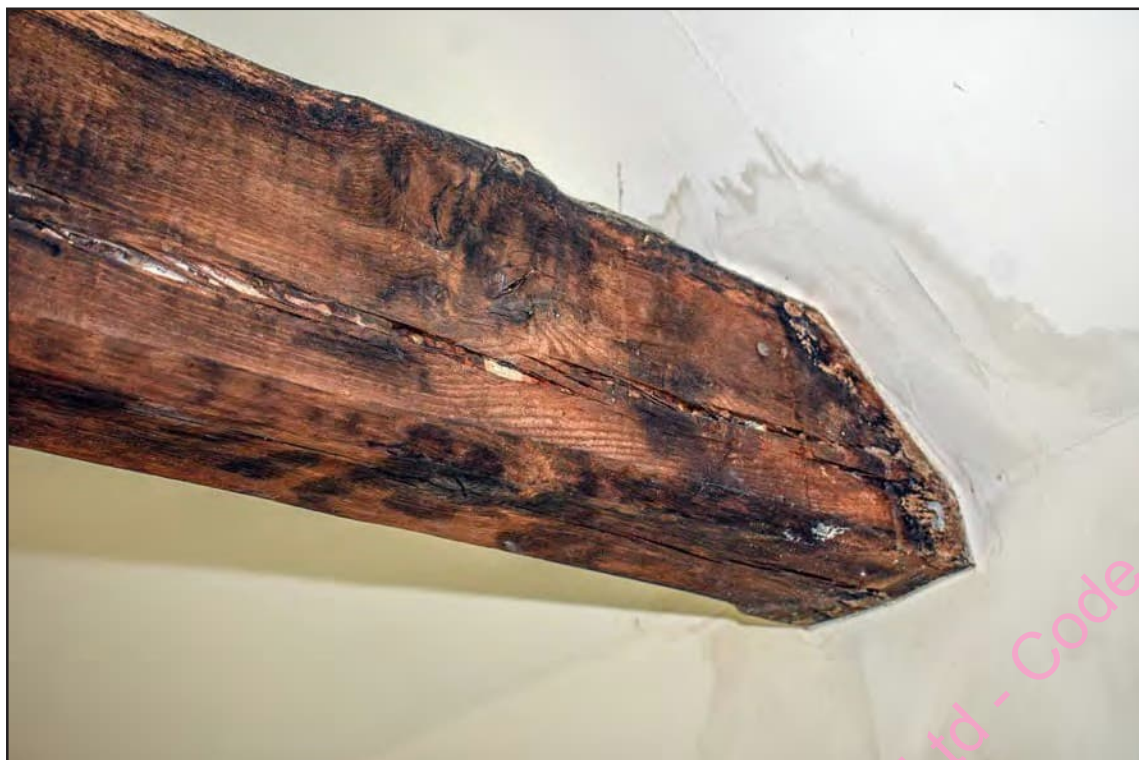
Photo A- 30: Detail of ceiling beam room G4

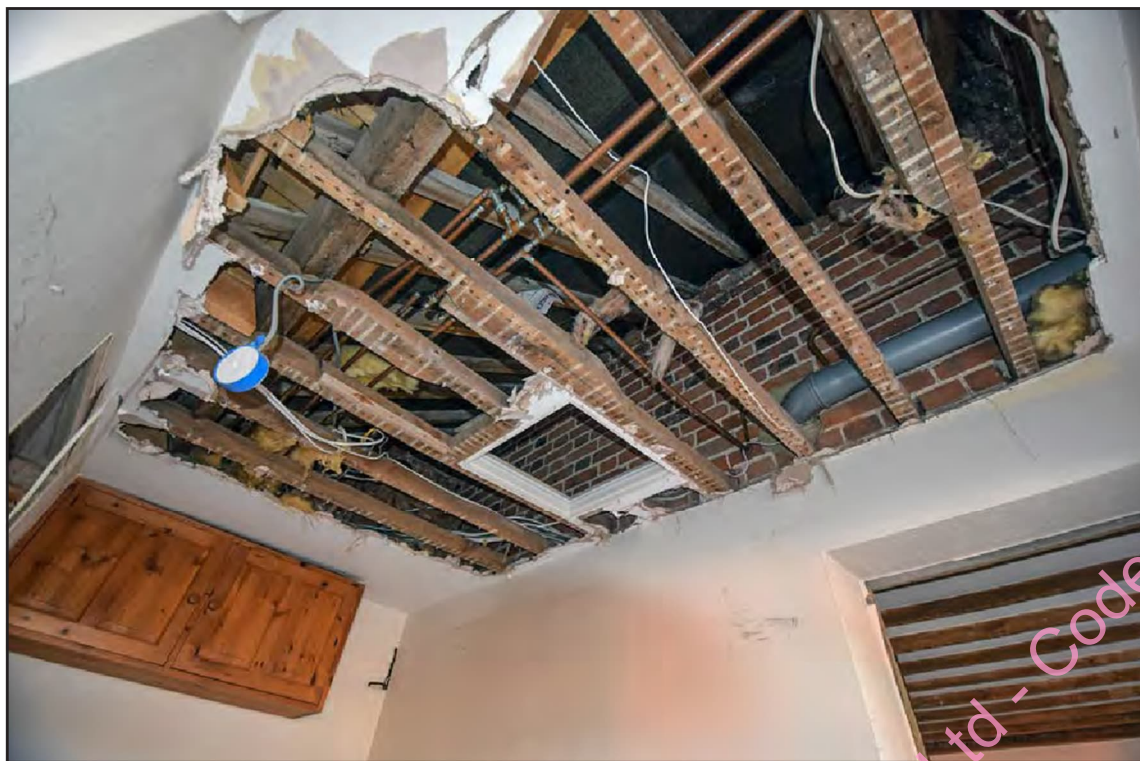
Photo A- 36: Lobby G6 during soft strip showing former exterior rear elevation

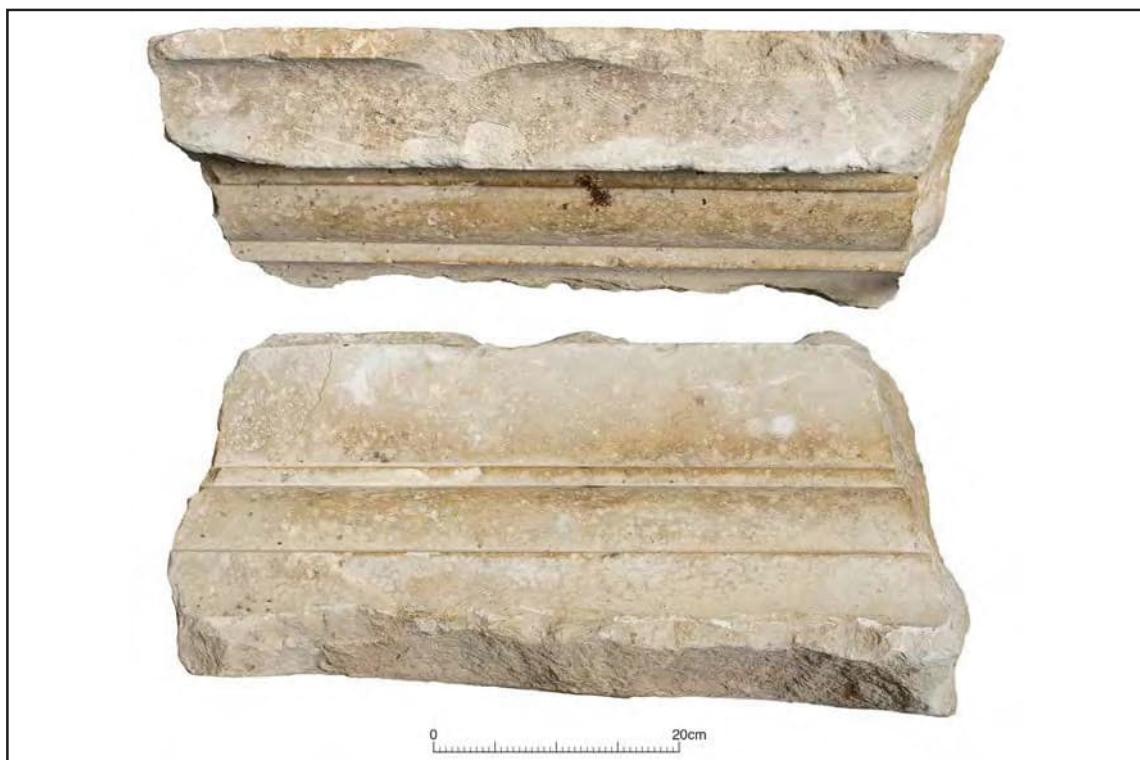
Photo B 3: Stone 001

| Stone No. | Dimensions | Description |
|---|---|---|
| 001 | Length: 620mm Width: 180mm Height: 235mm | Part of an architectural element, perhaps a decorative cornice or architrave. It has six faces with one moulded face along the length. It is a stepped, ovolo moulding typically used in classical architectural detailing. The other sides are broken and have traces of chisel marks suggesting it was worked and sized before being reused at Shepherd's Furze. |

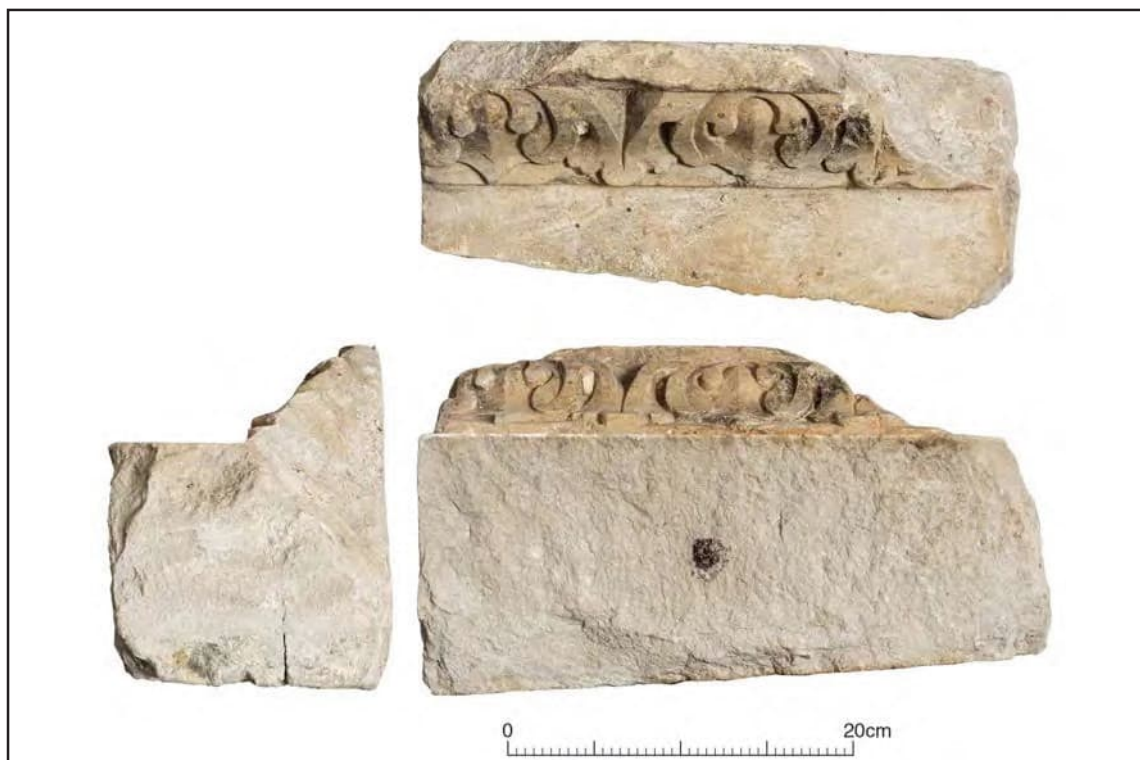
Photo B 4: Stone 002

| Stone No. | Dimensions | Description |
|---|---|---|
| 002 | Length: 320mm Width: 190mm Height: 110mm | Part of an architectural element, perhaps a decorative cornice. It has six faces with one moulded face. The moulded face features a band of finely carved acanthus leaves, a typical motif in classical architectural detailing. The other sides are broken and have traces of chisel marks and small grooves, suggesting it was worked and sized before being reused at Shepherd's Furze. |

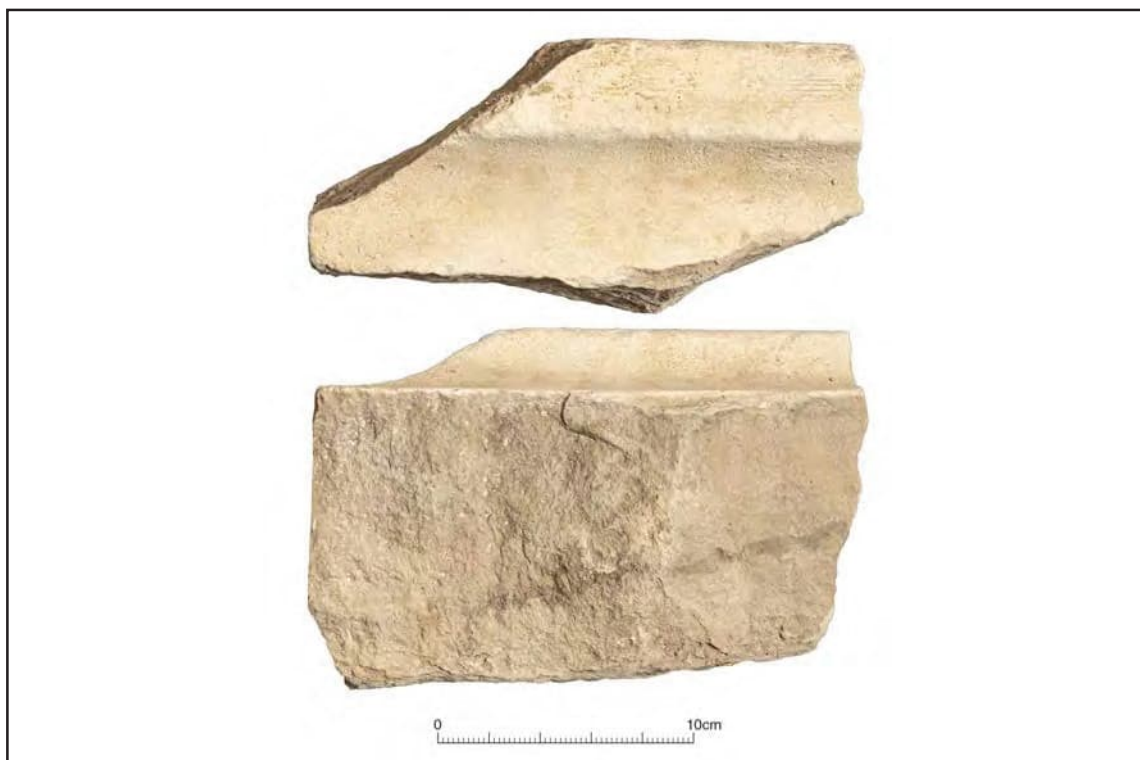
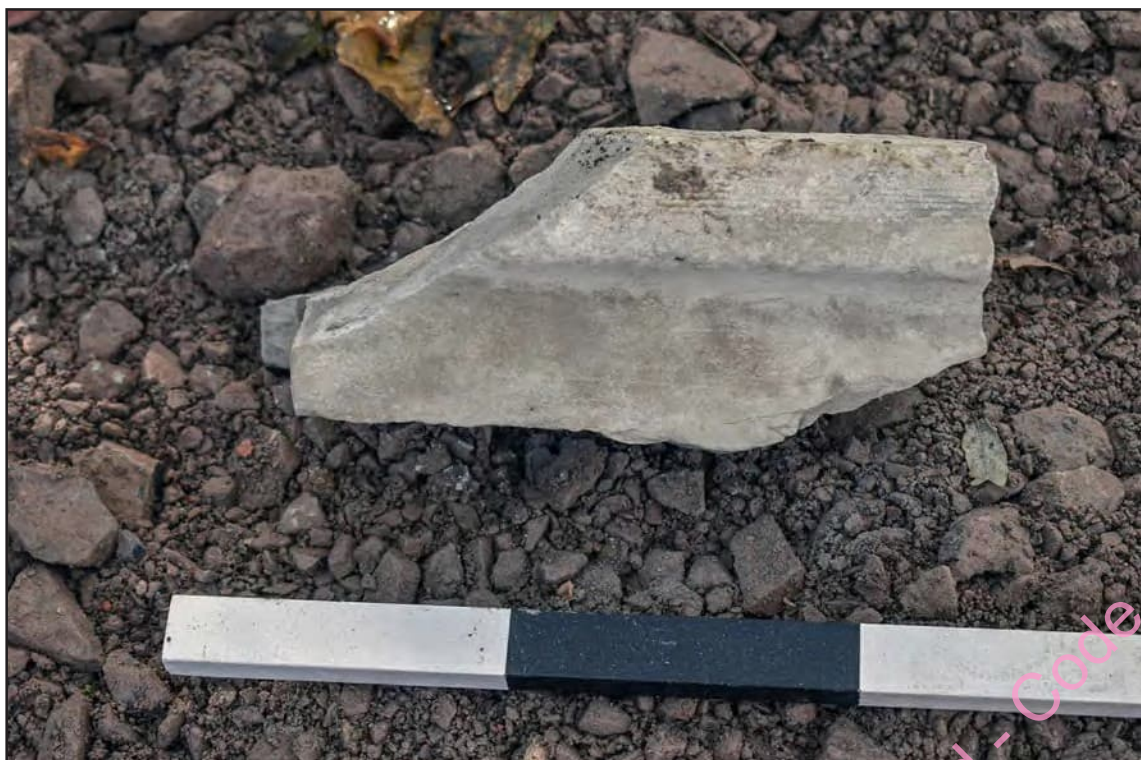
Photo B5: Stone 003

| Stone No. | Dimensions | Description |
|---|---|---|
| 003 | Length: 200mm Width: 120mm Height: 95mm | Part of an architectural element, perhaps a decorative cornice or architrave. It has six faces with one partially moulded face. It is in poor condition and the moulding has been damaged but can be seen to be simple carved stepping. The un-moulded planes are broken with chisel marks and some narrow grooves, suggesting it was worked for reuse at Shepherd's Furze. |

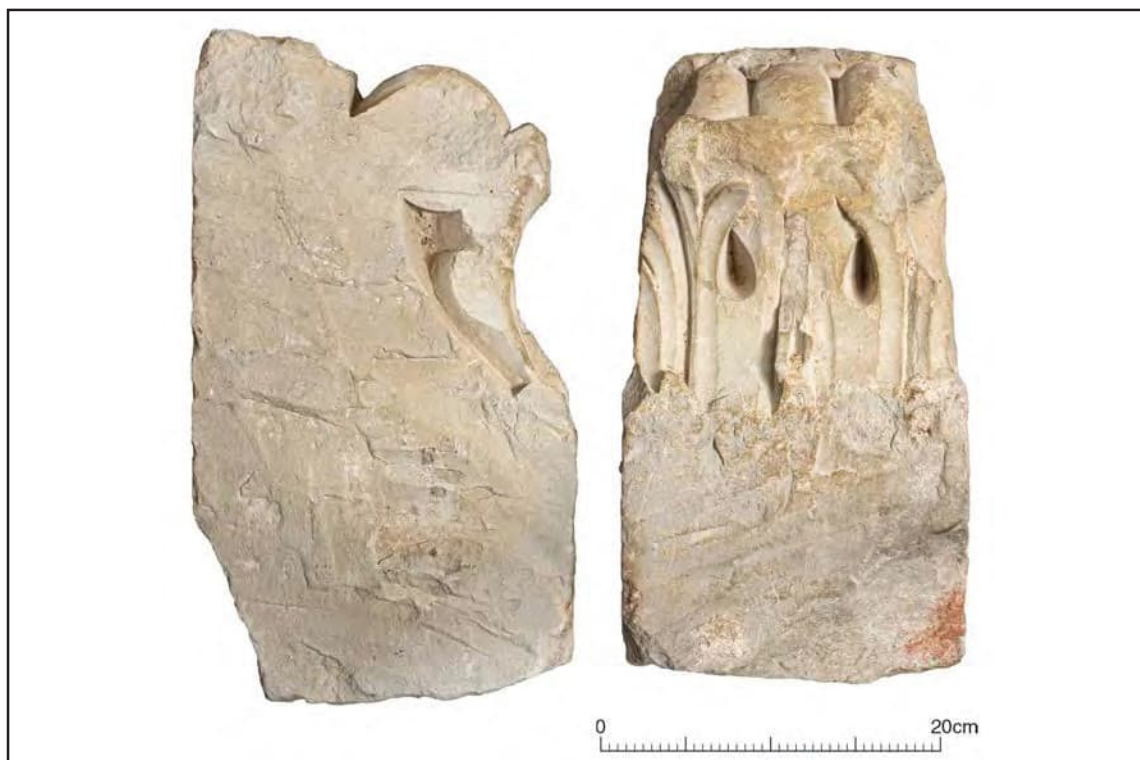
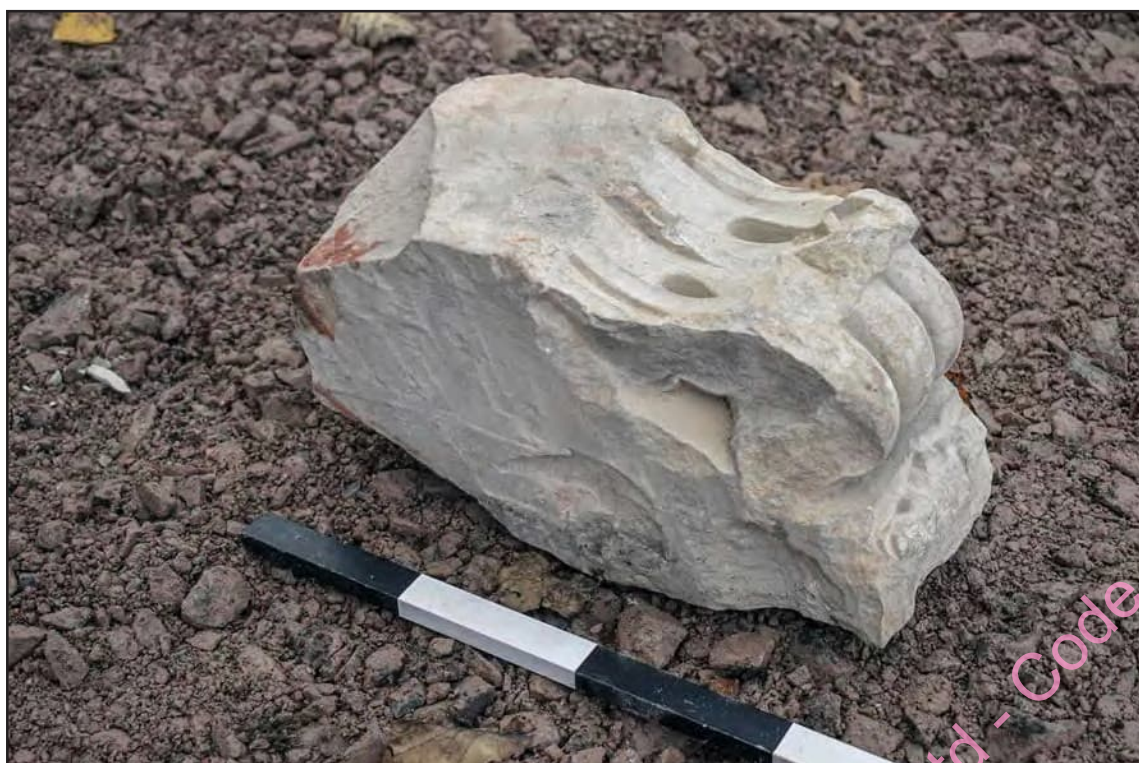
Photo B 6: Stone 004

| Stone No. | Dimensions | Description |
|---|---|---|
| 004 | Length: 180mm Width: 180mm Height: 300mm | Part of architectural detailing with six faces, one of which is moulded. It appears to be a modillion (a projecting bracket under the corona of a cornice) or part of the capital of a pilaster. It features decorative volutes over (broken) acanthus leaves, which are typical elements of the Corinthian order of classical architecture. The other faces are broken but there are traces of chisel marks and grooves on the face to the rear of the moulding, suggesting that it was worked for reuse at Shepherd's Furze. |

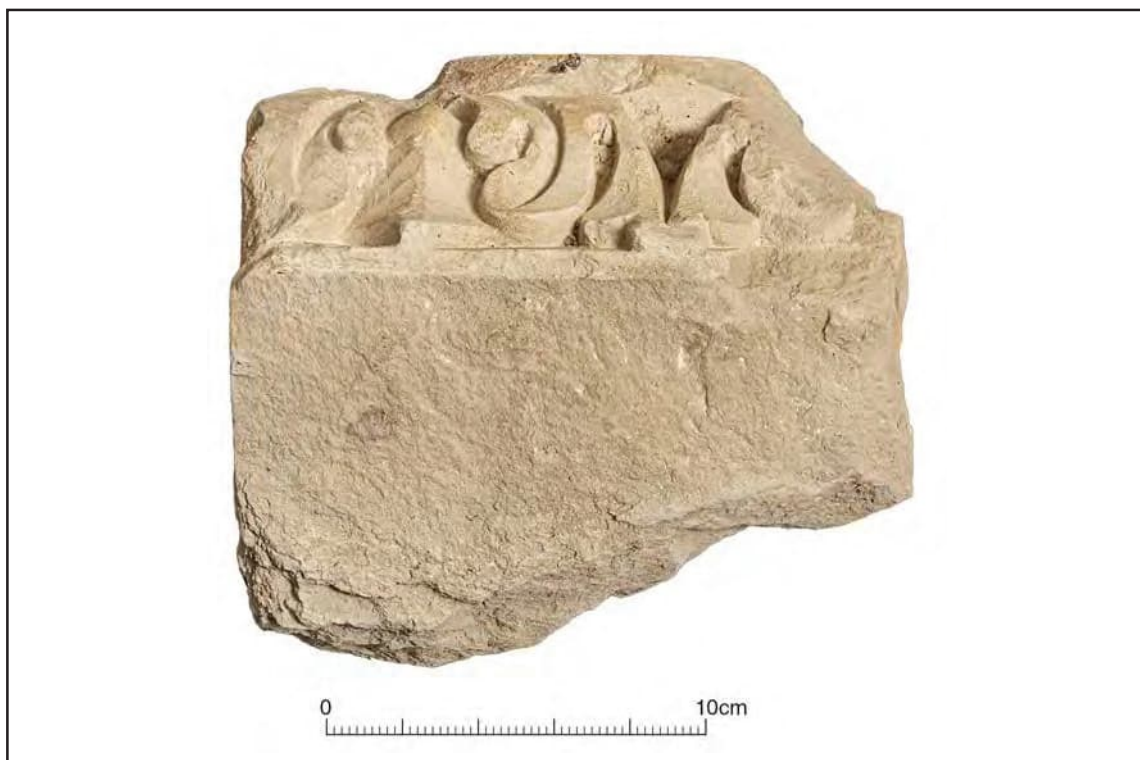
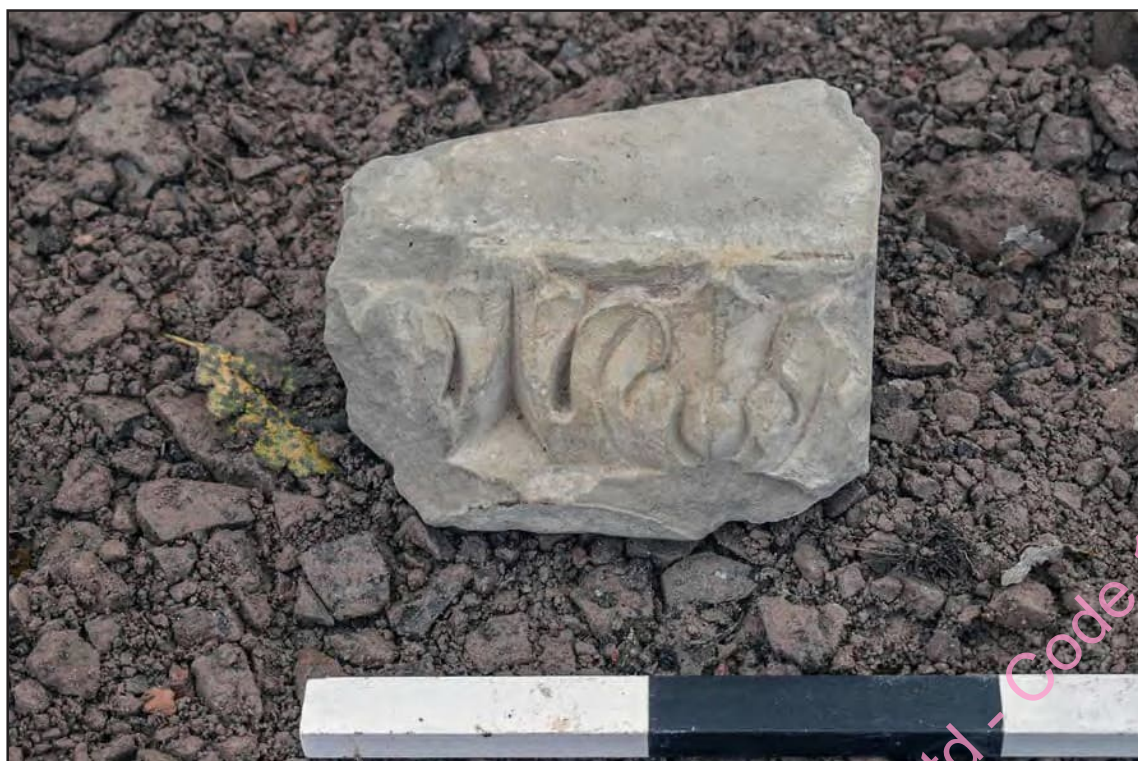
Photo B 7: Stone 005

| Stone No. | Dimensions | Description |
|---|---|---|
| 005 | Length: 170mm Width: 80mm Height: 160mm | Part of an architectural element, perhaps a decorative cornice. It has six faces with one moulded face. The moulded face features a band of finely carved acanthus leaves, a typical motif in classical architectural detailing. The other sides are broken and have traces of chisel marks and small grooves, suggesting it was worked and sized before being reused at Shepherd's Furze. |

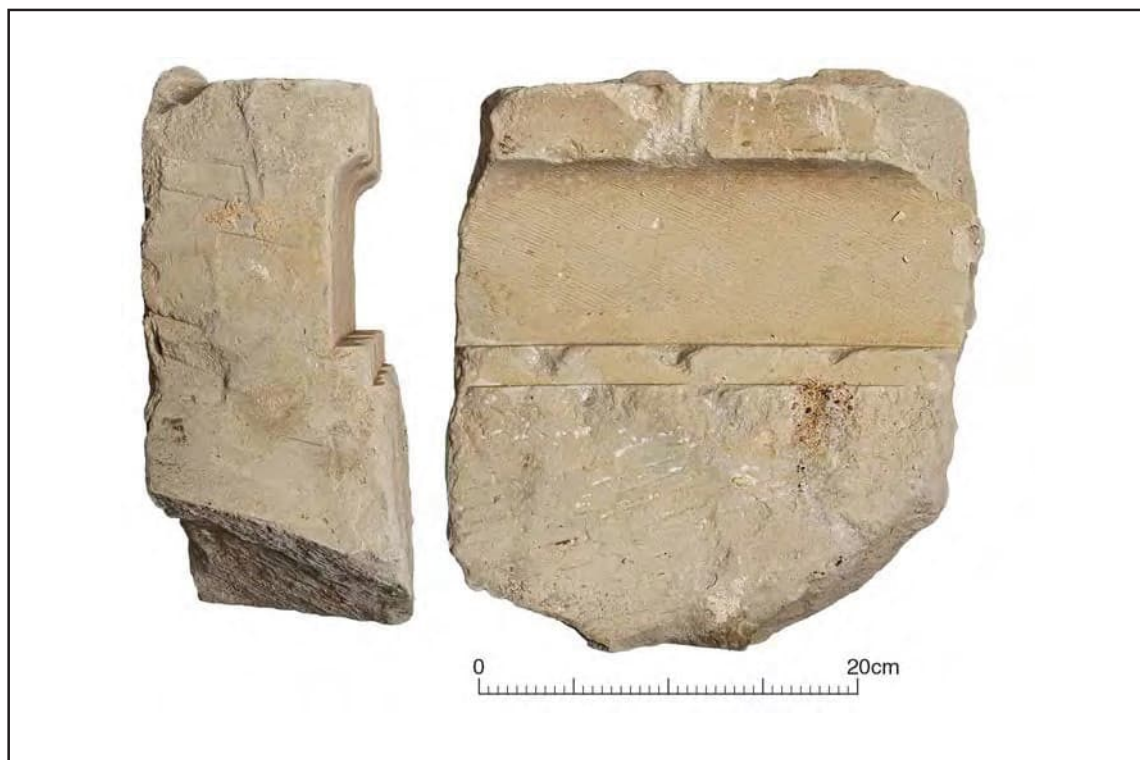
Photo B 8: Stone 006

| Stone No. | Dimensions | Description |
|---|---|---|
| 006 | Length: 250mm Width: 115mm Height: 280mm | Part of an architectural element, it has six faces with two decorative faces. The larger moulded face features clean, plain fillet moulding with perpendicular corners. Under the fillet is a smooth, flat plane and beneath this, stepping out on the same side, is a rougher plane with clear, consistent chisel marks. The other decorative face is smooth and polished. This may have been part of a frieze or architrave, elements which tend to have cleaner lines as part of a classical entablature. The other sides are broken with traces of chisel marks and small grooves, suggesting it was worked and sized before being reused at Shepherd's Furze. |

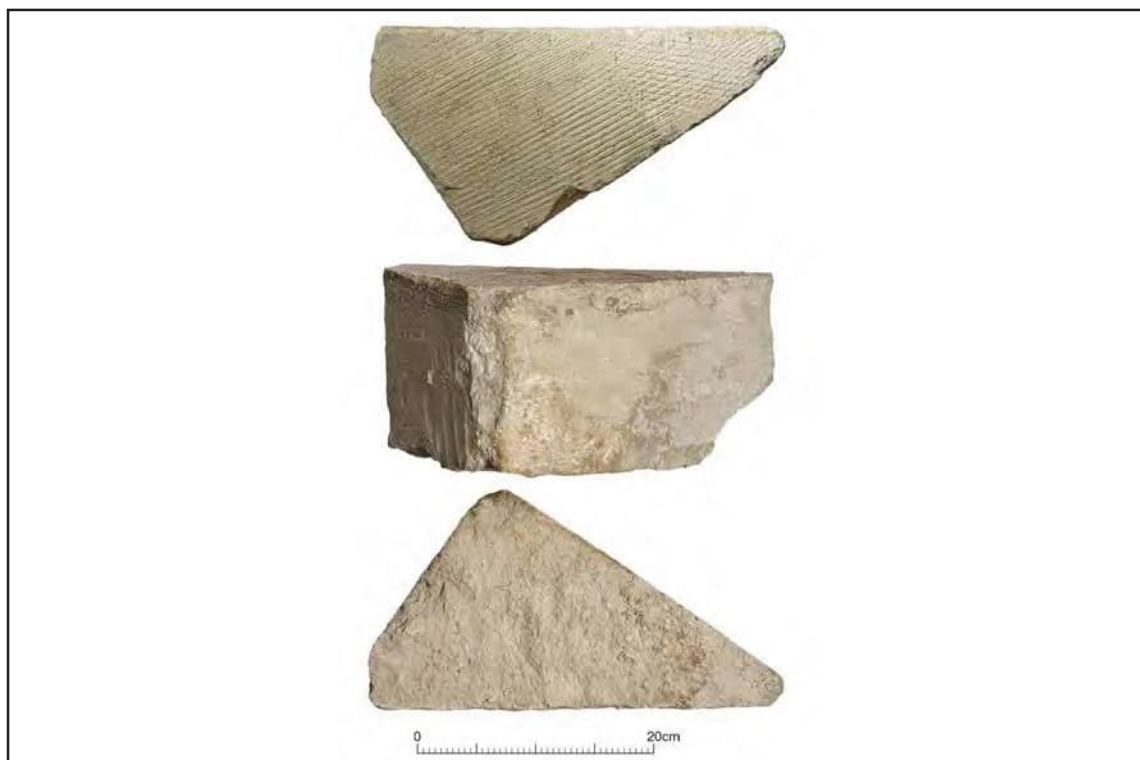
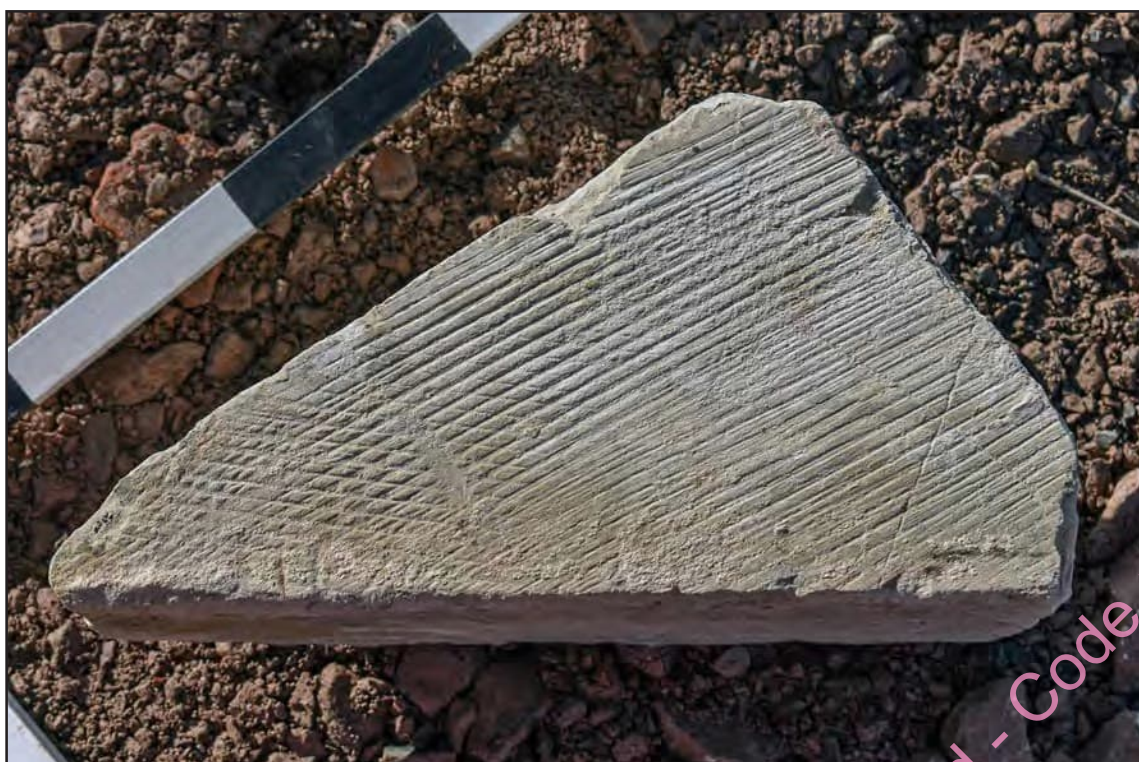
Photo B 10: Stone 008

| 008 | Length: 300mm Width: 100mm Height: 160mm | Part of an architectural element with five sides and is triangular in shape. One of its larger sides has cross-hatched grooves across its surface as if it was keyed for render with a claw chisel. Its sides are otherwise smooth and polished with some damage to the corners. It is not possible to identify what architectural element this originated from. |

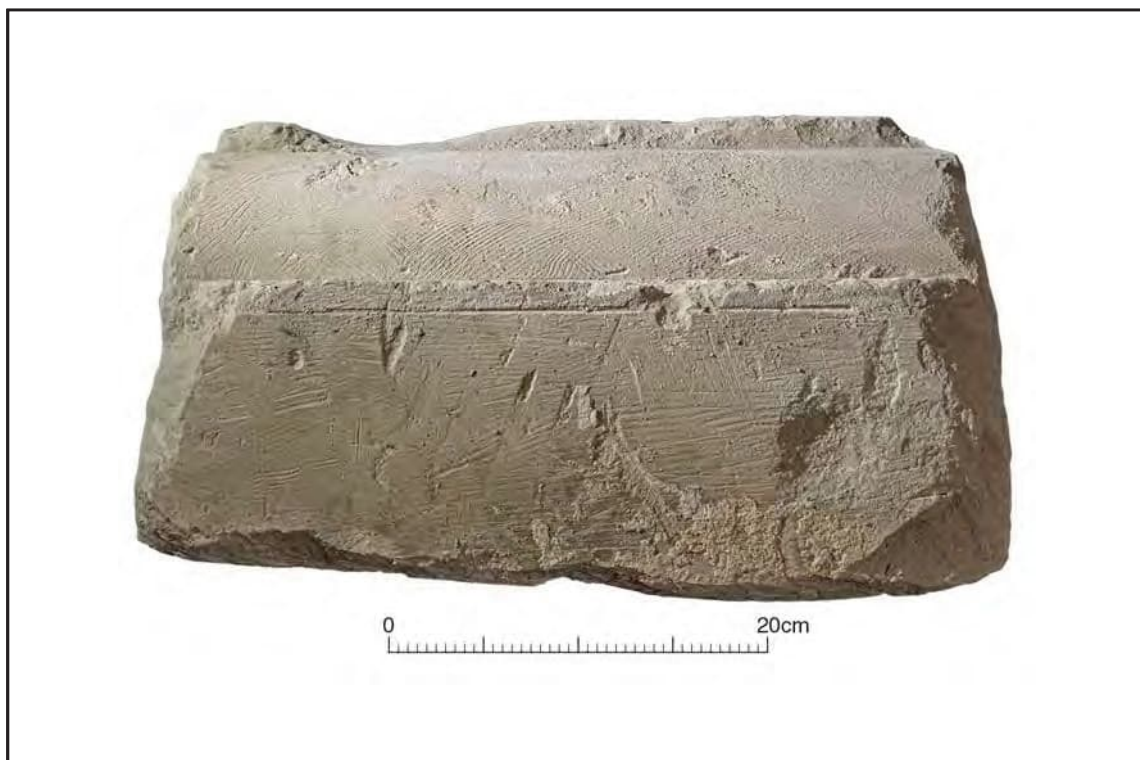
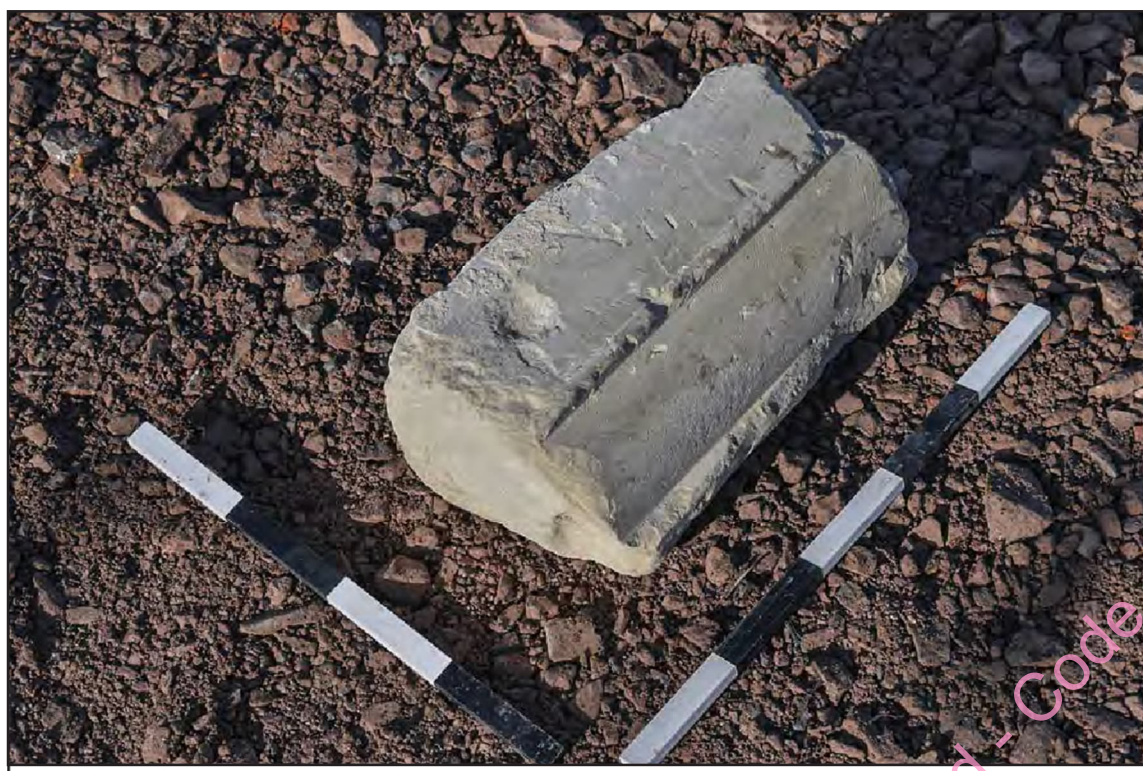
Photo B 11: Stone 009

| 009 | Length: 380mm Width: 145mm Height: 230mm | Part of an architectural element that has six faces, two of which are decorated. It is a stepped, ovolo moulding typically used in classical architectural detailing and probably formed part of a cornice or architrave. The other sides are broken and have traces of chisel marks suggesting it was worked and sized before being reused at Shepherd's Furze. |

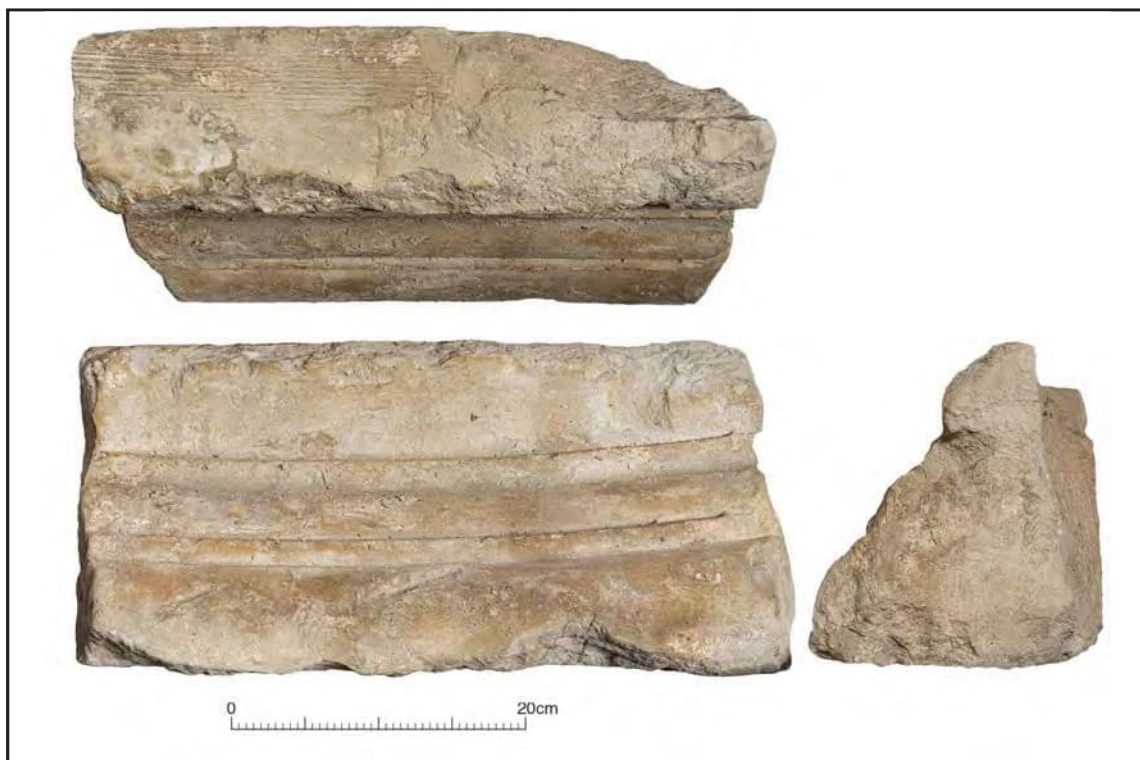
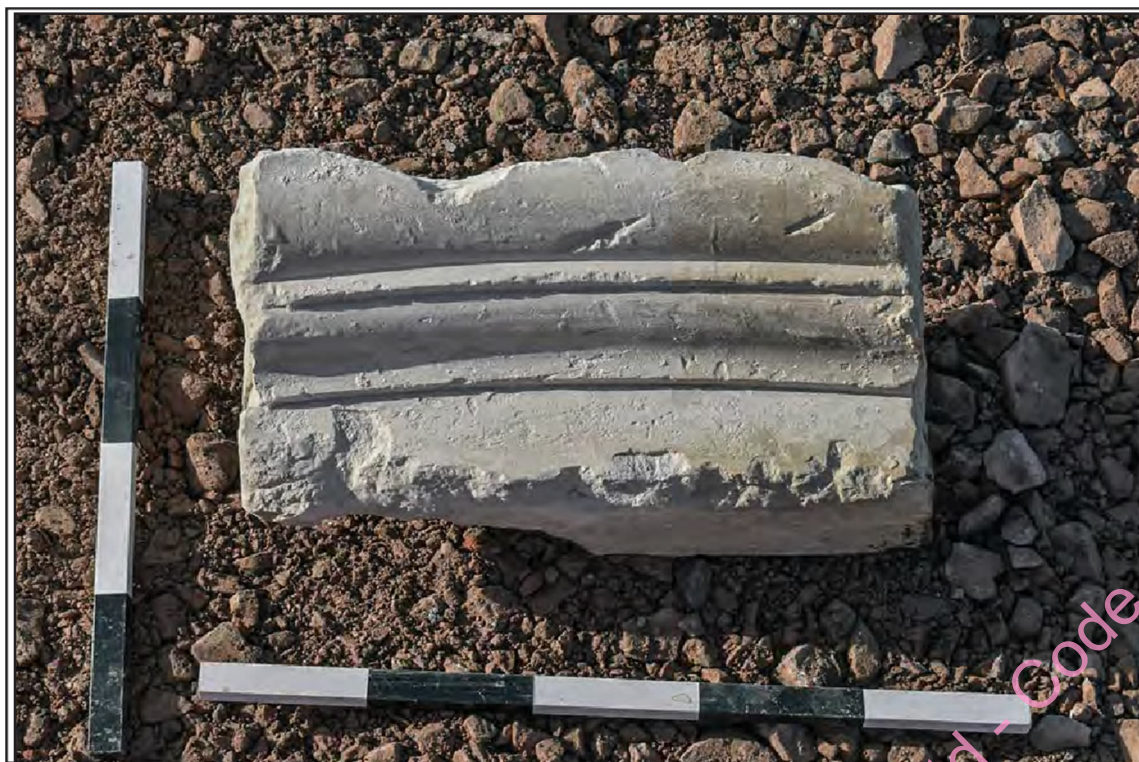
Photo B 12: Stone 010

| 010 | Length: 410mm Width: 190mm Height: 190mm | Part of an architectural element with six faces, one which is moulded. It features an ogee moulding and part of what may be an ovolo moulding, both typical of classical architectural detailing. It has a very gentle curve suggesting it is most likely an element of a window or other opening, such as the architrave or perhaps a curved pediment. The other sides are broken and have traces of chisel marks and small grooves, suggesting it was worked and sized before being reused at Shepherd's Furze. |

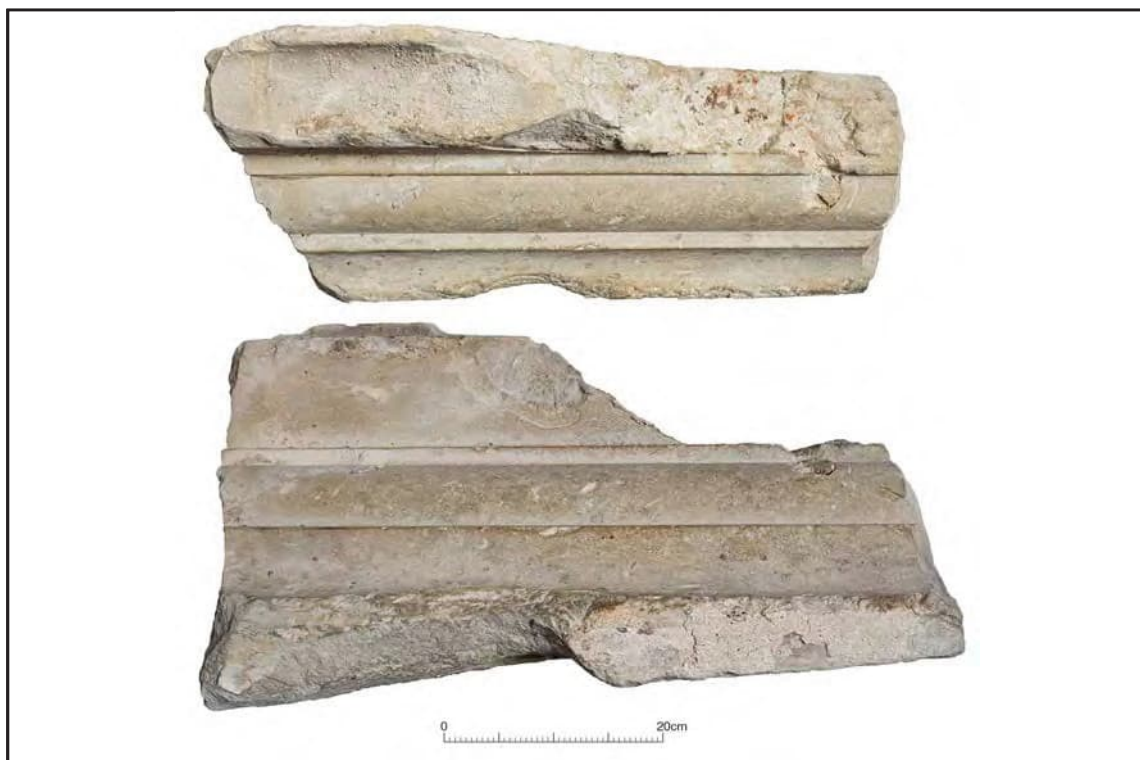
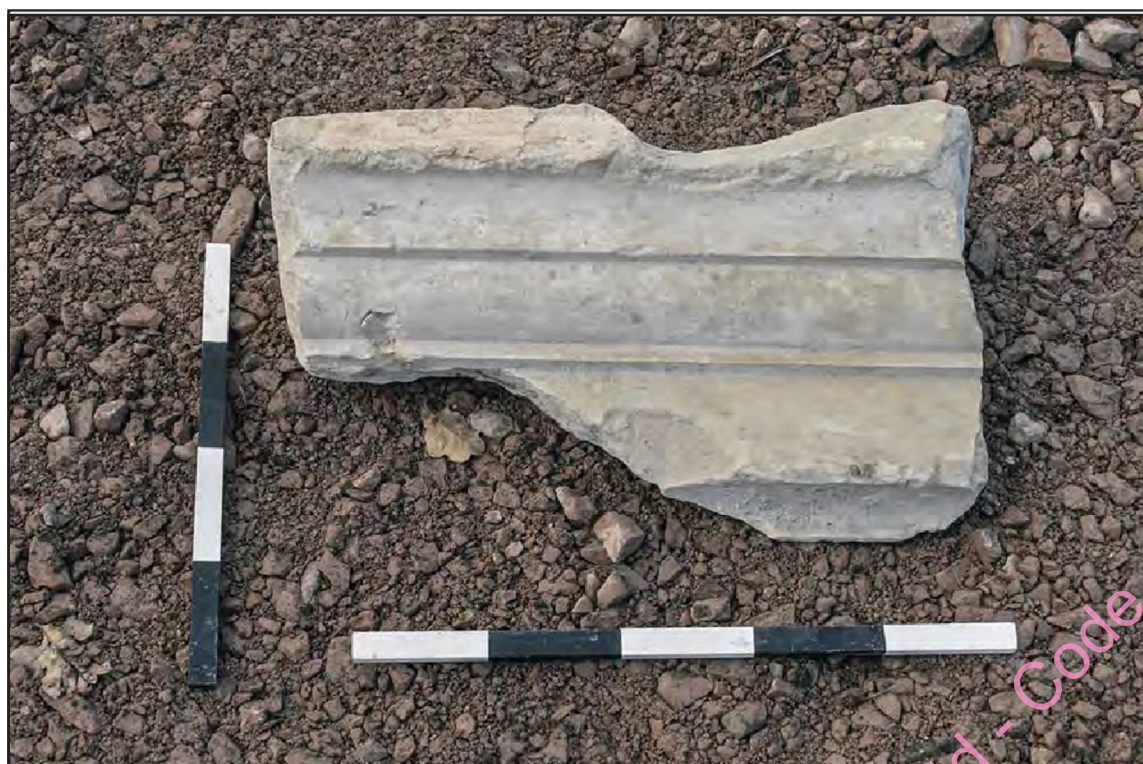
Photo B 13: Stone 011

| 011 | Length: 550mm Width: 210mm Height: 310mm | Part of an architectural element that has six faces with one moulded face along the length. It has an ovolo moulding, under a cavetto moulding typically used in classical architectural detailing. Under the moulding is a brought, flat plane suggesting it is part of the frieze of an entablature. The other sides are broken and have traces of chisel marks suggesting it was worked and sized before being reused at Shepherd's Furze. |
