1EW03 - Enabling Works Central

Historic Building Recording

Shepherd's Furze Farmhouse,
Steeple Claydon,
Buckinghamshire

Document Number: 1EW03-FUS_COP-EV-REP-CS06_CL09-000014

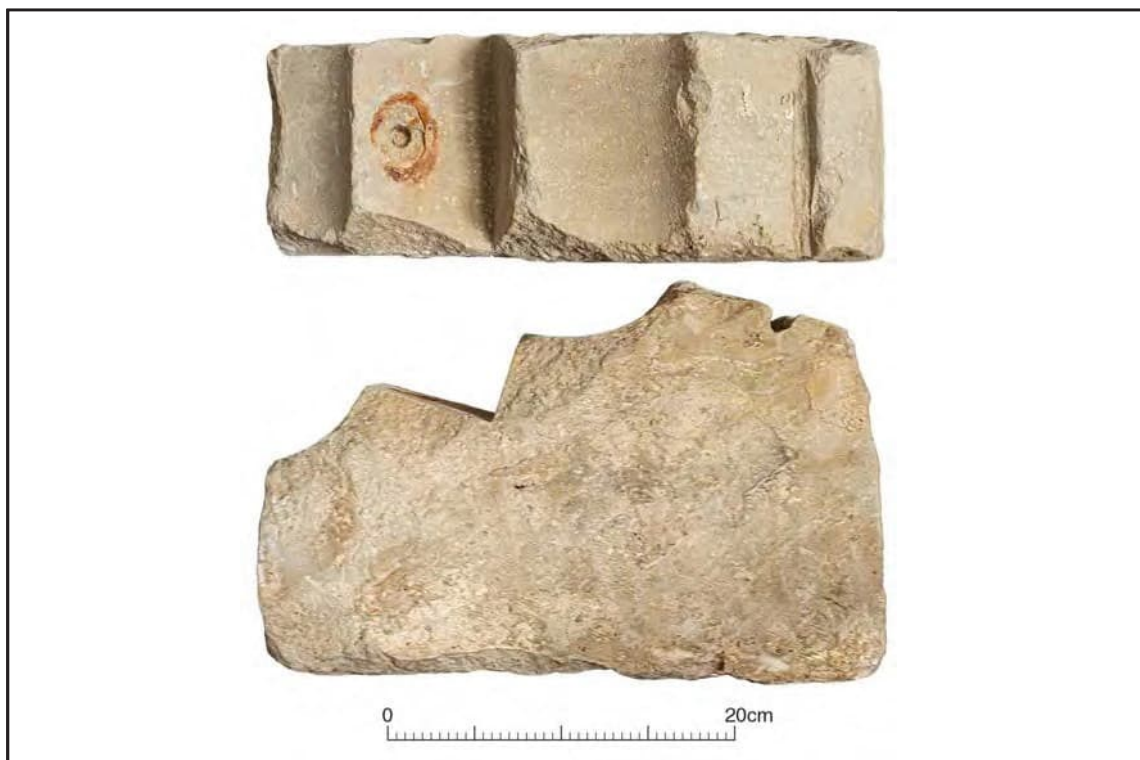
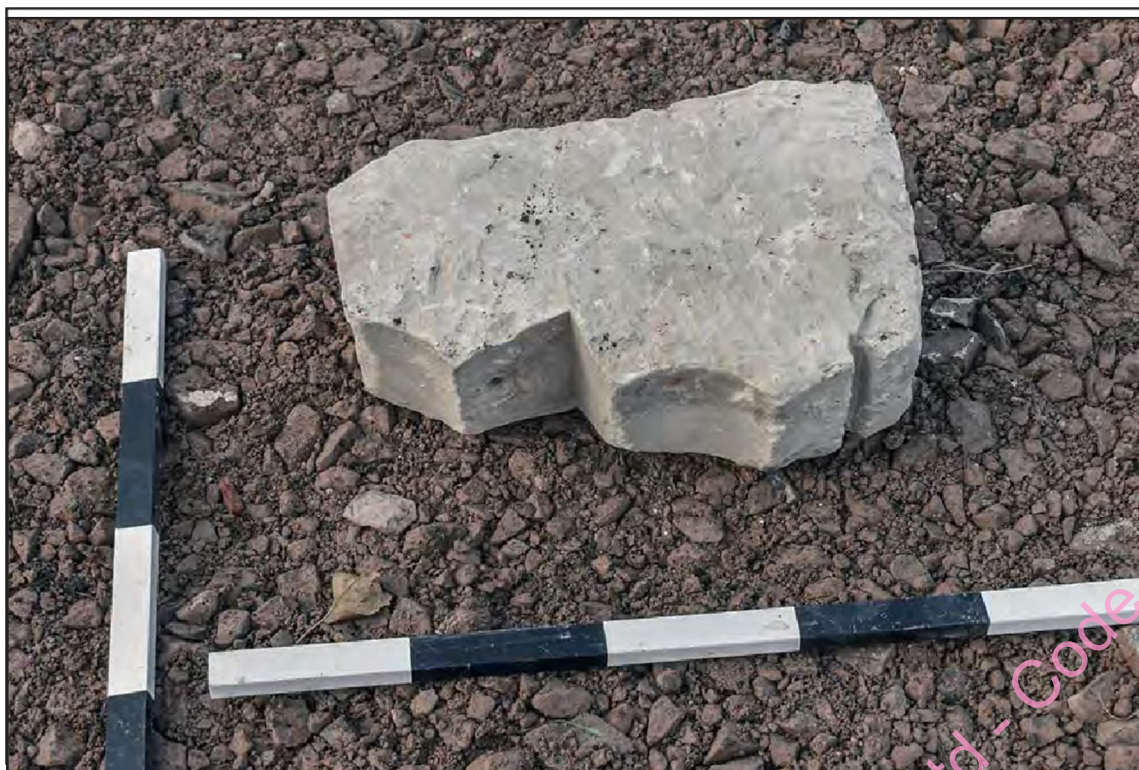
Photo B 14: Stone 012

| 012 | Length: 210mm Width: 115mm Height: 300mm | Part of an architectural element with 6 faces, one of which is moulded. The moulded face is long and narrow with two stepped cavetto mouldings. There is a deep groove at one end and in the step between the cavetto mouldings is a hole, perhaps for ironwork. This suggests that it may have been a structural component to a larger, decorated piece of architecture. The two larger faces of the stone have chisel marks but these might predate its reuse at Shepherd's Furze as it otherwise appears to be a complete, un-broken stone (albeit with some damage to the corners). |

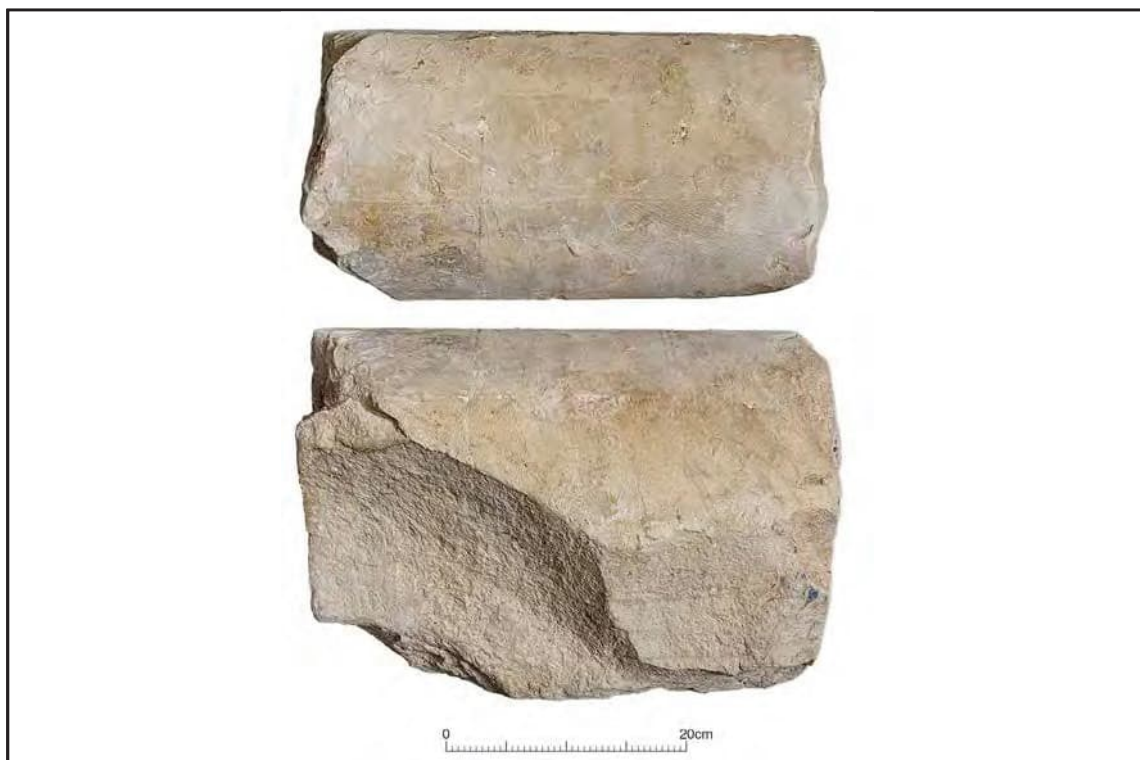
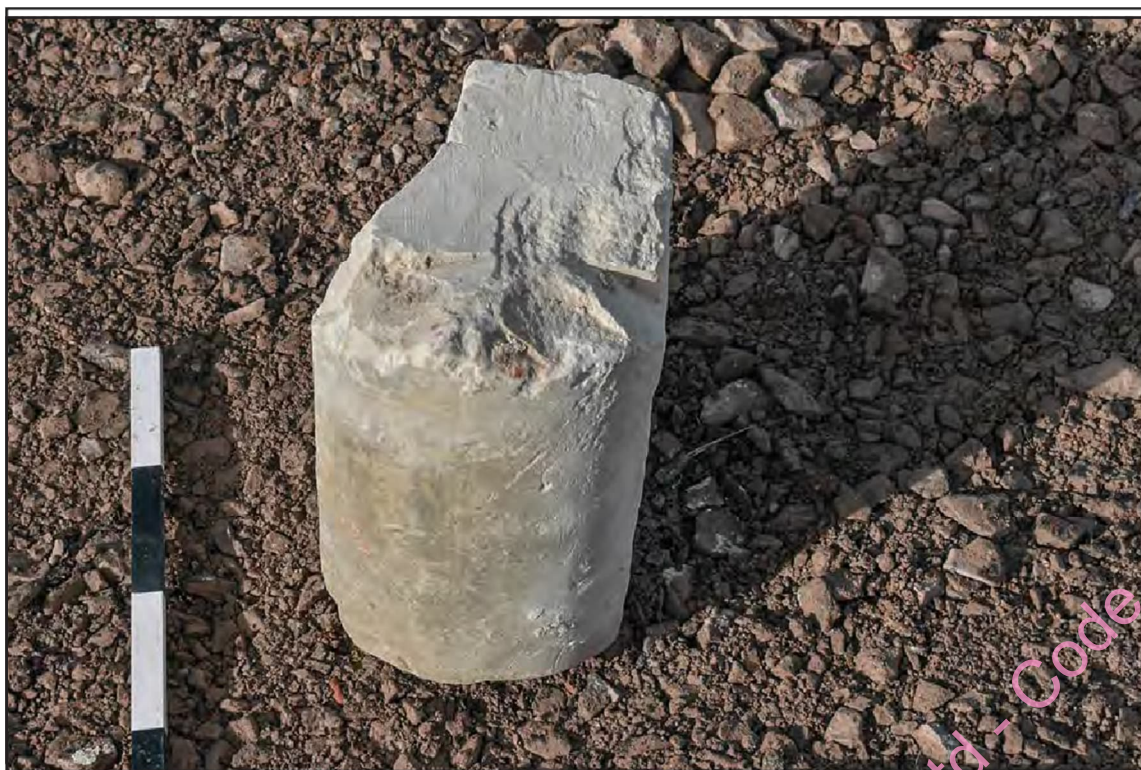
Photo B 15: Stone 013

| 013 | Length: 360mm Width: 195mm Height: 260mm | Part of an architectural element that is cylindrical on one side and broken on the other, with flat plane at one end. It may be a part of a large opening as it is not typical of architectural detailing of an entablature, unlike the other stones. Besides its smooth and broken faces, it does not appear to have been worked further for reuse. |

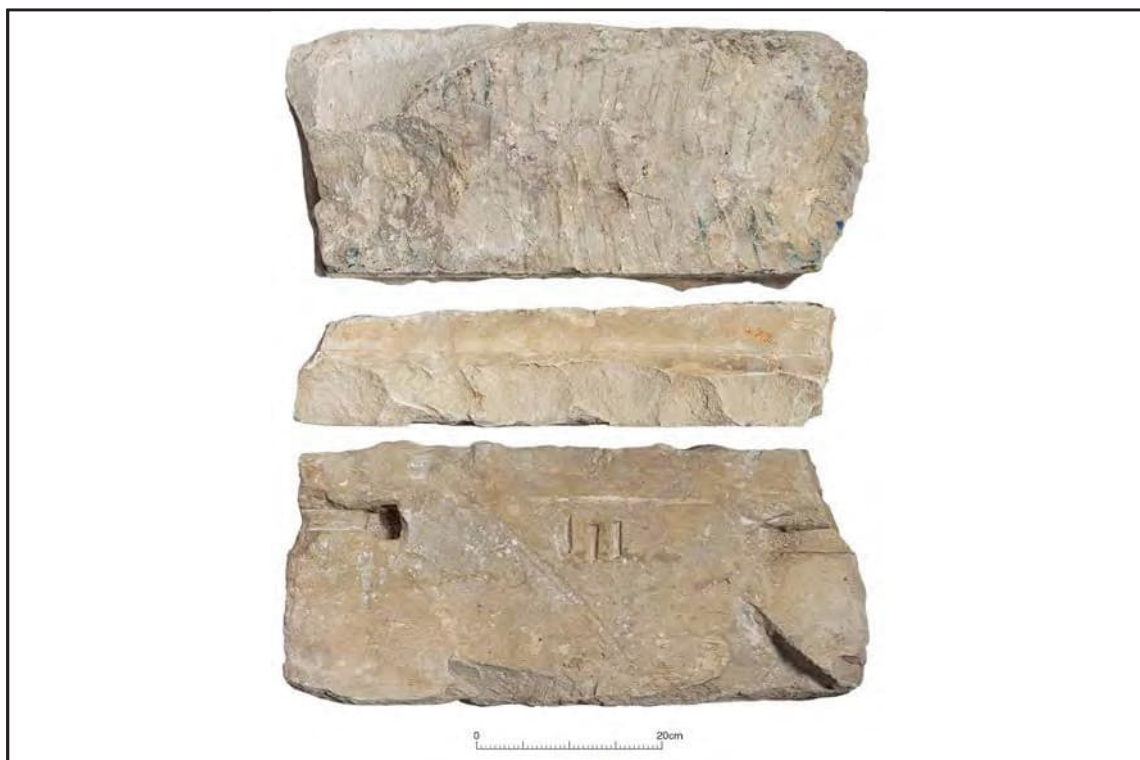
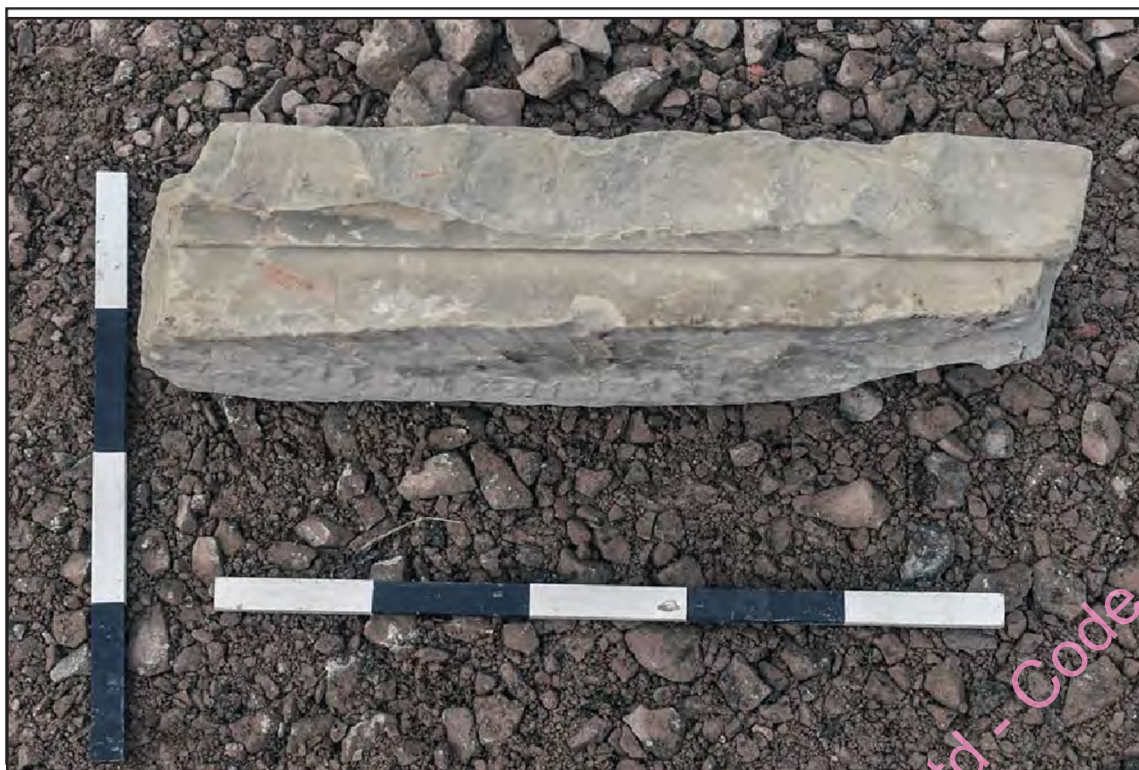
Photo B 16: Stone 014

| 014 | Length: 550mm Width: 115mm Height: 240mm | Part of an architectural element that has six faces, one of which has a smooth, shallow, stepped moulding, and broader rougher face that has grooves for ironwork. The grooves, one at each end, suggest it is a structural component of a larger piece of architecture. Between the grooves are three deep chisel marks, which are possibly a mason's mark for the Roman numeral for 3. It is otherwise broken and damaged around its edges, which may be reworking for reuse at Shepherd's Furze. |

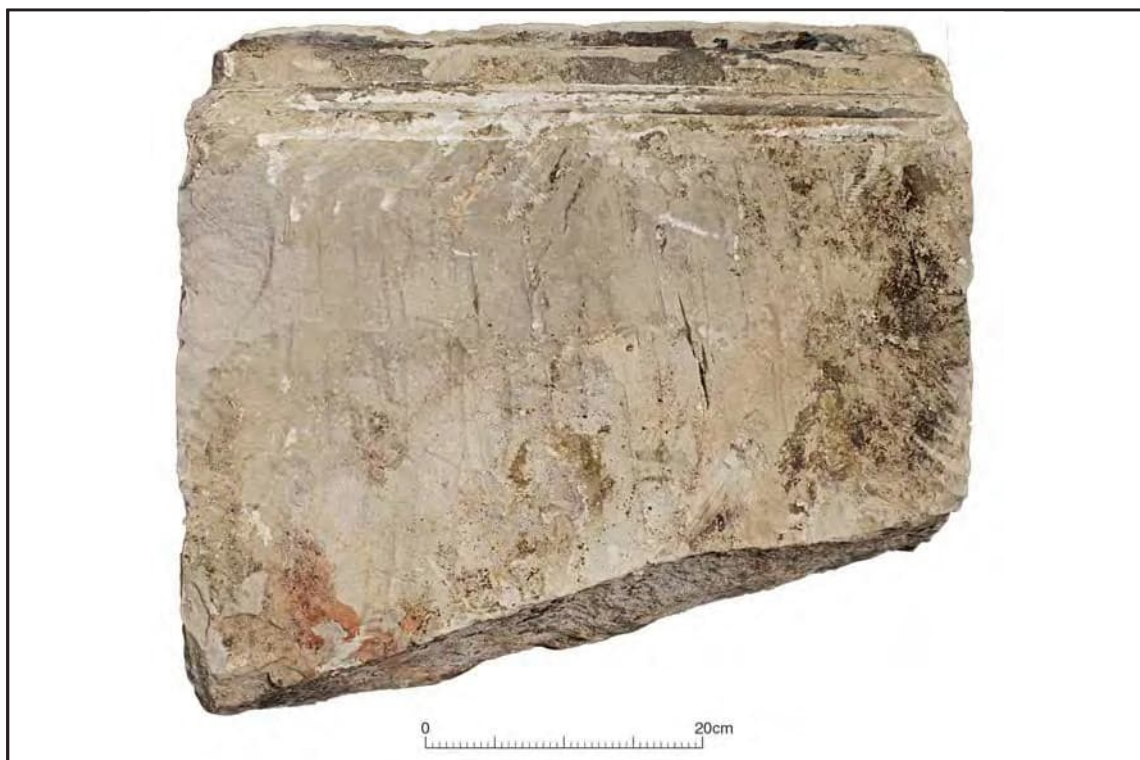
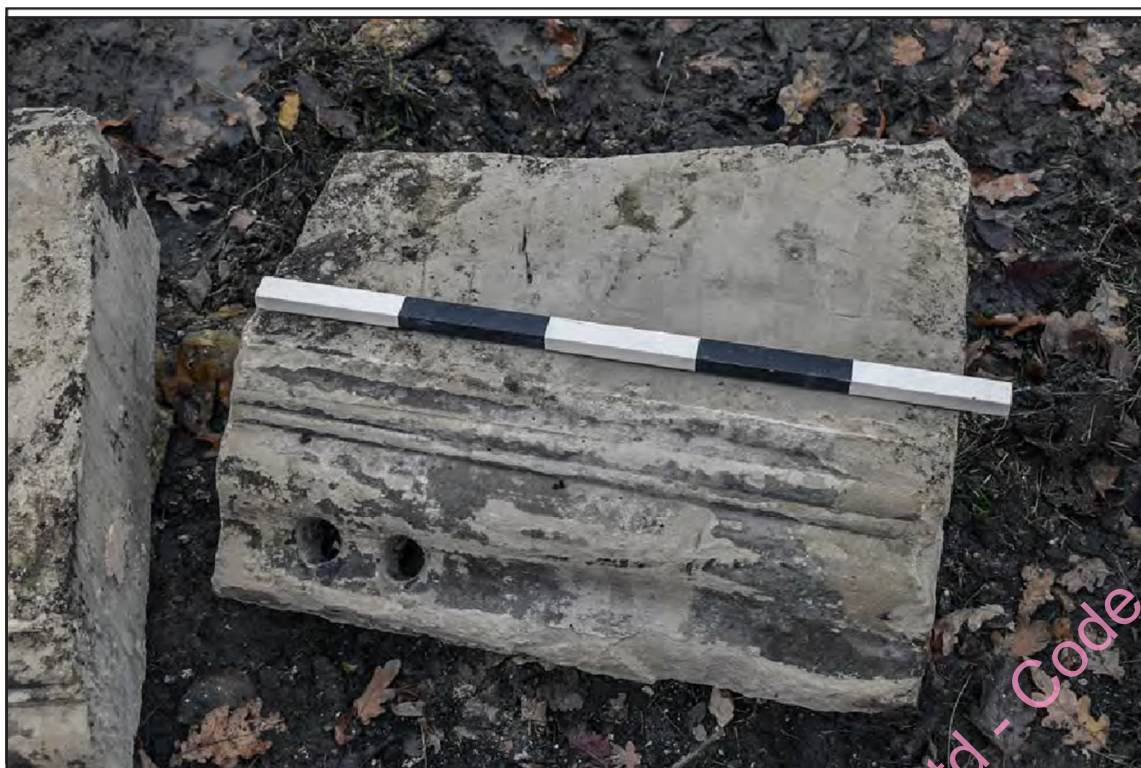
Photo B 17: Stone 015

| 015 | Length: 490mm Width: 480mm Height: 150 | Part of an architectural element that has six faces with one moulded face along the edge. The moulding consists of reeding over an ogee profile. At one end, there are two holes through the moulding, perhaps for ironwork. This is likely to be part of a cornice, the flat underside of which would have sat on the top of the entablature. It is broken along the opposite edge from the cornice but otherwise appears does not appear to be worked for reuse. |

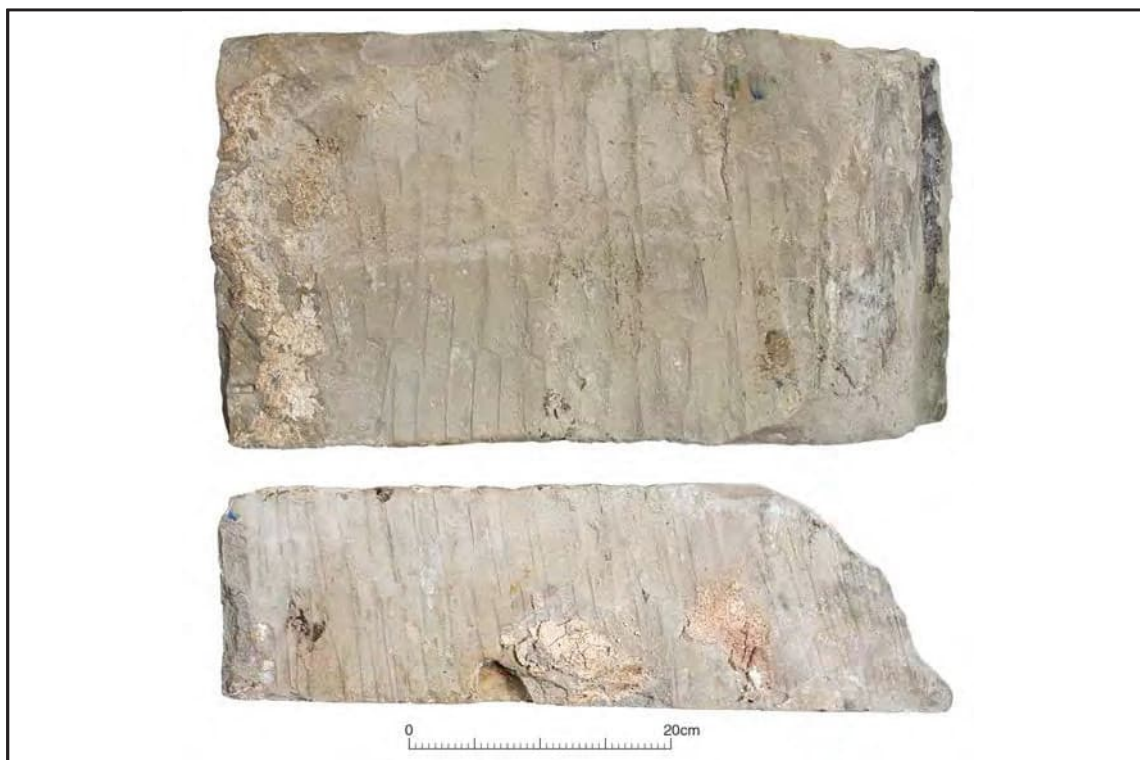
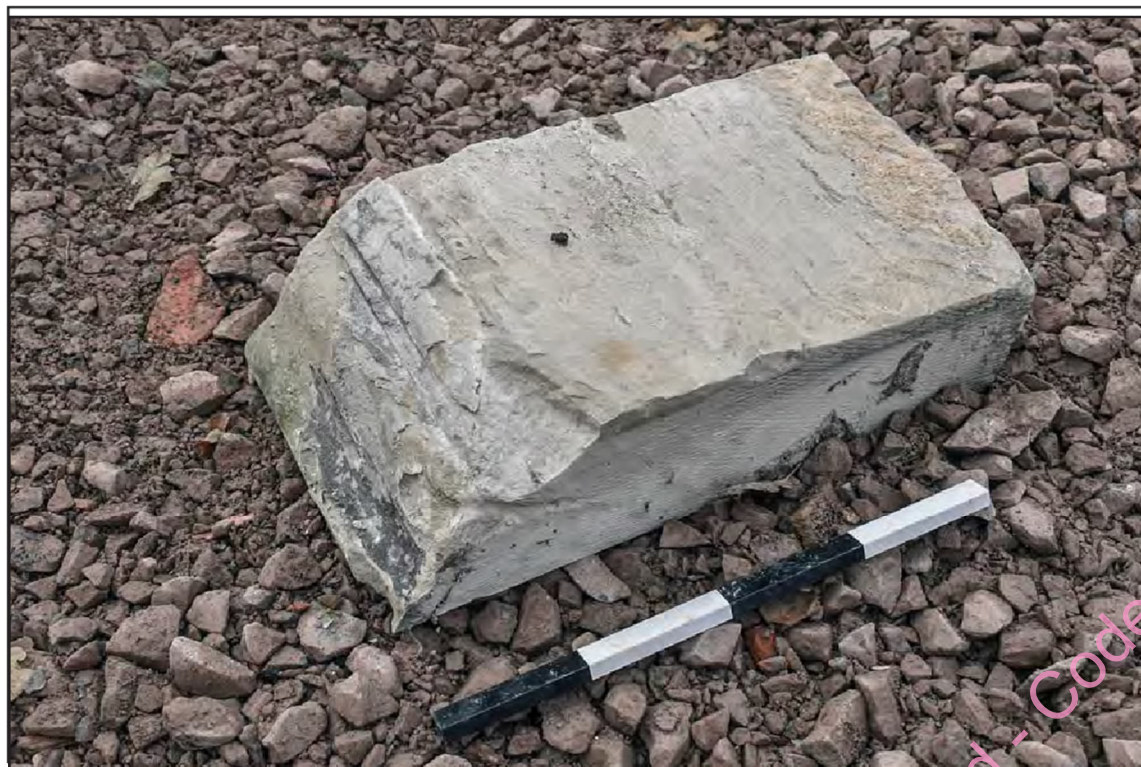
Photo B 18: Stone 016

| 016 | Length: 500mm Width: 260mm Height: 150mm | Part of an architectural element that has six faces with one moulded face along the edge. The moulding consists of reeding over an ogee profile. At one end, there are two holes through the moulding, perhaps for ironwork. This is likely to be part of a cornice, the flat underside of which would have sat on the top of the entablature and may be a part of the same structure as stone 015. It is more damaged than stone 015 but beside the broken edges and the original tool mark, it does not appear to be worked for reuse. |
