WP 029 D – Bucks Head Farm – Enabling Works North Contract Report for Historic Building and Setting Recording

Document Number: 1EW04-LMJ-EV-REP-NS06_NL16-029018

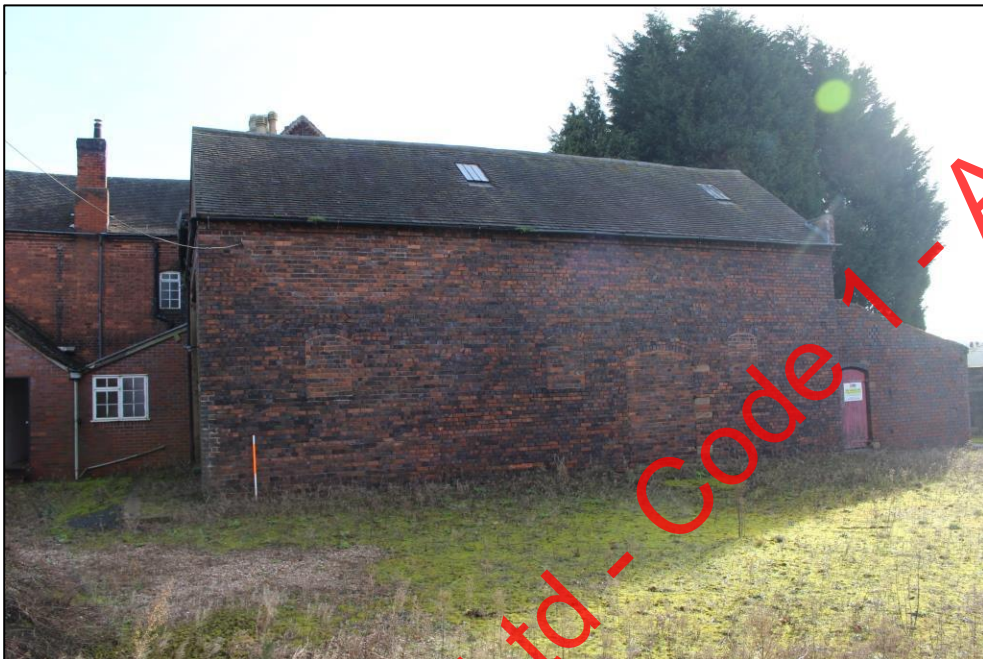
Plate 108: An overview of Building 2 from the west.

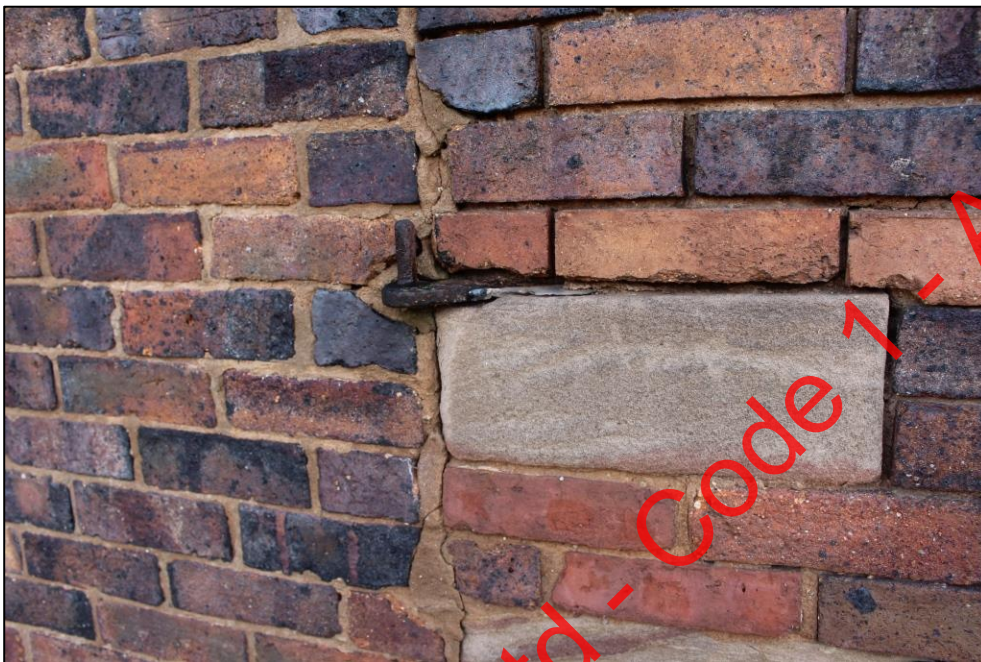
Plate 110: Detail of blocked window and door openings situated beneath segmental brick arches within the western elevation of Building 2.

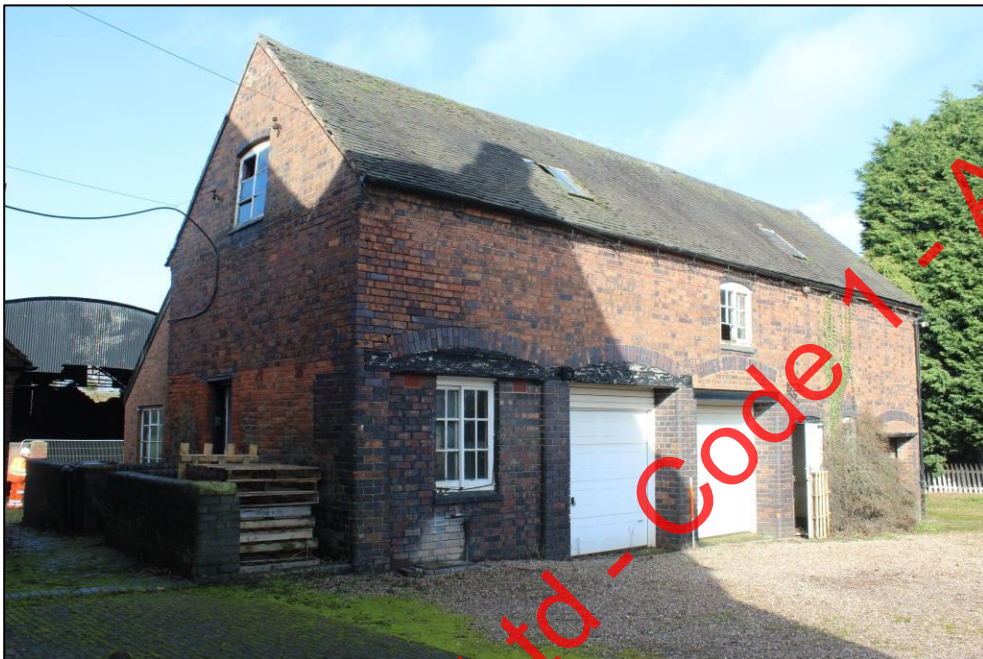
Plate 125: An overview of Building 3 from the south-east.

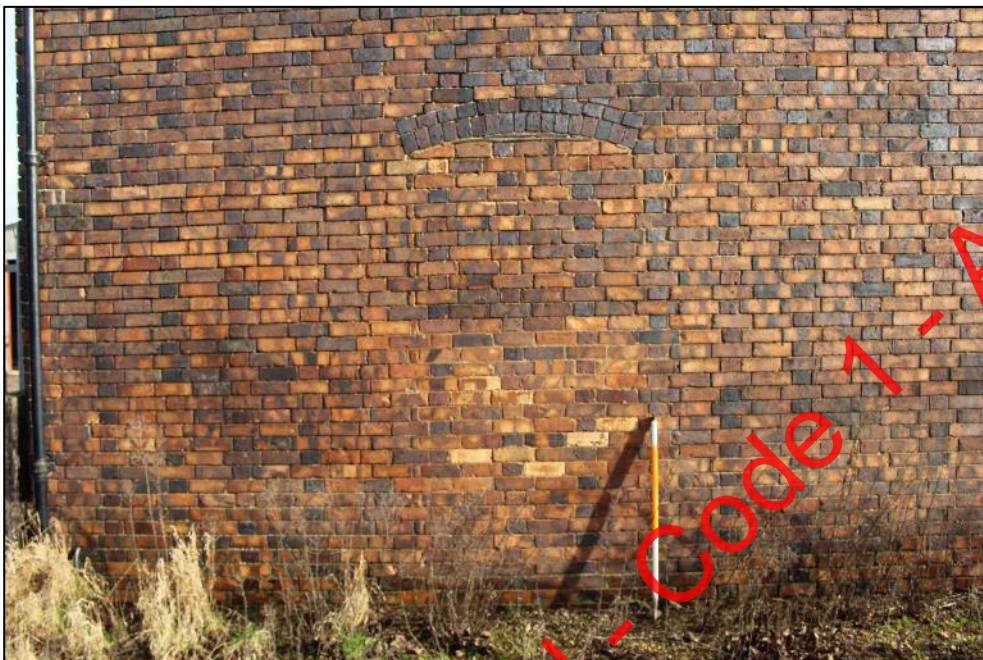
Plate 191: The blocked feature in the western elevation of Building 6.

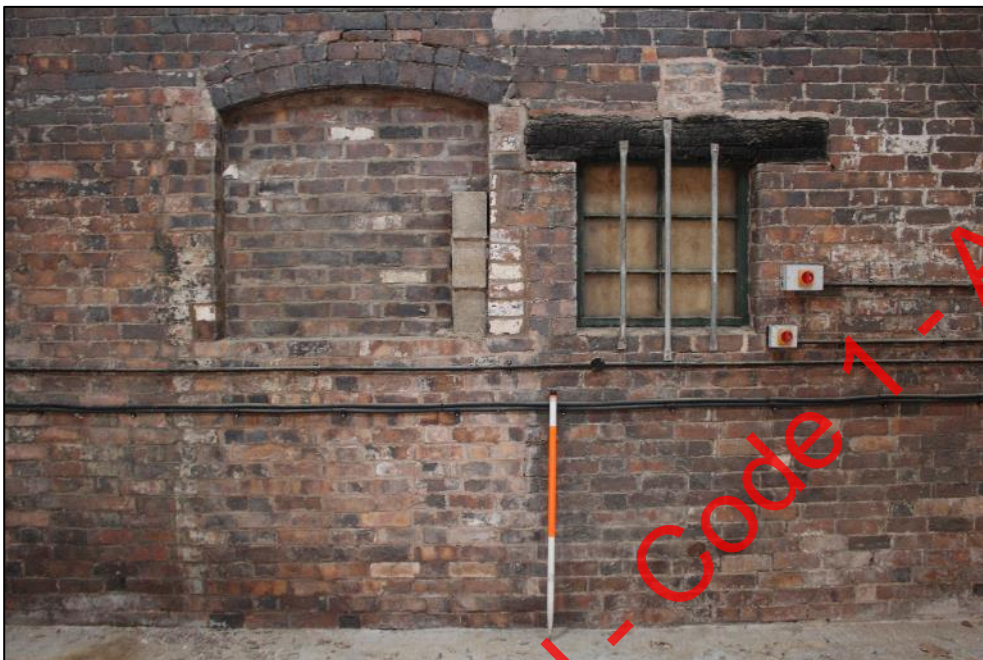
Plate 199: Detail of the two blocked windows in the eastern wall of Building 6.

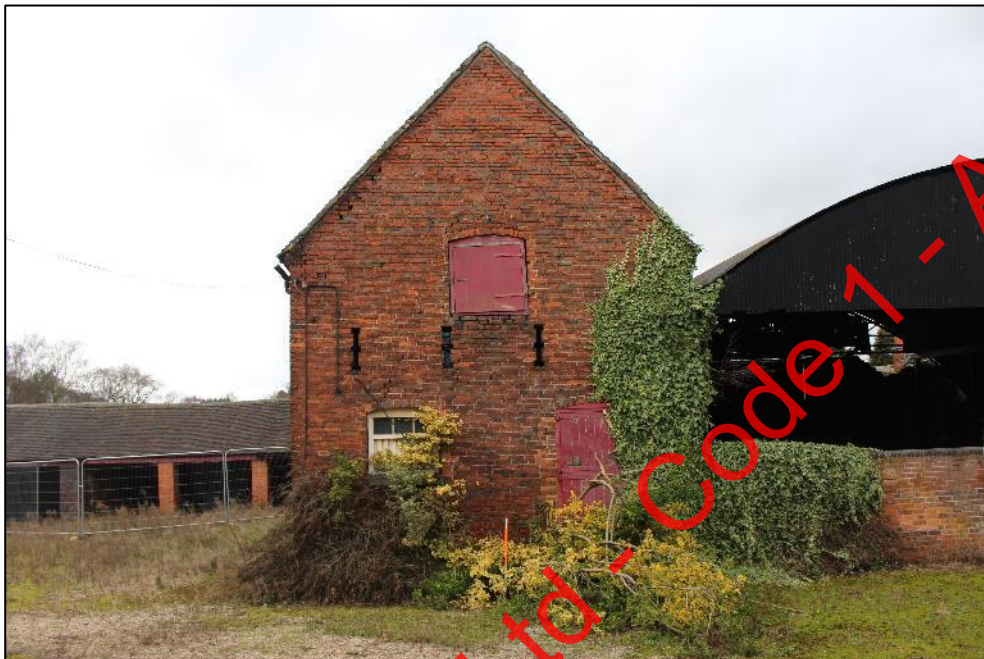
- 5.9.4 The eastern elevation of the barn (**Plate 205**) contains three apertures, two at ground floor level and one at first floor level. At ground floor level is a window on the southern side, this is a timber framed window, with louvres below and three lights of glazing above, separated by wooden glazing bars. Below this is a sandstone sill. To the north is a timber panelled stable doorway (**Plate 207**), hung on iron strap hinges. Above is a central pitching window (**Plate 206**), in a timber frame with what appears to be a replacement timber doorway, hung on iron strap hinges with an iron latch and fastener. At the base of the first-floor level, just below the pitching window, are four ventilation slits. All three apertures are covered with segmental brick arches.

Plate 205: The eastern elevation of Building 7.

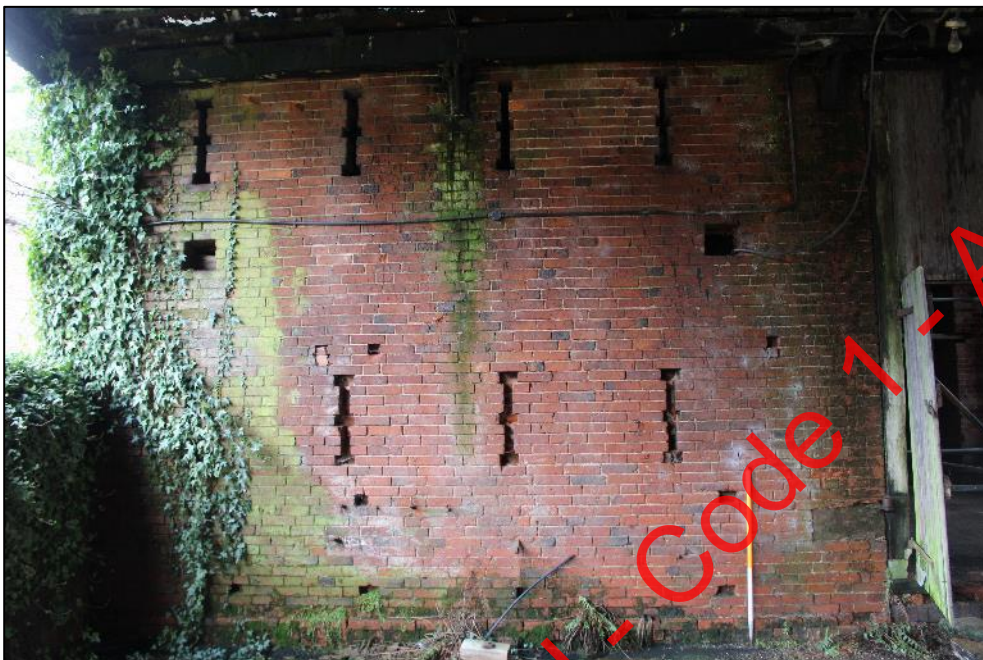
Plate 213: The eastern side of the northern elevation of Building 7, showing the ventilation holes and slits.

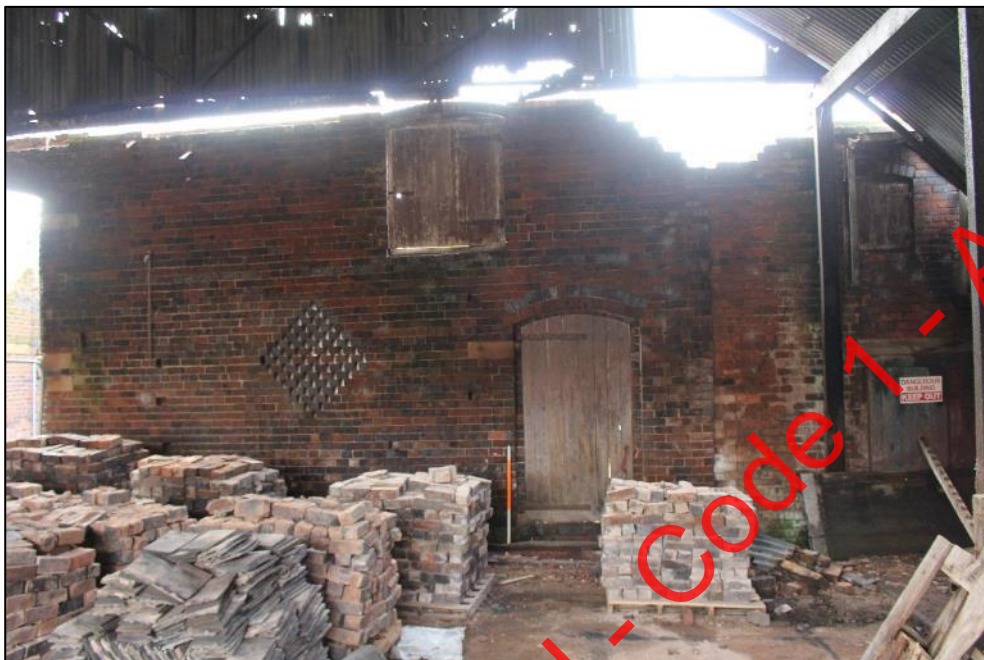
- 5.9.14 The eastern elevation (**Plate 233**) of the barn contains another large doorway mirroring the one found on the western elevation (**Plate 235**). To the north of this are two apertures, a doorway at ground floor level and a pitching hole above. The doorway is timber panelled, hung on iron strap hinges with pintels set in sandstone brick, and a brick segmental arch above. The pitching hole (**Plate 234**) contains a doorway not unlike the ground floor doorway; it is also timber panelled, with strap hinges and a brick segmental arch above. Between the northern doorway and the large door to the south is a diamond panel of ventilator bricks.

Plate 233: The northern section of the eastern elevation of Building 8.

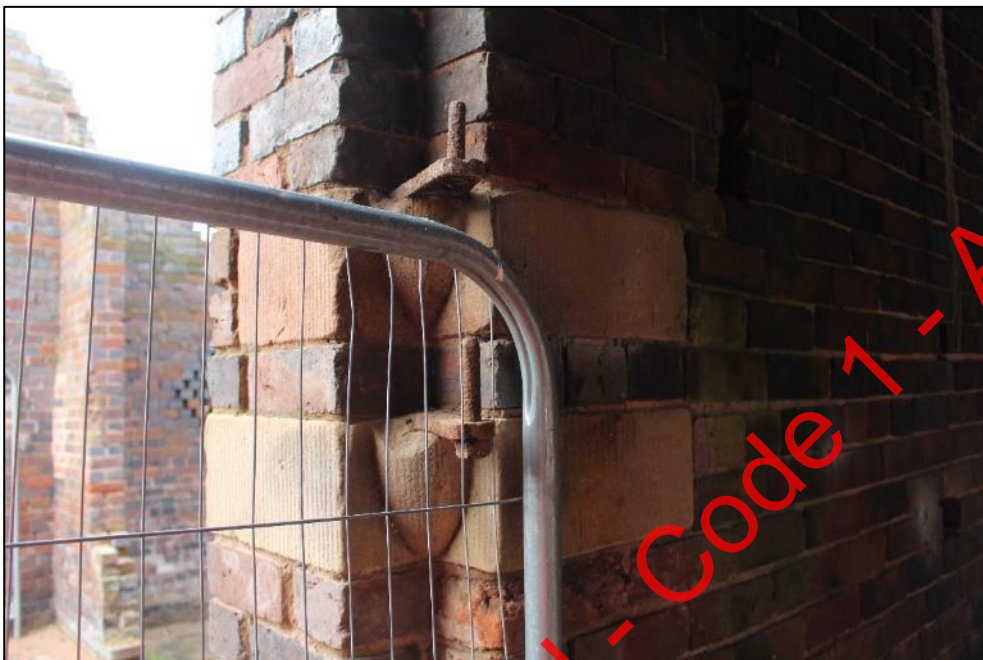
Plate 235: The large sandstone blocks and pincels attached to the large doorway in the eastern elevation of Building 8.

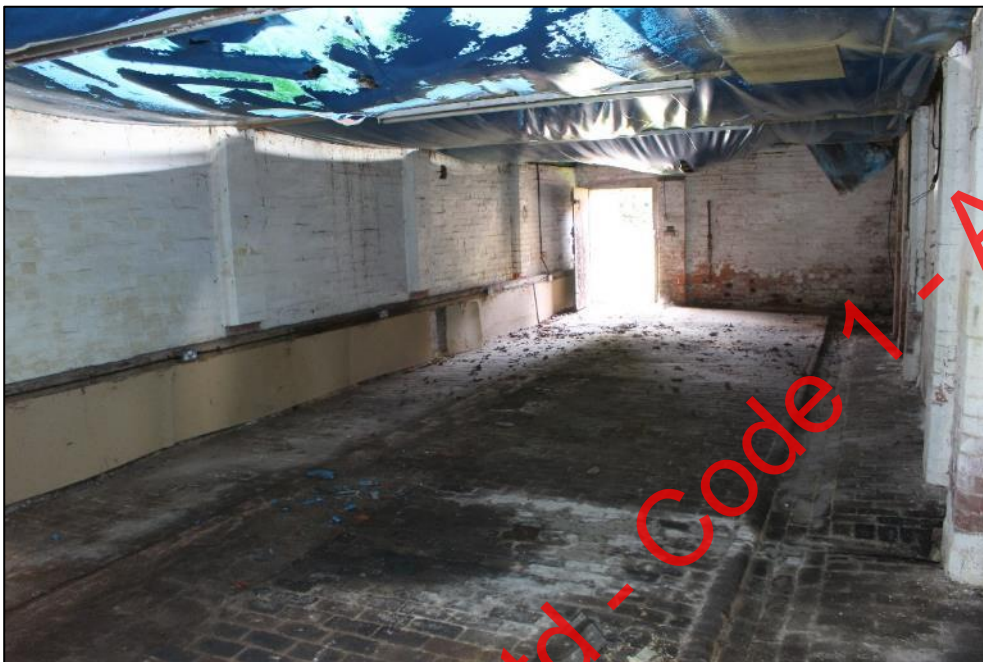
- 5.9.21 The interior of Building 9 (**Plates 247-252**) consists of a single open rectangular room, with whitewashed brick walls and a blue brick floor. Along both the northern (**Plate 248**) and southern (**Plate 251**) walls is a series of internal brick pilaster buttresses. These have been broken on the northern wall by a long strip on timber, that has been boarded below. It is possible that this relates to a former fixture along this wall, such as a feeding trough. The floor

Plate 247: The interior of Building 9, facing north-east.

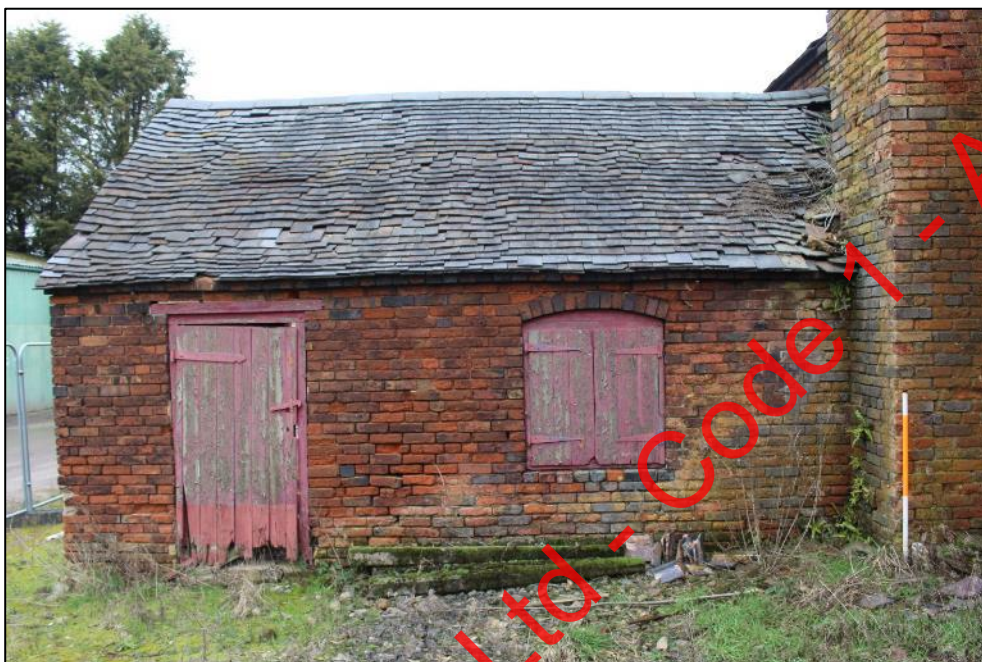
- 5.9.24 The southern elevation of Building 10a (**Plate 255**) contains the stack on its eastern side. To the west of this is a window and a doorway. The former (**Plate 256**) is a timber double hinged window, again hung on iron strap hinges. Above this is a segmental brick arch. The upper three course of brick to the southern elevation are of a grey brick which is distinct from the rest of the elevation and may suggest that the upper course of the wall has been repaired or

Plate 255: The southern elevation of Building 10a.

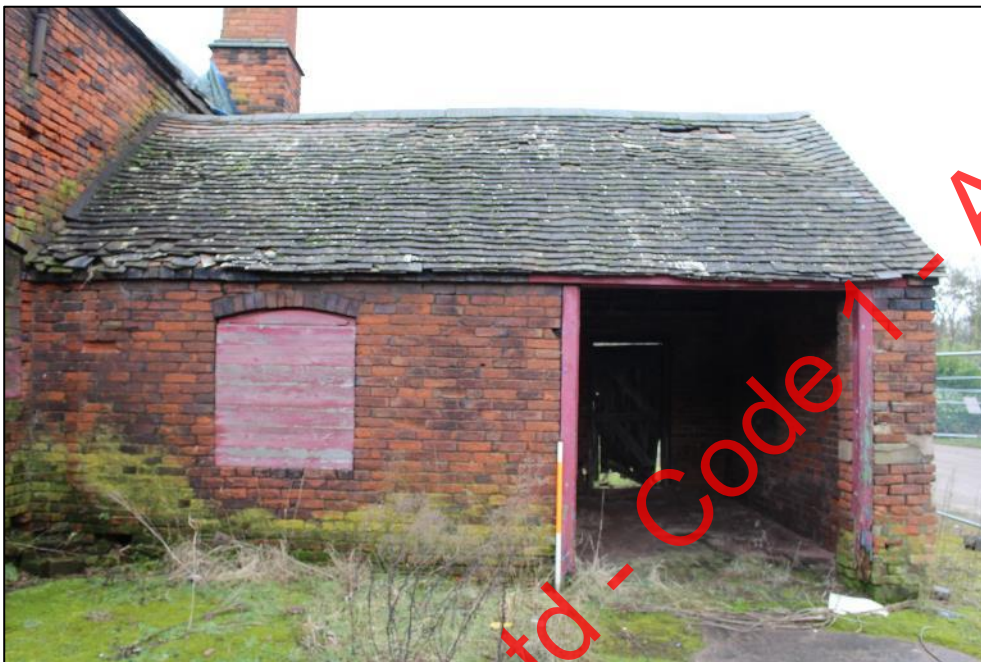
- 5.9.26 The northern elevation (**Plate 261**) of Building 10a contains another window, identical to the one on the southern elevation, however, this one has been boarded up. To the west of this is a large timber framed opening. On the western jamb of this is a large sandstone block that may have held an early pintel. This doorway would have been used to provide ventilation to this building, as well as to potentially provide a workspace for shoeing horses in poor weather conditions. To the east of this elevation, within the northern side of Buildings 10b's western elevation (**Plate 262**), is another window. This is identical in size and form to the ones situated on the northern and southern elevations of Building 10a.

Plate 261: The northern elevation of Building 10a.

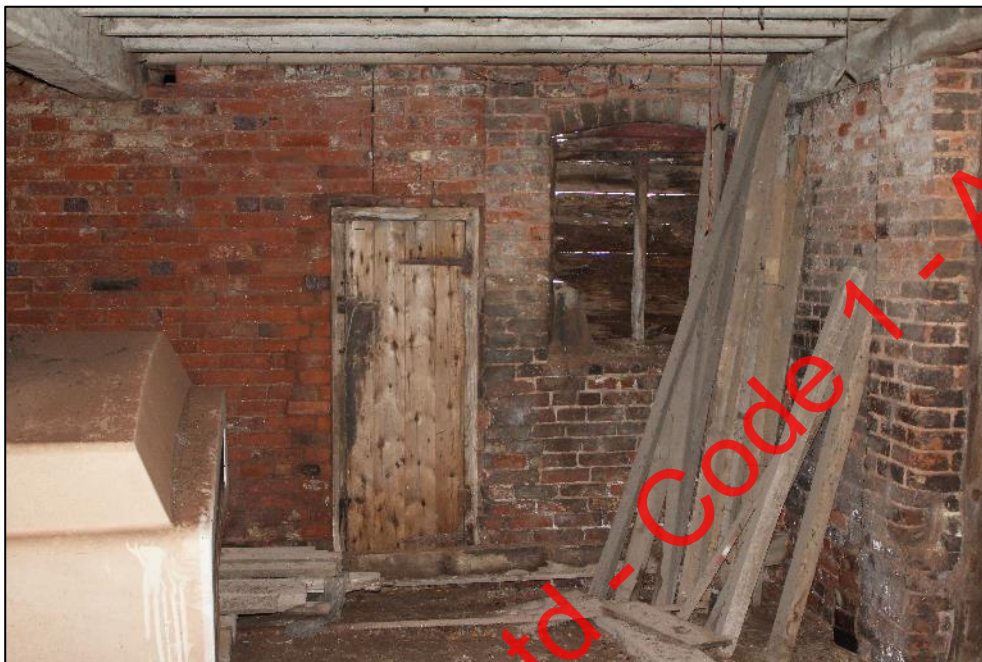
Plate 276: The northern end of the western wall of Building 10b. The break in brick coursing is visible to the right of the doorway.
