**Historic Building Recording
Report EH088/01**

Lower House Cottage, Wray, Lancashire

Historic Building Recording for Martin and Rebekah Huddleston

DATE ISSUED:	December 2020
JOB NUMBER:	EH088
REPORT NUMBER:	01 Version (1.0)
PLANNING REF:	20/00390/FUL
GRID REFERENCE:	SD 6376 6579
OASIS REFERENCE:	edenheri1-411477

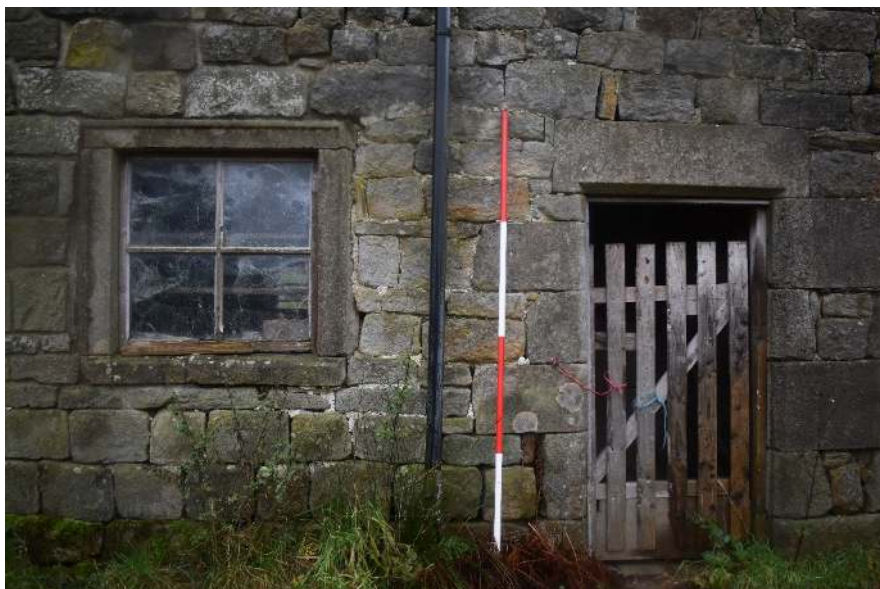
- 4.2.3 At first floor the elevation contained three two-light stone mullion windows, two of which were missing their mullions. All had chamfered stone surrounds similar in style to the central door frames. At ground floor a similar centrally placed window was noted to be a modified former mullion window, which had been reduced in width. This had been partially filled in on the south side and a modern four-light timber window frame had been inserted. The south end of the stone lintel had been cut to reduce its length, and the sill was broken (Plate 7). The infill appeared relatively recent.

Plate 7: Detail of adapted former mullion window and stone door frame, looking west.

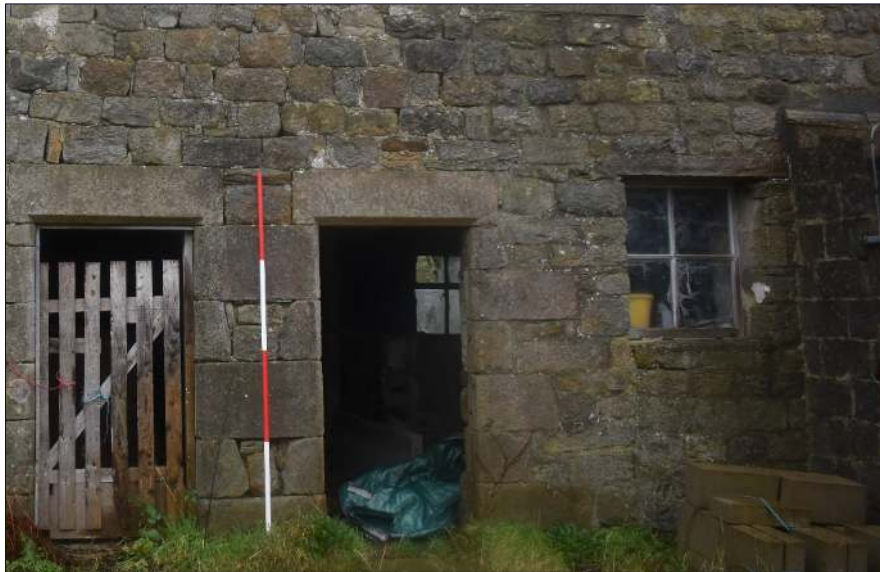
Plate 8: Ground floor window inserted into a blocked opening, looking west.

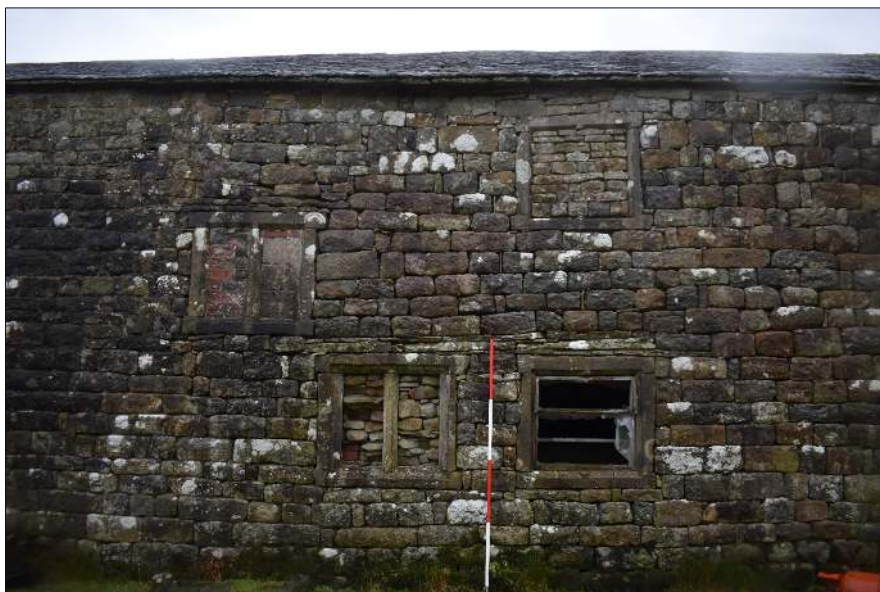
- 4.2.5 The west-facing elevation was accessed from the field to the south. This elevation was devoid of doorways but contained four windows at ground floor level, one at first floor, and one at an intermediate level, four of which had been filled in (Plate 9). This elevation contained two centrally placed mullion windows at ground floor level. One had been infilled with stone, the other had been fitted with a three-light timber window frame, the mullion having been removed. There was a further mullion window above at first floor, which also had been infilled, the mullion missing. At intermediate level was a further mullion window which was infilled with red brick and concrete breeze block (Plate 10). All had chamfered stone surrounds and originally had splayed mullions.

Plate 10: Mullion windows in the west-facing elevation of the survey building, looking northeast.

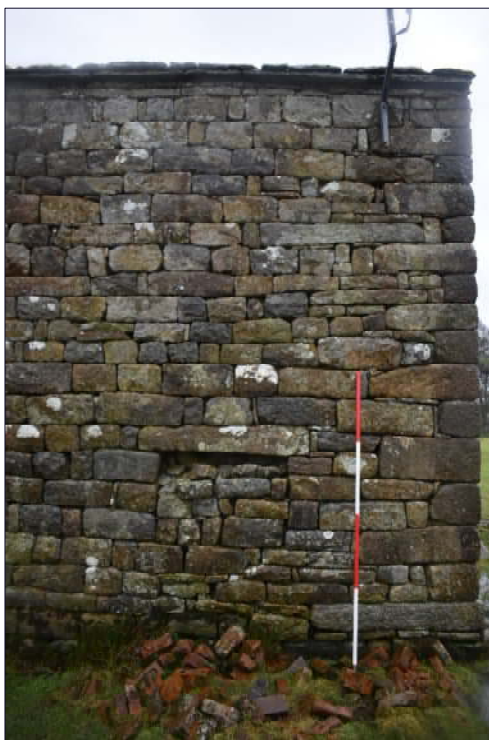
Plate 11: Blocked window in the west-facing elevation, looking northeast.

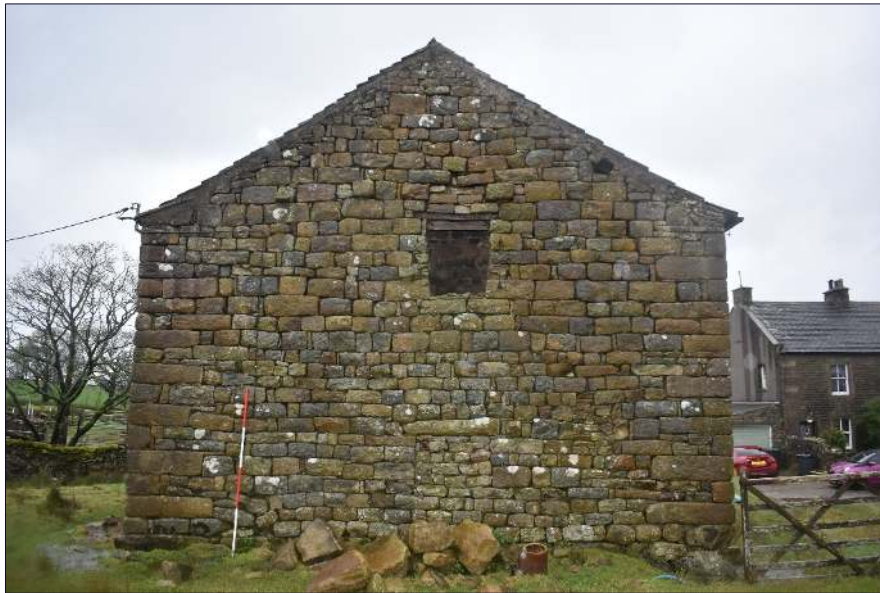
- 4.2.7 The southern gable contained a further small square window with a timber lintel at first floor level (Figure 9), and a blocked window with stone lintel at ground floor level (Plate 12). The northern gable was relatively featureless apart from a small opening at first floor level, which had a chamfered stone surround (Plate 13). This elevation had recently been re-pointed and may have been partially re-built. Large foundation stones were noted in the east side of this elevation underlying the modern lean-to, which appear to have been mortared (Plate 14).

Plate 12: Blocked window with open window above in the south-facing elevation, looking northwest.

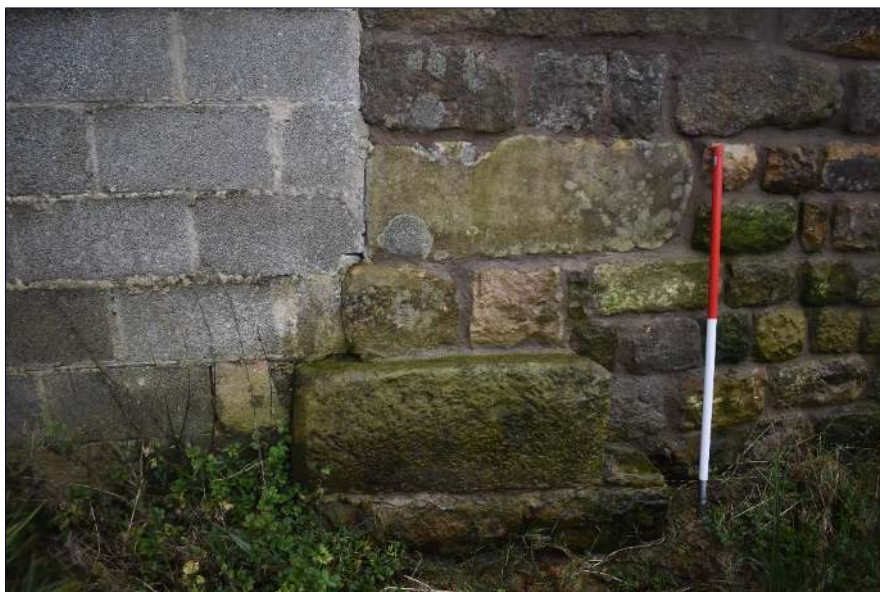
Plate 14: Foundation stones underlying the modern lean-to, looking south.

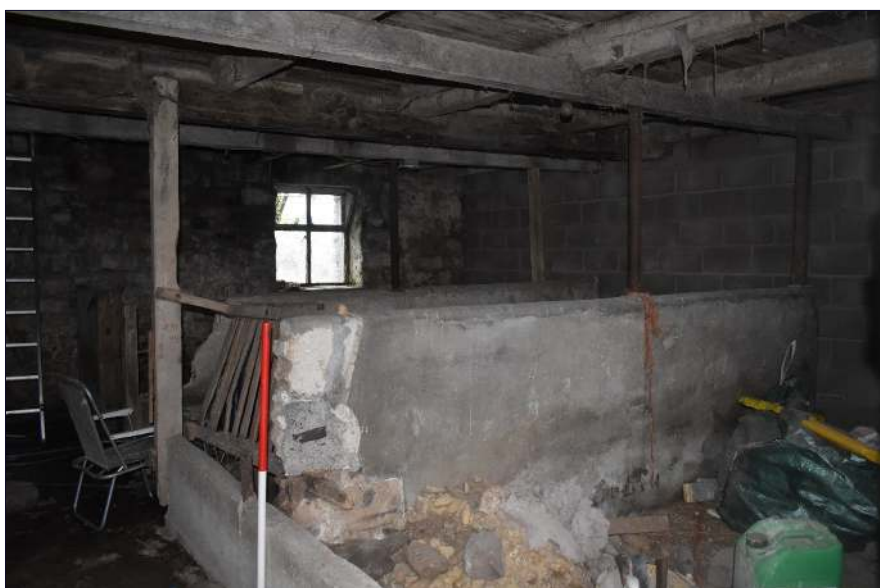
Plate 15: Interior of the northern room showing concrete partitions, looking northwest.

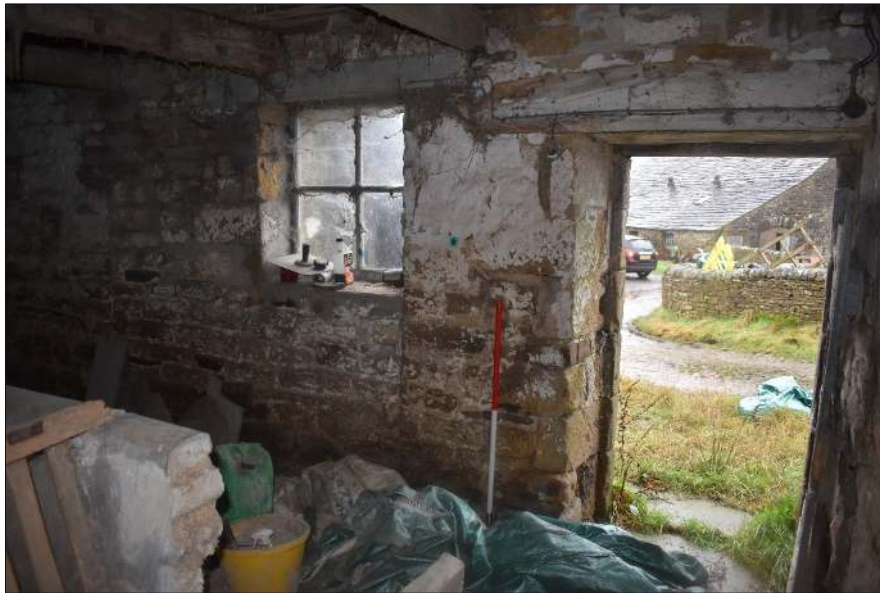
- 4.2.12 Evidence was visible in the east wall for the blocked opening as noted from the exterior (Plate 16). A centrally placed internal doorway with a timber lintel was also present in the south wall which had been blocked up with stone and painted over (Plate 17).

Plate 16: East wall of the northern room showing blocked opening and inserted window, looking northeast.

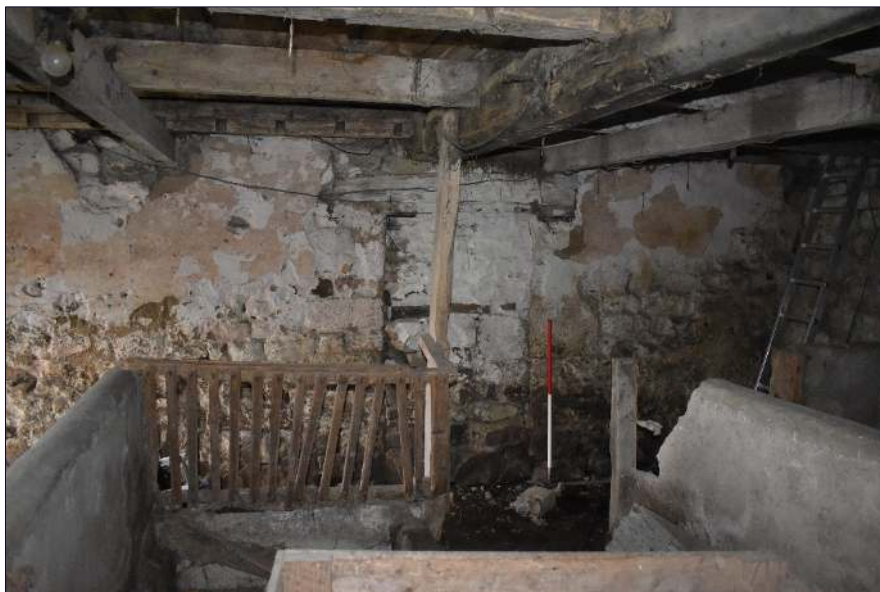
Plate 17: South wall of the northern room showing blocked internal doorway, looking south.

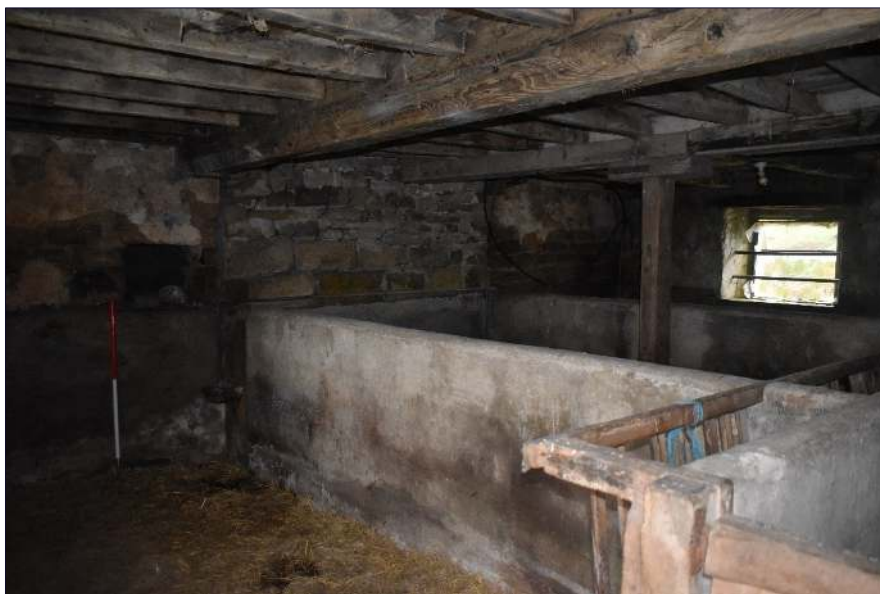
Plate 18: The central room showing concrete partitions and blocked fireplace with niche, looking southwest.

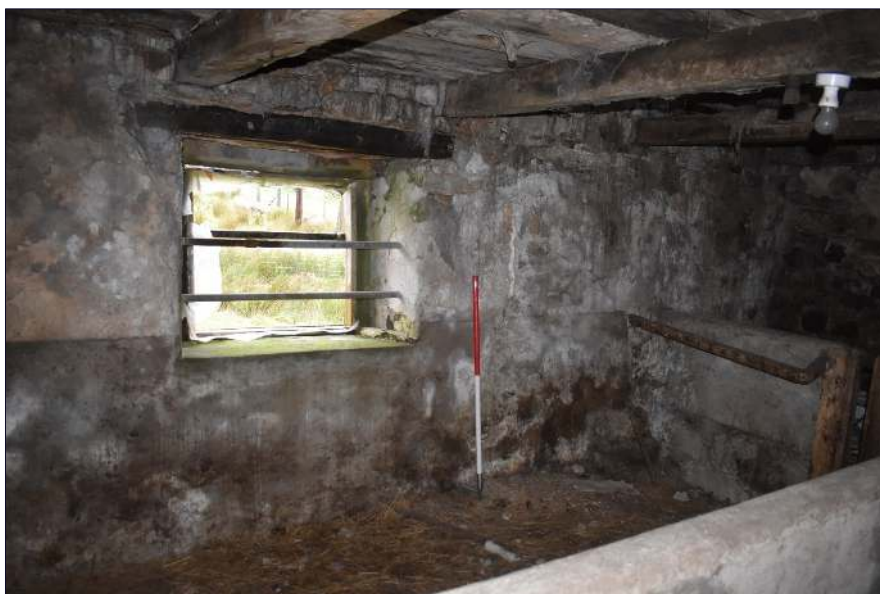
- 4.2.14 The room was lit by two former mullion windows in the west wall, one of which was infilled and plastered over, as seen from outside the building (Plate 19). The other window was missing its mullion, but the window opening was splayed and fitted with two iron bars as protection from cattle. A further former mullion window was present in the east wall, which also had a splayed opening internally, but had been partially blocked using concrete breeze blocks, and a four-light window inserted. This opening also had two horizontal iron bars fitted and was plastered over (Plate 20).

Plate 19: Former mullion windows in the west wall of the central room, looking northwest.

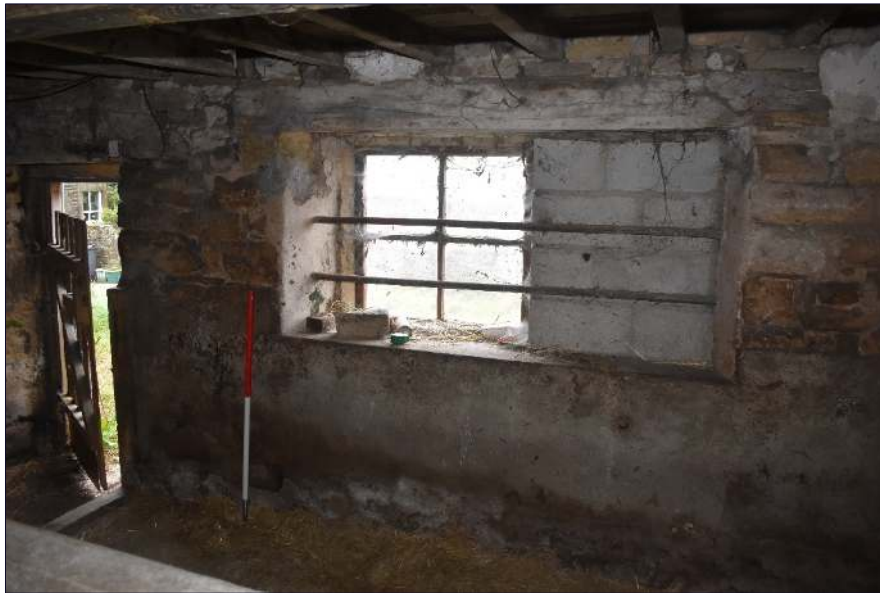
Plate 20: Modified mullion window in the east wall of the central room, looking northeast.

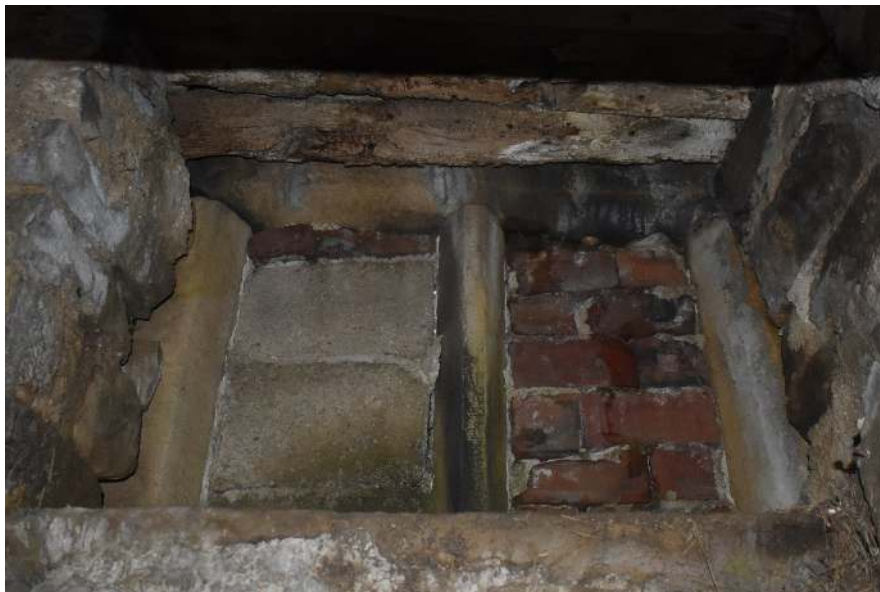
Plate 21: Blocked mullion window between floors in the west wall, looking west.

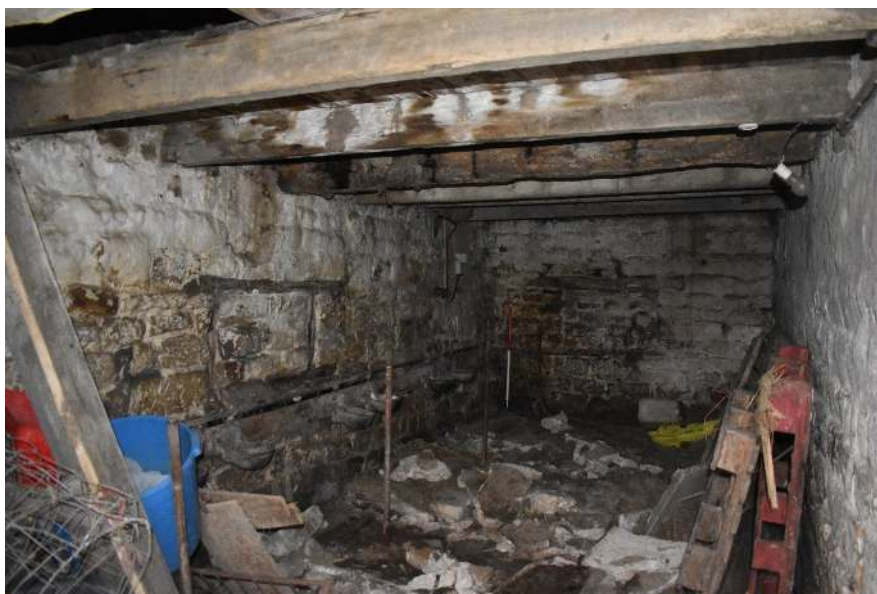
Plate 23: Blocked windows in the southern room on the ground floor, looking southwest.

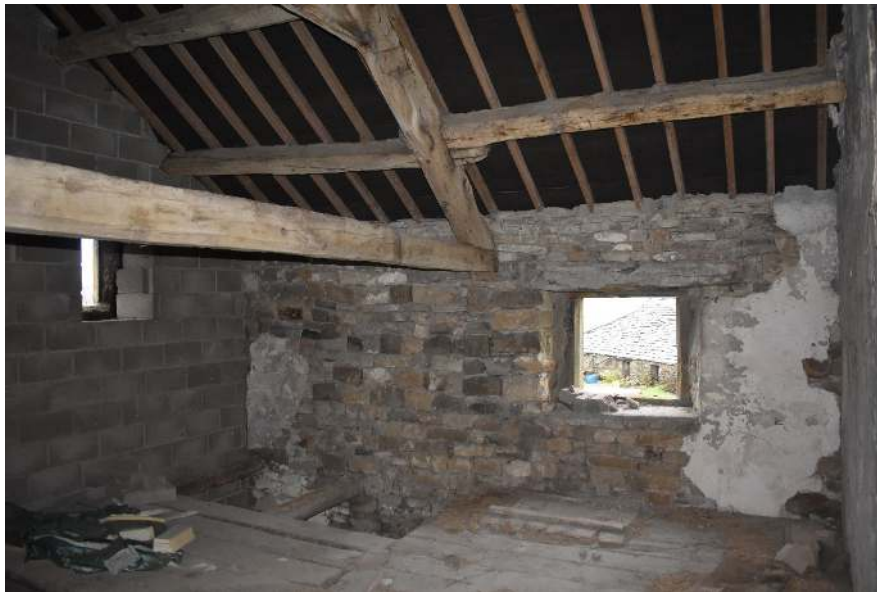
Plate 26: Former mullion window in the northern room on the first floor, looking northeast.

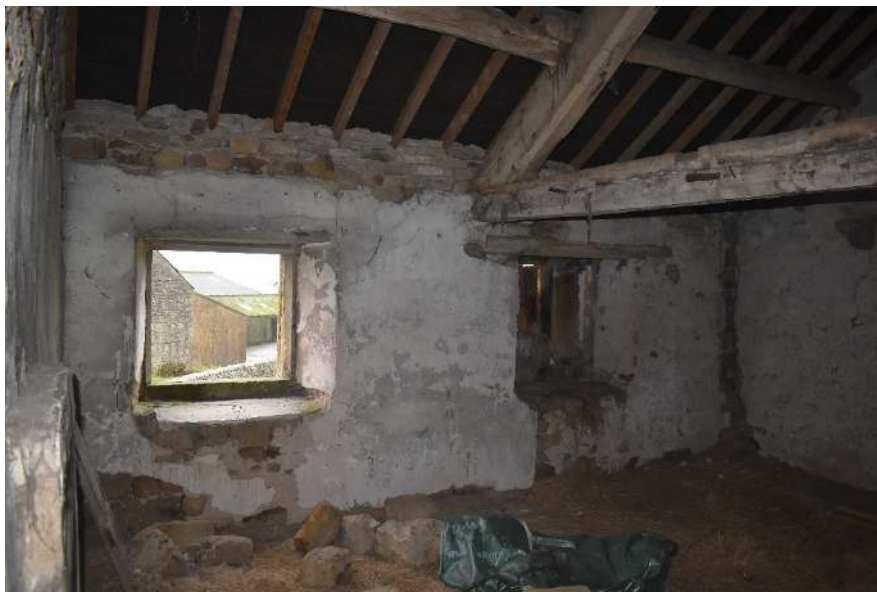
- 4.2.22 The central room was lit by two mullion windows in the east wall, one of which was filled in (Plate 27). The blocked window had a stone mullion *in situ*, but the other was missing. There was a further infilled mullion window in the west wall and the window between floors was to the north (Plate 28).

Plate 27: Mullion windows in the central room on the first floor, looking southeast.

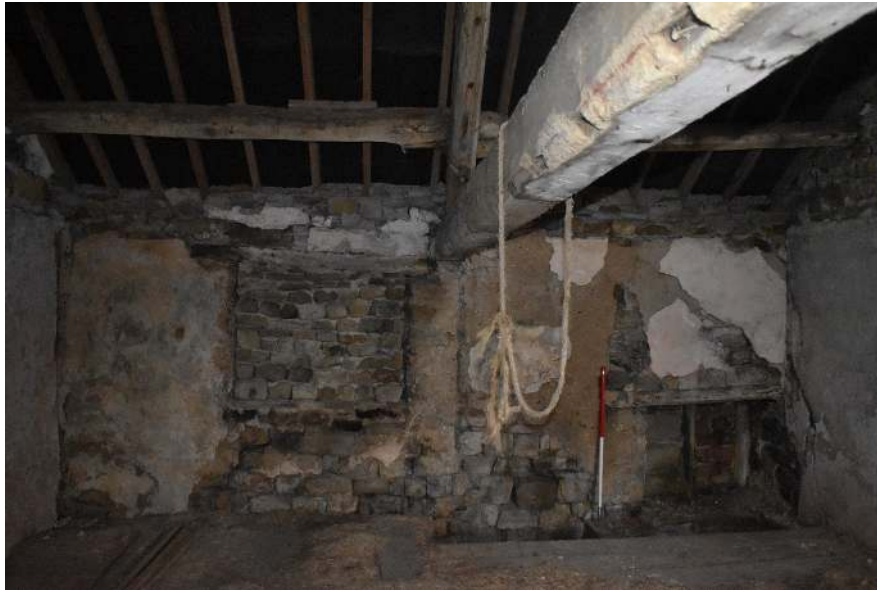
Plate 28: Blocked mullion windows in the central room on the first floor, looking west.
