Calcutt Farm, Houghton Regis, Bedfordshire A Measured Survey of a Moated Farmstead

J.M. BAILEY

SUMMARY

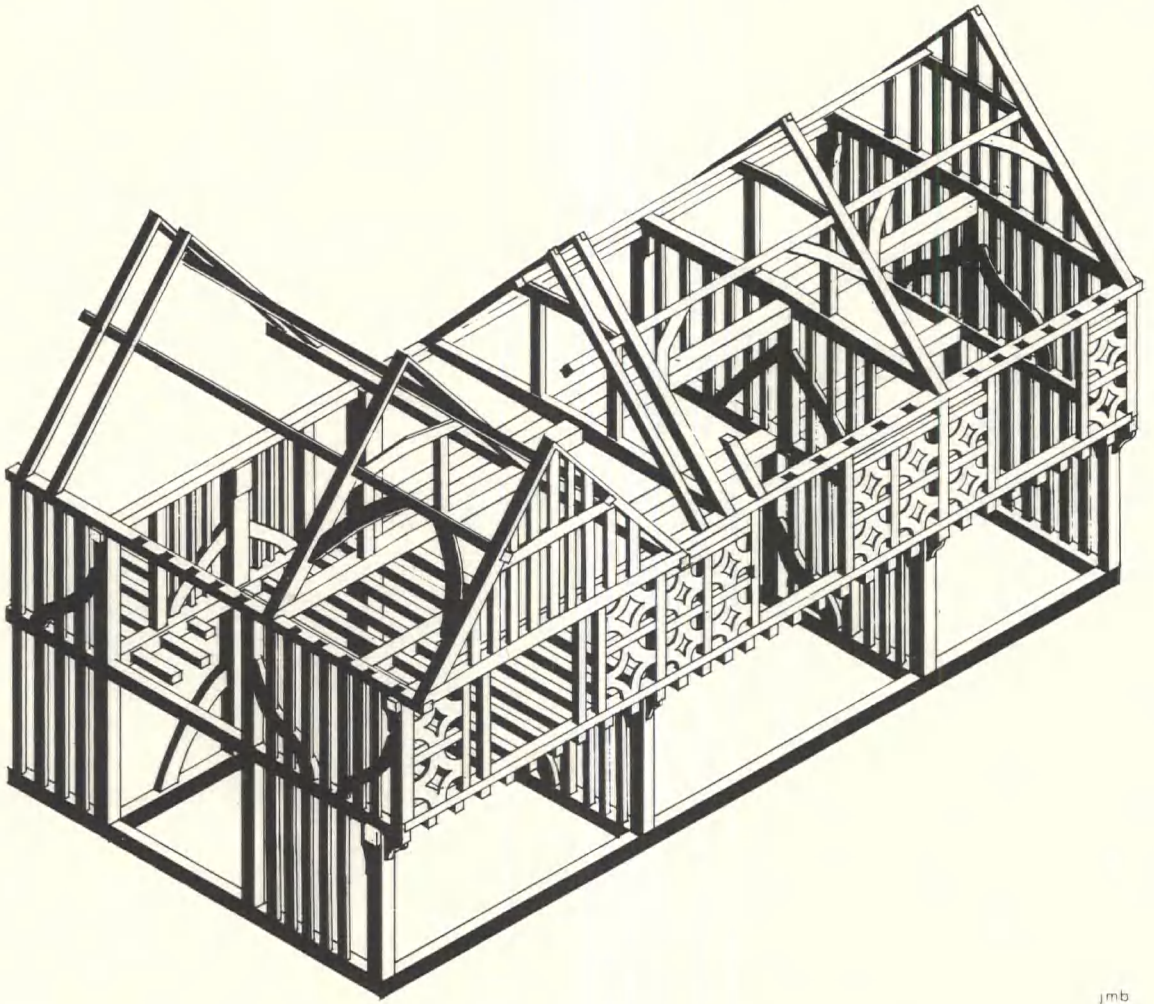
Fig 4 Isometric reconstruction of the original frame of Calcutt Farm, Houghton Regis, West gable infill and east wing studs conjectural; decorative infill panels shown are based on the mortise joint evidence.

The square panels alongside the window openings all have unpegged mortices on the centre of the inner face of each horizontal and vertical timber surrounding the panel. It is assumed that these would be for decorative braces and a conjectural arrangement of these is shown in figure 4. This form of decorative treatment is rare in Bedfordshire being in the "West country tradition," but there is an example at Meppershall where panels in the main elevation of the manor house are treated in this manner. The construction of the building, however, is not similar.⁵

The cross-halved joint used where the original east wing top plates cross the top plates along the front of the building indicate that the gable end projected beyond the front (west) face of the building as indicated in figure 4. Mortices in the top of the tie beam indicate that the east wing trusses were of queenpost construction.

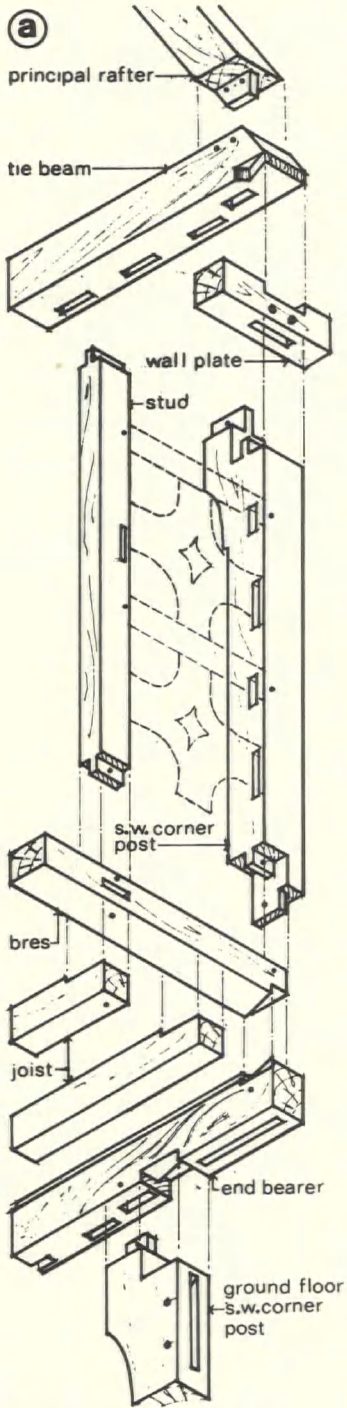
SOUTH WEST CORNER
VIEWED FROM N.W.

ner of the building is illustrated in figure 5A (north west corner similar). The first floor corner posts have foot tenons which tie the junction of the side bearer and bressummer. The side bearers are halved on the underside to fit over the ground floor top plates. A most complicated and unusual joint has been used for this purpose. The side bearers are rebated along their length to receive the floor boards which run from north to south.

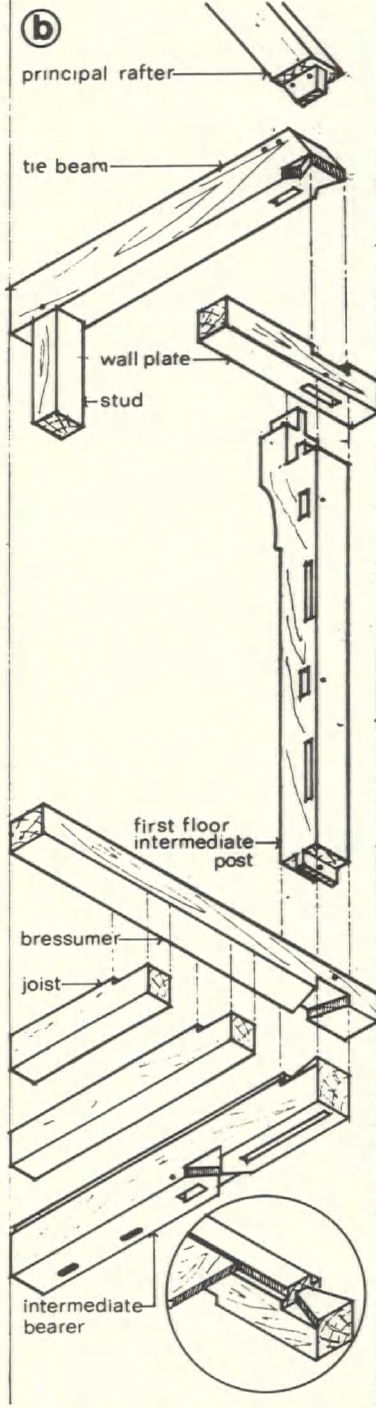
INTERMEDIATE POST JUNCTION
WEST ELEVATION FROM N.W.

The studs, although tenoned at top and bottom are not pegged. Figure 5B shows the construction of the western end of the southernmost intermediate frame.

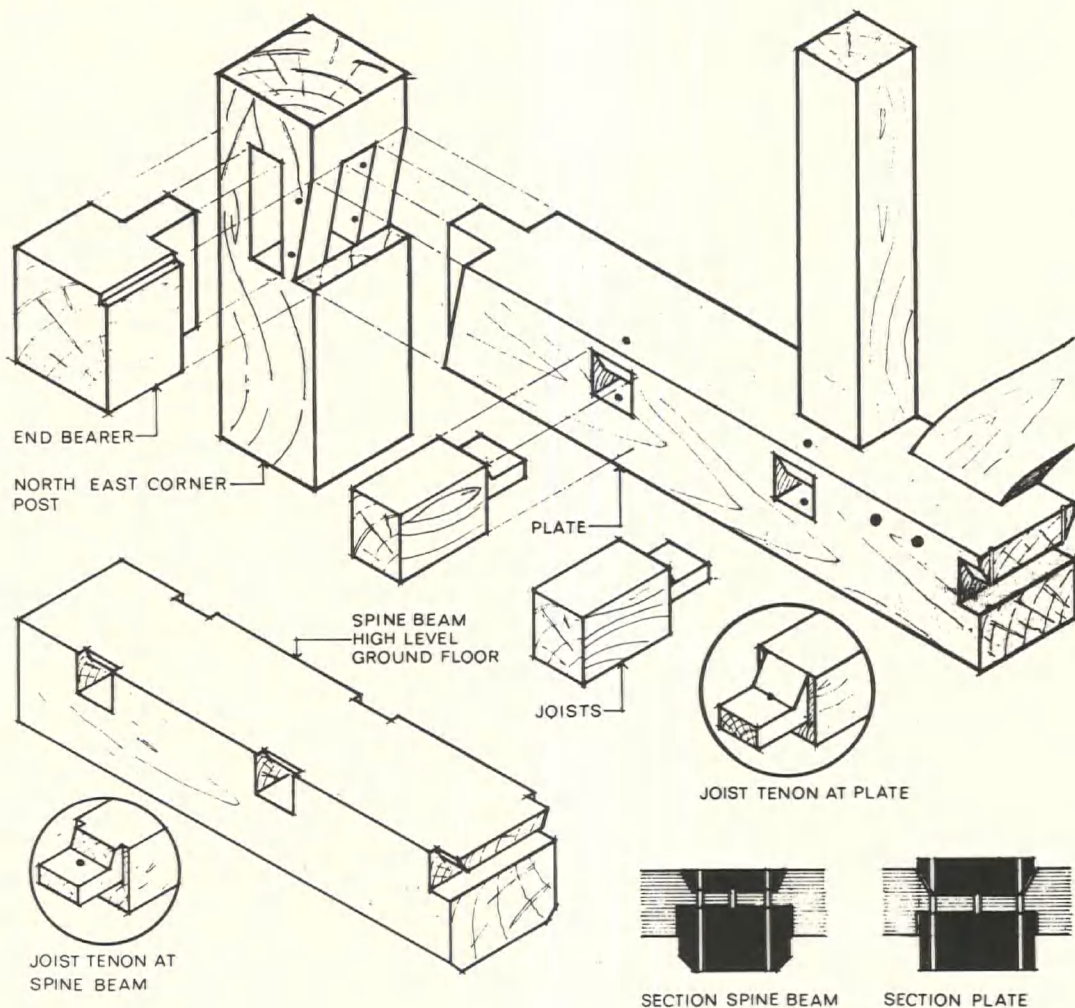
Fig 6 Calcutt Farm, Houghton Regis. Joints with the Floor Joists with the Spine Beam and the Rear Plate.

Floor joists are jointed to spine beam and rear plate by two variants of central tenons with diminishing haunch and peg, these are illustrated in figure 6. Also illustrated in figure 6 is the method of jointing the east ground floor top plate to the north east corner post. The joints are arranged so that the top of the joists are flush with the spine beam but lower by the width of the floor boards where they strike the plate. This allows the side of the floor boards to finish neatly against and flush with the platetop.

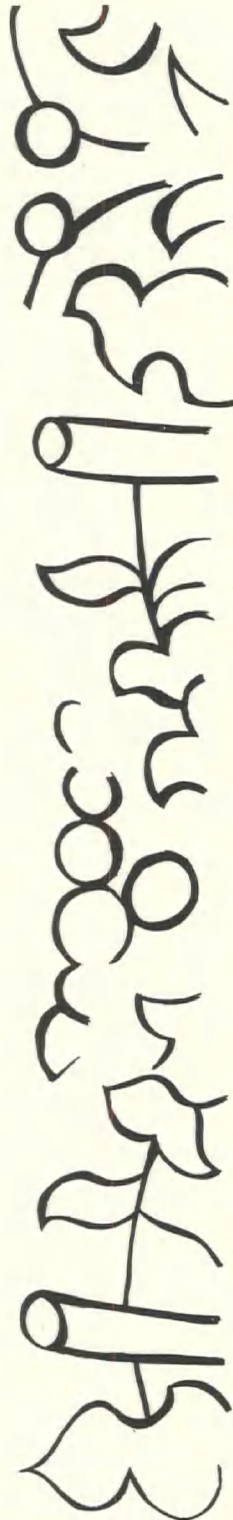
Fig 7 (Opposite). Calcutt Farm, Houghton Regis. Wall Painting. A section of the original.

A small section of painted wall decoration was found on the inner face of the door post to the first floor doorway between the north and central bays. A section of this design, which was white upon a red ground, is shown in figure 7. It

is a repeat design of a fairly large scale, not geometrical, but with fairly free and regular foliage, fruit and flowers. As the design goes around the doorhead it can fairly be assumed that it is not the remains of a design on a piece of reused timber. The design would have continued on the wall plaster now destroyed.

Dr E. Clive Rouse considers that the design is most likely to be early Elizabethan, but with only a small fragment to examine, it is not possible to give a close indication to date.
