# Lower Roxhill Farm, Marston Moretaine: a measured survey of a timber-framed building

J.M. BAILEY

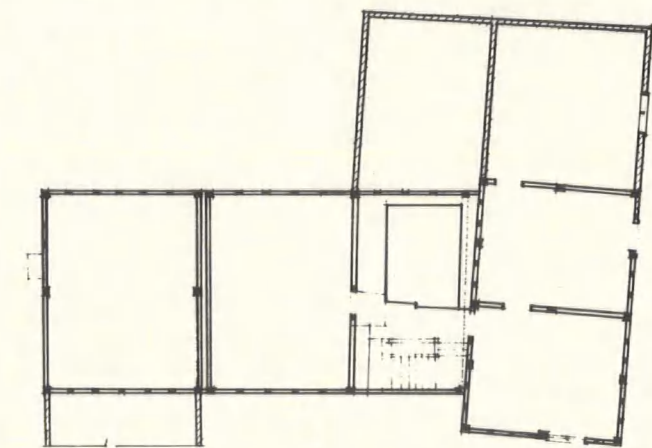
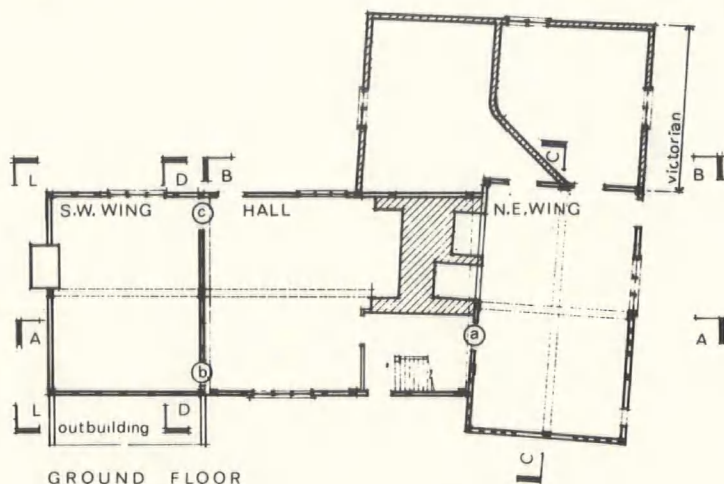
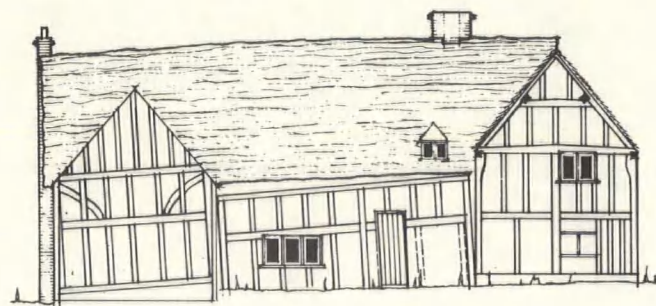
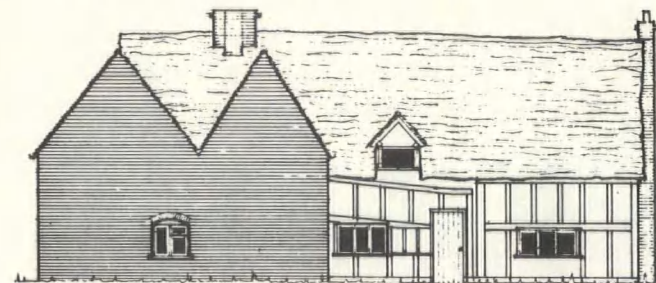
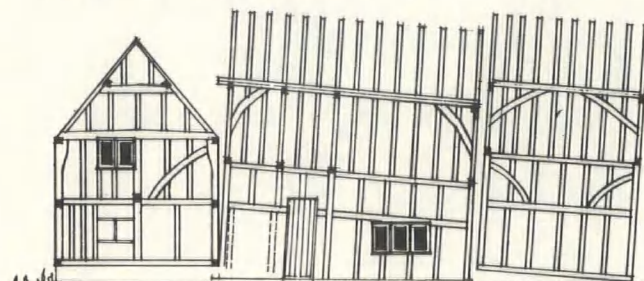
Fig 1 Plans, elevations and longitudinal sections.

The basic form of the original building was a hall with a two storey cross wing at either end. None of the three parts of the building is jettied and all seem to have been built, if not together, within a short period of time. Figure 1 shows the ground and first floor plans of the buildings as they now are. Running from south-west to north-east are the original south-west wing, hall and north-east wing. Extending to the north-west is a Victorian brick extension in two parts; the south-west part is of double storey height but

To the south-east is a range of late brick and timber-built outbuildings and stabling. Also shown on figure 1 are the north-west and south-east elevations together with a longitudinal section to the south-east. Both elevations have been drawn at an intermediate stage during the restoration when the pebble-dash had been stripped, but before new windows were added and doors repositioned. The south-east elevation is taken partly through the building. The longitudinal section has been simplified to show as much of the original work as possible and is a staggered view to miss the chimney and stair. Figure 2 shows the north-east and south-west elevations. Part of the outbuilding has been shown on the south-west elevation. The remaining sections and details in figure 2 are discussed in the body of this report. All of these sections have been much simplified to indicate the original work more clearly.

the south-west side of the south-east bay (door (a) on fig 1). As the wing was originally divided into two by what appears to have been an unbroken partition, there would logically have been a door in the south-west side of the north-west bay, also leading into the screens passage.

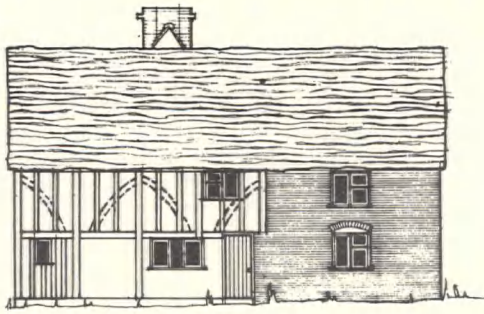
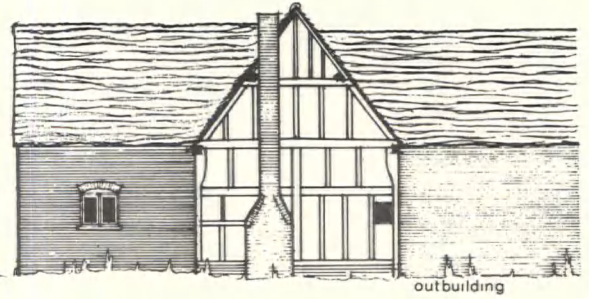
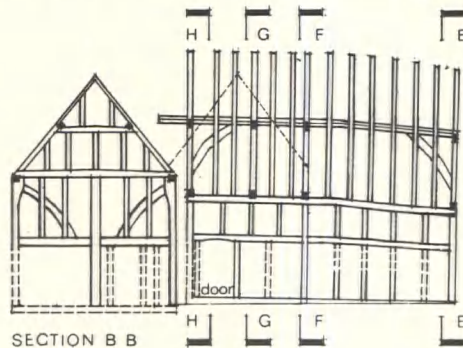
Fig 2 Elevations and Sections.

The roof has been much cut away and replaced but the location of the rafters can be seen and it is of clasped purlin construction. A simplified section through each truss of the hall is shown in figure 2. Section EE shows the south-west end of the hall from the inside. This was of very light construction with a queen post truss without studs above the collar. Below the tie beam the only structural members are the two braces from the underside of the tie beam to the corner posts. The remaining evidence of the north-east end of the hall, section HH, shows that this end was identical to the south-

west end. The central truss, section FF, is similar to the ends except that the braces strike the posts at a higher level. Section GG shows the additional truss forming what must have been the smoke bay. Only a small section of the collar and tie beam remain, as they were cut away by the inserted chimney. The trusses are of clasped purlin construction and, with the exception of the smoke bay truss, the principal rafters reduce in section above the collar.

An almost complete clasped purlin roof caps the building, with rafters and wind braces intact. In figure 2 there are sections through this wing, giving details of all evidence of original construction that can be seen so far. Section JJ looking to the north-west through the central truss indicates the two sloping queen posts that exist between the tie beam and purlins. The two curved braces at first floor level have also been indicated. A row of mortices along the underside of the horizontal beam would seem to indicate that there was an unbroken partition running across the wing at ground level and the studs have been indicated in chain dot.

In addition to the elevation on the south-west end of this wing a reconstructed detail (section LL) has been shown on figure 2. All of the existing evidence has been summarised on this section, with the studs shown in their original position. It has been assumed that all of the close studding at ground floor level was full height between mid-plate and ground cill. Section DD through the north east wall of the wing can be completely re-

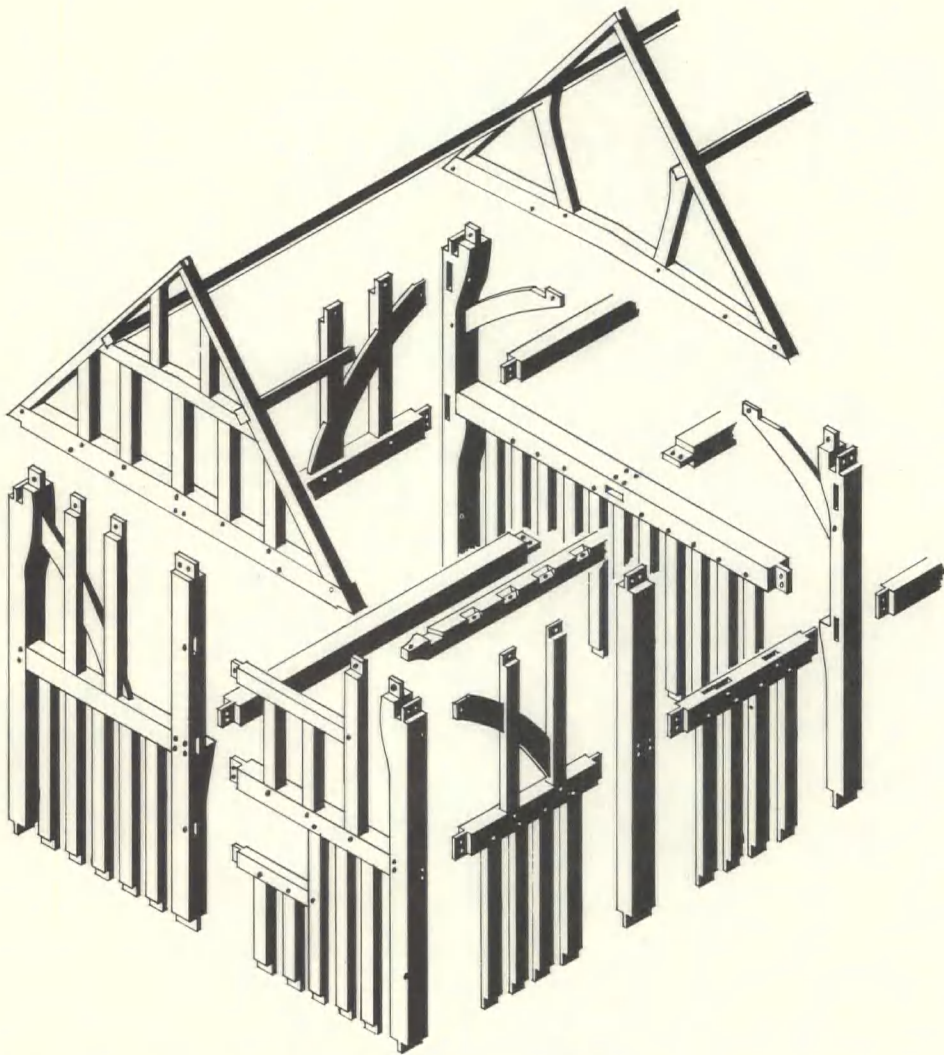
Fig 3 Exploded isometric view of north-east wing, looking from east.

Exploded isometric views of the north-east and south-west wings respectively appear in figures 3 and 4. The former (fig 3) is shown looking from the east and gives details of the carpentry for half of the wing. The window locations visible are shown on the south east elevation at ground and first floor levels. The partition across the centre of the wing has also been reconstructed. Further details such as rafter locations and wind braces are shown on the composite isometric drawing (fig 5). Figure 4 is an exploded view of the south west wing looking from the west. The original stair position is shown at the north east end of the wing. Also shown is the detail of the hipped end with the supplementary collar across the common rafters.
