**3 Market Place,  
St Columb Major  
Cornwall**

**Historic Building Recording  
and Archaeological Watching  
Brief**

For: **Silverlake Design Ltd**  
On Behalf of: **Mr Giddings**  
ISCA Project: **P02-0013**  
ISCA Report: **R02-0013-2**  
**July 2022**

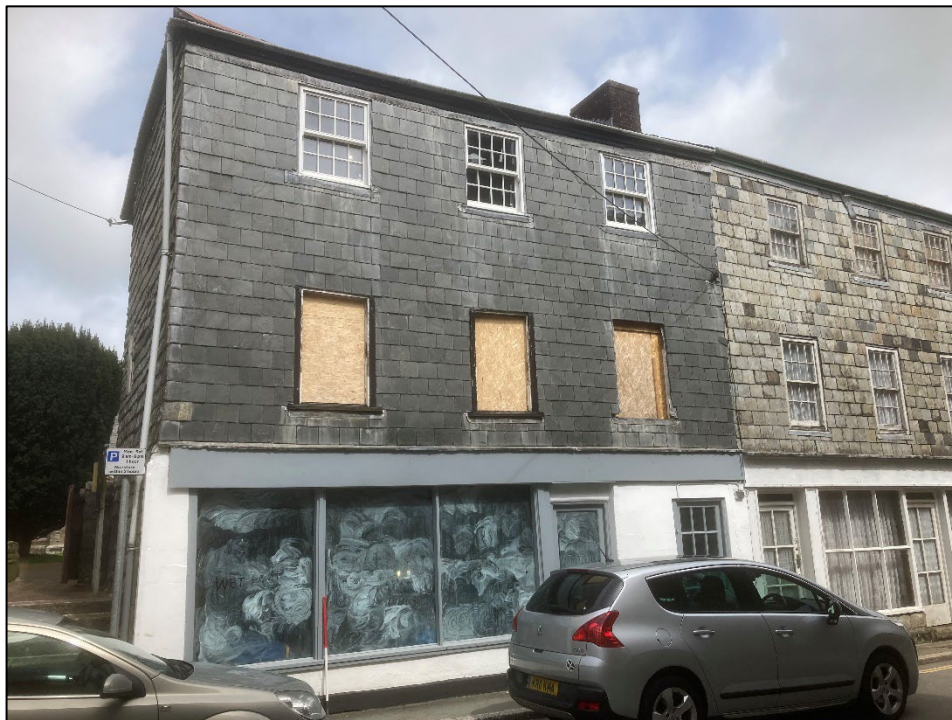
5.7. The south elevation of the building, above the shop front, is clad in modern artificial slate and is of sound repair (Fig. 5). This is contrary to the historical character of the western and northern elevations of the building which retain their rag slate cladding (Figs. 7 and 8). The slate cladding of the western and northern elevations is visibly less well preserved than the artificial slate cladding of the front of the building. The western and northern elevations have been subject to repair work in the past where artificial slates, of the same type as the front of the building, have been used as replacements for damaged slates.

**Figure 5:** External view of the shop front, view to the north

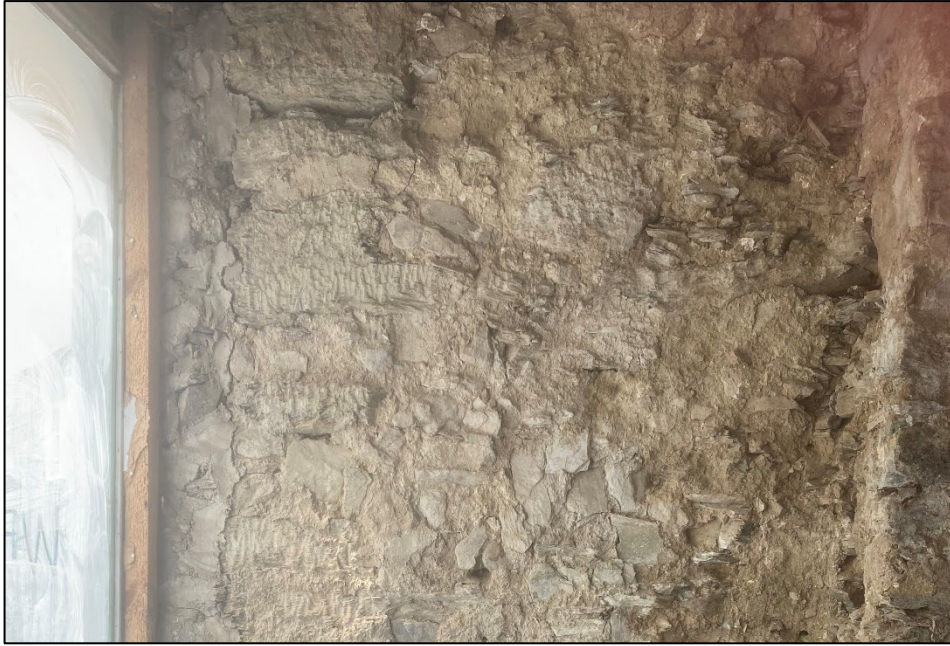
**Figure 6:** Photograph demonstrating the truncation of the historic western elevation. The truncation occurs where the wall meets the modern shop front. View to the west

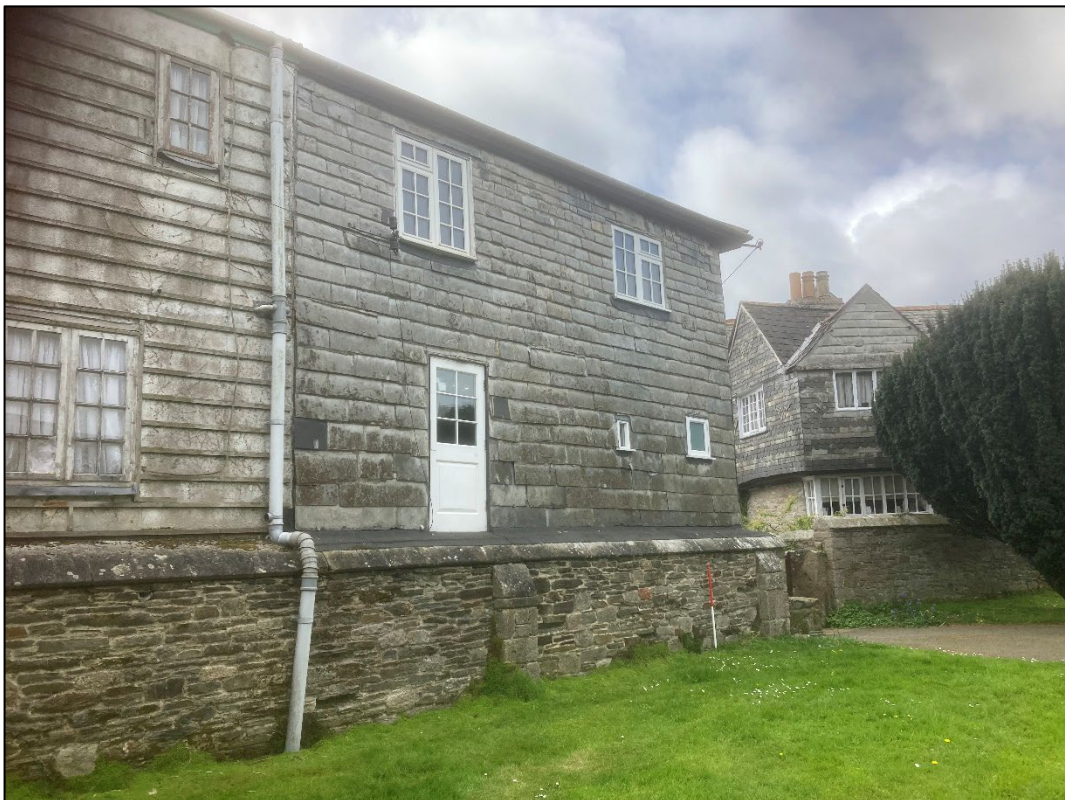
**Figure 7:** The buildings southern elevation facing the churchyard. View to the southwest

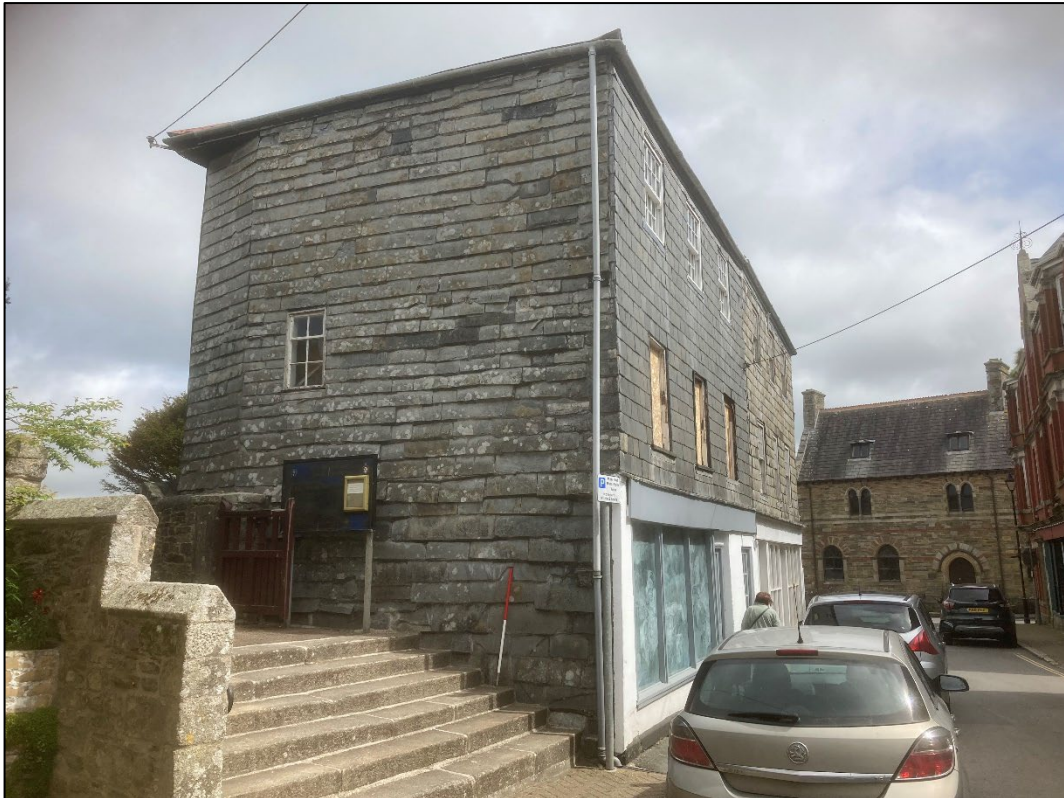
**Figure 8:** The buildings western elevation. View to the northeast

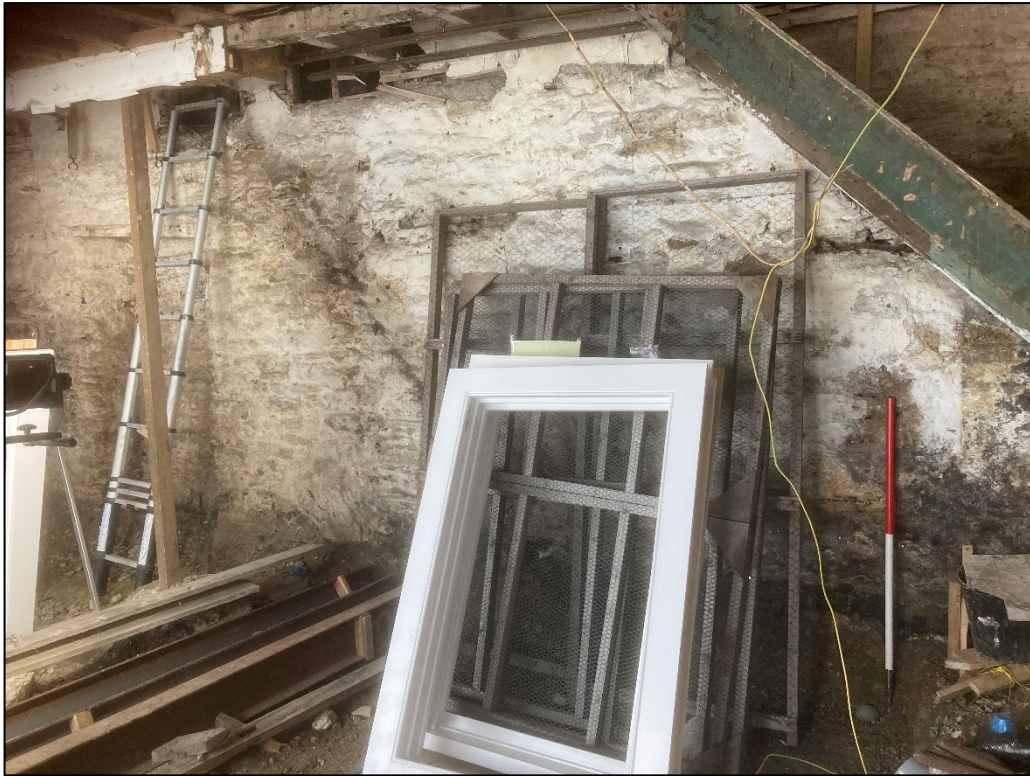
- 5.12. The western and northern walls are constructed of local Killas rubble laid in a clay mortar. Vestiges of clay plaster are still visible on both walls as well as small sections of earth/cob repair work. Both the western and northern walls are of the similar construction and likely contemporary, although the northern wall has appeared to survive in a better state of preservation and largely retains its limewashed face (Fig. 10).

**Figure 10:** Internal photograph of the northern elevation. The wall is constructed of local killas stone and largely retains a limewashed face. View to the north

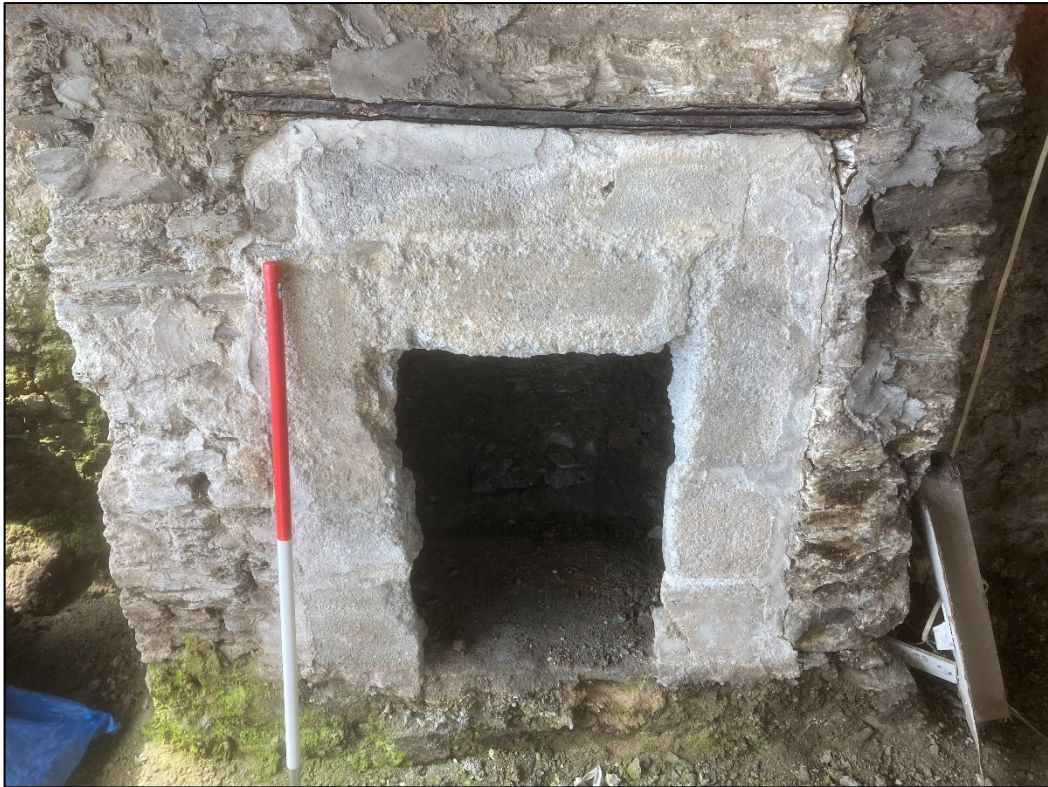
- 5.13. A fireplace stack is projected slightly off centre to the south of the western wall. The stack is of predominantly constructed of local killas stone with quoins approximately 2m from current ground level. The stack and the internal flue cavity are likely contemporary with the western and northern walls and survives from an earlier phase/building form.

- 5.14. The fireplace surround adjusted in the modern period with the edition of concrete breeze blocks which has reduced the size of the fireplace opening. The historic hearth was of adequate size to encompass a cooking hearth/kitchen space of an earlier arrangement. Beyond the current breeze block adjustment, the original surround is a wrought iron strap lintel that remains in-situ (Fig. 11). Mundic deterioration in the concrete breeze blocks is characteristic of properties built in the South West of England using concrete made of waste rock from mining, quarrying and beach gravel. The production of blocks using these materials took place from the turn of the 20th century until the 1950s. Mass production of concrete blocks became common after this time; however, this did not completely eradicate the use of local materials in blocks and foundations until the early 1960s ([cornwall.gov.uk](http://cornwall.gov.uk)).

**Figure 11:** The fireplace stack and flue on the building's western wall. View to the west

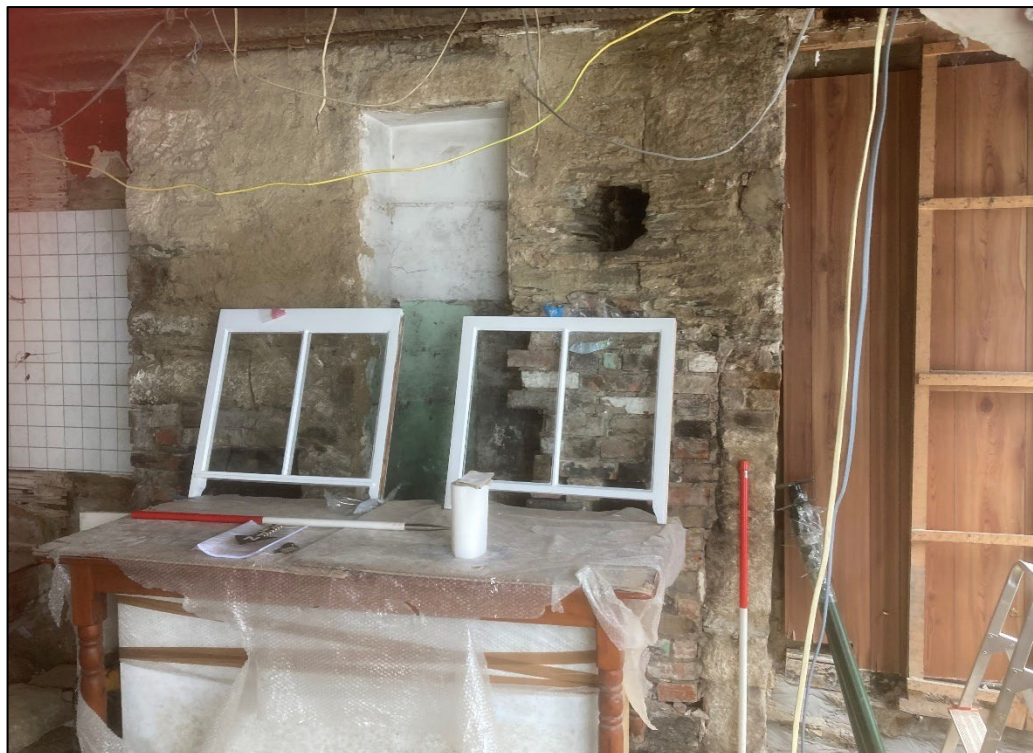
- 5.16. The Party wall to the east retains some lath and plaster. A studwork wall is visible behind the plaster between the buildings and likely dates to the renovation/remodelling of the building in the 19th century (Fig. 12).

**Figure 12:** The eastern party wall. View to the east

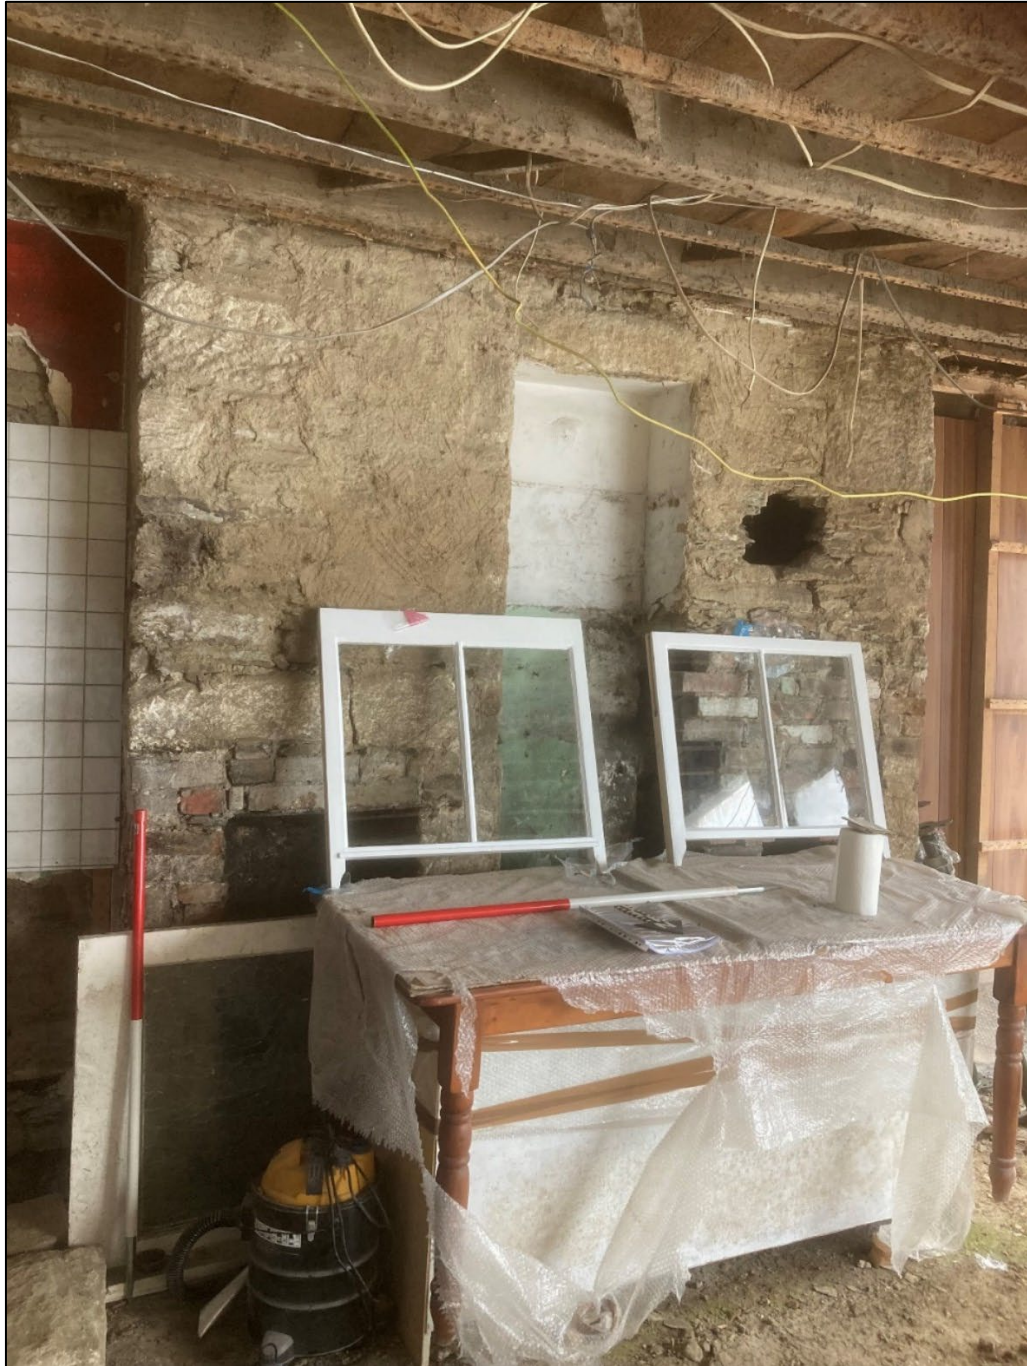
- 5.18. The flue projections are of local killas with some granite quoins roughly dressed. The mortar is composed of clay with some vestiges of a clay rich plaster. The left hearth of the eastern wall retains a granite lintel that has fractured. Probably to address this failure an iron strap lintel has been inserted with red brick infill to bear the granite (Fig. 13). The right hearth opening has been infilled with 18th-19th century red bricks suggesting repair work prior to late 19th century rebuilding. Two substantial sawn timbers within the flue projection appear to pre-date the 19th century re-building and are presumably structural from an earlier building phase.

**Figure 13:** The eastern flue stacks. An iron strap lintel and repair work in red brick are present within the northern (left) stack. View to the east

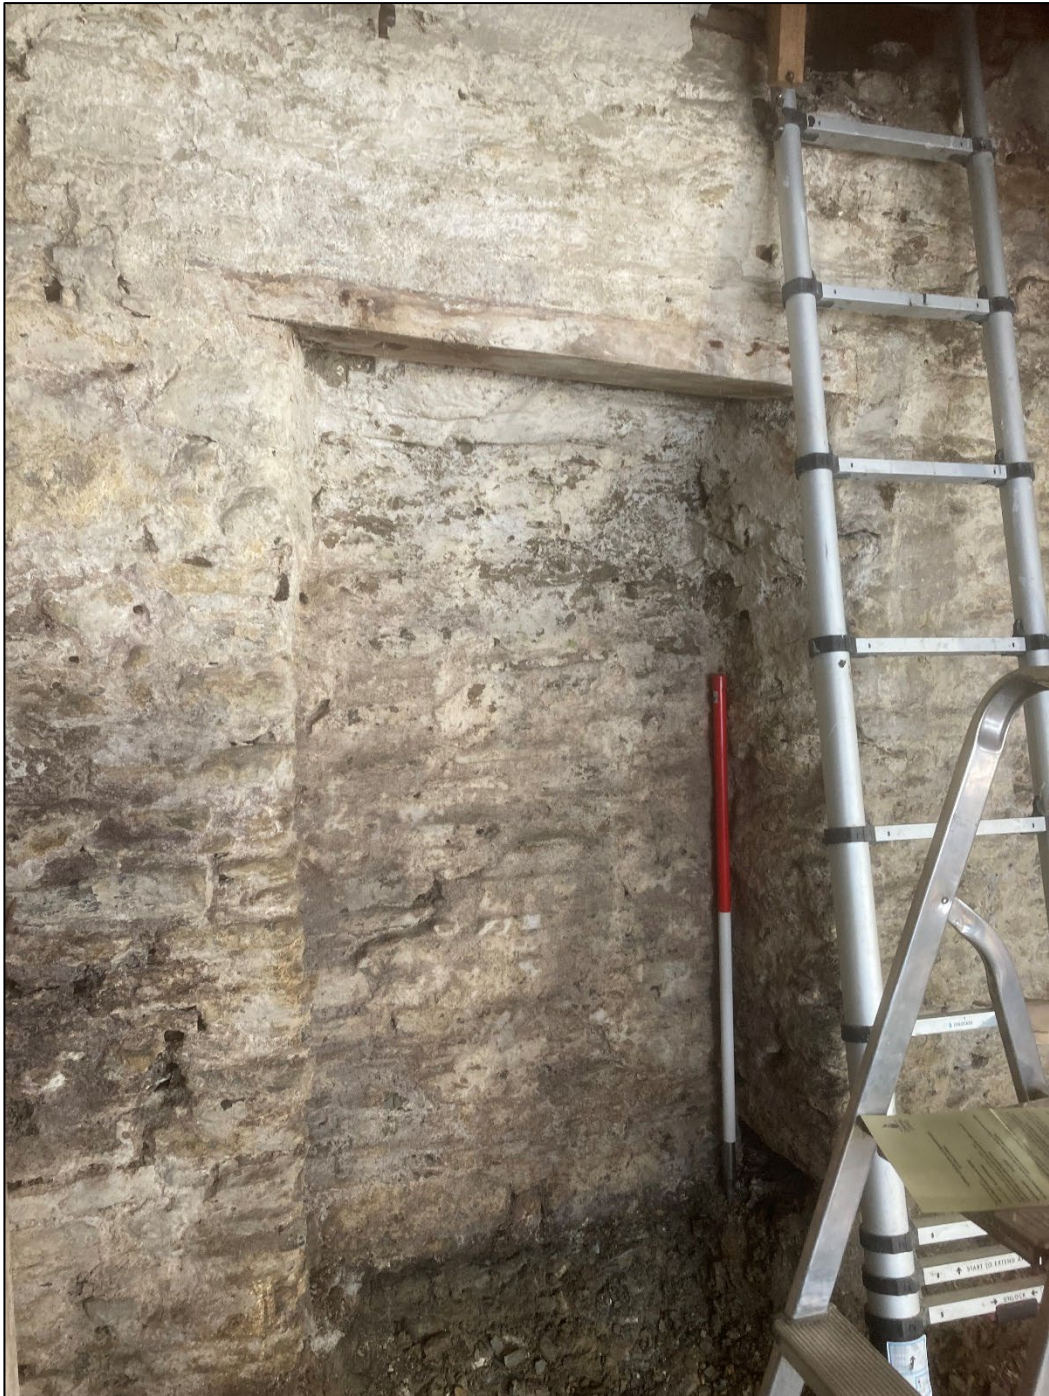
**Figure 14:** Door or alcove present in the northern wall. View to the north

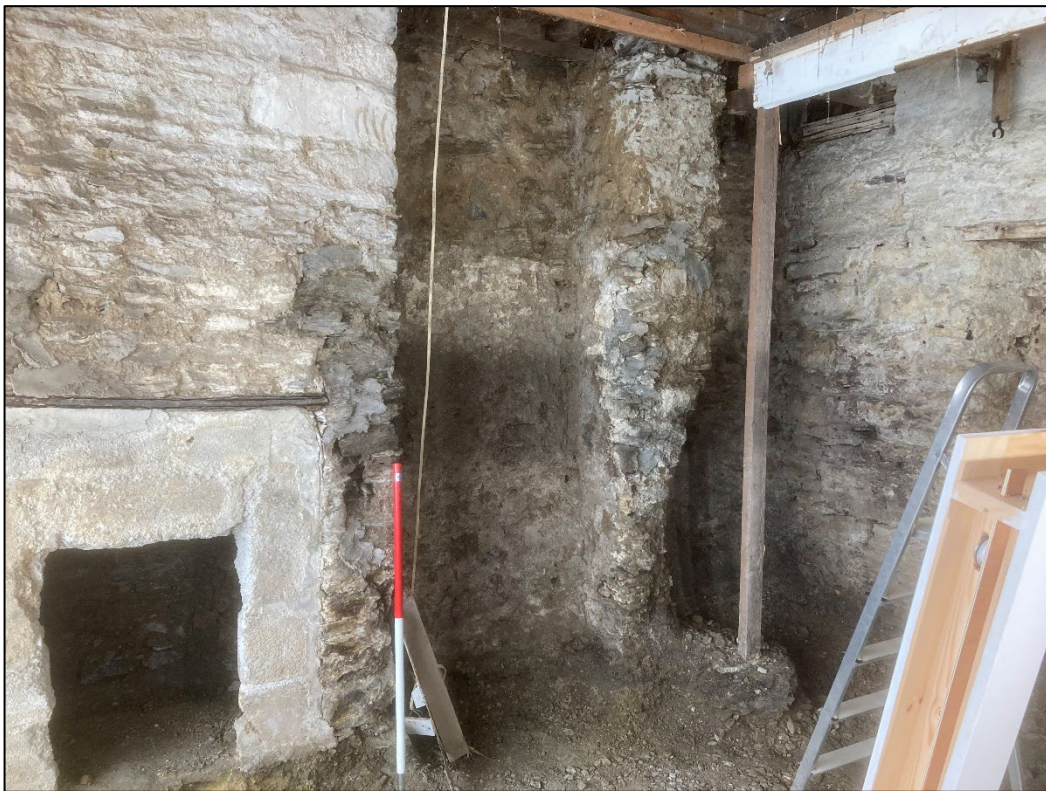
- 5.21. Although historic subdivisions are removed, a truncated wall on the northern part of the western wall still exists *in situ* and indicates the location of a historical subdivision. The wall is of local killas stone and similar in composition to the western and northern walls suggesting it is contemporary (Fig. 15).
- 5.22. To the north of this truncated wall, the corridor, or cavity, between the current northern wall and the projected route of the truncated wall likely served as a rear passageway serving

**Figure 15:** Truncated wall on the northern part of the western wall indicating the location of a historic subdivision. View to the northwest

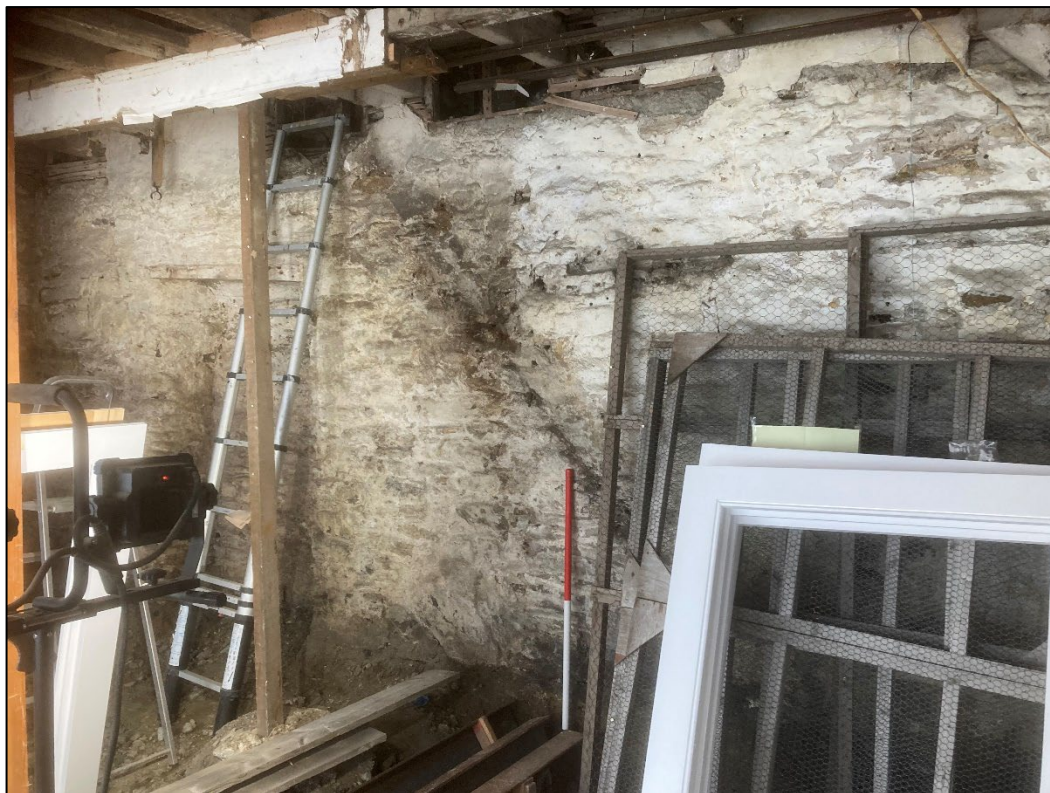
- 5.23. To the east of this opening, dark markings in a transversal direction relative to the wall indicate the presence of a former timber staircase (Fig. 16). A Transverse timber over the first-floor joists indicate there was once a subdivision with a further and heavier axial timber which bears joists from front elevation to back. Additional joists have been inserted from this to the north stone wall and clearly post-date the previous staircase. The axial timber, which also bore a subdivision, is structural support for the heavy joists of the first floor.
- 5.24. The in-situ staircase is a basic modern timber winder which has likely been altered to fit the current position with a winder to the ground floor level. The stairs show signs of extensive rot to the timbers abutting the wall. The stairs are not considered to be of heritage interest.

**Figure 16:** Photograph demonstrating the position of a former staircase along the northern wall. View to the northwest

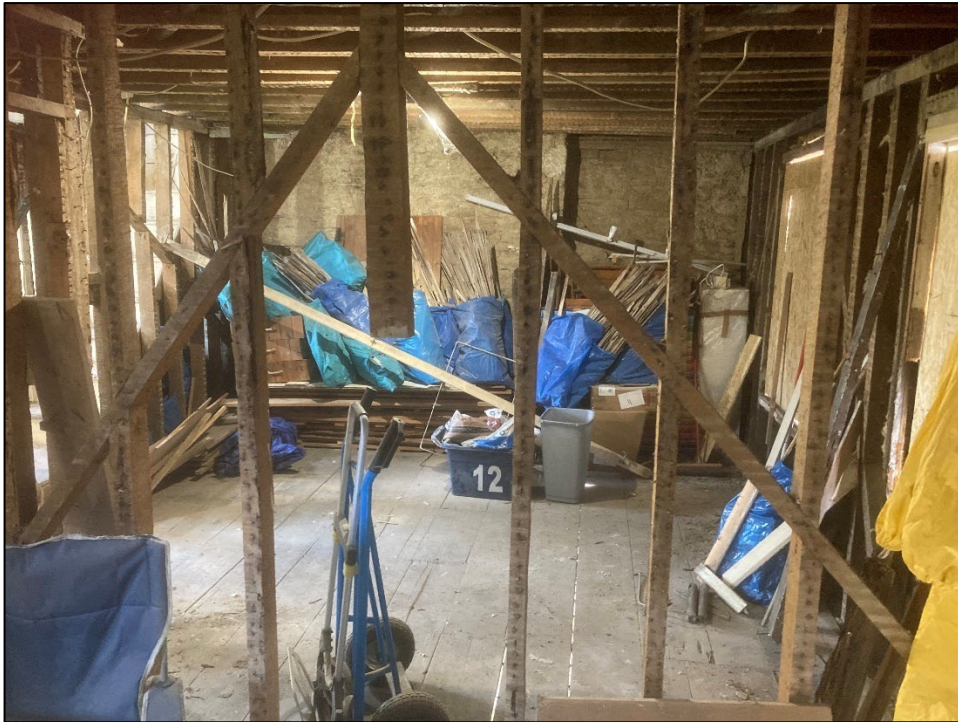
**Figure 17:** Internal subdivisions on the first floor are of timber stud. Their fibreglass boards have been removed. View to the east

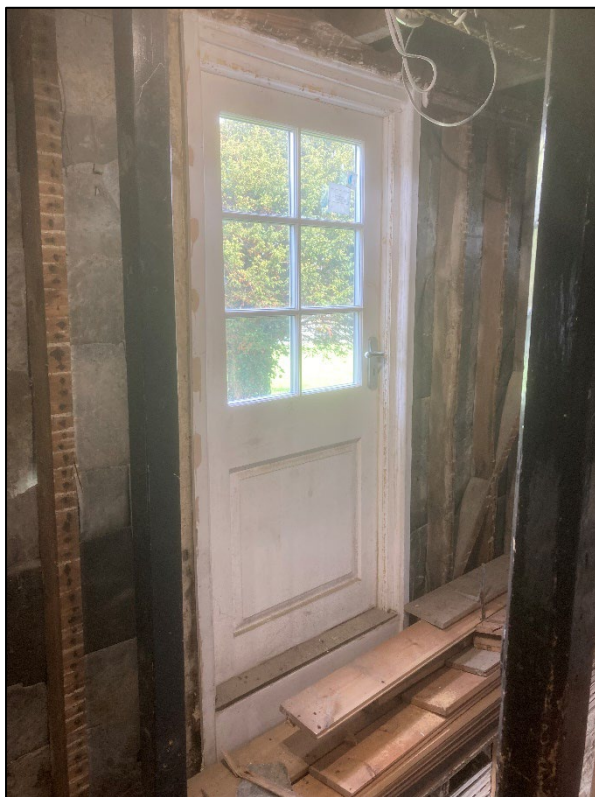
**Figure 18:** Door on the northern wall eastern side which once served a timber balcony overlooking the churchyard. View to the northeast

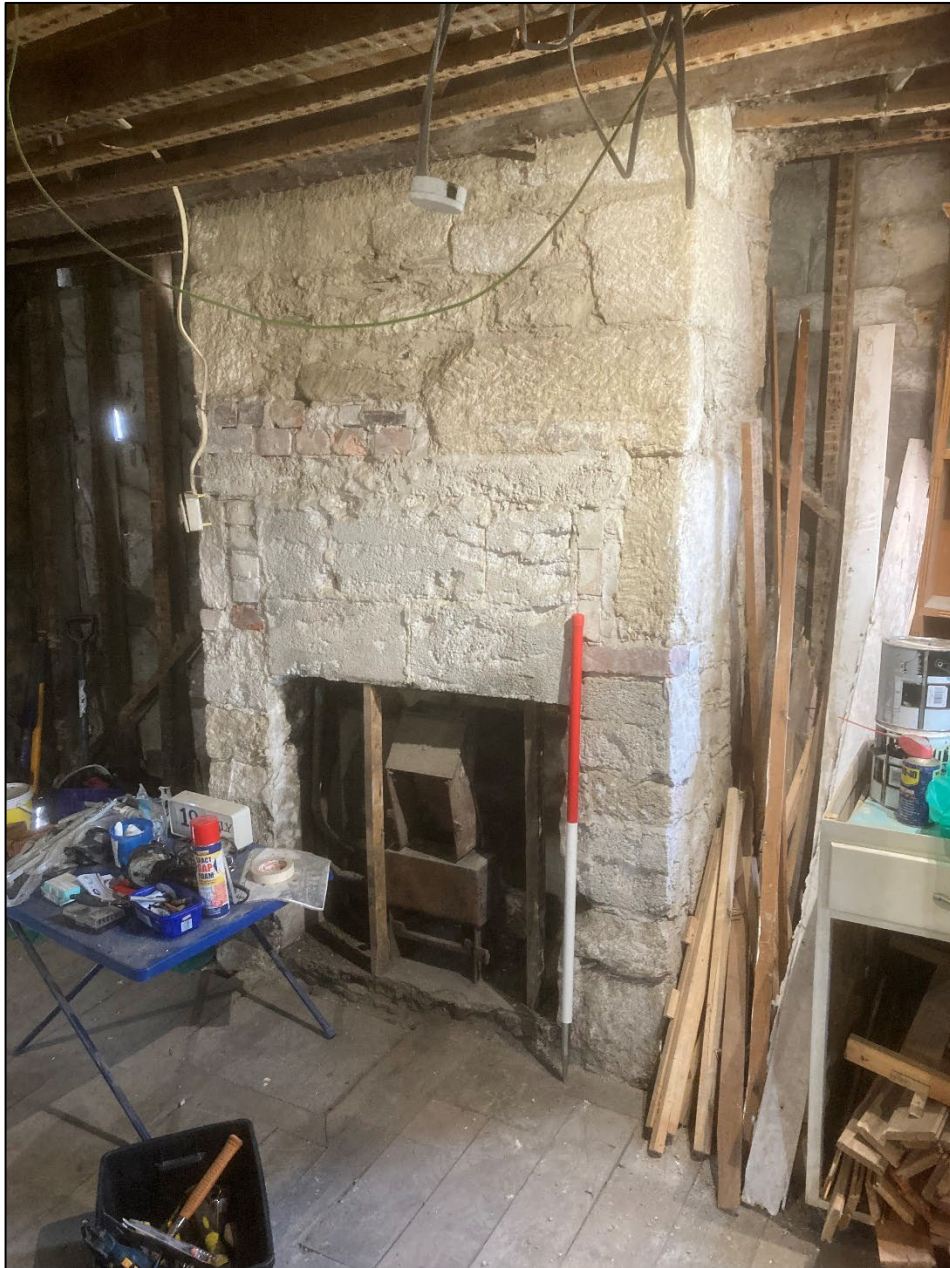
- 5.31. The western wall is of similar construction to that of the northern wall, of rag slate cladding direct to studwork. The stone stack/flue projection continues on to the first floor although a better construction and preservation of granite quoins and generally better construction suggests a rebuilding of the stack in this location likely to be contemporary with the structural work of the rest of the first floor. A hearth stone in the floor indicates it probably held a bedroom grate prior to the current mid-20th century boiler and may have historically been a larger surround (Fig. 19).

**Figure 19:** The continuation of the ground floor fireplace stack on the western wall. The stack appears to have been rebuilt from the first floor upwards. View to the southwest

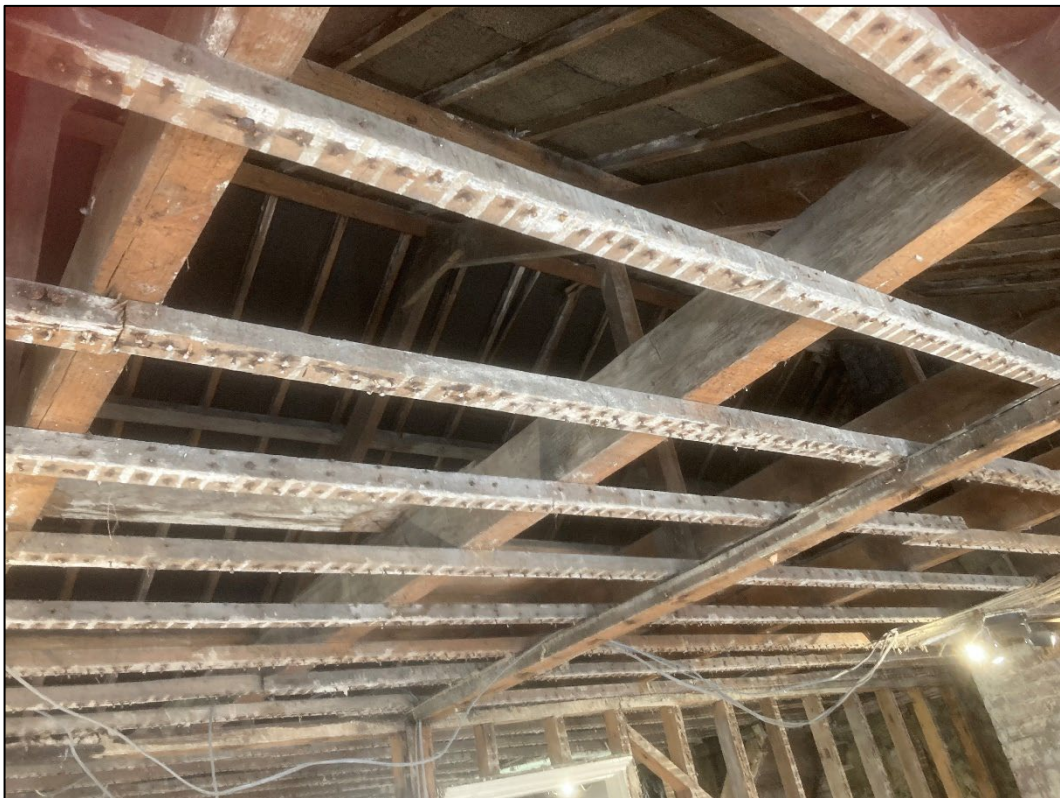
- 5.34. The roof space is constructed of queen post trusses with lapped collars (Fig. 20). Through purlins are probably relatively recent replacements, perhaps when the roof covering was renewed. The roofing itself consists of artificial slate with a red clay ridge over sarking felt and likely dates to renovation work carried out in the 1960s (Silverlake Design, 2001, 21).

**Figure 20:** The roof space constructed of queen post trusses with lapped collars. View to the northeast

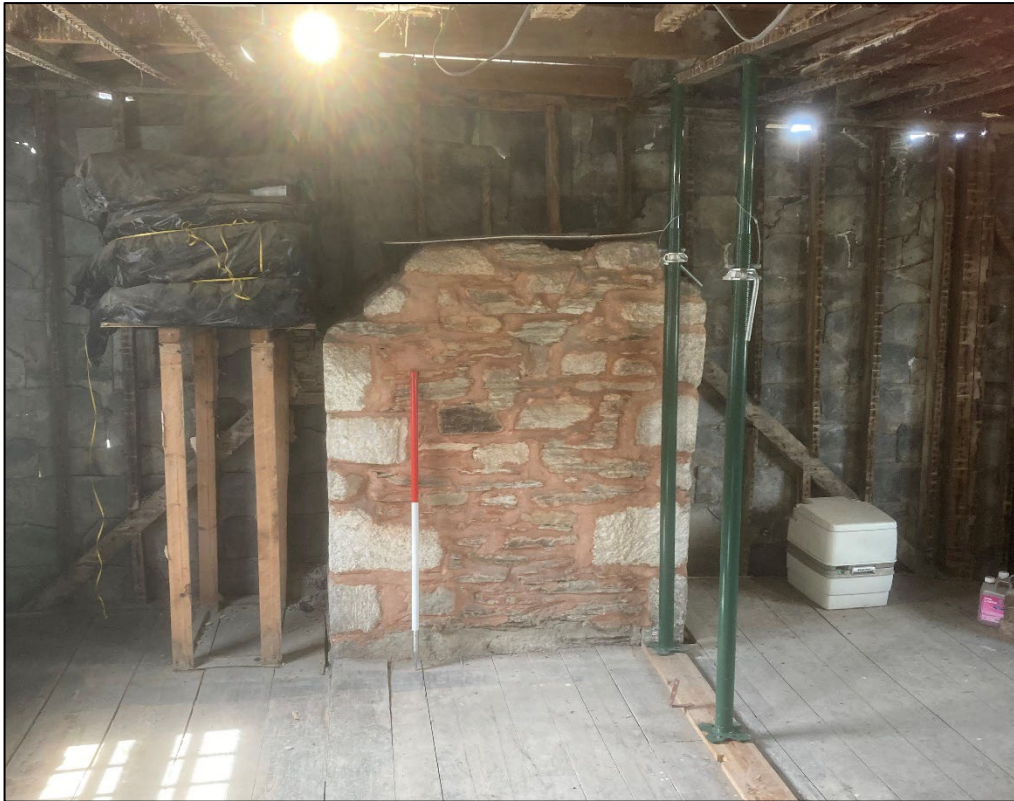
- 5.35. The most noticeable aspect of the second floor is the continuation of the stacks/flues from the previous two floors (Fig. 21 and 22). Neither the eastern brickwork stack or the western killas stone/granite stack reaches the roof space and may have been truncated to make way for the roof renovation in the modern period.

**Figure 21:** Continuation of the western flue stack. Slate cladding is visible on the buildings western wall. View to the west

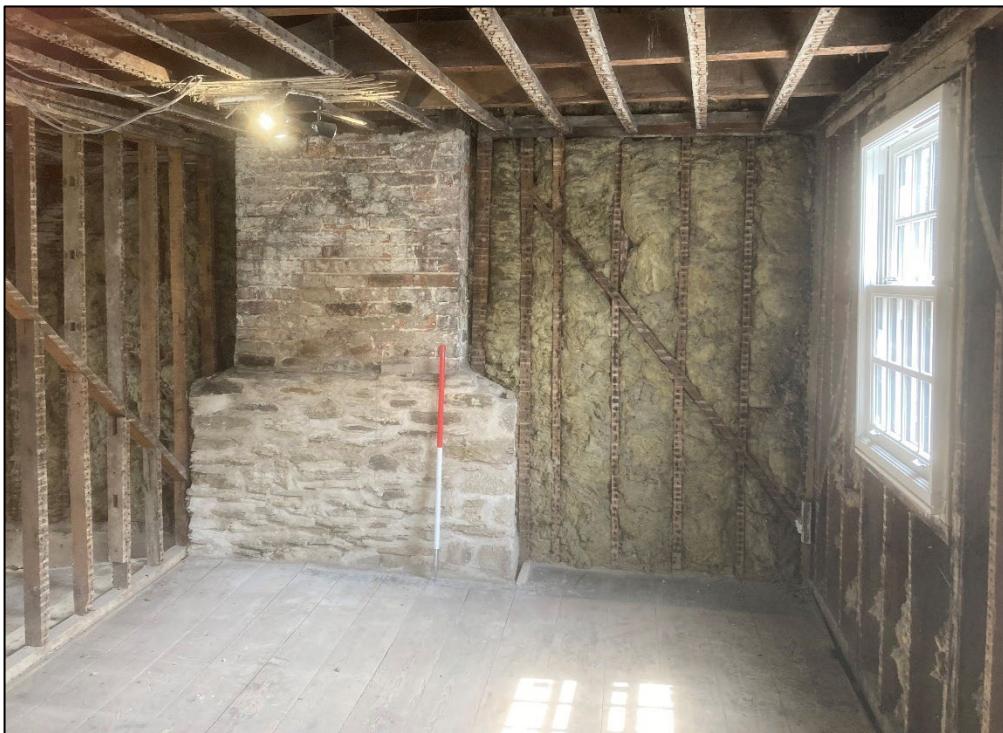
**Figure 22:** Continuation of the eastern flue stack along the eastern wall. View to the east

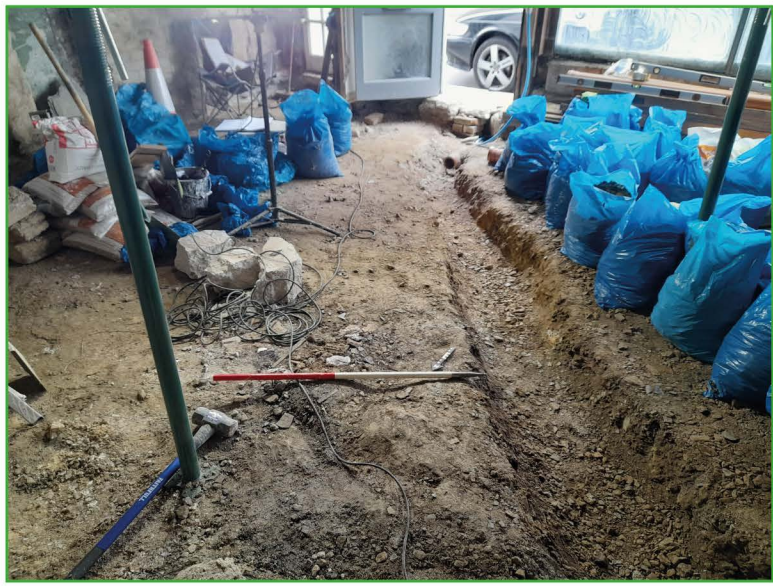
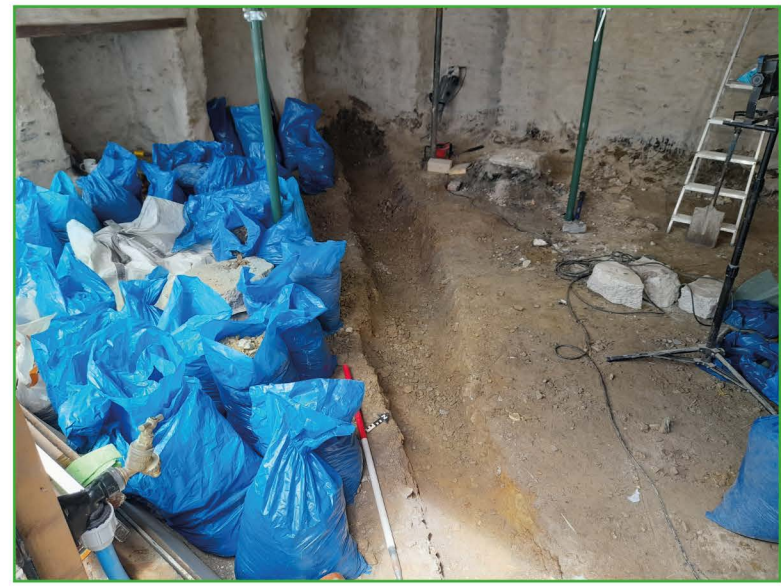
Figure No. 24

- 6.4. Below the 0.15m thick concrete slab (101), was a very compact layer of brown silty clay with a large quantity of 'shillet/killas stone (100), through which the service trench was dug. No underlying natural substrate was observed. There was no sign of any remnant footings, or a construction cut for the former east/west aligned wall, which would have formed the earlier northern elevation, indicating that the rubble material post-dated the removal of this wall and likely related to the later Victorian re-modelling of the building.

Post Excavation of Service Trench. Facing southeast (Scale at 1m)

Post Excavation of Service Trench. Facing northwest (Scale at 1m)
