RADNAGE. CHURCH OF ST. MARY.

REPORT OF CHURCH RESTORATION SUB-COMMITTEE.

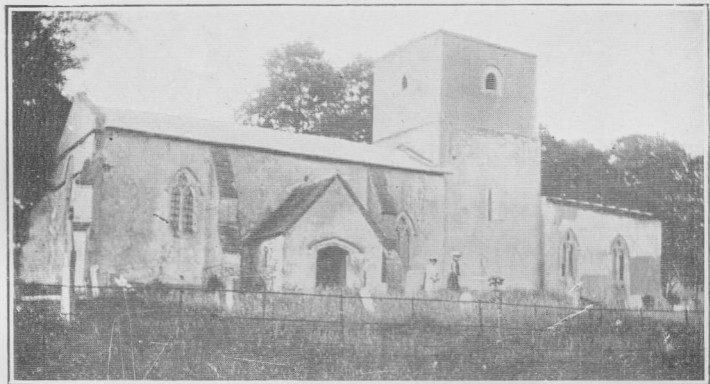
RADNAGE CHURCH.

General View from the South West.

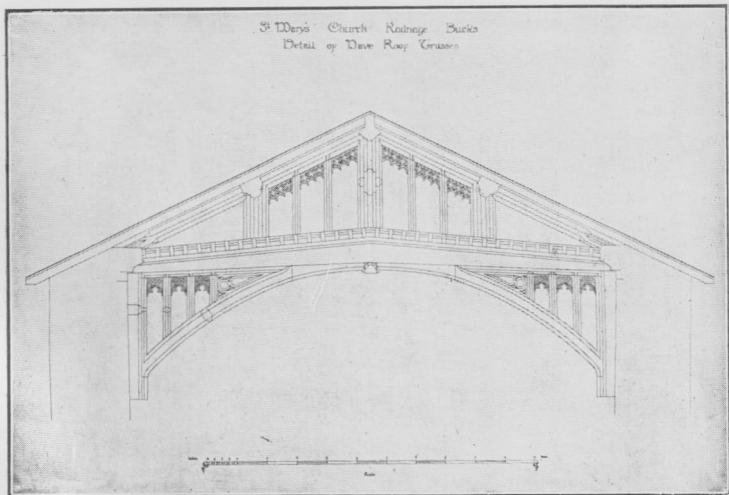
NAVE ROOF.

pointed arches below the Tower. These arches are of massive simplicity, and show up well in the darkened space below the Tower, separating the Chancel from the Nave in such a marked way. The 15th century oak-framed roof of the Nave has carved members, and is an excellent example of the carpentry of the period for which English roofs were famous.

Roofs.—The old lead requires adjusting in the welts and drips. No new lead should be used, and if new sheets are required the old metal should be re-cast at the site. Timbers probably require repair at the wall ends. All repairs must be done in position. Corbels may be introduced, if required. Timbers should be cleaned, and not oiled or stained in any way. On no account should any attempt be made to replace the missing moulded or carved parts of the roofs.

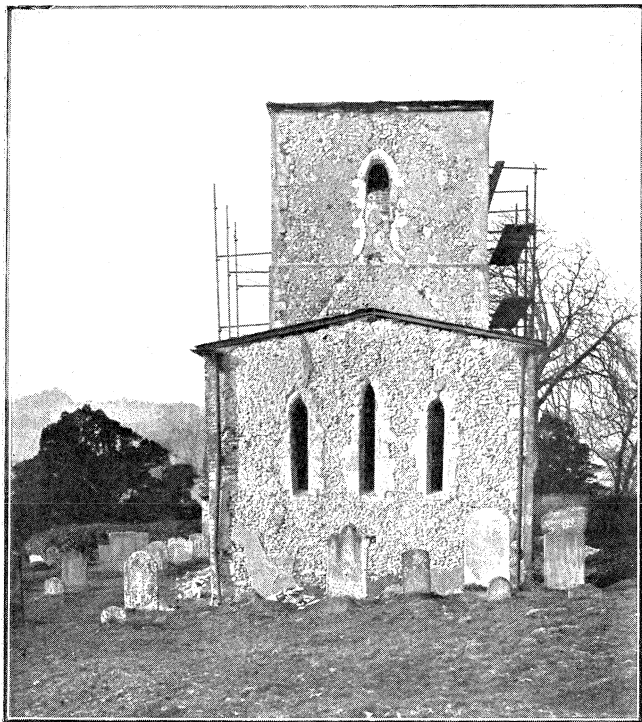
RADNAGE CHURCH.

View of East End.

Three lancets in the east wall form the chief interest of the Chancel, which is simple in its architectural character.
