# **BARN TO THE WEST OF 83 LONDON ROAD, SHARDLOW, DERBYSHIRE:**

**HISTORIC BUILDING RECORDING**

**Project Code: BLS**

**Report Number: 015/2018**

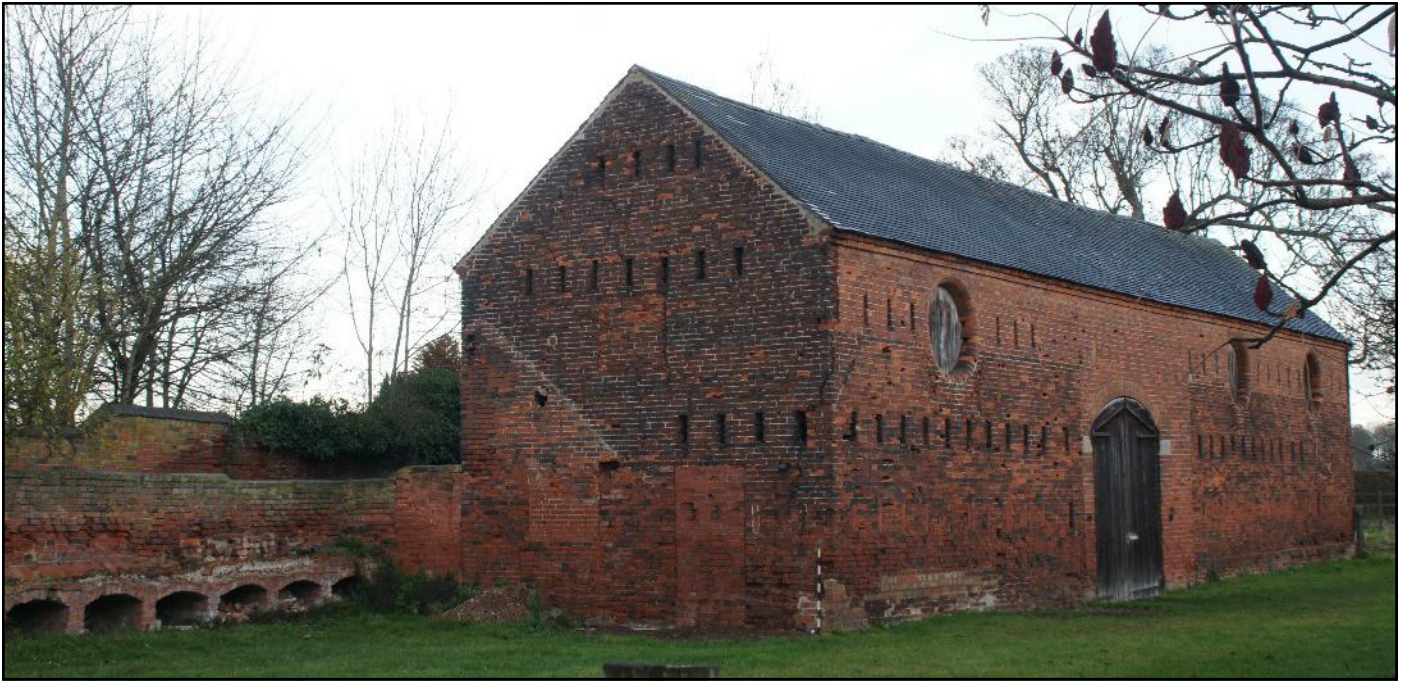
- 4.1.1 The barn is a four bay building (numbered 1–4 from west to east), of two storey height and brick built beneath a gable roof of Staffordshire blue tiles with a V-type ridge tile (Plate 1) The west and east gables and the lower three quarters of the north and south elevations are built of hand-made bricks measuring between 8 and 9 inches in length,  $4\frac{3}{8}$  to  $4\frac{1}{4}$  inches in width and  $2\frac{1}{4}$  inches thick, laid with one course of alternate headers and stretchers (the headers often vitrified) to between three and six courses of stretcher, which would be consistent with a mid-eighteenth century date. The walls rest on a brick plinth.
- 4.1.2 The west gable has had the lower of the four lines of ventilation slits infilled and a door and window, since blocked, inserted, probably when the cowhouse was erected/in use (Plate 2).

**Plate 1:** General view of the barn looking north-east. Note the cattle troughs extending along the boundary wall.

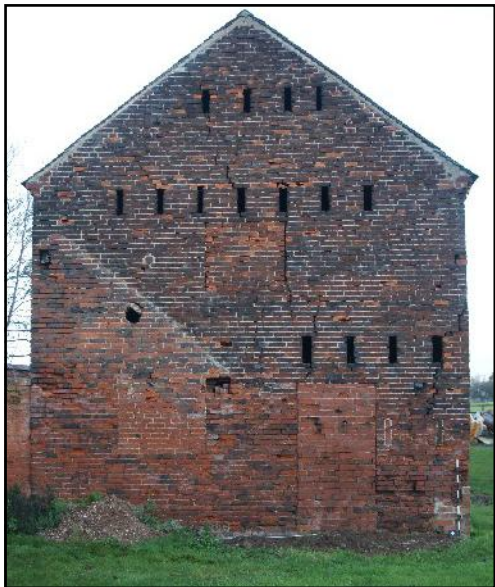
The roof line of the former cowhouse can still be seen in the gable. A second floor square pitching hole, now infilled, had been inserted.

**Plate 2:** The west elevation, viewed looking east.

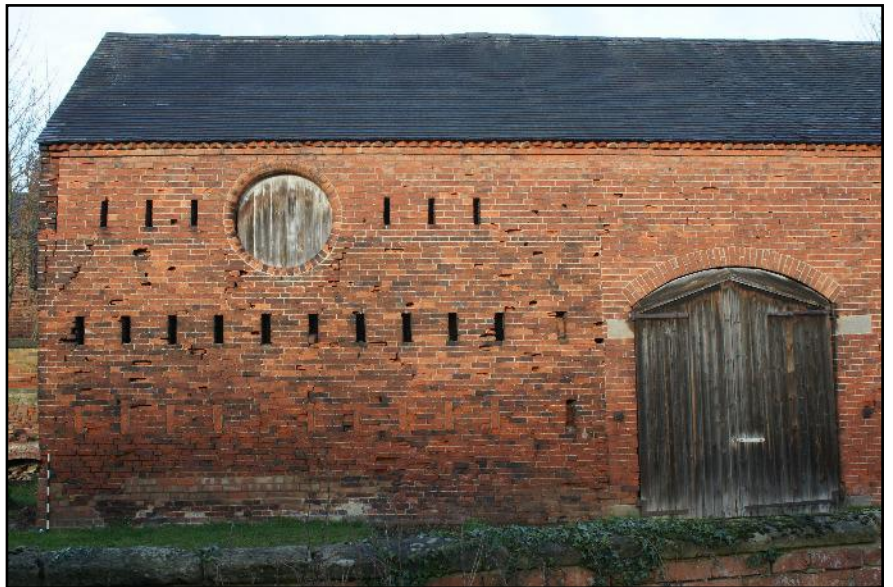
- 4.1.3 The south elevation has had the large central cart doorway of Bay 2 rebuilt with the upper 14 brickwork courses of the entire elevation replaced, a single oversailing course inserted and a course of sawtooth brickwork laid beneath the eaves (Plates 3 to 5). The bricks used measure between 9 and 9¼ inches in length, 4¼ to 4⅜ inches in width and 2¾ inches thick, indicating an early nineteenth century date of c. 1810-20, and laid three courses of stretcher to one course of alternate stretcher and header. The doorway has a segmental brick arch and has stone impost blocks. Large circular pitching holes have been inserted beneath the eaves of Bay 1, Bay 3 and Bay 4 (Plate 6). There are three lines of ventilation slits, the lower tier has been infilled.

**Plate 3:** The south elevation, western half, viewed looking north.

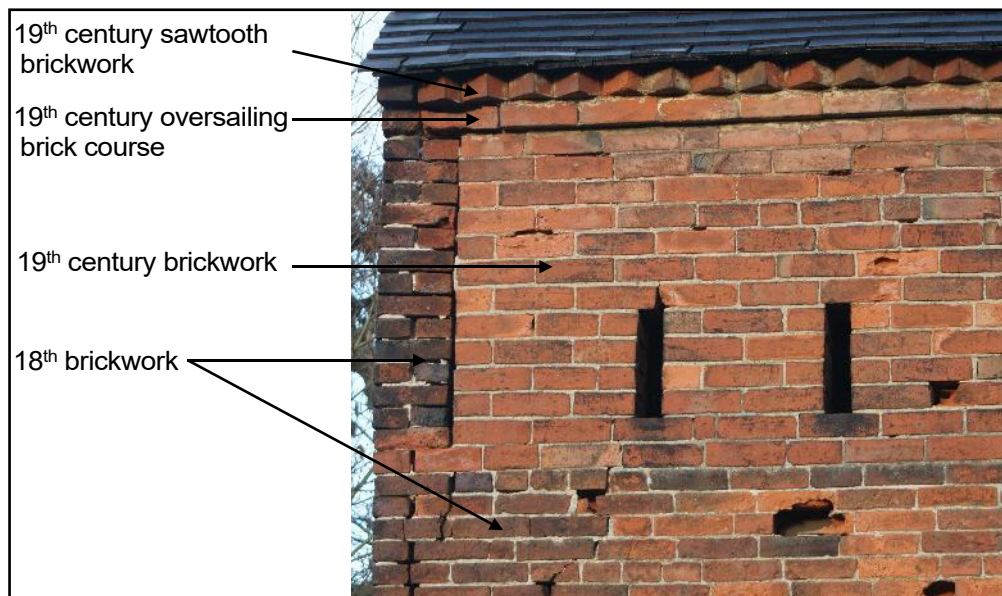
**Plate 4:** The south elevation, western end, viewed looking north.

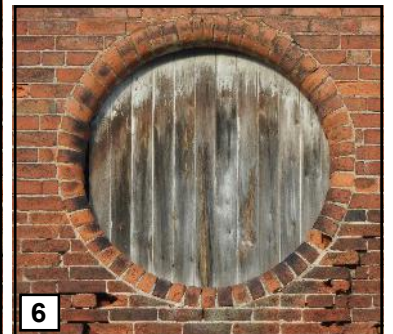
**Plate 5:** The sawtooth brickwork beneath the eaves.  
**Plate 6:** The circular pitching hole in the south elevation, Bay 1, viewed looking north.

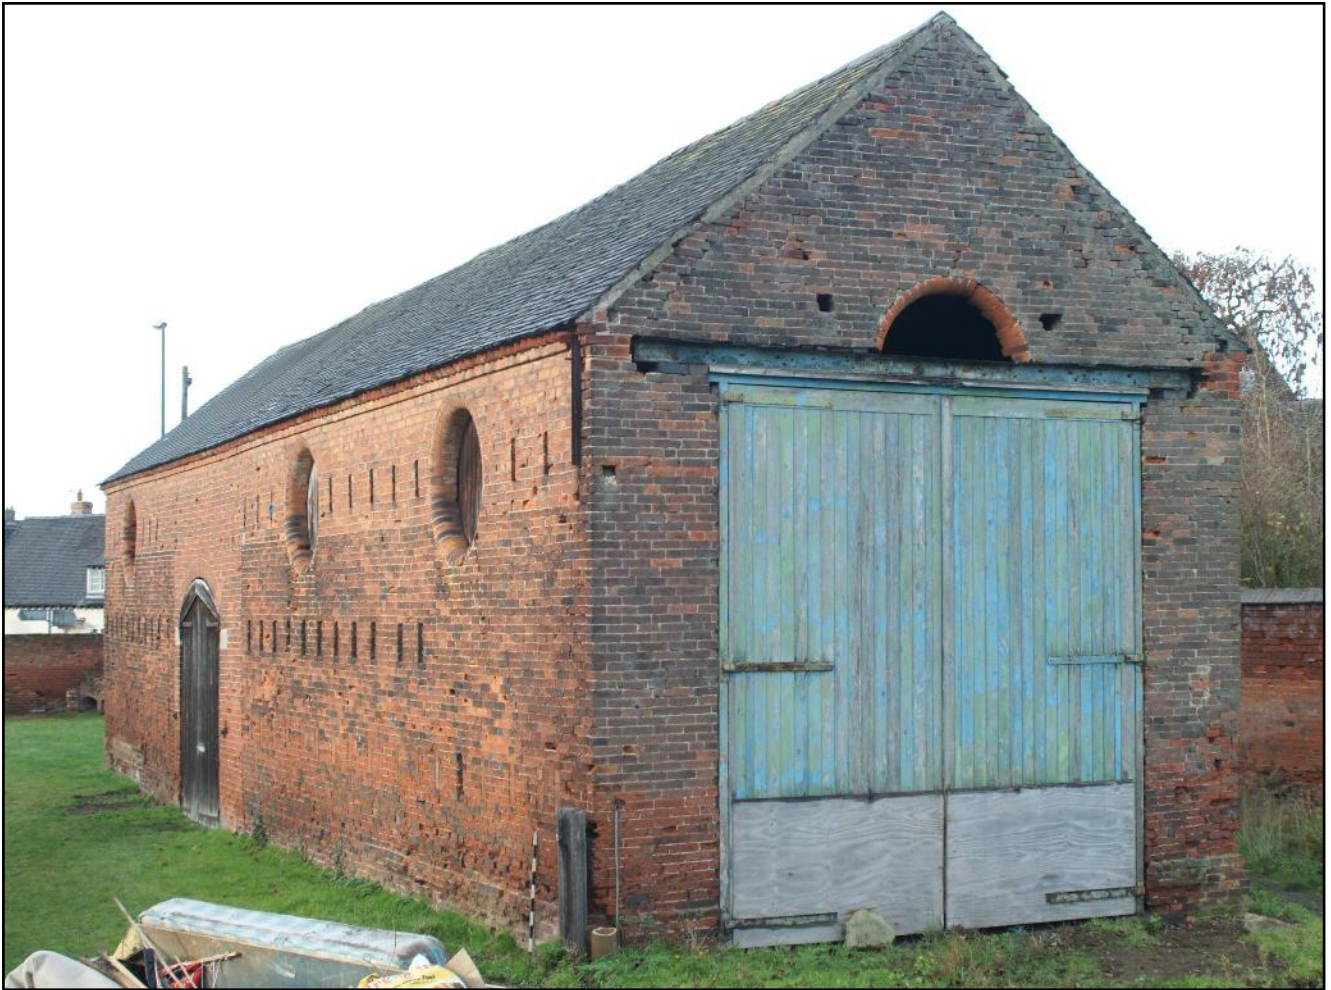
- 4.1.4 A circular pitching hole has been inserted into the east gable of the barn which was subsequently truncated by a set of large full height double doors during the twentieth century (Plate 7).

**Plate 7:** General view of the east gable and south elevation, viewed looking north-west.

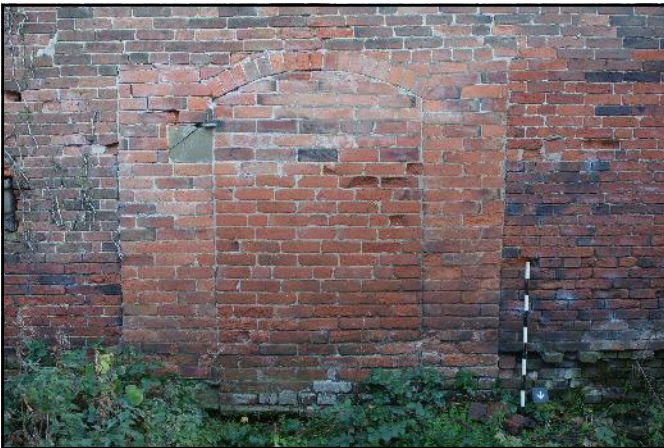
- 4.1.5 As with the south elevation, the north elevation has had its upper brickwork replaced and an oversailing and sawtooth course added. The lower of the three tiers of ventilation slits have been infilled. The original winnowing door has been replaced with one of brick with a segmental arch which has been infilled (Plate 8). A window and doorway were inserted into Bay 1 which have since been infilled (Plate 9).

**Plate 8:** The winnowing door, viewed looking south.

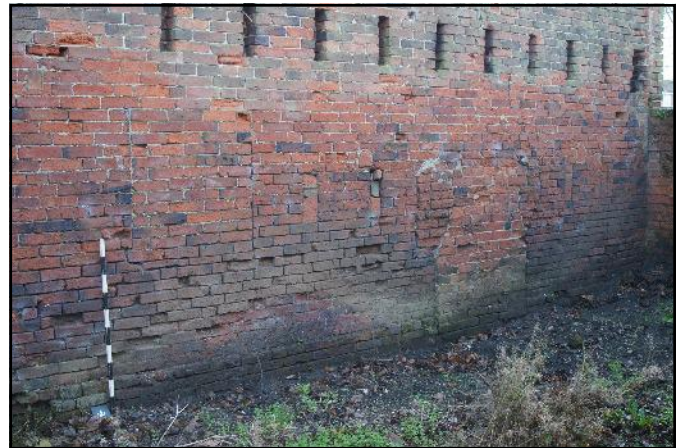
**Plate 9:** The blocked window, door and ventilation slits in the south elevation of Bay 1, viewed looking south-west.

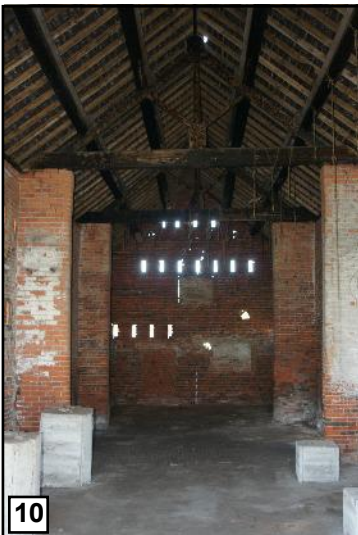
- 4.2.1 Internally the barn is divided into four bays by brick pillars, the upper courses of which are constructed of the same type of brick used in the later sections of the north and south elevations (Plate 10). The pillars support king post roof trusses which carry the roof (Plate 11). There are two sets of purlins, a plank ridge and a wall plate. A number of the common rafters and all the principal roof timbers are charred indicating that there has been a fire within the building. It is possibly this fire necessitated the rebuilding of the upper parts of the north and south gable though it would have to be noted that the gables do not exhibit any signs of fire damage. Each of the northern most pillars have had holes inserted into their south face, possibly for gates, suggesting that the barn was altered so that it could be subdivided, possibly to enable it to house livestock (Plate 12).

**Plate 10:** View looking west through the barn from Bay 4.

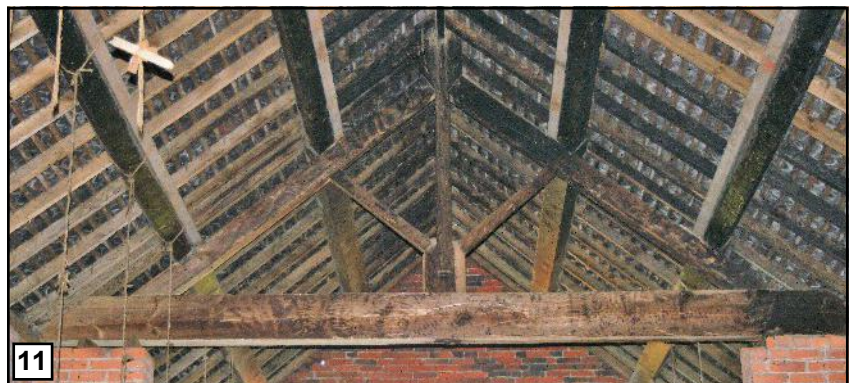
**Plate 11:** The west face of Truss 4, viewed looking east. Note the charring of the timbers.

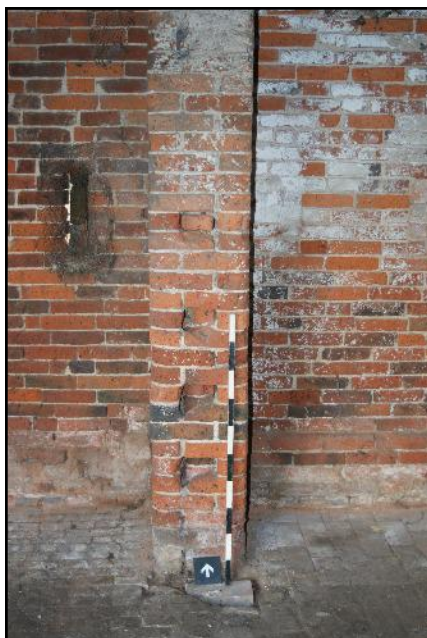
**Plate 12:** Holes in the south face of the pillar supporting Truss 2, looking north.

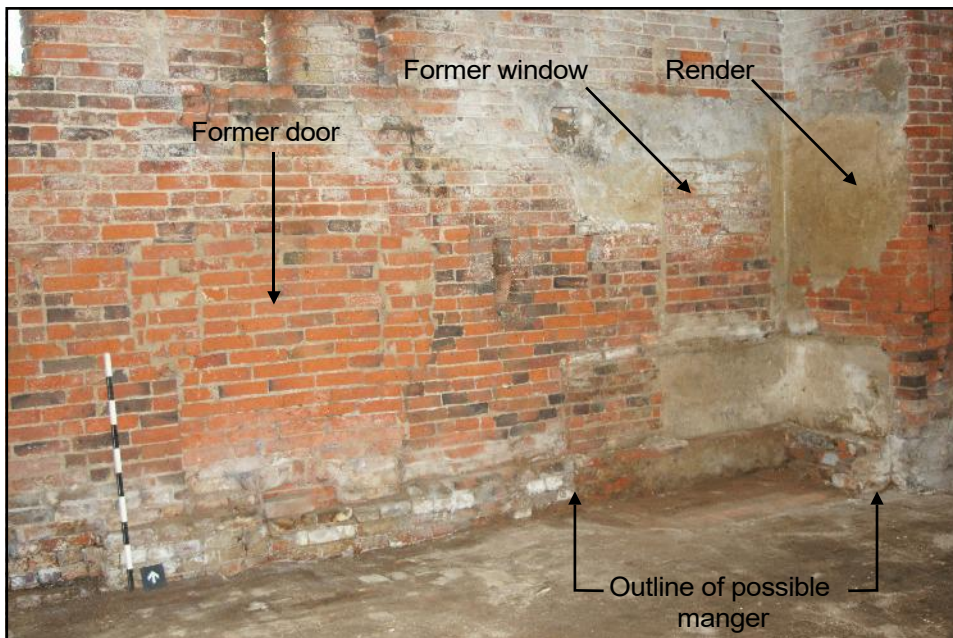
- 4.2.2 In Bay 1 the former openings in the west gable and north elevation are clearly visible. In places render comprising manure, straw and possibly lime, adhere to the walls. In the corner between the pillar supporting the truss and the north elevation is a former structure built of frog bricks stamped *William* measuring 3 inches thick, a common size from the 1860s onwards (Plate 13). An outline on the floor extends to the west adjacent to the wall. A similar outline is present adjacent to the south wall with a truncated pipe, possibly for water, by the wall. The rendered walls suggest that the bay was used to house livestock with the two structures probably mangers. Bricks comprising the floor were laid face up. The circular pitching hole retains its plank and batten shutter and rails.

**Plate 13:** The north wall of Bay 1 viewed looking north-east.

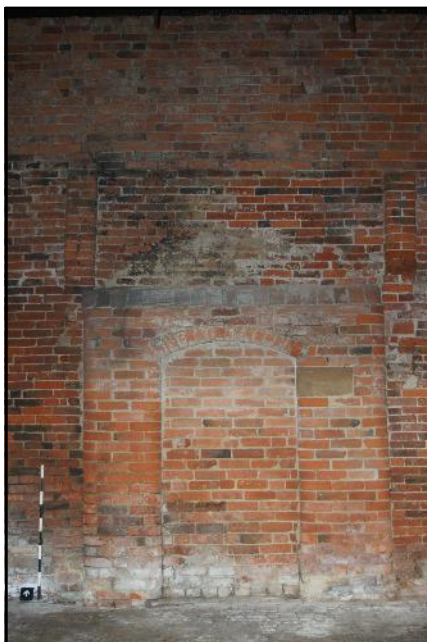
- 4.2.3 Bay 2 houses the threshing floor comprising bricks laid on edge. The winnowing doorway is quite ornate and sits proud of the wall with a segmental arch and bullnose bricks for the jambs and corners (Plate 14) Two narrow pillars above the door are part of, and contemporary with, the earlier eighteenth century phase of the building, their original height is unknown as along with the upper part of the wall have been replaced in the nineteenth century. The walls do not appear to have been rendered or whitewashed.

**Plate 14:** The winnowing doorway viewed looking north.

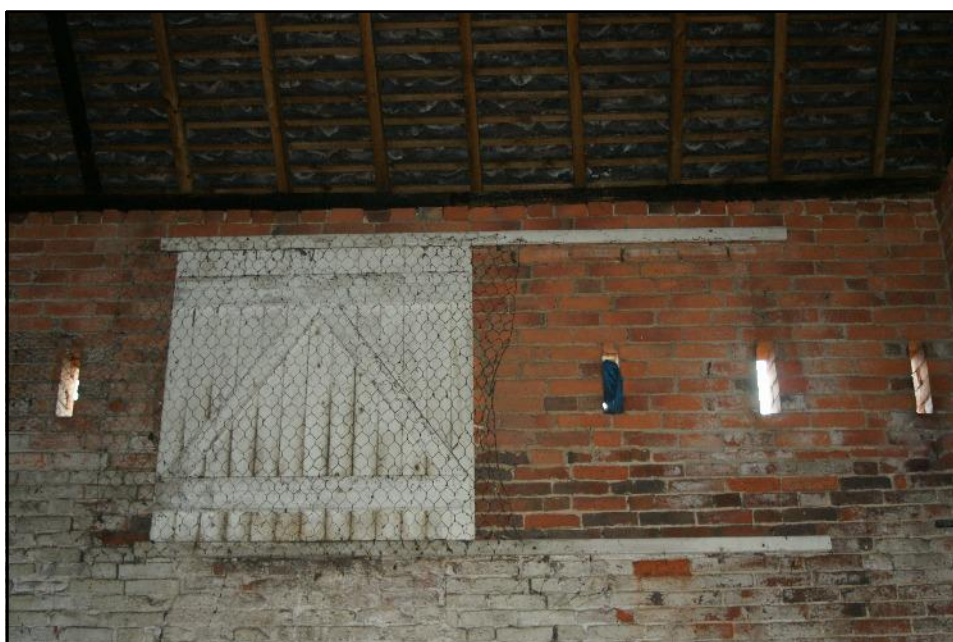
- 4.2.4 The floors of both Bay 3 and 4 comprise bricks laid face up. Four modern concrete blocks have been inserted in Bay 3. The walls have been whitewashed. The shutters and rails for the circular pitching holes are present on the south wall (Plate 15).

**Plate 15:** The upper part of the south wall of Bay 3 with the timber shutter and rails of the circular pitching hole, viewed looking south. Note the whitewash Adhering to the brickwork.
