# **OUTBUILDINGS TO THE REAR OF NORTHFIELD, MATLOCK ROAD, BELPER, DERBYSHIRE:**

**HISTORIC BUILDING RECORDING**

**Project Code: NBD**

**Report Number: 012/2018**

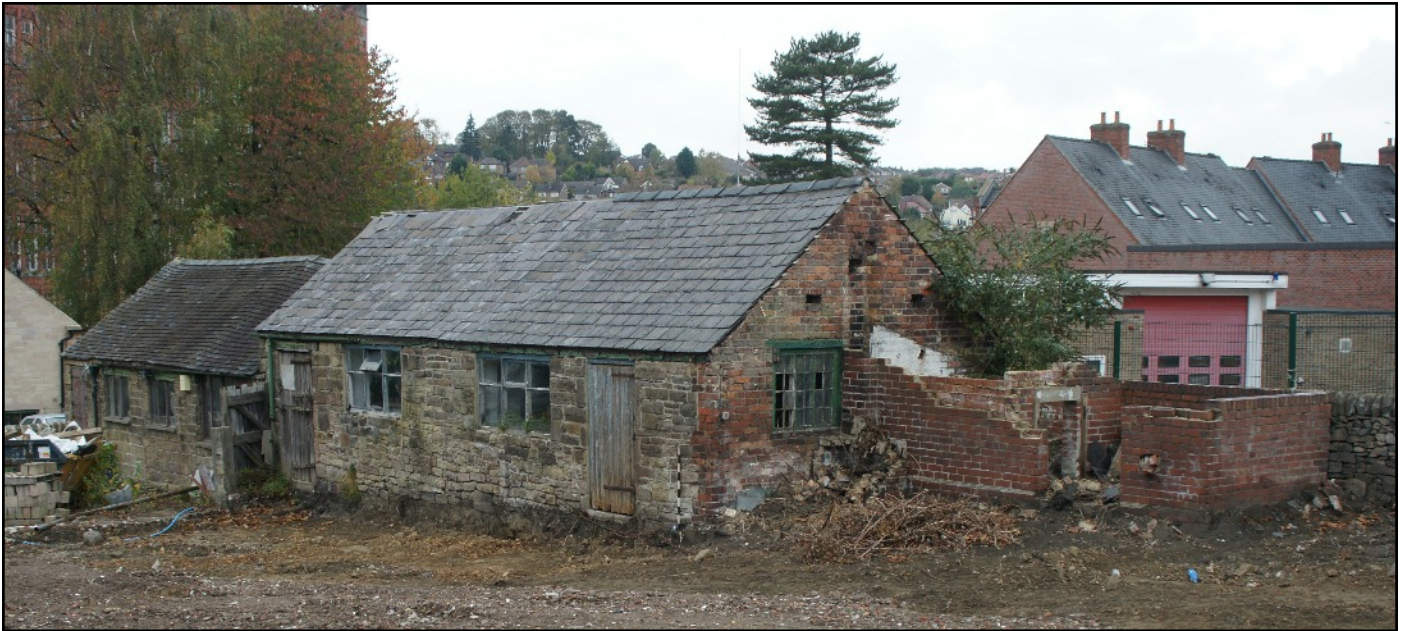
**Plate 1:** General view of the outbuildings with the West Section in the background and the derelict brick building in the foreground, viewed looking north-west.

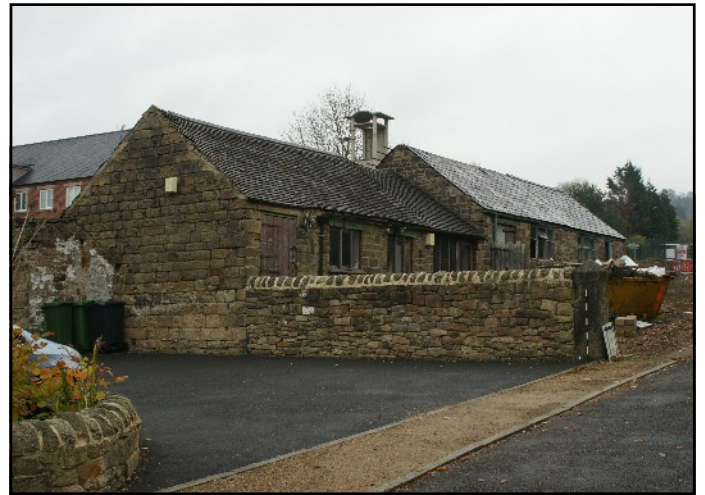
- 4.1.2 The three bay West Section was constructed in c. 1835. It is a single storey building with a loft, built of squared coursed stone beneath a gable roof of tiles with a V-shaped tile ridge (Plate 3 and 4).

**Plate 3:** The west gable and south elevation, viewed looking north-east.

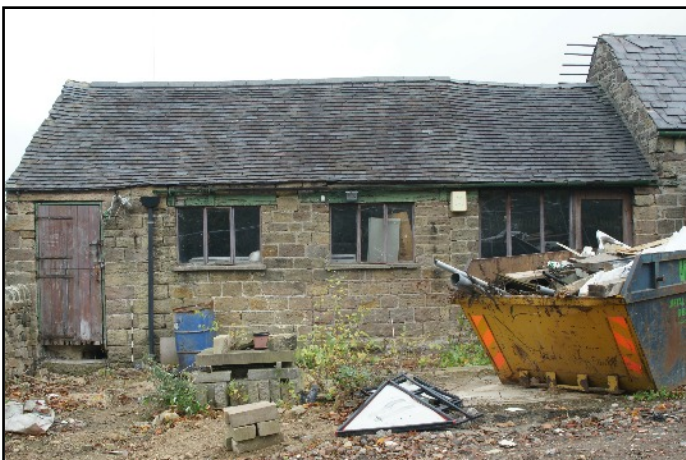
**Plate 4:** The south elevation of the West Section and Central Section, viewed looking north.

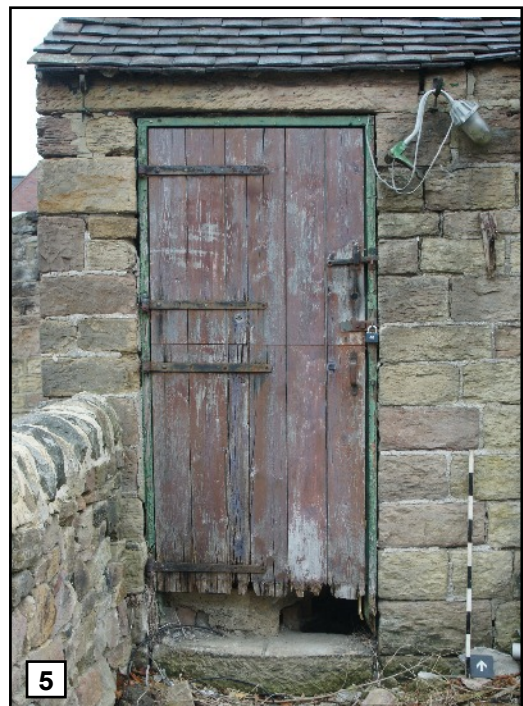
- 4.1.3 The south elevation has a tall narrow doorway at the west end with a timber plank and batten double door with wrought iron strap hinges with plain ends (Plate 5). The upper door has a latch and the lower a handle. The stone lintel above extends well beyond the door opening suggesting that the doorway has been narrowed. An additional doorway of similar dimensions was originally located to the east but this has been infilled and two window openings with timber lintels and concrete cills inserted. The three-light window frames are timber with the central window being side-hung and are late twentieth century in date. The roof line of the lean-to which formerly abutted the west gable is clearly visible with patches of whitewash still adhering to the gable and north boundary wall. A pitching hole for the loft

**Plate 5:** The door of the south elevation of the West Section, viewed looking north.

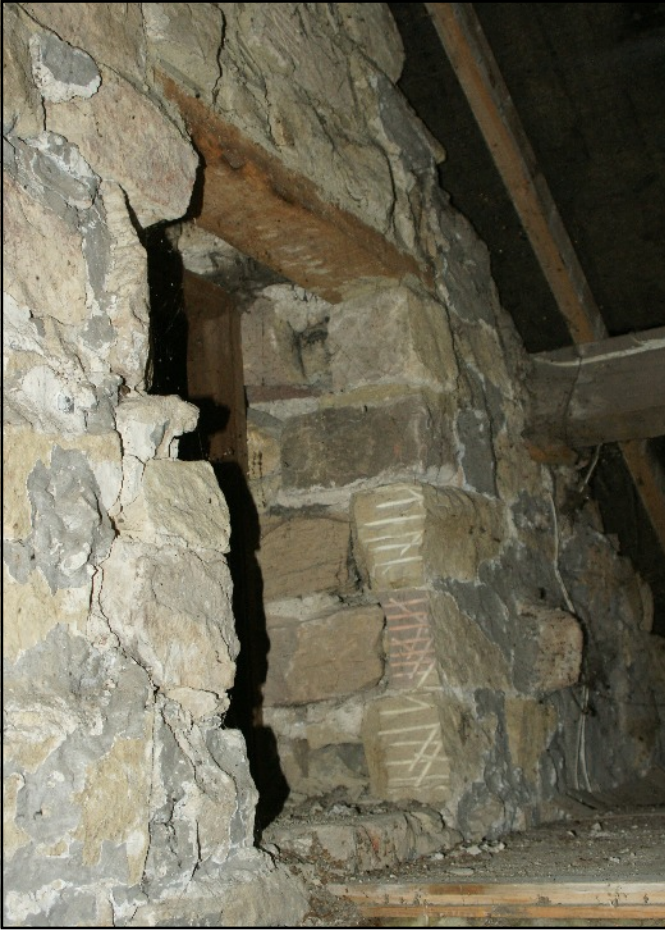
is present in the east gable (Plate 6). There are no openings, or former openings, in the north elevation.

**Plate 6:** The pitching hole in the east gable of the West Section, viewed looking south-east.

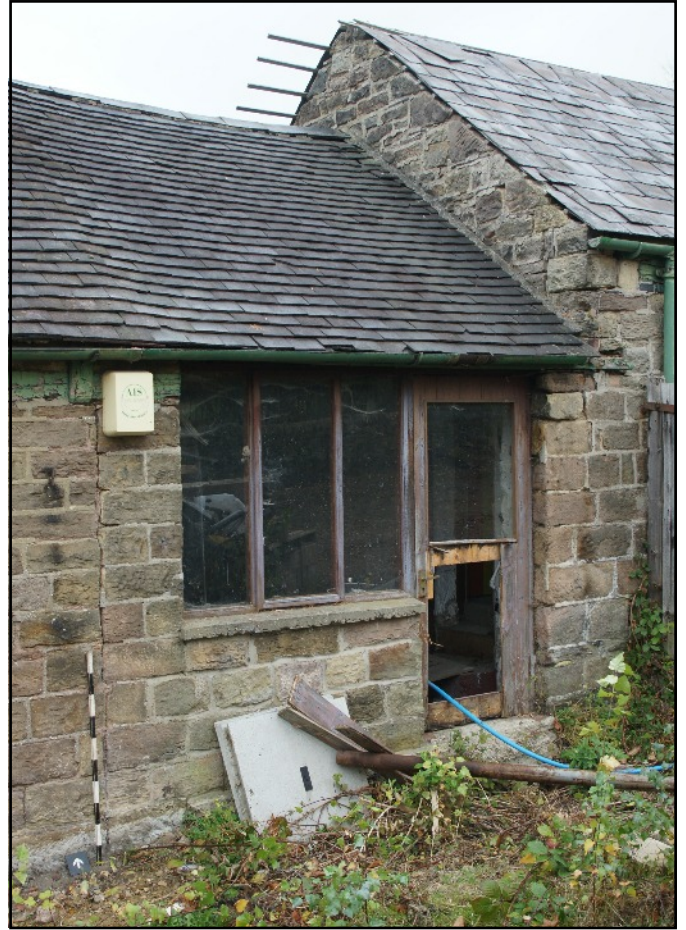
- 4.2.1 The single bay Central Section post-dates the West Section which it abuts rendering the pitching hole in the east gable of the West Section redundant. It is a single storey building with a loft and is built of squared coursed stone beneath a gable roof of tiles with a V-shaped tile ridge (Plate 7).

**Plate 7:** The south elevation of the Central Section, viewed looking north-west.

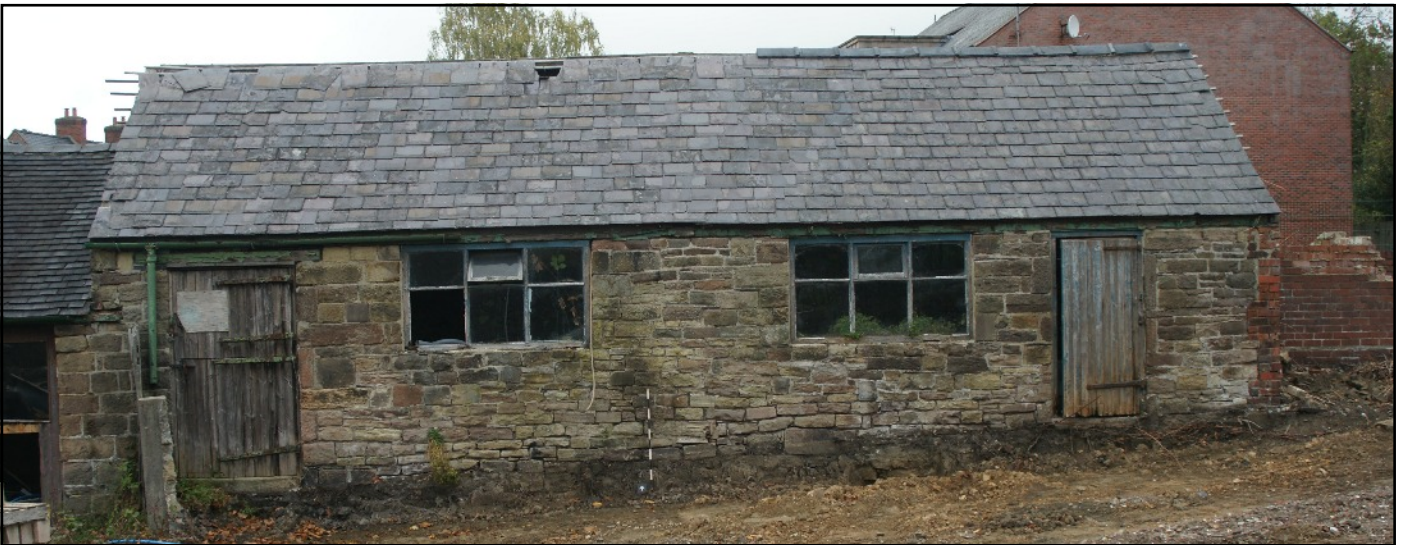
**Plate 8:** The south elevation of the East Section, viewed looking north.

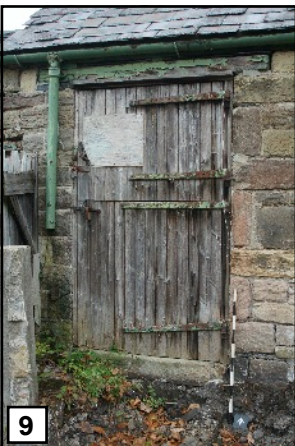
**Plate 9:** The door of the south elevation of the East Section, viewed looking north-west.

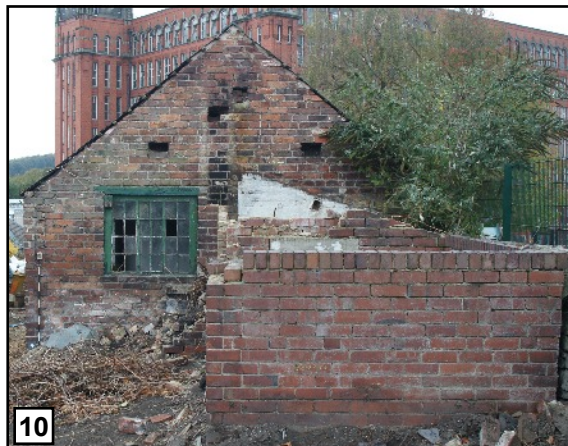
**Plate 10:** The east gable of the East Section, viewed looking west. Note the lean-to roofline of the former pigsty outlined in whitewash. The walling in the foreground is the yard of the pigsty.

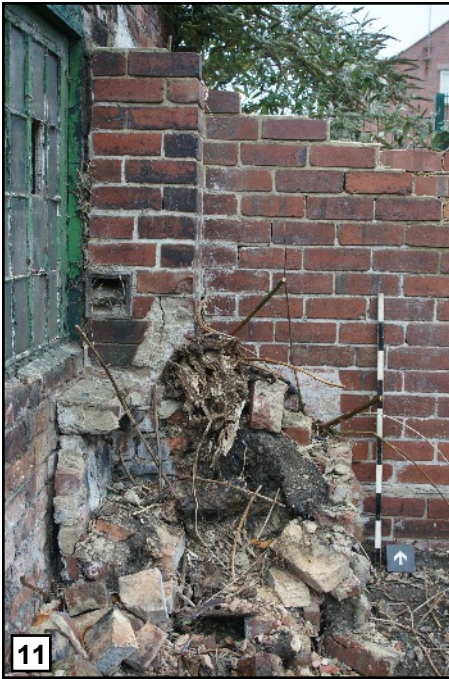
11

**Plate 11:** The external fireplace and chimney abutting the east gable of the East Section, viewed looking north.

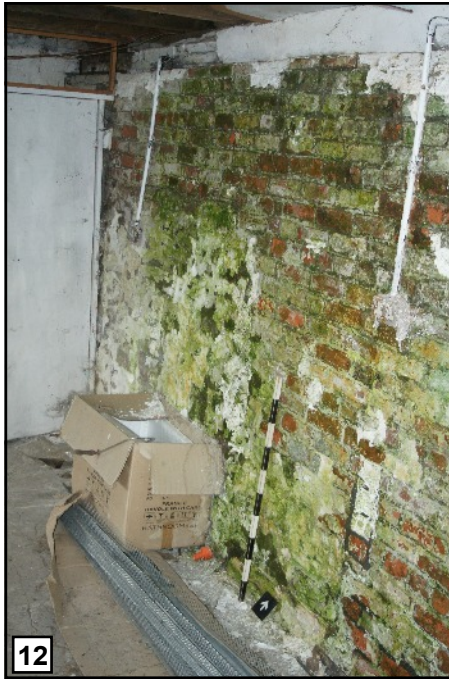
12

- 4.3.3 Internally the north wall of the western half is of brick and stone construction with the outline of potential former stalls present (Plate 12). The floor is of modern concrete. Exposed above are the joists and the west to east orientated softwood ceiling beam though there is no flooring creating a loft. The common rafter roof sits on wall plates and has a pair of purlins and a plank ridge (Plate 13). Of note the northern purlin has Baltic timber consignment marks (Plate 14). These marks were used by private shippers and importers of timber operating in the Baltic region and are often private marks put on by those through whose hands the timber has passed after being squared with some being sorter's marks distinguishing the different qualities of timber. Mortices and square indentations with holes for former nails or screws indicate that the purlin is a re-used timber, probably a former ceiling beam.

**Plate 12:** The internal north wall of the western half of the East Section with the outline of cattle stalls in the brickwork, viewed looking north-west.

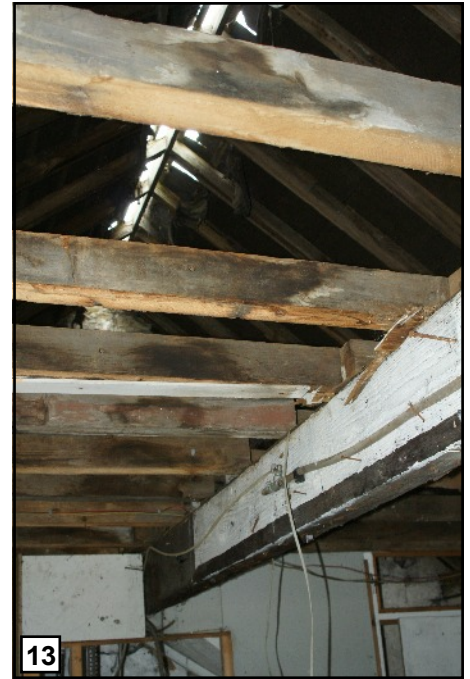
13

**Plate 13:** The ceiling beam, joists and roof of the western half of the East Section, viewed looking north-west.

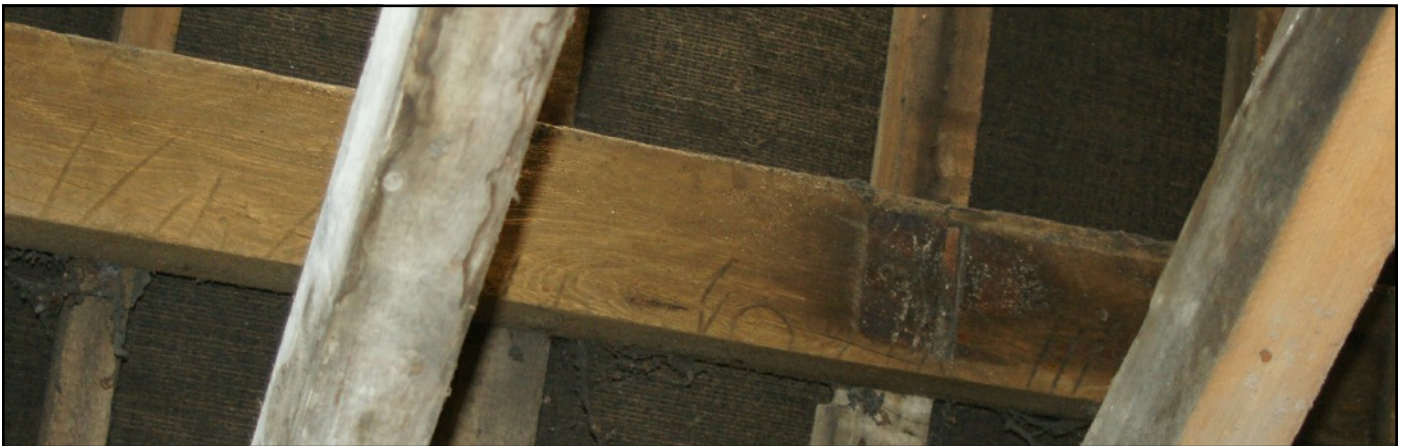
**Plate 14:** Baltic timber consignment marks on the northern purlin in the western half of the East Section.

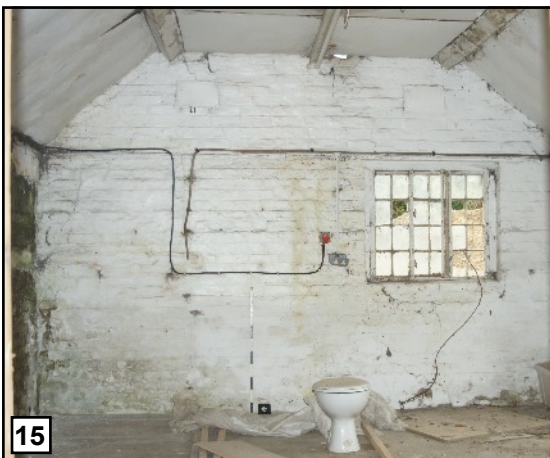
15

- 4.3.4 Potential former stalls are also outlined in the north wall of the eastern half of the building. The floor has been raised. There is no evidence to suggest that this part of the building had a former loft. Though the roof is boxed in the purlins are exposed, the southern one having Baltic timber consignment marks (Plate 15).

**Plate 15:** General view of the interior of the eastern half of the East Section, viewed looking east.

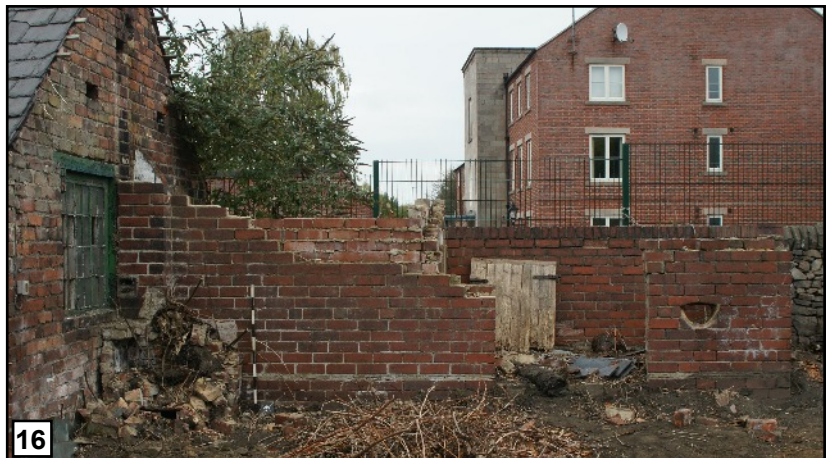
16

- 4.4.1 Abutting the east gable of the East Section is a small building extant by 1952 built of frog bricks stamped *Butterley Co. Ambergate* and laid in stretcher bond (Plate 16). The building is a former pigsty comprising the house with a lean-to roof which abuts the East Section with the yard extending to the east with chute and doorway still present in the south wall. Pigs are particularly associated with dairying, feeding on whey, that is the skimmed milk left over from butter and cheese making (Peters 2003, 73-3).

**Plate 16:** The south elevation of the pigsty, viewed looking north.
