## BUILDING SURVEY REPORT

# The ruins of the church of St Andrew Walberswick WLB 112

St Andrew's Church, Walberswick, Suffolk

Suffolk HER site code	<b>WLB 112</b>	OASIS Ref:	<b>davidgil1-265676</b>
Suffolk HER event no	<b>ESF24809</b>	Listed Building no	<b>285568</b>

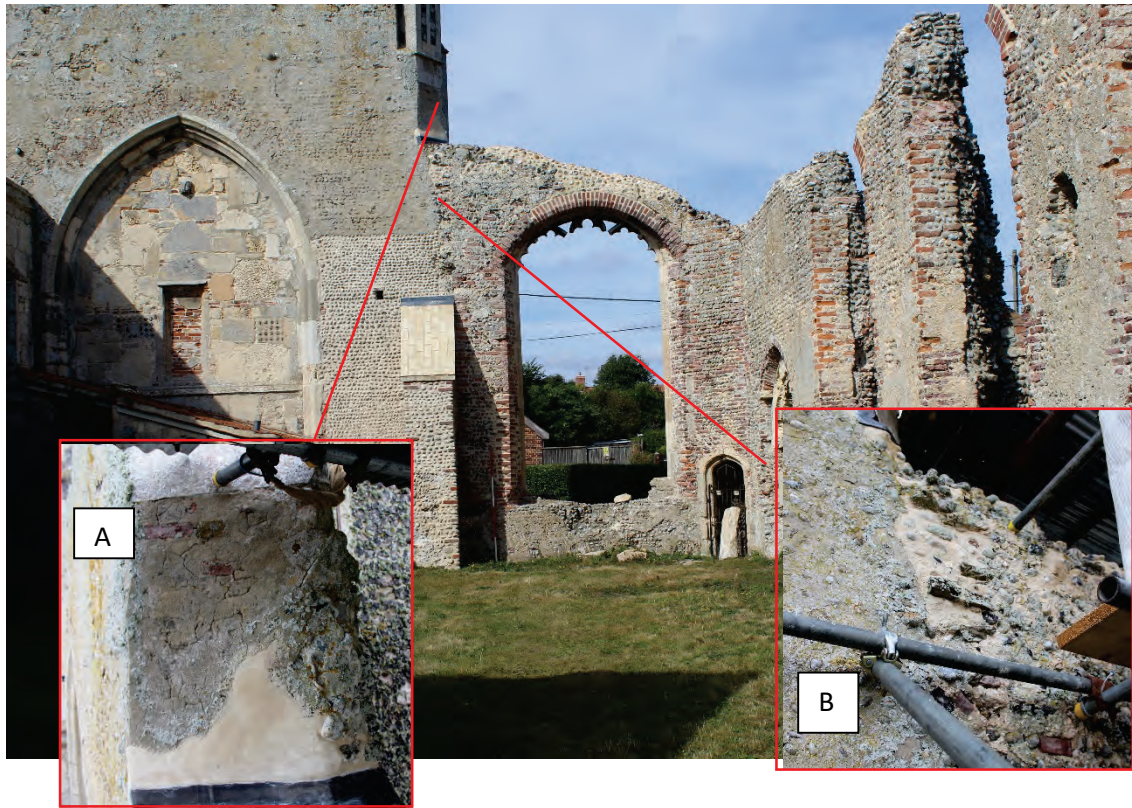
Plate 4. West end of the church showing remains of the clerestory above the aisle wall (*inset pic A*) and projecting broken bricks in the scar of the north respond (*inset pic B*). Note the embedded coping stone denoting the top of the parapet in pic. A

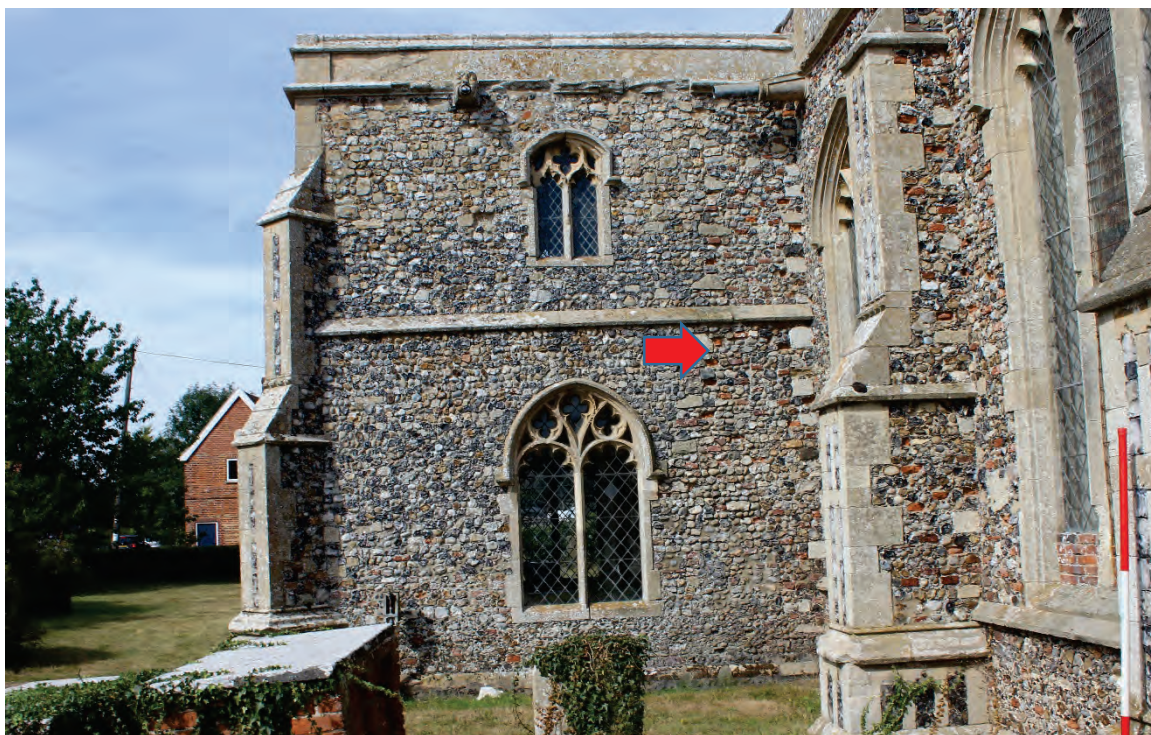
Plate 5. The south porch ground floor windows are in a decorated style and earlier than other windows in the church, the joint between the building of the porch and south aisle is arrowed.

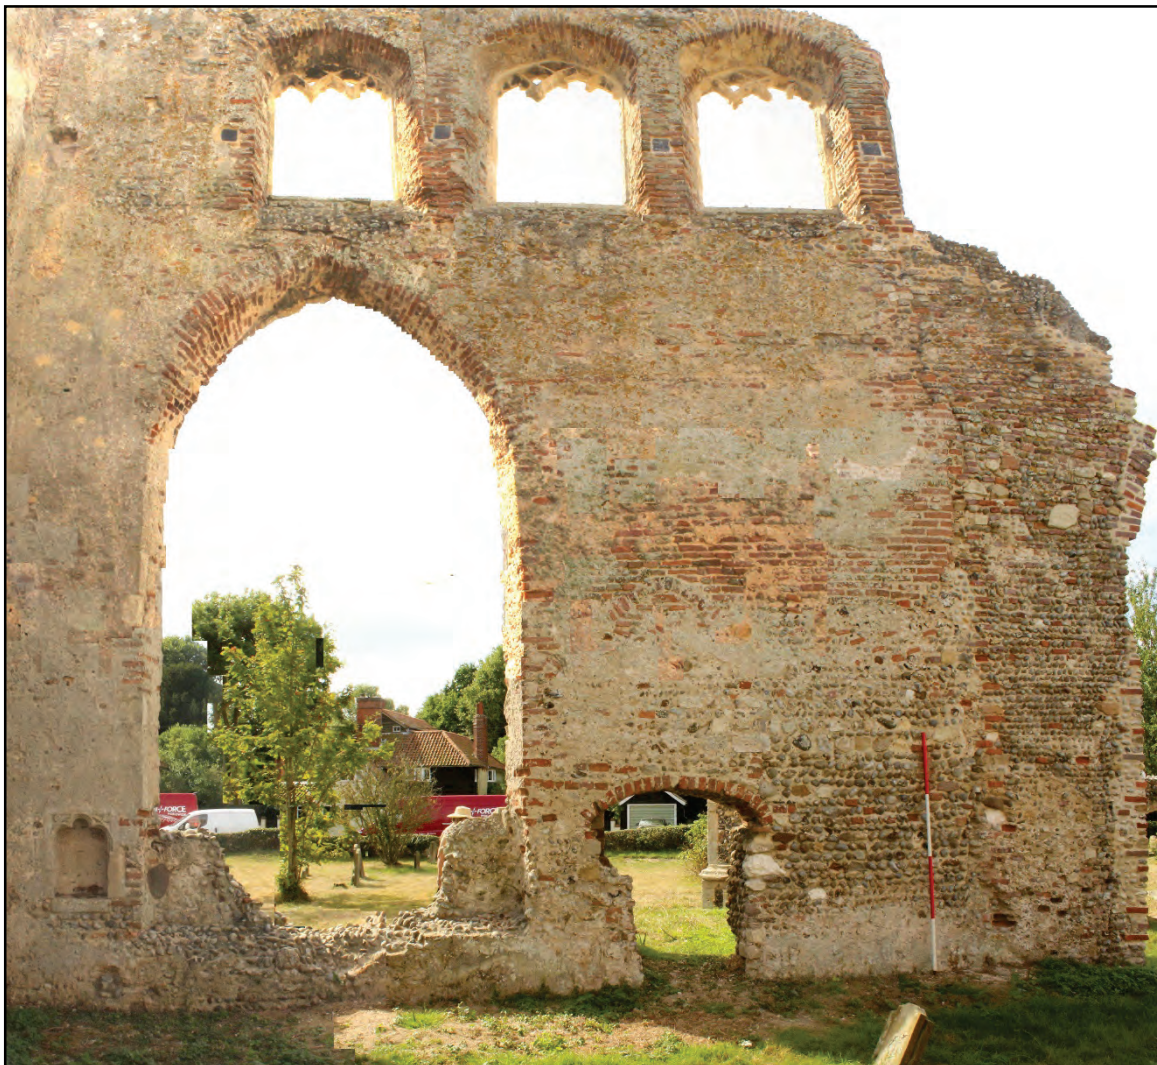
Plate 6. South wall of the chancel. The vertical joint where the chancel was connected to the nave can be seen to the right of the 2m scale. Above the priest door the wall face is composed almost entirely in brick a phenomenon which was not seen elsewhere and which contrasts with the nave and base of the chancel wall. The dropped sill at the base of the large window is thought to be a sedilia, whilst the priest door has been narrowed by building up the left jamb, the current ground level is c.0.5m above the medieval floor level.

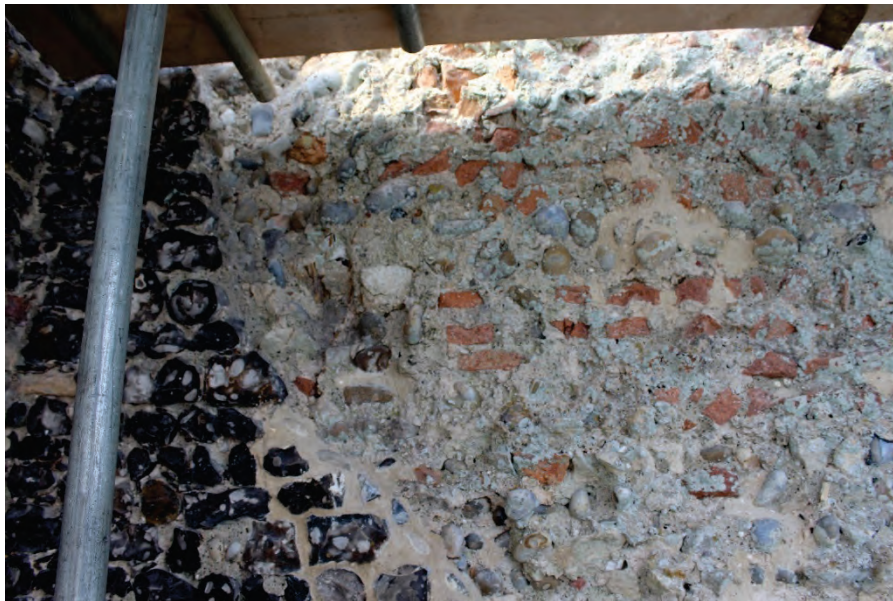
The lower section of the chancel, up to the height of the window sill, are composed largely of flint and are a different period of construction from the rest of the cell. Whether this change simply denotes a different building season or that the chancel was a reworking of an earlier building footprint is unknown. From sill level to the top of the clerestory there is an increased use of brick, particularly on the south wall where the interior is faced almost entirely with the material, a feature which is unique to this part of the church; this bias is also confirmed by an increase in the quantity of broken brick in the rubble core of the chancel's south wall (Pl.7).

Plate 7. Brick rubble core beneath the dressed black flint of the chancel south wall

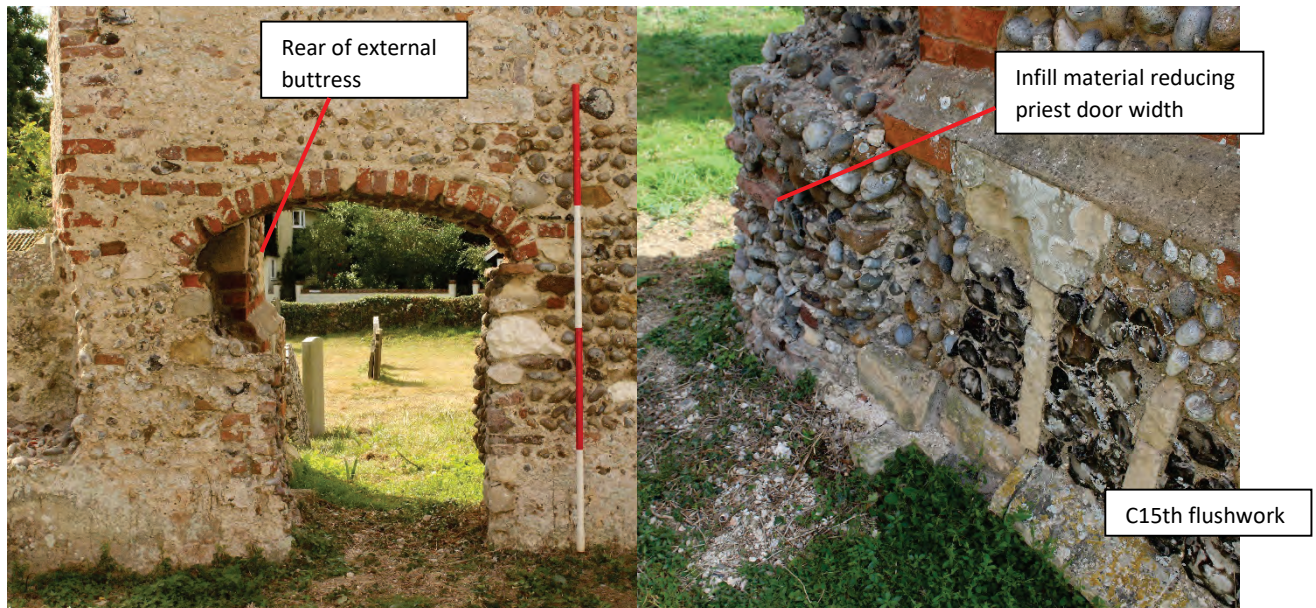
Plate 8. The priest's door in the south wall of the chancel (left). The ground level in the chancel has risen by c.0.5m giving the impression that the door head is low. The original door opening was partially blocked by the addition of an external buttress and the door width was reduced by building up the left jamb. The buttress partly blocking the priest door is shown on the right, it has been extensively rebuilt but the presence of decorative flushwork at the base of the buttress suggests that it is a C15th feature.

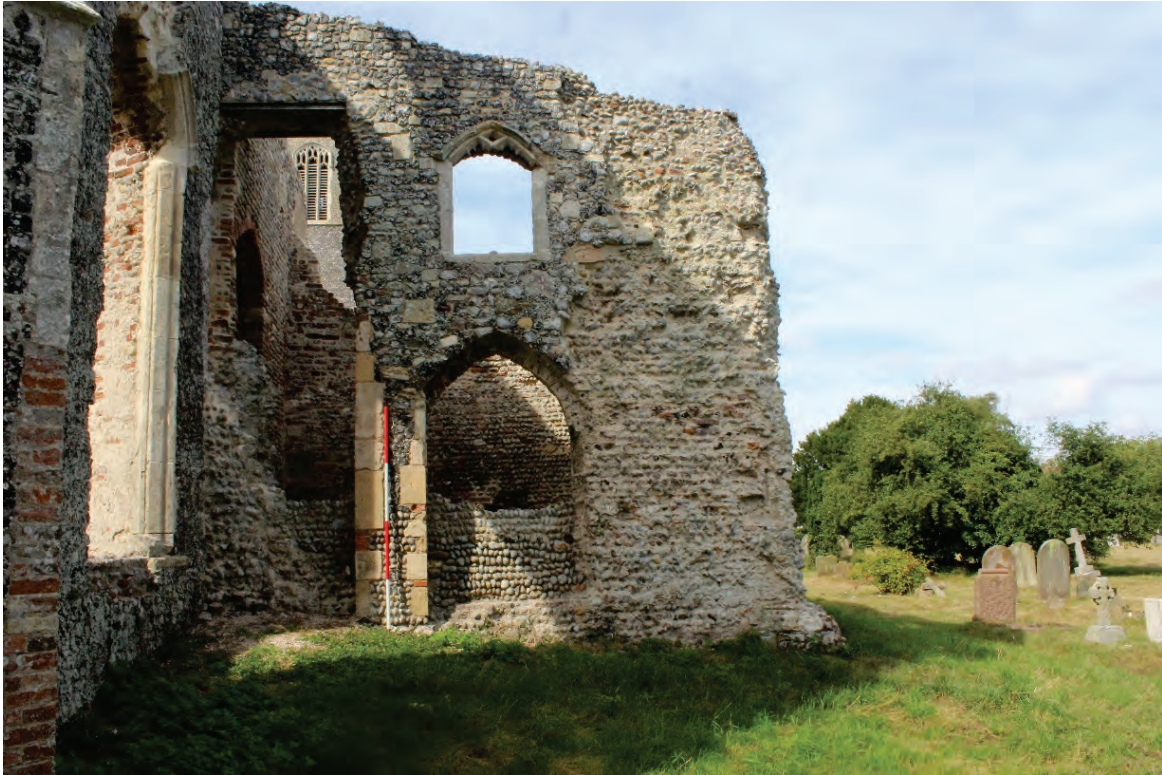
Plate 15. The exterior of the east wall of the north aisle, the elongated opening is the collapsed remains of a spiral stair. The windows light the ground and first floor rooms of the Sacristy. The limestone quoins behind the scale are all part of a modern repair.

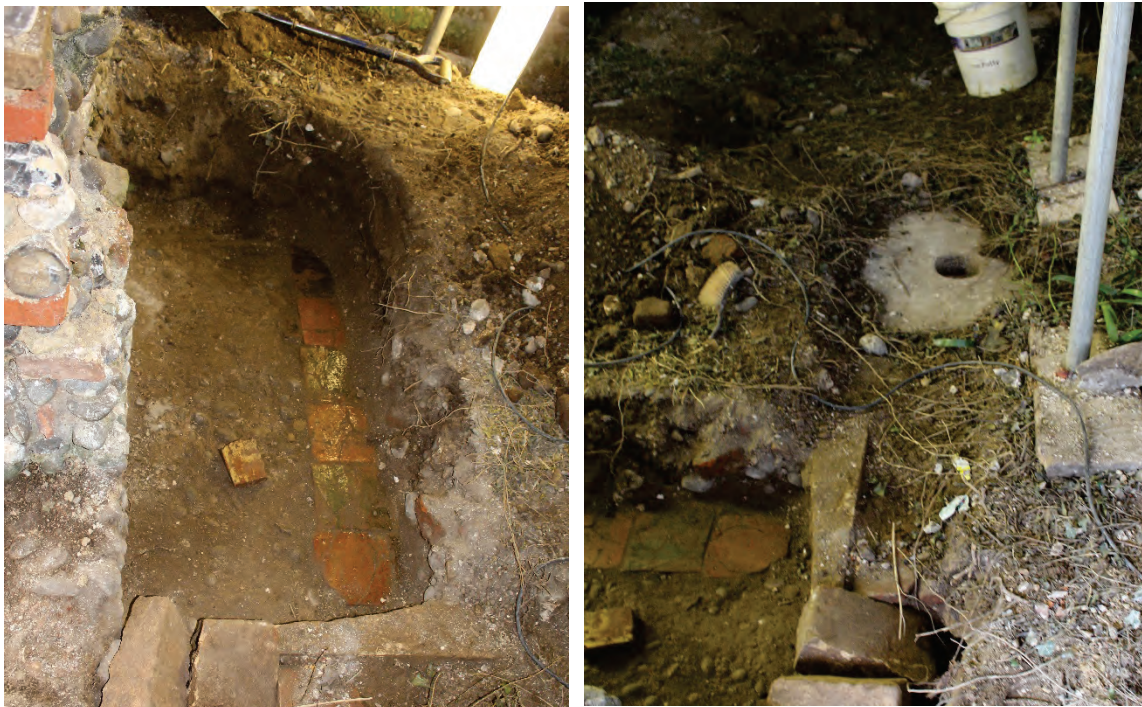
Approximately 300mm of a soft loose spoil has accumulated over the sacristy floor, the spoil was cleared away from a small area in the NE and SW corners and revealed medieval coloured glazed tiles in both locations suggesting that the complete floor surface remains intact (Pl.18).

Plate 18. Sacristy floor showing medieval coloured glazed tiles (left) and a pierced stone, possibly a post setting, set into the ground (right)

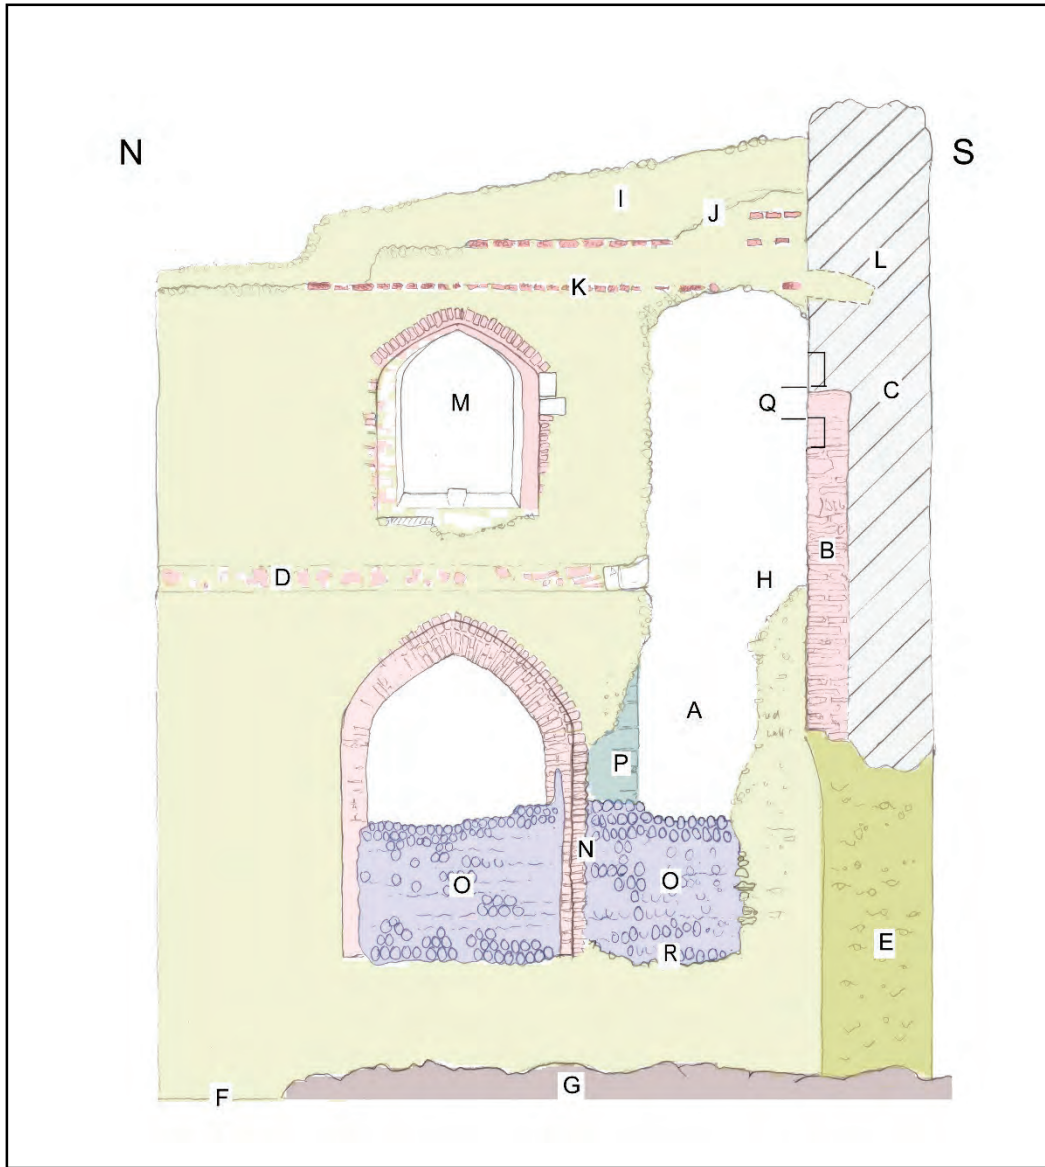
Figure 5 Elevation of the interior face of the Sacristy east wall.

Modern interventions include the partial blocking of the ground floor windows (Fig.5 (O)), to consolidate the structure and to keep people out and the external face on the south side of the east window has been built up with black flint and stone dressings (Fig.5 (P)) as part of a repair or somewhat confusing re-creation.

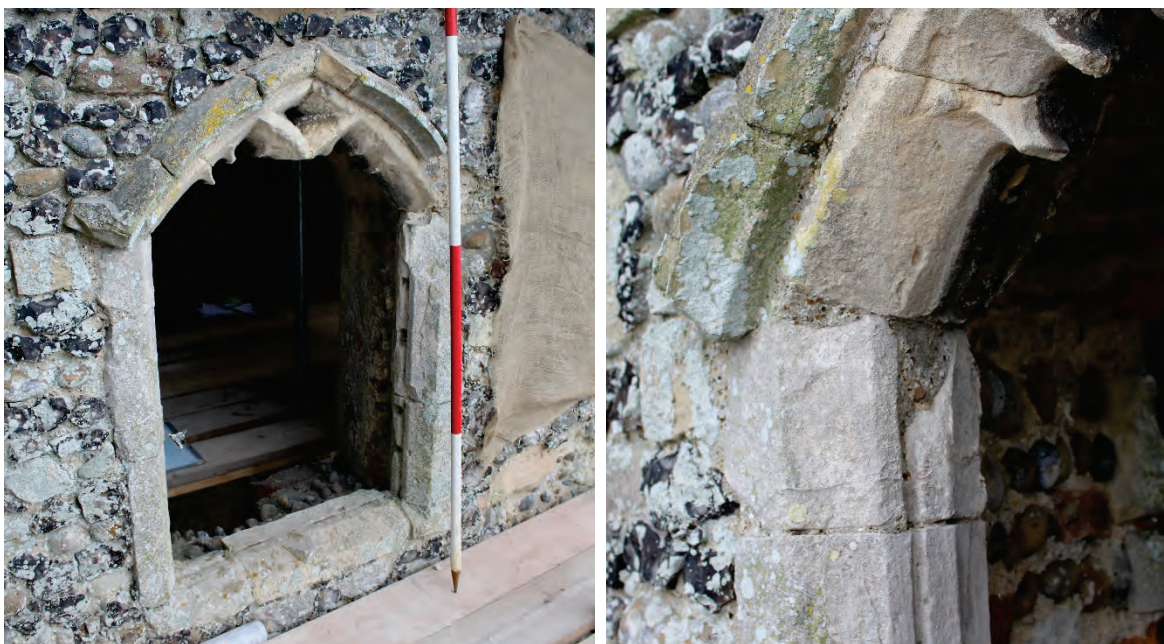
Plate 19. First floor window in the east wall of the north aisle. The tracery in the window head and the hood moulding resembles that used in the clerestory, however the stones here are mis-matched (right) and the hood-moulding too short suggesting that the window has been cobbled together from parts.

retained some of its tracery (Pl.19) and the stones that made up the jambs were a harder grey stone unlike the Ketton stone used for the north door or chancel east window. The tracery in the window head and the hood moulding resembled that of the north chancel clerestory windows, but was composed of ill-matched stones. There is no indication that the window was a later insert but it suggests that it was salvaged from stones from the previous church. Bits of old tracery do appear elsewhere in the core of the north aisle wall and are used 'on end' to create a flat surface within the external wall face.

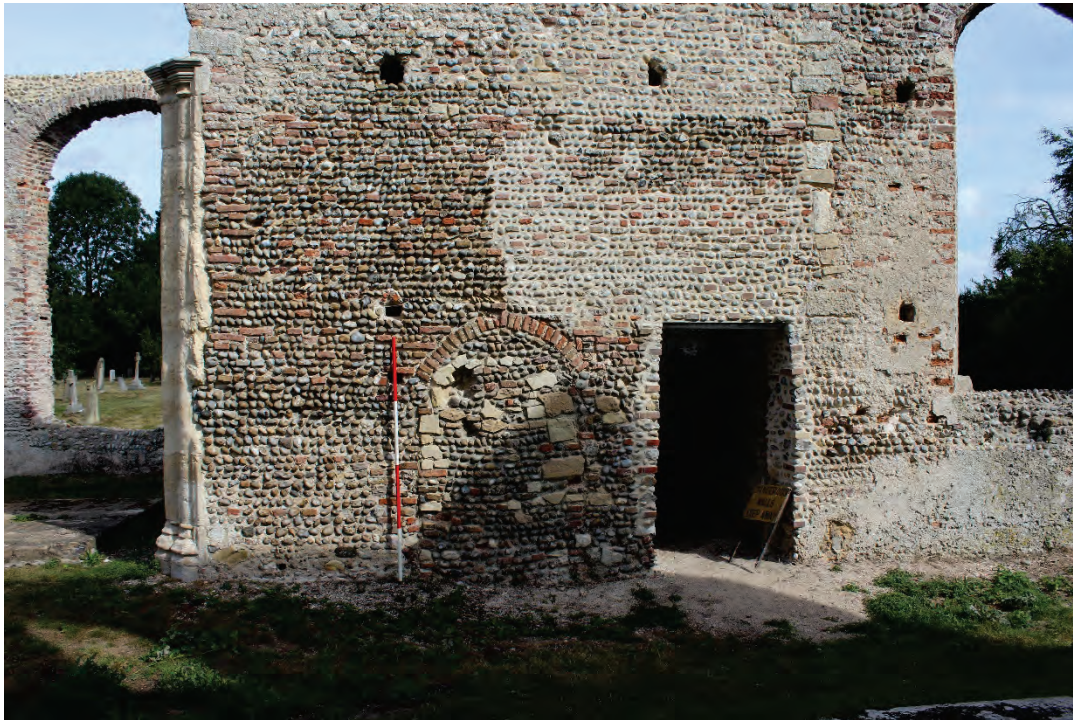
Plate 21 Interior of the north chancel with blocked and current entrances in to the Sacristy, following consolidation

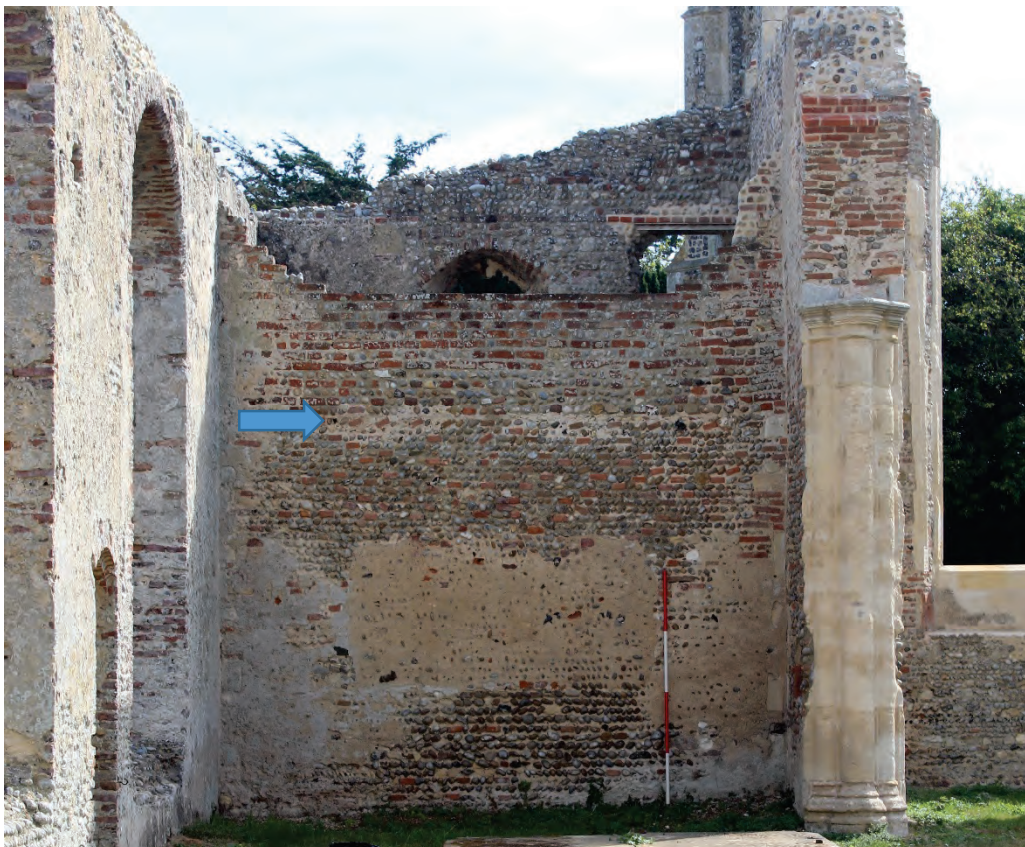
Plate 22. East wall of the chapel in the north aisle inserted after the exterior wall of the north aisle was built. The top half of the wall was later taken down to first level (arrowed) and rebuilt sometime in the post medieval period. In 1678 Edward Barker was paid five shilling plus a further nine shilling for materials and expenses 'for skrewing up the wall in the north aisle' – the brick size for the upper part of the wall would fit this date but a 'skrew' is a coping stone.
