Fairfax House, Castlegate, York

Faience Repair | Standing Buildings Watching Brief

File: 3162-2020-001

Date: 23 Oct 2020

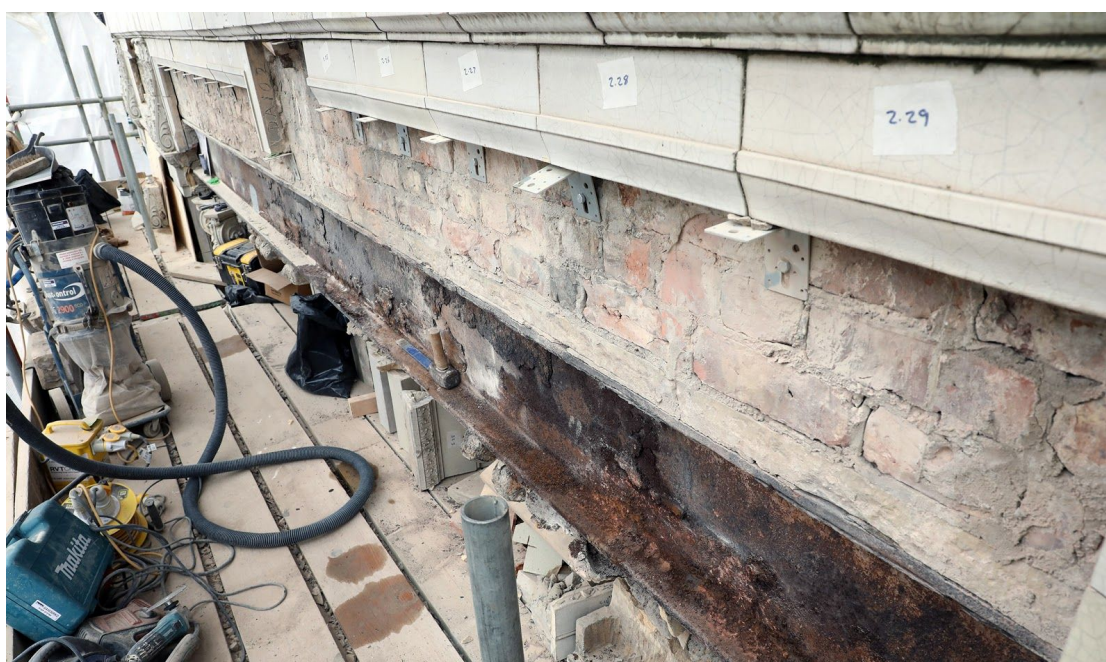
- 6.1 The faience pieces are white glazed, which is today heavily crazed, and they are separated by a fine white mortar. See drawing YAW-19-05-100 REV 02 for details of the extent of removal and repair/replacement. When the faience pieces were removed, they were found to have been mortared directly onto the earlier brickwork behind. Below the brickwork, a course of long limestone masonry sits on a large steel I-beam that acts as a lintel for the large opening forming the entrance lobby below (figure 2).

Figure 2 Removal of the faience pieces revealed the earlier brickwork behind, which is supported on a course of masonry sitting on a steel I-beam lintel.

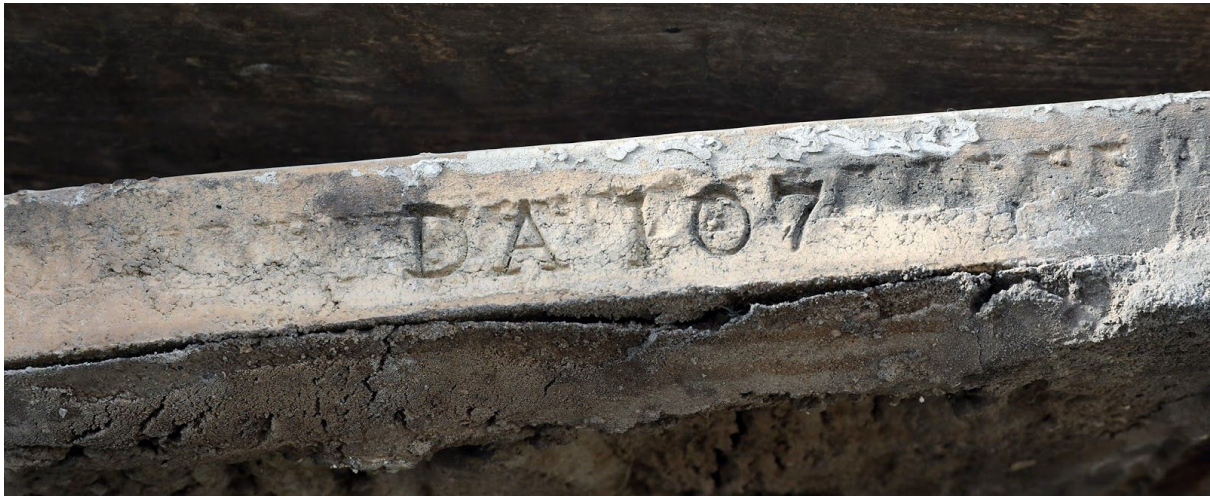
- 6.2 None of the faience pieces were found to have any maker's marks or logos, and the manufacturer is not known. Some of the faience pieces were however numbered on the sides, with the numbers prefixed "DA". Some of these labels were stamped (figure 3), while others were clearly incised by hand with a pointed tool or wire (figure 4). Faience was manufactured extensively throughout late Victorian Britain, and most manufacturers have ceased production or ceased to exist. The label DA, might be indicative of the manufacturer of these pieces, but it has not yet been linked to an individual firm.

Figure 3 Stamped label on the side of a faience tile, reading "DA 107", from a flat panel (tile 3.15).

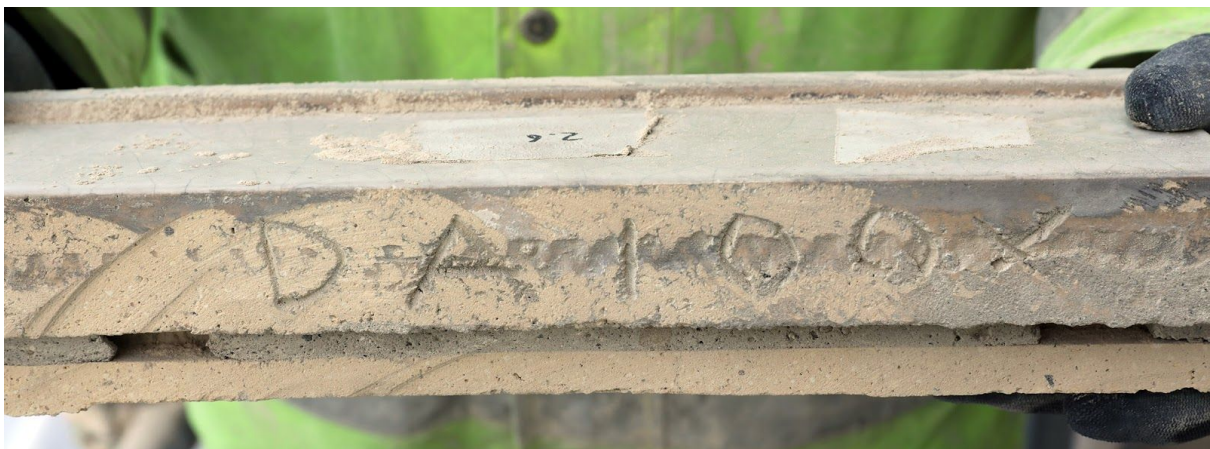
Figure 4 Handwritten label on the side of a faience tile, reading "DA 100X", from a flat panel (tile 4.4).

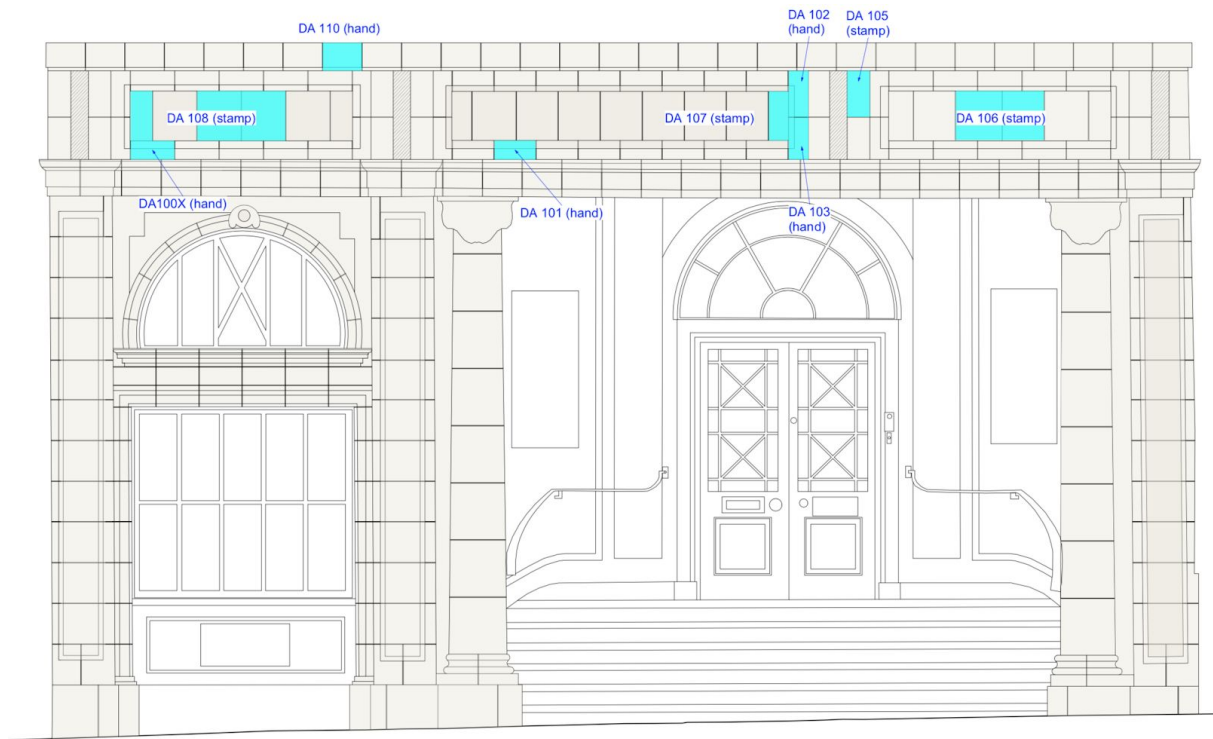
- 6.2 The numbering scheme relates to the course and bay location rather than to the shape of the faience piece. That is, the numbering for identical pieces changes depending on its location within the Fairfax House scheme. For example the central rectangular panels in the centre of each bay are respectively labelled DA106 (left bay), DA107 (centre bay) and DA108 (right bay). Despite these rectangular panels being identical, they are numbered according to their location within this particular faience scheme. This indicates the faience was produced specifically for this scheme, rather than being standard mass produced pieces.
- 6.3 Not all faience pieces contain labels, indeed most are blank. The numbering of the labels doesn't seem to reflect any particular order, either from base to top or left to right (figure 5).

Figure 5 Location of identified lapels (stamped or handwritten) on the faience pieces (base drawing © YCT).

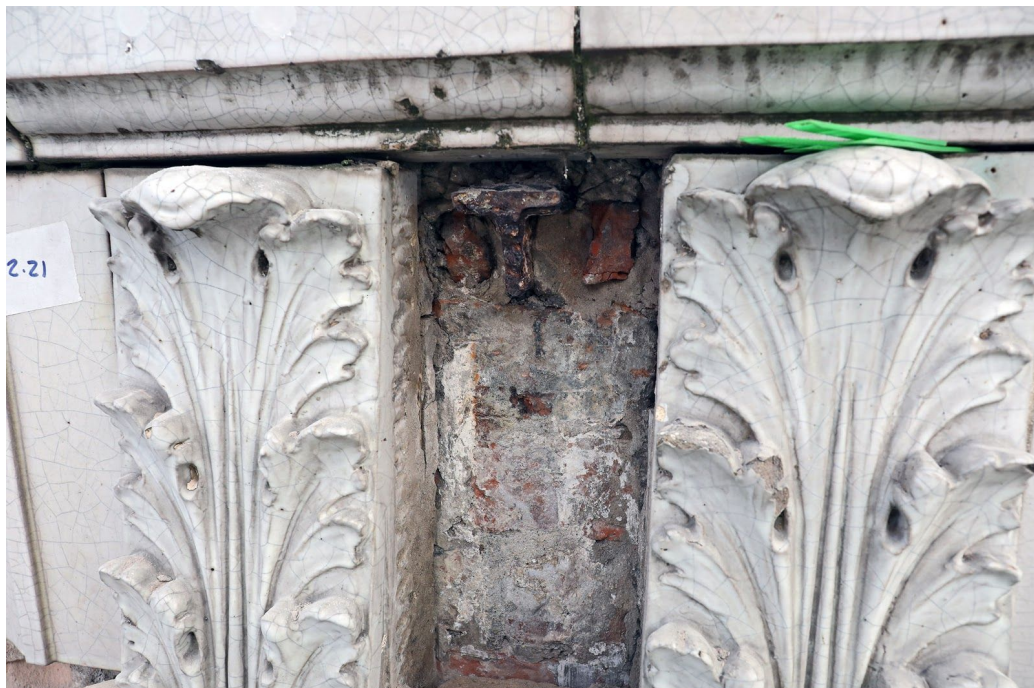
6.4 Four rectangles of cementitious mortar mark the mounting locations of a former canopy that accompanied the faience facade. Between pairs of acanthus scrolls these plain concrete panels were painted white. When this later material was removed, a piece of small-section steel I-beam was revealed in each, representing the mounting points for the canopy frame (figure 6). It is not known how these panels were originally decorated, but they were presumably not faience.

Figure 6 Canopy mounting location between two acanthus brackets, with the broken T-section joist visible at the top following the removal of the white-painted concrete.

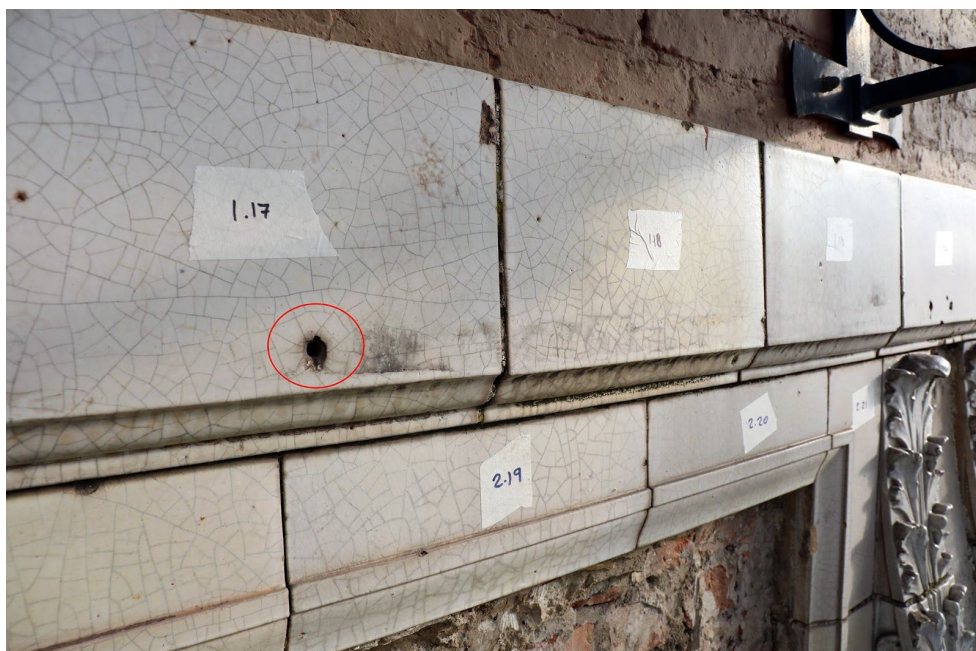
- 6.5 There is evidence of regular holes drilled into the top course of the faience, presumably relating to the fixing of a canopy (figure 8). The holes have been drilled through the faience.

Figure 8 One of the small holes (highlighted in red) drilled into the top line of faience tiles as part of a canopy mount.

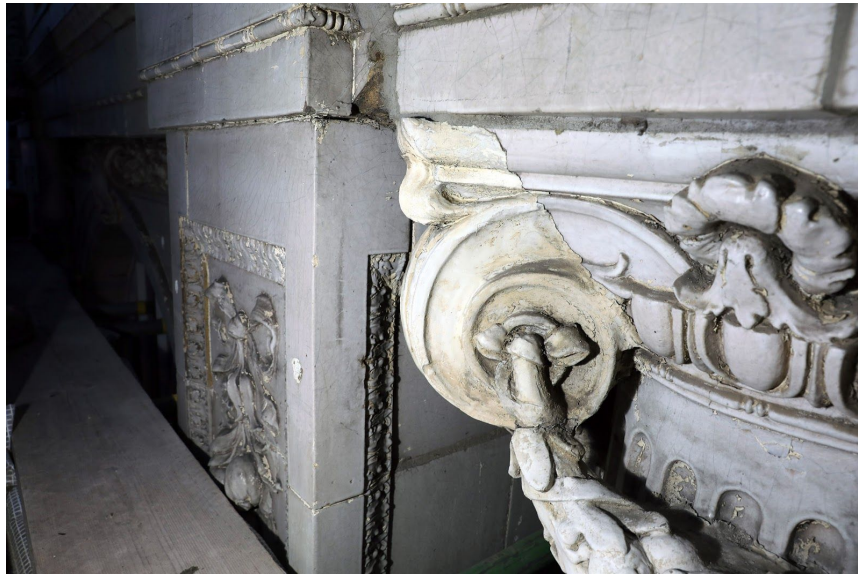
- 6.6 The left composite capital (6.5) flanking the entranceway has clearly been repaired at some point in the C20th (figure 9). The course above it (tile 5.12) has clearly also been repaired and has been pinned back in place with 2 stainless steel pins into the course above.

Figure 9 C20th repair to the left volute of the composite capital (6.5).

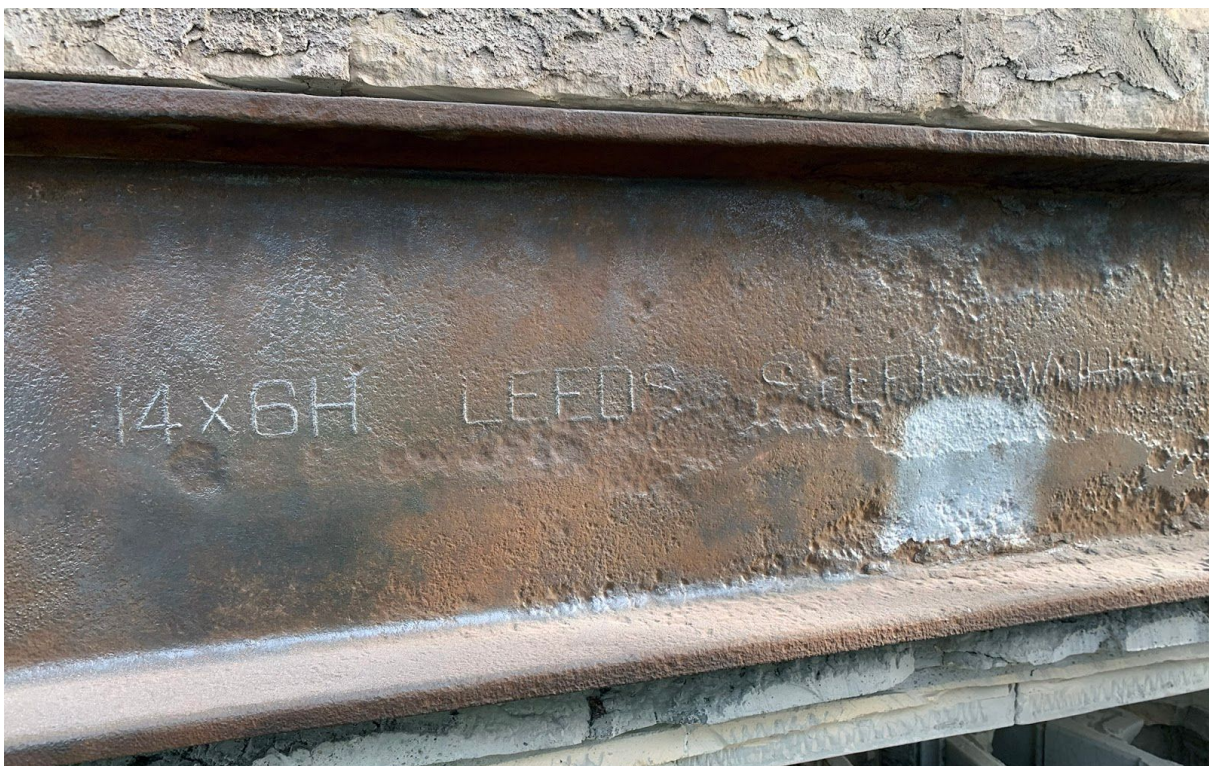
- 6.7 Written in the exposed face of the steel I-beam lintel is the text “14x6H LEEDS STEEL WORKS ENGLAND” although corrosion is starting to make the text illegible (figure 10). The figures represent the I beam’s dimensions in inches. Leeds Steel Works operated from 1888 until 1935, occupying a 10 acre site with four blast furnaces at Hunslet, Leeds.

Figure 10 Visible lettering on the face of the Steel I-beam following cleaning. Corrosion from water ingress has deteriorated the beam and reduced its legibility to the right.

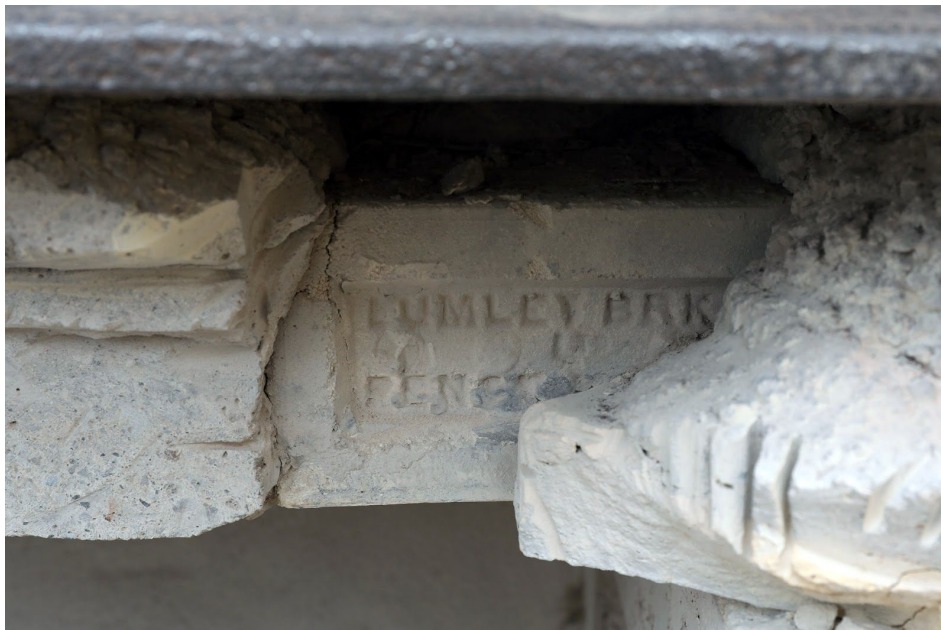
- 6.9 Below the steel lintel, a course of bricks forms the soffit of the entranceway opening. The bricks are laid on their sides, and on one the stamp is partially visible, revealing it was made by the Lumley Brickworks (figure 12).

Figure 12 Lumley Brick forming the soffit of the opening, immediately behind the composite capital at the right side of the entranceway. © [Solway Past](#)

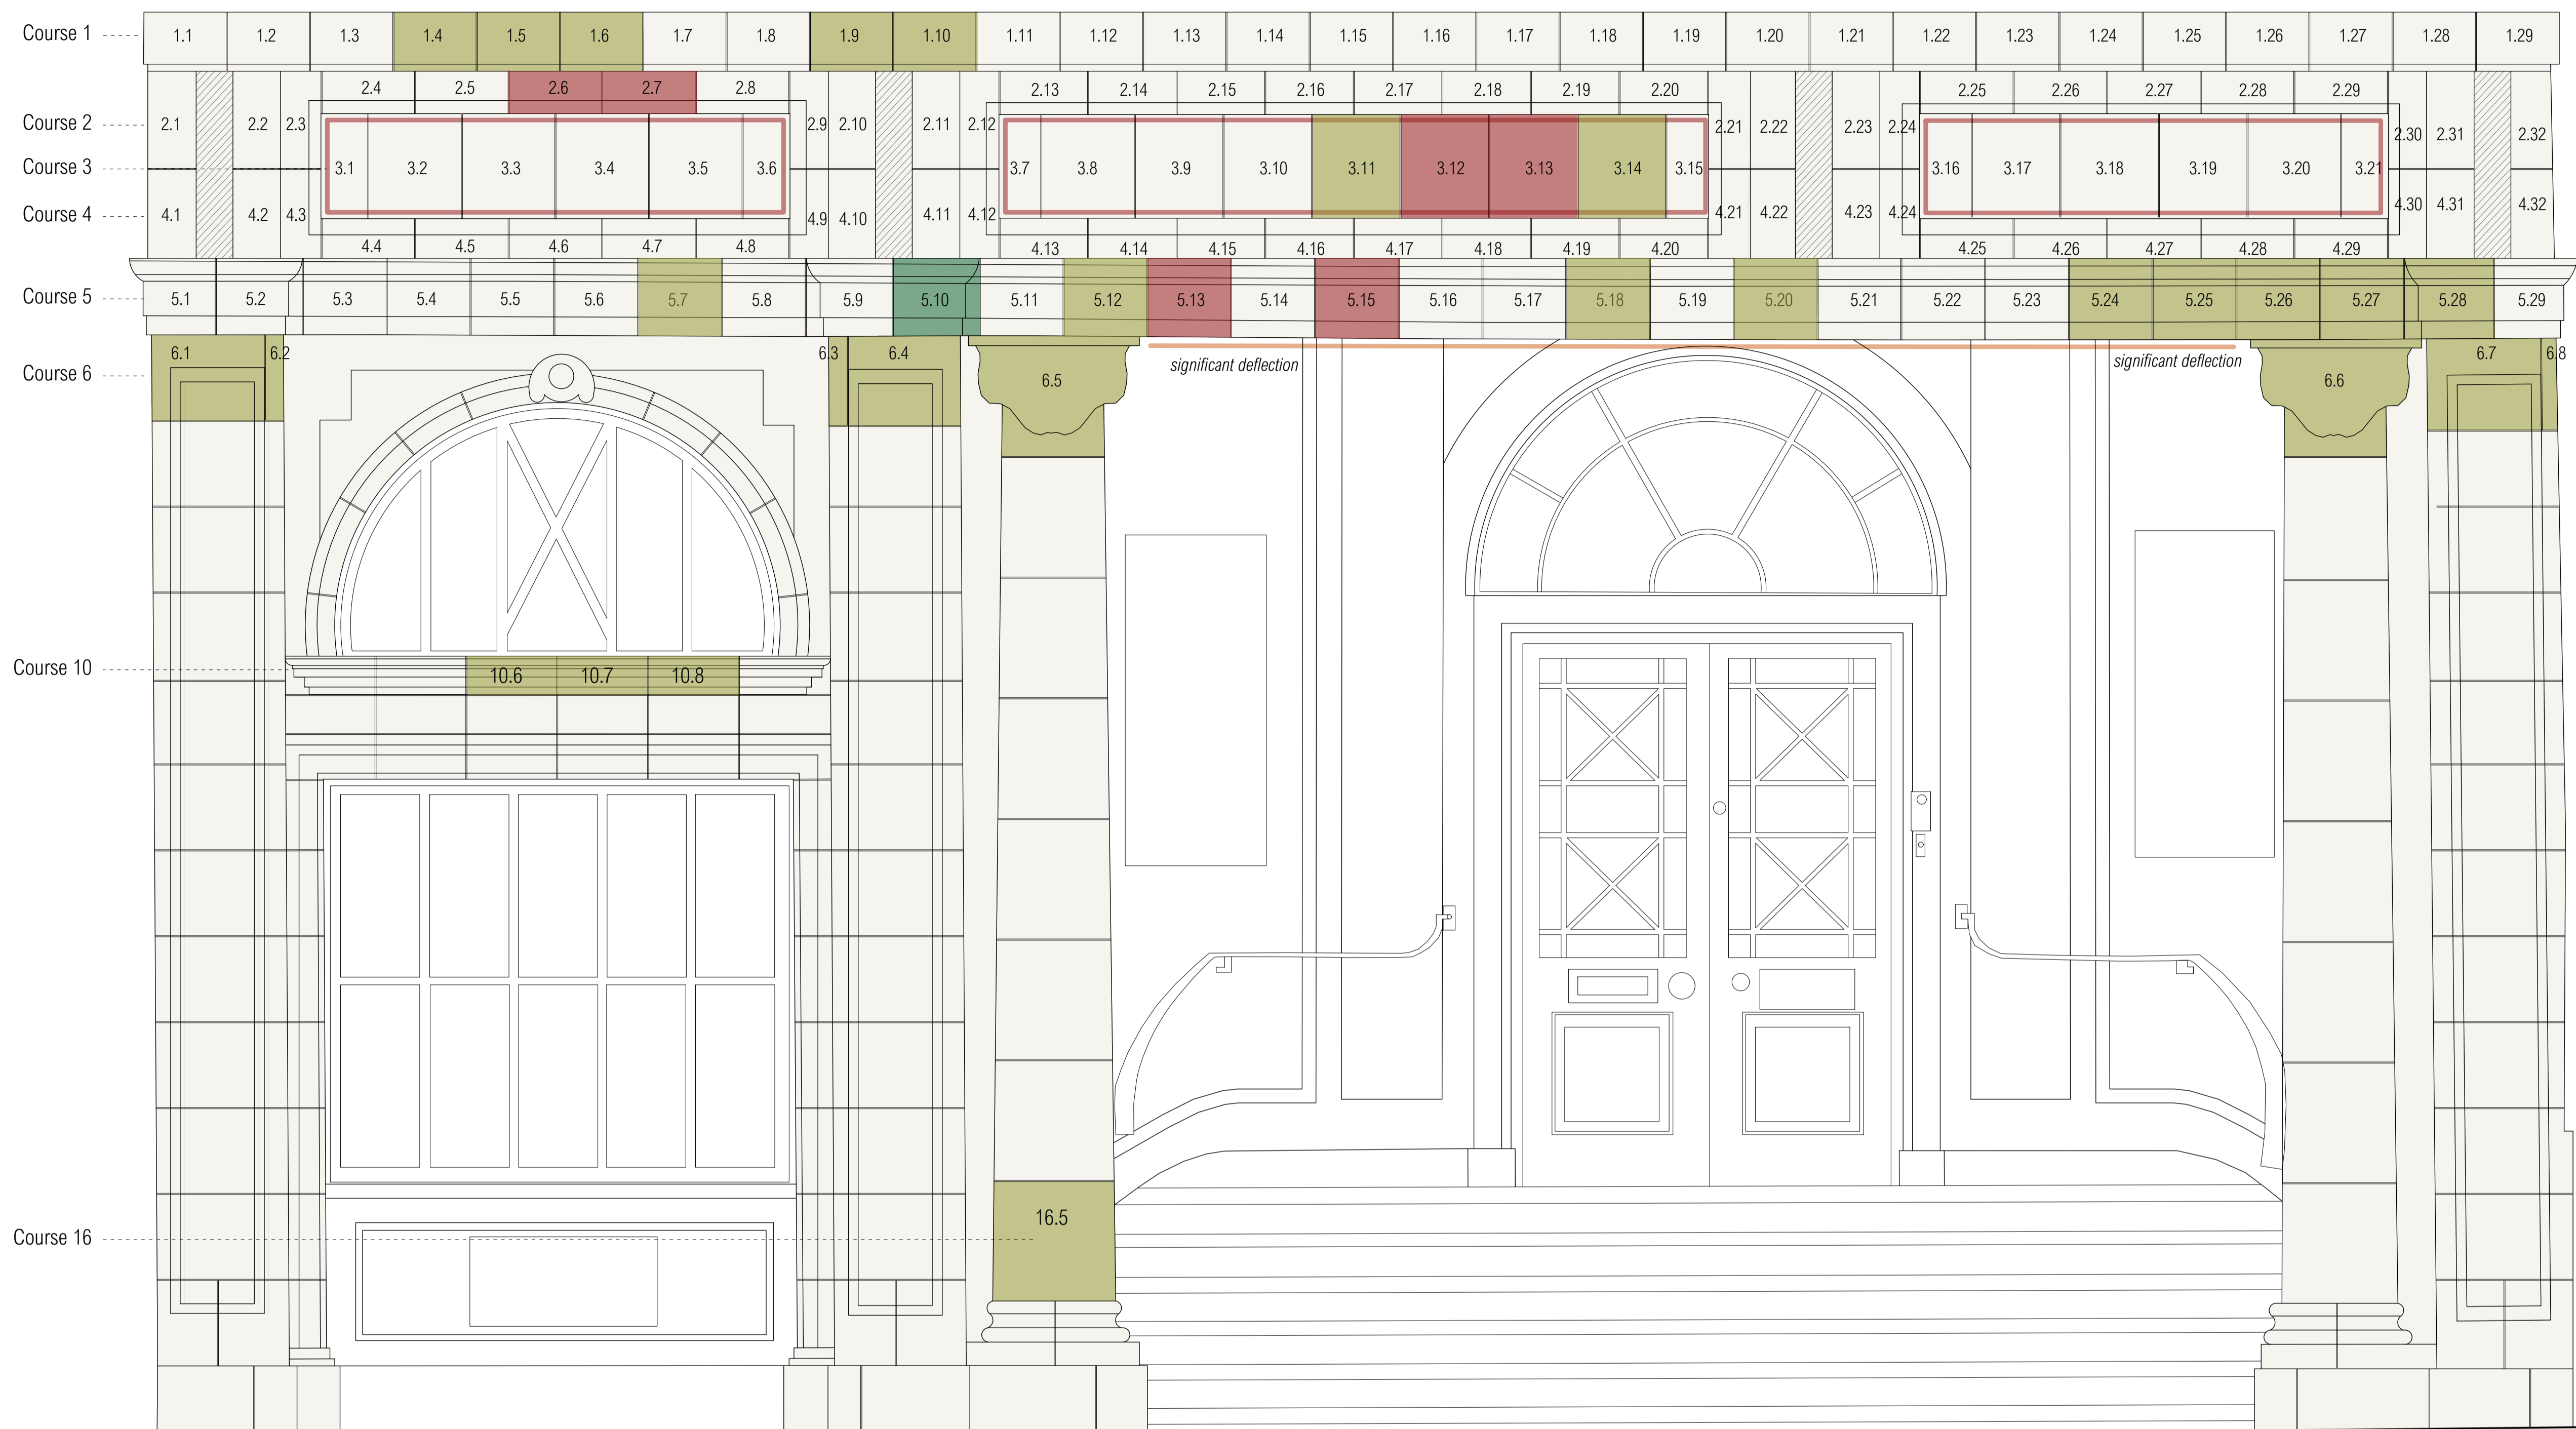
Detailed Elevation 1:15

- Loose tile | Potential to fall free.
- General area of loose tiling with potential to fall.
- Fractured tile | Small fragments loose and in danger of falling.
- Tile out of position but not loose | May become loose without intervention.
- Signs of structural movement | Areas to tiles above need to be removed to permit further investigation.
