WAGON REPAIR SHED, CHADDESSEN SIDINGS FIREPLACE WORKSHOP, WYVERN WAY, DERBY HISTORIC BUILDING REPORT

Document Title	Historic Building Report
Prepared for	Montagu Evans
Prepared by	TEP - Market Harborough
Document Ref	8712.01

Job Number:	8712
Project Name:	Wagon Repair Shed, Chaddesden Sidings, Wyvern Way, Derby
OASIS Number:	theenvir1-420821

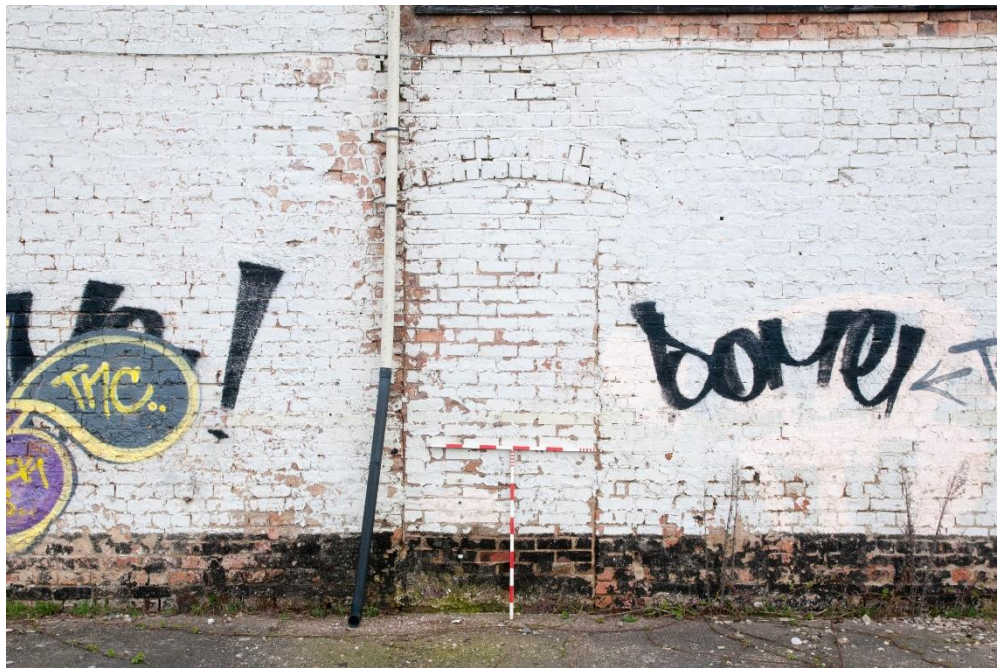
Figure 3 Detail of blocked door on the south elevation

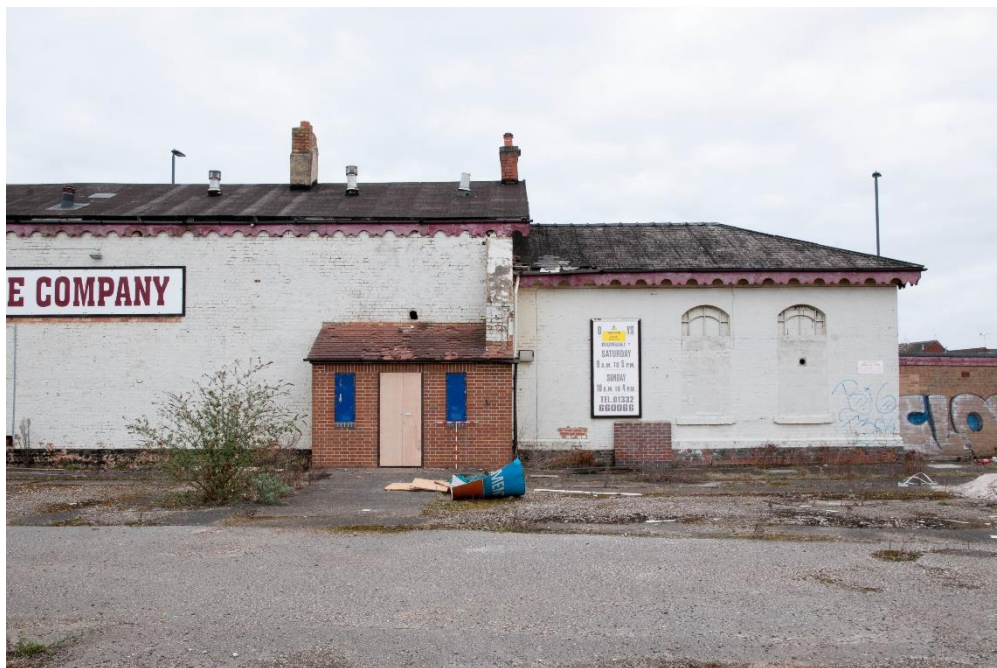
- 5.21 The porch access was a modern brick-structure occupying a rectangular footprint c4.4m in width and projecting 1.4m out from the main wall-face (Fig 4). Examination of aerial views of the site suggest that this structure was added c2000-2006. The porch abutted the wall of Building 1 and has a cat-slide roof of clay tiles and includes a central door flanked by narrow windows. Partly incorporated into the porch were the remains of a southward wall return representing the only remains of the wider wagon repair shed.

Figure 4 The east end of the south elevation with modern porch

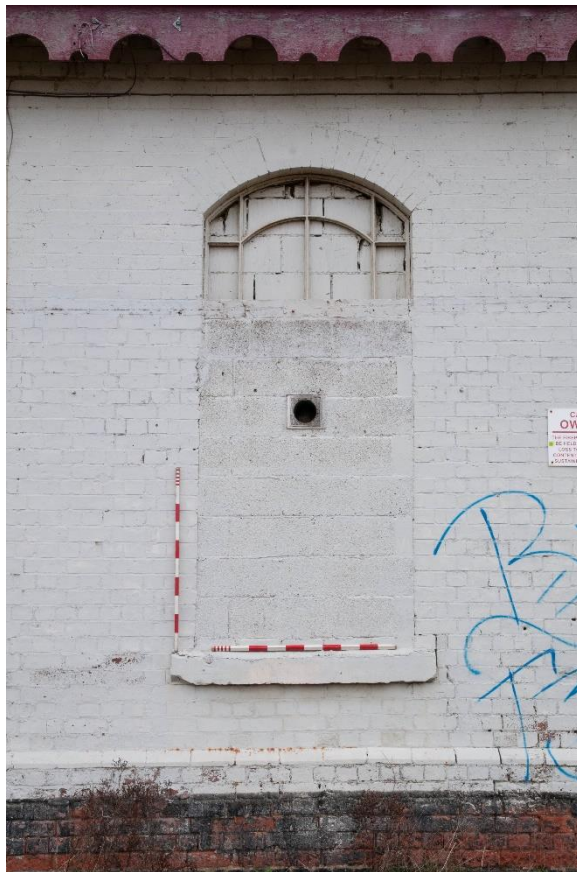
Figure 7 Detail of blocked window on single-storey block

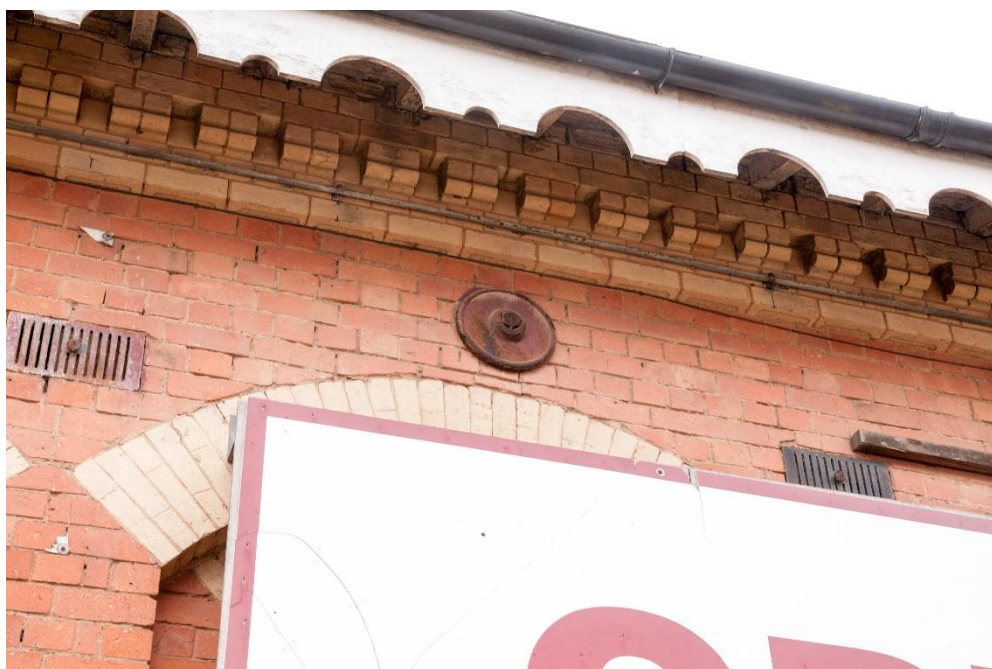
- 5.13 Rectangular ventilation holes with metal grates were positioned at first floor level at the interval between each window. A single example of a circular tie-rod plate was noted on the elevation, at least one other of these is visible on a 1980s view of the elevation (Fig 17).

Figure 17 Detail of the ventilation grates and tie rod plate

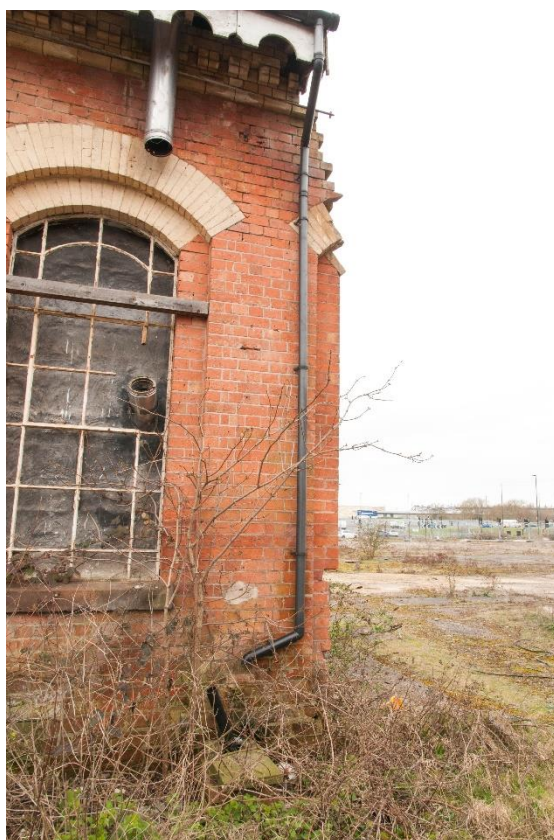
- 5.27 At both sides of the wall were the truncated remains of the demolished wall continuations. That on the north included the remains of a window jamb and window arch (Fig 18). The wall was comprised of brick in English bond and had been roughly repaired in brick and concrete breeze blocks. A rolled steel joist was inserted in front of the wall face as part of the repairs in order to consolidate and strengthen the structure.

Figure 18 The west end of the north elevation showing remains of former window

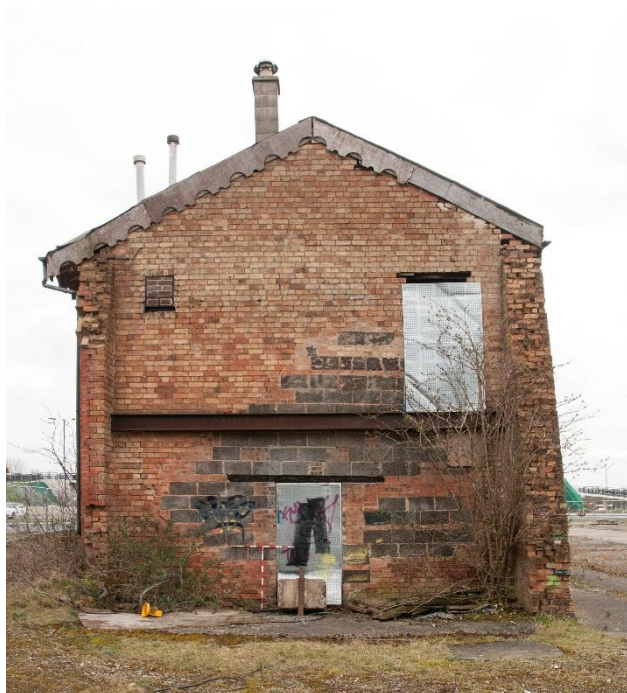
- 5.26 As noted previously the building was formerly longer than its present extent; this is evident on the west elevation which comprises a much repaired former internal partition wall (Fig 19).

Figure 19 The repaired west elevation with remains of wall returns; showing blocked doors and inserted RSJ

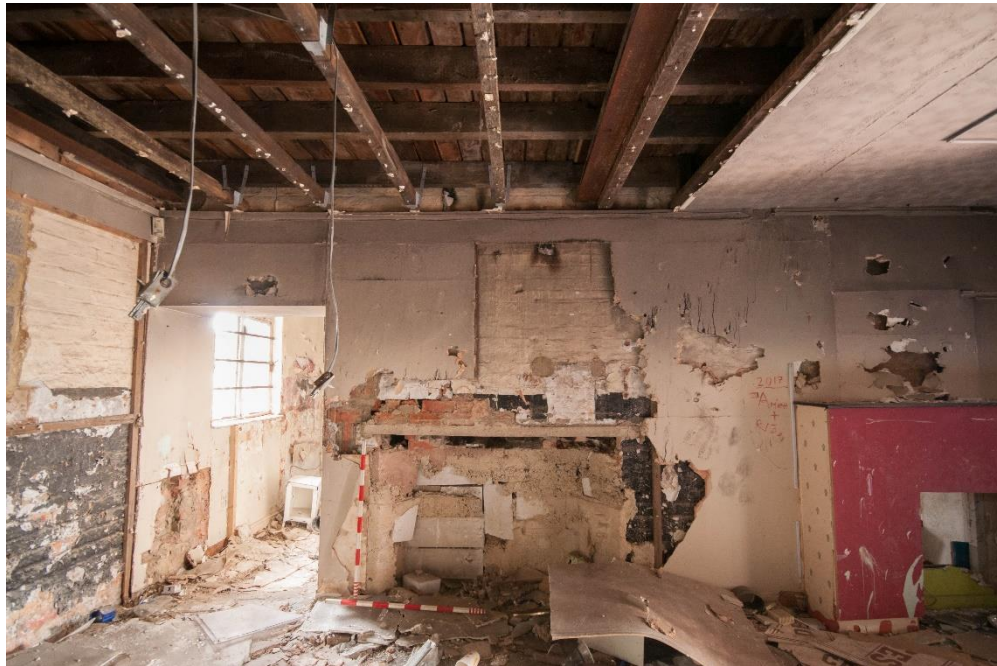
- 5.36 A fire opening was located at the east side of the room, opening into the chimney stack located on the east gable wall. The fire opening had splayed reveals in brick and crude repairs in cement had been carried out and a concrete lintel inserted. The fire opening had not been utilised as part of the fireplace workshop and the opening had been covered over with plasterboard which had fallen away by the time of this survey.

Figure 21 The east wall of Room 1 with remains of fireplace

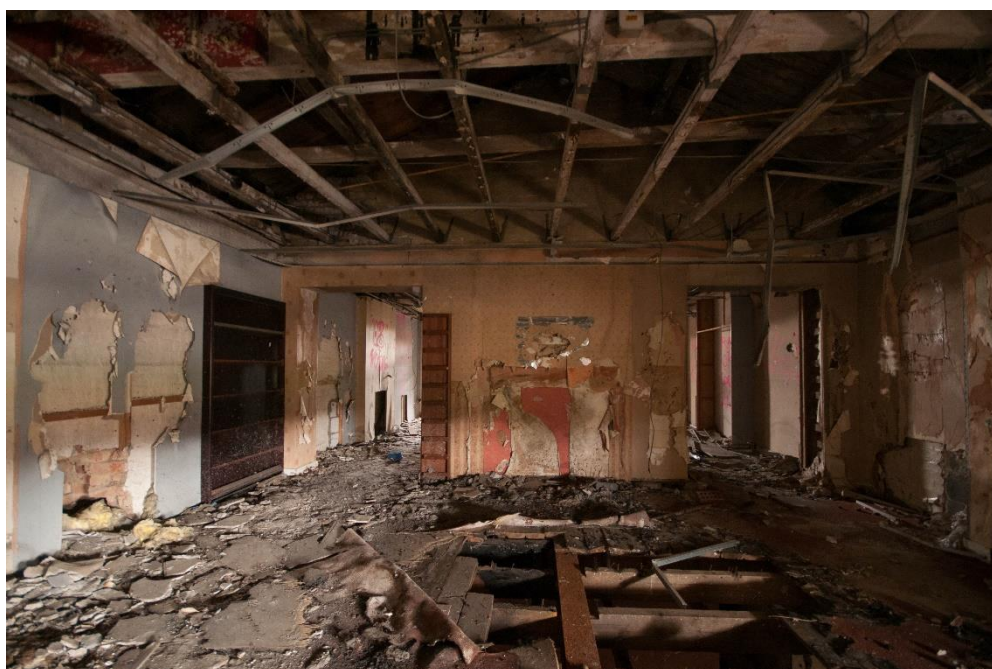
- 5.35 The ceiling / first floor was comprised of closely spaced softwood joists on edge and spanning between the north and south walls. Below the N-S joists were another set of joists spanning longitudinally E-W and carried in joist pockets in the walls and metal brackets slung under the N-S joists. The plasterboard of the ceiling was attached to the lower joists and electrical cables were passed through the intervening space. The overlying floor surface was comprised of wooden boards. The joists were fire damaged in several areas of the building due to arson.

Figure 33 The first floor, looking west, showing fire damage to the floor
