**PIRTON GRANGE GATEHOUSE  
PIRTON  
HERTFORDSHIRE**

**HISTORIC BUILDING RECORDING,  
DOCUMENTARY RESEARCH AND  
ARCHAEOLOGICAL MONITORING**

Document: 2012/95  
Version: 1.0

30th August 2012

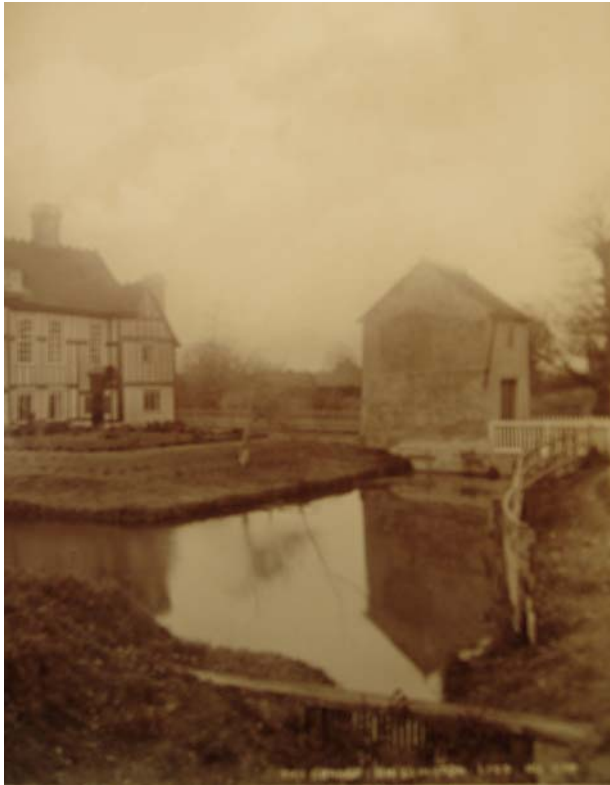
**Pirton Grange & Gatehouse 1895 (HRO Gerish Box 61) detail showing Gatehouse**

The photograph above shows some repairs to the render on the south wall of the gatehouse. It has a tiled roof with decorative ridge tiles and there are wooden doors at its entrance (E elevation), above which is a small window at first floor level.

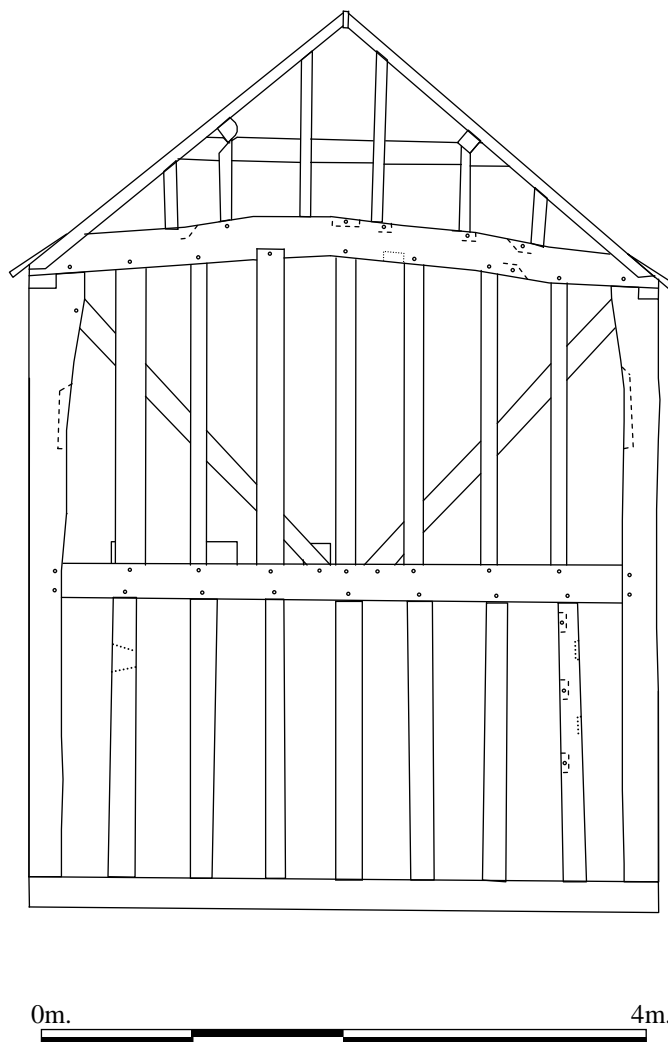
**Figure 4: North elevation (scale 1:50)**

The base of the frame on this side show considerable decay. The sill beam, lower parts of studs and the bases of corner posts were lost or badly decayed.

The surviving original structure consists of the corner posts, end girt, tie-beam and some of the studs (Figure 4 and Plate 13). Empty mortises along the top of the tie-beam indicate the original location of vertical studs to support the gable. An angled mortise noted at the west end of the tie-beam suggests that the gable may have contained diagonal braces.

The studs at ground and first floor level include some replacements, however the arrangement of mortises and peg holes suggest that these occupy the original locations. The frame contains mortises for possible arch braces at the upper corners of the wall; long mortises infilled with plaster are found in the corner posts with a corresponding angled mortise in the underside of the tie beam, towards its west end

The end wall contained evidence for a considerable amount of repair. All of the studs in the gable, above the tie-beam consisted of machine-sawn, squared timber. A number of the studs at first floor level, likewise, had been replaced with machine-sawn, waney-edged timber. One of these had been let into a notch in the tie-beam to form a lap joint. This type of repair could have been made to the standing structure. A similar empty notch, 0.8m to the west suggests the location of a similar stud which has since been replaced. At least three of the other replacement studs are fixed with pegged mortise and tenon joints at top and bottom indicating that the frame must have been at least partially dismantled to carry out the repair. Long, straight tension braces extending from the centre of the side girt to the top corners of the wall may have been added during repairs to the structure.

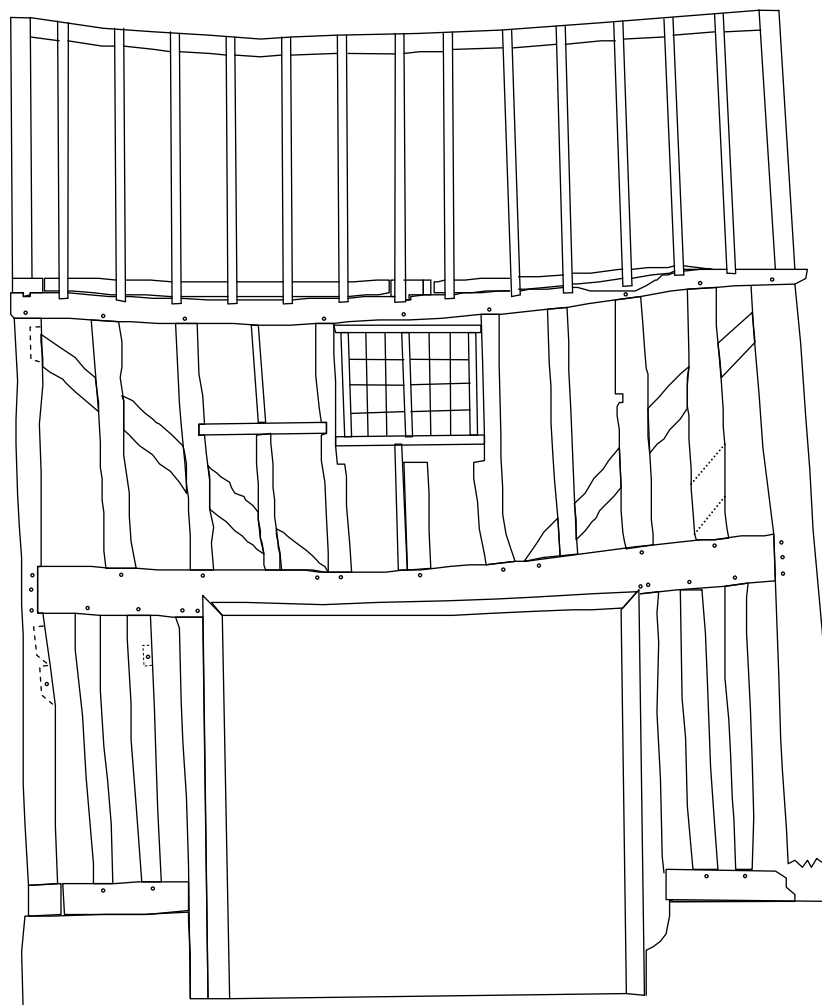
**Figure 5: East elevation** (scale 1:50)

The frame on this face is largely intact with some loss of detail in the sill beam and the base of the corner posts due to decay.

Surviving original structure consist of the decayed sill beam, corner posts, side girt, wall plate and most of the studs (Figure 5 and Plate 14). A small number of empty mortises indicate possible reuse or alterations, however the evidence is ambiguous. The south-east corner post contains two empty mortises just below its junction with the side girt. At the top of the same post an empty mortise lies in front of the mortise for the head of the tension brace. The northernmost stud in the first floor wall had a shallow diagonal cut out for a possible brace, but no corresponding evidence for any such timber existed to either side.

Some modification is evident at first floor level. At the time of the survey the wall contained a central window. This was evidently a later insertion which truncated the timber frame. A truncated stud remains below the window and a peg hole above indicates its original continuation. A gap below the window suggests the location of a missing sill beam or deeper window.

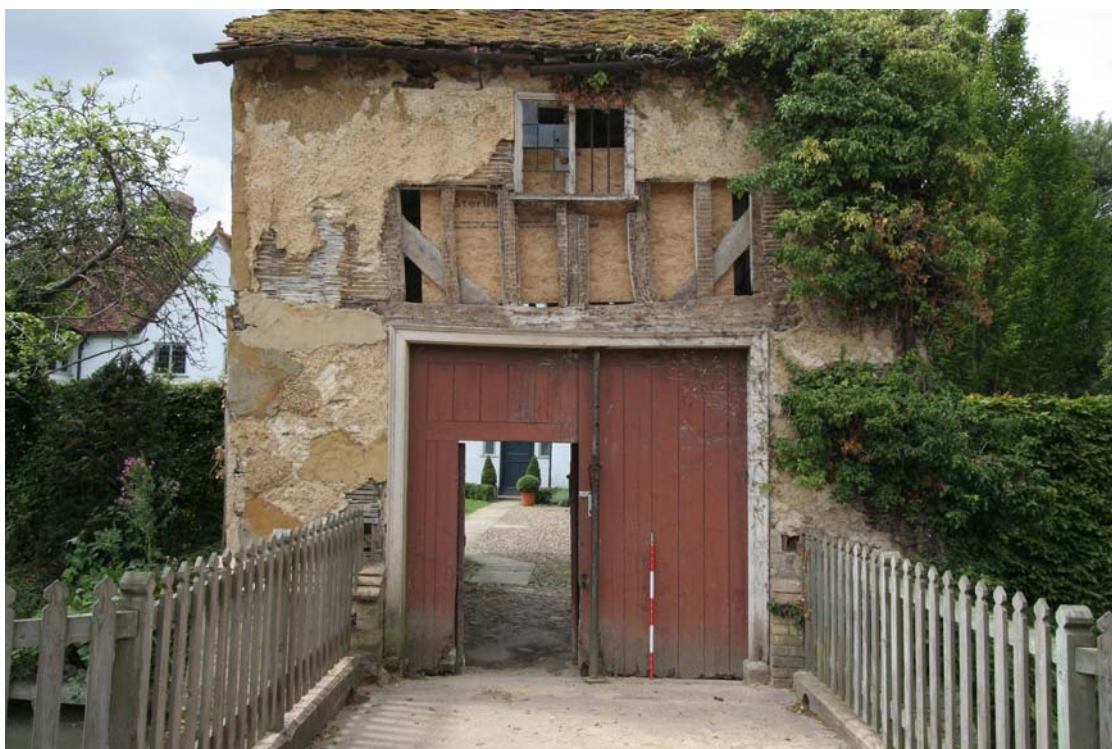
**Plate 2: East elevation**  
(After partial removal of plant growth and external render)

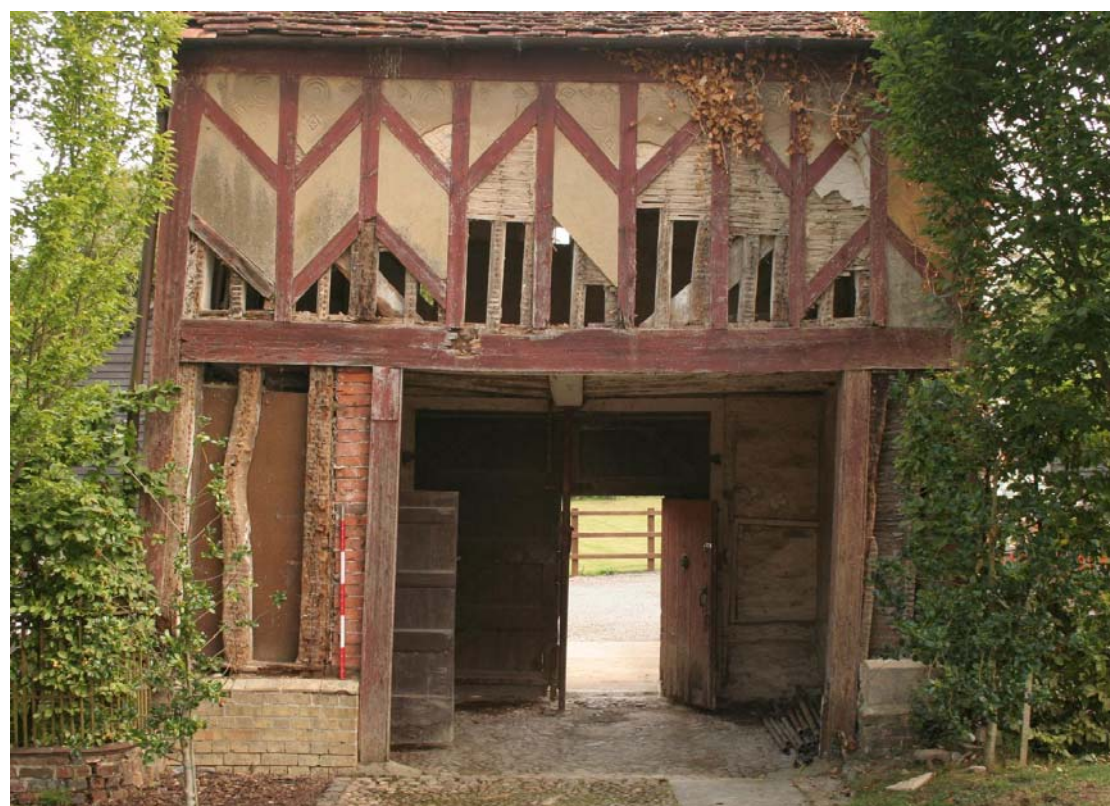
**Plate 4: West Elevation**

(After removal of plant growth and partial stripping of external render)

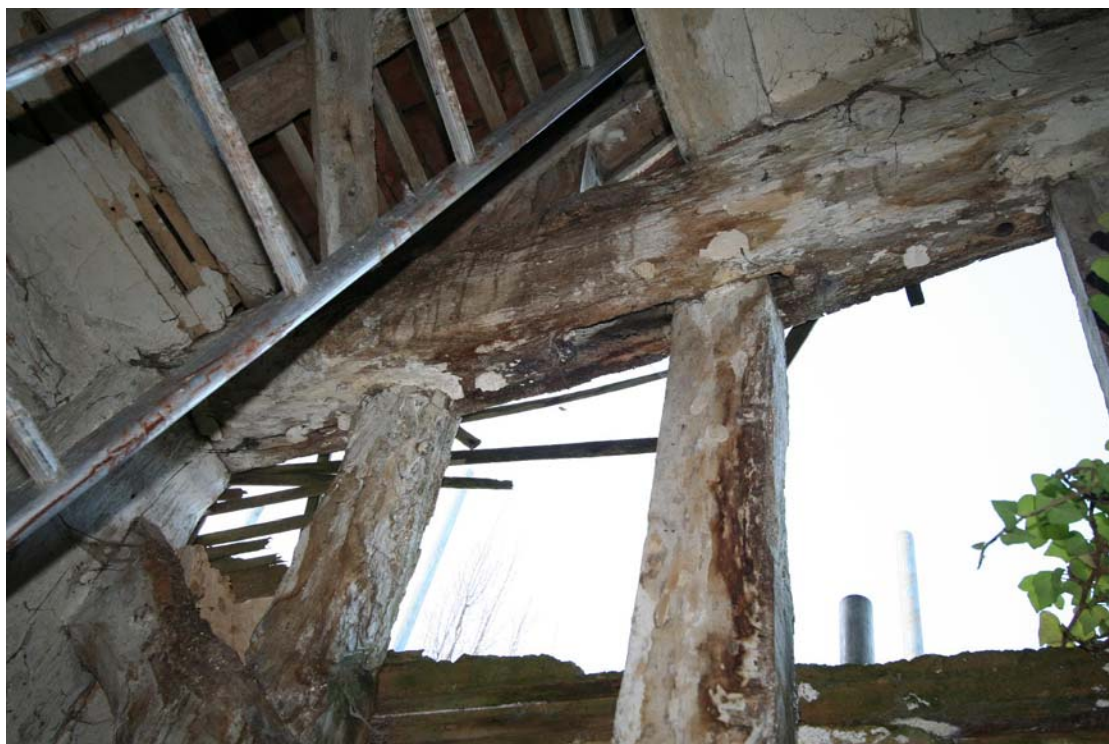
Evidence for the infill survives in the form of stave holes and grooves (Plate 17). Holes the underside of the tie beam and side girt are spaced at three per panel. A corresponding groove exists in the upper face of the end girt, but any evidence in the sill beam was lost due to decay.

**Plate 17: First floor interior, detail**  
(Showing stave holes and empty mortise at west end of north tie beam)

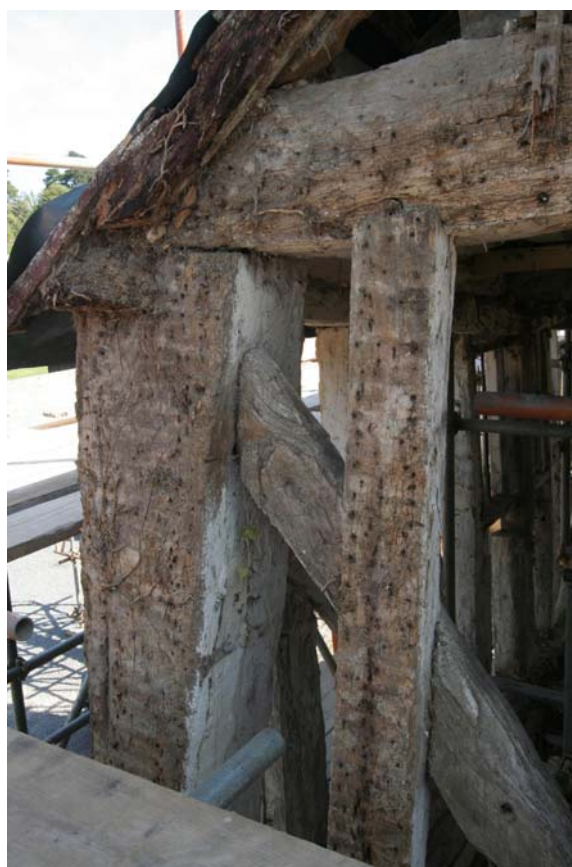
**Plate 18: First floor exterior, north east corner**  
(Showing plaster filled mortise in the white-washed face, below the diagonal brace)

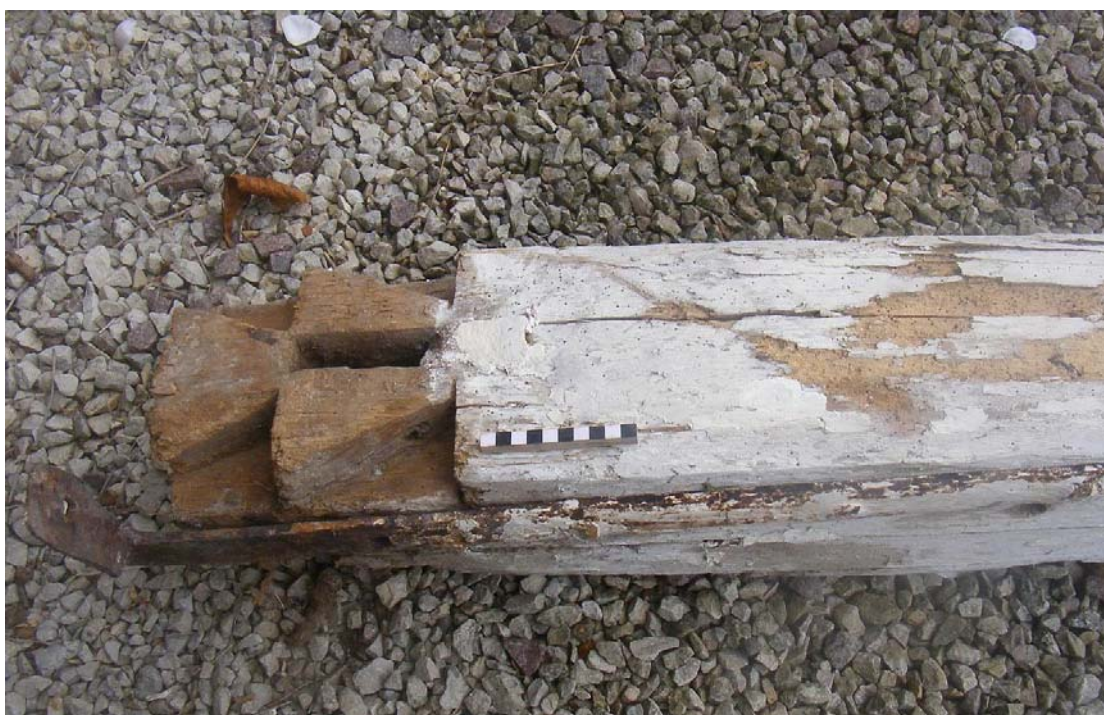
A break in the western end on the beam and decay meant that the beam had to be replaced as part of the current works. On removal an unusual dovetail joint was found in its lower face. This consisted of a double lap dovetail with a mortise through the inner part of the dovetail (Plate 19). The inner end of the mortise had been filled with plaster where it would have been visible inside the building, this corresponds to the whitewashed section of the beam in Plate 19.

**Plate 19: Central tie beam, detail**

(East end of tie beam after removal showing a double dovetail in underside)
