**HARRINGWORTH MANOR COTTAGES
HARRINGWORTH, NORTHANTS**

ARCHAEOLOGICAL BUILDING RECORDING

Document: 2014/8
Version: 1.0
January 2014

Albion Archaeology Project Code: HMC2319

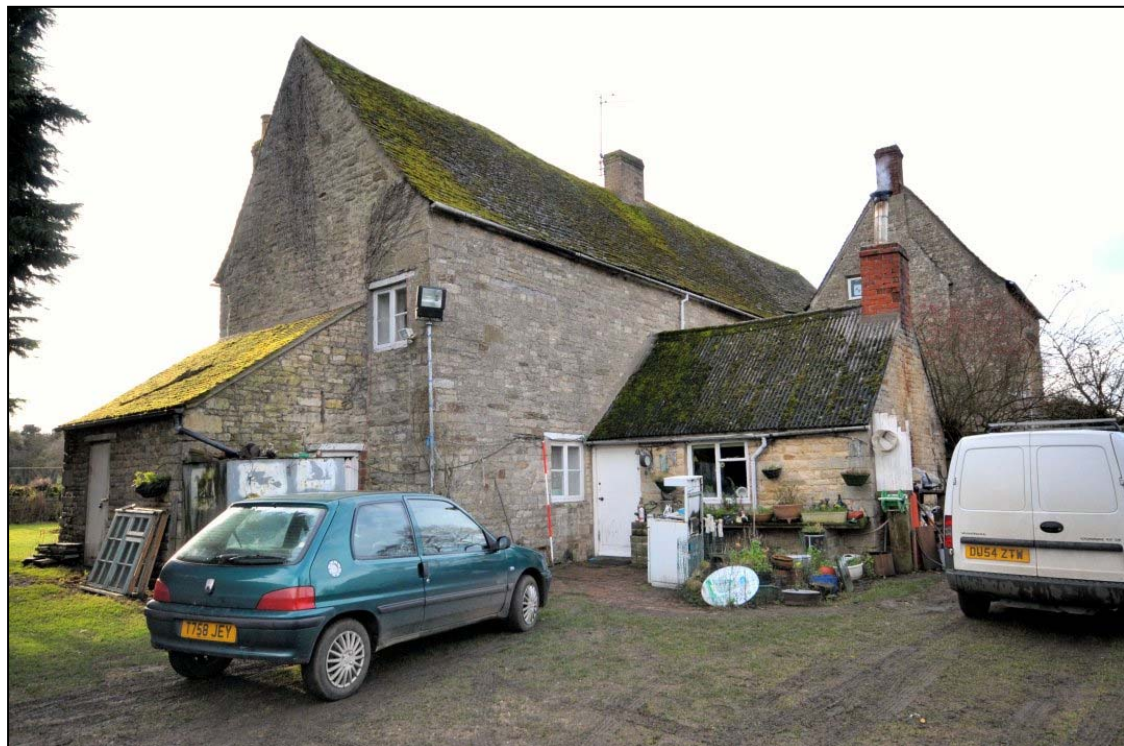
Figure 14: Building from the north-east

Shows rear side of main range with lean-to store to left, single storey extension at right and north range at rear right

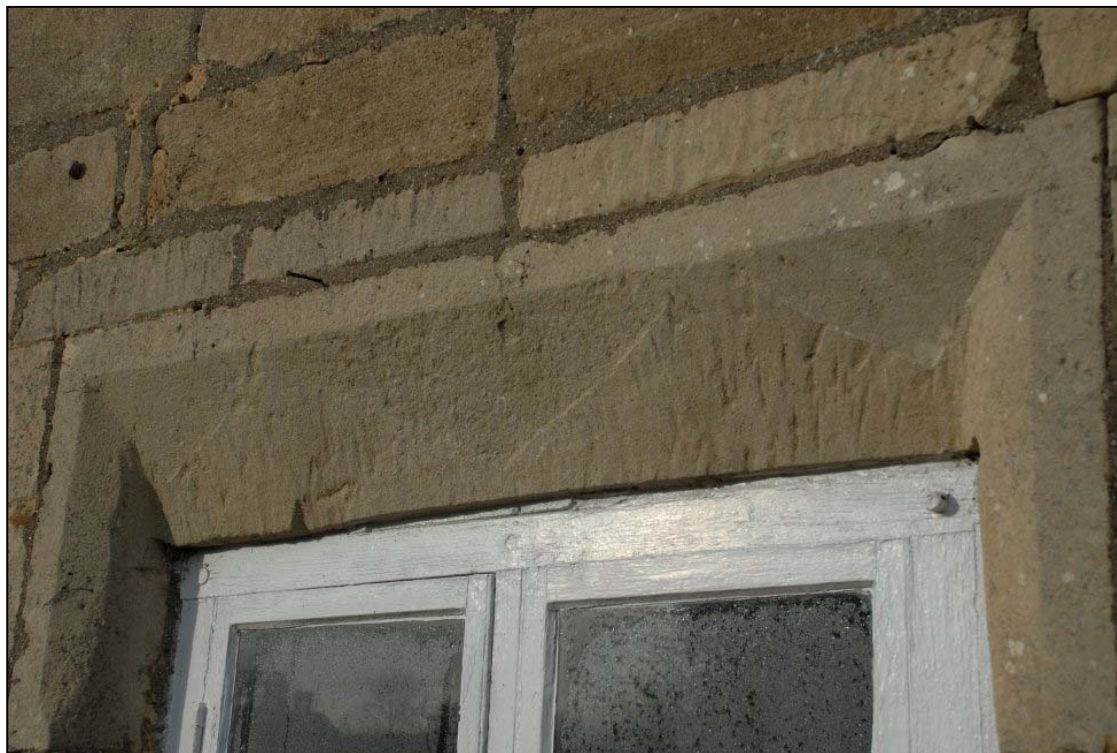
Figure 18: Detail of ground floor window in south wall of the main range

masonry around the window suggest that it has been reset. The plain chamfered head has two roughly dressed triangular areas (Fig. 18) suggesting that it was recut from a window that originally contained two lights. The first floor window in this bay is a 15th century window with two cusped ogee-headed lights and a hood mould above. Ashlar masonry filling the lower part of the opening appears to be a later addition because the jambs can be seen continuing down to the sill below.

Two roughly dressed triangular patches are visible in the lintel. Probably caused by cutting away tracery in the head of the window opening

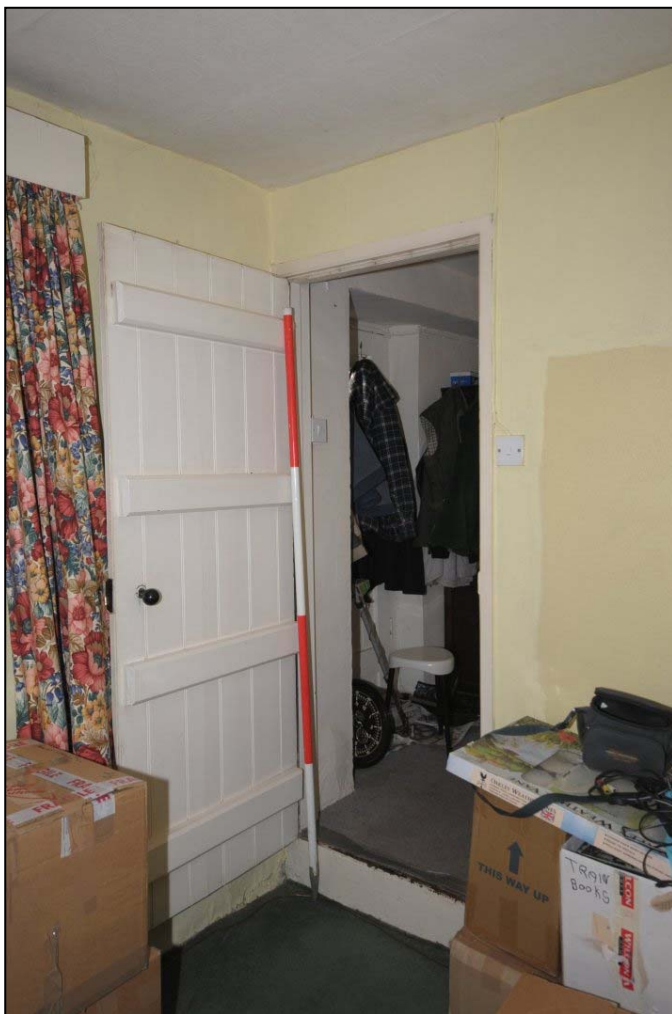
Figure 23: Room G2, door to entrance lobby

The rooms on both the ground and first floor in the eastern cottage have a standardised plank and ledge internal doors (Fig. 23). These are 6 plank doors with beaded mouldings on both faces. They have 4 ledges on the rear with surface mounted locks of probable early 20th century date.

Standard type of plank and ledge door used in the east cottage

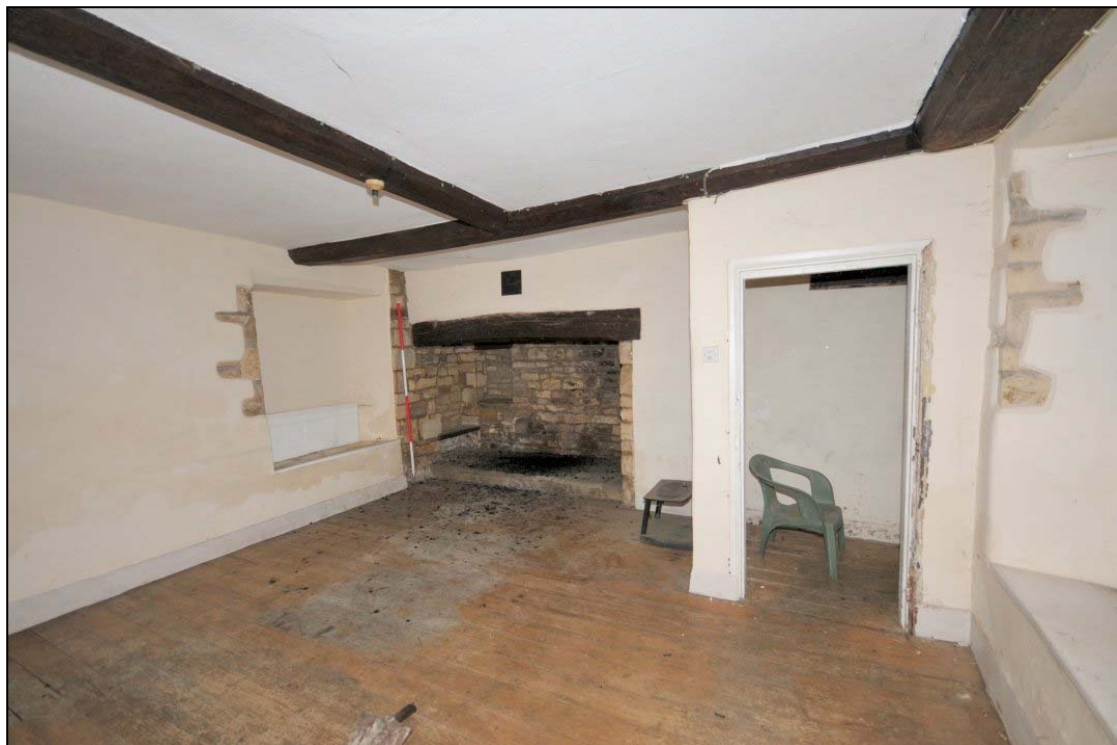
Figure 26: Room G4 facing north-east

Shows entrance lobby on the right and a blocked opening to the left of the fireplace

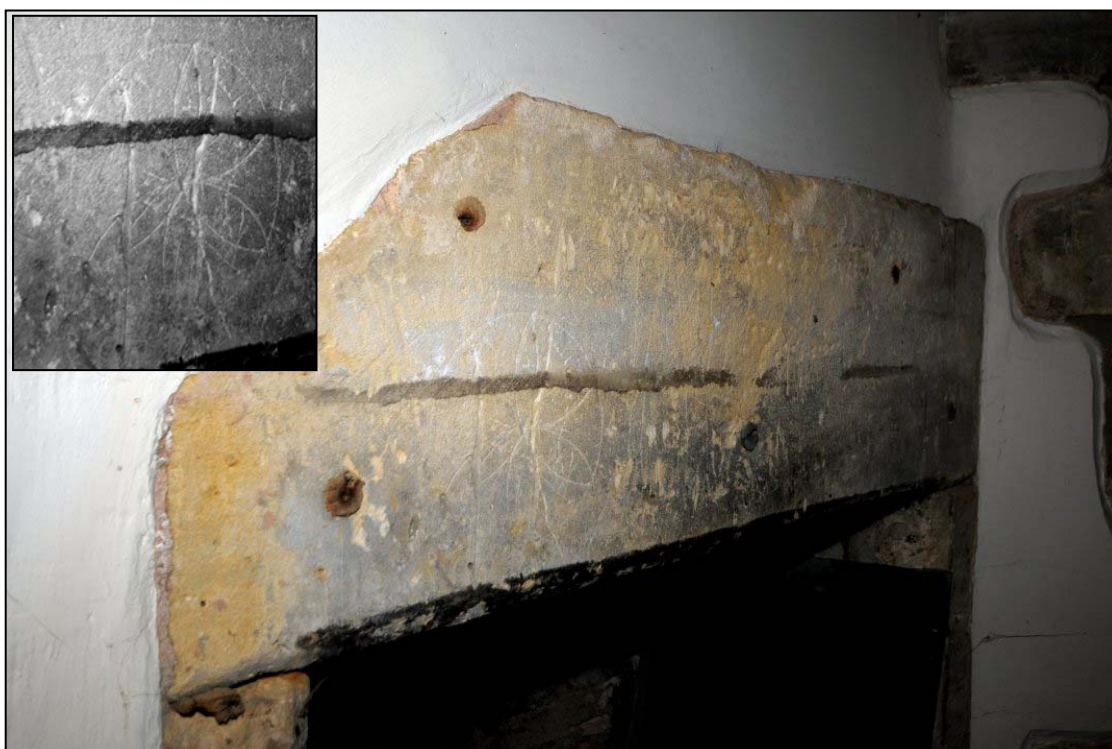
Figure 28: Detail of fireplace in room G4

Inset shows enhanced image of inscribed daisy wheel pattern

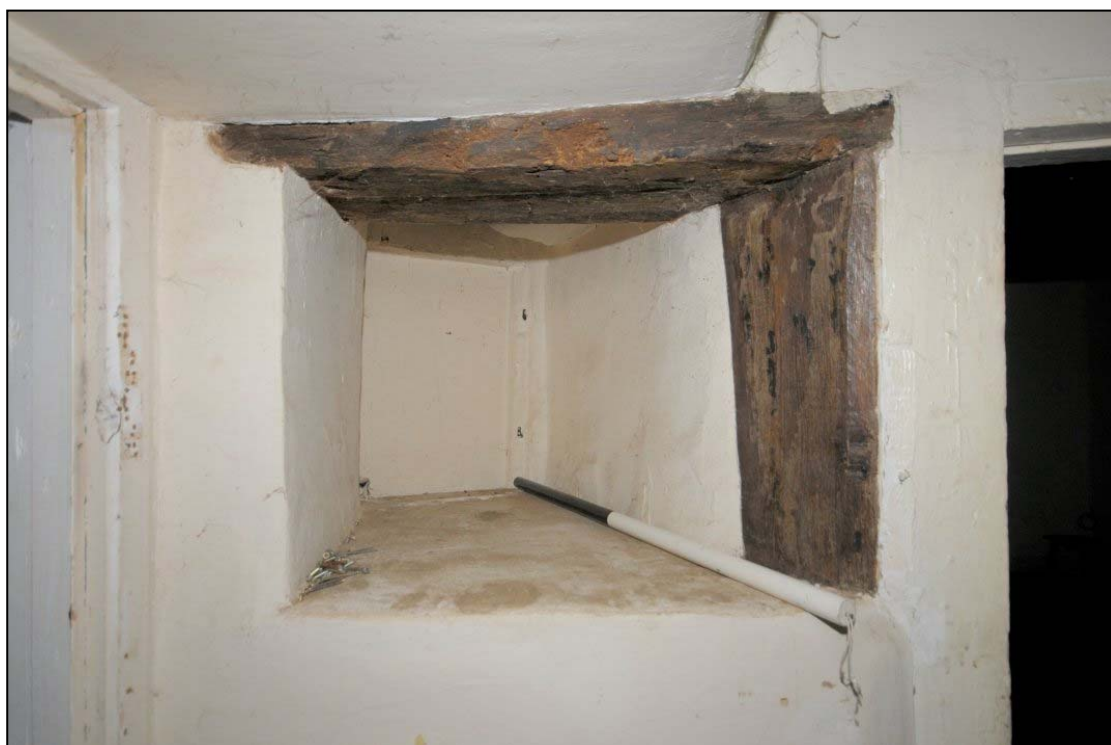
Figure 32: Detail of squint facing north-east

Remains of pintle hinges are visible at the right hand side of the blocked opening

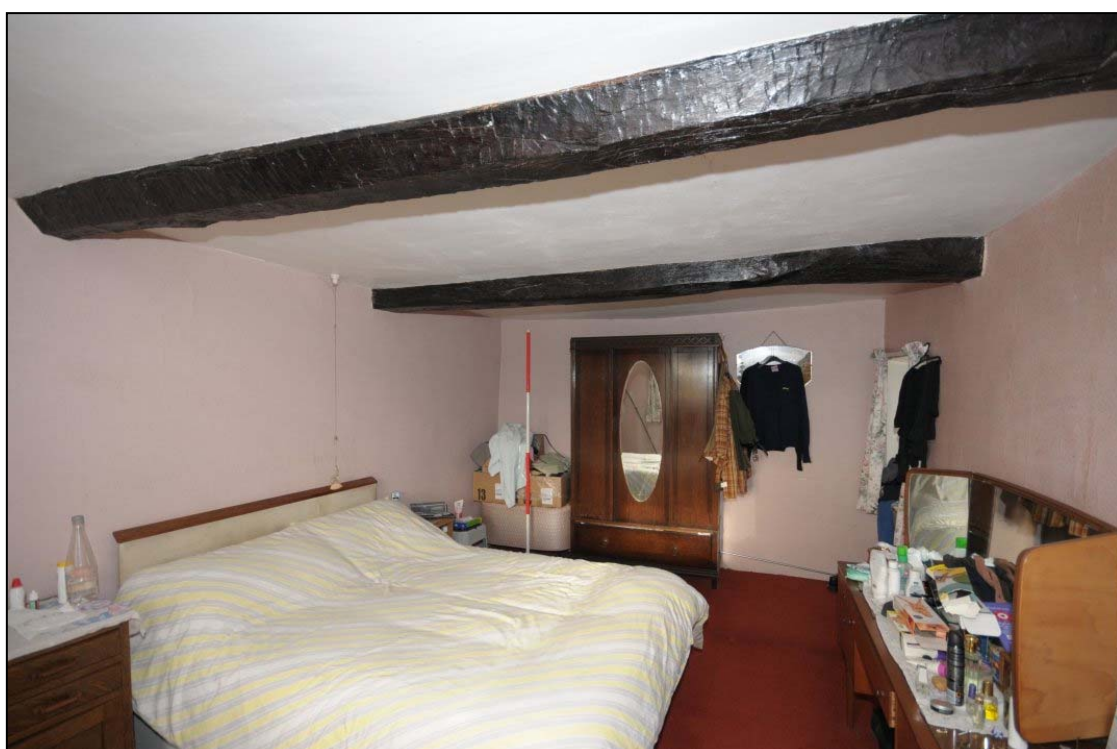
Figure 38: Room F1, facing north-west

Showing reused beam with deep chamfer at top of image

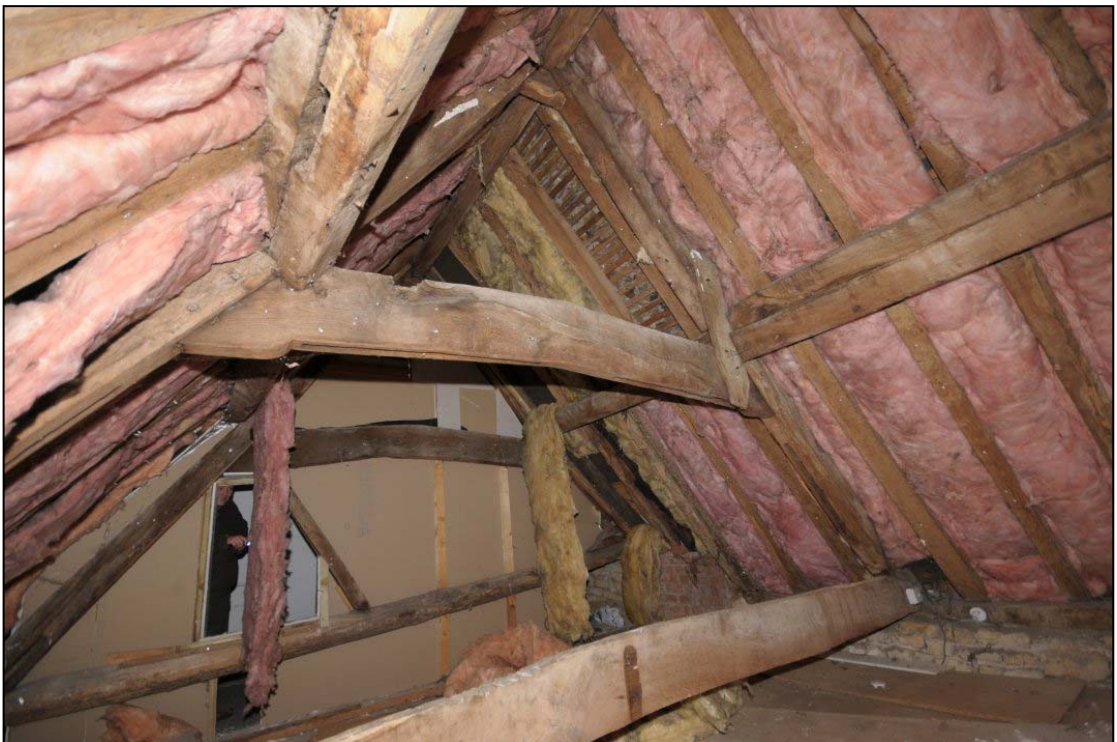
Figure 54: Attic S1, facing north-west

Shows roof truss with slots for arch braces in undersides of the collar and principle rafters

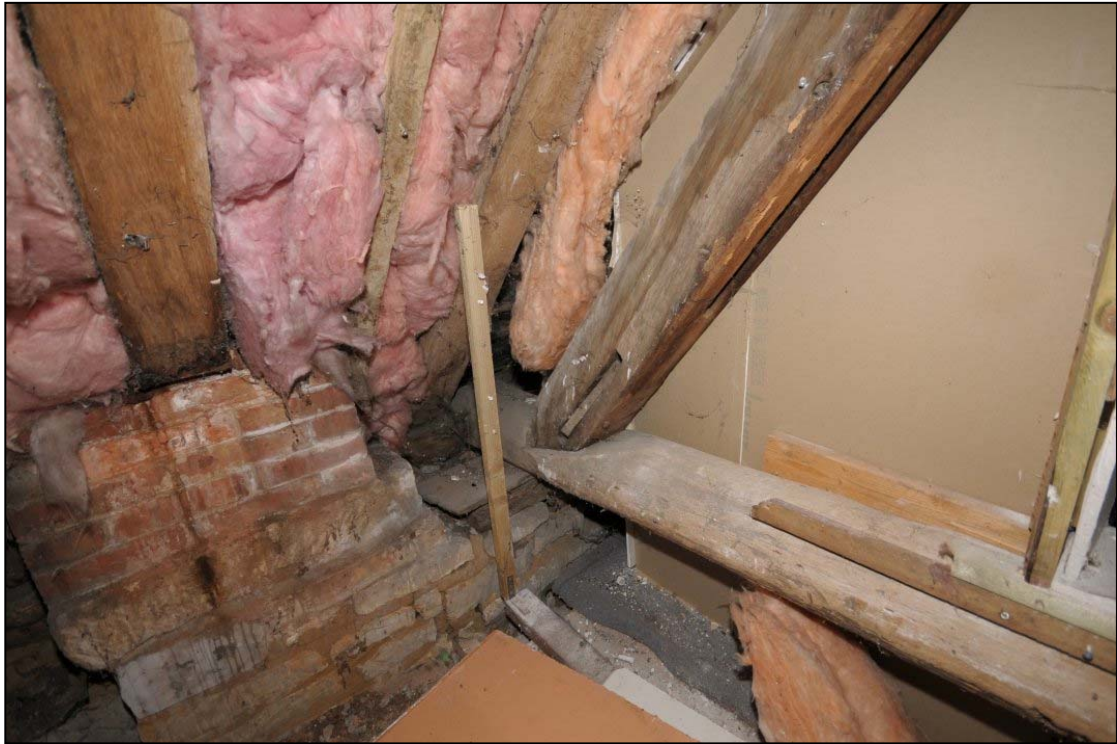
Figure 55: Attic S1, facing south-west

Showing rafter with mortises for lower end of wind brace and arch-brace as well as a round tie-beam, notched to take the foot of the rafter

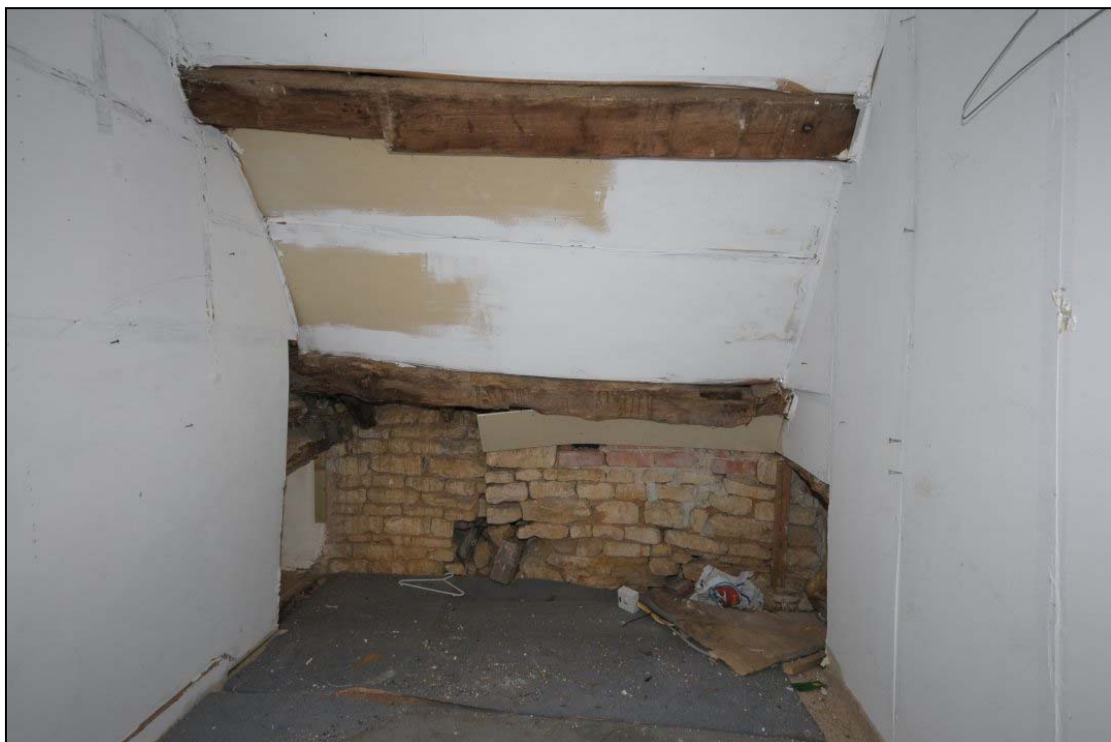
Figure 56: Attic S2, facing north

Shows offset in limestone masonry of north wall.

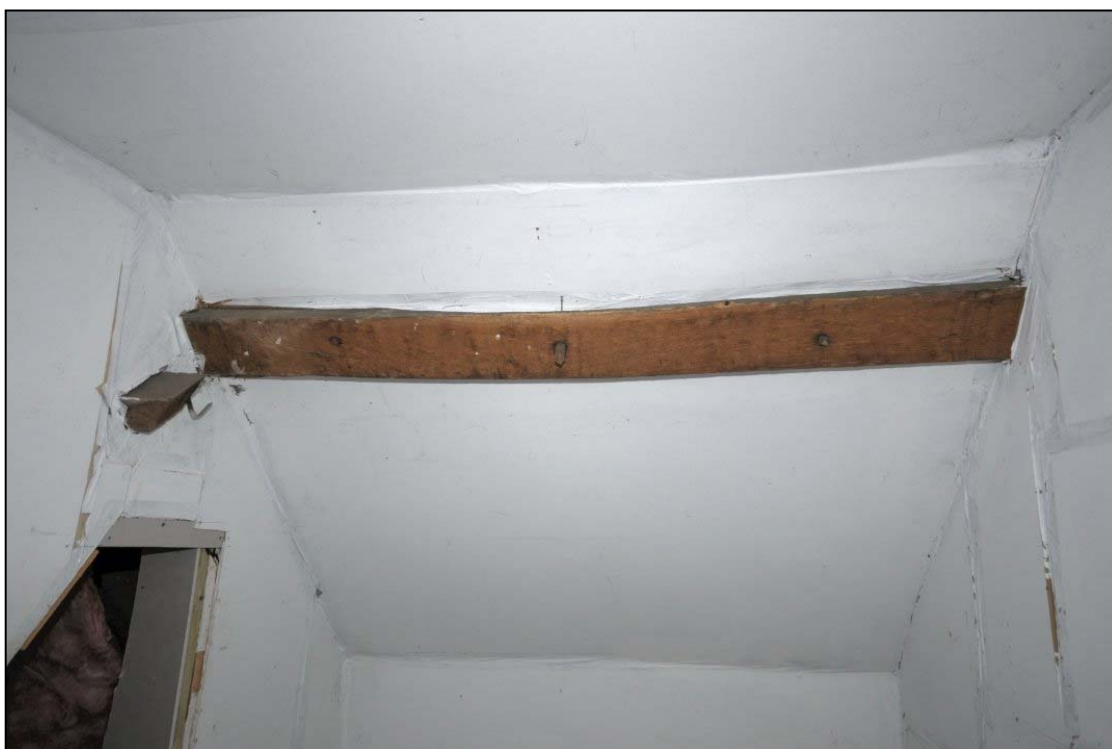
Figure 58: Attic S2, facing south

Showing existing purlin and cut off purlin stub at left
