**FALCON COTTAGE
VILLAGE ROAD
DENHAM
BUCKINGHAMSHIRE**

**HISTORIC BUILDING RECORDING
AND
ARCHAEOLOGICAL OBSERVATION,
INVESTIGATION, RECORDING, ANALYSIS AND
PUBLICATION**

Project: FCD2732
Museum accession no: AYBCM 2015.164
OASIS ref.: albionar1-233910

Document: 2016/88
Version: 1.0

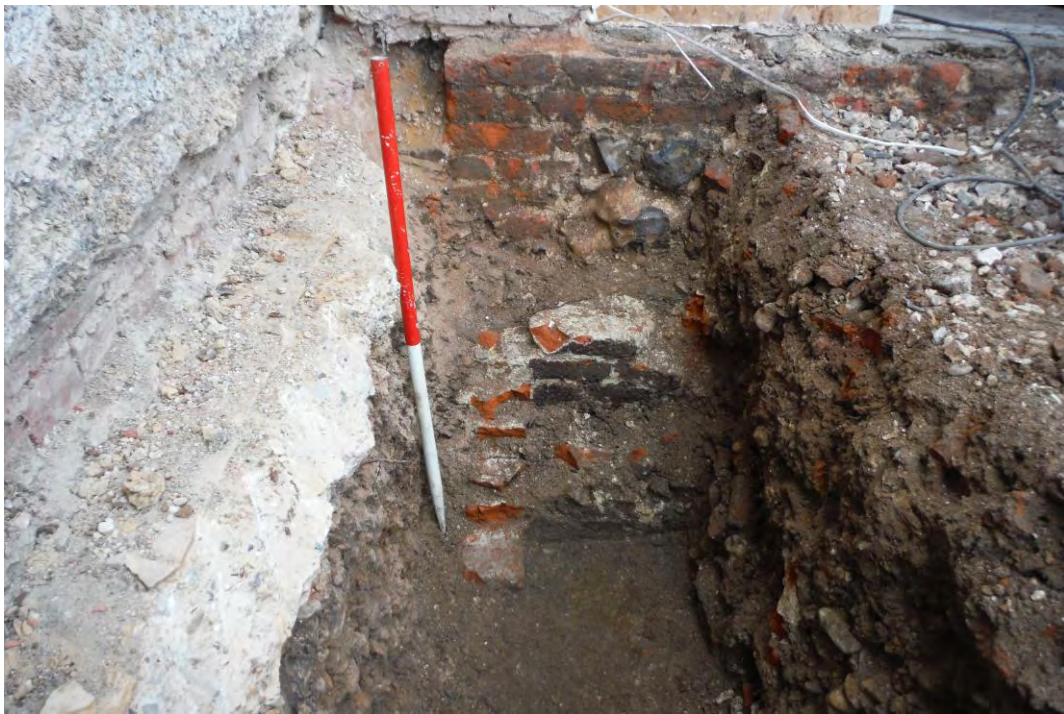
Image 28: North-west corner of footing trench against the cottage, revealing the robbed-out remains of the corner of another building [116]/(117). The cottage footing [113] - (115) is at least 6 courses deep in this area (compare with Figure 12: image 31). Scale 1m in 50cm divisions.

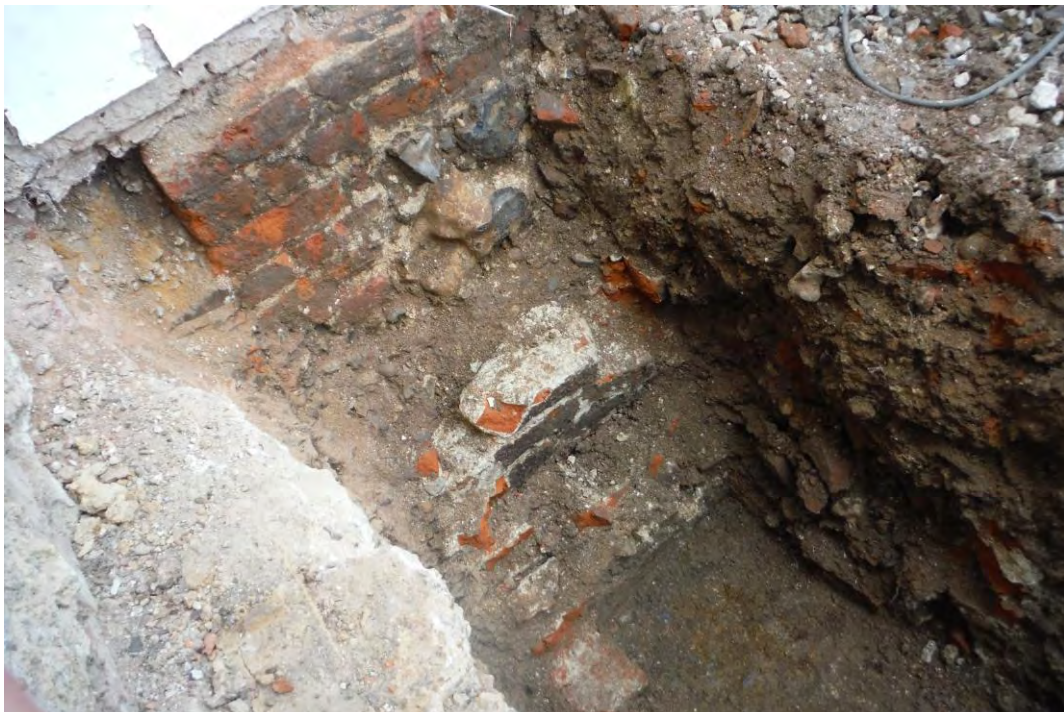
Image 29: Detail of the narrow gap between the cottage wall footing [113] and the demolished building [116]. The foundation trench for the cottage wall appears to have been infilled with flint nodules (115). The two footings are separated by a thin band of material (118).

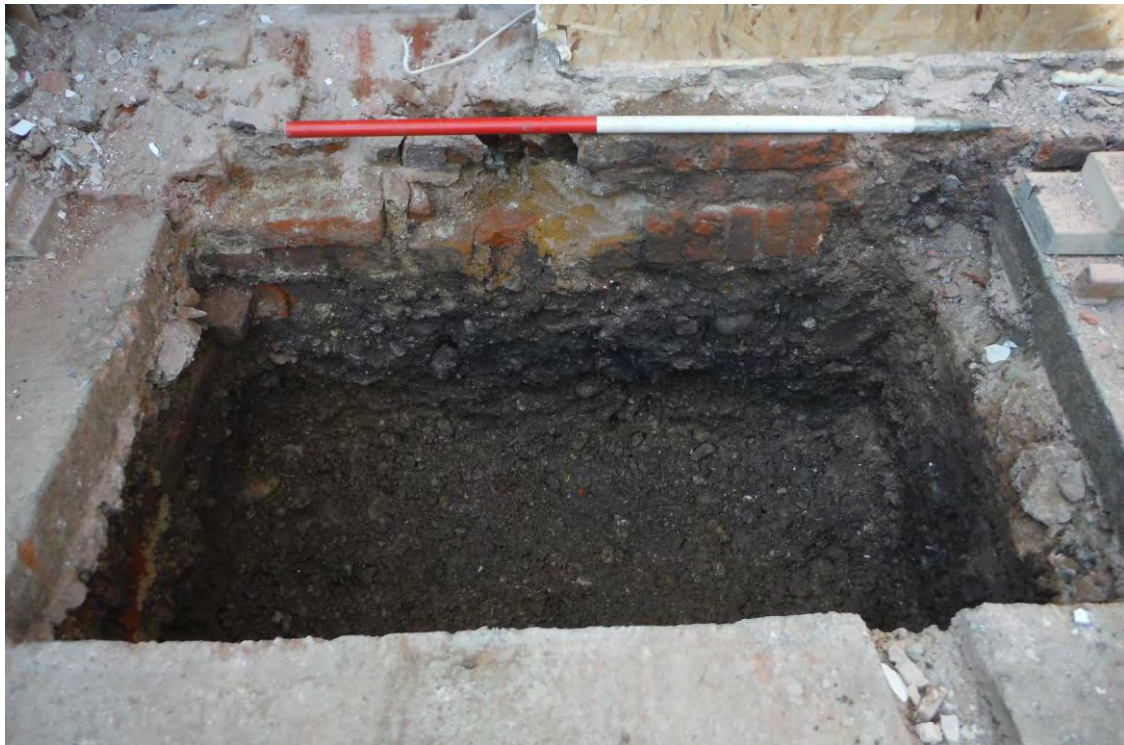
Image 30: Central pit exposing the footing for the cottage [119] / (120), with the underlying deposit (118). Scale 1m in 50cm divisions.

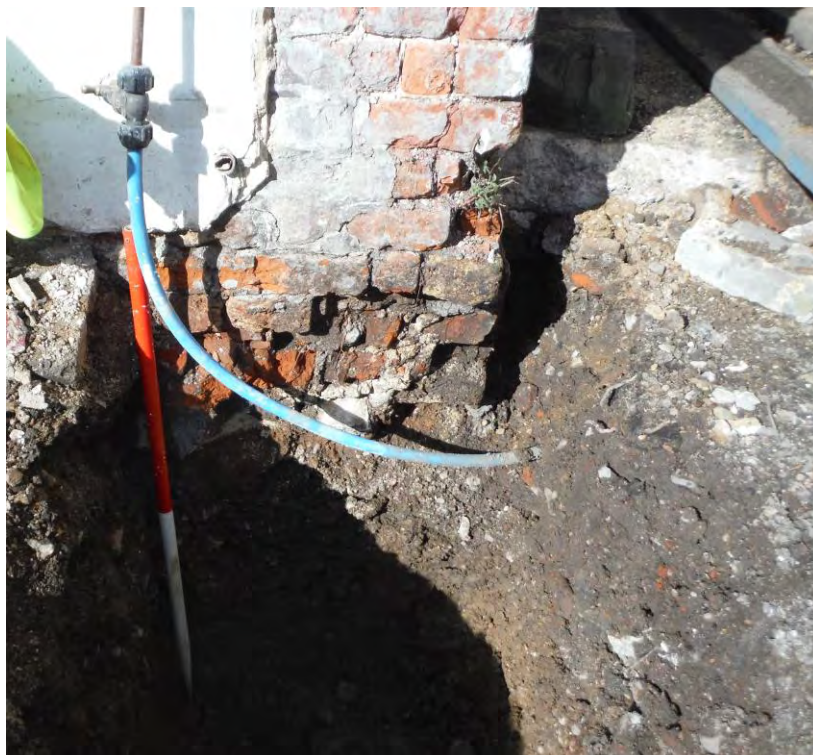
The brick foundation was exposed in three areas. It was most substantial to the south-west (114), where six courses (0.35m) were revealed. The bricks (220mm x 105mm x 65mm) were regular coursed and bonded with light grey mortar. The construction cut [113] was very narrow and was filled with flint fragments in this area (115) (Figure 11: images 28 and 29). Further north, the test pit revealed the continuation of the foundation [119], up to 0.25m deep, comprising three courses of brick (120) — the upper two stretcher-laid, with headers for the lowest course (Figure 12: image 30). The northern corner of the cottage comprised four courses of heavily weathered bricks (Figure 12: image 31).

Image 31: North-west corner of cottage revealing shallower footings, which are four courses deep. Scale 1m in 50cm divisions.

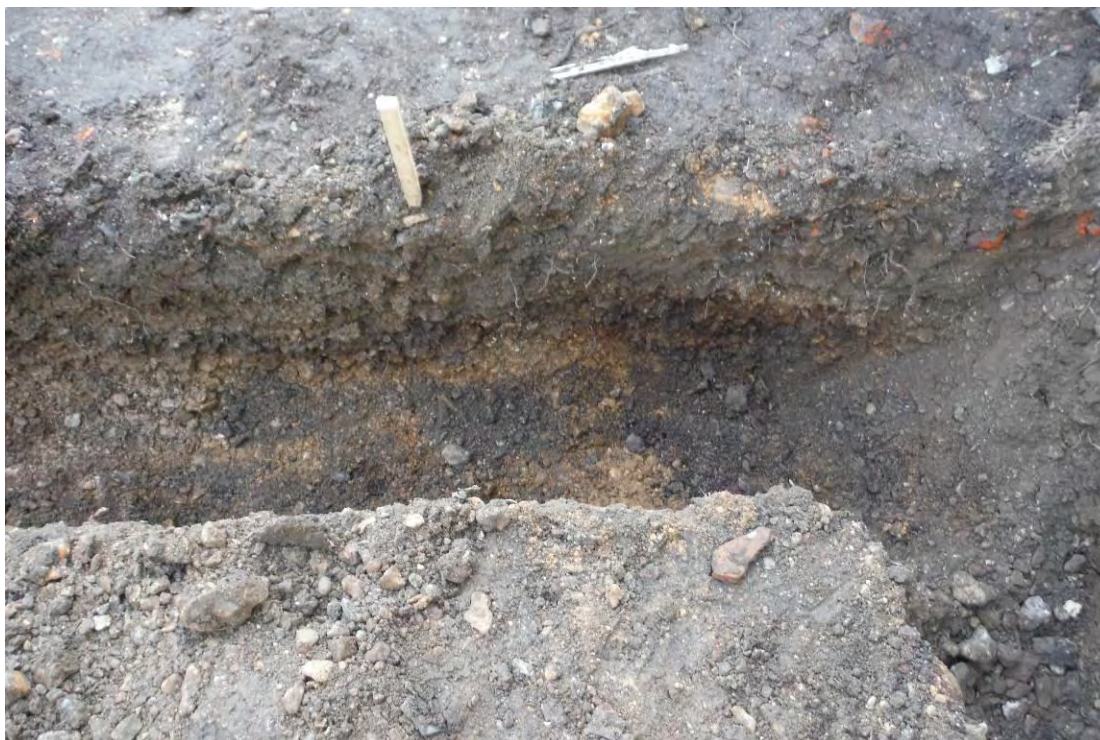
Image 32: South-west corner of footing trench with large pit [125] and associated fills (101) and (102) to the left, and pit [126] to the right with fills (105) and (106).

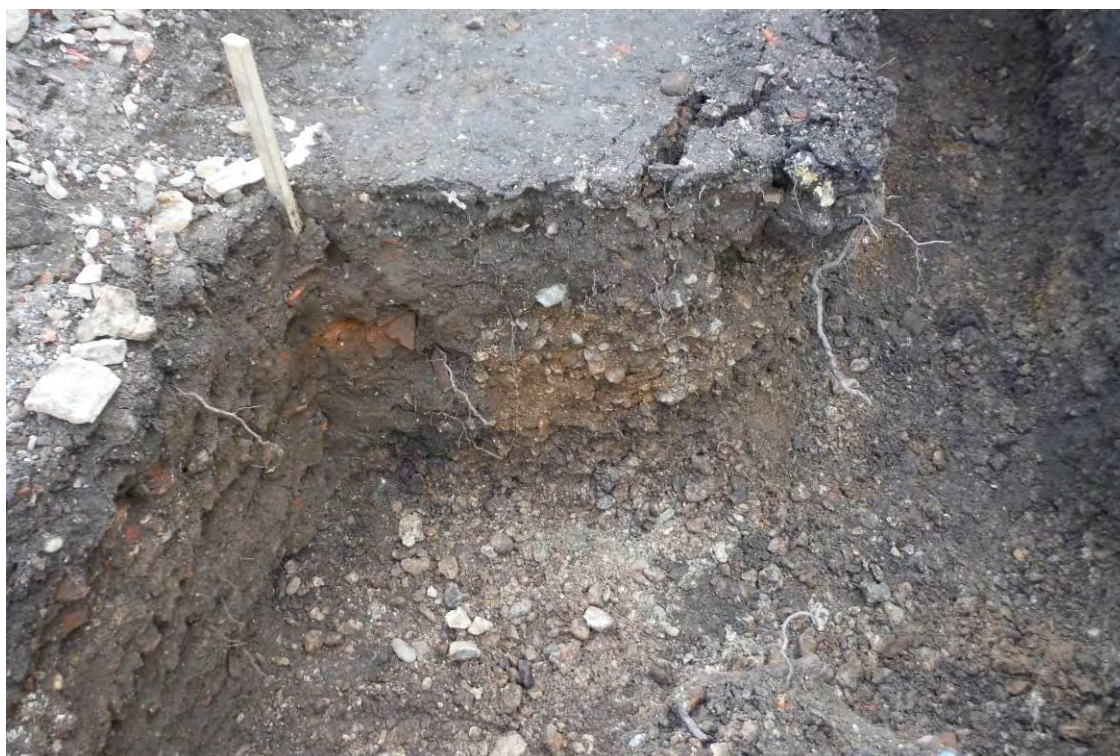
Image 33: West edge of pit [132], dug into the gravel geological strata. This would appear to be a continuation of pit [109] to the north, rather than wall footing (207) to the south.

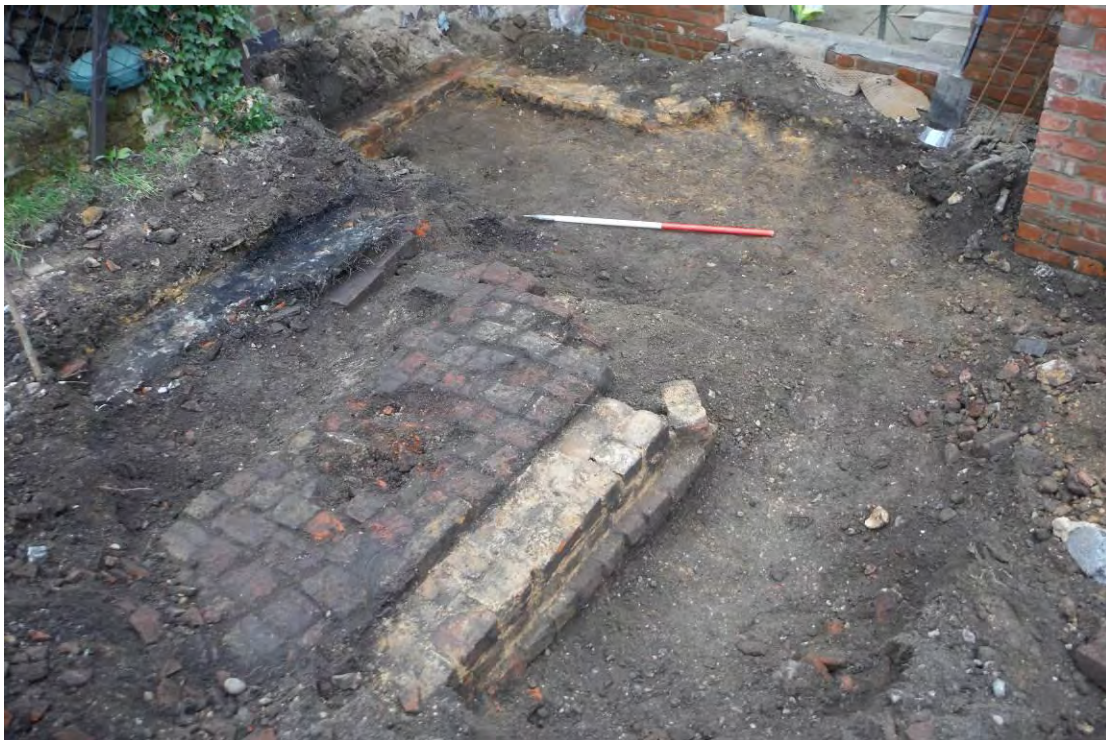
At the southern margin of the area were a series of structural remains, comprising an L-shaped wall foundation in the south (207), with a roughly parallel stepped wall footing (205) to the north-east. Within the area defined by the footings was a brick surface (206). These remains would appear to define a robbed-out building aligned roughly east-west, at least 3.75m long (12'+) by c. 2.15m wide (7') (Figure 14: image 34).

Image 34: General view Area 2, with the new extension under construction (top right of image). Scale 1m in 50cm divisions.

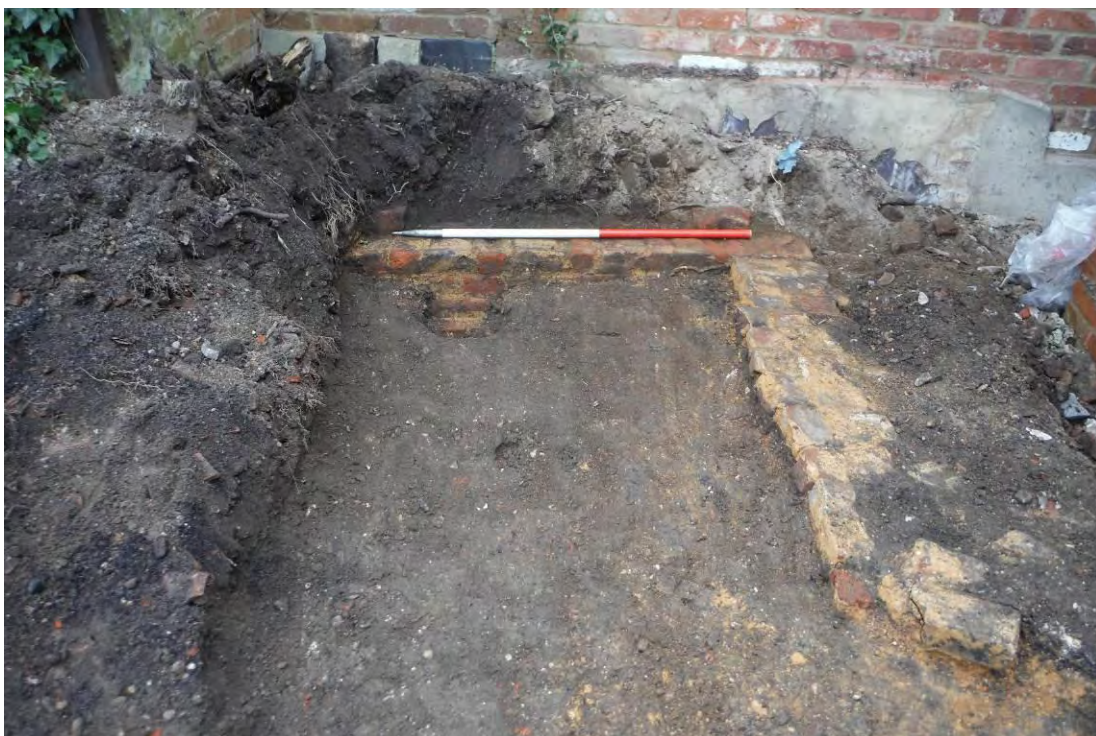
Image 35: General view of wall footing (207), looking to the south. Scale 1m in 50cm divisions.

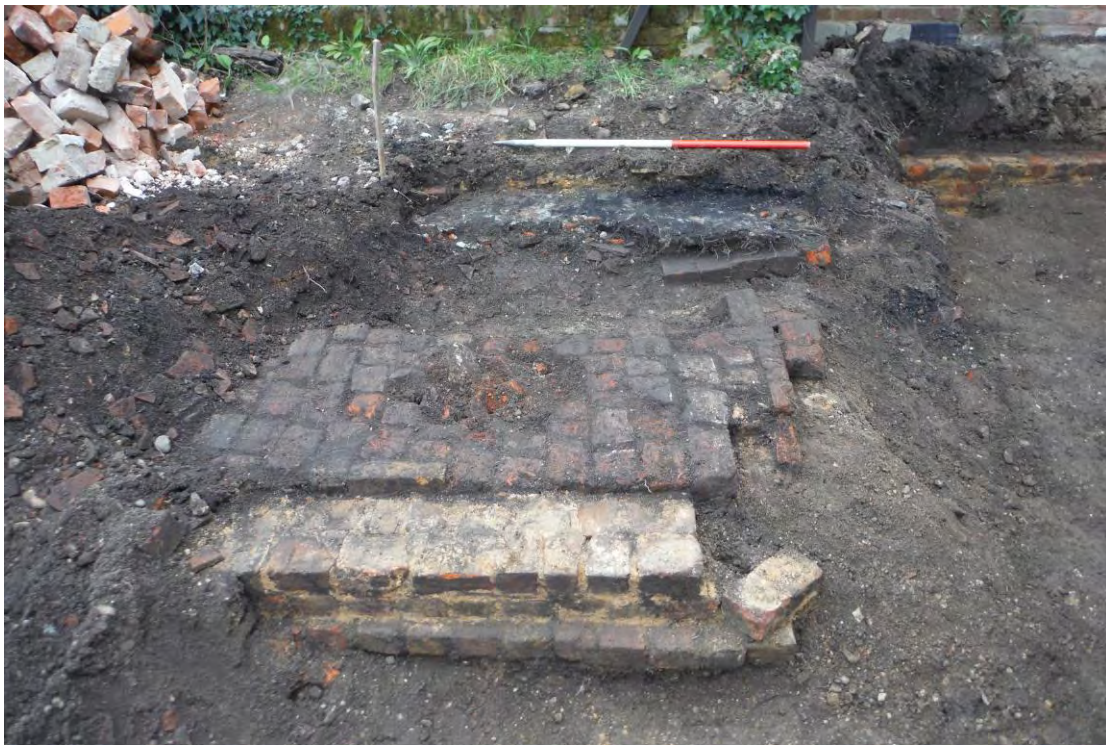
Image 36: Detail of stepped brick wall footing [204] and (205) and brick surface (206).
Scale 1m in 50cm divisions.

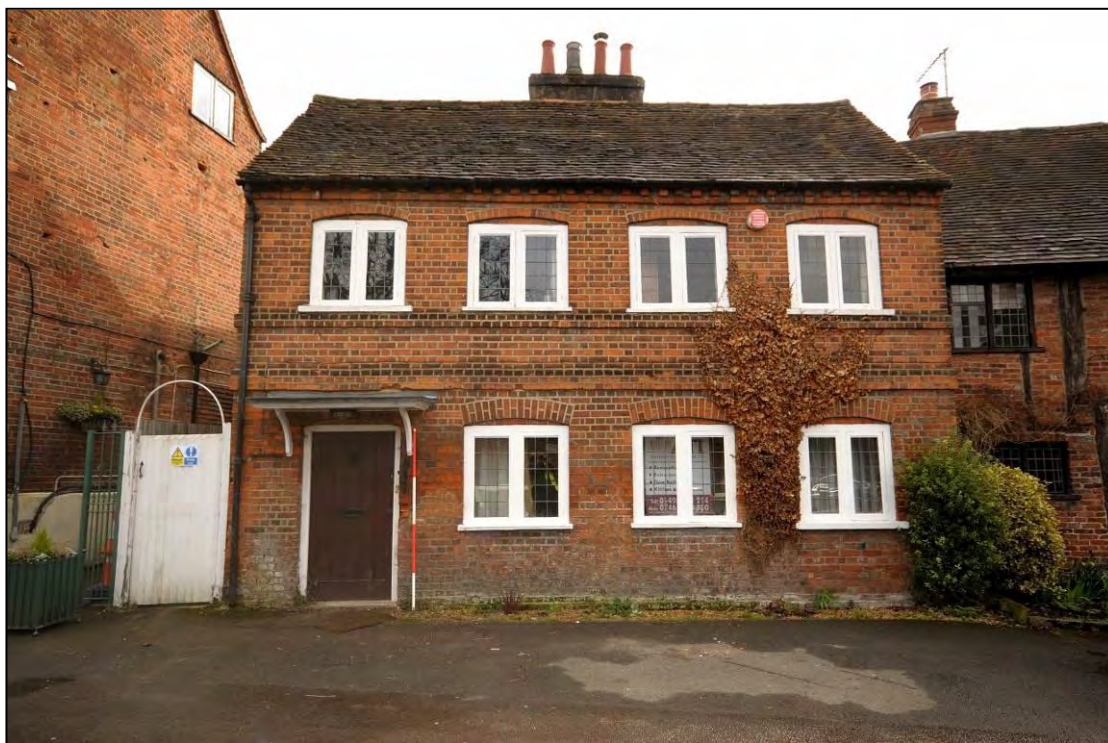
Image 1: Front (west) elevation

Note different brick below window at right where a former doorway has been altered to a window opening (Scale 2m).

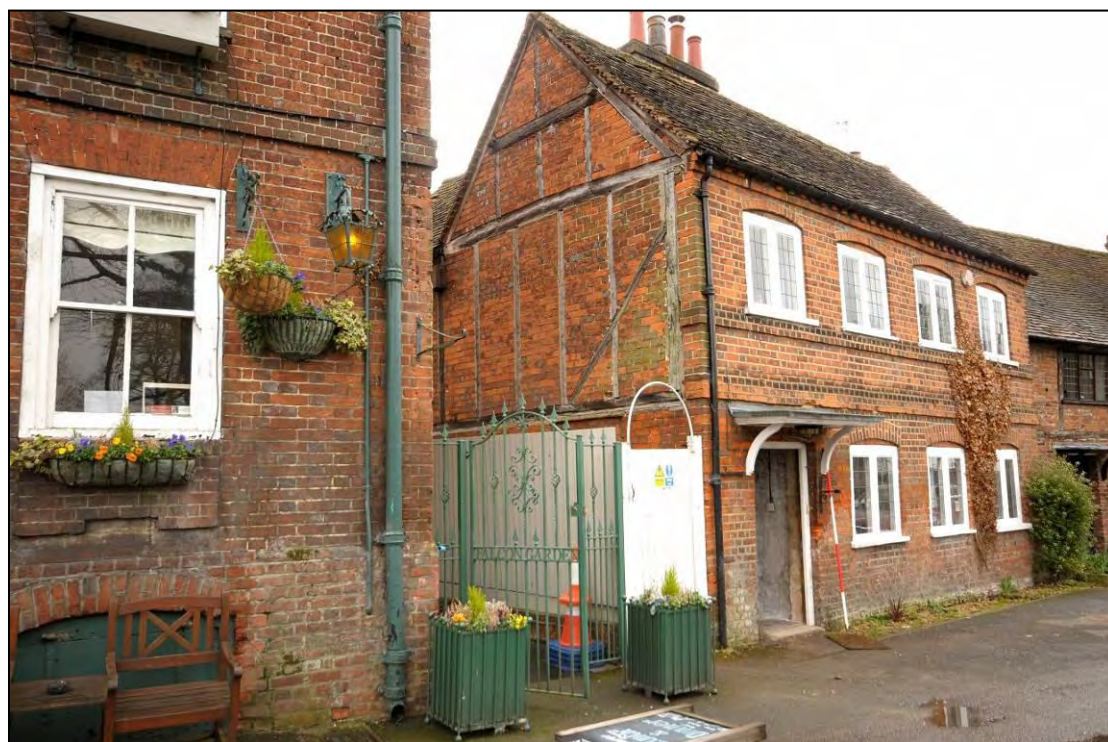
Image 2: Building viewed from north-west

Shows contrast between brick front and timber framed north end (Scale 2m).

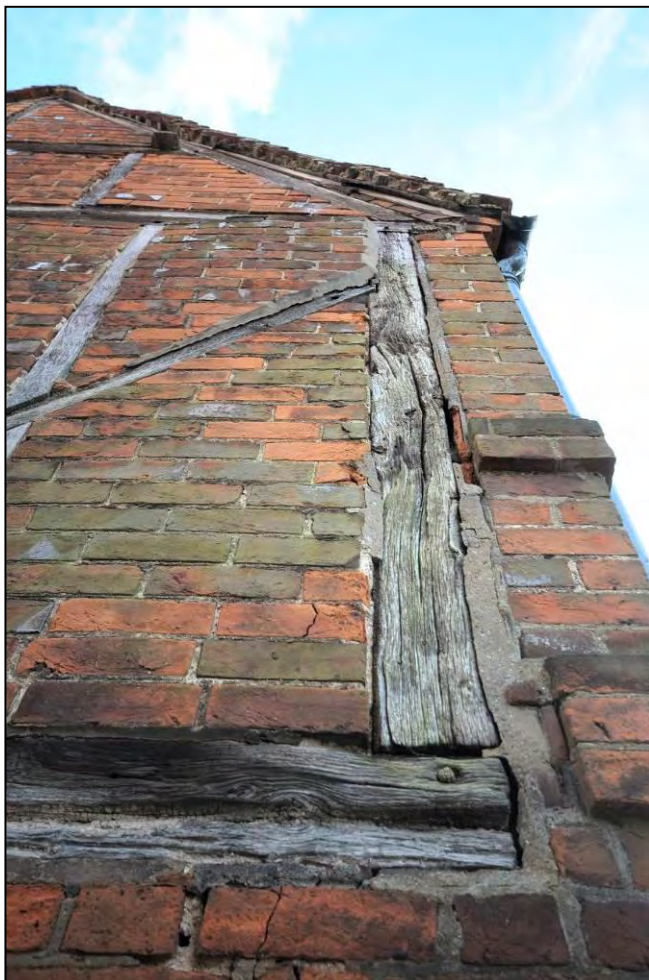
Image 3: Side (north) elevation

Shows timber frame with brick infill behind brick front wall at right.

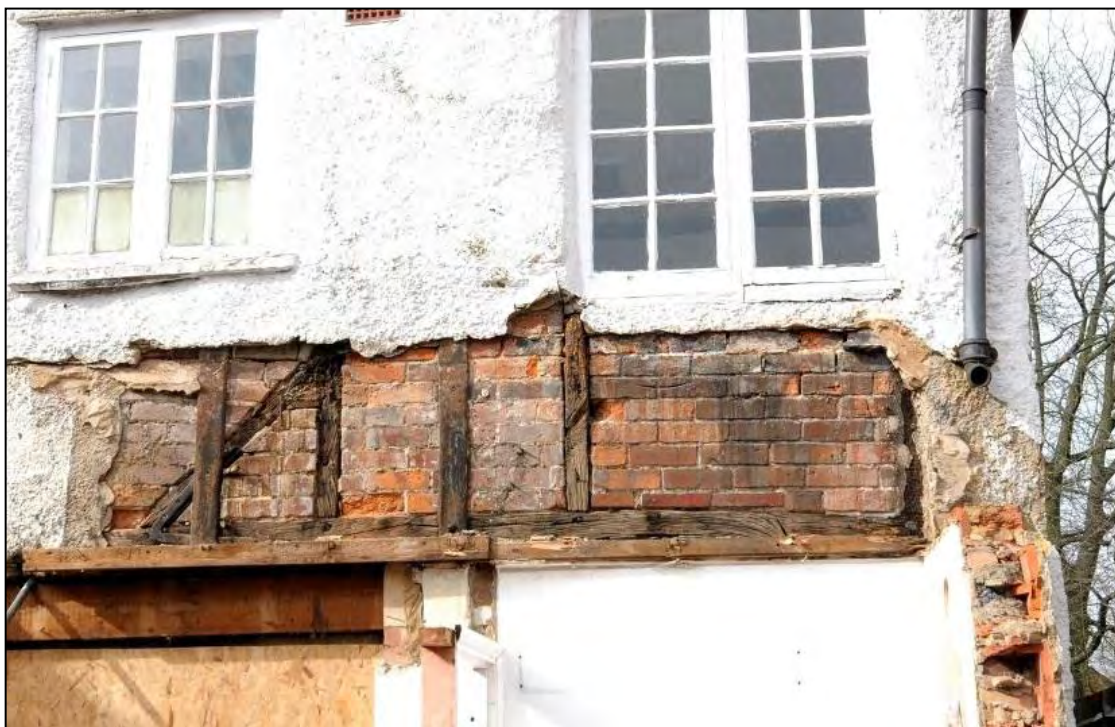
Image 5: Rear (east) elevation (detail)

Detail of previous image showing timber frame exposed where modern extension has been removed.

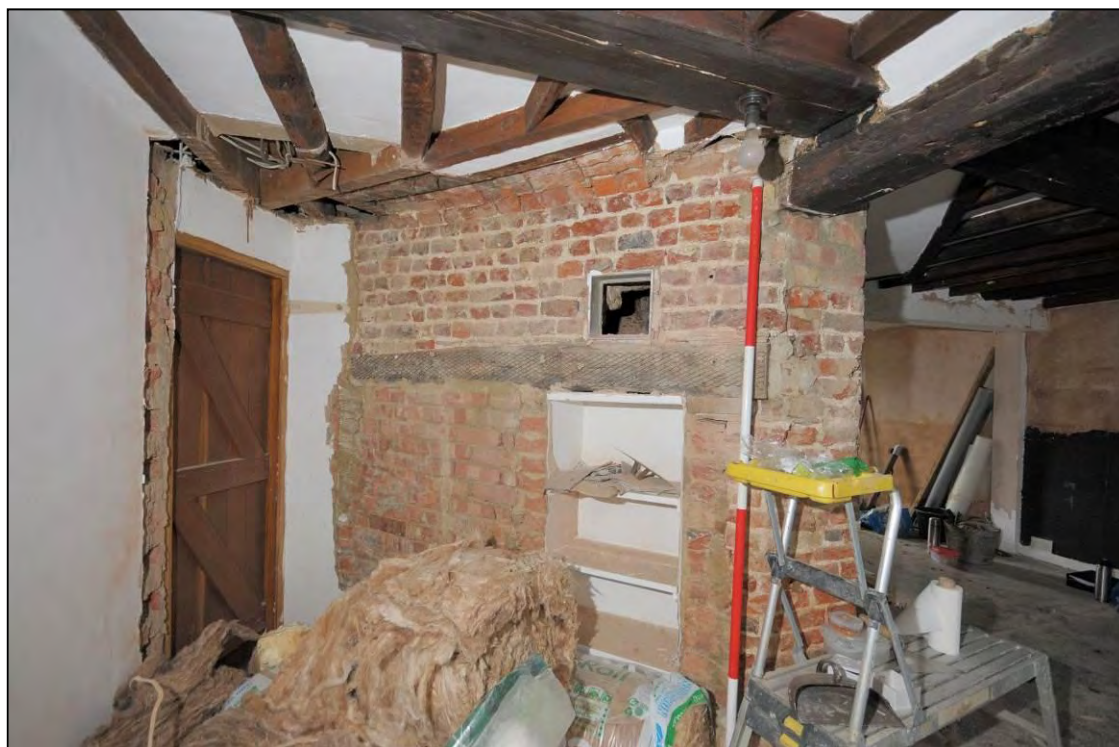
Image 7: Living area, northern fireplace

Shows fireplace blocking with shelves and timber lintel above (Scale 2m).

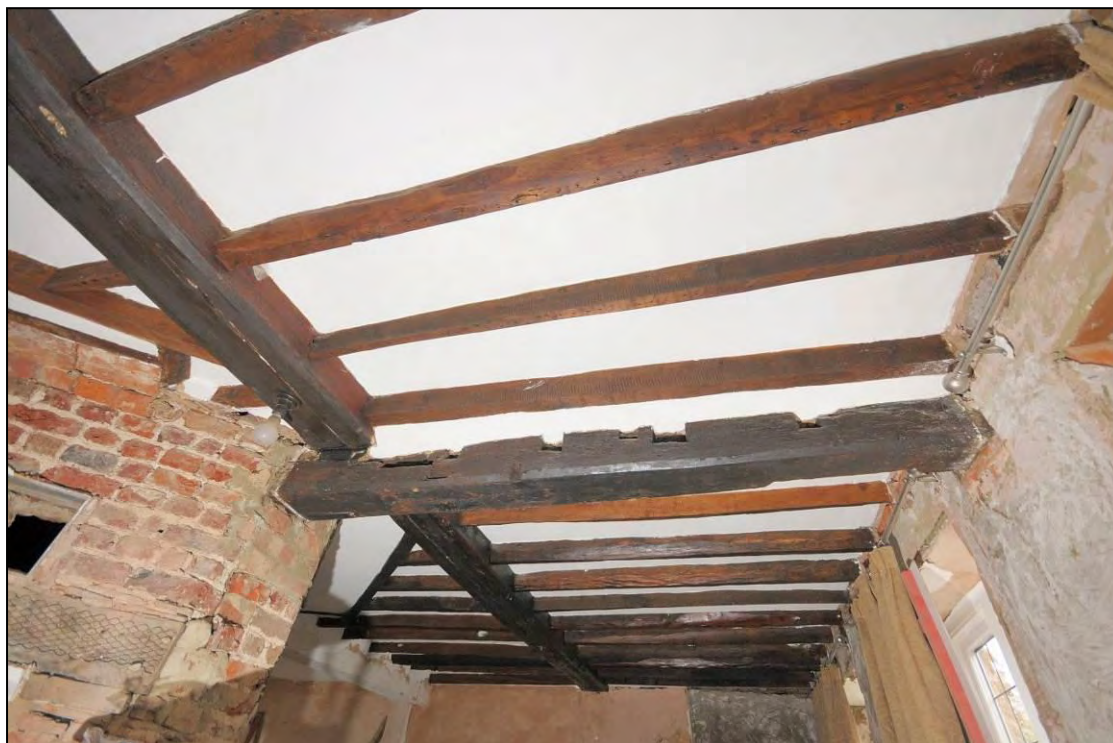
Image 11: Living area, ceiling

Shows reused inserted ceiling beam, supporting the ends of the two axial beams where a wall was removed to link these rooms.

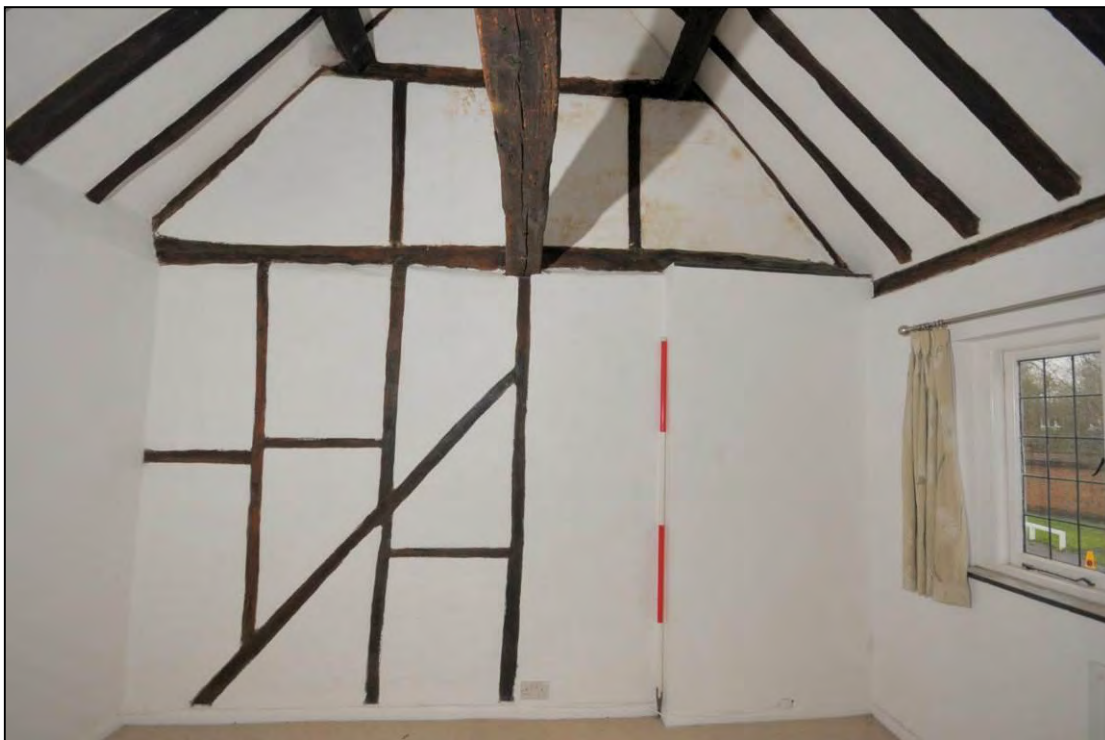
Image 13: Bedroom 1, looking south

Showing primary bracing in eastern half of wall (Scale 2m).

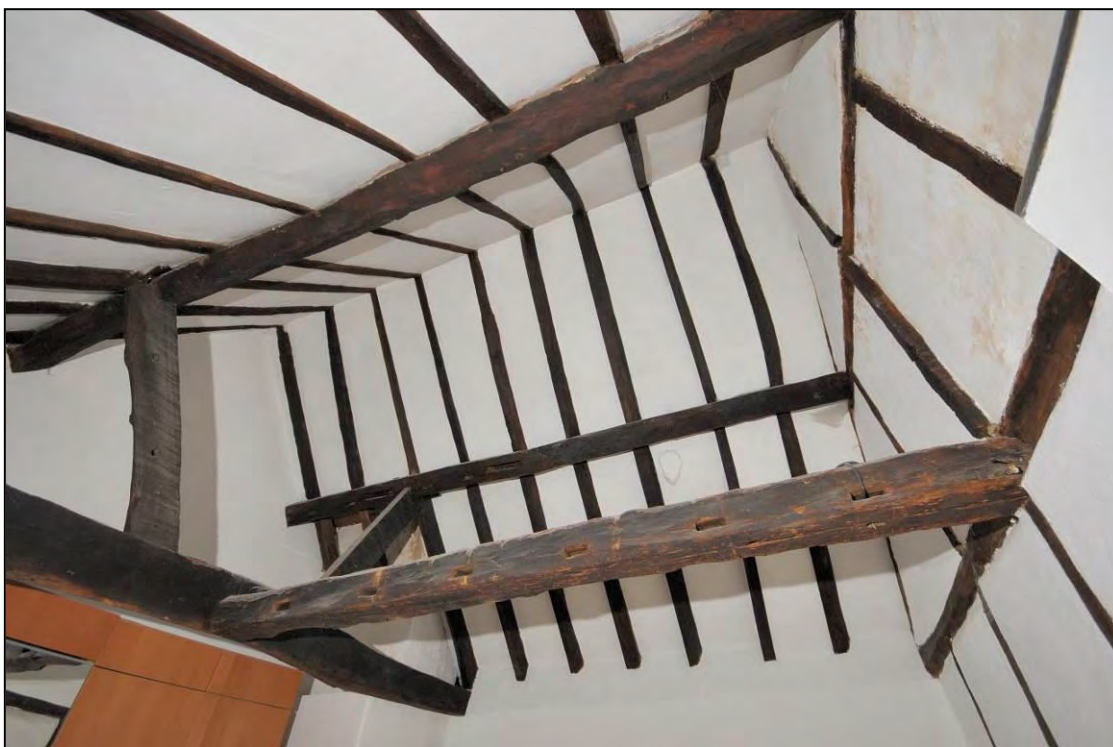
Image 14: Bedroom 1, roof

Looking east, showing axial beam with empty mortise holes for former ceiling or attic floor.

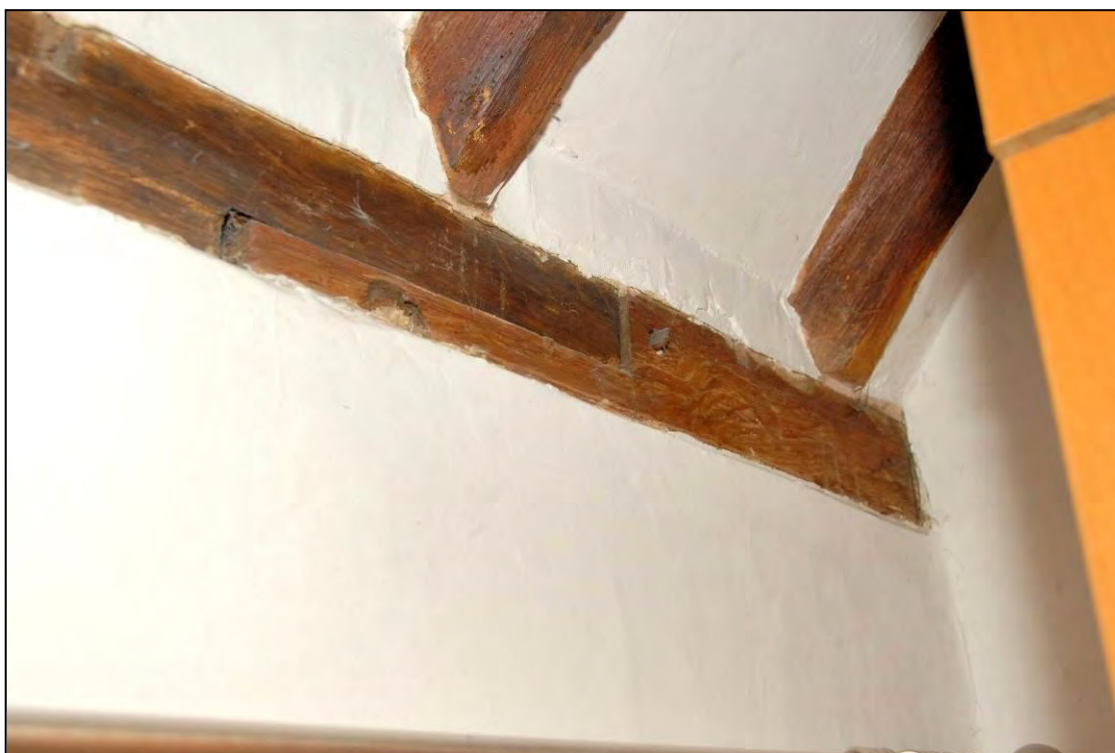
Image 16: Bedroom 1, scarf joint in wall plate

Face-halved scarf joint in wall plate in north-west corner of room.

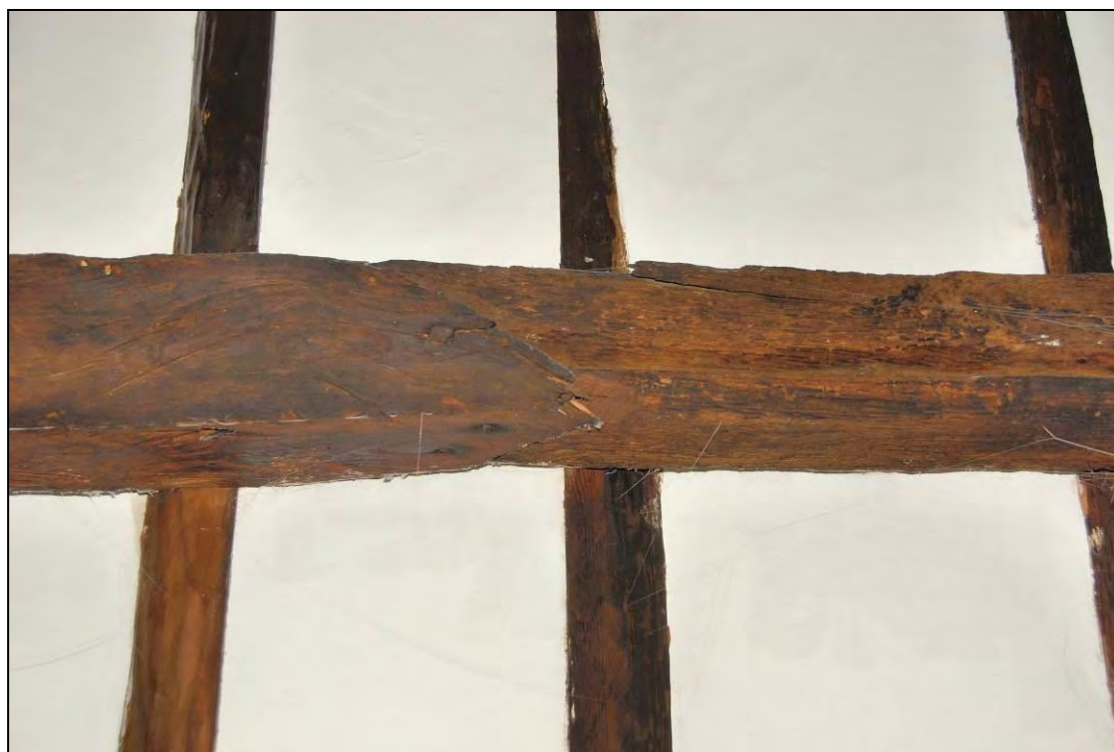
Image 19: Bedroom 2, scarf join in purlin

Shows scarf in front (western) slope of roof. The purlin ends abut at a diagonally cut face and are fixed with nails.

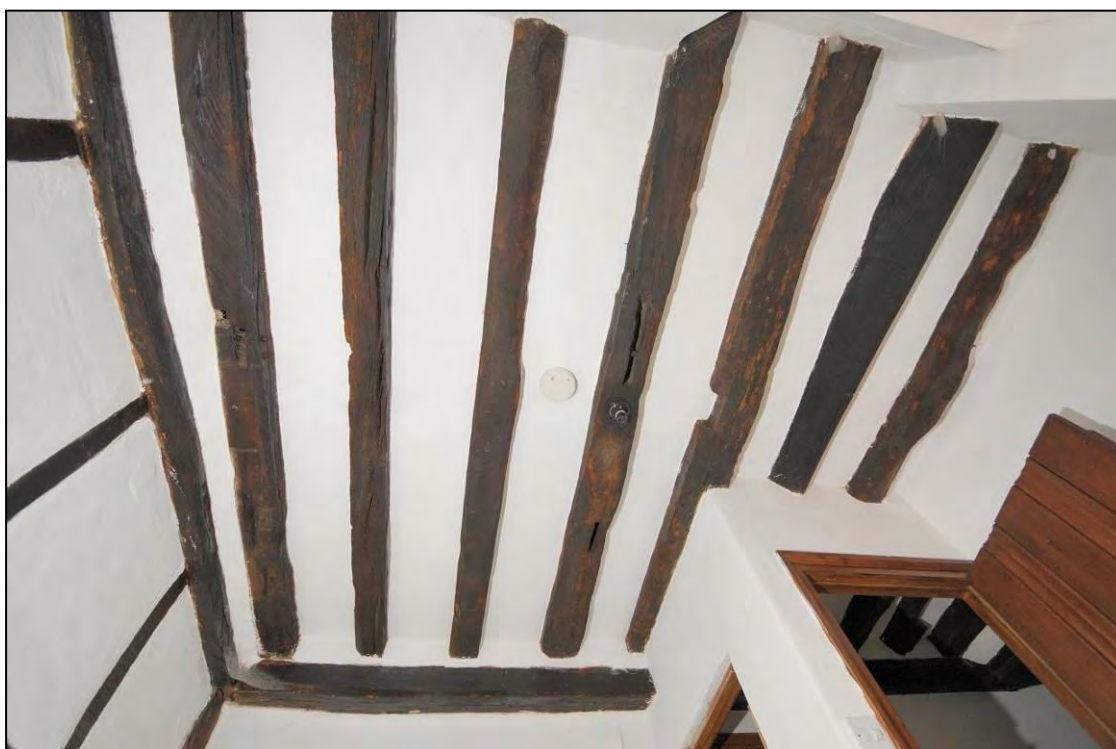
Image 23: Rear range, study ceiling

Looking west, showing joists made from reused timber with mortise holes and blackened former bressumer (fireplace lintel) towards the right.

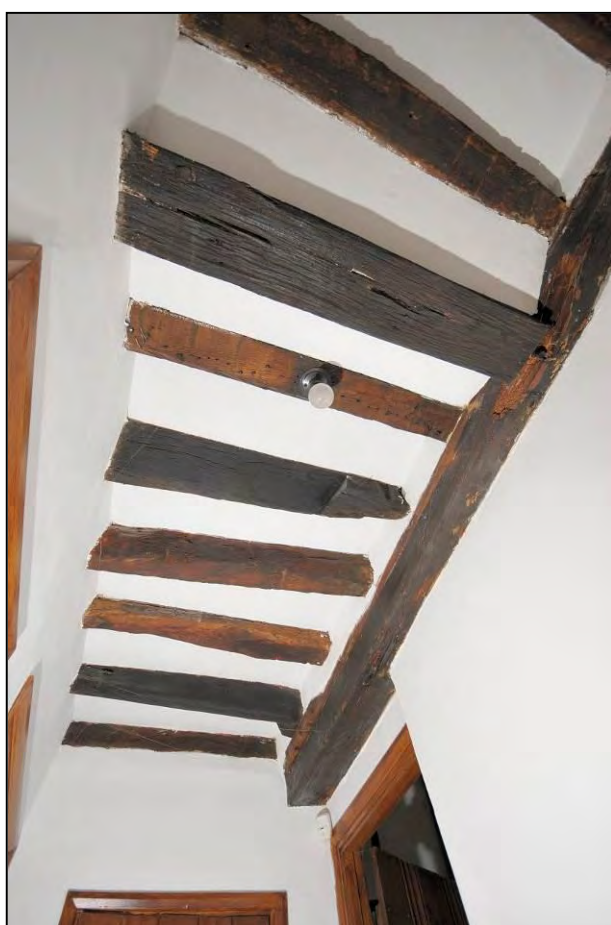
Image 24: Rear range, corridor ceiling

Looking south-west, showing wall plate in rear wall of front range (at right), beam below gable valley mortised into wall plate and joists made from reused timber. The latter includes two bressumer beams (fireplace lintels) which are visible as the darker joists in the mid and lower part of the image.

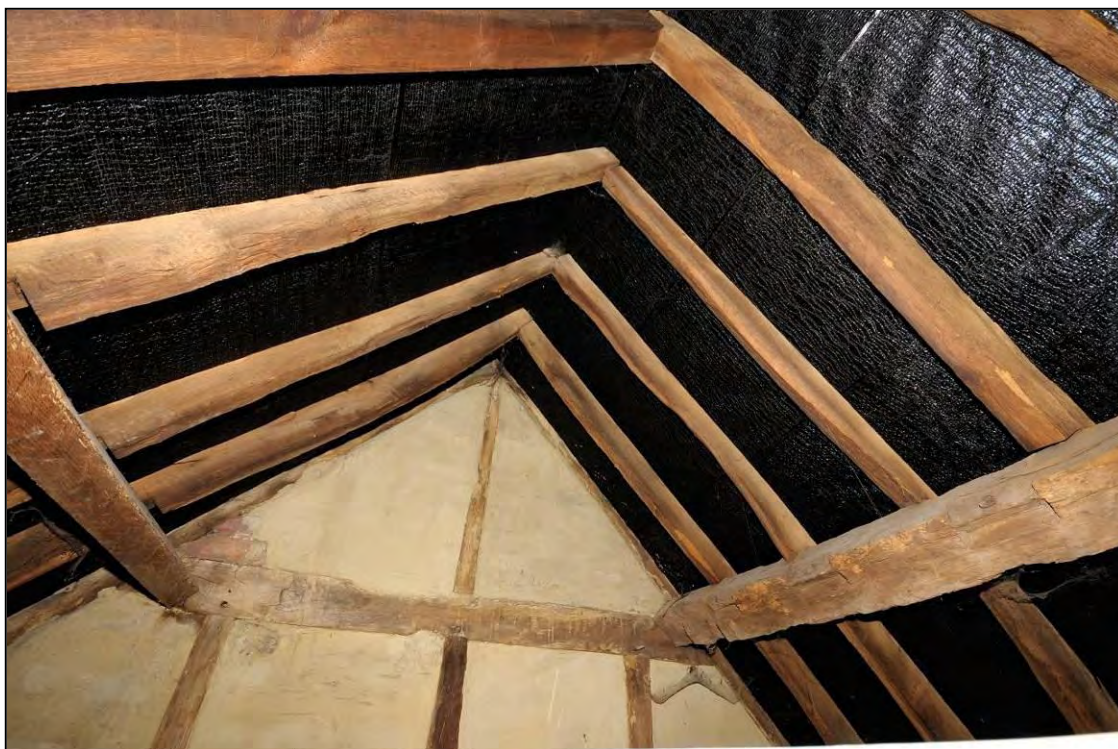
Image 25: Roof over northern part of rear range

Looking eastwards, showing reused wall plate used for southern (right-hand) purlin and renewed northern (left-hand) purlin.
