**CHALTON CROSS FARM
THE WOODSIDE LINK
HOUGHTON REGIS
BEDFORDSHIRE**

HISTORIC BUILDING RECORDING

Document: 2017/198
Version: 1.0

Project: EL2692
Museum accession no.: LUTNM 2015/340
OASIS reference no.: albionar1-310463

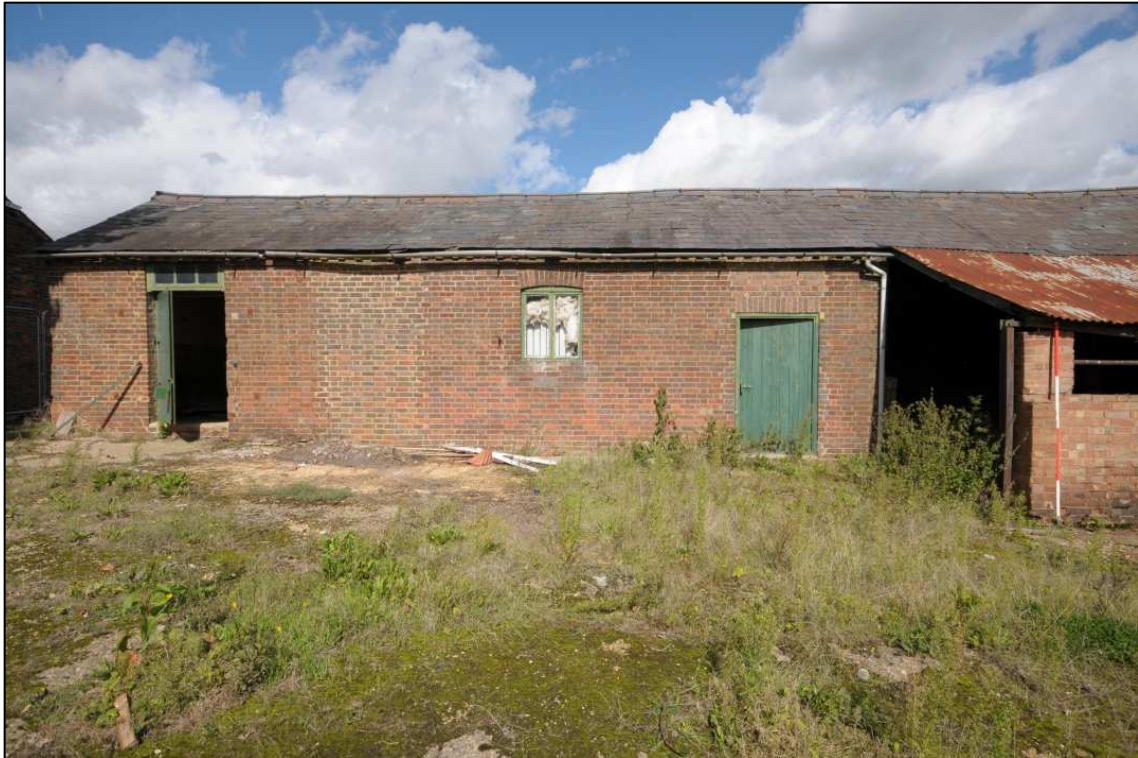
Image 5: North range: front of compartment C1

Shows doors, window and blocked opening

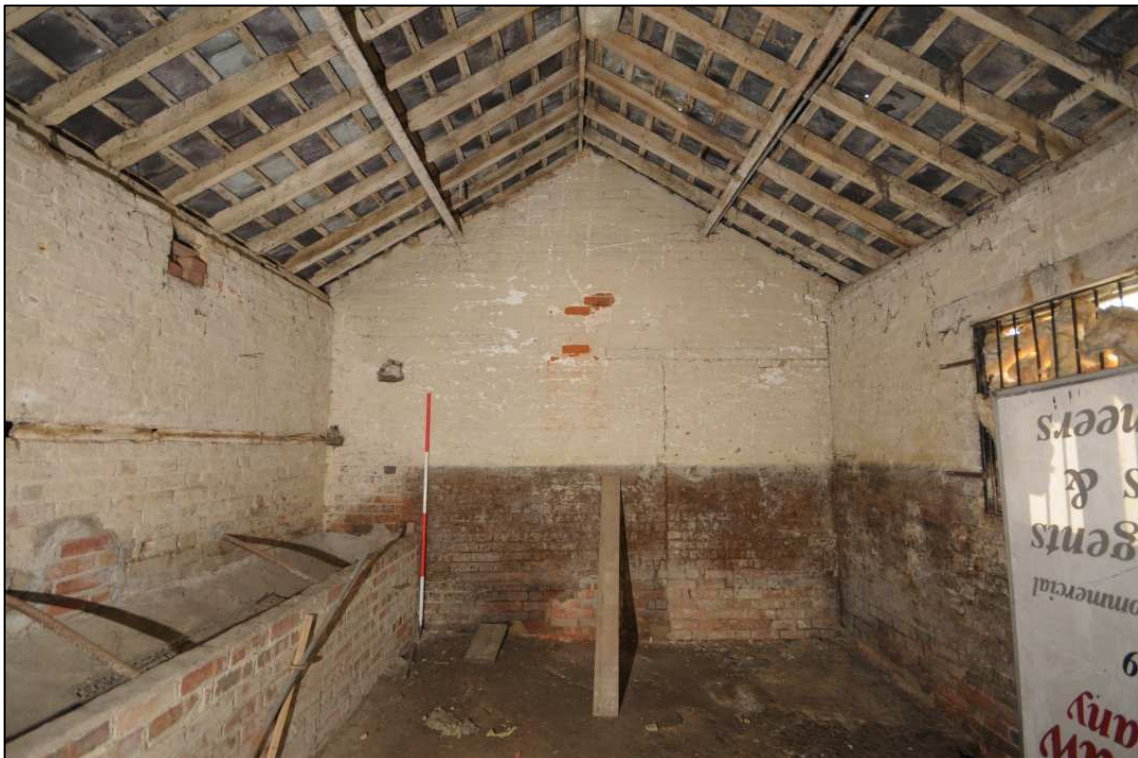
Image 6: North range: compartment C1, looking east

Shows east wall with blocked door opening at right (scale 2m)

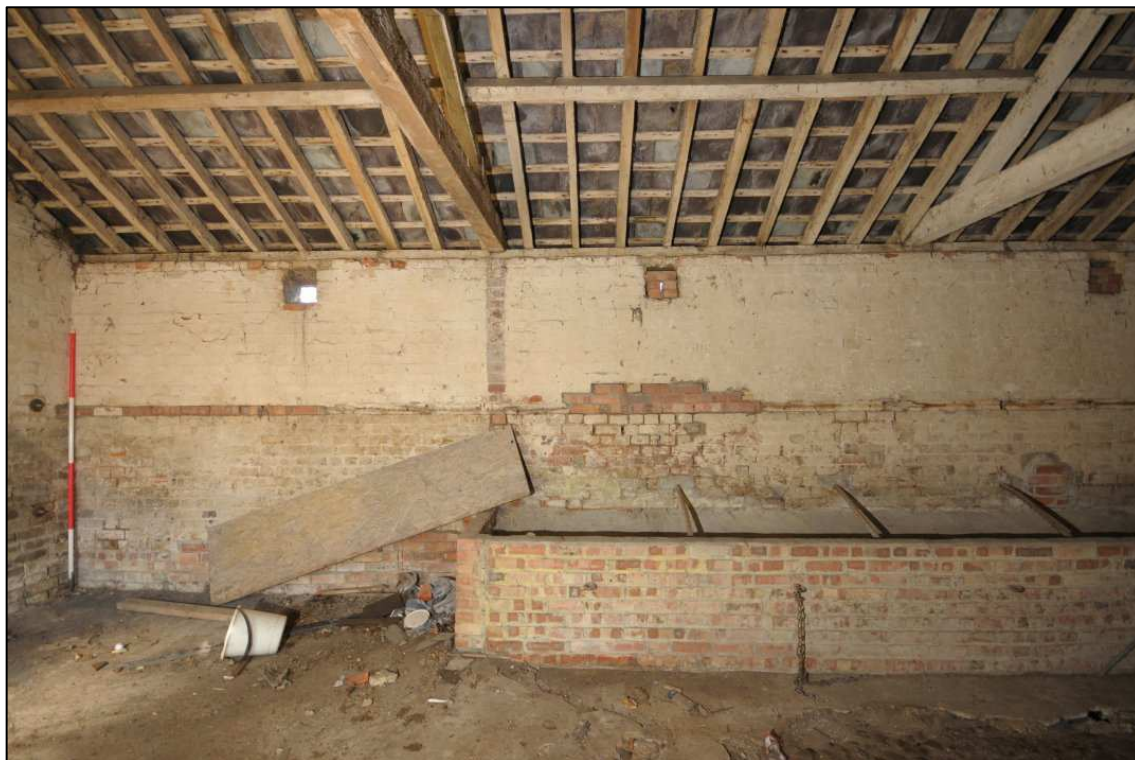
Image 7: North range: compartment C1, looking north

The rear wall contained three small ventilation holes, one in each bay located just below eaves level. A brick feed trough on the rear wall extending across the central and eastern bay was in Fletton brick (20th-century) that could have replaced an earlier timber trough. Timber fixings embedded in the rear wall above the trough indicated the location of the hay rack that would have formed part of the original construction of this compartment.

A 'shadow' formed by missing whitewash on the front and rear walls indicated the position of a former transverse partition wall that would have separated the left-hand bay. This wall had not been tied-in to the brickwork and is likely to have been a later addition, probably inserted at the same time as the cut-in door opening in the front wall.

Shows feed trough, blocked ventilation holes and paint 'shadow' on rear wall left by removal of partition wall (scale 2m)

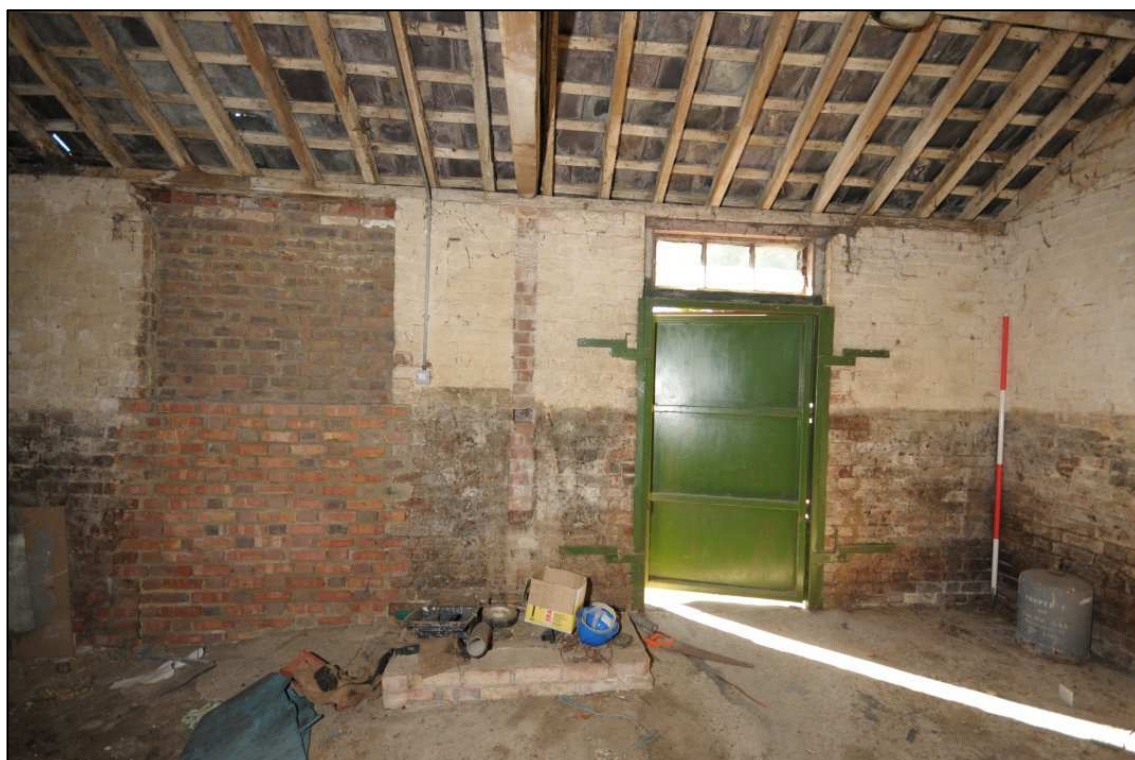
Image 8: North range: compartment C1, looking south

Shows door, blocked opening and 'shadow' left by former partition wall (scale 2m)

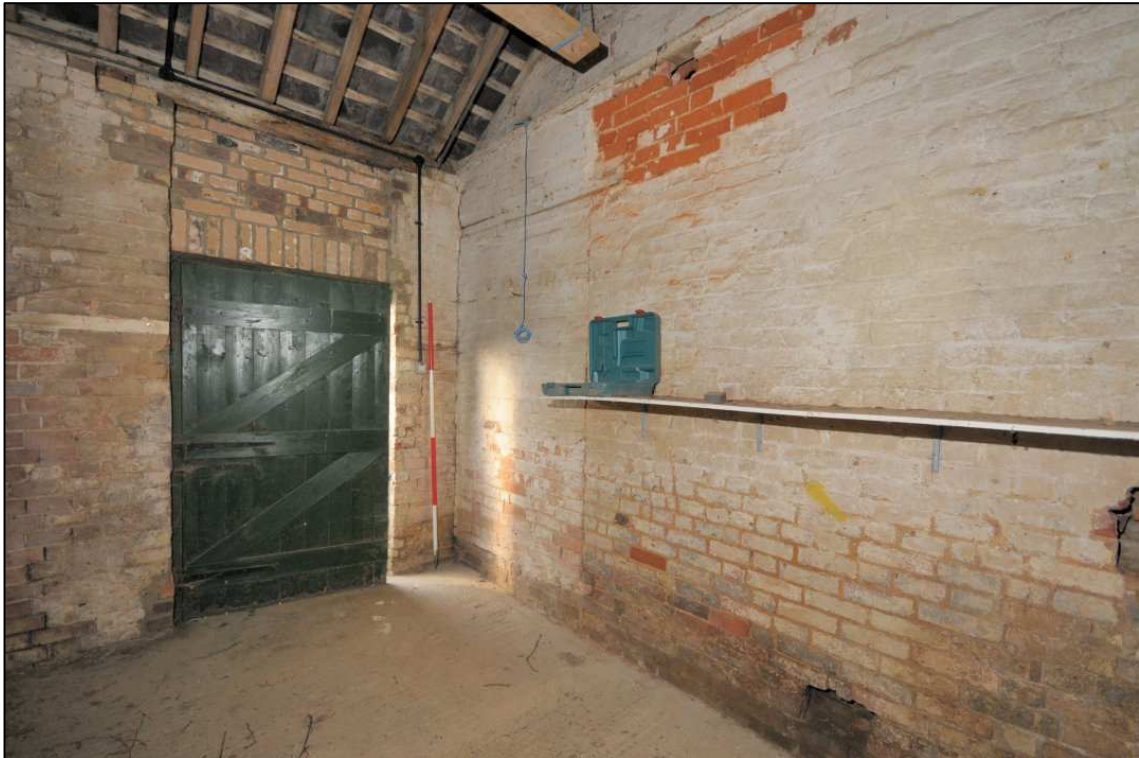
Image 11: North range: compartment C2, looking south-west

It had an external door in front (south) wall and a blocked internal door opening to compartment C1 (described above). The external door opening was a modern addition; the jambs showed repaired, ragged brickwork with a flat arch and brick infill above the door up to eaves level in modern brickwork. The door was a modern ledged and braced plank door. Undisturbed brickwork on the upper right side of the door jamb suggests that the cut-in door replaced an earlier window opening.

Shows door in front wall with the blocked door opening to C1 to the right (scale 2m)

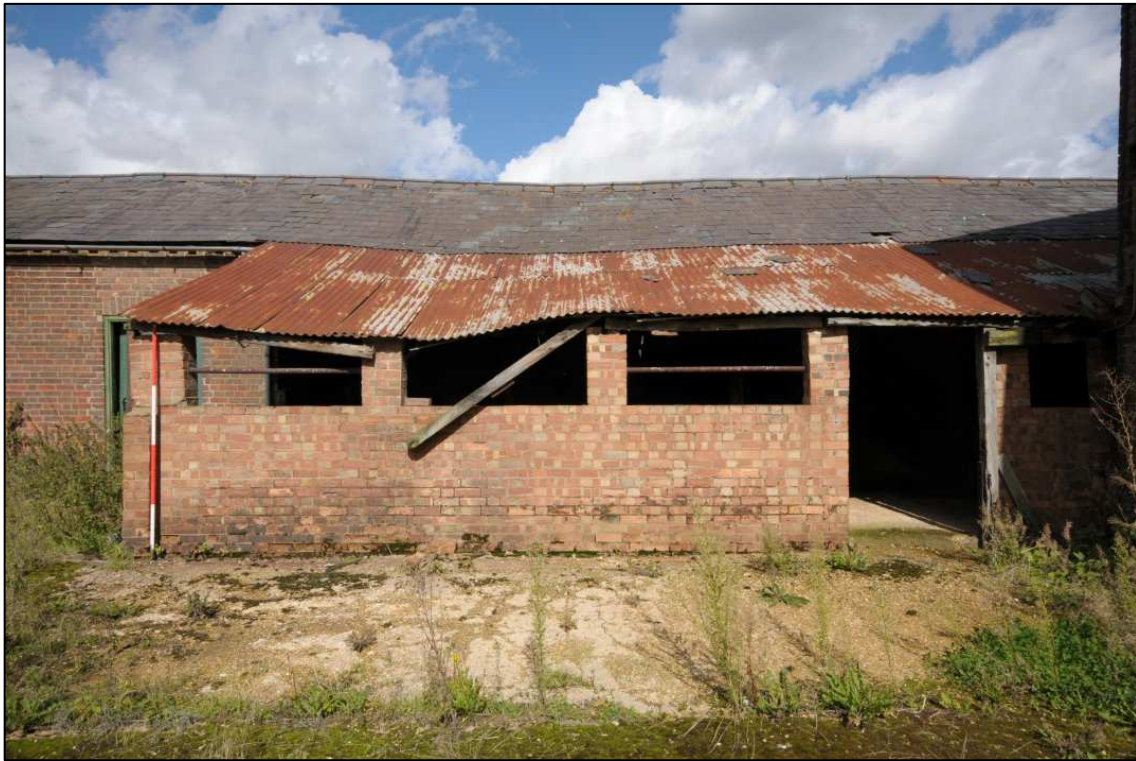
Image 17: North range: compartment C4, looking north
Showing front wall with Fletton brick and corrugated iron roof (scale 2m)

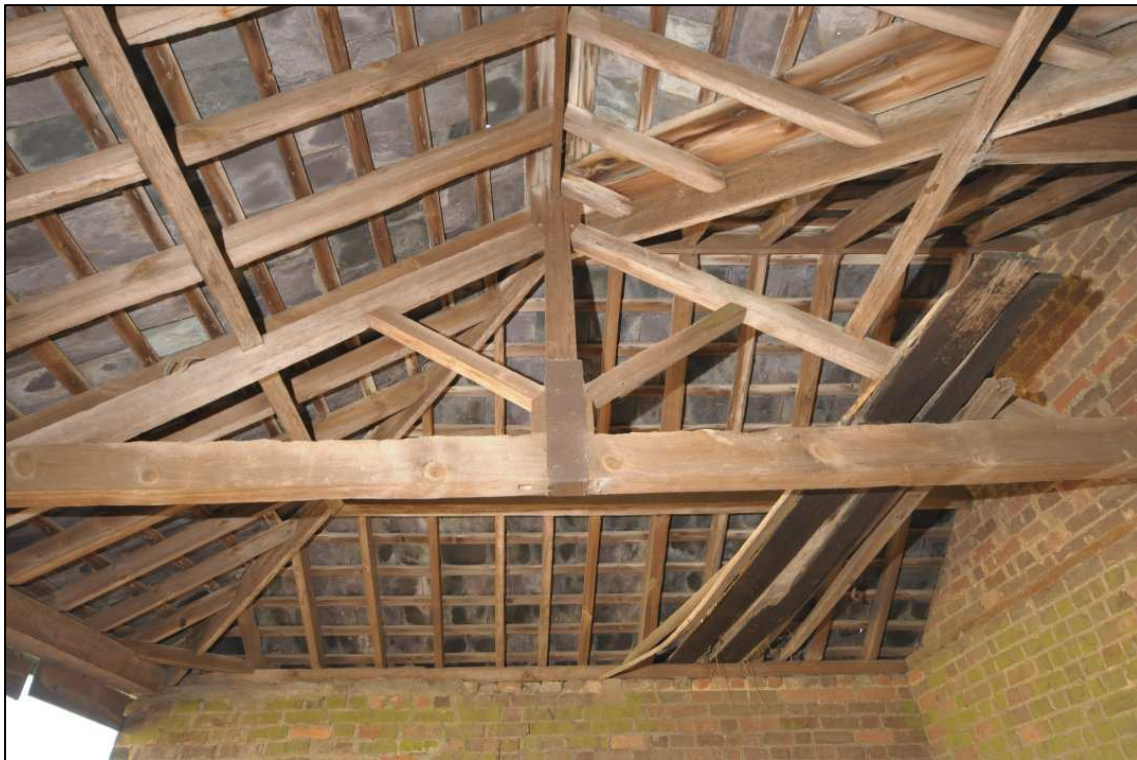
Image 22: North range: compartment C5, roof structure

The roof was hipped at its eastern end and was supported by two kingpost trusses. At the open north front it was supported by a timber post whilst the eastern post had been replaced in the 20th century with an I-section RSJ. There were no internal fittings. The floor was in modern concrete. In the rear wall a series of six regularly spaced, partial depth holes had been cut into the brickwork at *c.* 1.5m above the floor; however, the function of these is not clear.

Looking east showing eastern roof truss supporting hipped roof

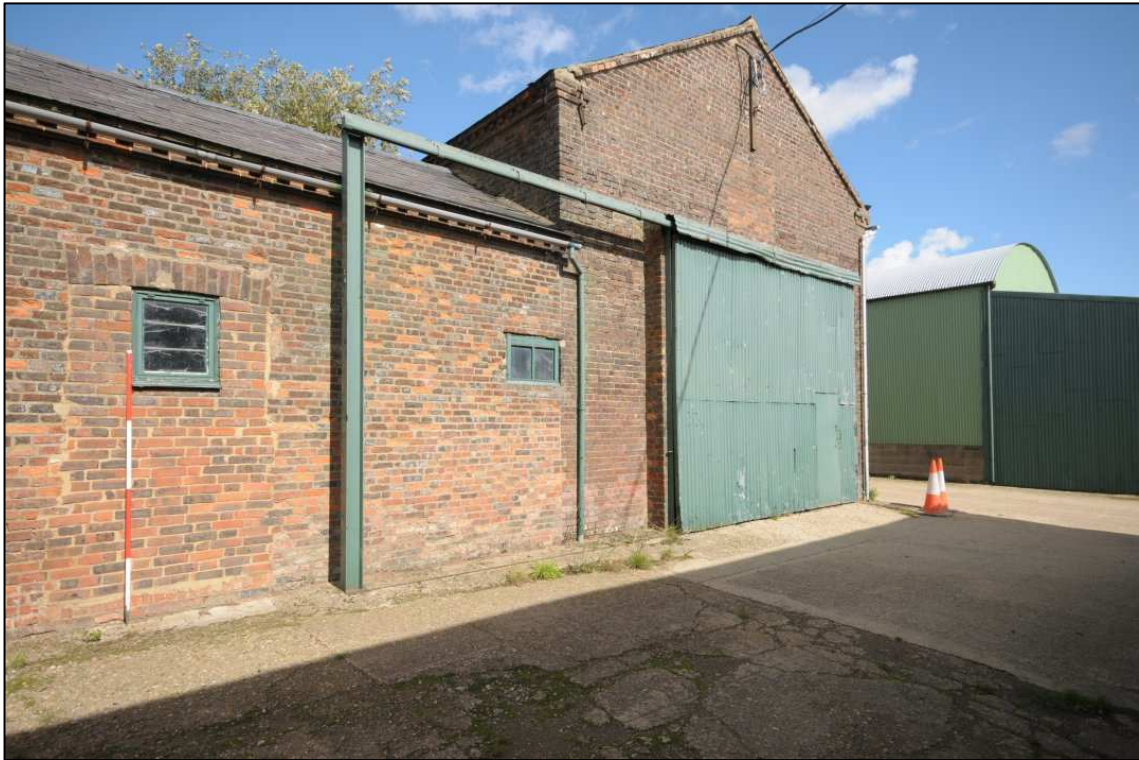
Image 23: East range: exterior of south end

The most recent alterations to the farmyard were connected with its use for the repair of agricultural machinery — the most obvious alteration being the large sliding door at the south end of the east range. A range of large portal-framed buildings incorporating a grain store was built to the south of the original farmyard (Figure 6).

Shows end of compartment C6 with sliding door and relationship to south range to left (scale 2m)

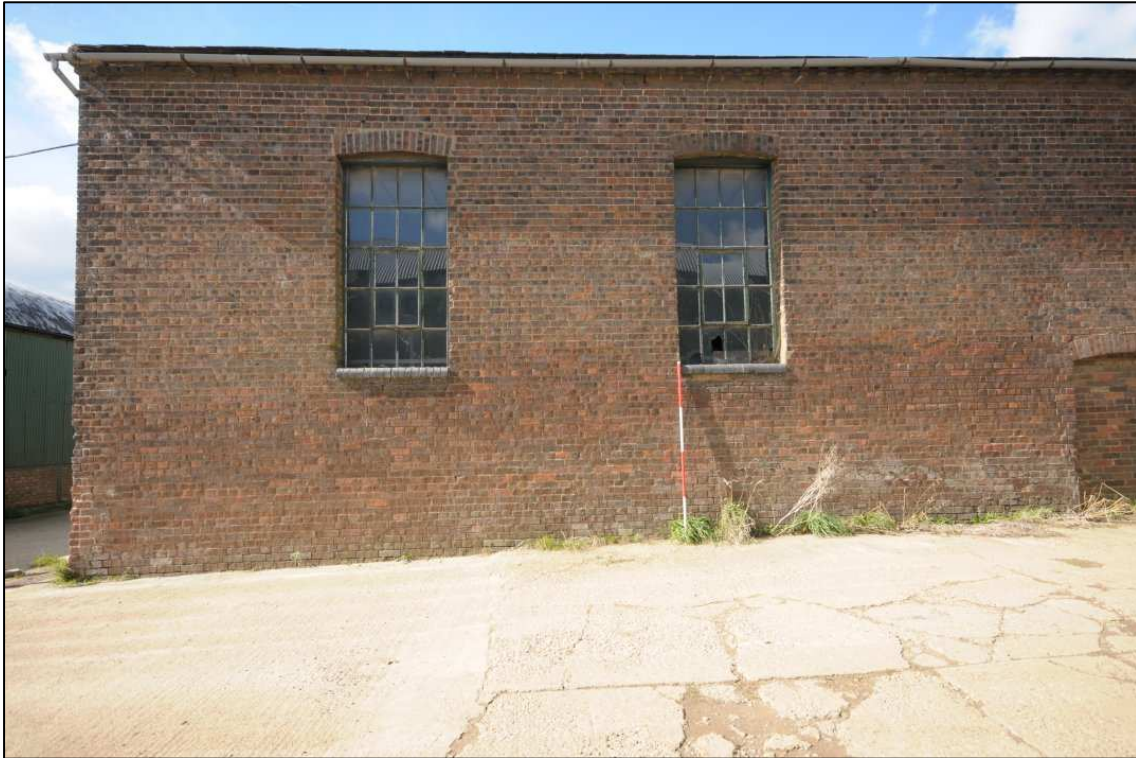
Image 25: East range: east wall, south half

Shows metal-framed windows and blocked low-level opening at right (scale 2m)

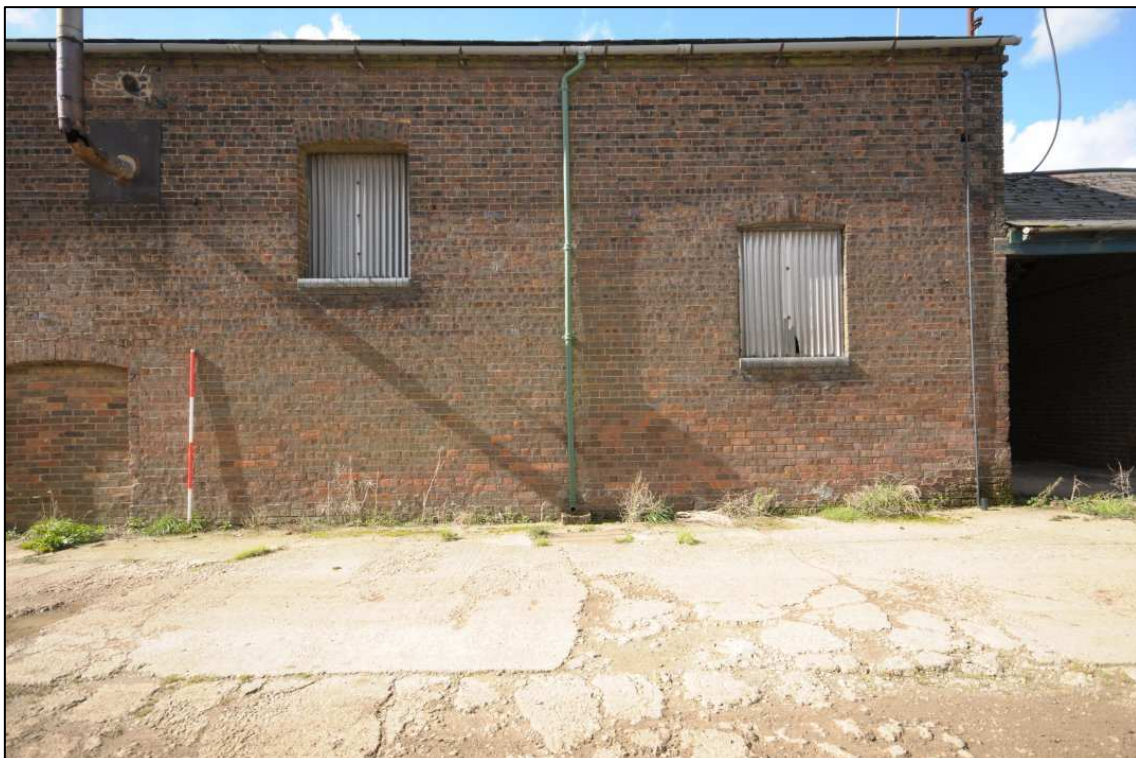
Image 26: East range: east wall, north half

Shows openings and blocked low-level opening at left (scale 2m)

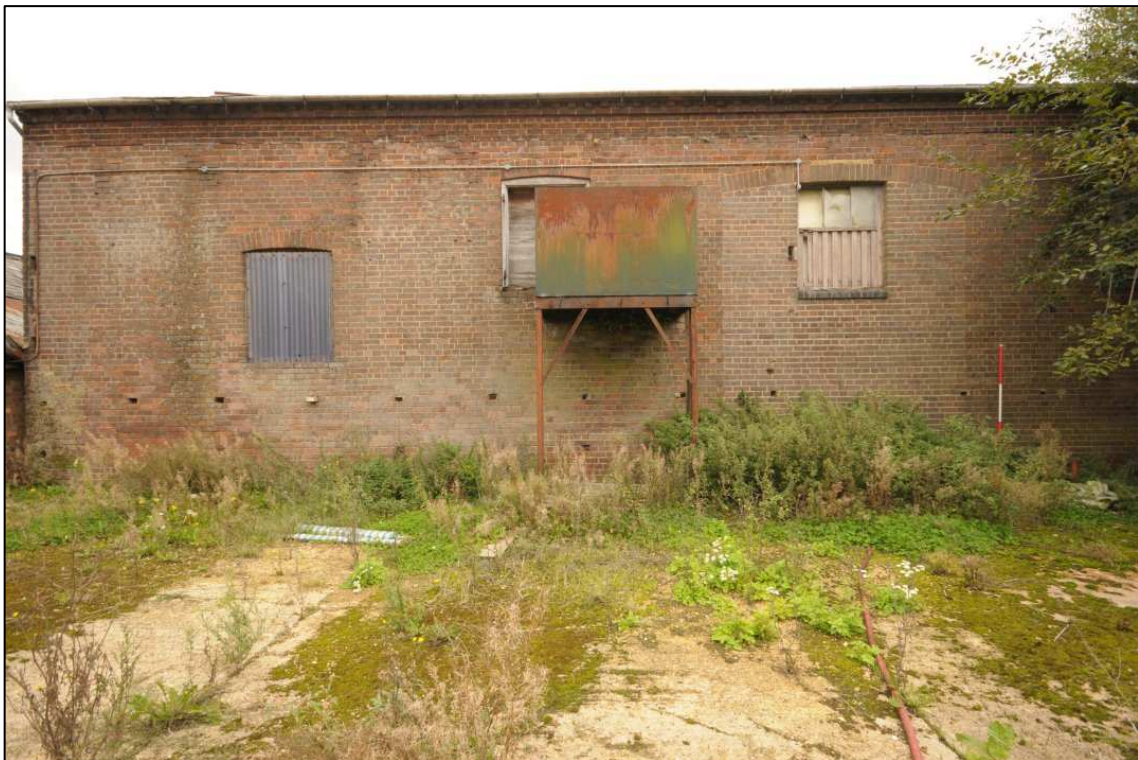
Image 28: East range: exterior of west side

Shows blocked full-height door opening with inserted window at right (scale 2m)

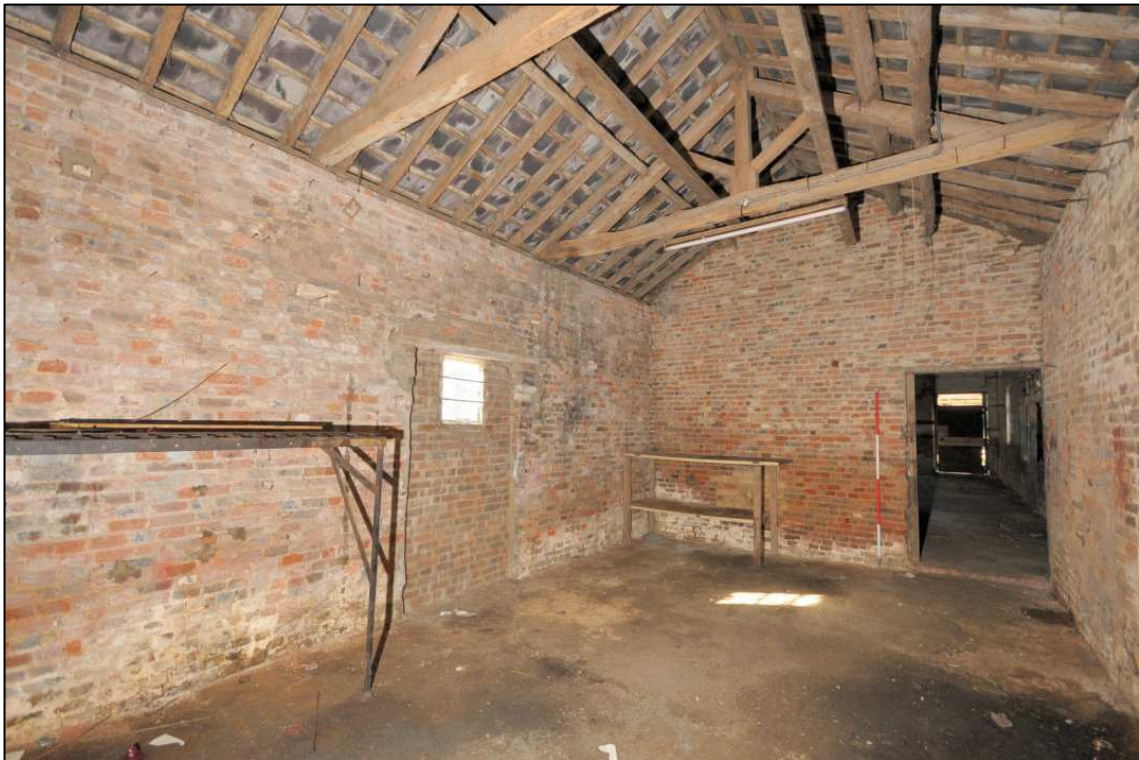
Image 33: South range: interior of compartment C7, looking south-west
Showing blocked opening in south wall at left and door to compartment C8 at right (scale 2m)

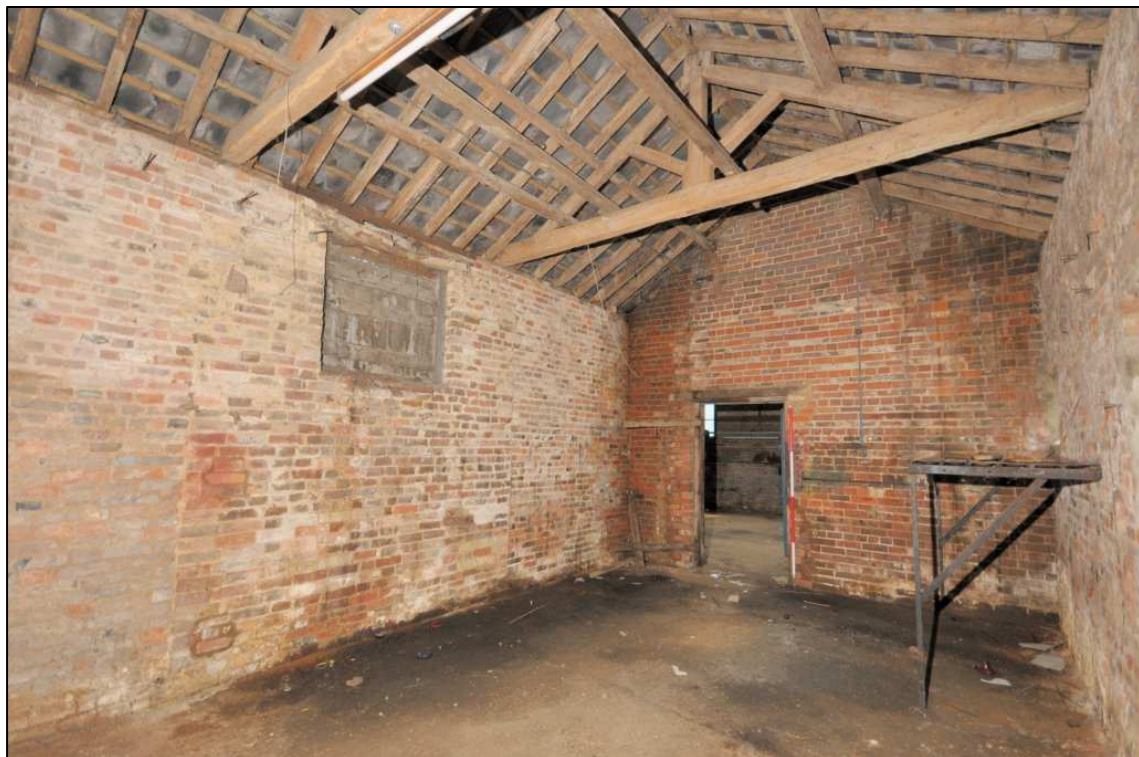
Image 34: South range: interior of compartment C7, looking north-east
Showing large blocked opening in north wall at left and door to compartment C6 in end wall (scale 2m)

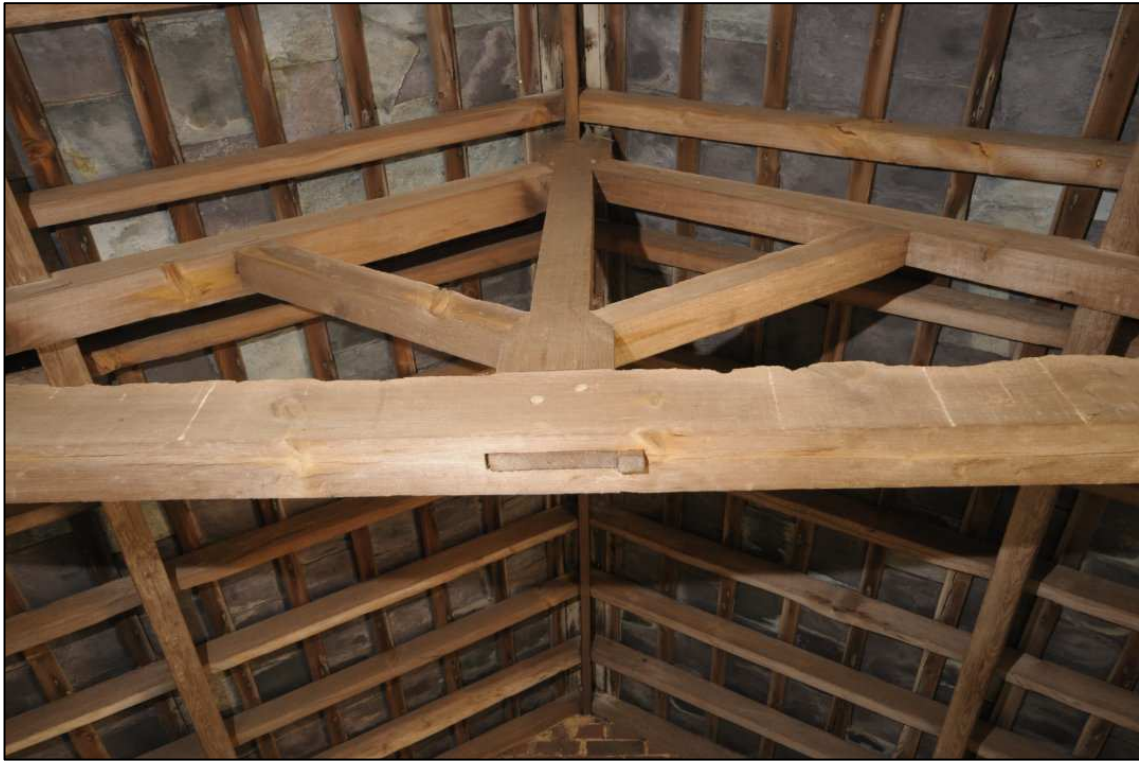
Image 45: Detail of kingpost roof truss in north range

This truss shows construction details of the trusses used throughout the north range and in compartment C7 in the south range. It has pegged joints and a wedge to lock the base of the kingpost in place. The wedge is clearly visible in this example because it had slipped down slightly.
