**CHURCH OF ST PETER
ARLESEY
BEDFORDSHIRE**

ARCHAEOLOGICAL WATCHING BRIEF

Project: SPA3412
OASIS ref.: albionar1-348426
Museum accession no.: BEDFM 2019.43

Document: 2019/46
Version 1.0

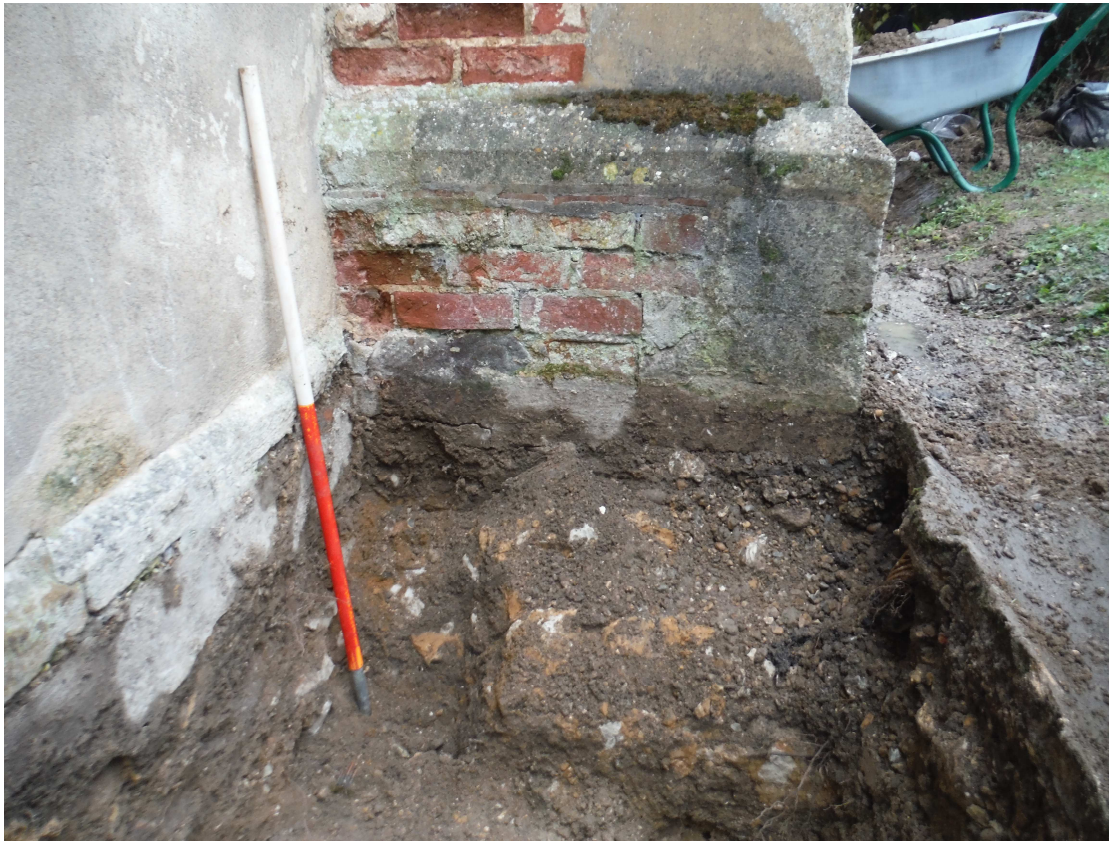
The nave wall is supported by three buttresses, the middle one of which effectively splits the drain in two with each portion measuring *c.*8.75m long, 1m wide and 0.6–0.9m deep. During these works foundations and previously buried lower portions of the buttresses were exposed. The buttresses were shown to have been repaired with differing materials to the wall fabric (Plate 1). They are likely to be 16th-century or later in date (British History online).

The pilaster buttress foundations on the south side of the nave were exposed during excavation of the French drains. The foundations on all three comprised large unshaped clunch stones (Plate 1), the largest measuring 500mm x 600mm. The multiple repairs made to the buttresses on both sides of the church mean the date of the foundations is difficult to determine. The buttress foundations were not exposed to their full depth during the monitored drainage works.

In addition, the near full depth of the pilaster buttresses was exposed and recorded. The buttresses sat on large unshaped limestone blocks and had been subject to multiple repairs, using differing materials.

Plate 1: Trench 1 – pilaster buttress foundation, looking east (1m scale)

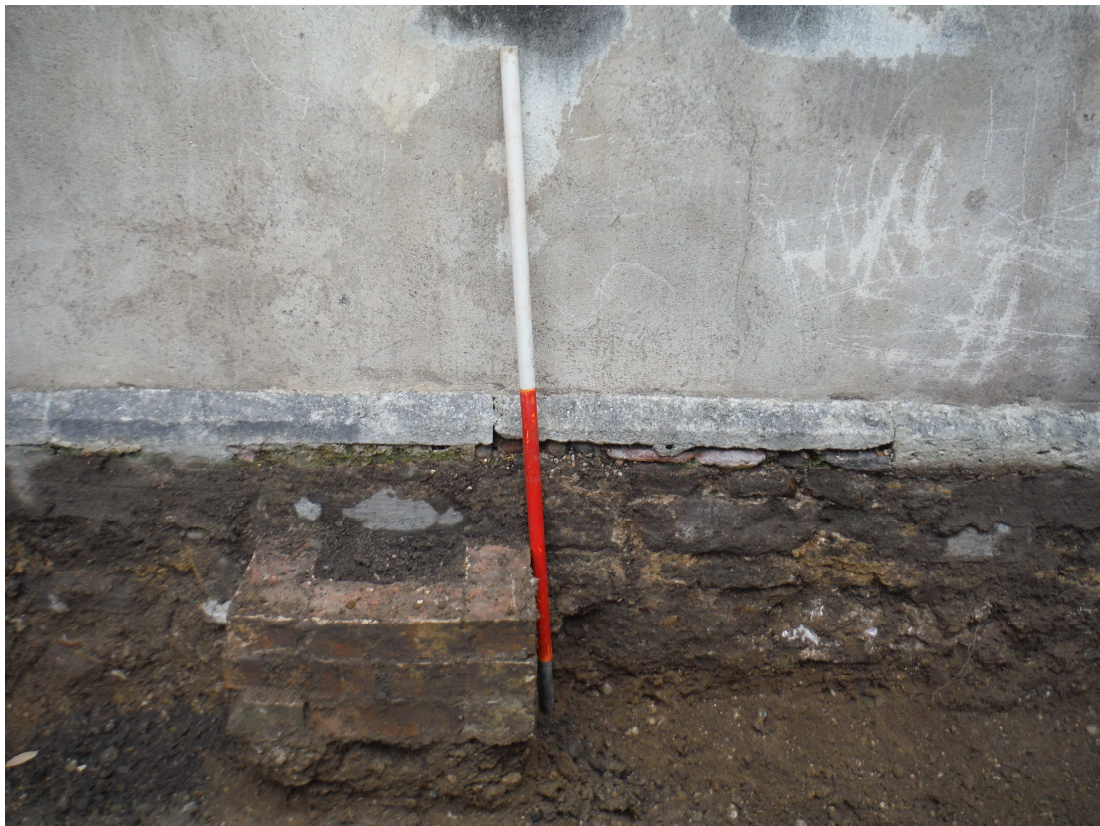
The inside vertical face of the trench exposed the nave foundation to its full depth, including 0.1m into a mortar bedding layer beneath the foundation (104). The foundation comprised roughly hewn, randomly coursed clunch separated by light grey-yellow sandy mortar. Individual stones ranged in size from *c.*160mm x 40mm to 400mm x 250mm (102) (Plate 2), visible to a height of *c.*0.5m, above which the wall fabric is obscured by patchy render (as is the case for the majority of the nave).

During these hand-excavations the remains of two red-brick drains were found (103). They are likely to represent the gullies for previous downpipes (Plate 2) and are likely to be no earlier than late Victorian in date.

Plate 2: Trench 1 – nave foundation, south side, looking north (1m scale)

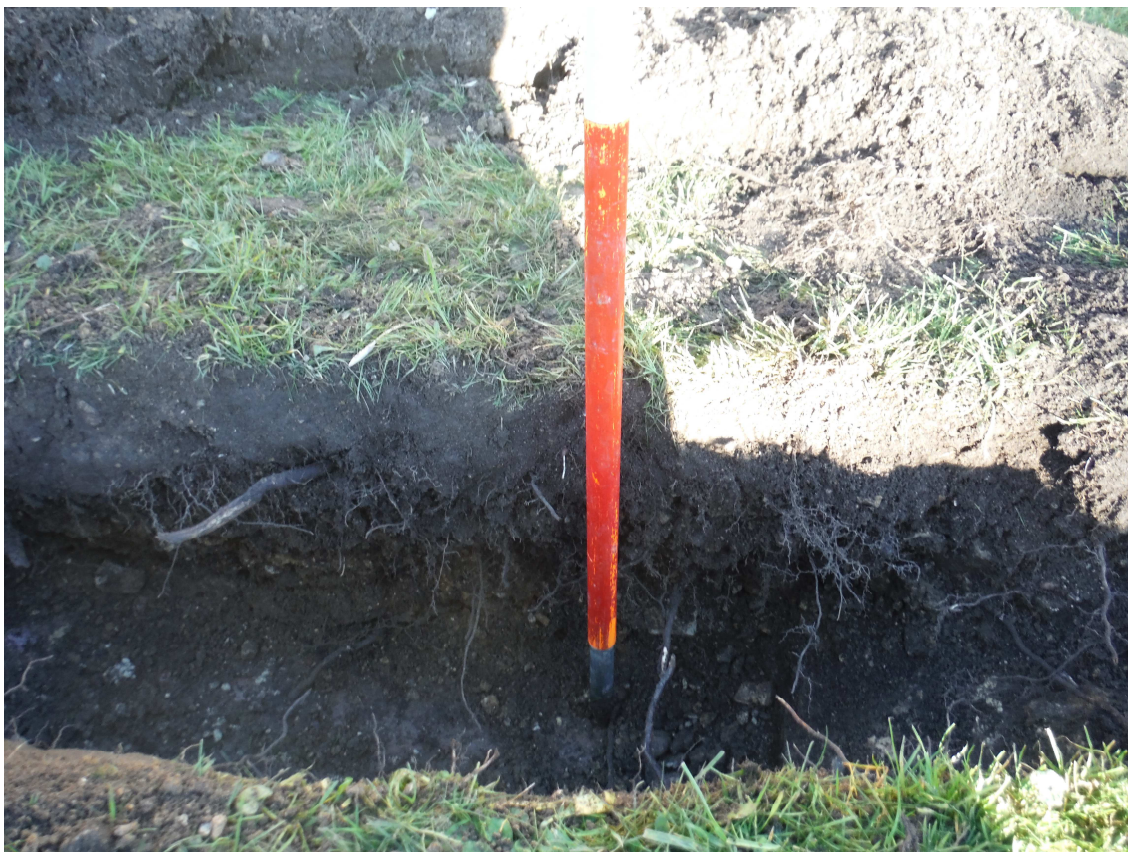
A drain was excavated 1.5m south of the vestry, connecting the east end of Trench 1 with an existing soakaway 3m south of the chancel (Figure 2.). The trench was 5m long x 0.3m wide x 0.6m deep.

The overburden comprised dark brown silty graveyard soil (106) to a depth of 0.2m. Beneath this was loose mid-grey silty soil (107) with occasional large limestone fragments, measuring < 0.25m; it contained an existing ceramic drain. One fragment of human bone was recovered and left on site for reburial.

Plate 3: Trench 2 – looking south (0.5m scale)

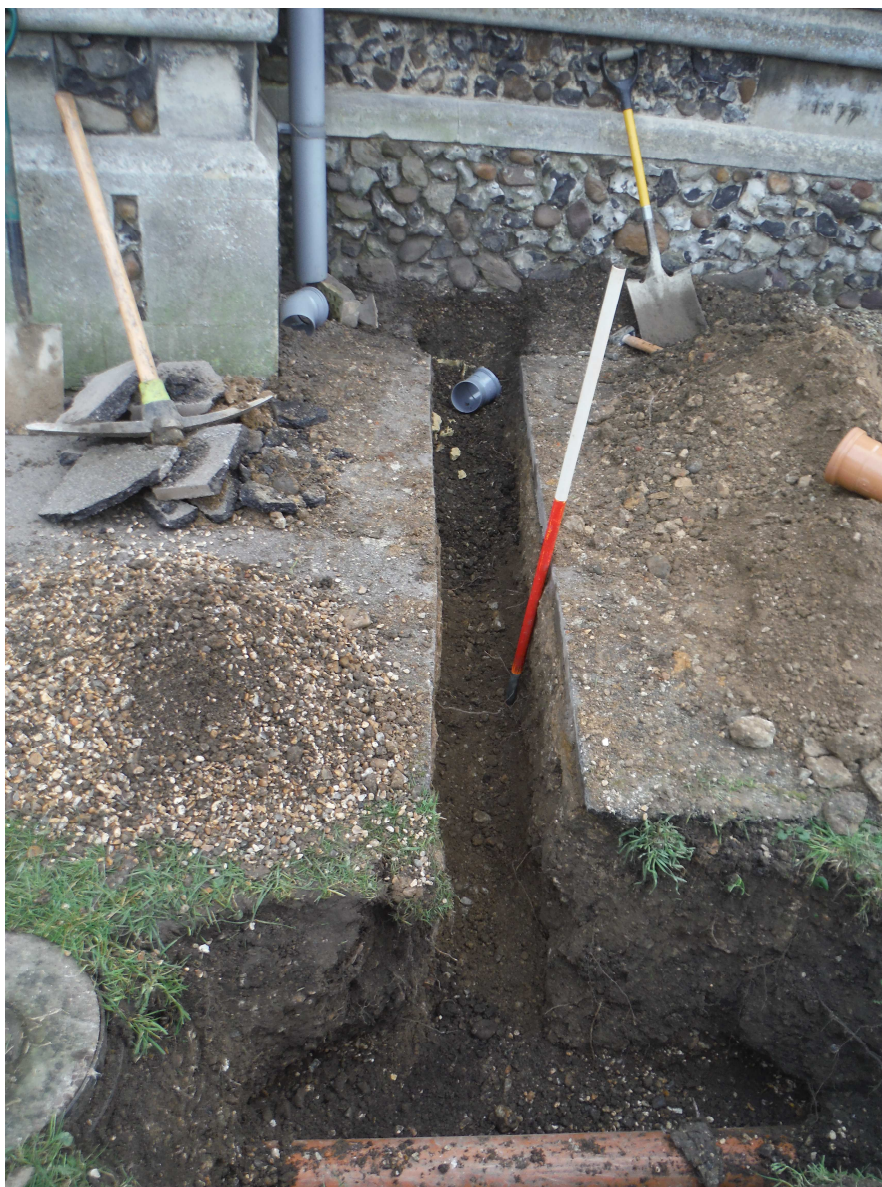
Trench 3 was excavated east-west, perpendicular to the 19th-century tower. It was 2.6m long x 0.3m wide x 0.45m deep and ran from the tower wall through the tarmac path to form a T-shaped, 1.4m-long north-south end. This end of the trench cut through the edge of the graveyard to connect with an existing drain (Plate 4; Figure 2). None of the tower foundations were exposed and no human remains were disturbed.

The uppermost deposit in Trench 3 comprised shingle filling of the existing French drain (100) to a depth of 0.10m. Stratigraphically beneath this was cemetery soil (106) tipping towards the tower wall and found only at the east end of the trench. The drain abutted the tarmac path (108), which was bedded on firm, yellow sand (109) to a depth of 0.26m. Directly beneath this lay mid-brown-grey silty graveyard soil (110), which was excavated to a depth of 0.19m.

Plate 4: Trench 3 – looking east towards tower (1m scale)

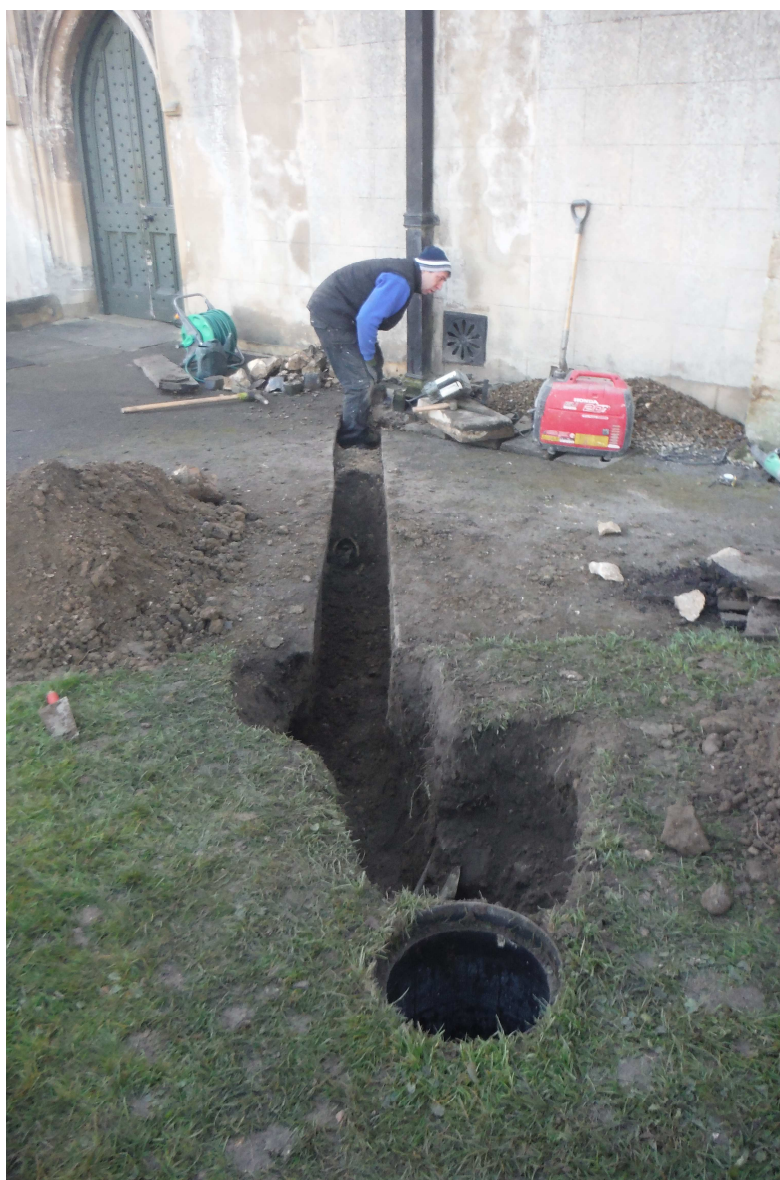
Trench 4 was aligned NW-SE and was excavated from an existing drain close to the north-west corner of the nave. It extended for 5m to meet an existing manhole (Plate 5; Figure 2). The first 2.6m of this trench, from the manhole, broke new ground but thereafter followed an existing pipe trench to the north-east corner of the nave (Plate 5).

The trench cut through tarmac (108) to a depth of 0.08m. Directly beneath this lay graveyard soil (106) to a depth of 0.7m. A single human bone was recovered from this material and left on site for reburial. No graves were disturbed and no church fabric was exposed during the excavation of this trench.

Plate 5: Trench 4 – looking south-east towards north-west corner of chancel
