**157 BEDFORD ROAD
WOOTTON
BEDFORDSHIRE**

**ARCHAEOLOGICAL OBSERVATION
INVESTIGATION AND RECORDING**

Project: BRW1728
Document: 2012/184
Version: 1.0
OASIS: albionar1-100638

25th October 2013

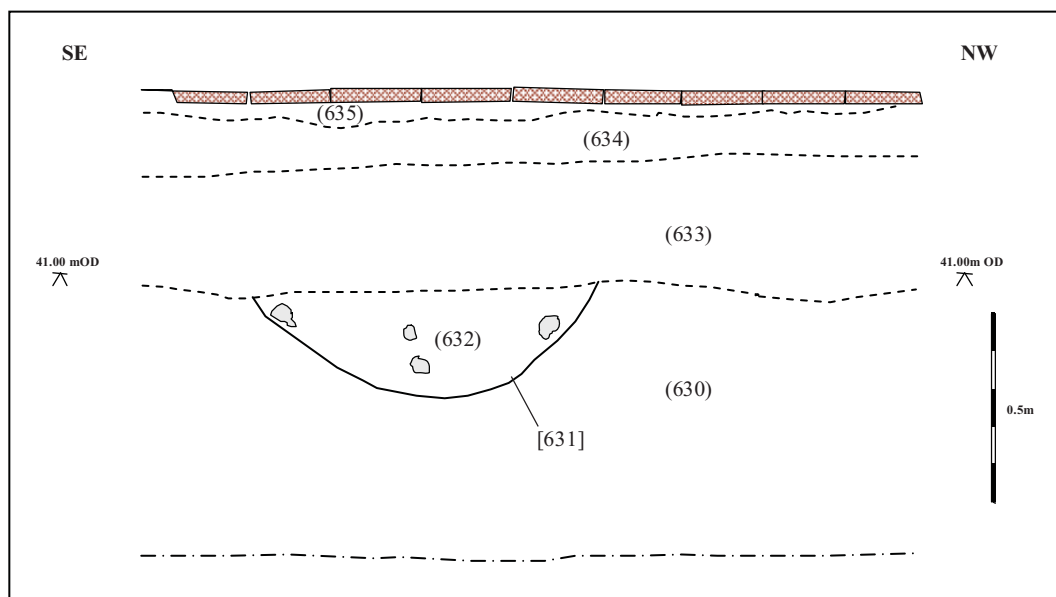
Figure 12: Section (pantry wall foundation trench)

The north-east-facing section of the foundation trench revealed the sequence of deposits beneath the pantry floor tiles, including two levelling layers above a buried former top soil and underlying geological deposits. They comprised from top to bottom (Figure 12 and Photo 13):

- 0.06m thick levelling layer of light grey-brown clay silt with occasional small and medium stones (635);
- 0.15m thick levelling layer of loose brown-yellow sand with moderate amounts of modern (post-1750) brick and tile fragments (634);
- 0.38m thick topsoil layer of mid grey-brown clay silt with occasional small and medium stones (633);
- > 0.70m thick geological layer of mid blue-grey clay with large patches of orange sandy clay with frequent gravel (630).

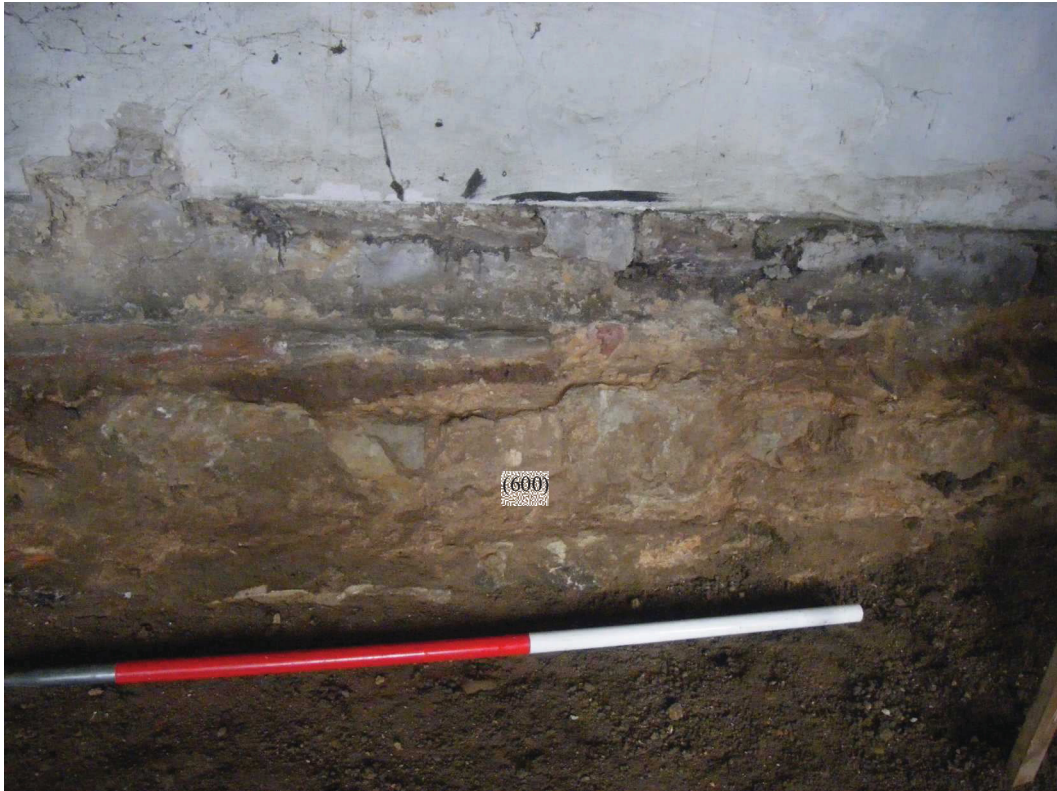
Here, the foundations of the lobby-entry dwelling (Photo 1) were substantial in character, comprising roughly hewn blocks of pale grey sandstone (600). The foundations were random coursed and bonded with a light-greyish-yellow fine mortar in good condition. The base of the timber frame sat directly on these foundations.

Photo 1: Foundations in the 'dining room' of the lobby-entry dwelling

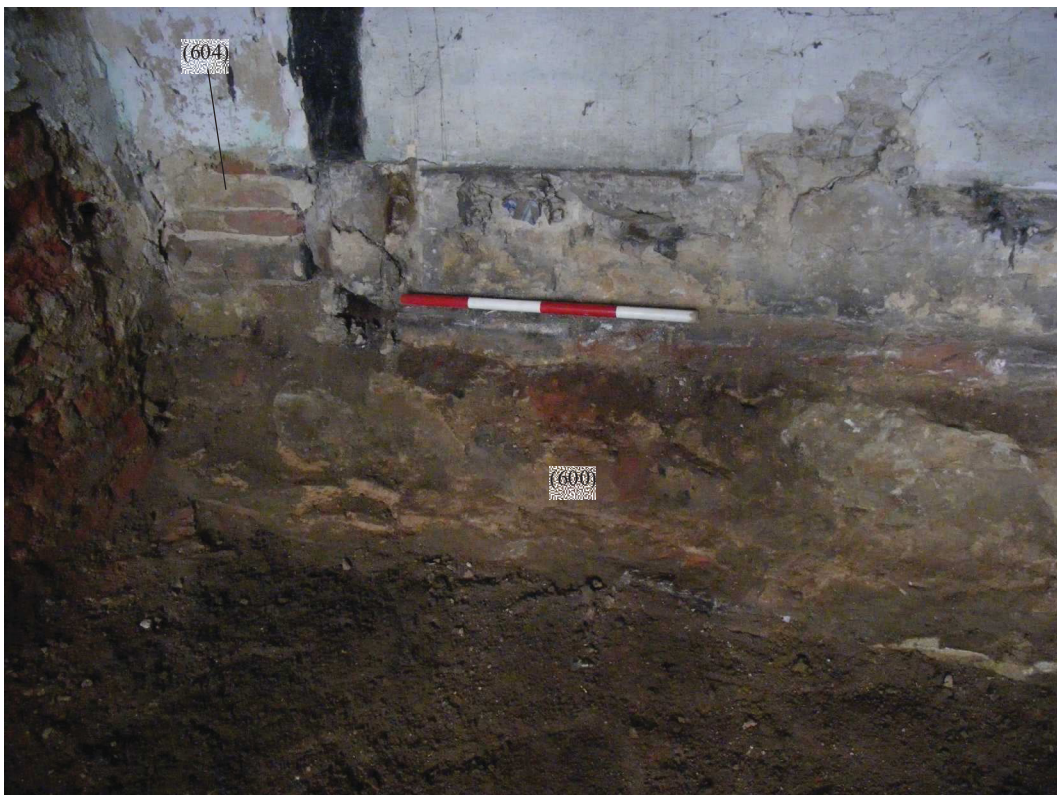
Above the foundations, some brick patching (604) was observed close to the fireplace (Photo 2). The brickwork had been used to make-good an opening in the wall and fill the void behind the chimney stack. Originally the lobby-entry dwelling would have had two opposing doorways and a smaller, central fireplace — as was the custom for dwellings of this period. These observations suggest that the north-east facing door was blocked by the insertion of the brick fireplace. Further evidence for this was observed in the pantry (see 4.13 below).

Photo 2: Brickwork in north corner of 'dining room'

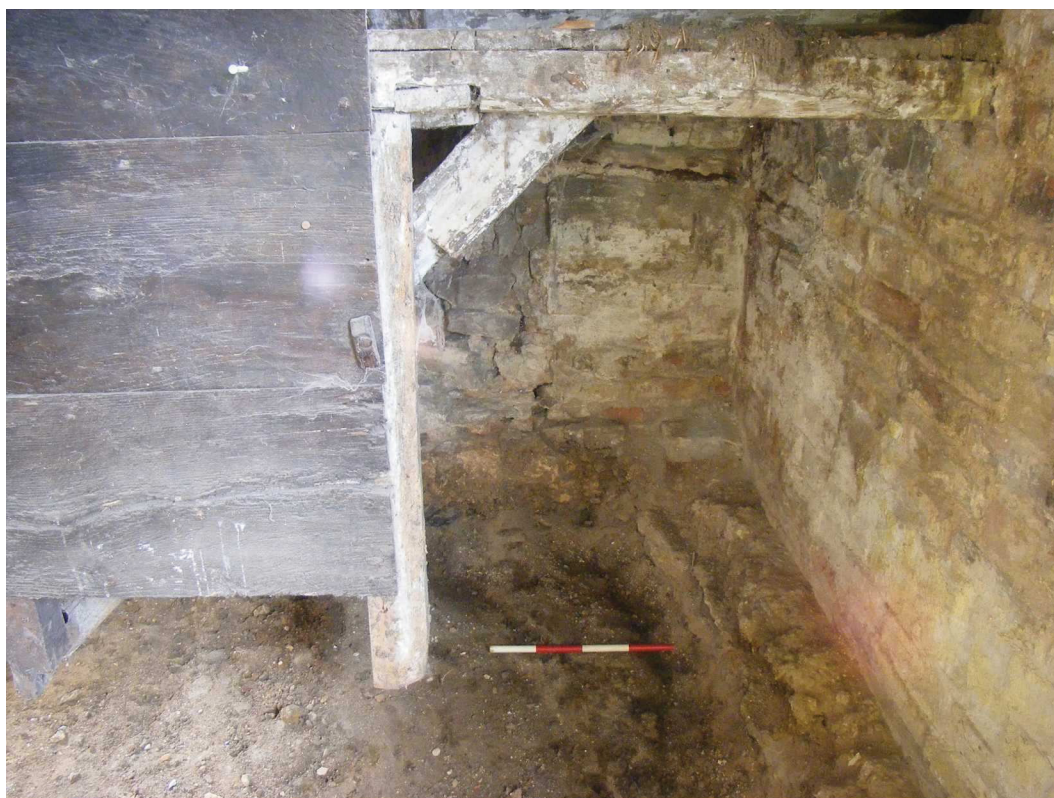
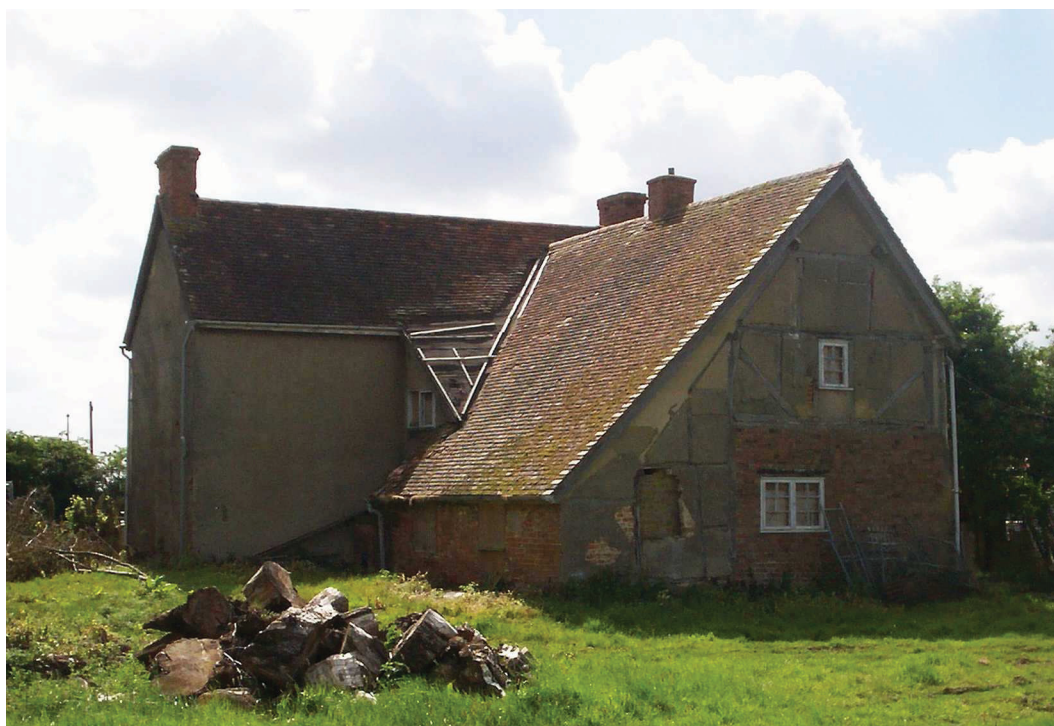
The foundations within the kitchen (600) were of similar construction, except at the north-west end of the building, where they had been replaced and the entire gable rebuilt in brick to first-floor level (Photos 3 and 4). It was also observed that the base of the timber frame of the north-east wall had moved out off-centre of its foundations (Photos 5, 6 and 10). This suggests that the lobby-entry dwelling suffered significant structural movement, presumably due to decay of the timber frame at the north-west gable end of the building, which allowed the entire frame to spread outwards towards the north and west.

Photo 3: Foundations of north-west gable of lobby-entry dwelling

Photo 4: North-west gable of lobby-entry dwelling, exterior view

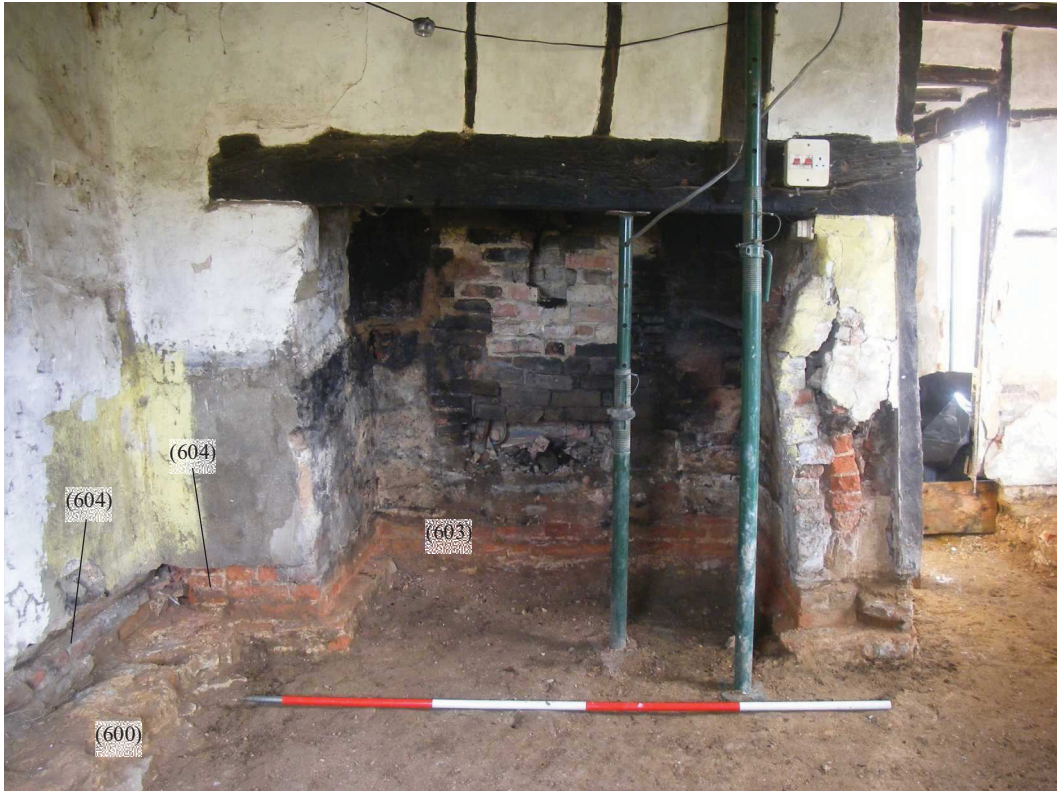
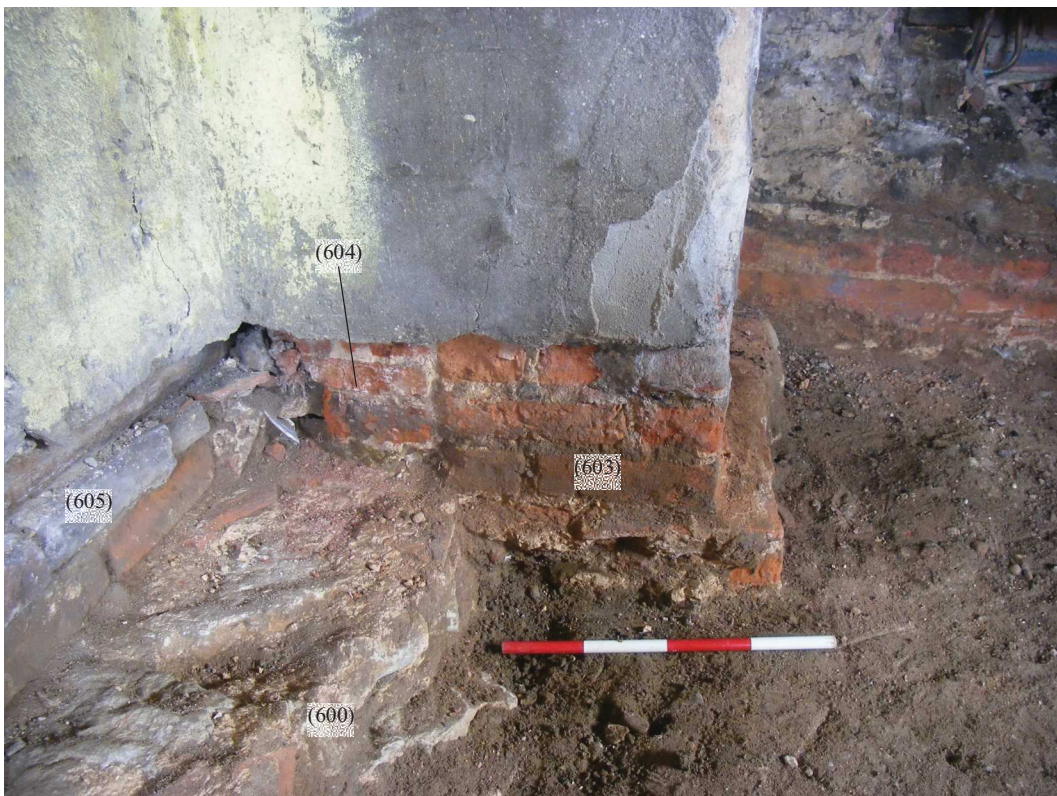
Viewed from the kitchen side, the left-hand side of the fireplace (603) clearly abutted the foundations of the north-east wall (Photos 5 and 6). However, above the foundations, brickwork (604) had been inserted to make-good a gap between the chimney stack and the kitchen wall.

Photo 5: The 'kitchen' fireplace in the lobby-entry dwelling

Photo 6: Brickwork infilling adjacent to the fireplace in the lobby-entry dwelling

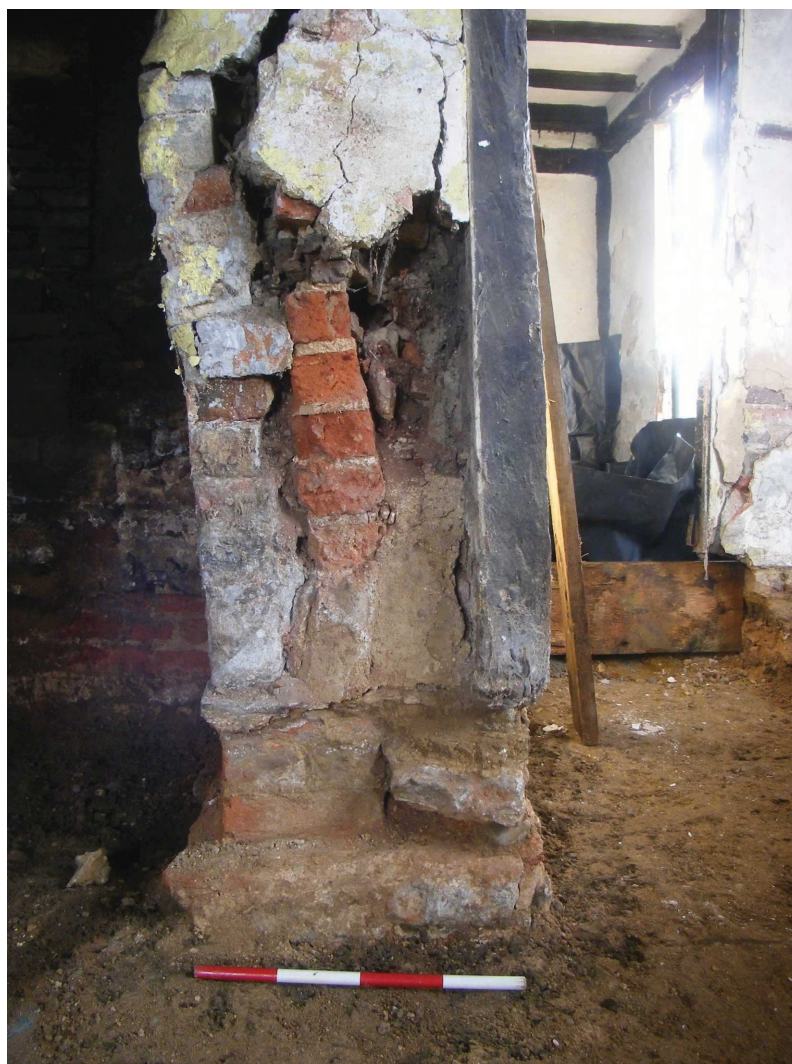
As far as could be observed, the left-hand pier of the fireplace was entirely founded on brickwork. However, the right-hand pier had a foundation comprising large blocks of pale grey sandstone (Photo 7). The right-hand pier was also in poor condition, comprising several builds of brick and timber studwork.

Photo 7: Detail of construction, right-hand pier of the fireplace

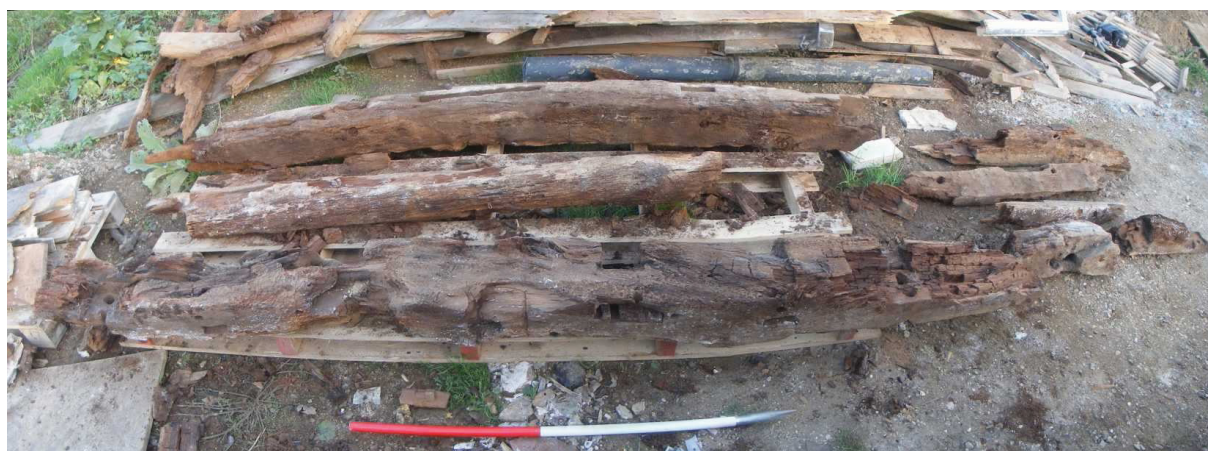
The floors within both the lounge and sitting room comprised floor boards laid on wooden sills. The latter were re-used former structural beams, probably originally taken from a demolished dwelling or agricultural building. The floor boards and sills were in very poor condition and had been removed before the start of archaeological attendance (Photo 8).

Photo 8: Former structural timbers re-used as sleepers beneath the floor boards in the end-stack dwelling

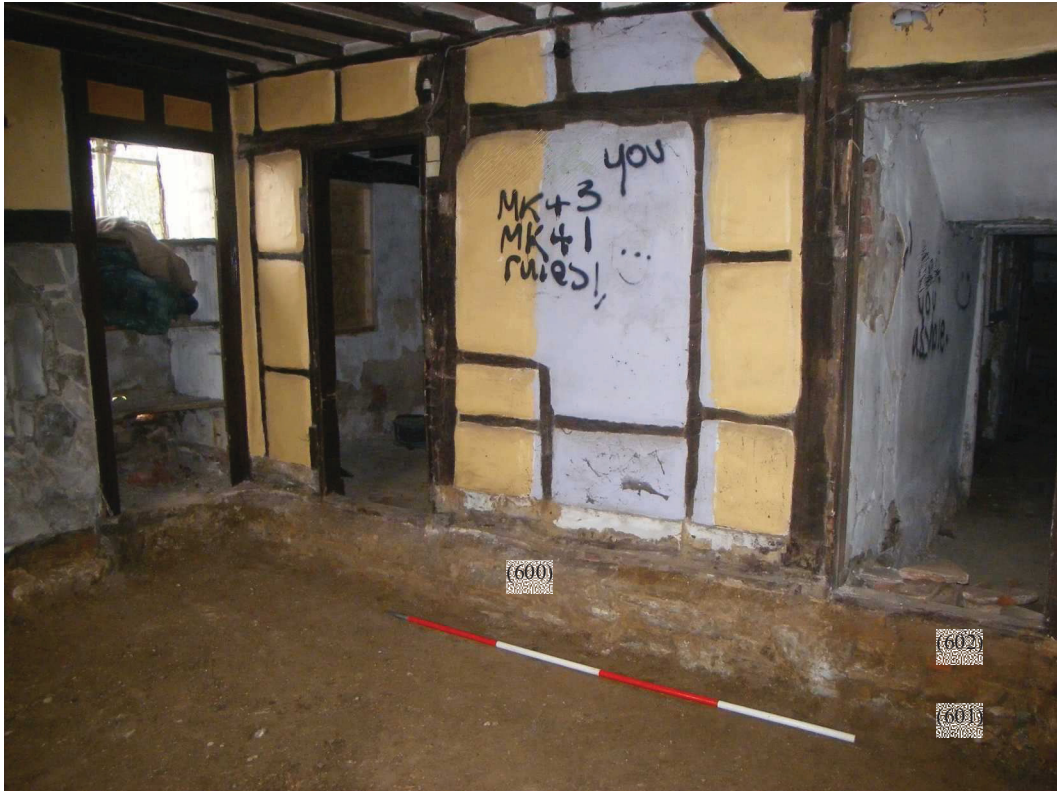
The exposed foundations (600) of the lobby-entry dwelling were visible on the north-west side of the lounge (Photo 11). This would have originally comprised the outer face of the east gable of the earlier building and the foundations were clearly more substantial in character than the foundations of the end-stack dwelling, comprising roughly hewn blocks of light grey sandstone. The foundations were random coursed and bonded with a light greyish-yellow fine mortar in good condition, which was well spread over the stone suggestive of re-pointing.

Photo 11: Foundations of the south-east end of the lobby-entry dwelling visible from inside the end-stack dwelling (Photo digitally altered to remove obscene Graffiti)

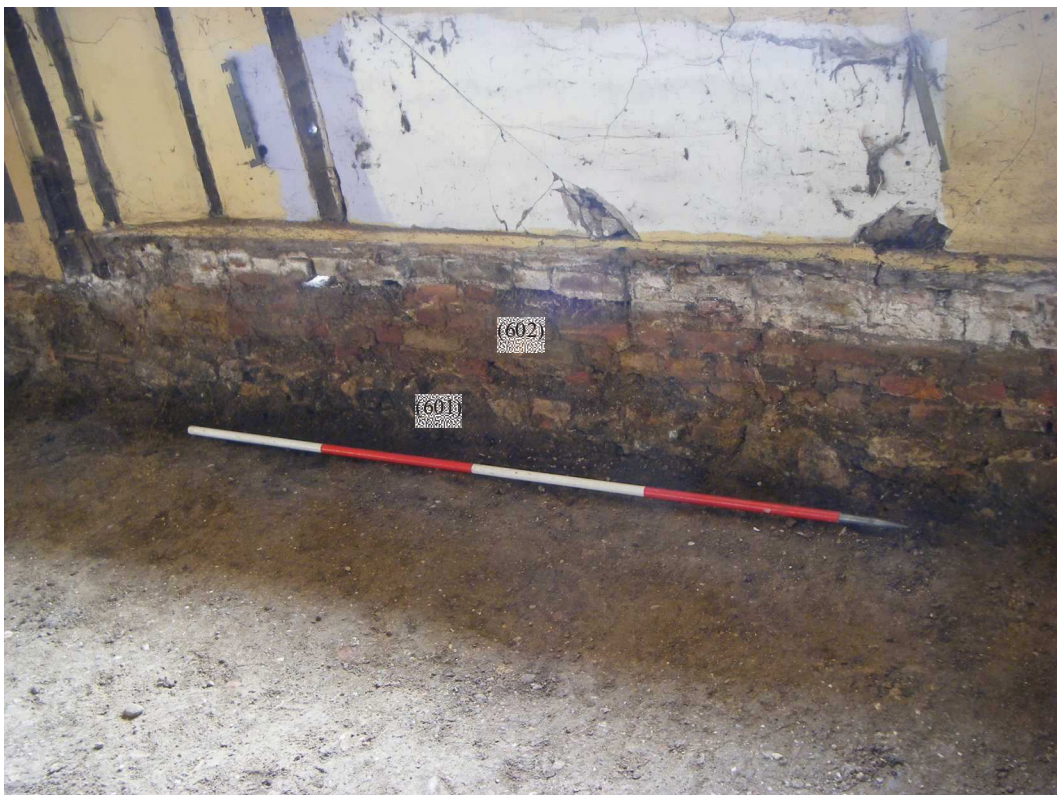
The exposed foundations of the end-stack dwelling itself comprised a base of stone blocks (601) beneath a dwarf wall of brick (602), which in turn carried the sills of the end-stack dwelling (Photo 12). The stone foundations were at least 0.12m wider than the brick wall they supported.

The light grey sandstone blocks were poorly bonded. The dwarf wall (602) was 0.36m high and comprised four courses of mid pinkish-red bricks. The bricks were 170–200mm long and 60mm thick, laid in stretcher bond, bedded in greyish-yellow sandy mortar that was in good condition.

Photo 12: Foundations, dwarf wall within the end-stack dwelling

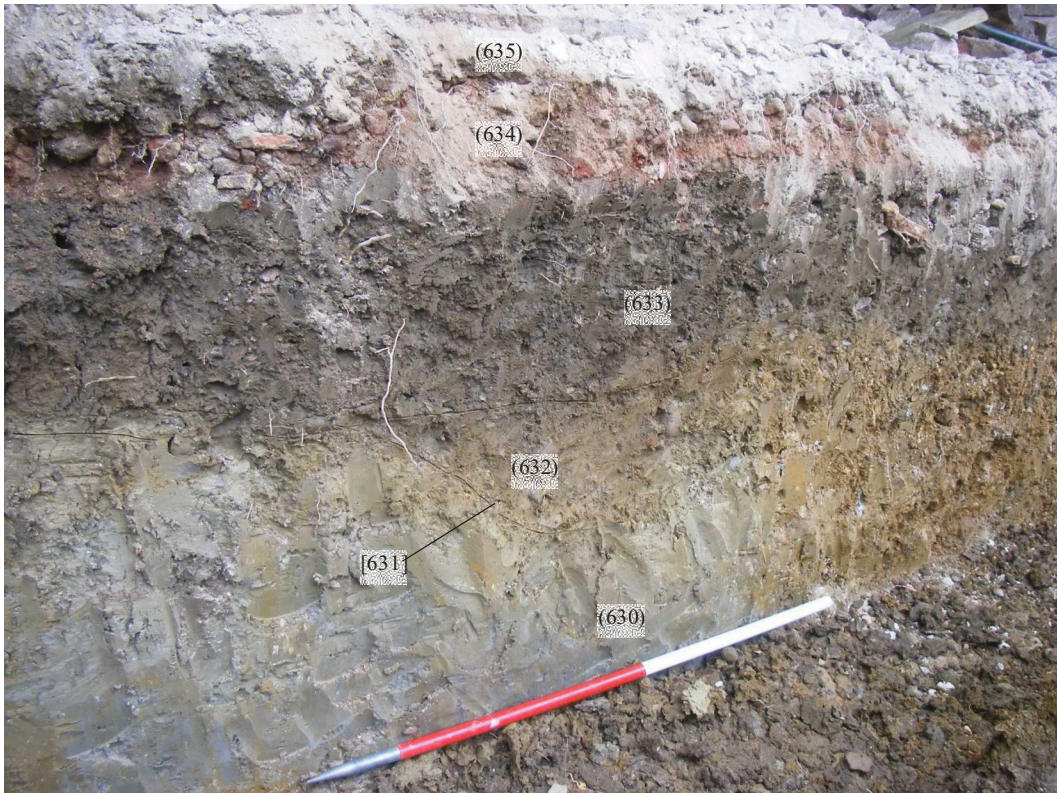
A concave-sided feature [631] that was sealed by layer (633) was identified in the north-east facing section of the new foundation trench (Figures 8 and 14). It was 0.90m wide and 0.28m deep and contained a deposit of light orange-brown clay silt with occasional charcoal flecks and medium stones (632). It did not contain any artefacts.

The feature did not extend to the opposing side of the foundation trench and is therefore considered to have been a pit. The date of the pit is not known but it predates the pantry wall and the compact nature of its fill (632) suggests that it is of considerable age, possibly medieval or older.

Photo 13: Small pit in the south-west side of the pantry wall foundation trench

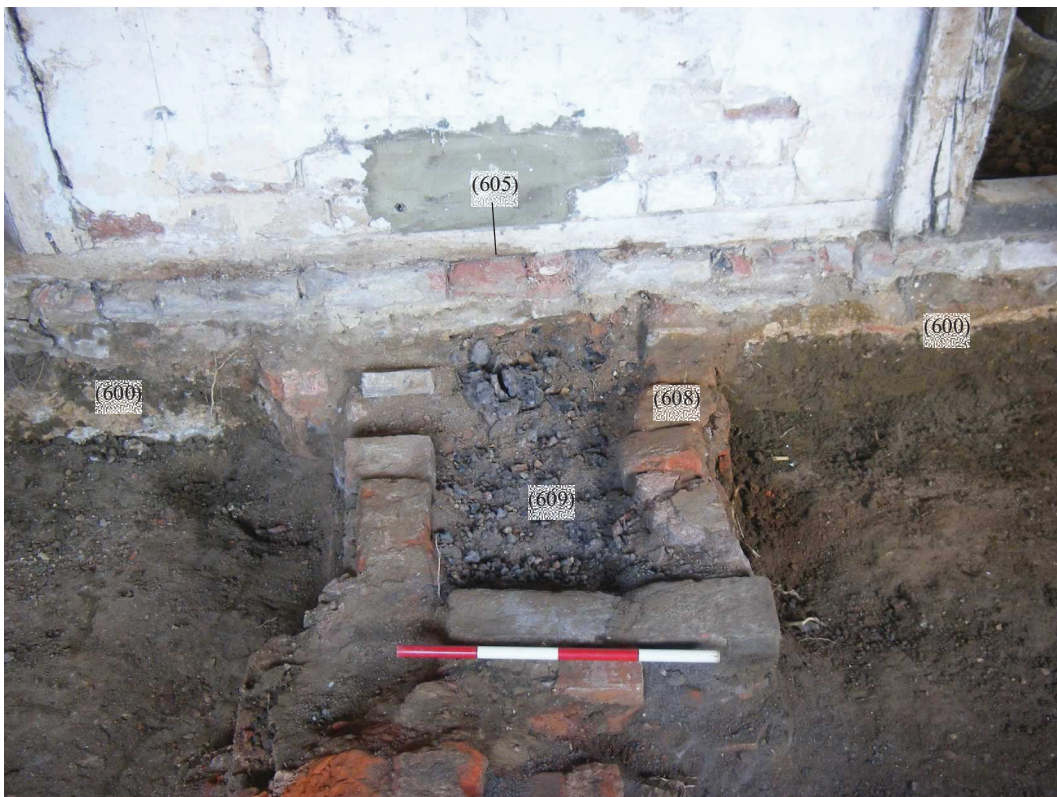
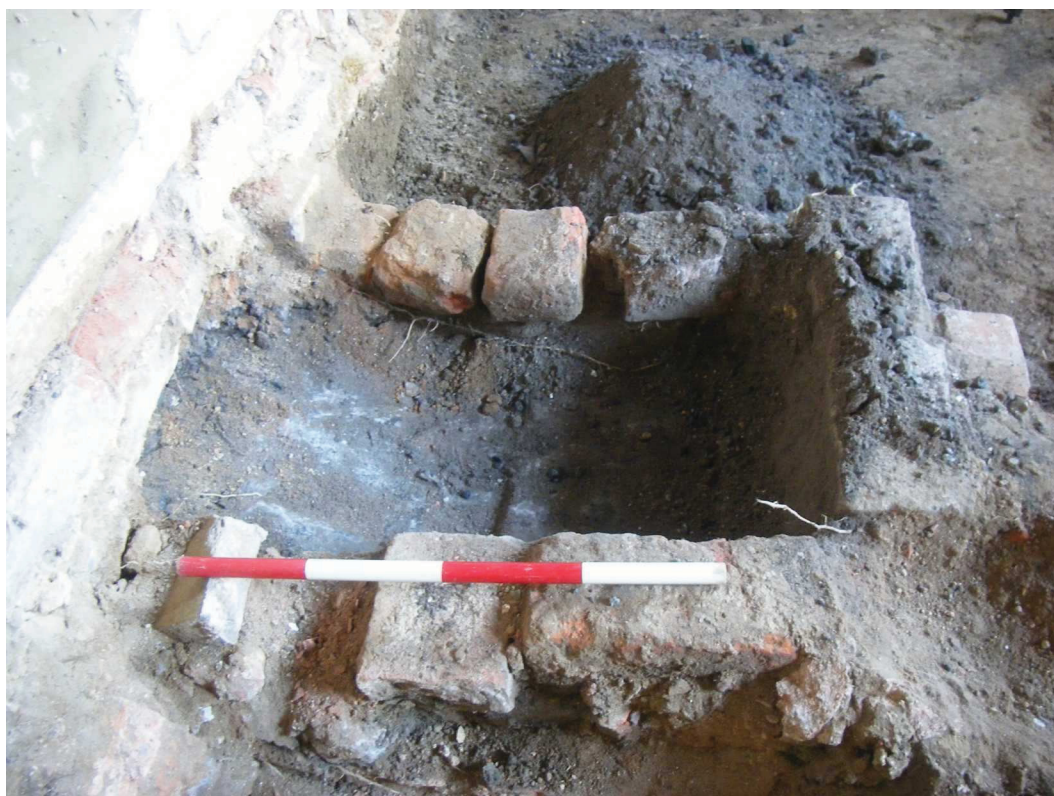
The brick 'ash chute' and collection box (608) (Photo 14–16) may have been a later feature added to the first build pantry / corridor. It was 0.7m long, 0.5m wide and had survived to a depth of 0.12m. The structure comprised two courses of large, un-frogged bricks (188–215mm long, 105mm wide and 42–62mm thick). They were not bonded with mortar. The structure contained soot and hard fragments of fuel ash (609) from its last use, after which it was buried beneath the floor levelling layer (629). The fuel ash comprised burnt clay and other material that had reached a very high temperature, perhaps as the result of a mishap or accident such as a chimney fire (Holly Duncan, pers. comm.). When the fuel ash was removed, the sloping brick base of the chute was observed (Photo 16); this ran beneath the sill of the lobby-entry dwelling and had been created by removing part of the stone foundation (600). From inside the lobby-entry dwelling the chute would have been adjacent to the fireplace as if it had been placed to receive ash from the fire. The exact purpose of this structure is unknown. We can speculate that it may have been used to transfer hot coals for a variety of purposes: to heat a copper, or for smoking meat, perhaps? But this is unlikely, given that the proximity of the wooden sill. It may have been simply a bespoke, labour-saving solution to facilitate the disposal of cold ashes.

Photo 14: 'Ash chute' collection box (608) with final use deposit (609) still *in situ*

Photo 16: 'Ash chute' collection box (608) with fill removed
(Note the bricked-up void beneath the timber sill.)

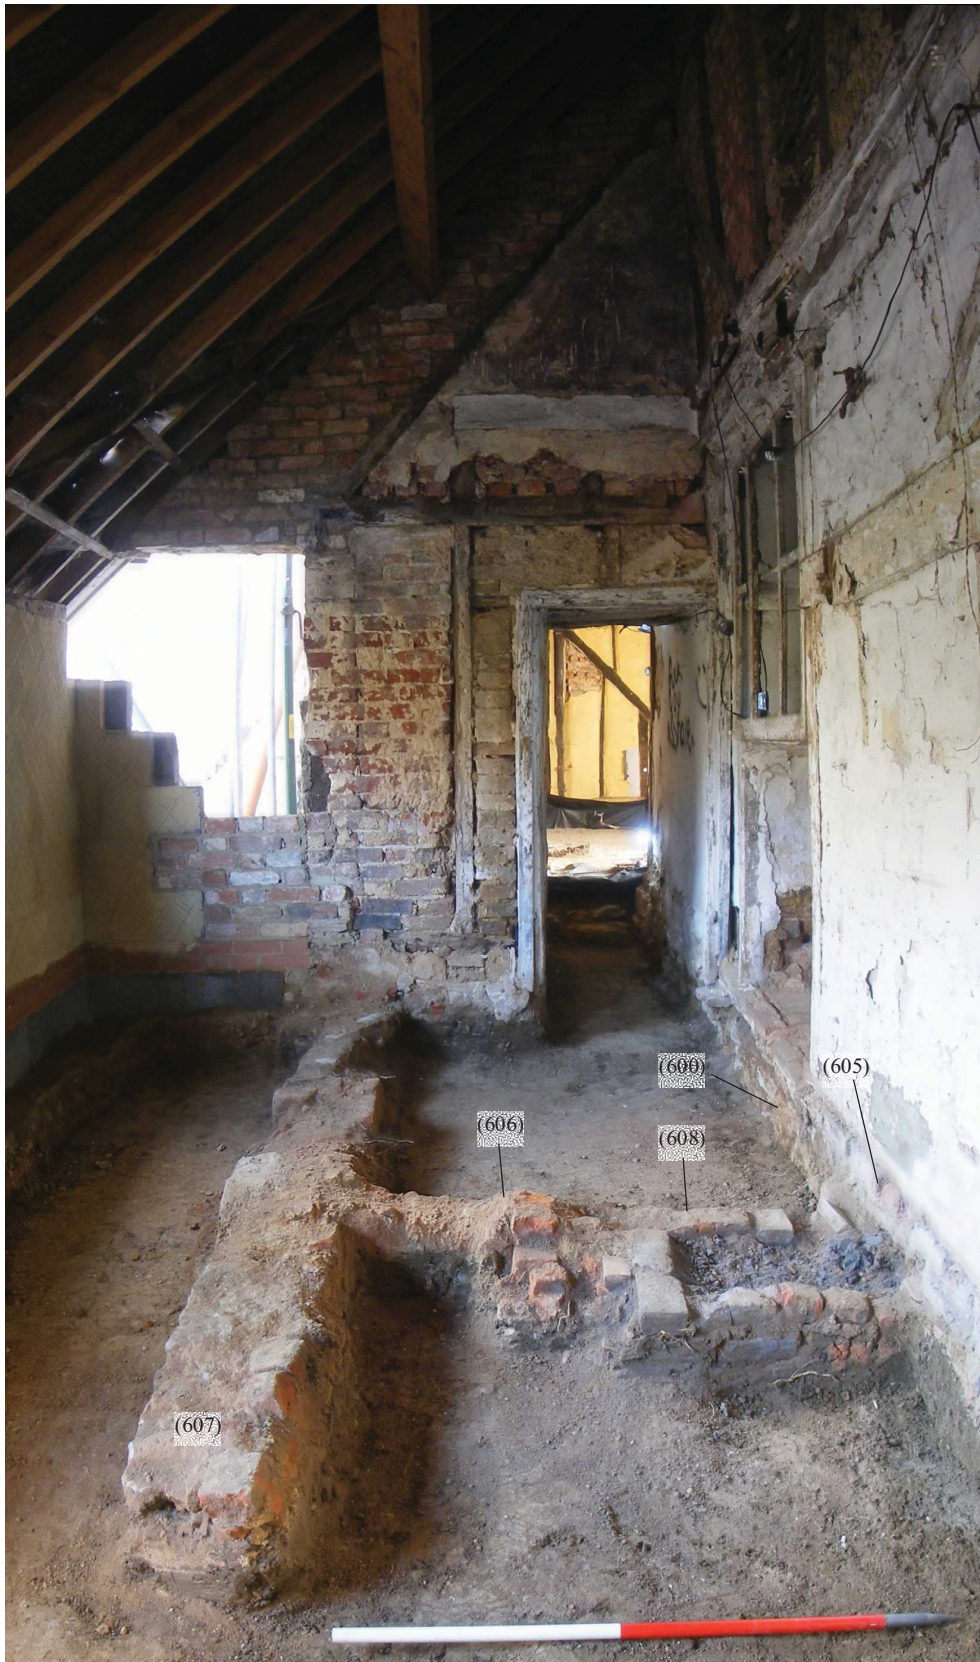
Ground reduction within the pantry also exposed the shallow foundations of an earlier, narrower pantry or corridor (Photo 15). These comprised two wall foundations and a small brick chute and ash collection box.

Foundation (607) ran down the middle of the pantry from its south-east end, continuing for at least 3.5m; it survived for two thirds of the length of the pantry. It comprised a single random course of pale grey, roughly squared sandstone blocks. The south-west (inside) face of the sandstone course had been consolidated by a course of un-mortared pinkish red bricks (606). The bricks were 174–208mm long, 90mm wide, and 60mm thick.

Photo 15: Foundations and ‘ash chute’ collection box within the ‘pantry’ extension
(Several phases are visible in the walls behind.)

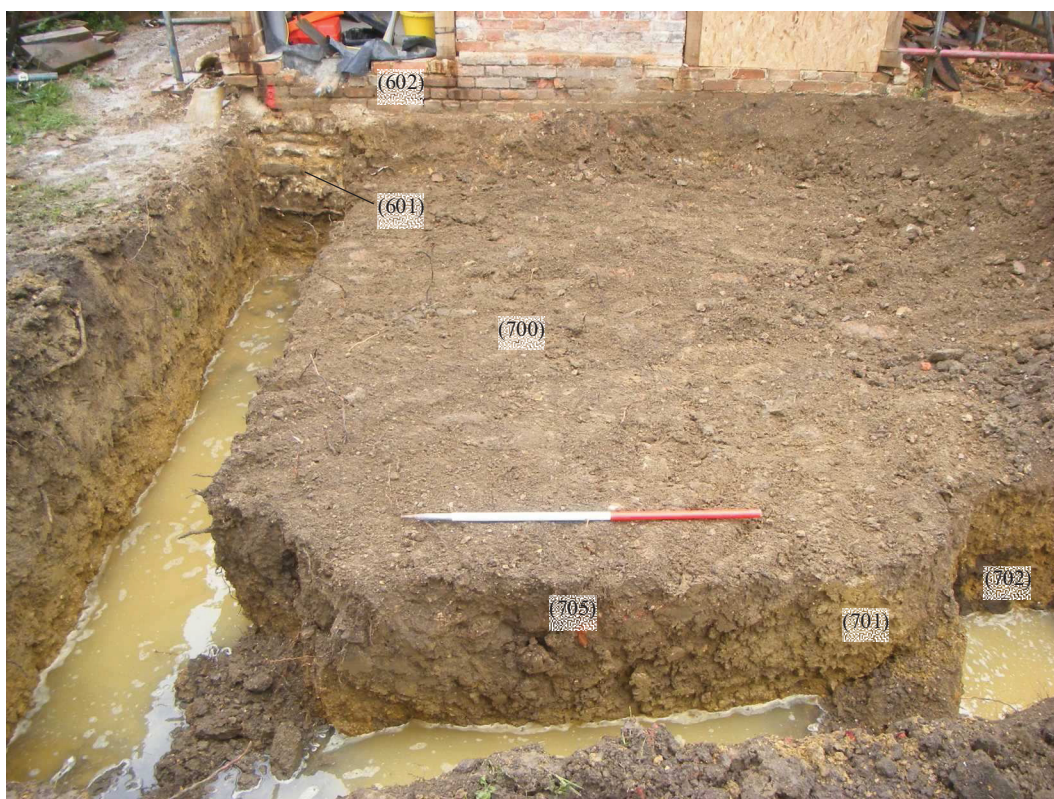
A single feature [703] was identified in the north-east foundation trench for the new build lounge (Figures 8 and 13; Photo 17). It was 1.90m wide and 0.32m deep, with a concave-sided, flat-based profile. It contained mid-brownish-grey clay silt (704), which produced no artefacts. The feature was sealed by the buried former topsoil layer (701). A depression in layer (701) that followed the profile of the ditch had been levelled with a mid-brownish-grey sandy silt deposit (705); it contained post-medieval brick and roof tile fragments. Above this was the topsoil layer (700).

Photo 17: Features observed in the foundation trench for the new build extension

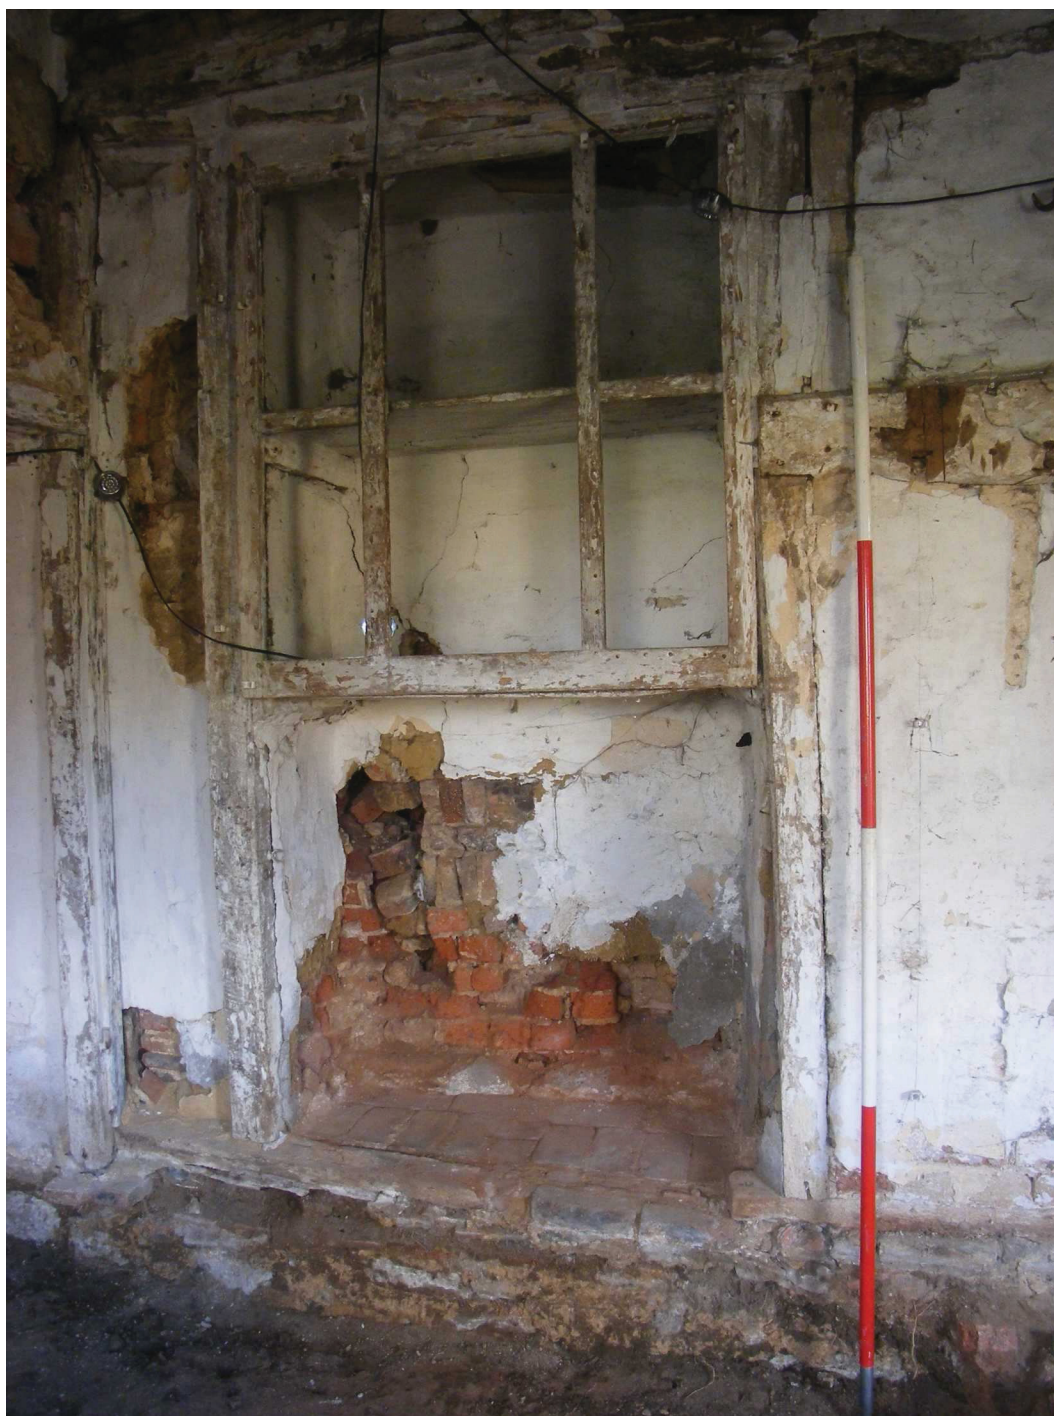
As previously described, the former opposing doorway of the lobby-entry dwelling became blocked off when the present chimney stack was constructed. The former doorway recess was clearly visible in the south-west pantry wall, where it had been carefully converted into a pantry cupboard (Photos 15 and 18). It is noted that the conversion of the opposing doorway into a cupboard provides good evidence that the earlier, smaller pantry / corridor must have been added by the time the fireplace was constructed, or it would have been more likely that the old doorway would have been bricked up.

Photo 18: Former opposing door of lobby-entry dwelling that was later blocked by the addition of the fireplace (The recess was converted into a cupboard)
