**DODFORD MANOR FARM  
DODFORD  
NORTHAMPTONSHIRE**

**HISTORIC BUILDING RECORDING**

Document: 2011/82  
Project: DM1782

July 2011

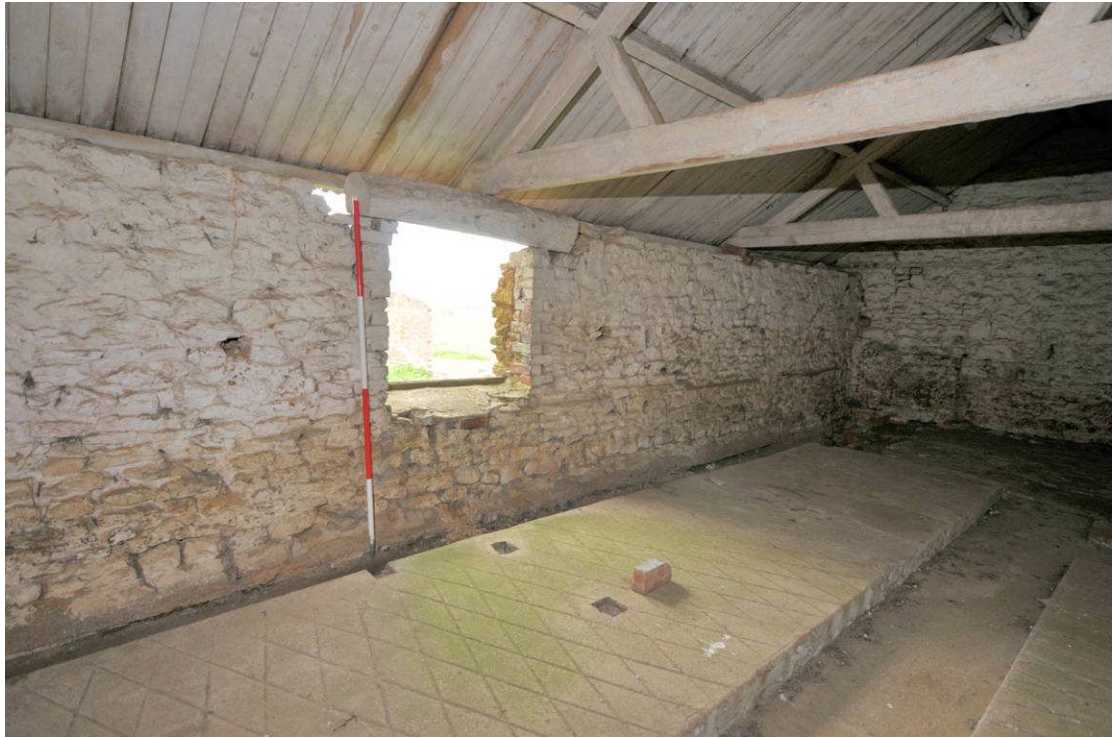
Plate 8: Cow house (Building B), interior

In plan form the building contains 6 bays and measures approximately 20m x 6m. The existing roof sits on a timber wall plate and is constructed using simple tie-beam trusses made out of machine-sawn timbers (Plate 8). Internally the roof has been lined with close-boarded timbers onto which the roof covering is attached. Any former roof covering has since been replaced with corrugated metal sheet.

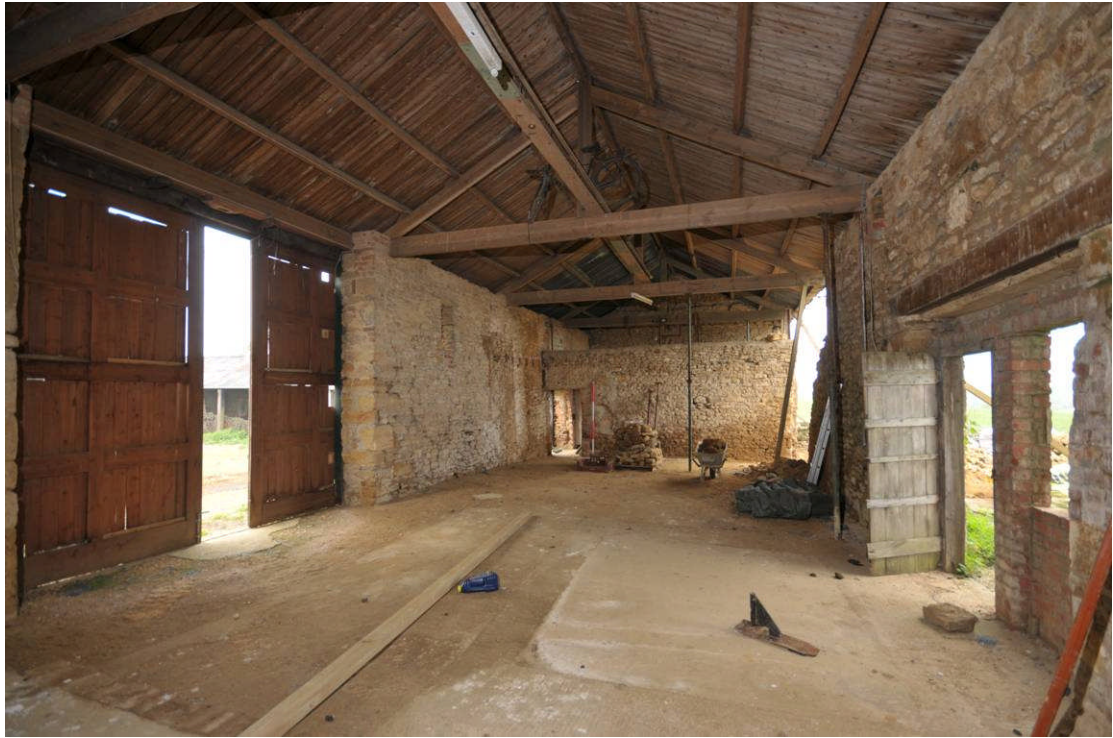
Plate 18: Barn (Building C), interior

The full-height opening in the southern elevation has remained largely unaltered as is evidenced by the rough block quoining forming the door jamb, although brick insertions have been made by way of repair and infilling of holes (Plate 18). The opposing opening in the northern elevation (Plate 13) has however been altered over time. Initially to half-height as evidenced by the insertion of a stone lintel and infill above and then by the insertion of brick to form a standard door and adjacent window opening. Brick infill has replaced the stone quoining on the eastern side of the door, although the stonework remains intact on the western side. The construction of the adjacent Dutch barn against the door opening was probably the catalyst for decreasing the size of the opening still further. Although there appears to be evidence of infilling above the inserted stone lintel at half-height level (Plate 18), there are no quoin stones to indicate a former full height door. These higher quality stones may have been removed for use elsewhere prior to the blocking.

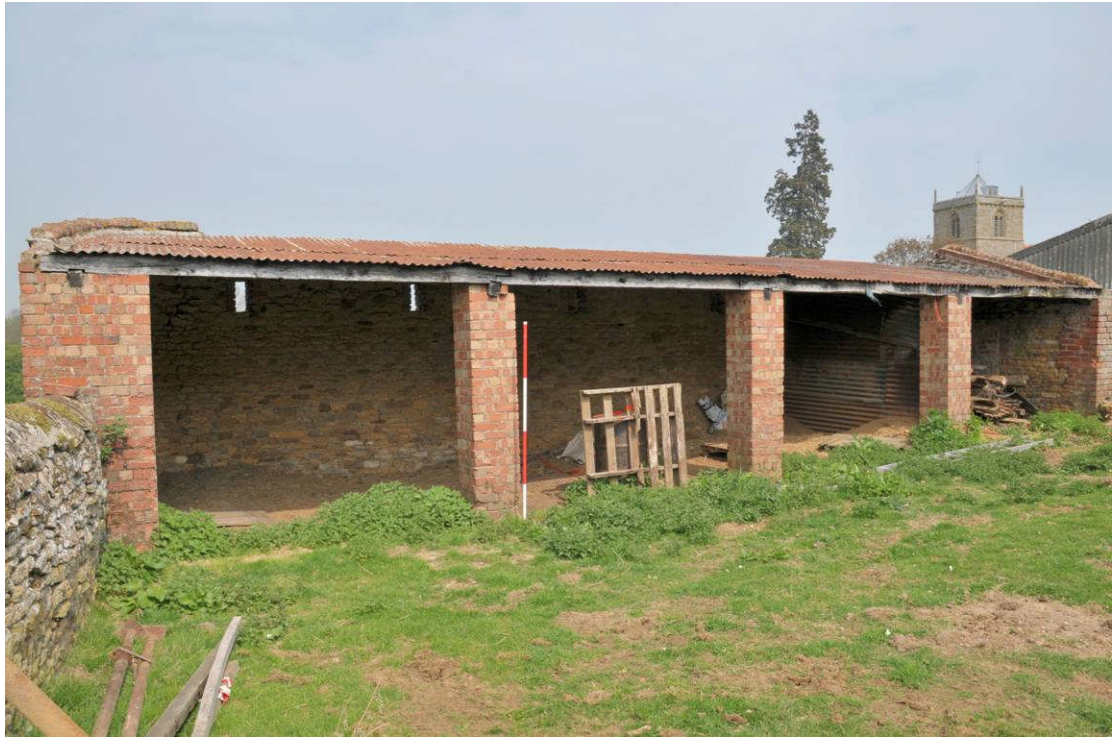
Plate 22: Open-fronted shed (Building D), southern elevation

Although the brick piers and altered roof (Plate 22) are a relatively recent replacement and various openings have been blocked, this structure retains its historic plan.
