**THE OLD BAPTIST CHAPEL SCHOOL ROOM
LITTLE STAUGHTON
BEDFORDSHIRE**

**ARCHAEOLOGICAL BUILDING RECORDING AND
INVESTIGATION**

Project: LS1945

Document: 2012/100 v.1.1

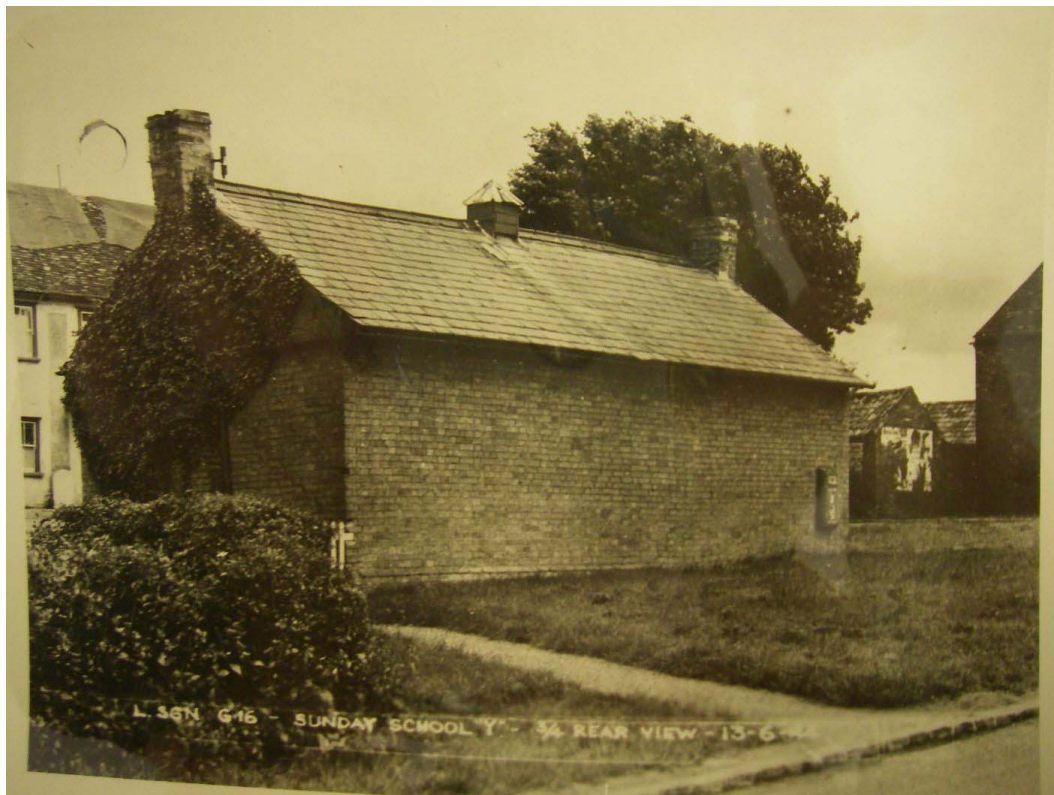
Figure 7: School room, west-facing side 1944

The western side of the building facing the main road, originally had no windows, as shown on the photographs of the school room dating from 1944 (Figure 7). After WWII two hopper windows were inserted at either end of the wall. These had heavy wooden frames with narrow wooden hoppers on the inside and a chain or cord operated mechanism at their apex to open and close the windows. They were half the height of the full sash windows in the eastern façade and consisted of six rectangular and arched window panes (Figures 13 and 17).

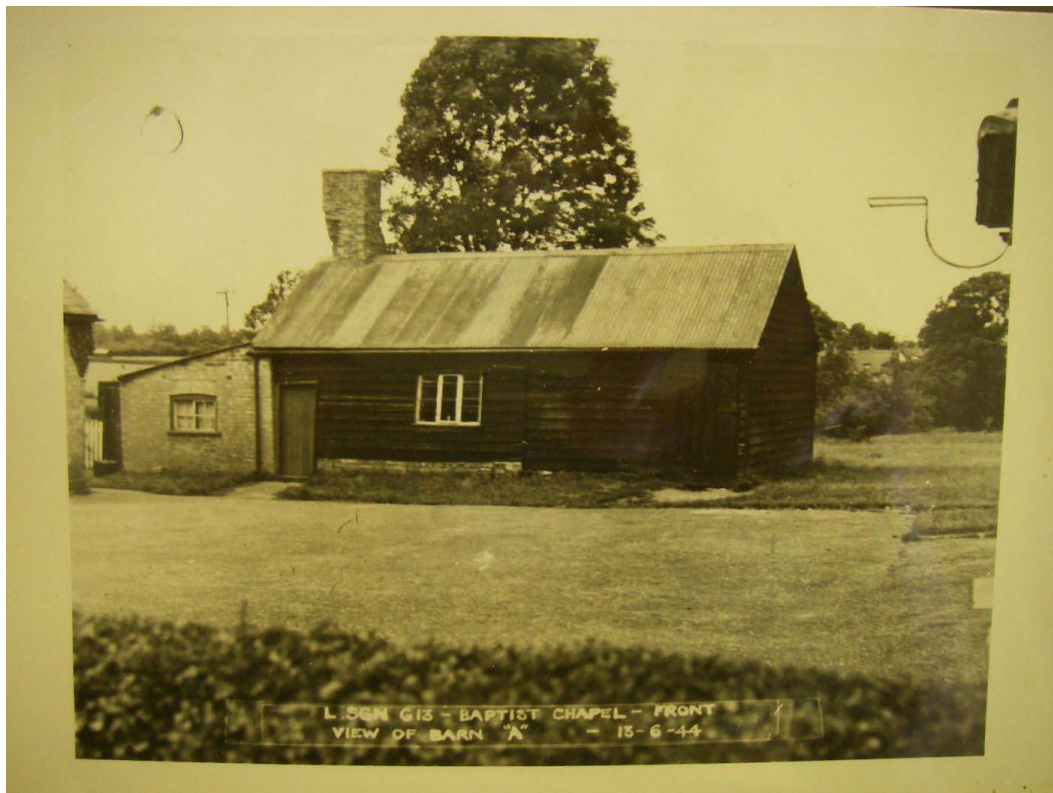
Figure 9: Caretaker's cottage and barn, south-facing side 1944

The building remains represent the westernmost part of the original caretaker’s cottage which was a much larger weatherboard structure with a higher pitched roof and substantial central chimney (Figure 9).

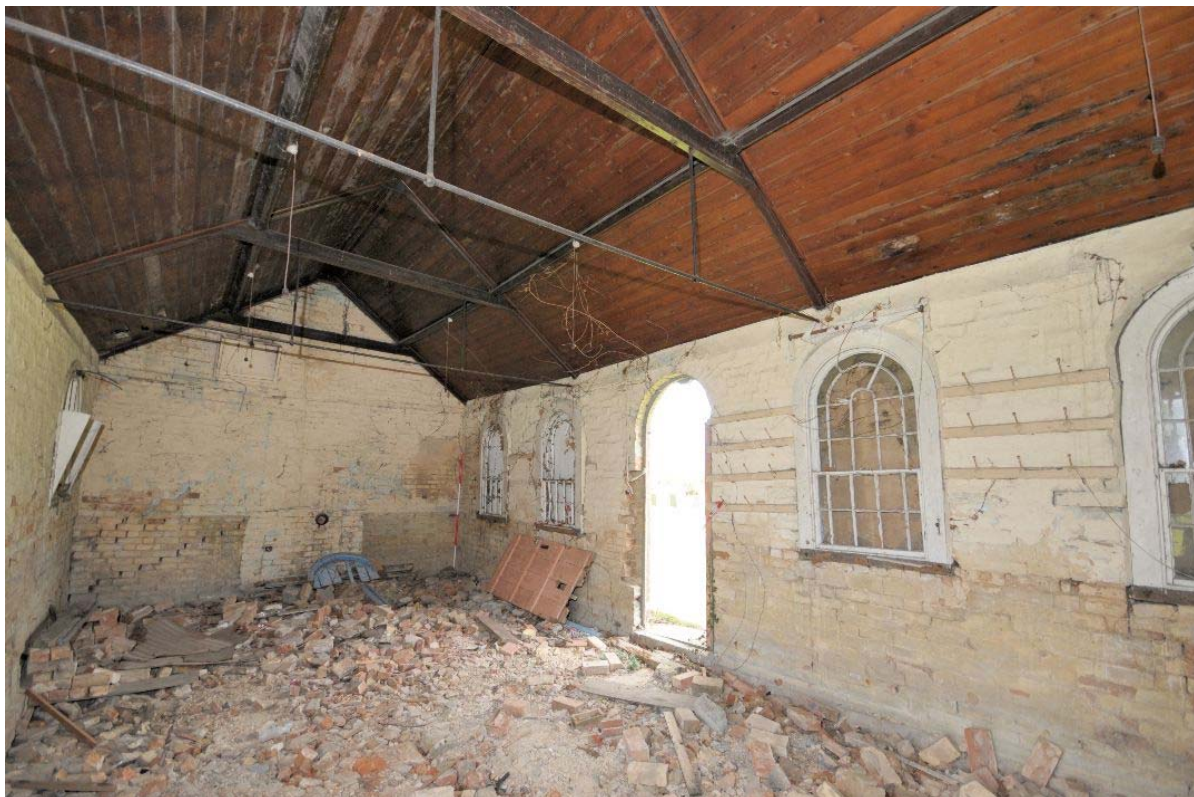
Figure 15: Internal view, looking NNE

A chimney existed at either end which served two respective internal fireplaces. These were of a simple recessed construction with vertical sides and a flat segmented arch made up of vertical bricks. The fireplaces were bricked up probably fairly recently with yellow bricks in an English bond (Figure 15).

The school room had a low pitched, open roof, which was slate-covered and had thin, internal, metal braces and cross struts (Figure 15). A small ventilation tower in the centre of the roof visible in the 1944 photographs (Figures 6 and 7) was subsequently removed.

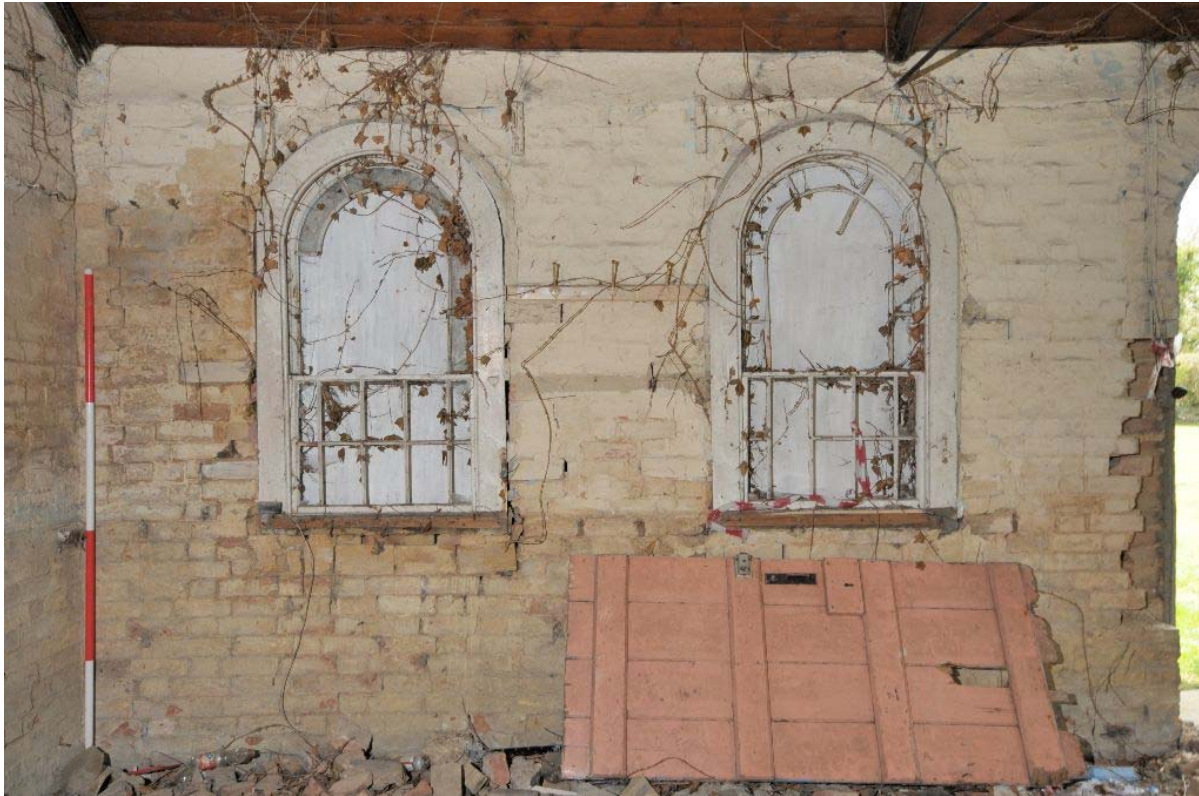
Figure 16: Windows in eastern side of building plus plank and batten door

The windows consisted of wooden sash frames with a lower, moveable 5 x 2 paned window section and a fixed upper 5 x 2 plus arched panes (Figure 16). The panes were rectangular and framed by narrower margin lights.

The precise date of the construction of the school room is unclear, but elements of the building fabric certainly confirm a date in the early 19th century. In particular, the narrow margin lights of the main east-facing windows were a common feature of sash windows in the early 19th century⁶. However, it is not possible to establish if the window frames, fixtures and fittings were original features or replacements in the same style.

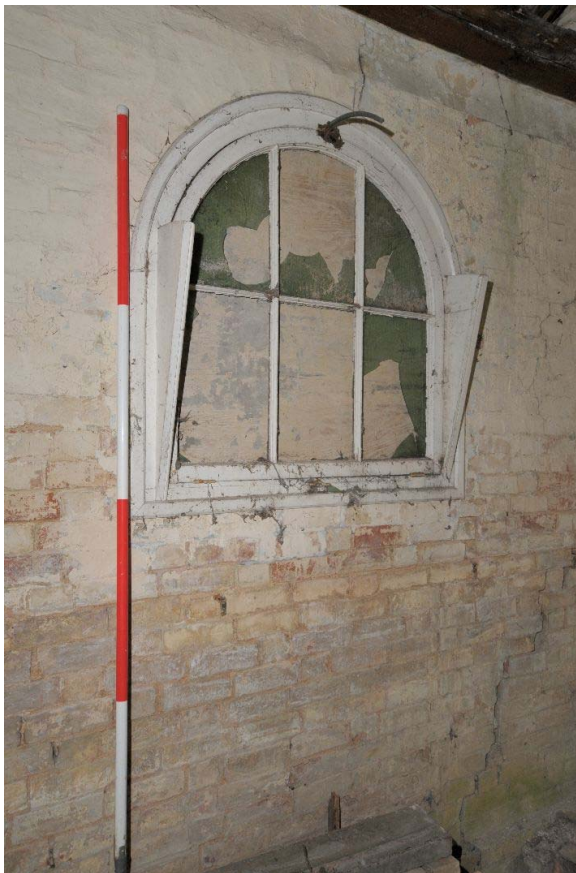
Figure 17: Hopper window in western side of building

All windows had been boarded up — the eastern windows with simple chipboard, the western ones with boards painted to represent the original windows behind them. One of the hopper windows was knocked out when a car hit the western wall of the school room, creating a big hole in the side of the building.

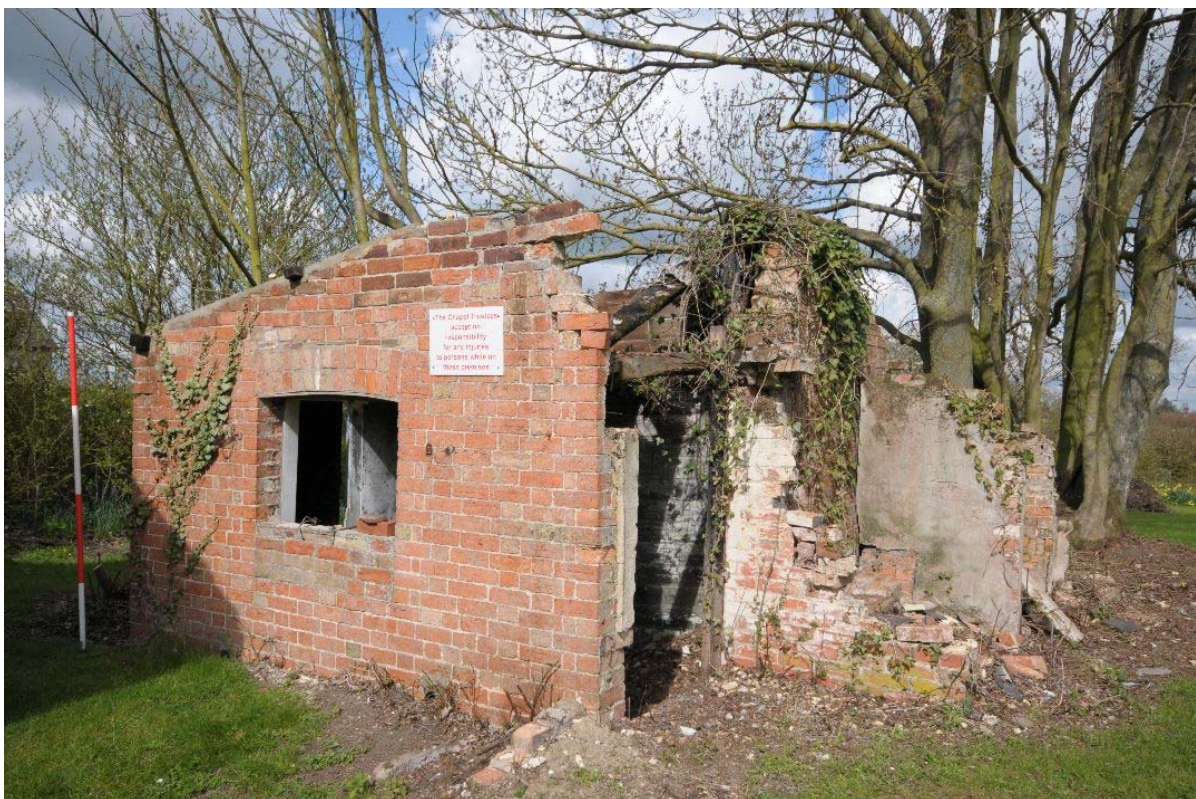
Figure 19: Caretaker's cottage southern side (compare with Figure 9)

A small outbuilding stood to the north-east of the school room. This is described as a “caretaker’s cottage” and “barn” on photographs of the 1940s, but had been largely demolished and the remains converted into a toilet block in the 20th century. It is not described in detail here as at the time of the recording works it was derelict and partly demolished. It had also suffered extensive fire damage.

The surviving building was a small red brick structure, built in Flemish bond with queen closers along the building’s edges and around its window and door openings (Figure 19). The northern and eastern side of the building were built of a weatherboard construction. The windows were rectangular with flat segmented arches made up of two rows of vertical bricks. A simple plank door in the western side of the building may represent an original doorway. A small fireplace also survived in one of the internal walls.

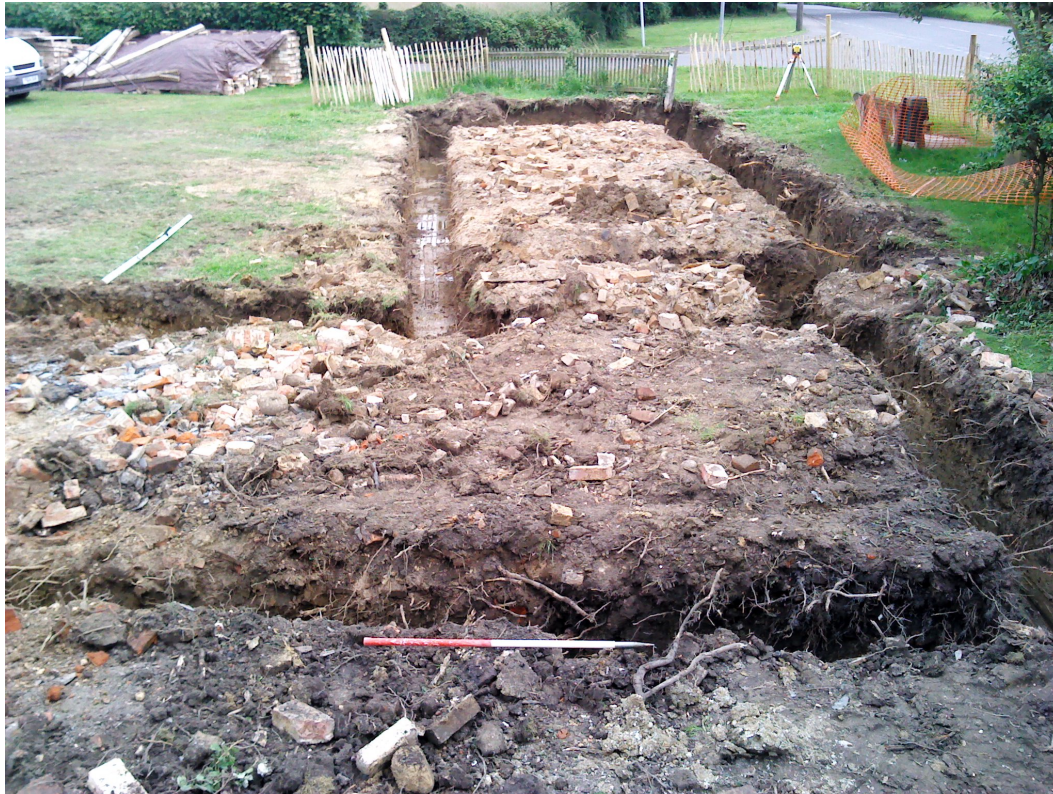
Figure 21: General view of excavated footings

Topsoil (2) comprised a dark brown grey clay silt 0.15–0.40m thick, which would suggest an old cultivation soil. In the central and eastern side of the DA this deposit overlay a 0.20–0.38m thick subsoil (5), comprising mid grey brown clay silt. Undisturbed glacially derived light blue-grey chalky clay (6) was reached throughout the footings trench at a depth of 0.32–0.70m below ground level (Figure 20: section 1).

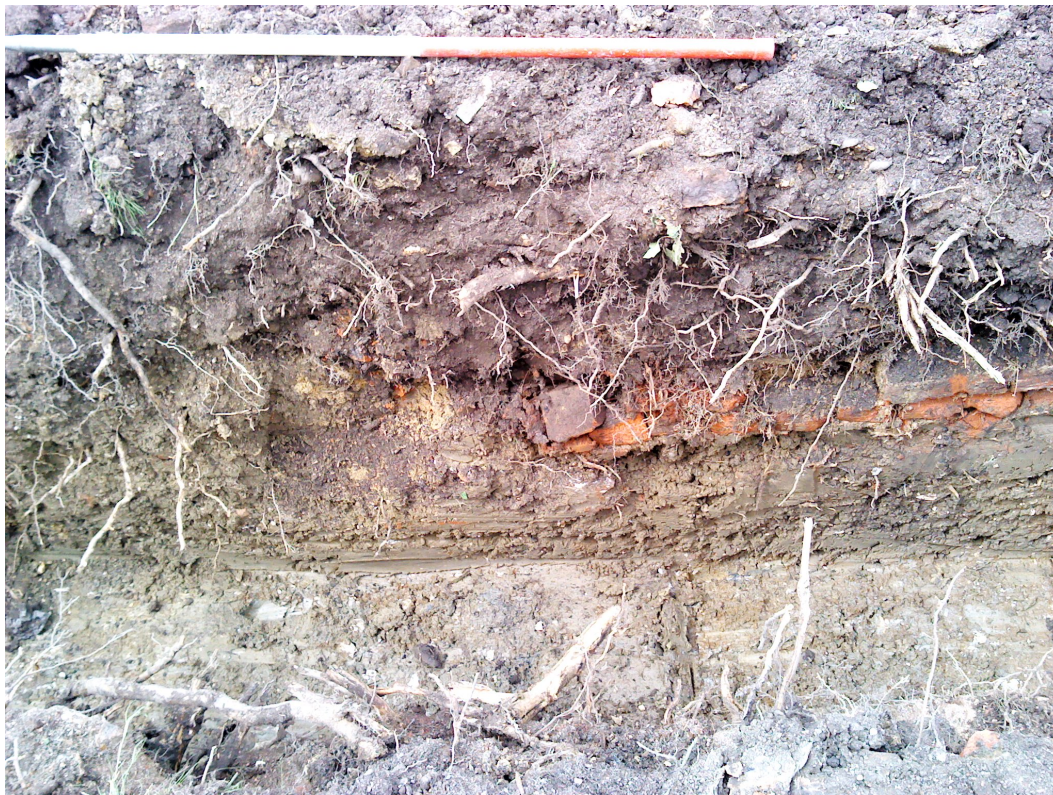
Figure 22: Brick structure [12] in section above ditch [7]

A linear band of bonded bricks (12) was exposed below the garden soil (1) at the northern limit of the DA (Figures 20 and 22). The two courses of NE-SW aligned red bricks were traced for *c.* 2m. The nature of this structure is unclear. It may define the footing of an earlier building, possibly associated with the caretaker's cottage or its predecessor.
